RESIDENTIAL PROPERTY INSPECTION REPORT

Chicago Bungalow

2847 N Kedzie Ave, Chicago, IL

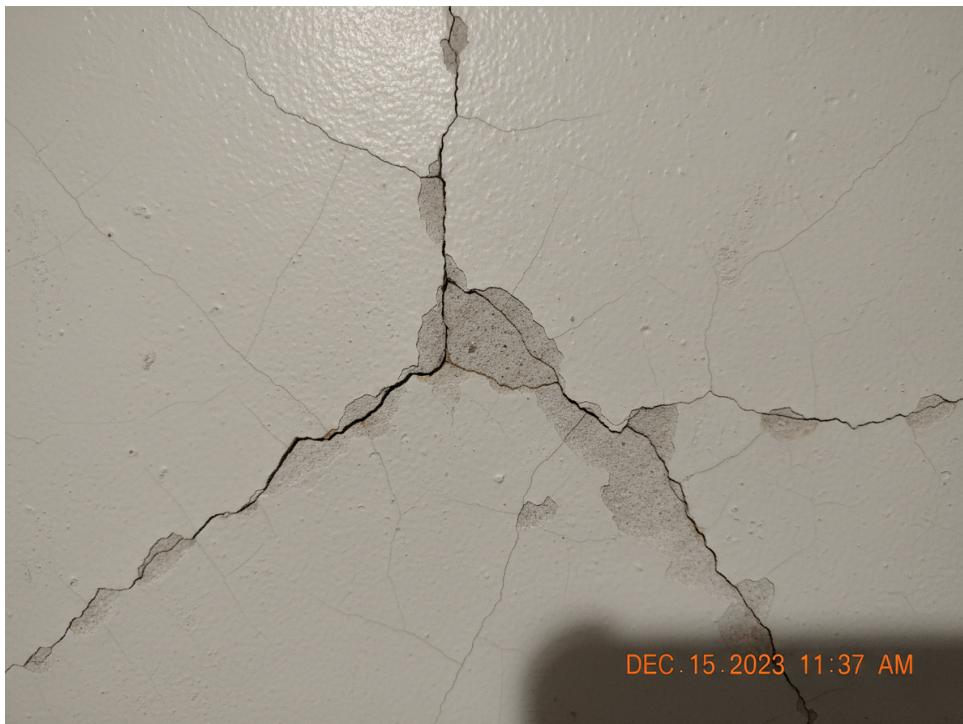
Photo: FOUNDATION & STRUCTURAL

Foundation walls appear structurally sound with no visible signs of settlement or movement. No remediation recommended.
