INWARD EQUIPMENT INTERCHANGE

CONTAINER NO :TEMU2861180

Tally Report

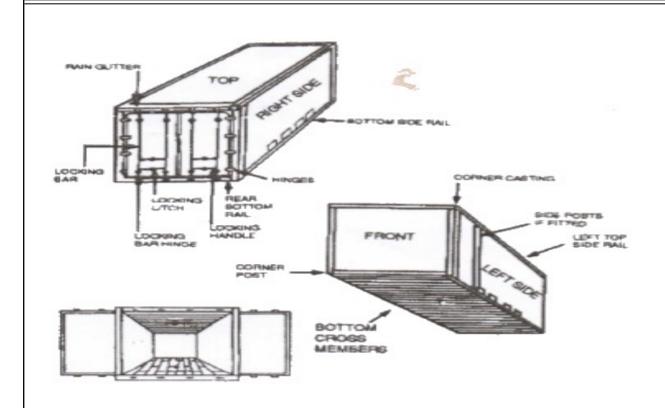
MINOR DENTS AND SCRATCHES SEEN

Repair Code	Description of Damage/Repair Qty	Hours Labour Cost\$	Material Cost Total Cost
BSRF ST/1	Straighten Bottom Side Rail Flange upto first 15 cm	0.15	96
BSRF ST/1	Straighten Bottom Side Rail Flange upto first 15 cm	0.15	96
BSRF ST/1	Straighten Bottom Side Rail Flange upto first 15 cm	0.15	96
