## **HMCS *Canada/Queen of Nassau* Archaeological and Structural Assessment HMCS *Canada* Expedition - 2025**

Matthew Lawrence, Brenda Altmeier, Tane Casserley; NOAA/ONMS

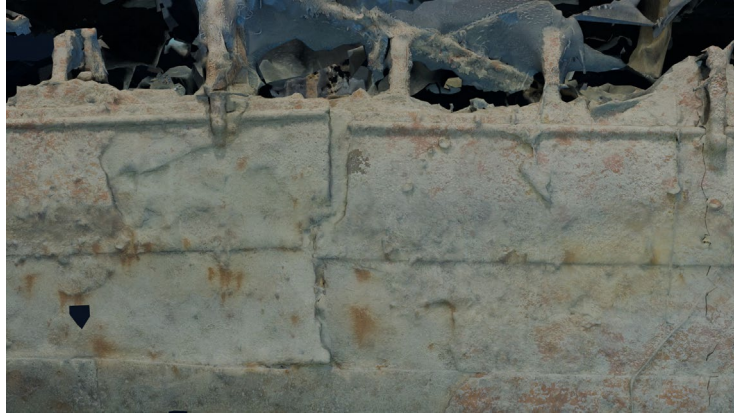
For the first time, the project's complete photogrammetric modeling of the steamship's hull provided observable evidence of the boiler explosion reported by the crew. Review of the 2025 expedition's 3D model by its creator Roger Lacasse, revealed fractures of the hull plating on both starboard and port sides (Figures 2-7). The fractures extended through one course of hull plating down from the gunwale. The fractures were outboard of the boiler room clearly indicated by the position of the smoke stack (Figure 8). The hull fractures may have been further exacerbated by the hull's vertical orientation as it sank. Investigators do not believe the fractures represent damage resulting from the unsupported weight of the bow as it currently rests. No obvious fresh corrosion was apparent in the 2025 imagery suggesting ongoing structural deformation in this area.

Figure 2. Port fracture depicted in a capture from the 3D model (Roger Lacasse, HMCS *Canada* Expedition).

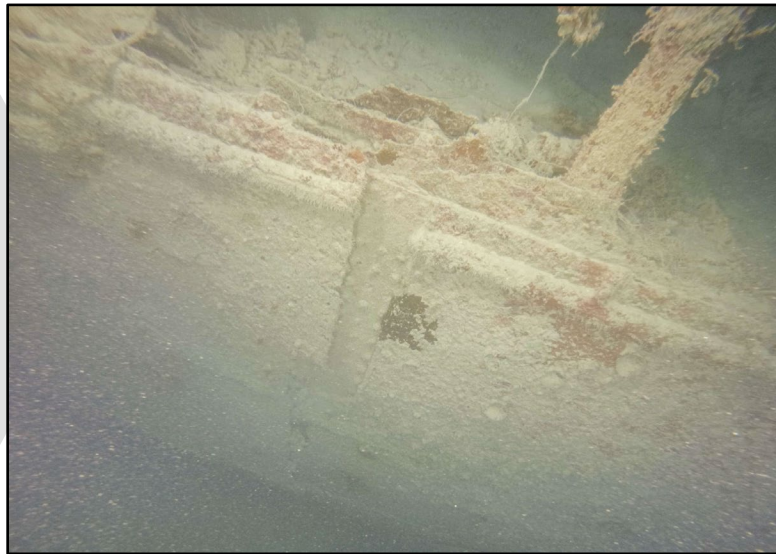
Figure 3. Photograph of the portside fracture (Roger Lacasse, HMCS *Canada* Expedition).

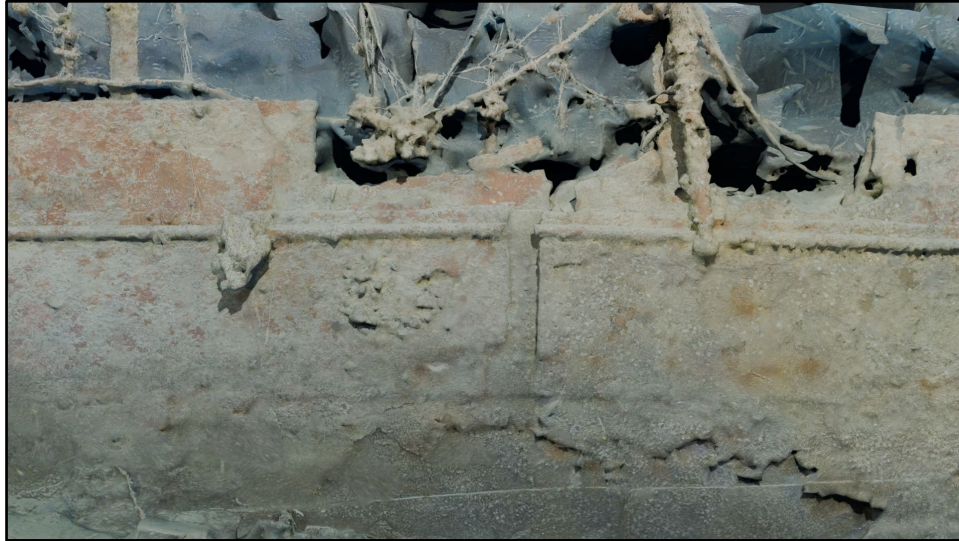
Figure 5. Starboardside fracture depicted in the 3D model (Roger Lacasse, HMCS *Canada* Expedition).

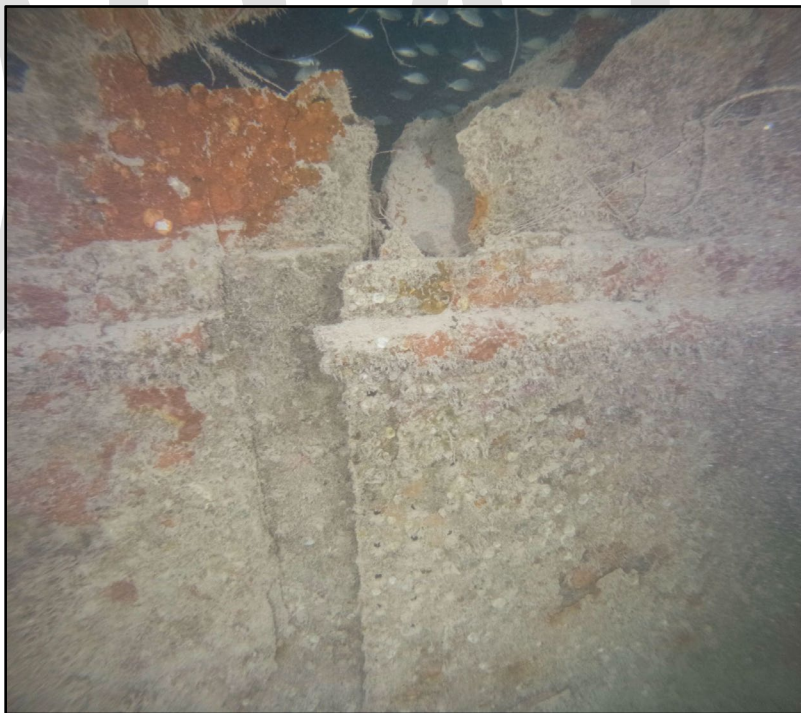
Figure 6. Starboard fracture photograph, note the empty rivet holes where the plating was pushed outward (Roger Lacasse, HMCS *Canada* Expedition).

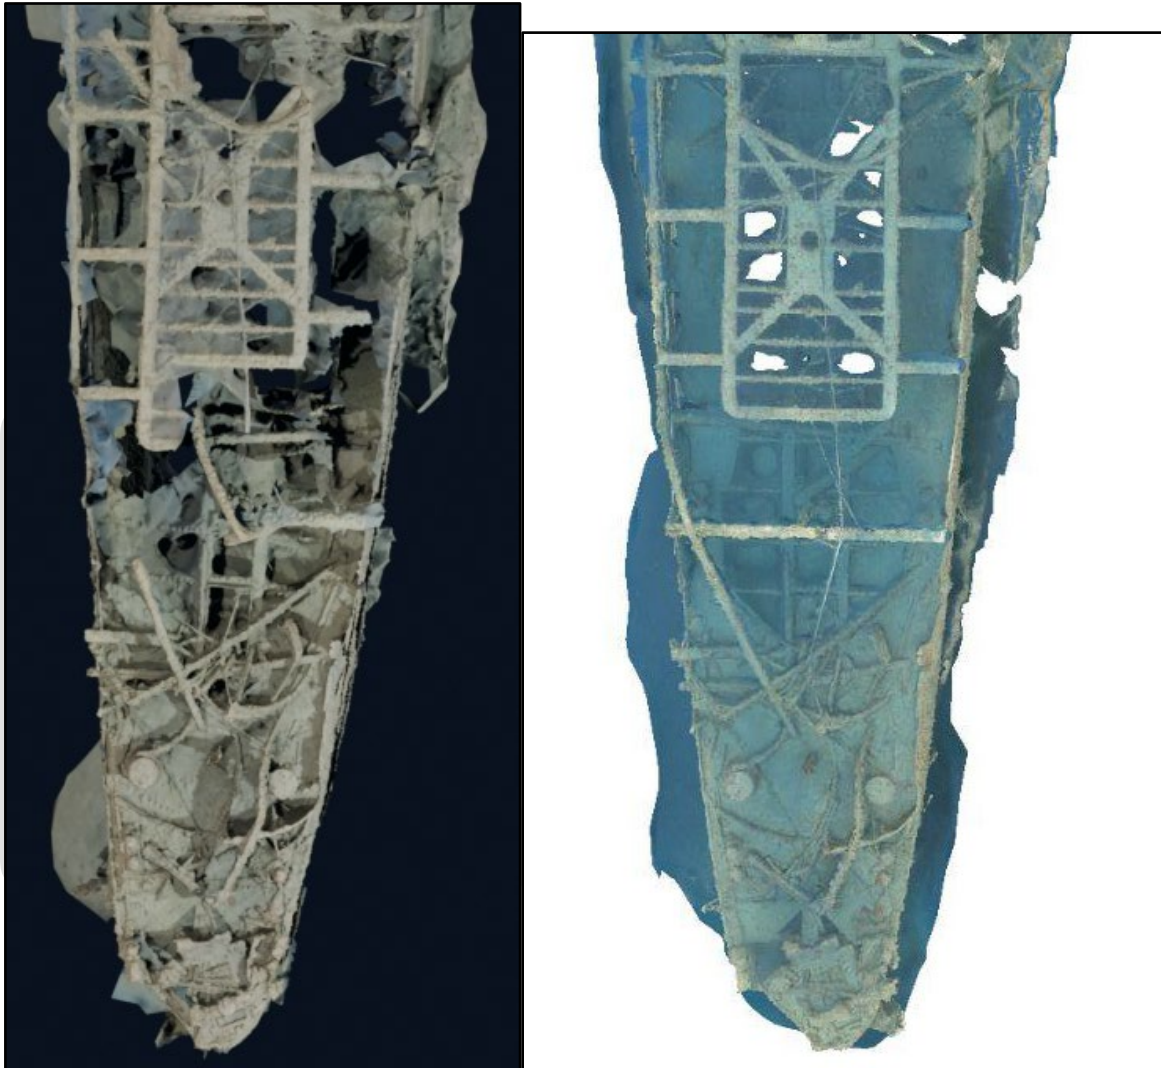
than the Zephyr/Blender workflow. The most obvious differences between the models are visible in the stern area. Zephyr/Blender did not accurately generate the weather deck covering structure, truncating or misrepresenting several of the steel beams (Figure 16).

Figure 16. Planview models created with differing software processing methodologies (Zephyr/Blender, left and Metashape, right) show the most distinct differences in the stern section.
