Vibration Analysis Report

Generated on: 2025-03-21 10:40:59

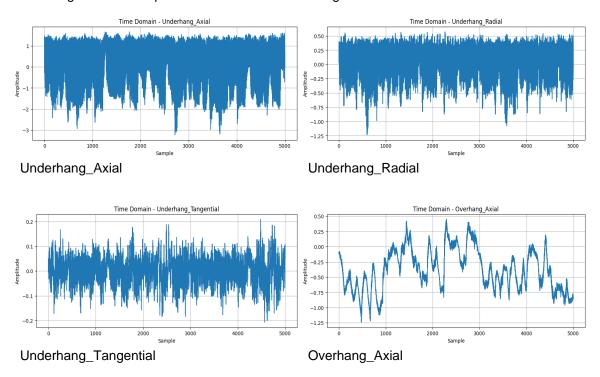
Time Domain Analysis

The machine is showing signs of a light fault in the horizontal-misalignment at the underhang location.
