PROPERTY INSPECTION REPORT FORM

251 N Bristol Ave, Los Angeles, CA 90049

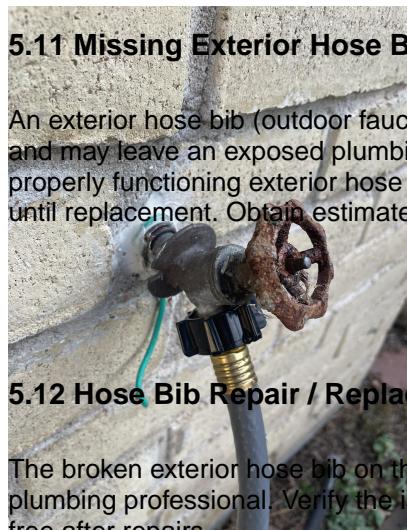
5.10 Hose Bib Handle Damaged or Missing

The handle for the exterior spigot was damaged or missing. Repairs or replacement as needed are recommended to be performed by a qualified individual to ensure proper operation.

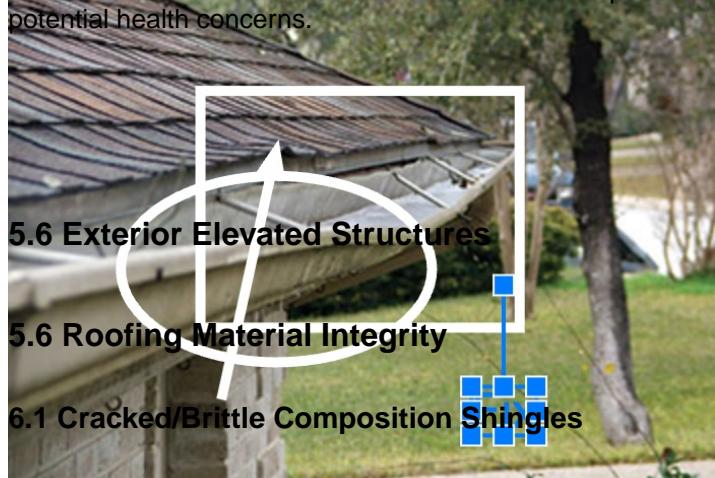
One or more composition roof shingles exhibited cracking and/or brittleness. Cracked and brittle shingles typically indicate that the roof is nearing the end of its useful life. It is recommended to have a qualified licensed roofing contractor further evaluate and perform necessary repairs.

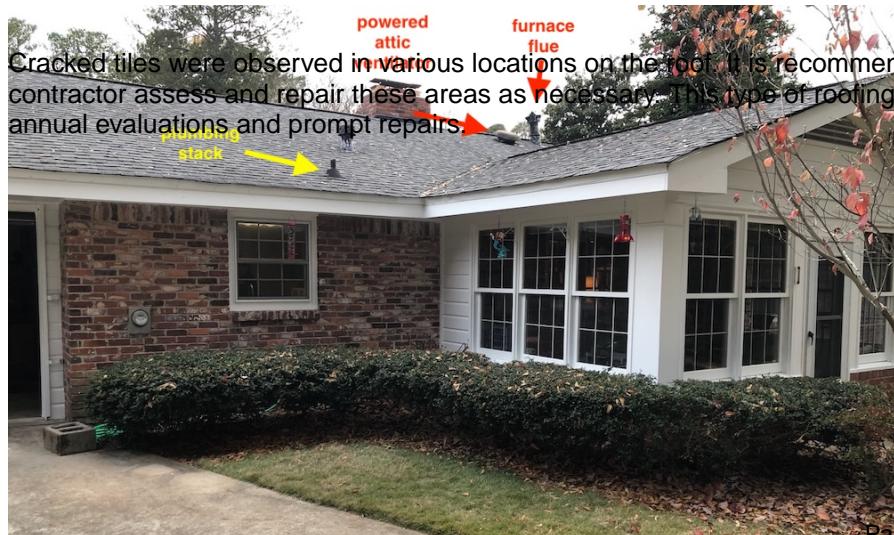
6.2 Cracked Roof Tiles

Cracked tiles were observed in various locations on the roof. It is recommended that a qualified roofing contractor assess and repair these areas as necessary. This type of roofing system typically benefits from annual evaluations and prompt repairs.

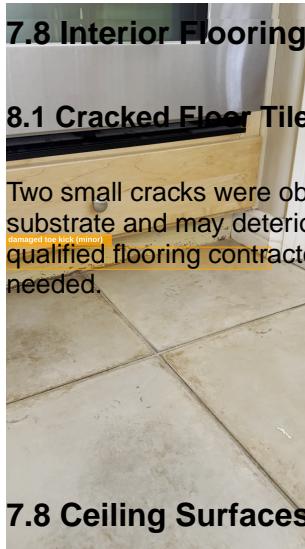
8.1 Cracked Floor Tile

Two small cracks were observed in the kitchen floor tile. Cracked tile can allow moisture to penetrate the substrate and may deteriorate further over time. Recommend repair or replacement of the affected tile(s) by a qualified flooring contractor and verify the integrity of the surrounding substrate and grout. Obtain estimates as needed.

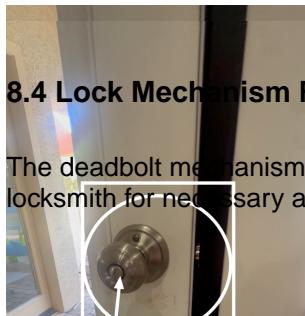
8.3 Damaged or Missing Door Hardware

The door handle is either damaged or missing. It is recommended that a qualified professional evaluate and repair or replace it as necessary.
