Report - Uzbekistan's Sardoba Dam Failure

Sardoba Reservoir Flood in Uzbekistan (May 1, 2020)

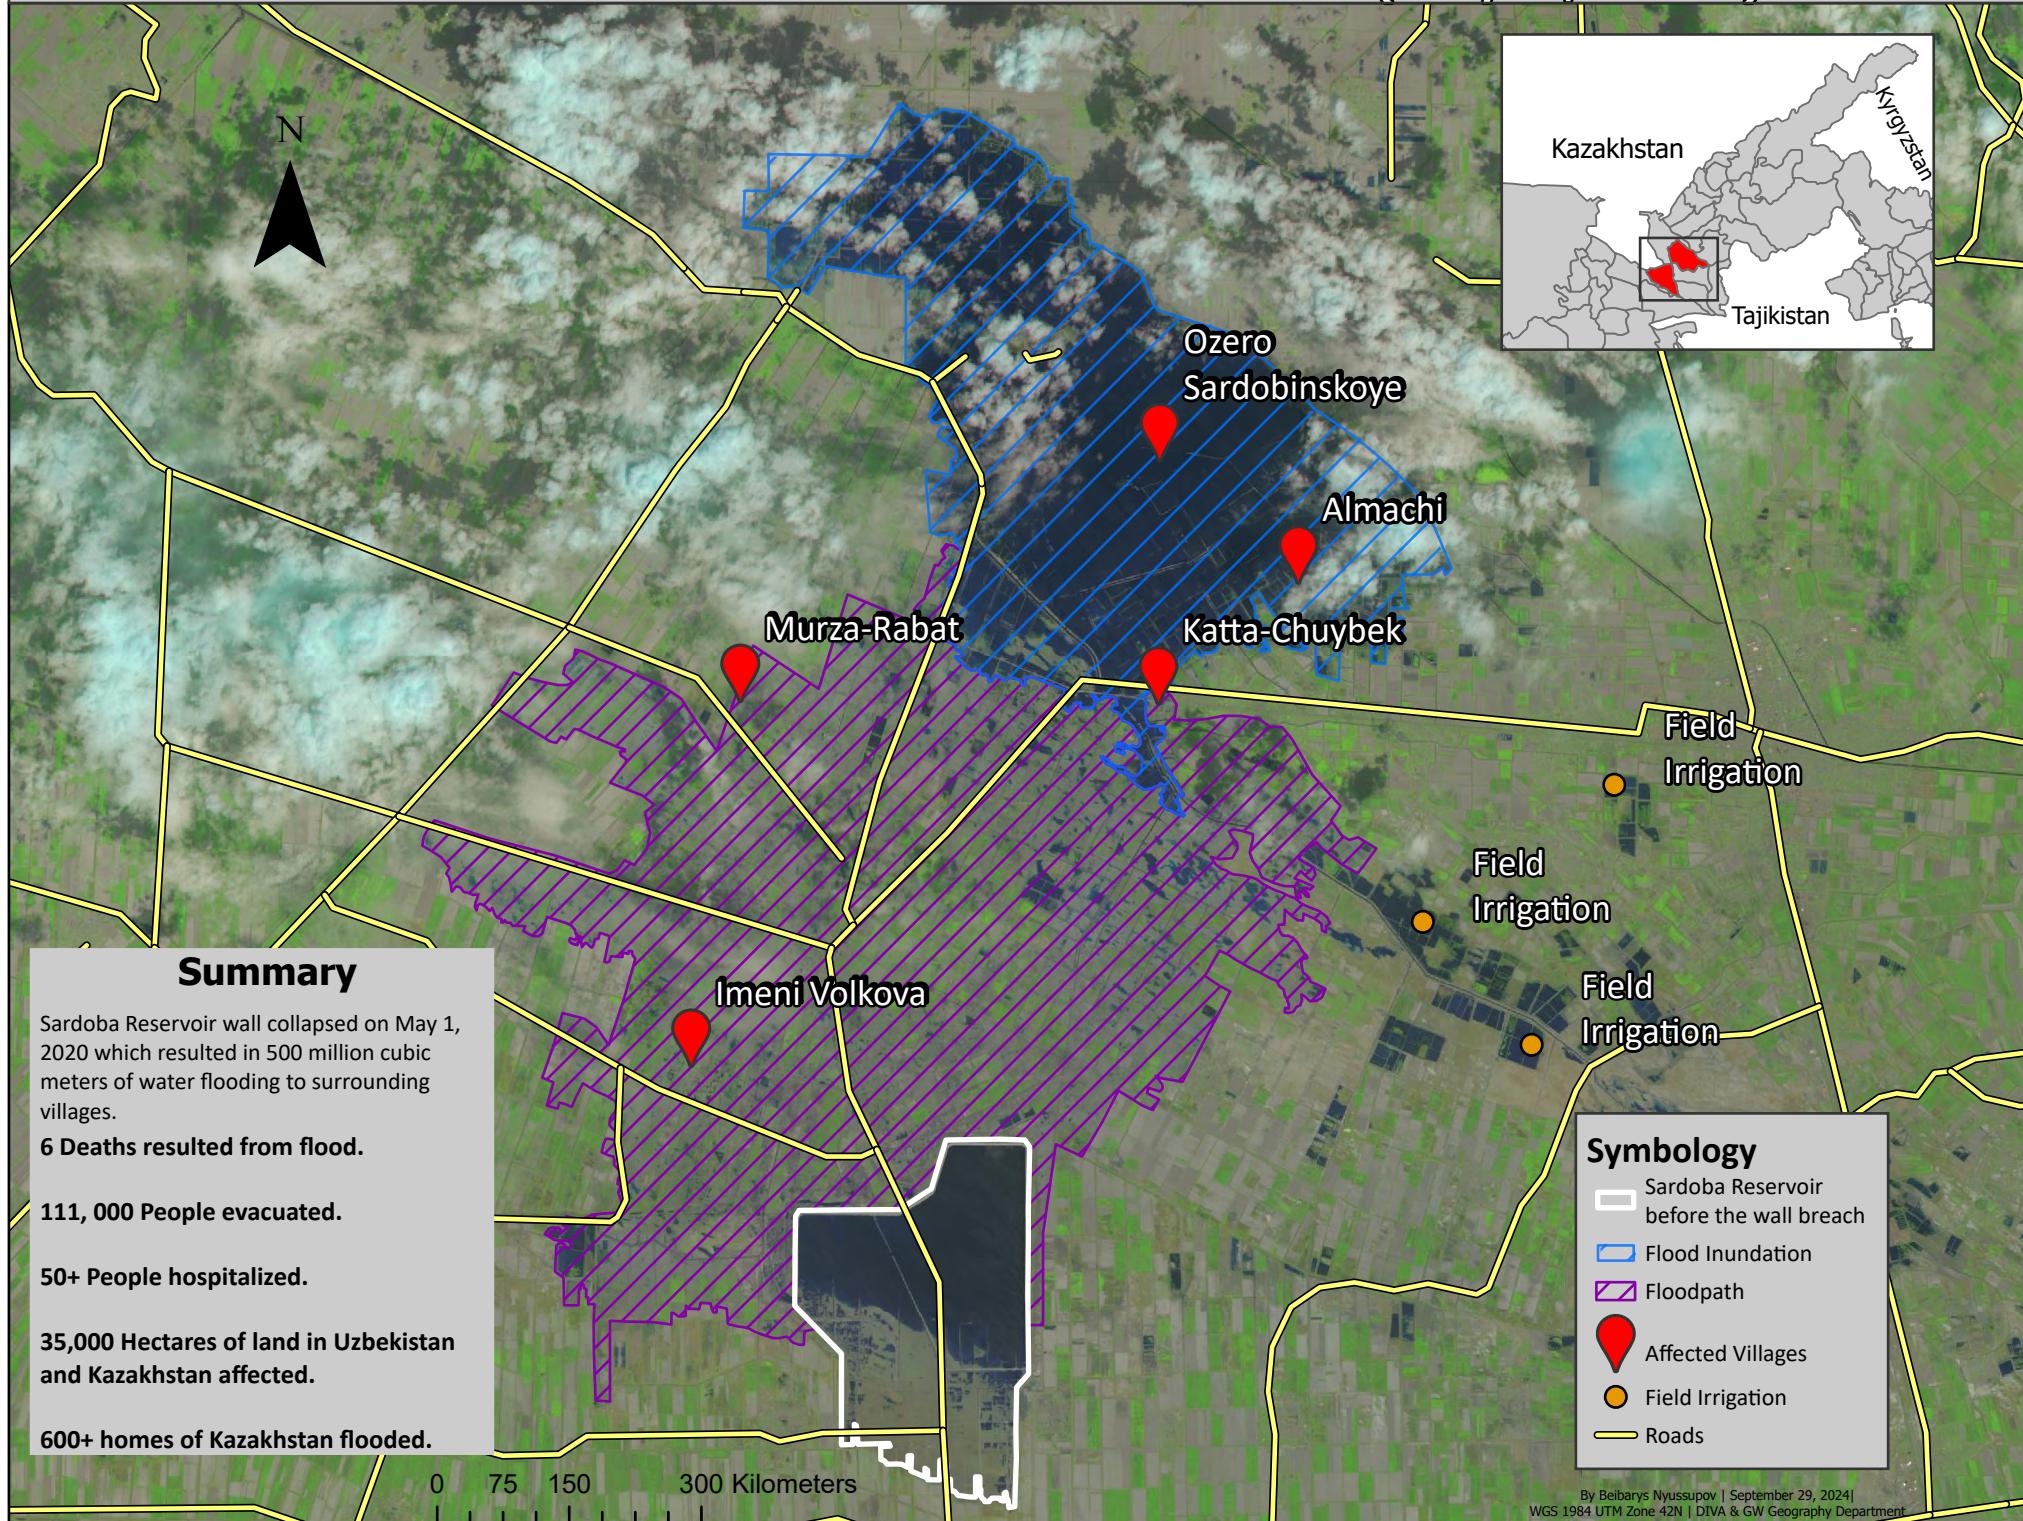
Looking at the map, the white highlighted area represents the Sardoba Reservoir before the wall breach and equals approximately ~56 square kilometers. Purple and blue hatched areas represent the Flood pathway and the pooled area. The floodpath area is around 342 square kilometers, and the inundated area is 191 square kilometers.

Significant places affected are represented by red tear symbols on the map. Four villages and one lake area were affected by the Sardoba dam failure. Flooded villages are: Almachi, Katta-Chuybek, Murza-Rabat, and Imeni-Volkova. The lake area is: Ozero Sardobinskoye. The map also shows the roads and Field irrigation points in the study area, represented by yellow and orange colors. The analysis was based on the satellite images provided by DIVA; the actual area of impact might deviate slightly from what is shown on the map, depending on the measurements used.
