Operations log for S-Pol for PRECIP 2022

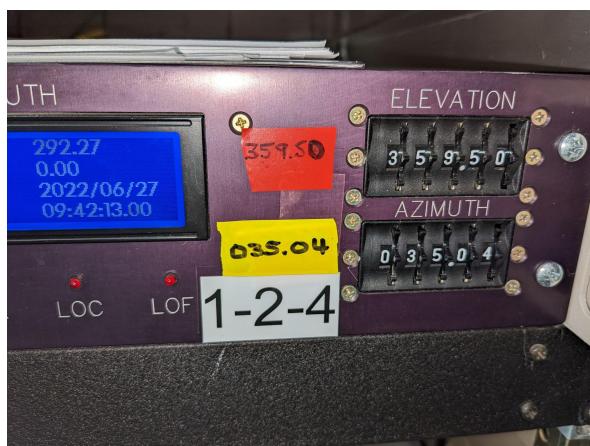
Before adjustment.

Then adjusted the azimuth setting by -0.08 deg to get azimuth in alignment with the sun.
