# Golf Cart Progress

CAN, Networking and Localization

NEWSLab NTU · August 2026

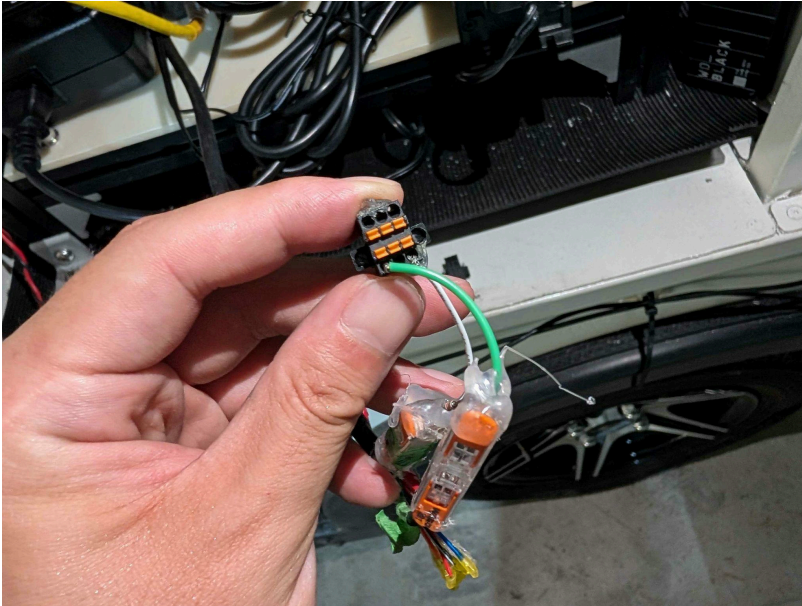
Broken CAN bus connector

The IMU's CAN bus connector had exposed resistors and connection points, which were damaged while tidying up the chassis wiring.

A manufacturer will redo the entire wiring, replacing it with plastic-coated, less easily damaged cable.

The wiring moves to an RS232 female connector, with a fabricated RS232 male connector on the host side.
