SAN FRANCISCO FIRE DEPARTMENT

**Safety Investigation Report
Line of Duty Deaths
133 Berkeley Way
June 2, 2011
Box 8155
Incident # 11050532**

February 2012

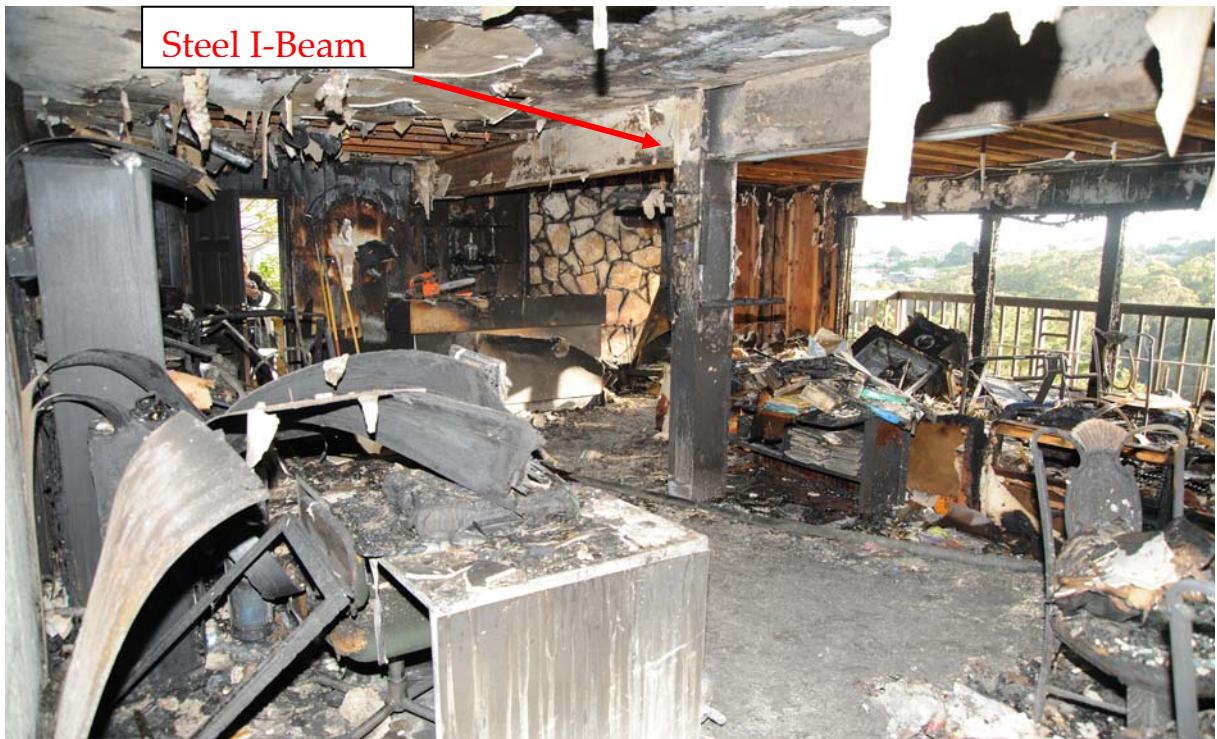
Sublevel 1 (Fire Room) with steel I beam.

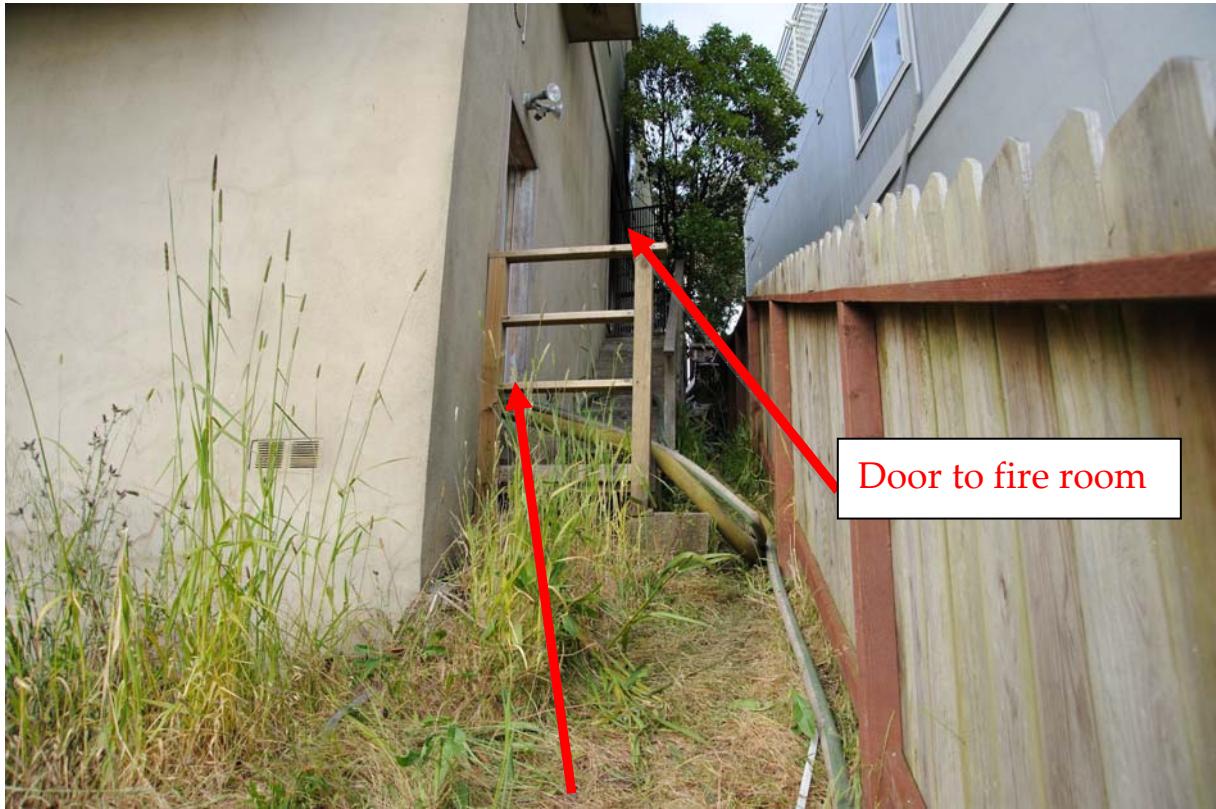
Sublevel 2 access door

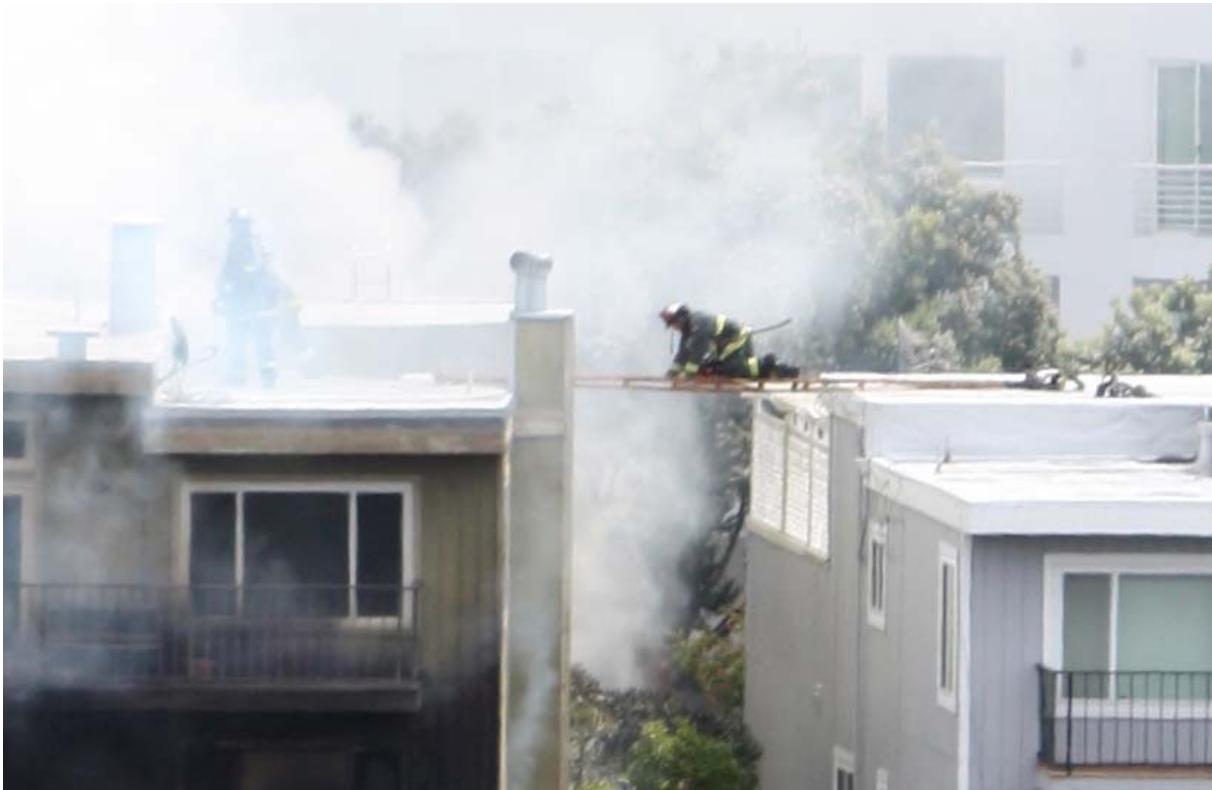
Truck 11 bridging between Bravo and the Fire Building. Bridging is an extremely dangerous maneuver and should only be used in an emergency/life saving situation.

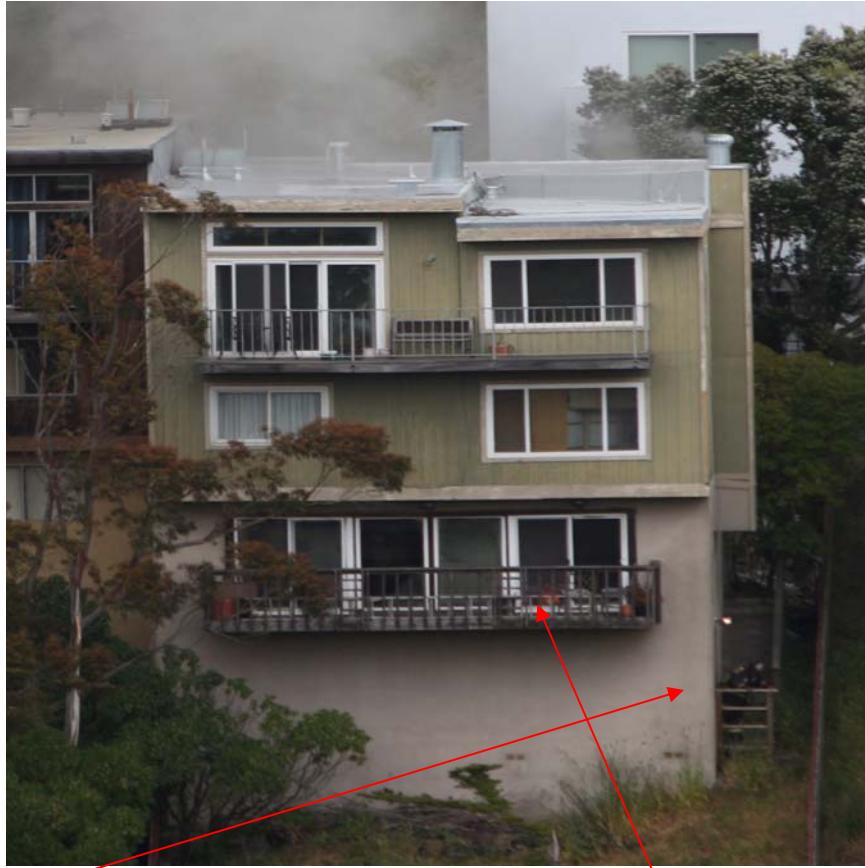
10:57:18 Battalion 9 forcing entry into Sublevel 2. Note fire in lower right hand window (6567)

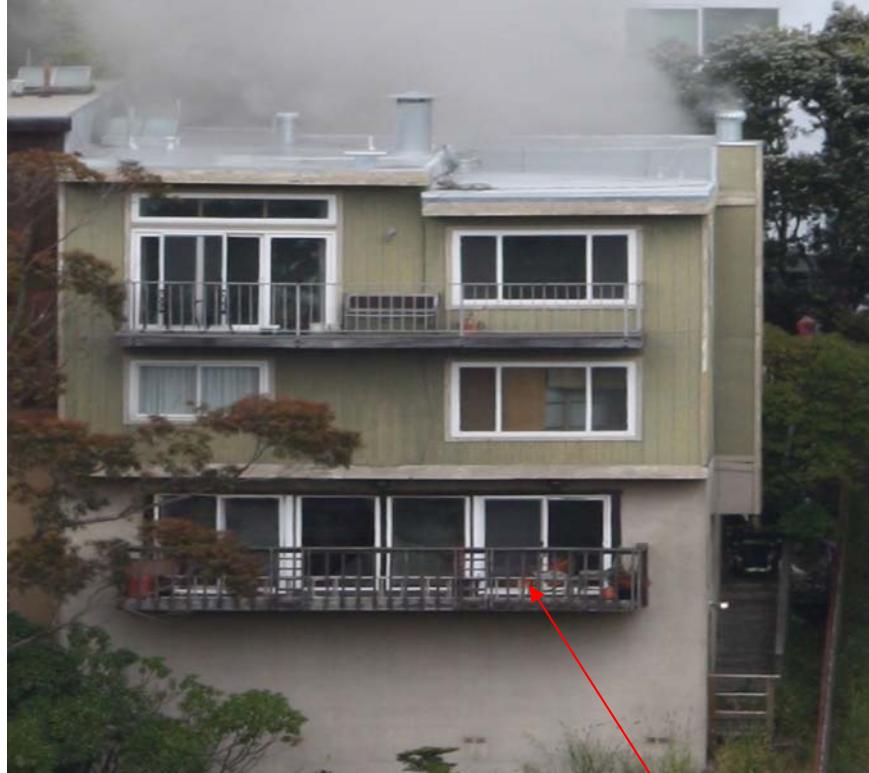
10:58:21 Battalion 9 is checking door to Sublevel 1. Note fire in window is growing (6572)

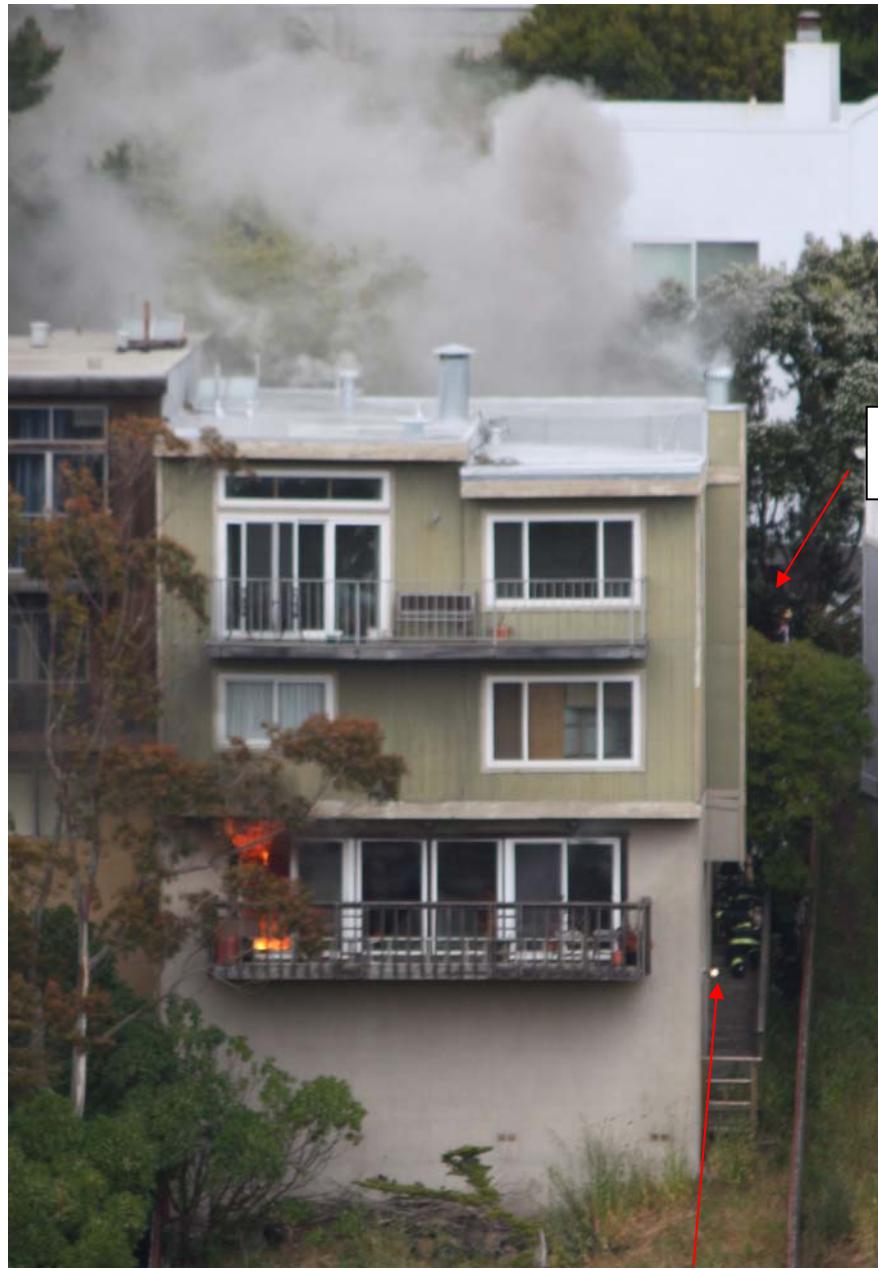
The investigation identified that the failing of the window on Sublevel 1, located near the seat of the fire and directly across the stairwell leading to the ground floor, led to the extreme fire behavior which ultimately caused the death of two Firefighters. This fire was in a stage of deprived oxygen when the window failed, causing a rapid extreme high heat event to occur. The extreme heat followed the natural flow path up the interior stairs where Victims 1 and 2 were located.

10:58:42 Window in the rear of Charlie Side fails. Battalion 9 and Engine 11 at door of Sublevel 1. Crews have not made entry into Sublevel 1. Note smoke conditions change in the front of the building and IC has moved due to smoke obscuring the Command Post. (6574)

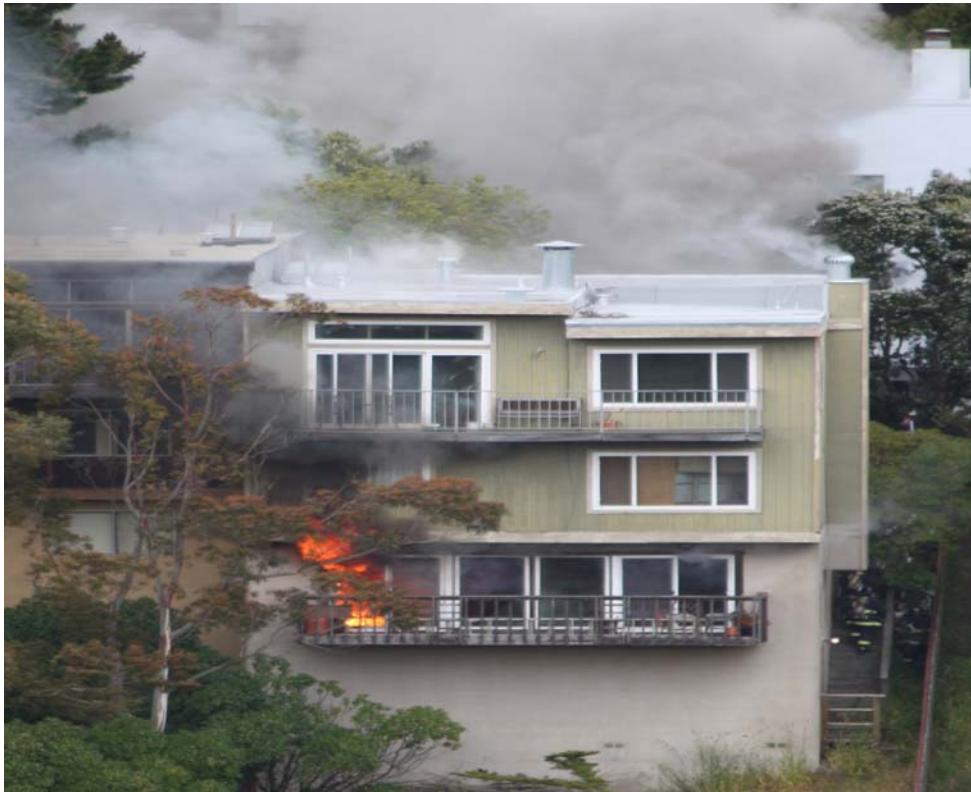
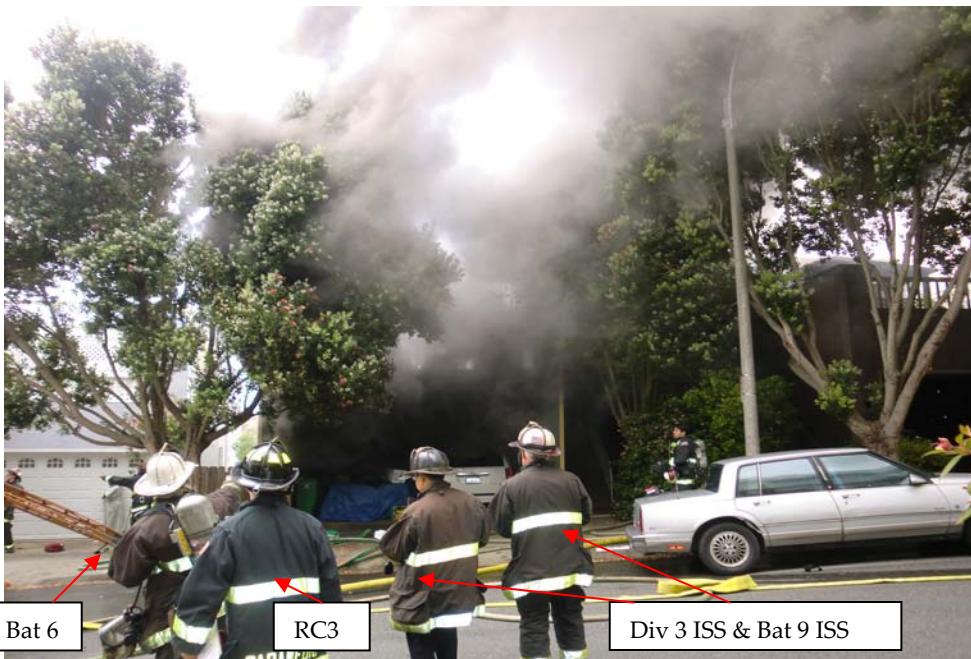
These two pictures were taken one second apart. Top picture shows rapid fire spread in Charlie/Delta corner. Note Engine 11 and Battalion 9 have not yet breached door. Bottom picture shows Battalion 6 conferring with the Incident Commander (not in frame). At this time, Engine 24 and Rescue 1 Team A are inside garage attempting to gain entry through access door from garage. During the post incident interviews, both crews reported that they confronted extreme heat conditions (See Rescue Squad 1 Findings).

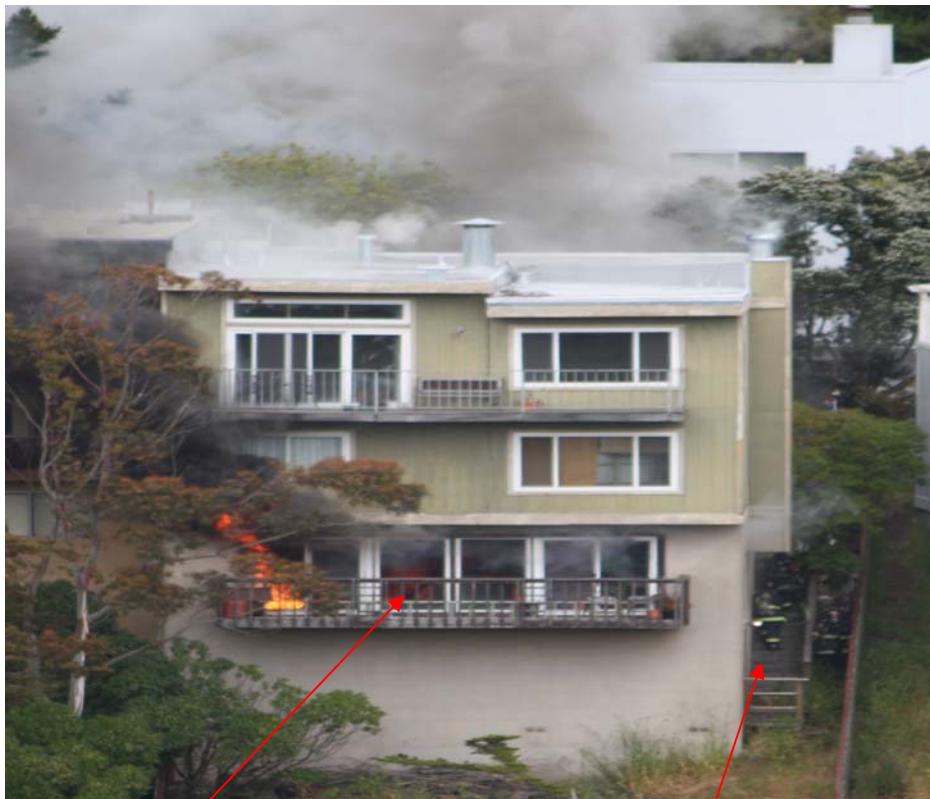
10:58:54 Note fire growth on Sublevel 1. Crews have not yet made entry. (6576)

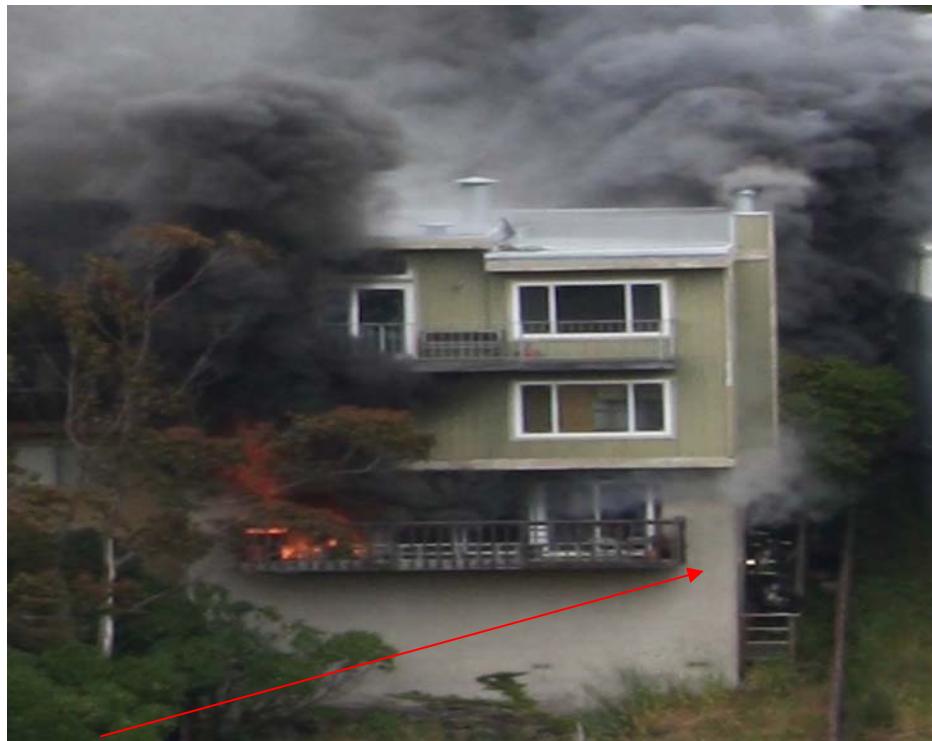
10:59:23 **Engine 11** and **Battalion 9** make entry to Sublevel 1. Battalion 9 requests additional hoseline to assist. Note the smoke change on the Bravo side along with the change in the front. (6577)

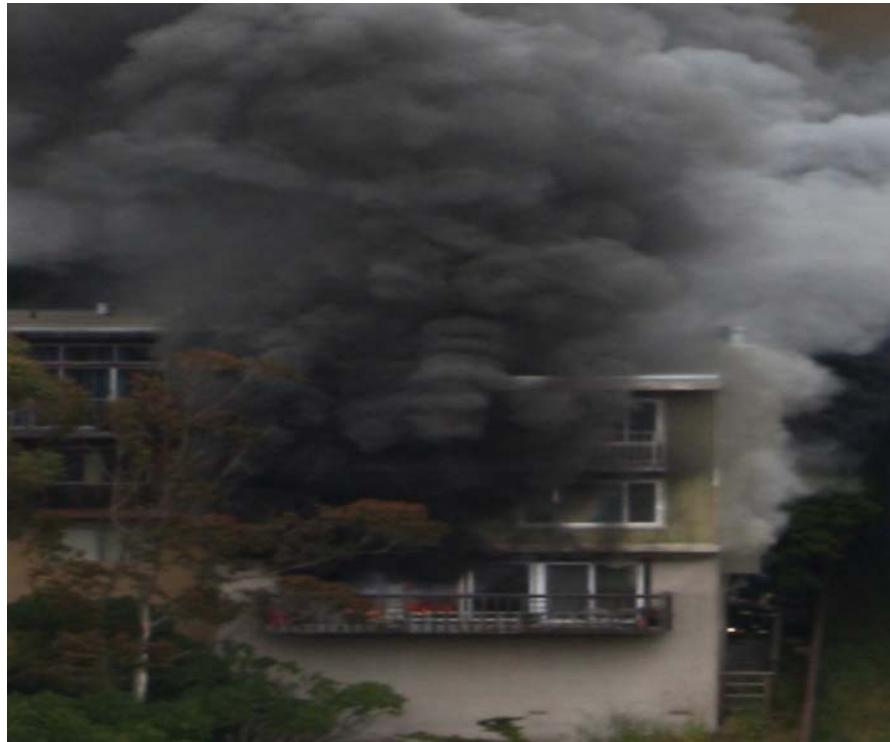
10:59:54 Note change of smoke color coming front Sublevel 1 door (Bravo Side) due to water application (6580)

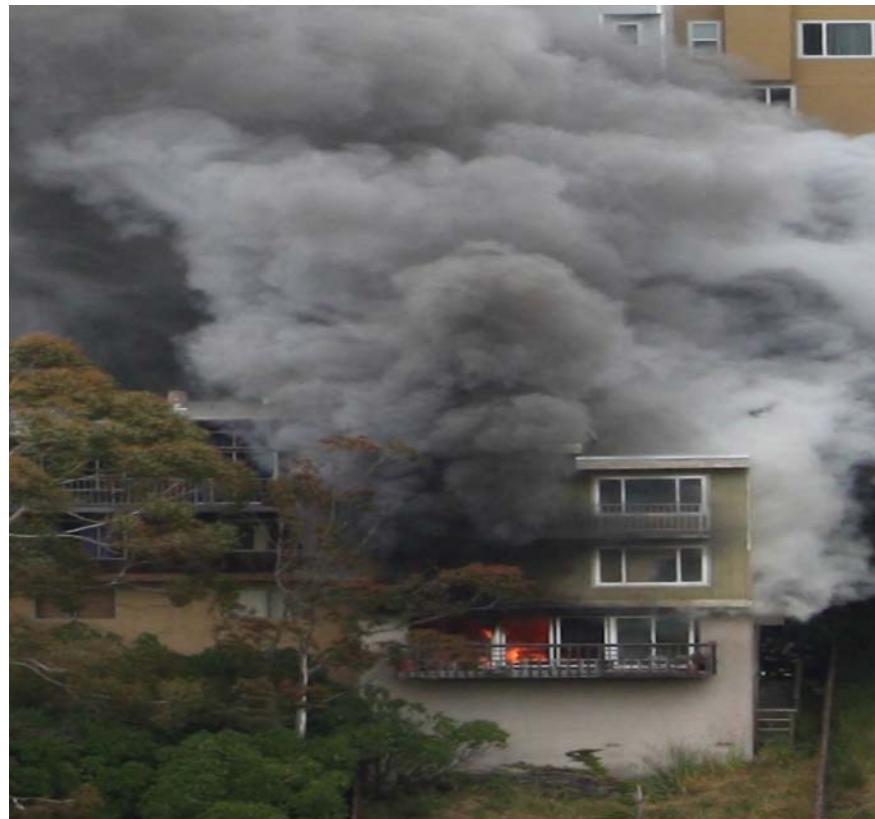
10:59:58 Note second window from the left has failed. Smoke conditions continue to change, due to application of water. (6582)

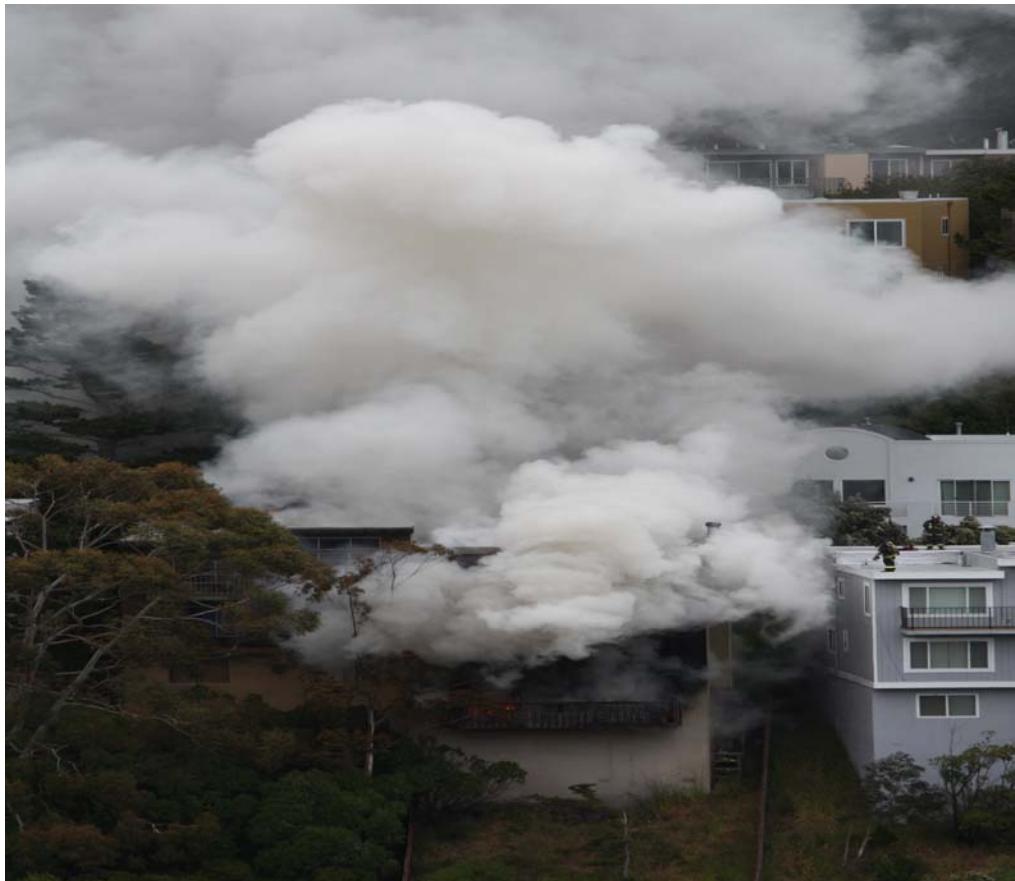
11:02:21 Note bulk of fire has been knocked down (6596)

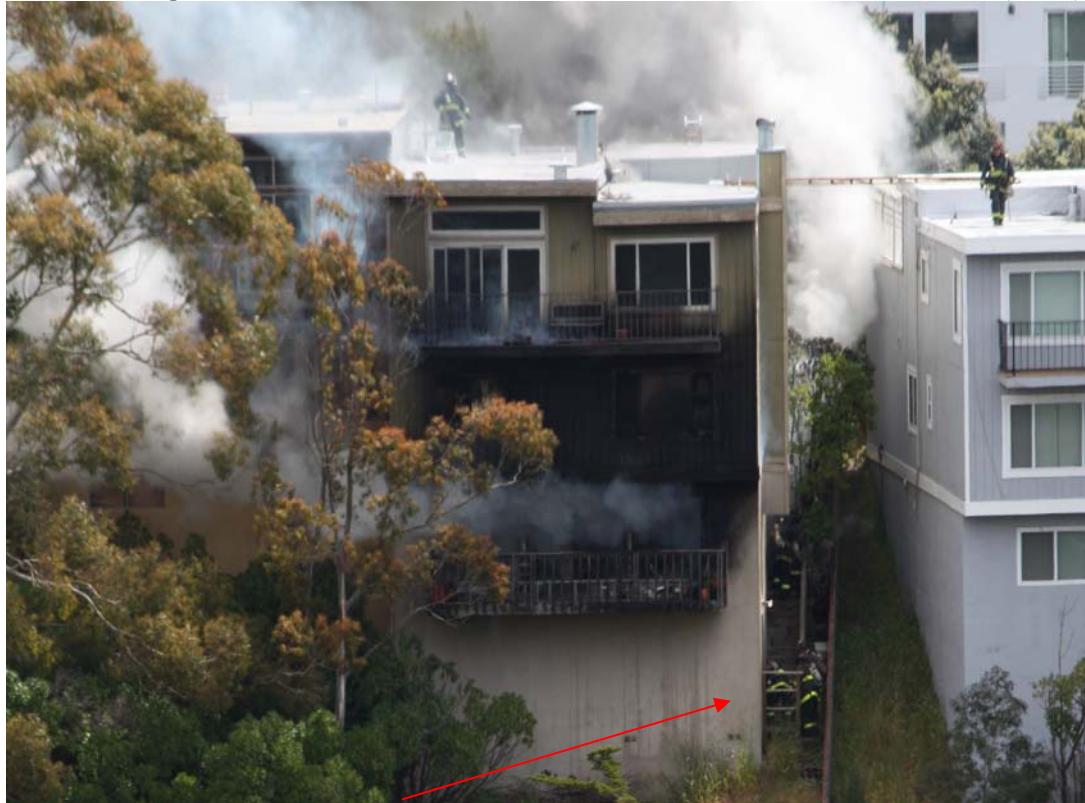
11:04:08 Engine 32 on hill and Rescue 1 Team A on stairs to fire room (6602)

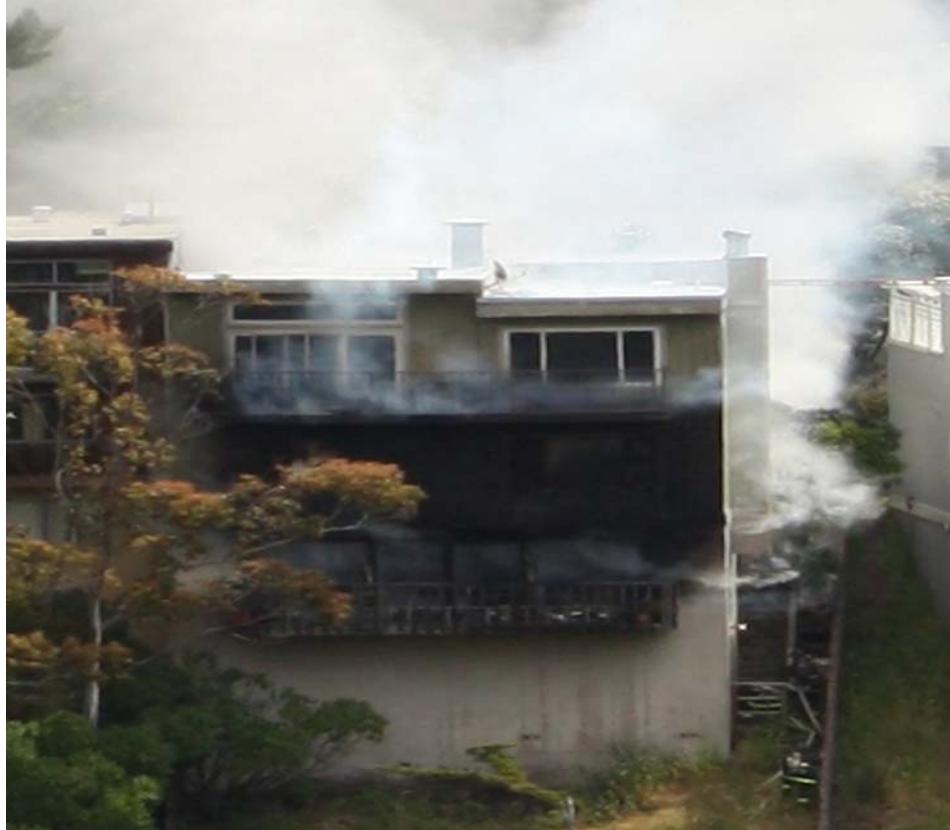
11:04:51 Battalion 9 reported in this time frame that fire was knocked down (6605)

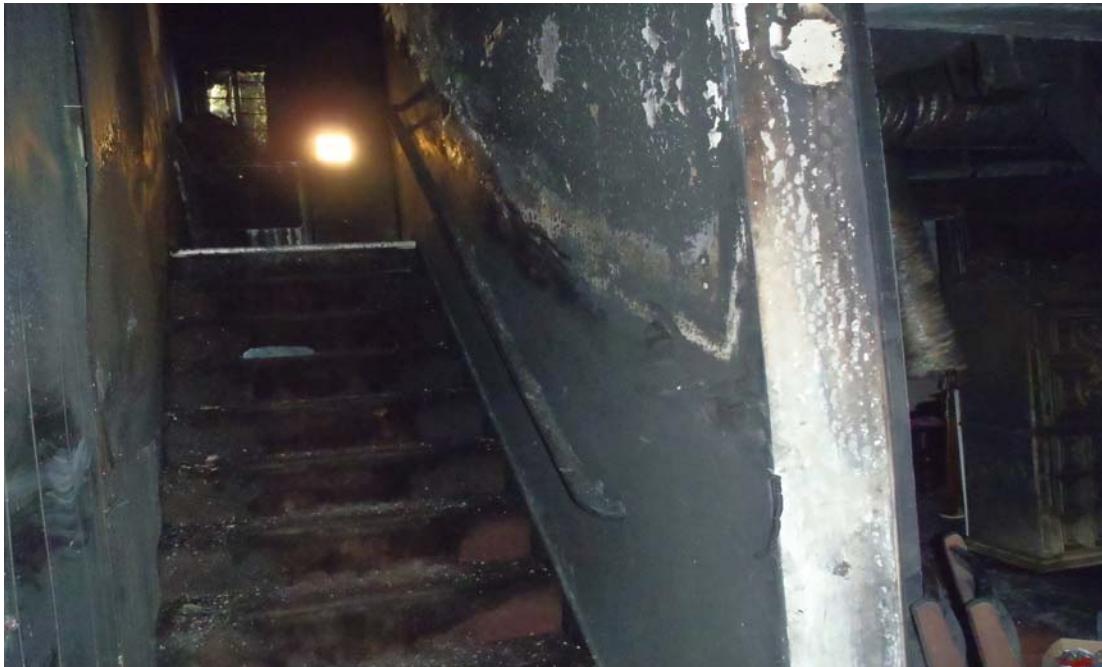
Looking up the stairs from the fire room, note the heat damage on the walls

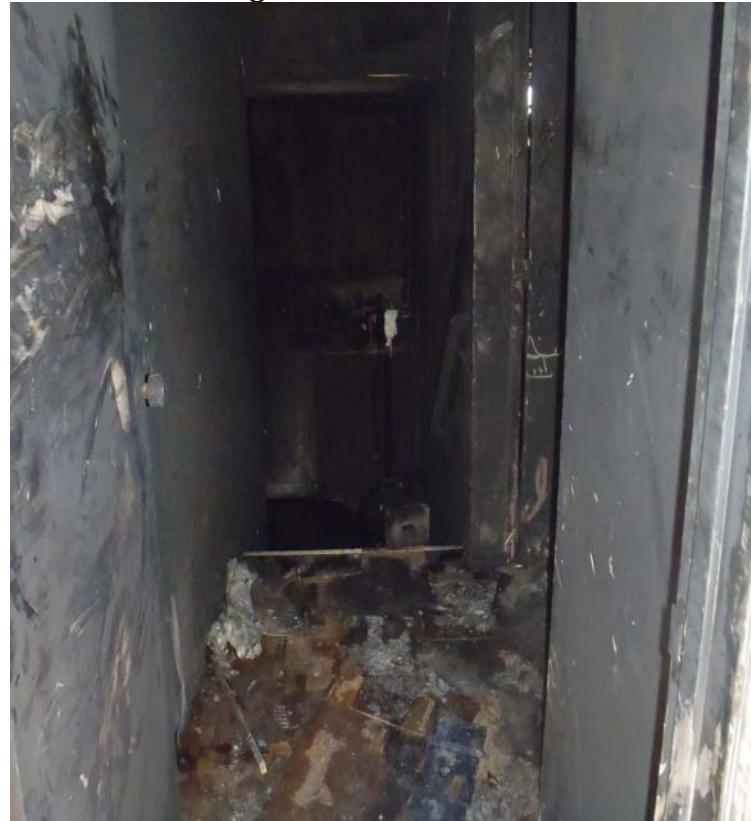
Color of the smoke being generated, indicates a hot and high carbon based fire

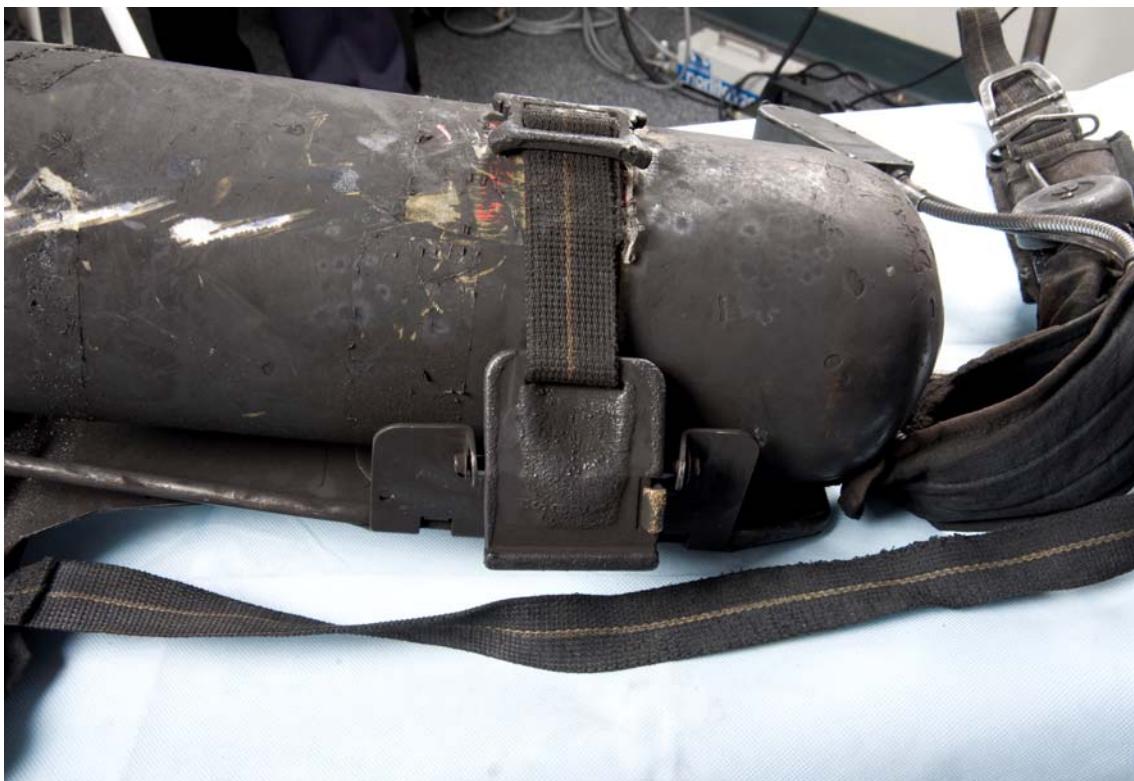
Note amount of carbon material that has been baked onto the SCBA of Victim 1

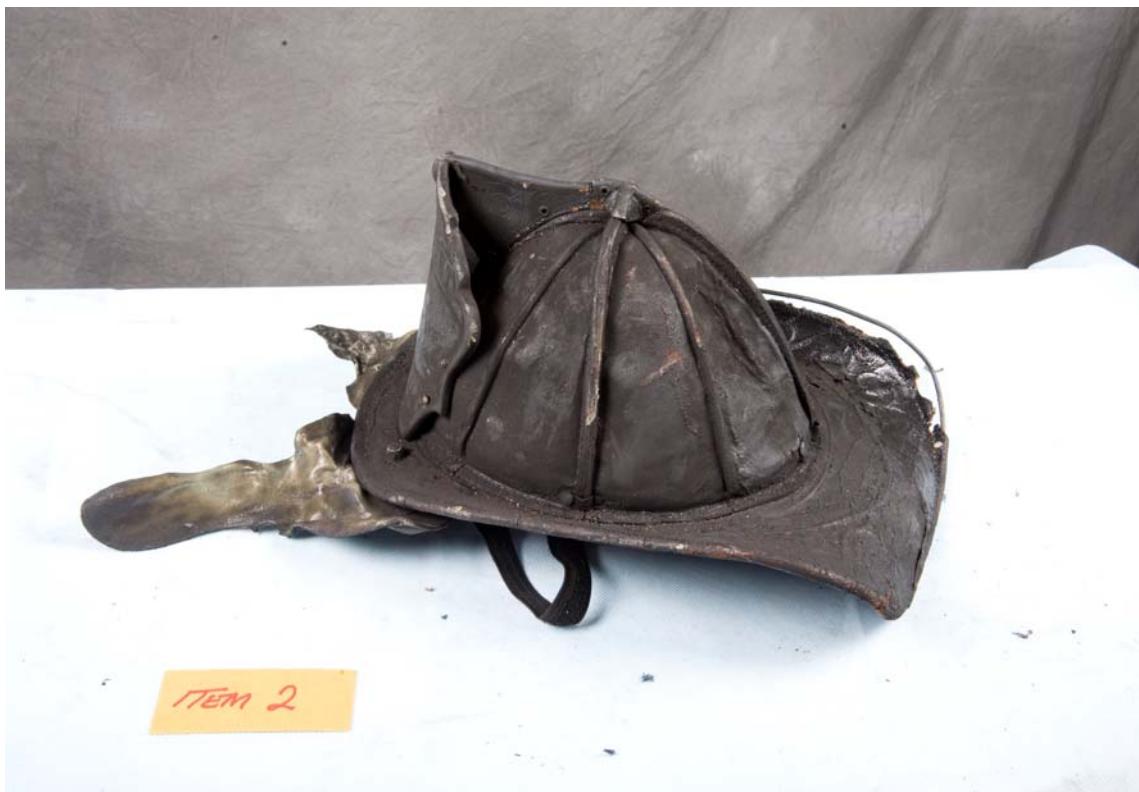
Note heat damage to helmet and the carbon material on the helmet

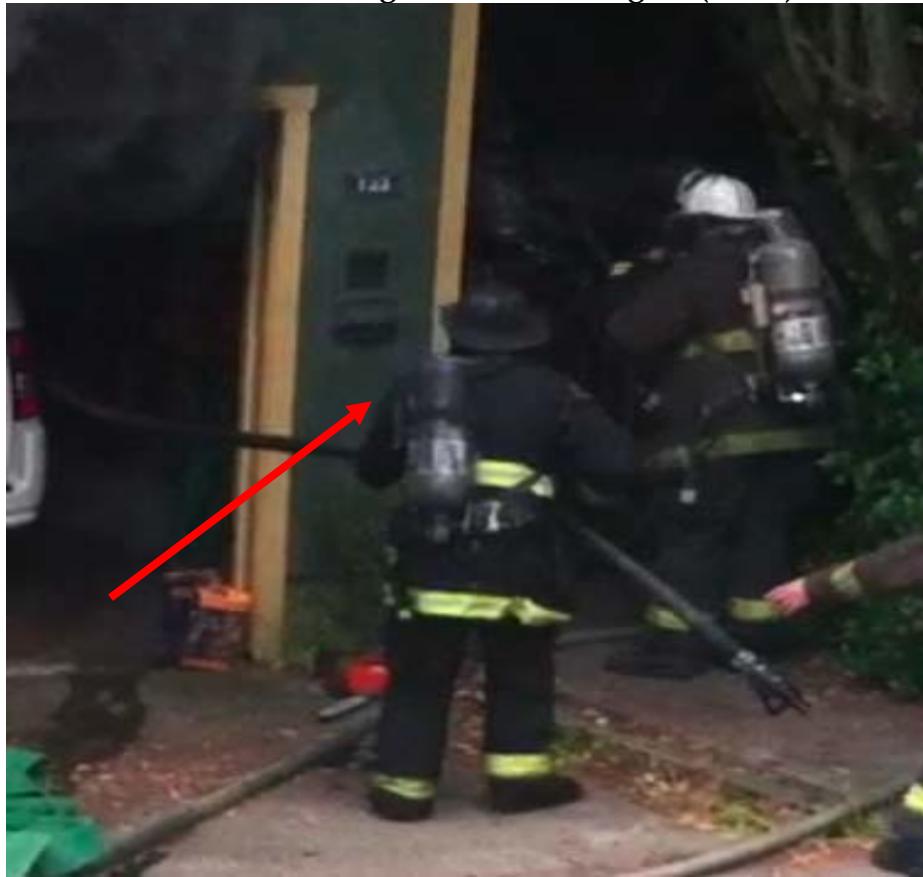
Note Engine 24 Officer's gear (sooted after attempting to make entry through the garage)

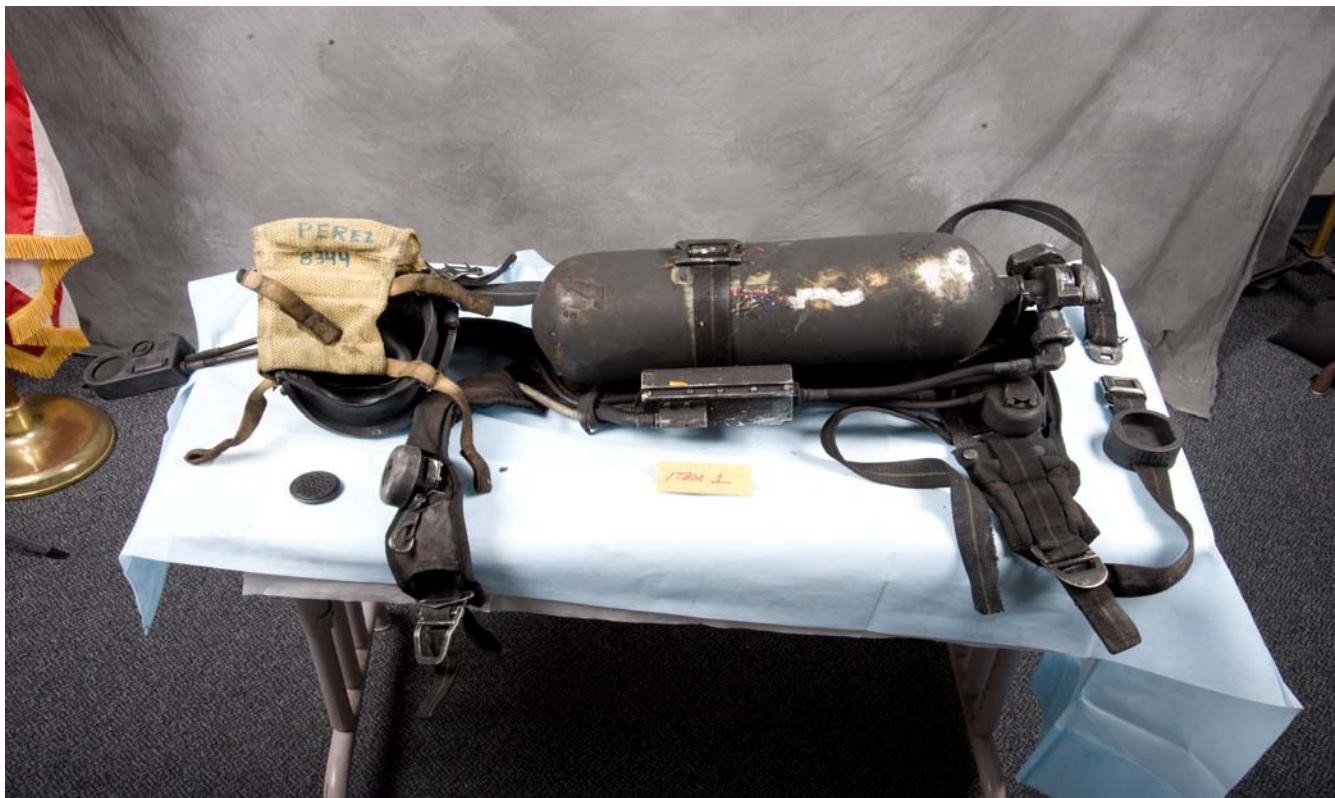
Victim 1's SCBA note the heavy sooting

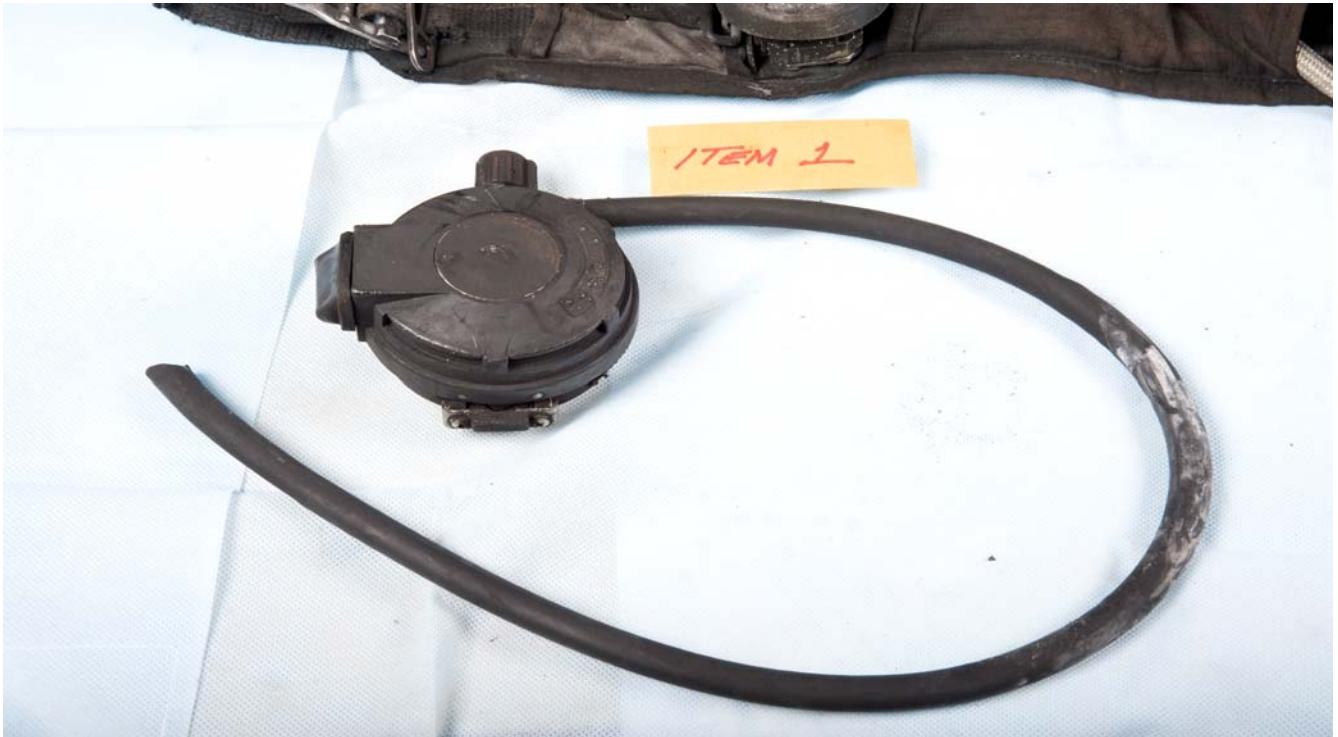
Victim 1's SCBA low pressure hose. This hose was cut during rescue operation
(hose/mask was wedged under vehicle's tire in garage).

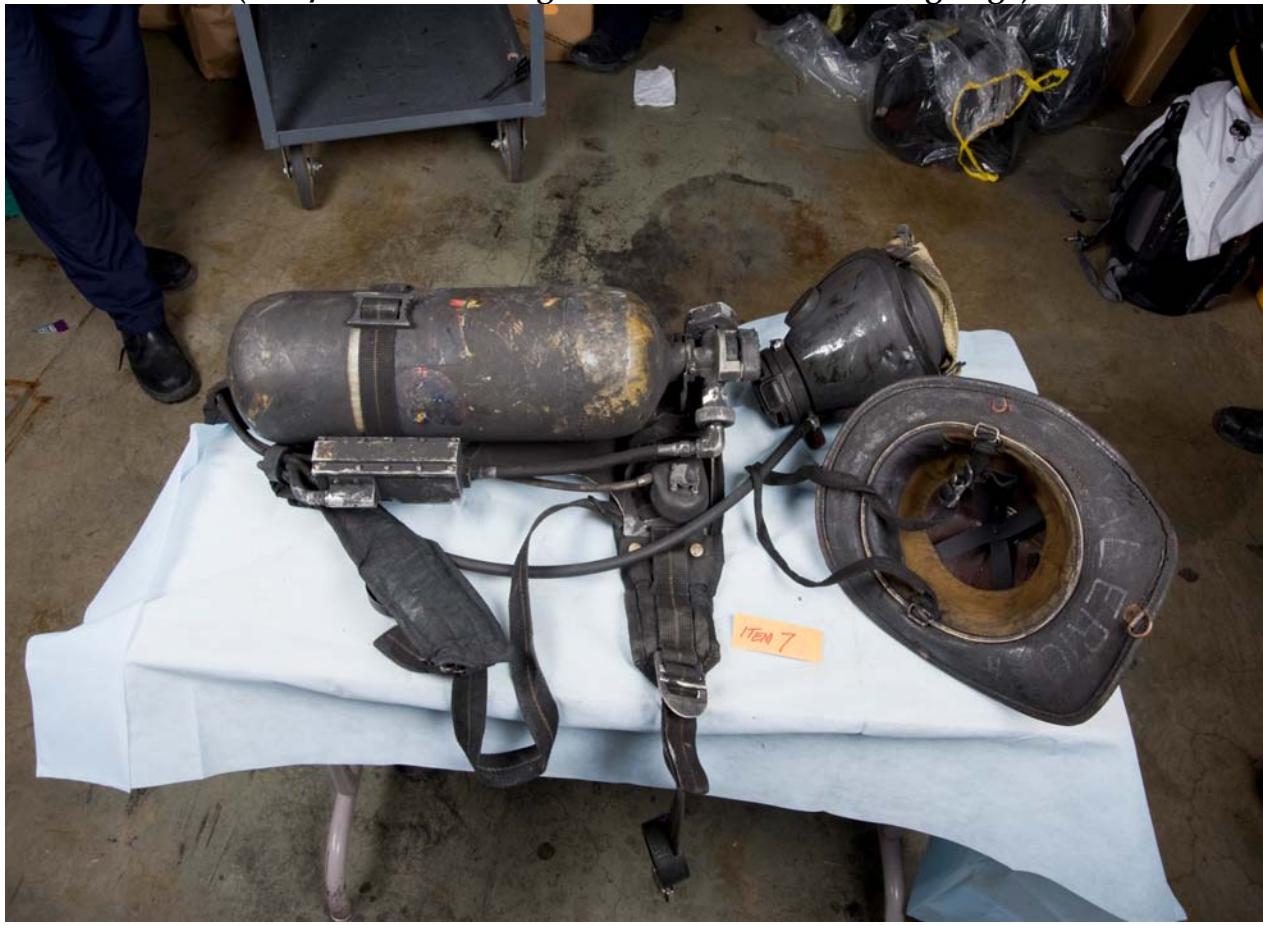
Victim 2's SCBA with Helmet, note the heavy sooting.
