SAN FRANCISCO FIRE DEPARTMENT

**Safety Investigation Report
Line of Duty Deaths
133 Berkeley Way
June 2, 2011
Box 8155
Incident # 11050532**

February 2012

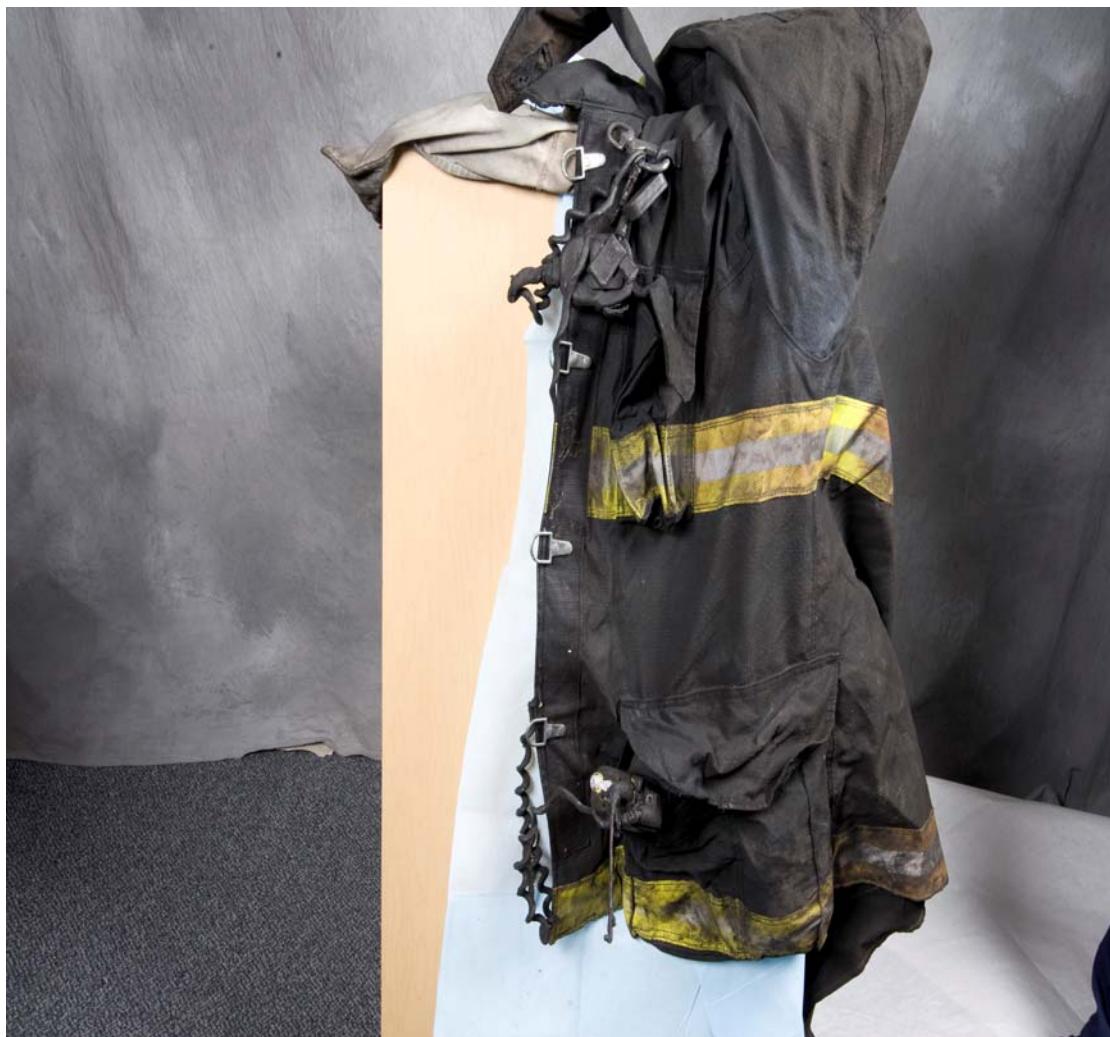
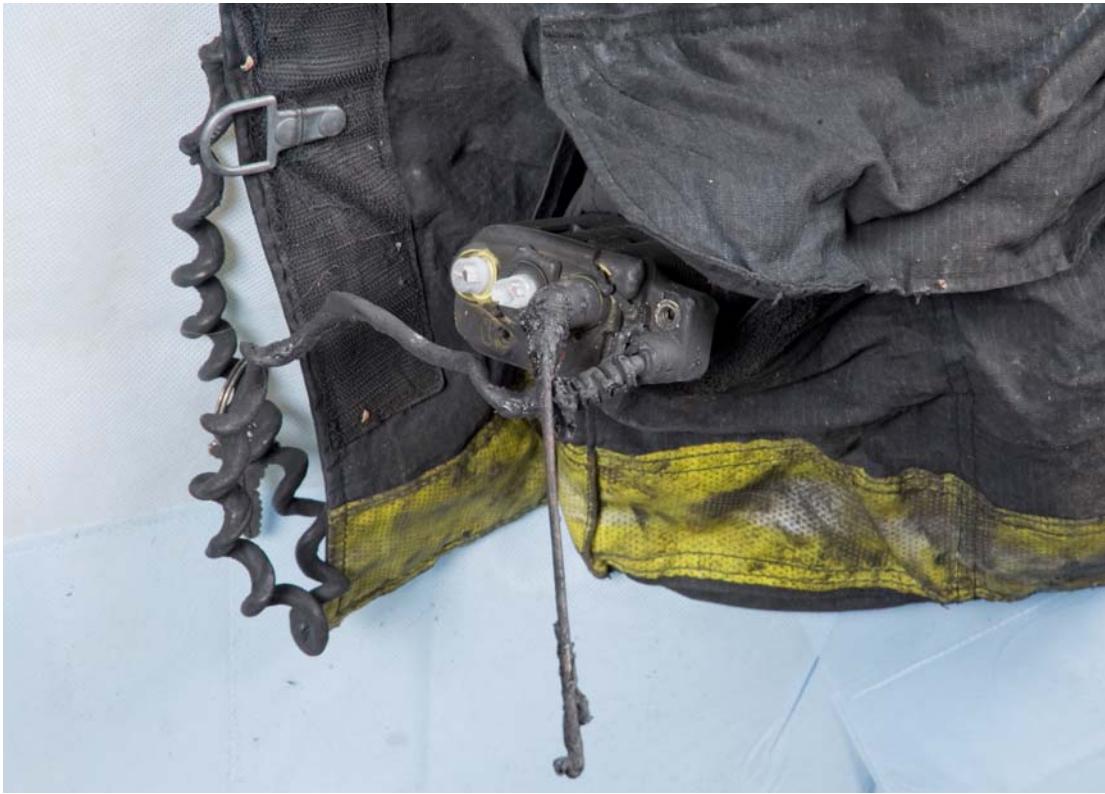
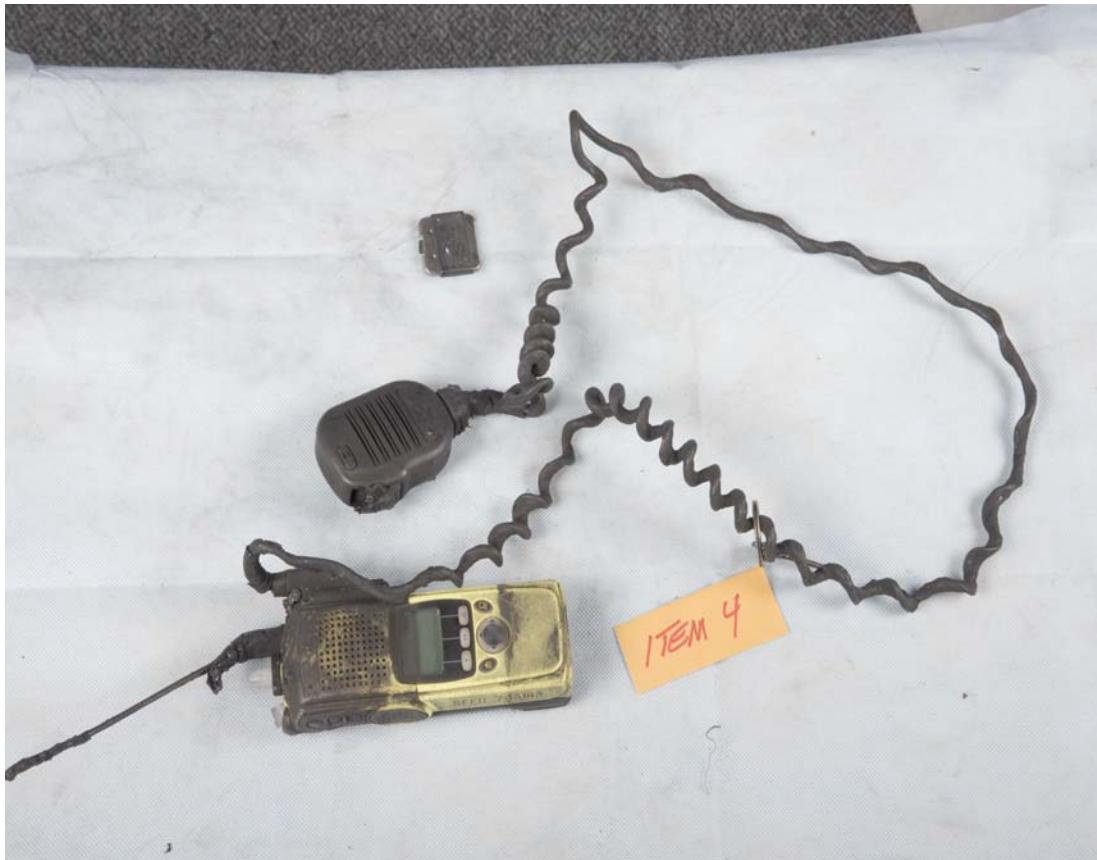
The Safety Investigation Team noticed severe heat damage to the portable radios remote speaker/microphones on Victims 1 and 2 and had the radios tested. The testing indicated that the remote speaker/microphones failed to operate correctly due to heat damage. The Safety Investigation Team was not able to determine, after testing, exactly when the remote speaker/microphones failed. The investigation has shown that multiple attempts were made to contact Engine 26 with no response. The investigation also found that no radio transmissions of distress were received from Victims 1 or 2.

All members operating on the fireground were equipped with an 800 Mhz Fire Department issued portable radio. All Firefighter's radios were equipped with remote speaker/microphones. Victim 1 and 2's radios showed extreme heat damage.

Victim 1 had a portable radio located in the large lower left coat pocket with the remote speaker/microphone running along the outside of the coat to the collar area.

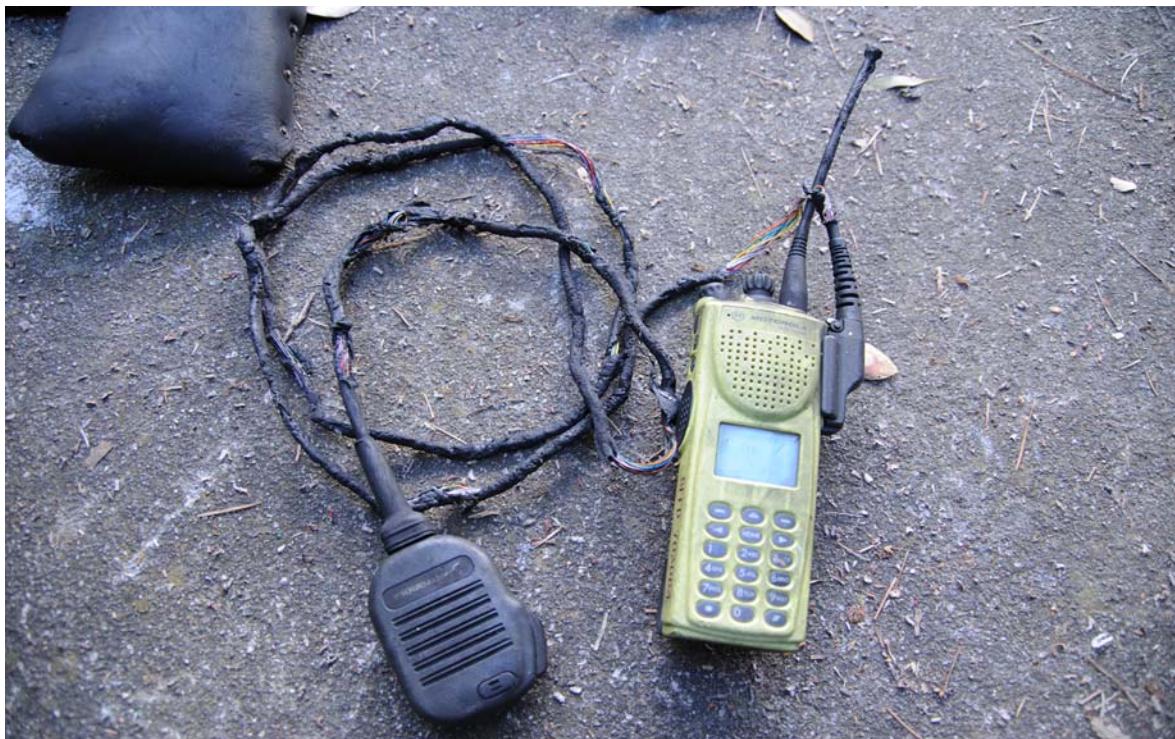
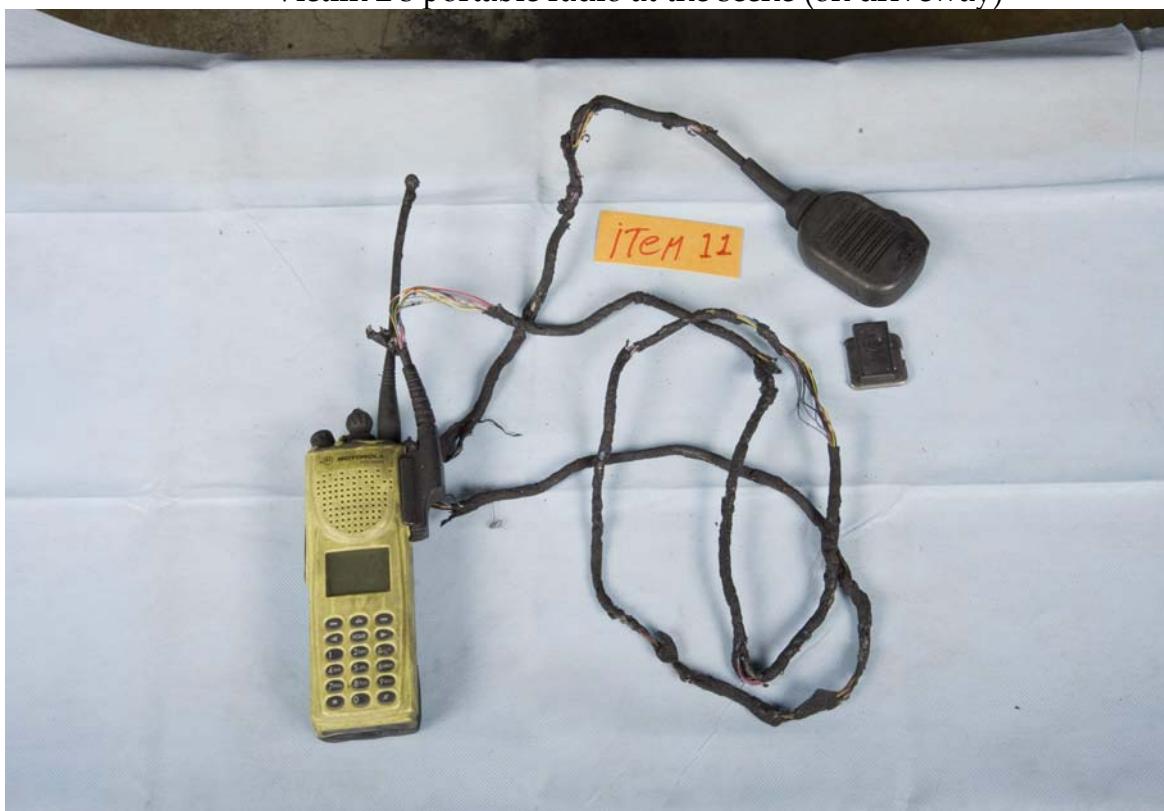
Victim 2's portable radio at the scene (on driveway)

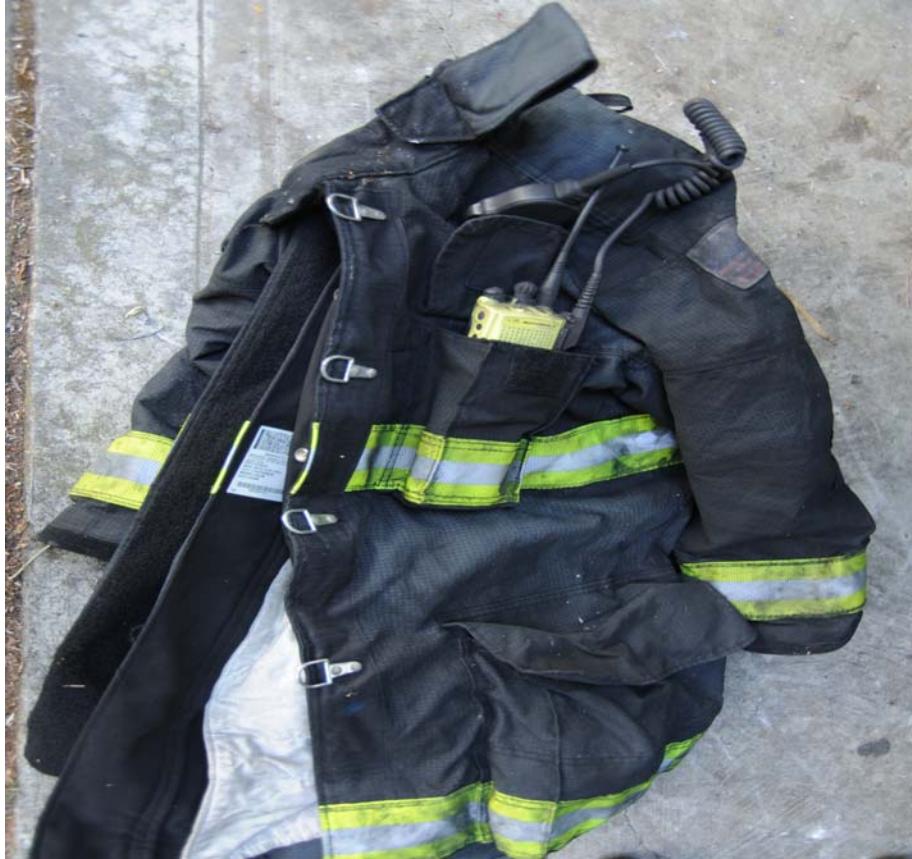
Victim 2's portable radio

Victim 2's remote speaker/microphone failed due to high heat/fire, causing no transmit or receive functions.

The test also showed that even with the damage that the remote speaker/microphone cord received, the Emergency Button on Victim 1 and 2's portable radios still operated correctly.

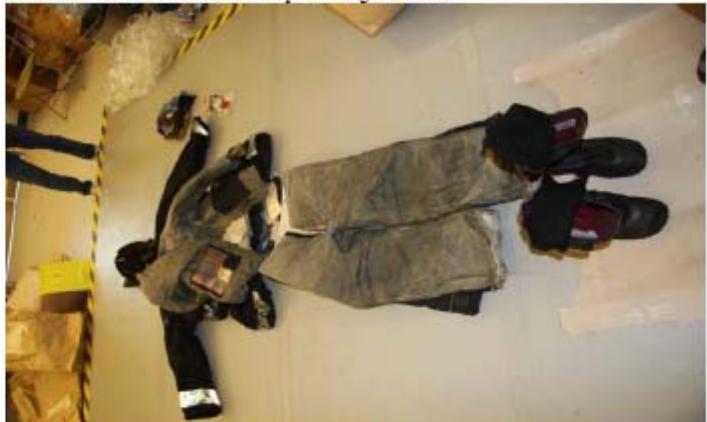
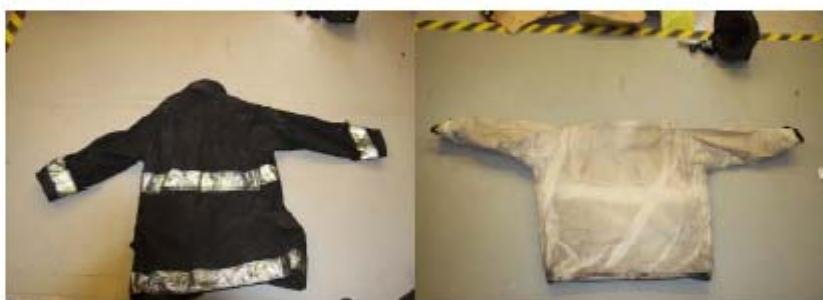
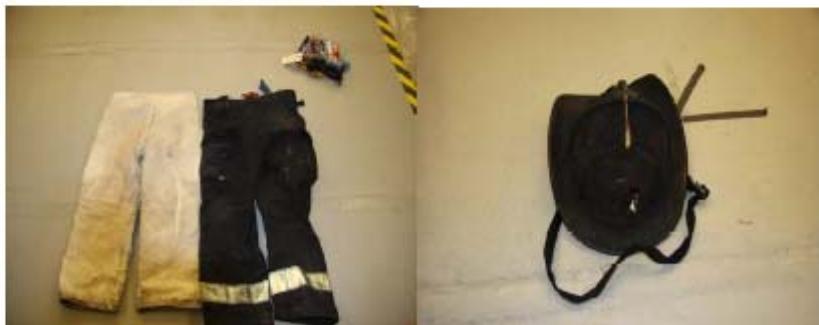
The turnout gear coat of Victim 1 showed dye sublimation from high levels of heat exposure, indicating extreme levels of heat exposure in those areas. The pants of Victim 1 and the coat and pants of Victim 2 do not indicate any dye sublimation. In both cases, although the heat may have been at severe emergency levels, the materials used in the gear did not reach extreme temperatures to have destroyed the fabrics. The degradation temperature of the high heat and flame resistant fibers used in the various outer shells of the garment are approximately 800°F to 1000°F for the Fusion (Nomex and Kevlar) outer shell and 1000°F-1200°F for the PBI Matrix (PBI and Kevlar) outer shell.

Based on the condition of the materials, the surface temperature of the garment fabrics did not reach degradation temperature, otherwise heavy charring or break open would have occurred. Flashover conditions can expose Firefighters to air temperatures of approximately 1800°F. In these extreme conditions, in less than 45 seconds, enough heat can transfer through the protective clothing system to cause severe injury or death to a Firefighter wearing full protective clothing; however, depending on the conditions, the exposure may not be high enough and long enough to cause the garment materials to reach degradation temperature.

Victim 2 Gear Reviewed. Additional photos of gear on file.

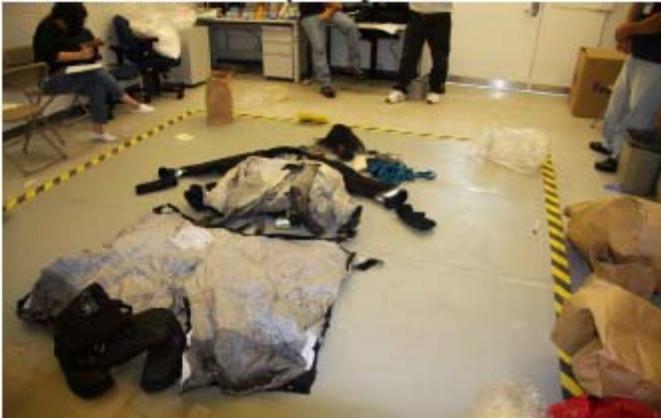
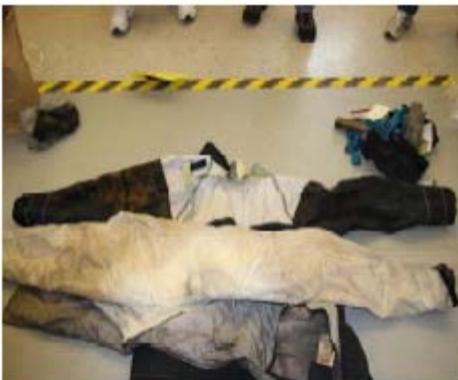
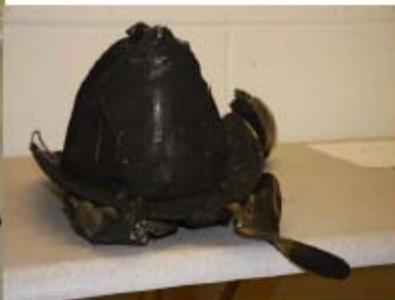
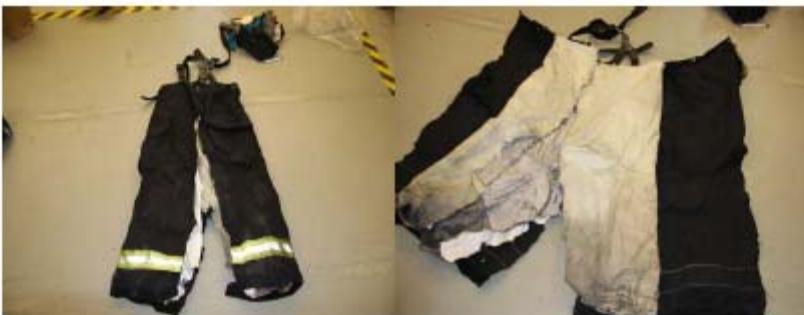
Victim 1 Gear Reviewed. Additional photos of gear on file.

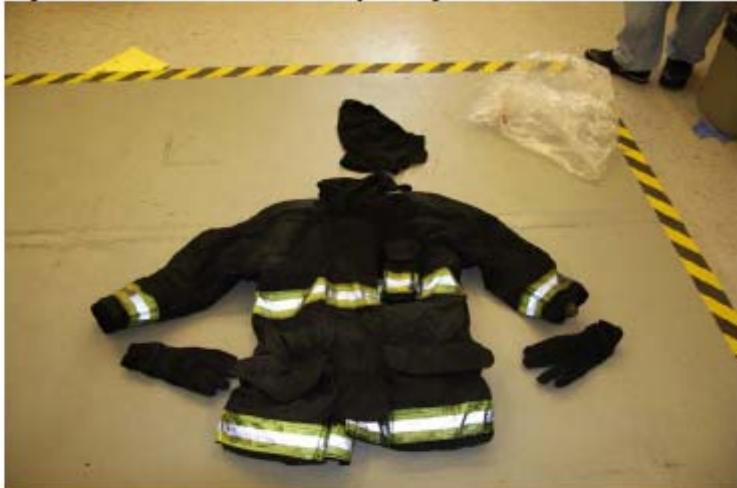
Engine 24 Officer Gear Reviewed. Additional photos of gear on file.

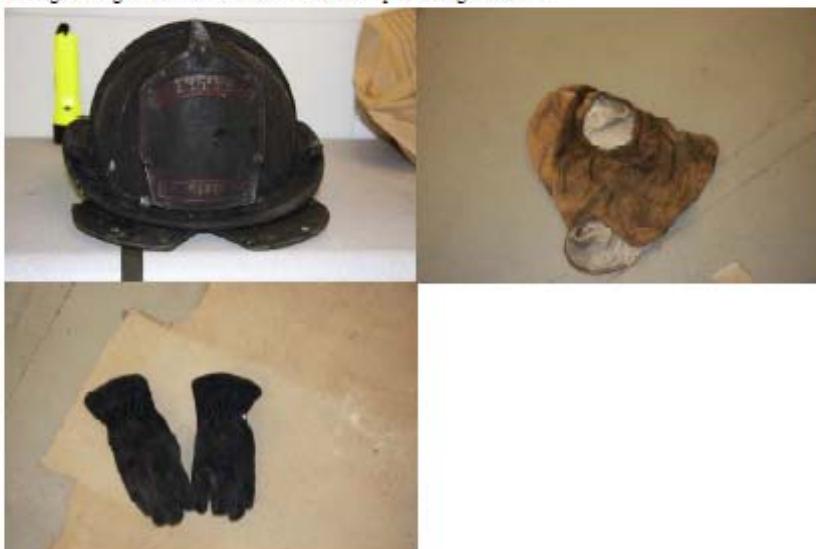
Firefighter Engine 11 Gear Reviewed. Additional photos of gear on file.
