JABAL HEMALAYA FOR INSPECTIONS

Certificate of Thorough Visual and Functional Examination of  
Manlift (MEWP)

Certificate No: JHI-1912-25-C2

Equipment Details: MOBILE ELEVATING WORK PLATFORM – TELESCOPIC BOOM LIFT (MEWP)

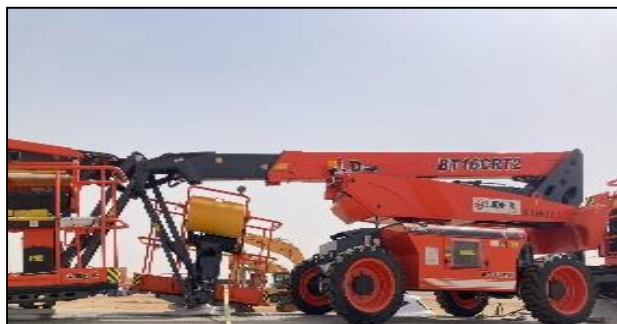
## IMAGES FOR MANLIFT

At the time of inspection, the equipment was found satisfactory.
