## Certificate of Thorough Visual and Functional Examination of Scissor Lift

Certificate No: JHI-1885-25-C3

Name of the owner company:  
SUDHIR EQUIPMENT RENTAL COMPANY

SCISSOR LIFT

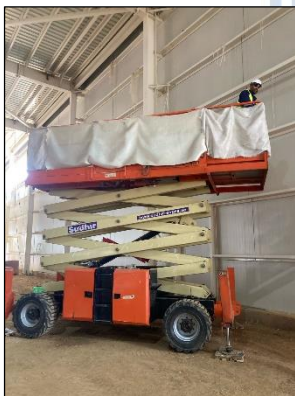
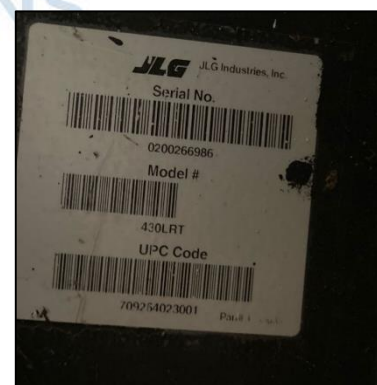
### IMAGES FOR SCISSOR LIFT

At the time of inspection, the equipment was found satisfactory.
