## Certificate of Thorough Visual and Functional Examination of Scissor Lift

Certificate No: JHI-9804-26-C2

Equipment Details: **SCISSOR LIFT**

DINGLI & 2024

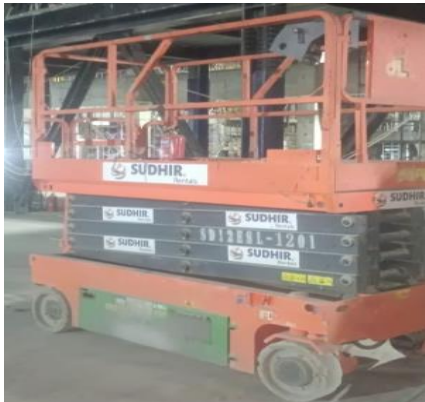
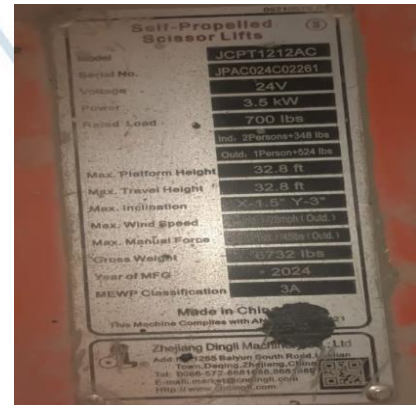
### IMAGES FOR SCISSOR LIFT

At the time of inspection, the equipment was found satisfactory. After Any Major Repair Proof Load Needs to be Conducted
