# MAGNETIC PARTICLE INSPECTION REPORT

| Equipment Description & Location: | RT-Crane (Main Hook & Auxiliary Hook) | Type of Inspection & Technique: | Wet Visible MPI |
| Equipment Part/Serial No.: | SRC-RT-050-024 (Main: HCZ2455016<br>Aux: YM2024020204)) | Surface Condition: | Cleaned to bare metal |

| LIFTING EQUIPMENT<br>INSPECTION REPORT | Area<br>DAMMAM | Inspection Date<br>22/10/2025 | | Inspection Time<br>14:00 | Previous Sticker | |

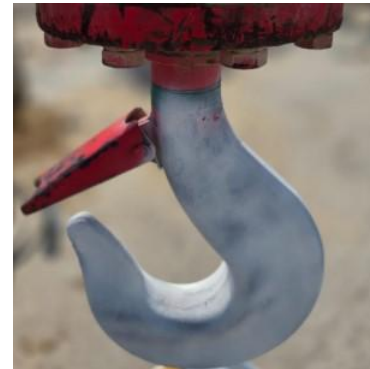
## Reference Pictures

| Result: | No relevant indication observed at the time of inspection on the area available for testing. | |
| Remarks / Notes: | VISUAL & MPI INSPECTION OF THE HOOK WAS CARRIED OUT ONLY ACCESSIABLE AREA AND NO VISIBLE DEFECT WERE FOUND. | |
