Report No.: 246054

| <b>LIFTING EQUIPMENT<br/>INSPECTION REPORT</b> | <b>Area</b><br>DAMMAM | <b>Inspection Date</b><br>28/07/2025 | | <b>Inspection Time</b><br>7:00 | <b>Previous Sticker</b> | |

## CERTIFICATE OF TEST AND THOROUGH EXAMINATION OF MOBILE CRANE

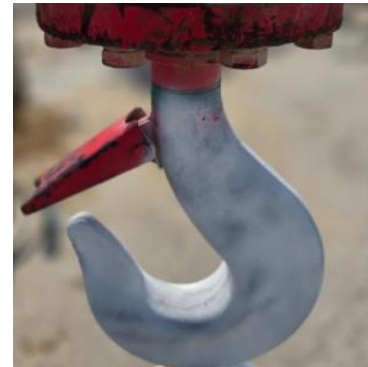
## Reference Pictures

| Result: | No relevant indication observed at the time of inspection on the area available for testing. | |
| Acceptable: | ACCEPTED | Next visit due on: 29/07/2026 |
