## OWNERSHIP CERTIFICATE

## CERTIFICATE OF TEST AND THOROUGH EXAMINATION OF MOBILE CRANE

Report No.: 246827

| <b>SAUDI ARAMCO INSPECTION CHECKLIST</b> | | | SAIC NUMBER<br><b>SAIC-U-7007</b> | ISSUE DATE<br><b>12-Jan-23</b> | DISCIPLINE<br><b>ELEVATING/LIFTING EQUIPMENT</b> |

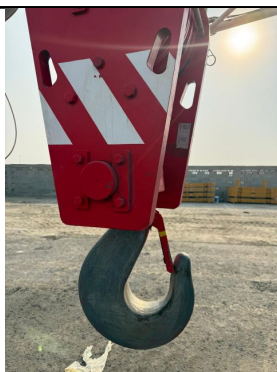
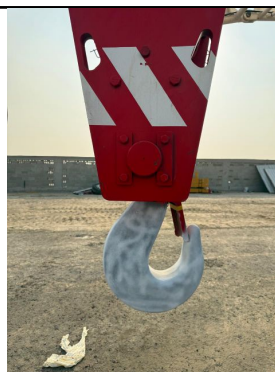
Magnetic particle inspection was carried out on above description critical & available area and found free from surface cracks or flaws at the time of inspection

(ACCEPTED)

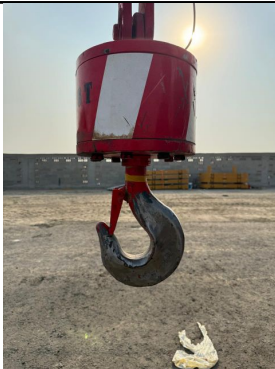
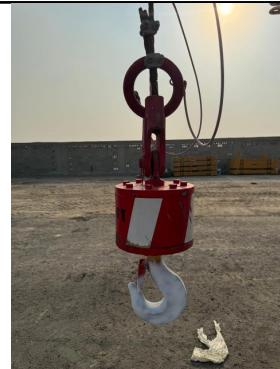
Magnetic particle inspection was carried out on above description critical & available area and found free from surface cracks or flaws at the time of inspection

(ACCEPTED)
