## Certificate of Thorough Visual and Functional Examination of Manlift (MEWP)

Certificate No: JHI-6047-26-C11

Name of the owner company:  
SUDHIR EQUIPMENT RENTAL COMPANY

Equipment Details: **MOBILE ELEVATING WORK PLATFORM – ARTICULATED BOOM LIFT (MEWP)**  
Type: **DIESEL POWERED ARTICULATED BOOM PLATFORM LIFT**

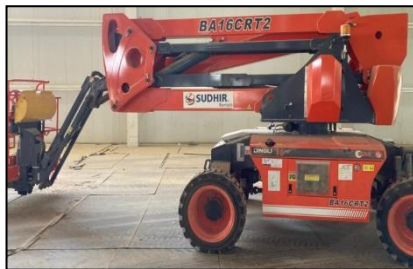
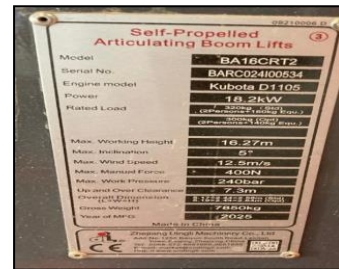
### IMAGES FOR MANLIFT

At the time of inspection, the equipment was found satisfactory.
