## Certificate of Thorough Visual and Functional Examination of Manlift (MEWP)

Certificate No: JHI-6081-26-C7

Date of Inspection: 13-01-2026

Equipment Details: **MOBILE ELEVATING WORK PLATFORM – TELESCOPIC BOOM LIFT (MEWP)**  
Type: **DIESEL POWERED TELESCOPIC BOOM PLATFORM LIFT**

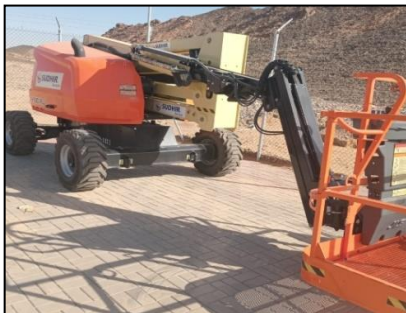
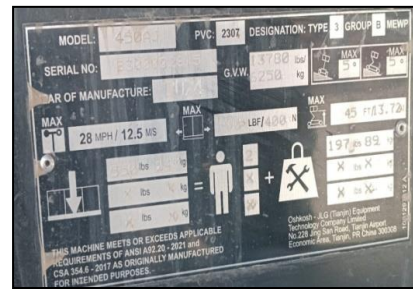
### IMAGES FOR MANLIFT

At the time of inspection, the equipment was found satisfactory.
