Certificate of Thorough Visual and Functional Examination of  
Manlift (MEWP)

Certificate No: JHI-2895-25-C5

Date of Inspection: 12-06-2025

MOBILE ELEVATING WORK PLATFORM – TELESCOPIC BOOM LIFT (MEWP)

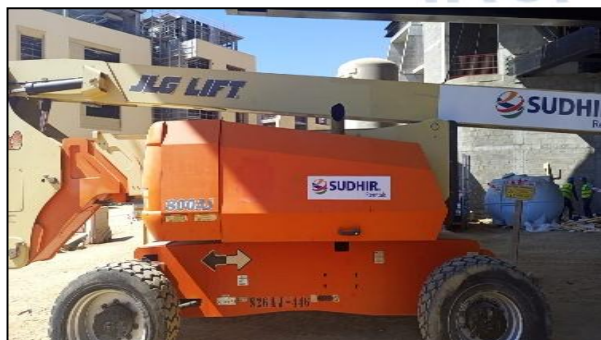
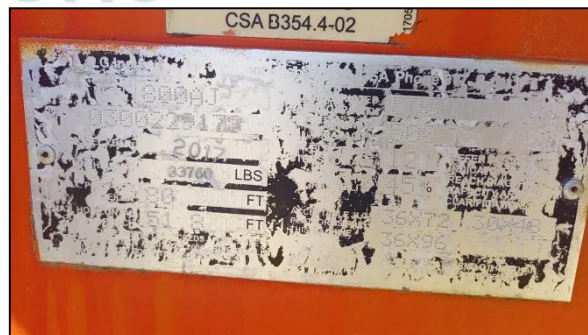
## IMAGES FOR MANLIFT

At the time of inspection, the equipment was found satisfactory.
