Certificate of Thorough Visual and Functional Examination of  
Lorry Loader Crane

Certificate No: JHI-2983-25-C1

Date of Inspection: 19-06-2025

Equipment Details: DIESEL POWERED TRUCK MOUNTED HYDRAULIC OPERATED TELESCOPIC BOOM LORRY LOADER CRANE

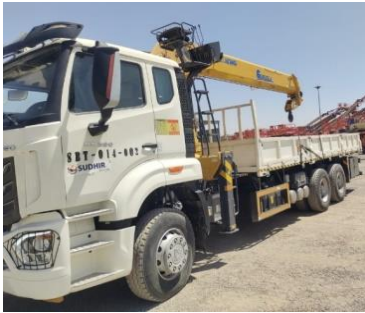
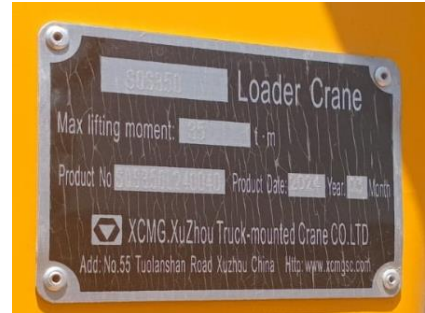
IMAGES FOR LORRY LOADER CRANE

At the time of inspection, the equipment was found satisfactory
