## Certificate of Thorough Visual and Functional Examination of Scissor Lift

Certificate No: JHI-5119-25-C24

Name of the owner company:  
SUDHIR EQUIPMENT RENTAL COMPANY

Equipment Details: ELECTRIC SCISSOR LIFT

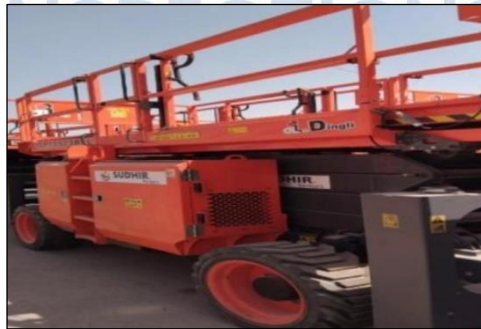
### IMAGES FOR SCISSOR LIFT

At the time of inspection, the equipment was found satisfactory.
