# Hardware Diagnostic & Infrastructure Report

NCB TECHNICAL SOLUTION — PROFESSIONAL ARCHITECTURE  
& SERVICE

**System Engineer:** Naveena C B  
**Location:** Harihar, Karnataka, India

**Date:** June 19, 2026  
**Status:** Technical Deployment Finalized

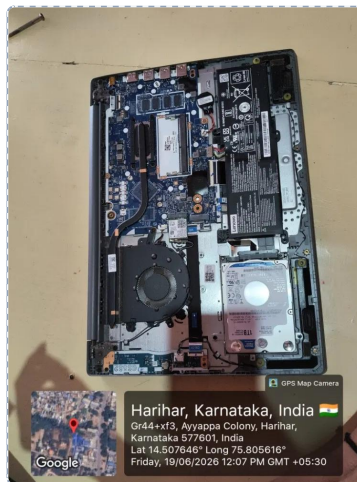
**Figure 1: Internal Chassis Components**

Physical hardware verification log from Harihar, Karnataka. Confirms factory 1 TB SATA HDD layout, cooling fan module, memory placement, and system board architecture.

Physical diagnostic imaging of the internal motherboard confirms additional high-speed interface availability alongside existing storage infrastructure.

| Storage Interface Slot | Status | Engineering Recommendation |
|---|---|---|
| M.2 NVMe Slot | ✓ AVAILABLE (OPEN) | Install a 256 GB NVMe SSD or 512 GB NVMe SSD. Migrate the Windows 11 installation onto this solid-state drive. |

| Recommended Step | Implementation Mechanics | Expected Performance Lift |
|---|---|---|
| <b>M.2 NVMe SSD Integration</b> | Install a dedicated 256 GB or 512 GB high-speed solid-state drive into the discovered open M.2 terminal. Fresh install or clone Windows 11 to run strictly from the SSD. | Eliminates operating system dependency on slow mechanical storage paths. |

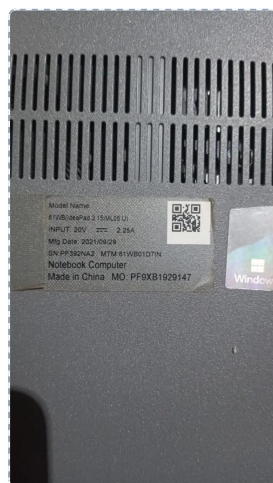
**Figure 2: Regulatory Identity Label**

Lower panel regulatory sticker scan verifying system attributes: Lenovo IdeaPad 3 15IML05, MTM 81WB01D7IN, Input 20V/2.25A, and Serial Number PF392NA2.
