Repair List

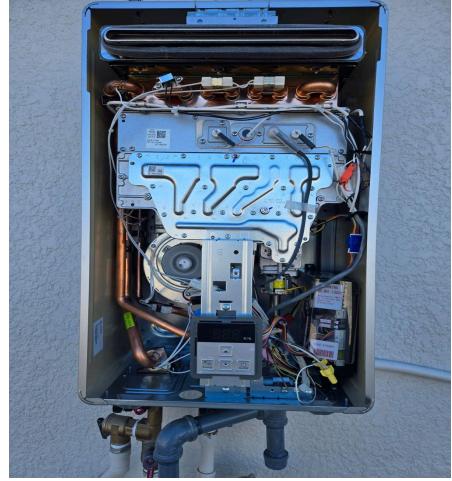
Tankless Water Heater	The box is missing an adapter for WiFi for smart home connectivity.

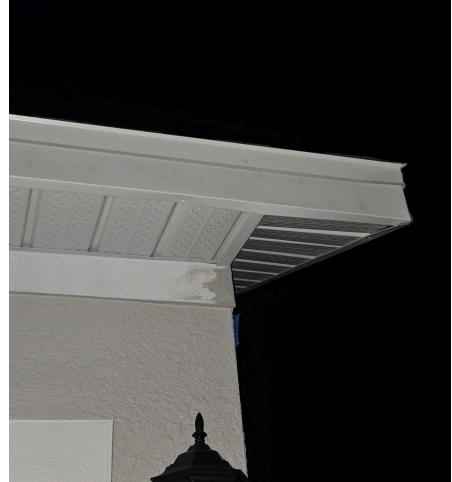
N
Outside Small Garage	Facing the small garage, the trim near the roof, the paint is incomplete

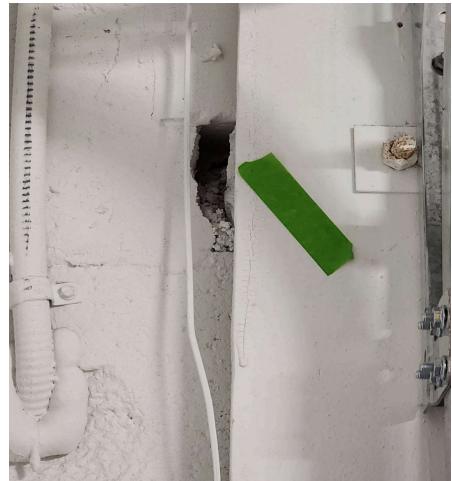
N
Garage	Inside the 2 car garage, face the street, look to the left between the garage and door. There is a huge hole.

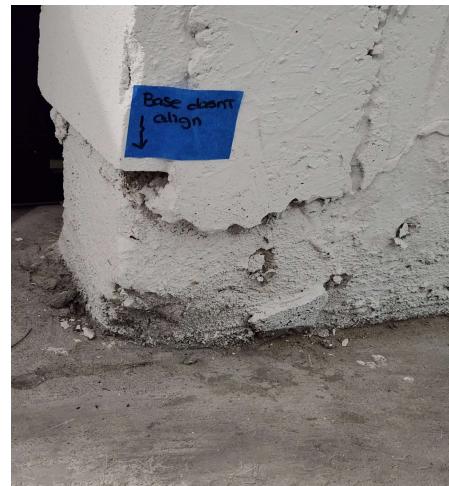
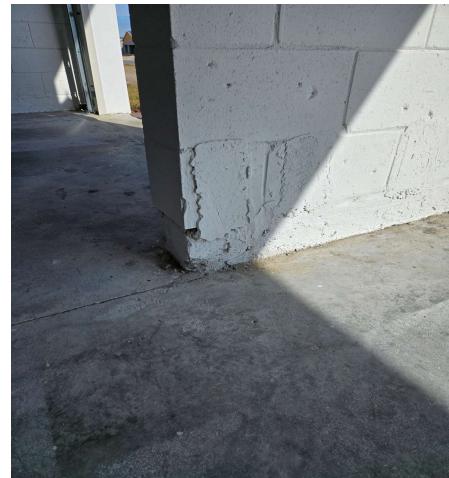
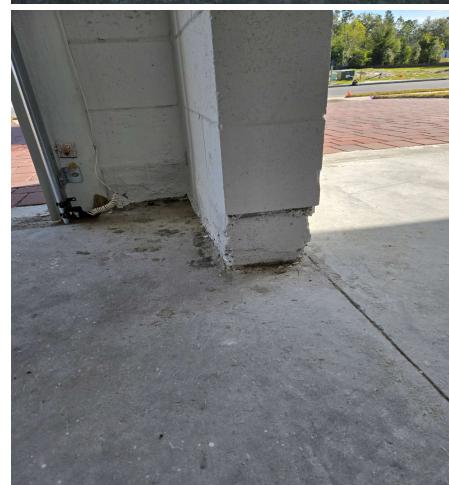
Garage
Supporting
Wall

Inside the 2 car garage facing the street, look to the left wall closest to the garage. The base is not complete and looks like something bit off the bottom side. For a new house with the price paid, it shouldn't look broken and is unacceptable.

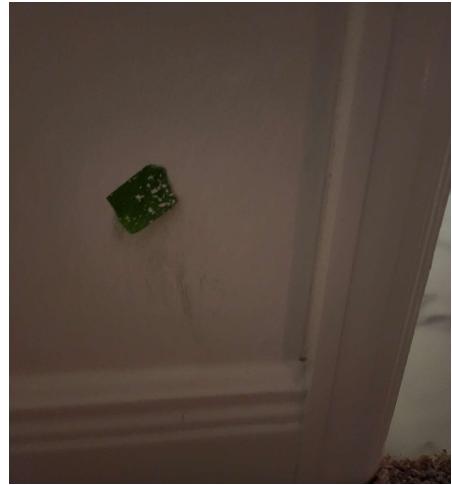
N
Master Wall	As you walk through the master door, look to the bottom right. There is a discolored scrape, looked like the paint was scraped off.

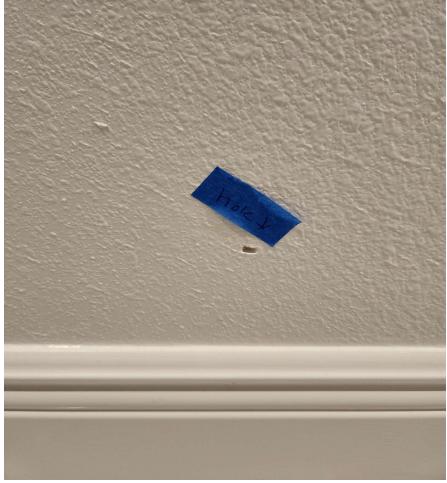
Hallway to the bathroom	Go to the bathroom. Past the left closet Bottom wall there is a hole

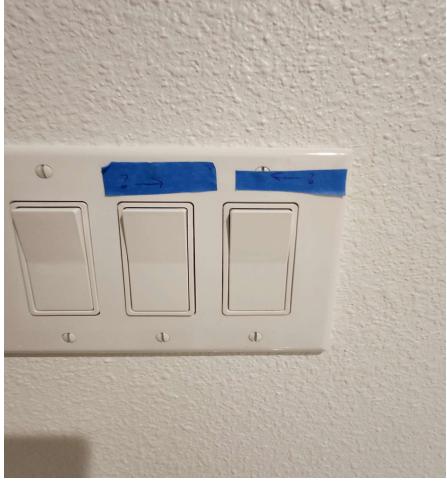
N
Light Switch, switched His/Her section	Facing the light switch for the lights above the sinks. The left switch turns on the right light and the right switch turns on the left light. The left switch should be consistent with the left light and the same for the right.

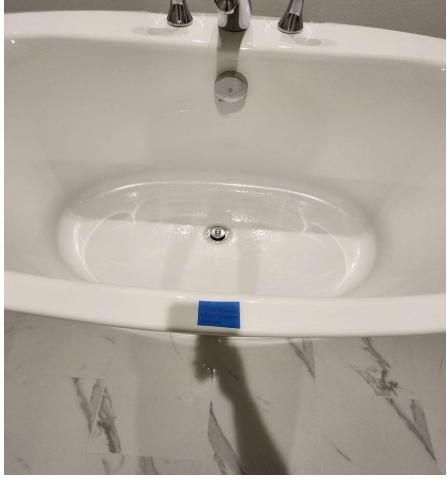
N
Master tub	If you press on the rim or go inside there is a squeaky sound

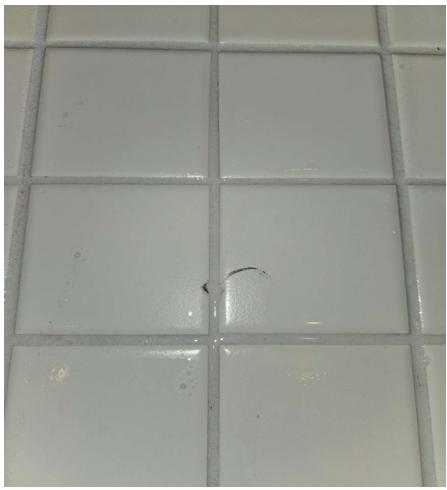
Master shower tile	The shower tile on the floor is cracked and could lead to water leakage.

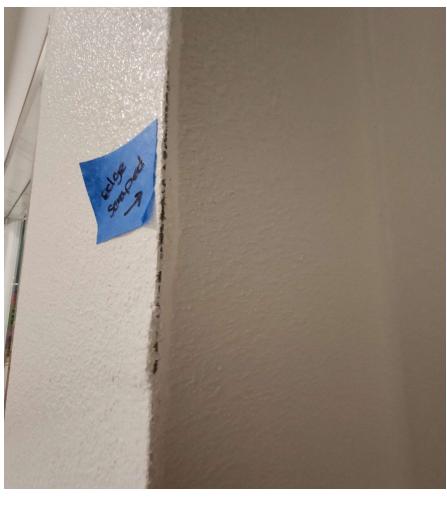
N
Master bathroom: Edge along the wall	Left side of the shower has a scrape along the edge

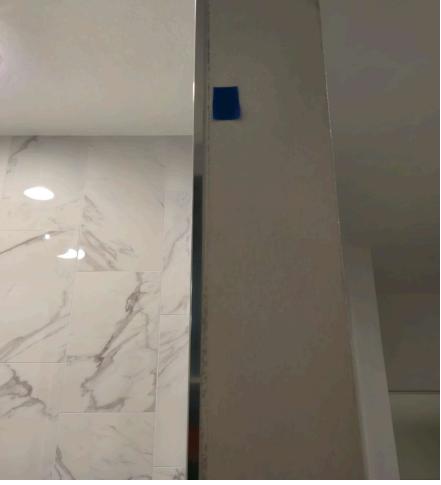
Master bathroom: Edge near the shower	Right side at the shower entrance is a scrape along the lining edge

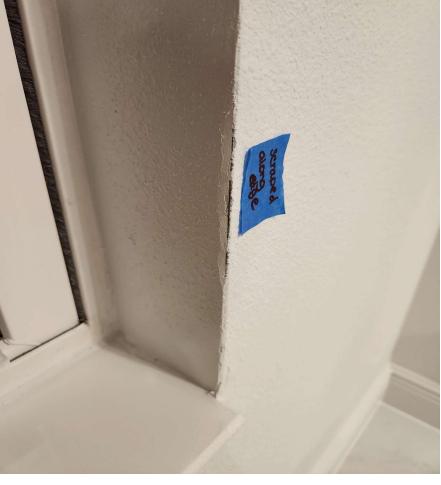
N
Master bathroom window	Some paint came off the window edge

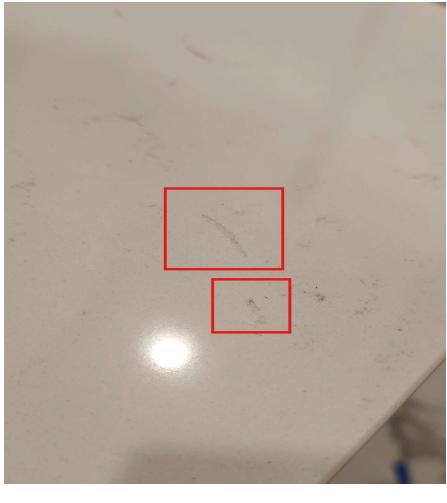
N
Kitchen Island	The kitchen island near the refrigerator shows a score.

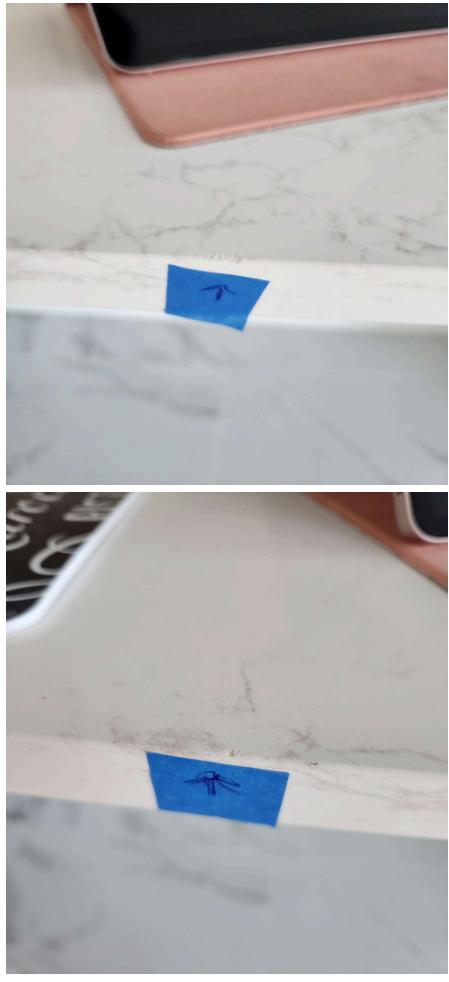
Kitchen Island	<p>The kitchen island near the living room shows 2 scratch/chip on the edge and not a smooth finish along the edge.</p>

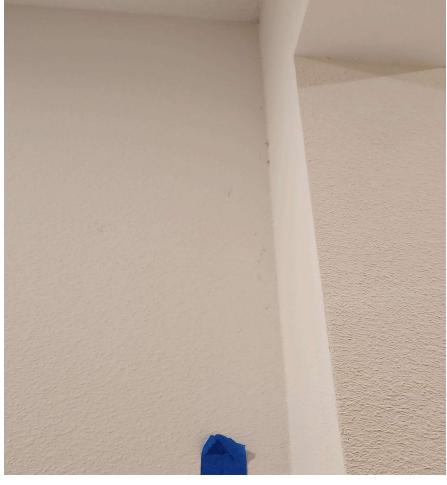
N
Kitchen corner wall	Extra material sticking out from the wall

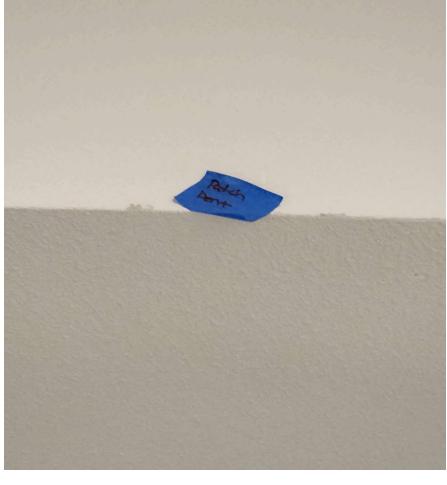
N
The divider between the kitchen and living room	The area facing the kitchen near the pantry have some discoloration

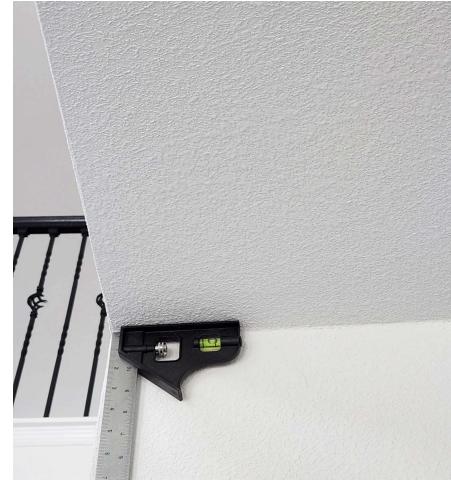
The 90 degree corner is slanted. It's very obvious especially at night when the shadow cast in the corner. It appears lopsided

Left side is OK

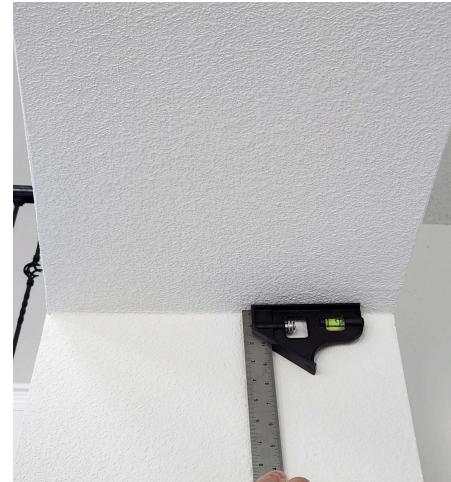
Right side lop by a quarter inch

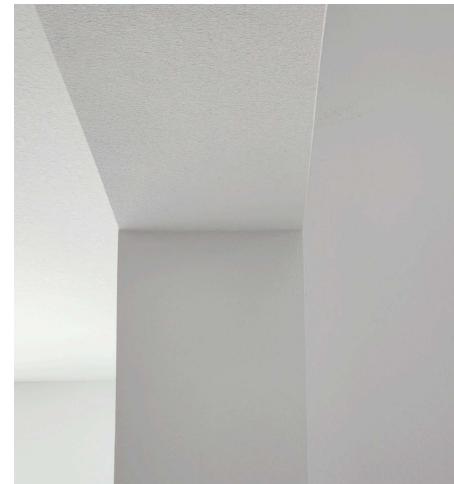
The other side is fine

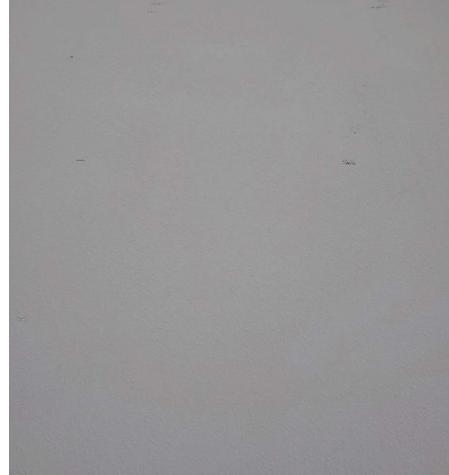
Living room under the two top windows	There are 2 spots that can't be cleaned.

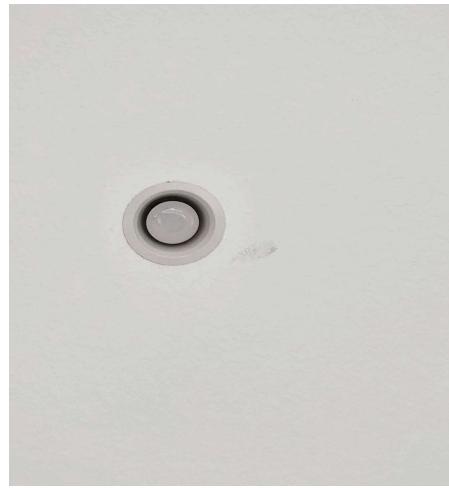
N
Living room ceiling by the back door	Black discolored spot in the ceiling

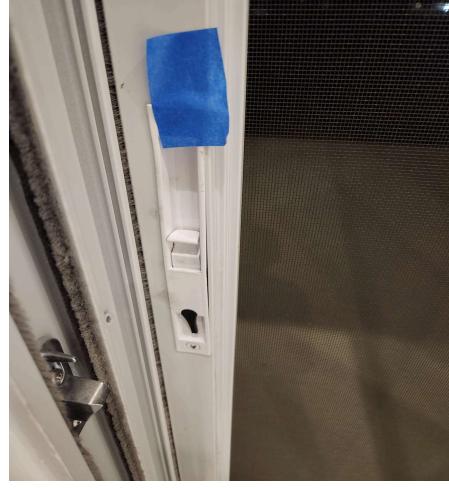
N
Facing backyard in the living room. The left screen door.	The screen door doesn't lock no matter how hard I push the door in.

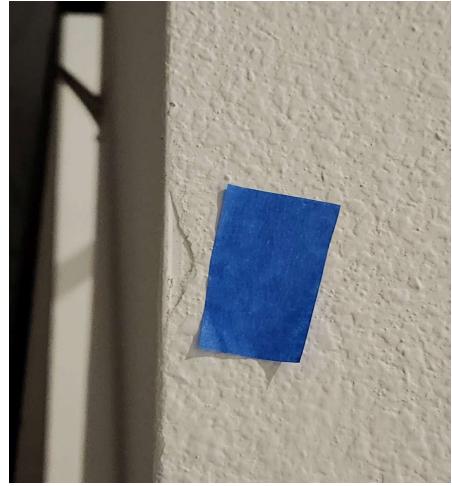
Going up the stairs on the right side.	Paint and drywall fell off

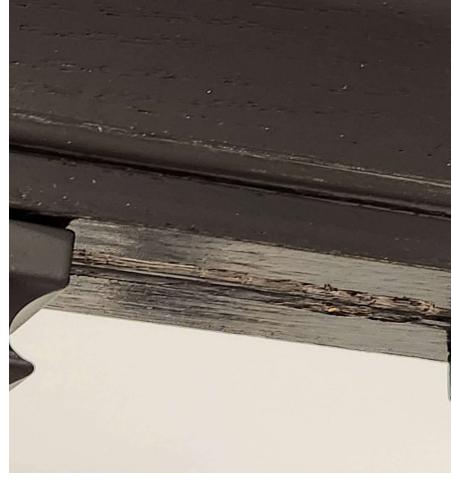
N
The last rail leading to the back jack and jill room	Ths one stair rail is rough enough to cause a splinter, the other rail underside look smooth and clean.

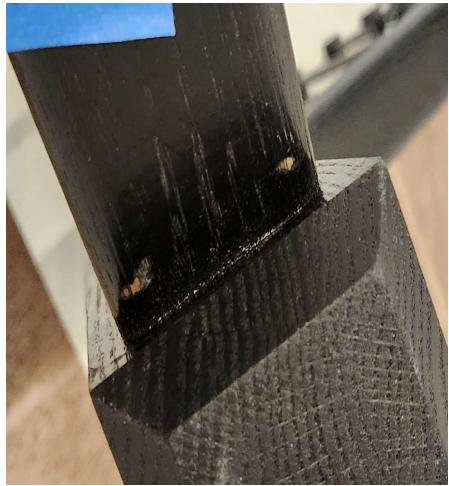
Middle stair joint	In the crease of the stair joint has missing paint and shows the raw wood.

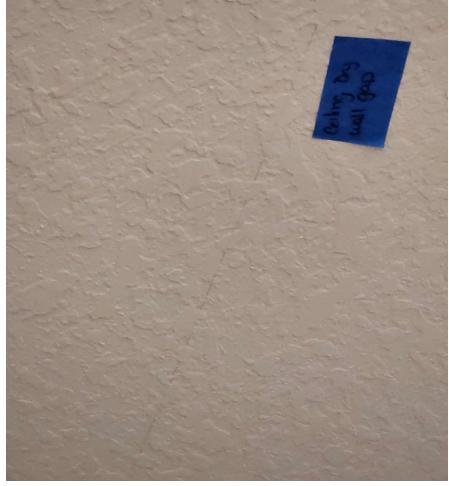
Location	Issue	Image	Resolved
Second floor near the loft	A line between the drywall is exposed in the ceiling

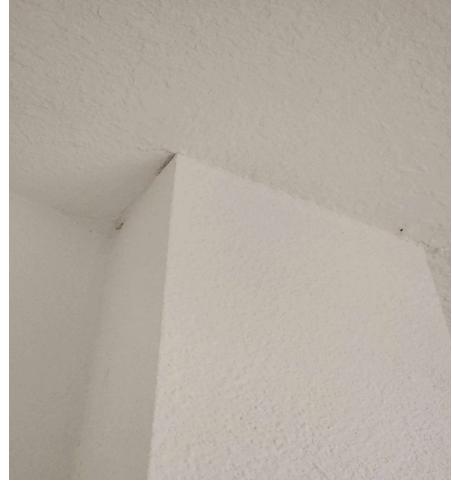
Room facing the backyard (not the jack and jill)	Outside of the room, the hall top notch shows is disconnect with the ceiling

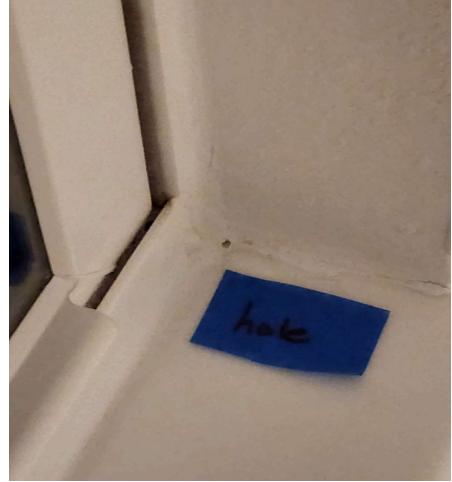
Location	Issue	Image	Resolved
The Jack and Jill room facing the backyard	Hole in the corner window

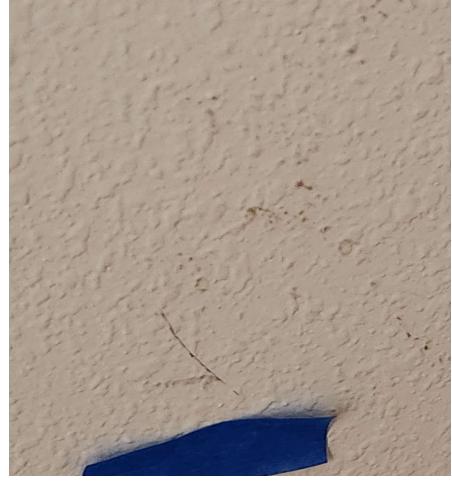
N
The Jack and Jill room facing the backyard	Near the closet at the lower wall is scratched

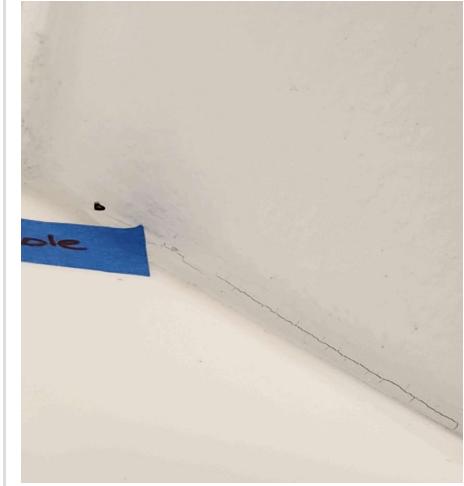
Laundry room window	Hole in the corner and crack along the side

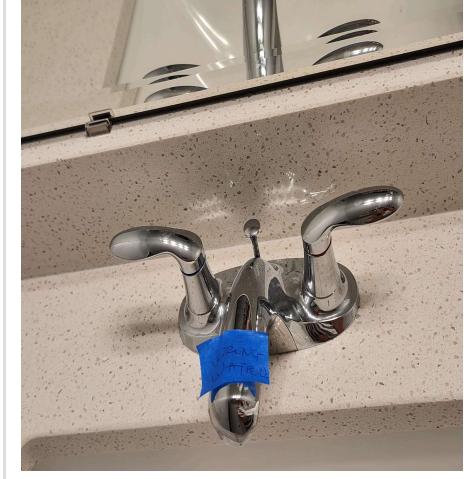
N
1) Bathroom with shower	The left sink has the hot and cold color mixed. Red color faucet should be on the left and blue on the right

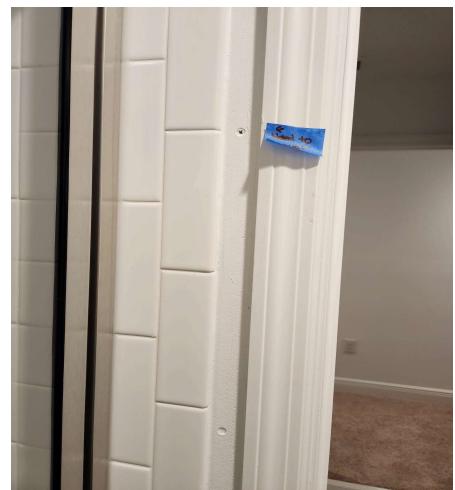
3) Bathroom with shower

Missing a patch to one of the nail.
Should the nail top impression show through? Should this be smooth?
