Technical Report

DETAILS	Name of organisation	Warwick Medical Ltd.
	Company number	08157826
	Name of experimenter	Chris Softas (Conduction of experiments, Report writing) Marc Bruggeman (Experiment planning)
	Tests performed	Chemical degradation of polyester badges in different cleaning solutions/tensile strength testing
	Date	30/05/2023 – 31/05/2023

Scope

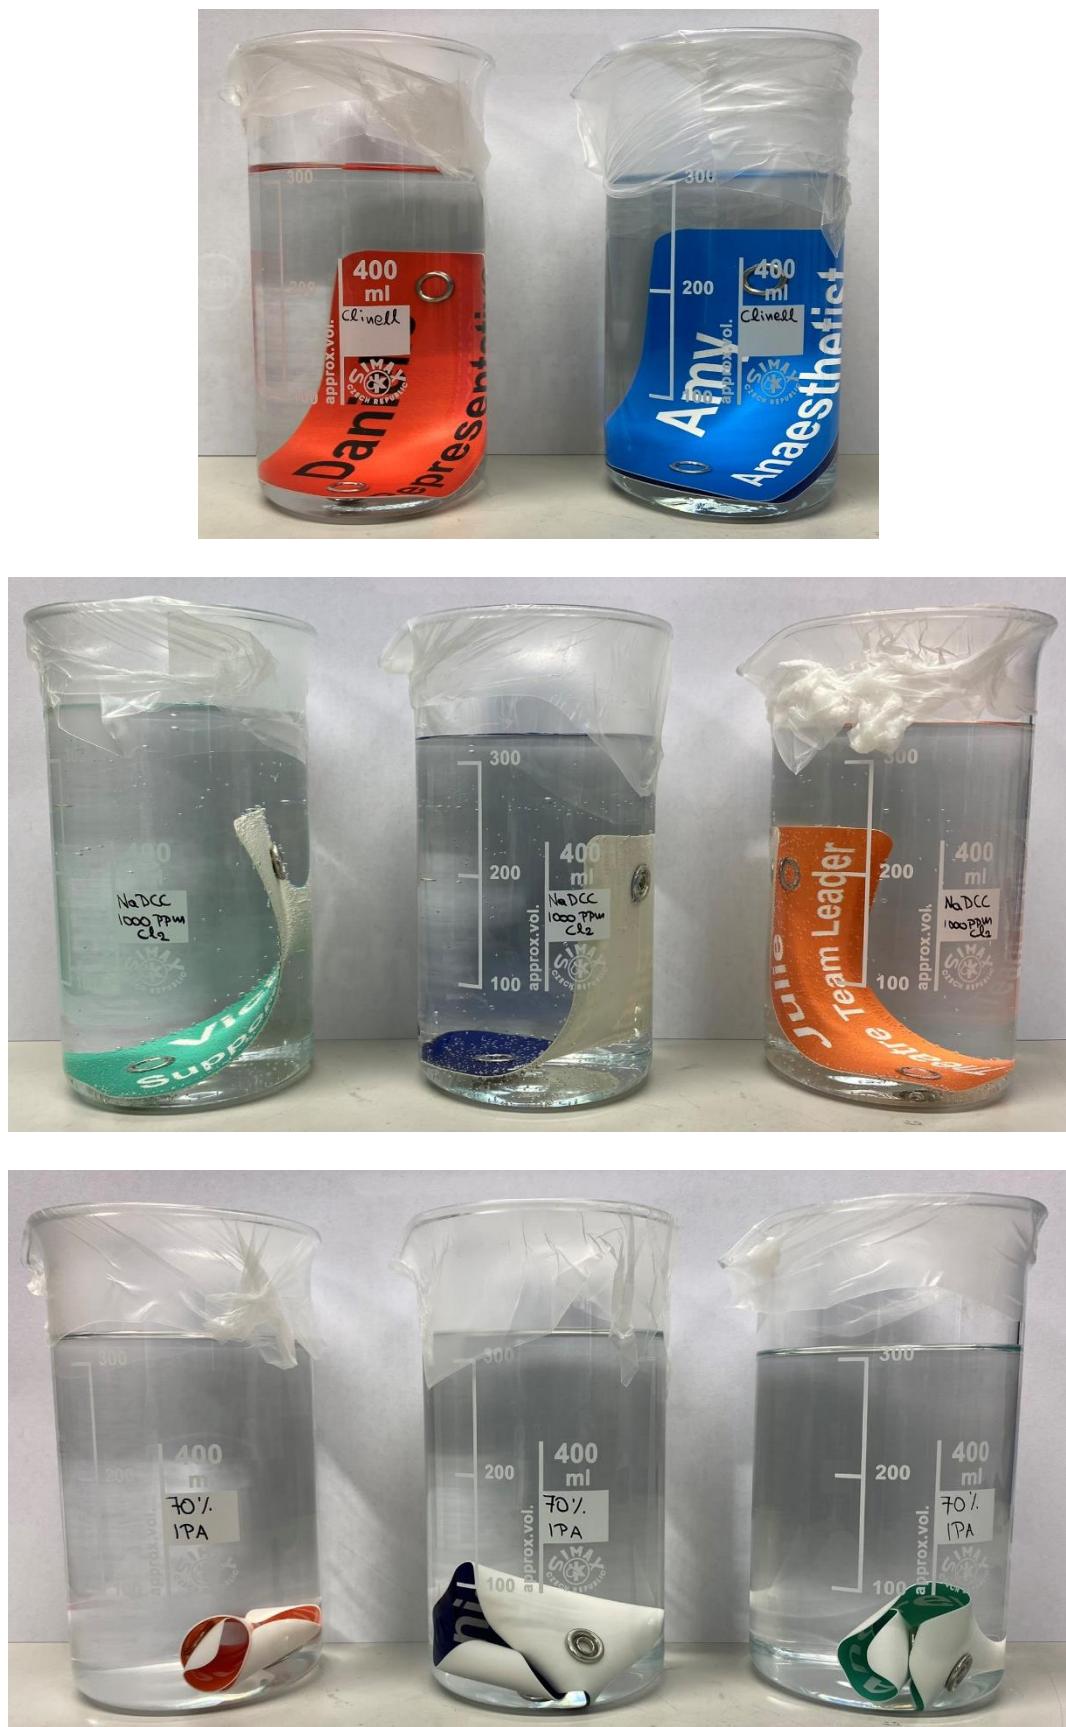
At the 25-hour mark, the orbital shaker was turned off and the beakers were visually inspected for pigment leaching or any other form of chemical degradation. No pigment leaching was observed in none of the test groups, since the cleaning solutions were transparent, as it can be seen in Figure 8. Additionally, no deformations were observed on the Clinell and Actichlor test groups. However, that was not the case for the 70% IPA test group since all the badges exhibited severe warping.

Figure 8: Clinell (up), Actichlor (mid) and 70% IPA (bottom) test groups, post the chemical degradation experiment.

1. The badges tested in the 70% IPA cleaning solution were significantly warped, by the end of the 25-hour immersion period.
2. The badges tested in Actichlor cleaning solution (1000 ppm of available Cl₂) exhibited a slight discoloration/yellowing on their back, by the end of the 25-hour immersion period.

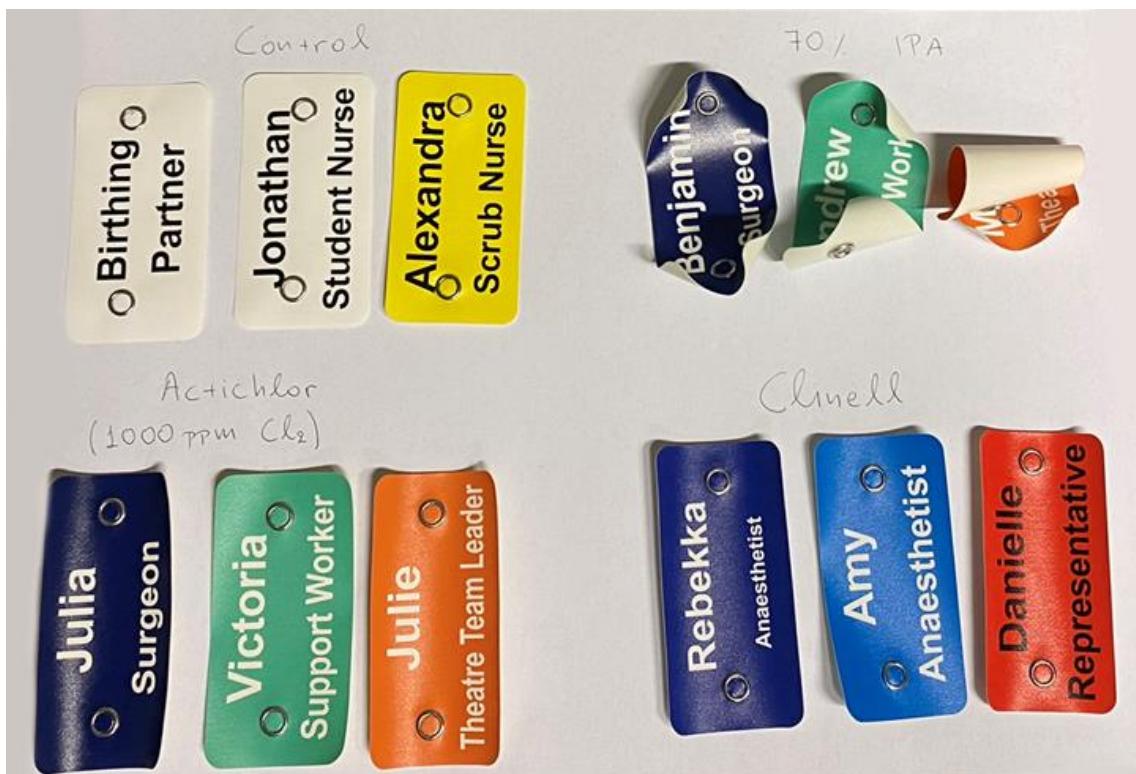
The badges were removed from the beakers and were patted dried with tissue paper to remove any excess solution potentially left on the surface. No discoloration was observed on the front of the badges for all the test groups, as presented in Figure 9. Similar observations were recorded for the back of the Clinell and 70% IPA test groups, whereas limited yellowing was observed on the back of the Actichlor test group, as presented in Figure 10. Lastly, no damage was observed on the metallic popper fastening system throughout this study.

Figure 9: Front side of the polyester badges, post the chemical degradation experiment.

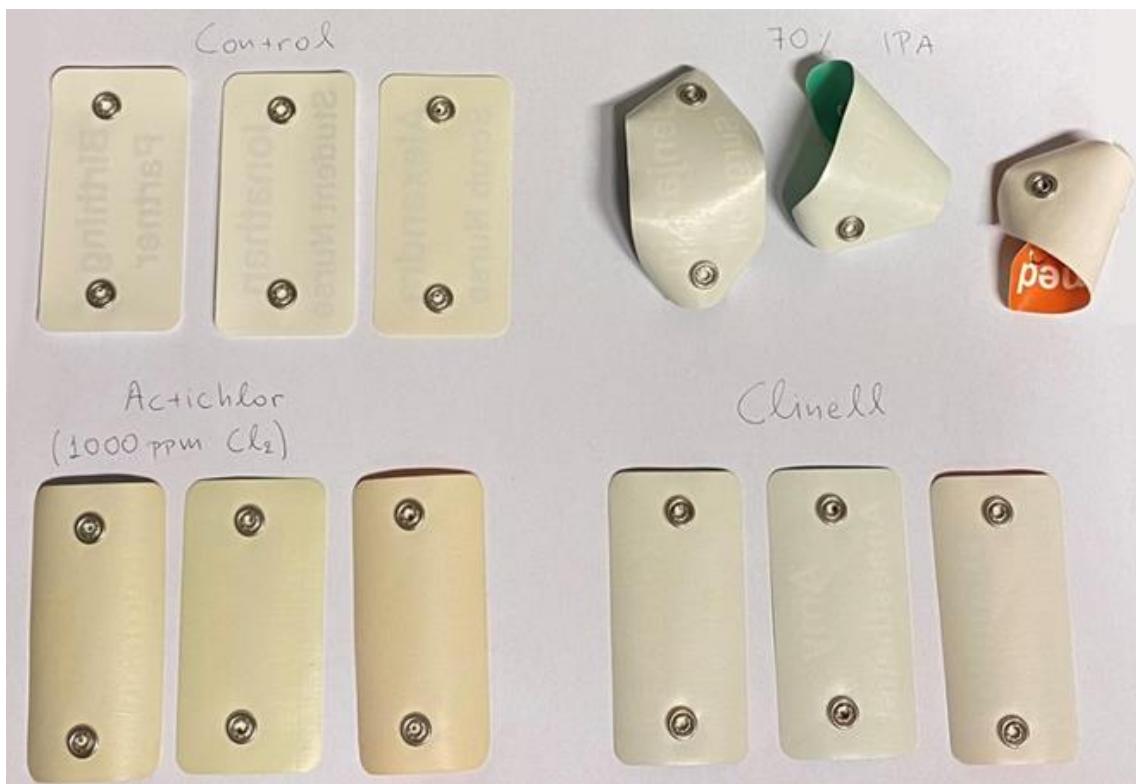
Figure 10: Back side of the polyester badges, post the chemical degradation experiment.

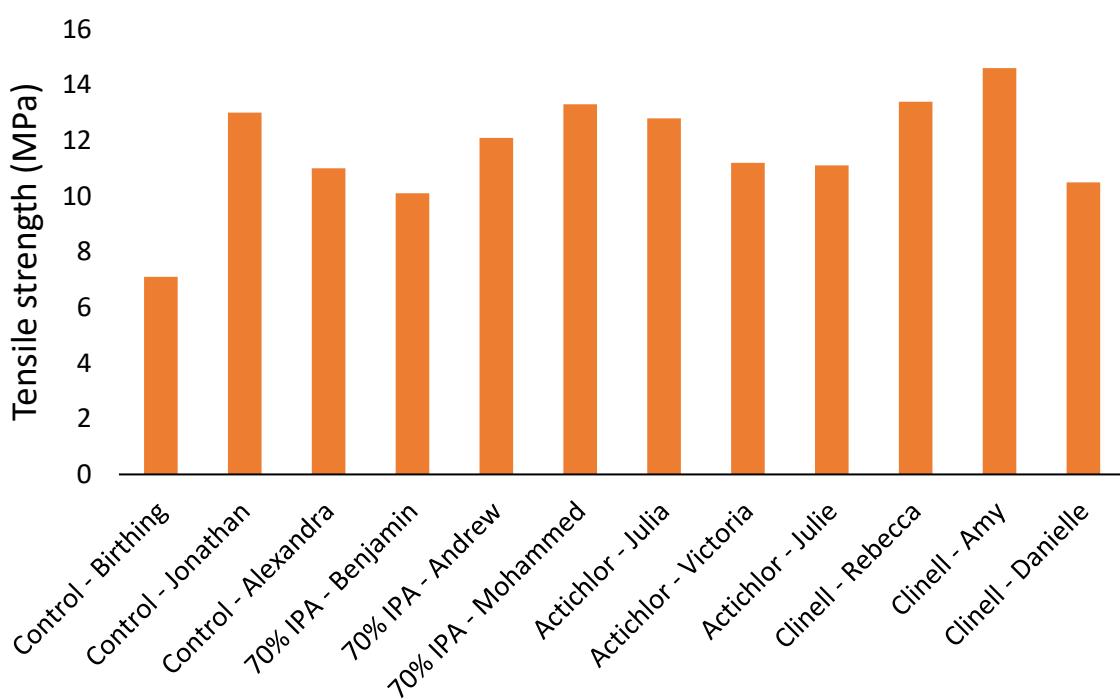
Figure 12: Tensile strength for all test groups

² The tensile strength values for the “Birthing” control badge are significantly different compared to the rest of the data points, due to a mounting issue while testing. The outskirts of the badge’s popper were clamped instead of the fabric on the outer part of the badge, leading to a different form of failure compared to the rest of the badges. In this specimen the failure was observed on the lower part of the popper instead of the upper part, as per all the other samples.

No significant difference was detected in terms of the tensile strength recorded between the badges in the control group and the chemically treated ones. All the badges exhibited similar behaviour, as previously seen in the graphs presented in Figure 12 and Figure 13. The tensile strength recorded for the control group ranged between 11 – 13 MPa. Similar values were recorded for the chemically treated samples (i.e., 70% IPA: 10 – 13 MPa, Actichlor: 11 – 13 MPa, Clinell: 11 – 15 MPa). Therefore, the mechanical performance of the badges did not deteriorate due to the exposure in the cleaning solutions.

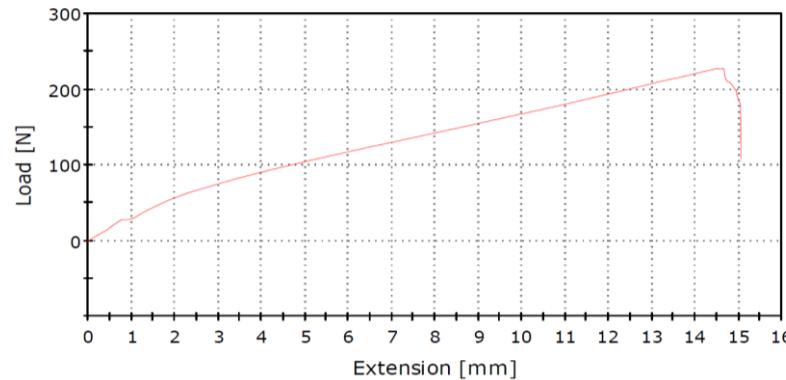
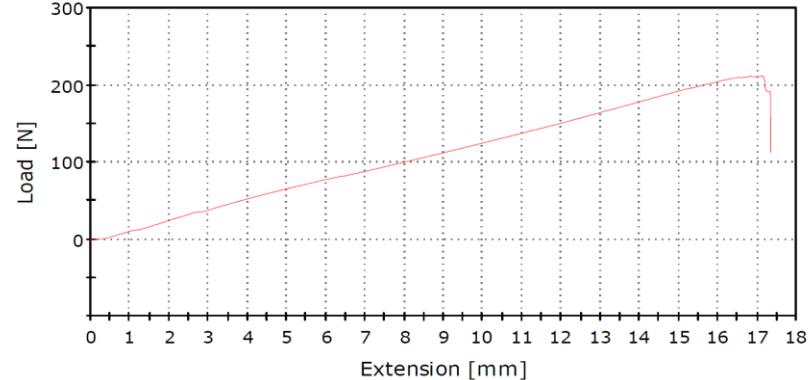
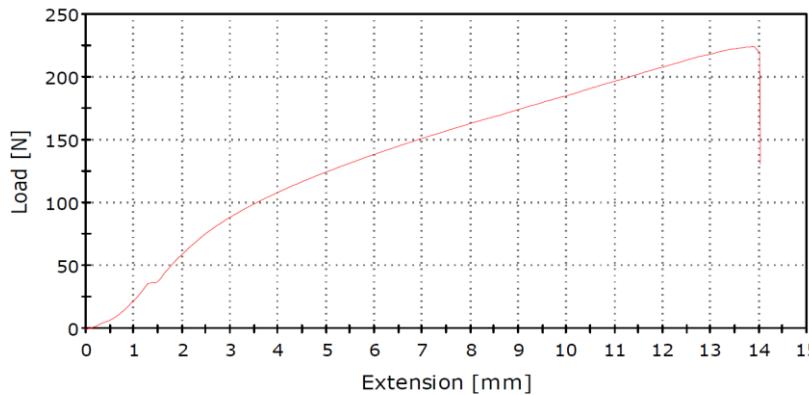
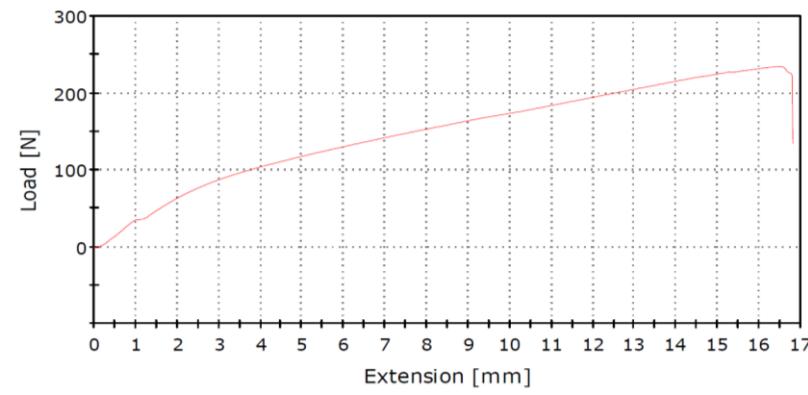
Figure 13: Selected tensile strength graphs for all test groups, pre (control – Jonathan) and post the chemical degradation experiments (70% IPA – Andrew, Actichlor – Julia & Clinell – Rebecca).

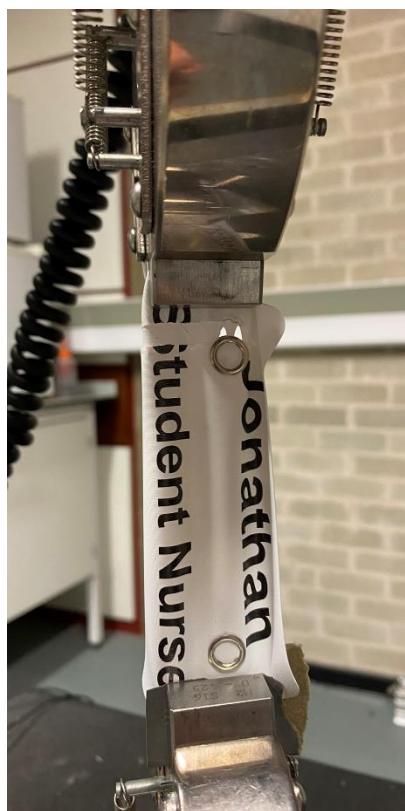
The visual inspection of the tested samples confirmed that all of the badges failed in a similar manner. More specifically, each badge exhibited one or two horizontal tears above the popper closer to the short end, as presented in Figure 14 and Figure 15.

Figure 14: Failure point during tensile strength test.

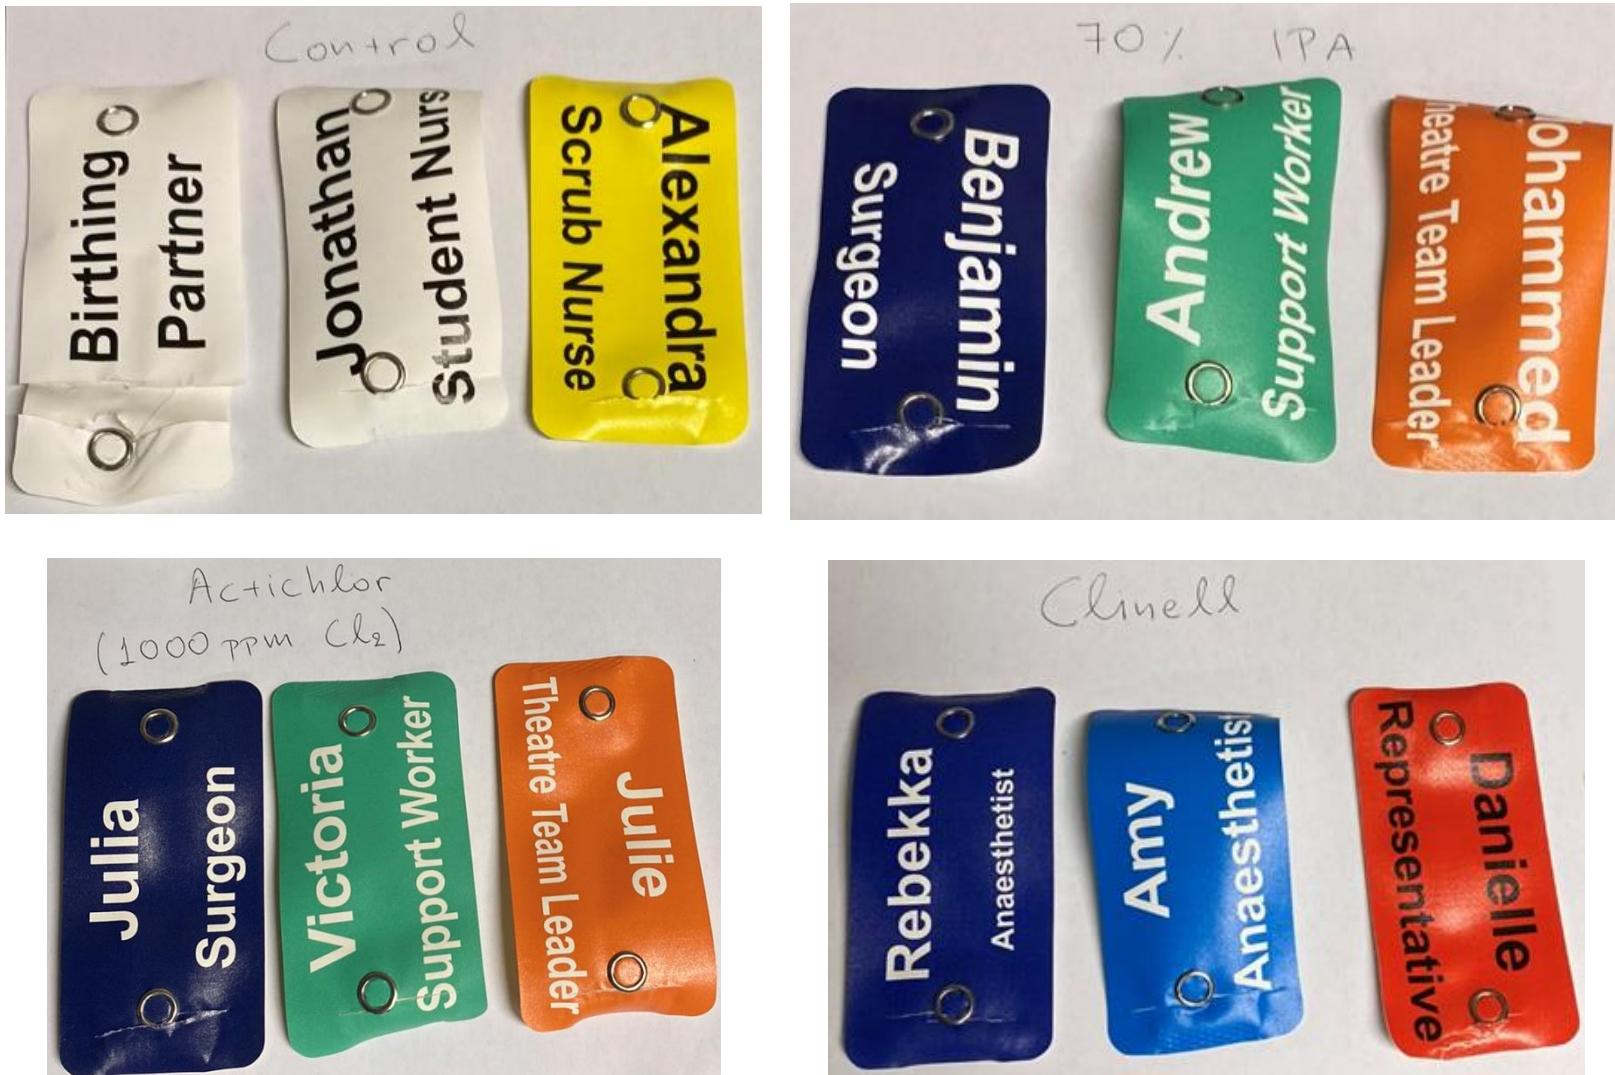
Figure 15: Front side of the polyester badges, post the tensile strength tests.
