# **STRUCTURAL SURVEY REPORT**

**SUMAN TULSIANI  
C.H.S. LTD.**

**3rd Cross Road, Lokhandwala Complex,  
Andheri (West), Mumbai - 400 053**

**28.02.2020**

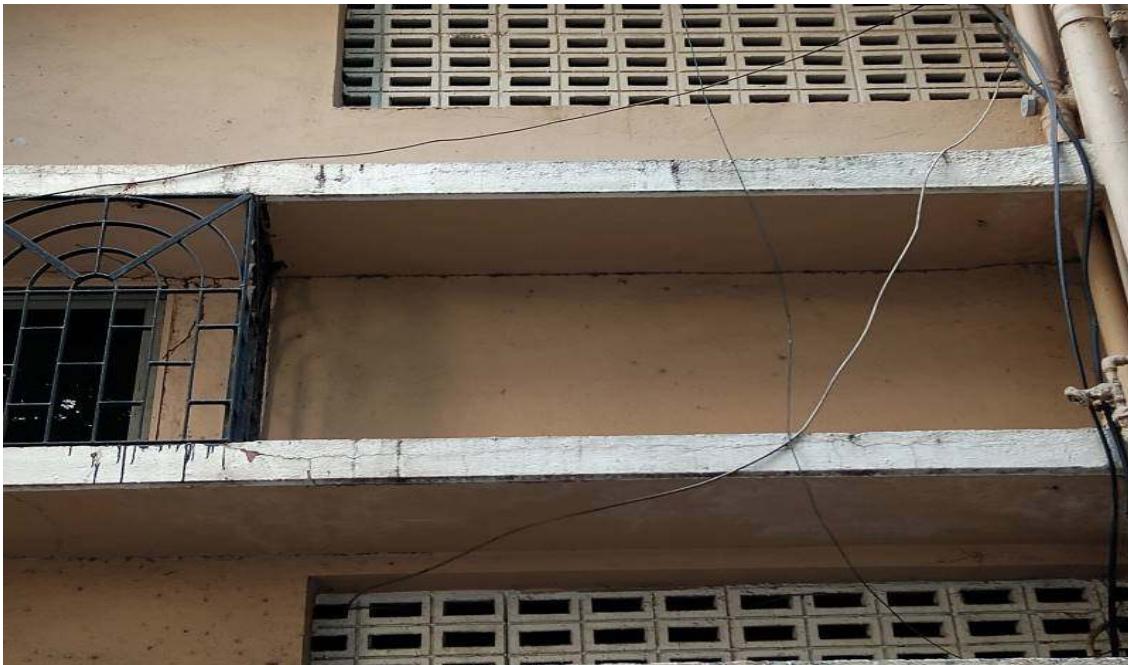
**A, B, C, WING EXTERNAL**

East side 1<sup>st</sup> floor chajja edges are having structural cracks.

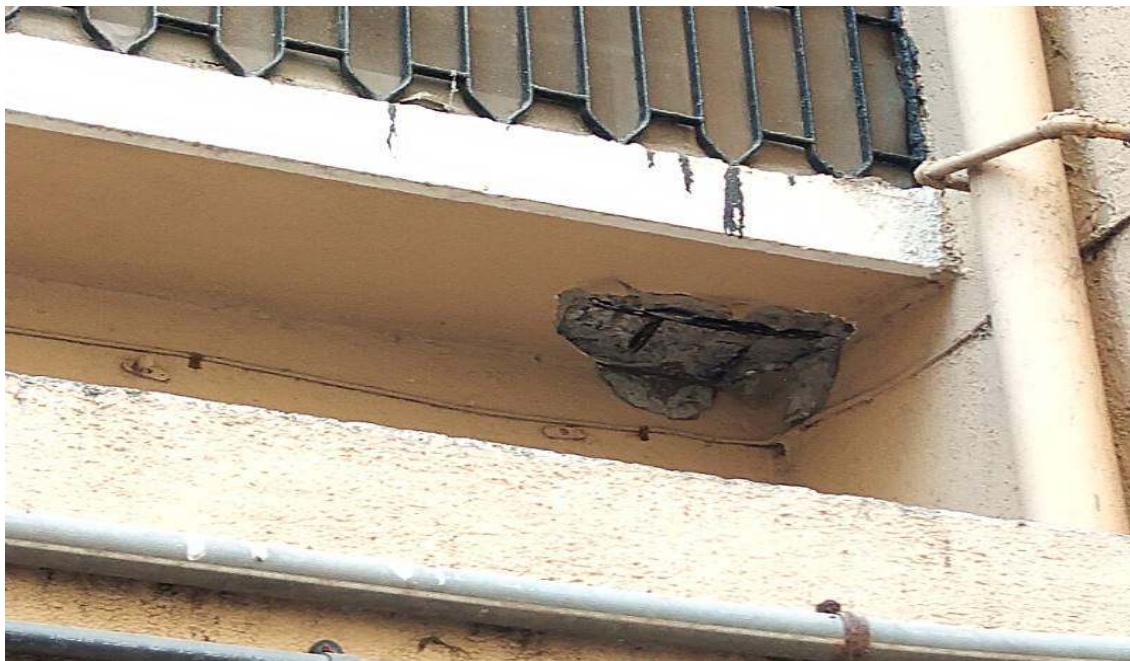
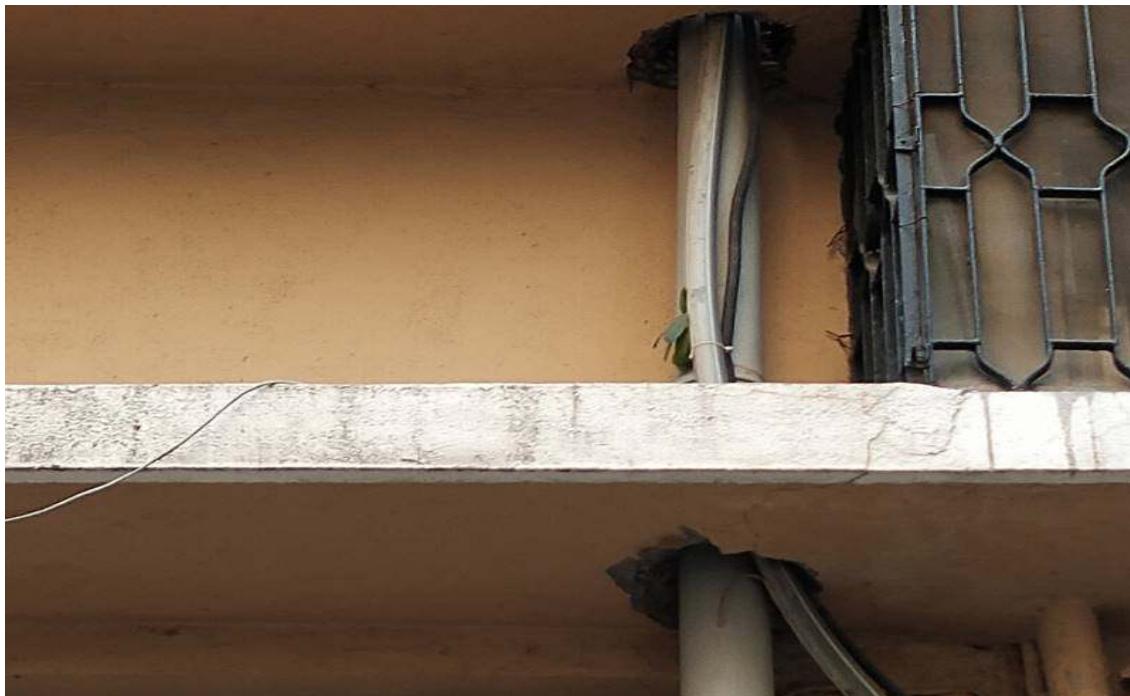
**A, B, C, WING EXTERNAL**

East side 1<sup>st</sup> floor chajja bottom cover concrete is fallen down & steel is also visible.

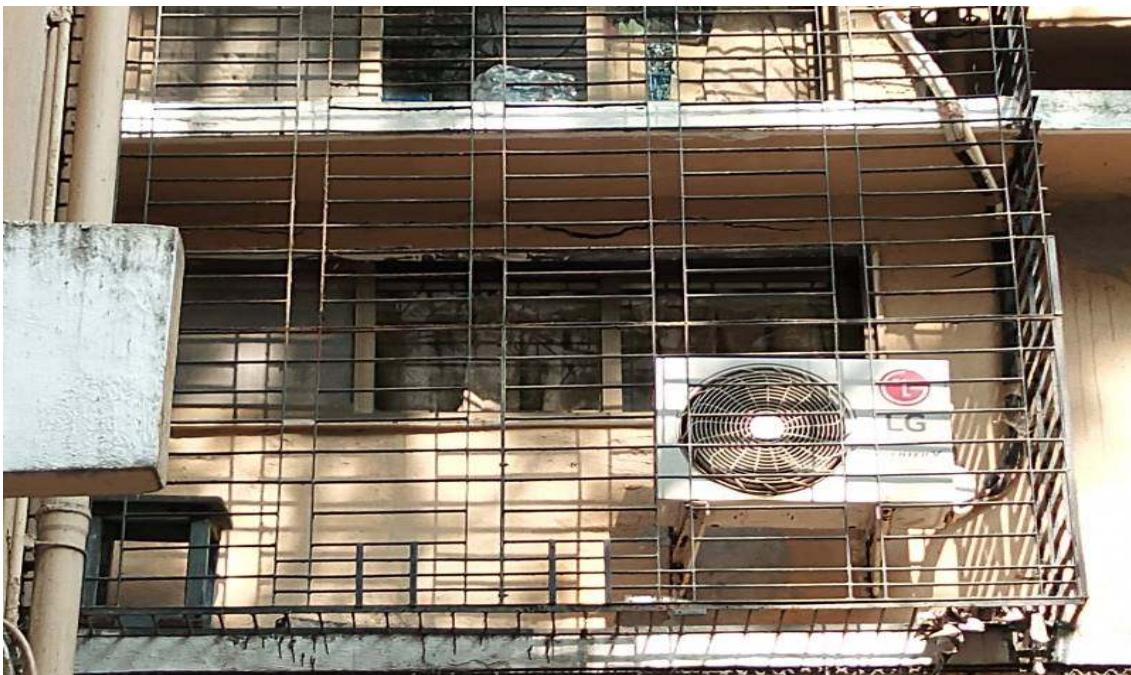
**A, B, C, WING EXTERNAL**

West side window beam has structural cracks.

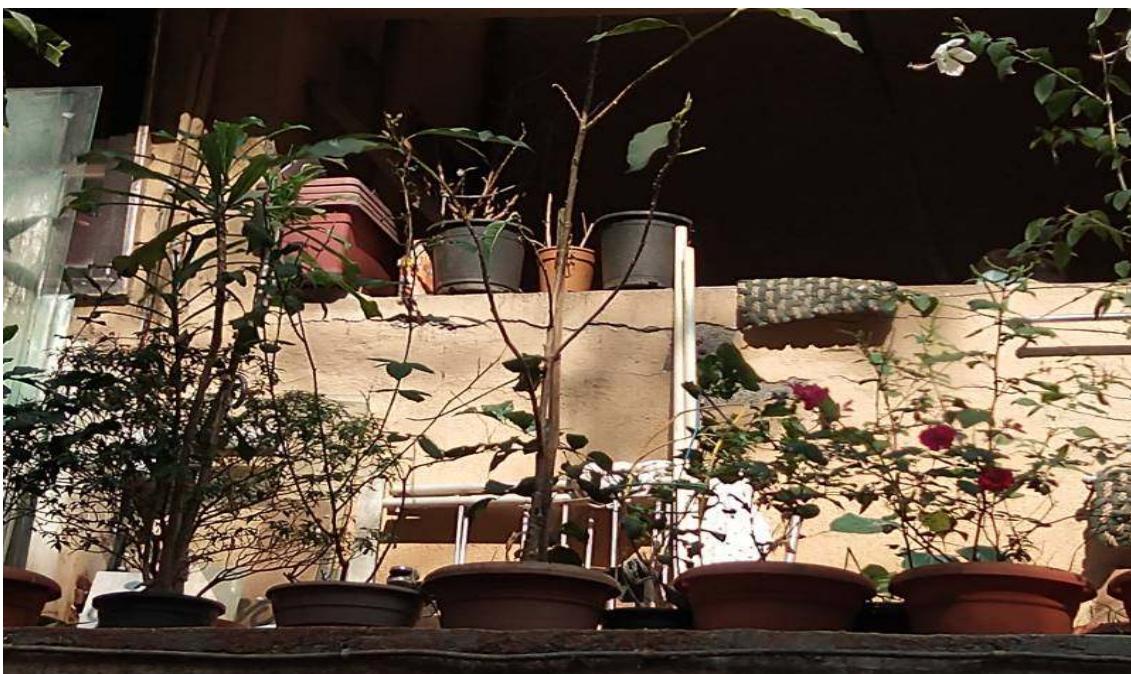
**A, B, C, WING EXTERNAL**

West side balcony pardhi is damaged badly having wide structural cracks.

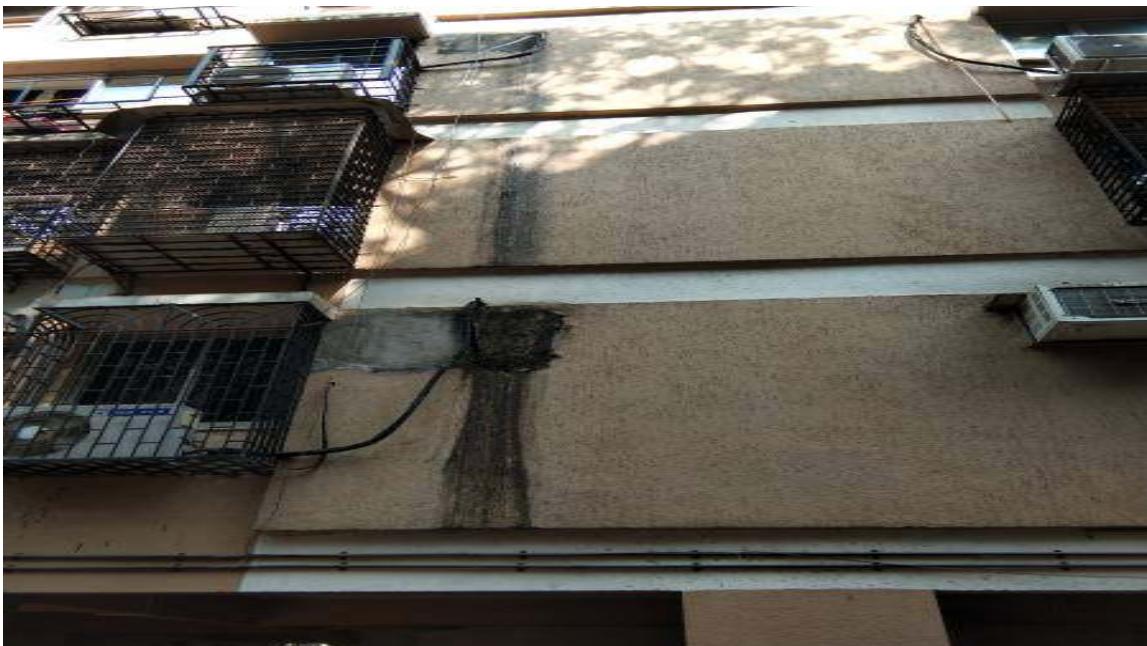
**A, B, C, WING EXTERNAL**

West side 1<sup>st</sup> floor AC outlet is causing leakage.

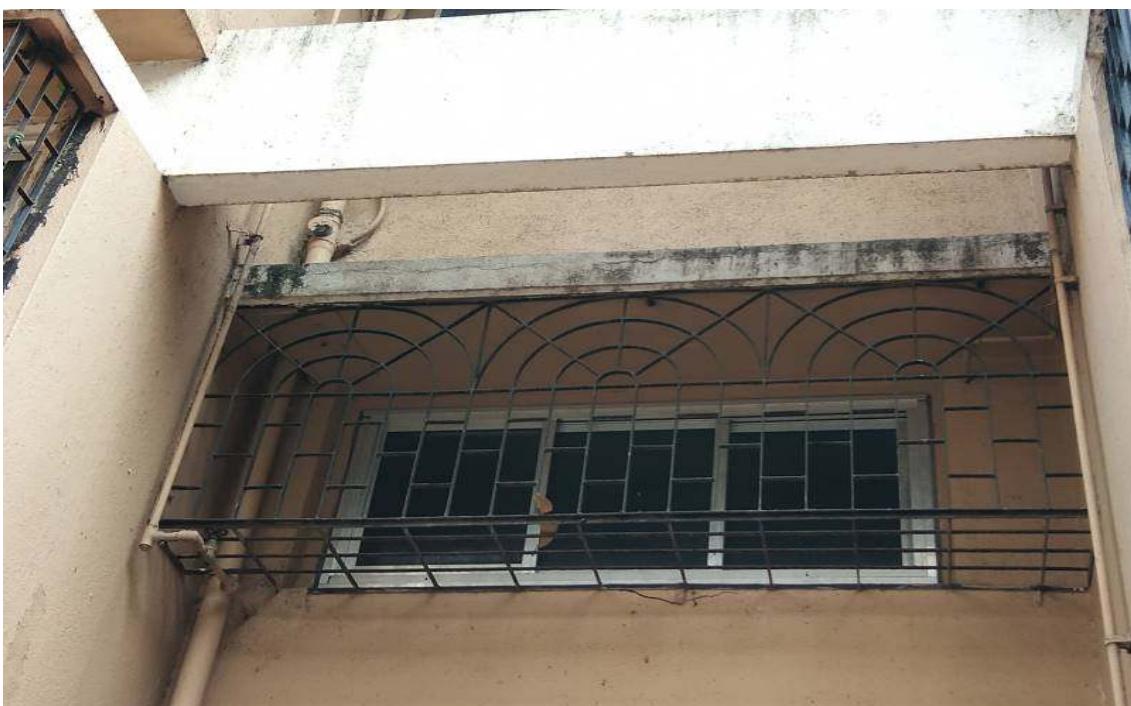
**A, B, C, WING EXTERNAL**

North side window chajja edges are having structural cracks.

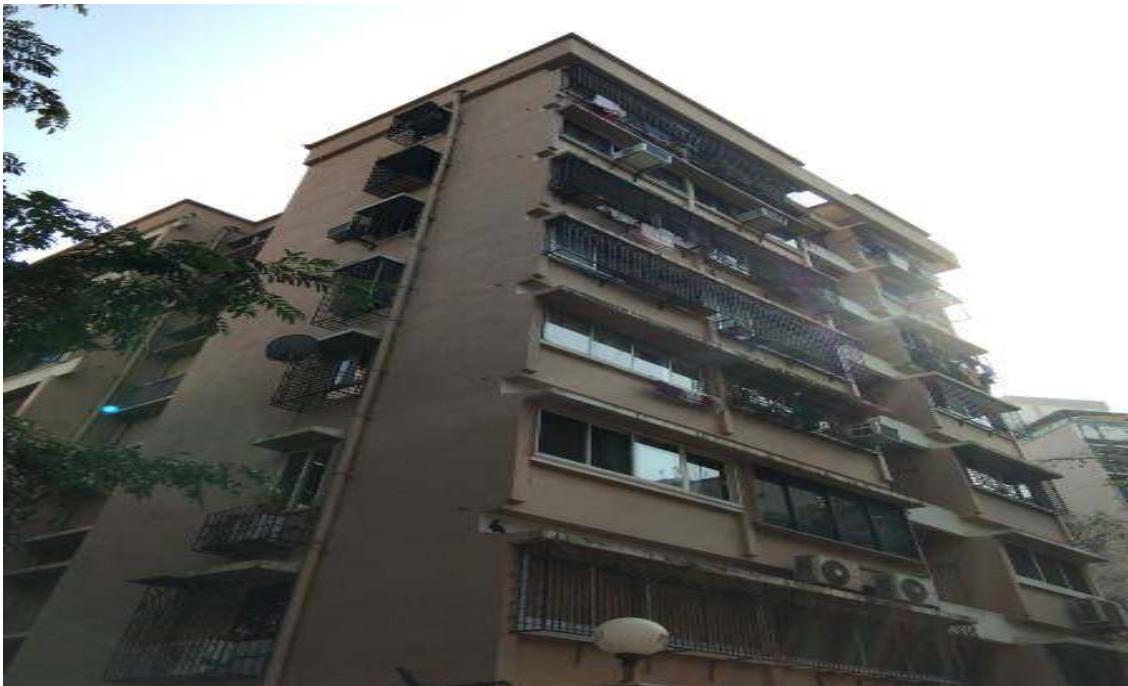
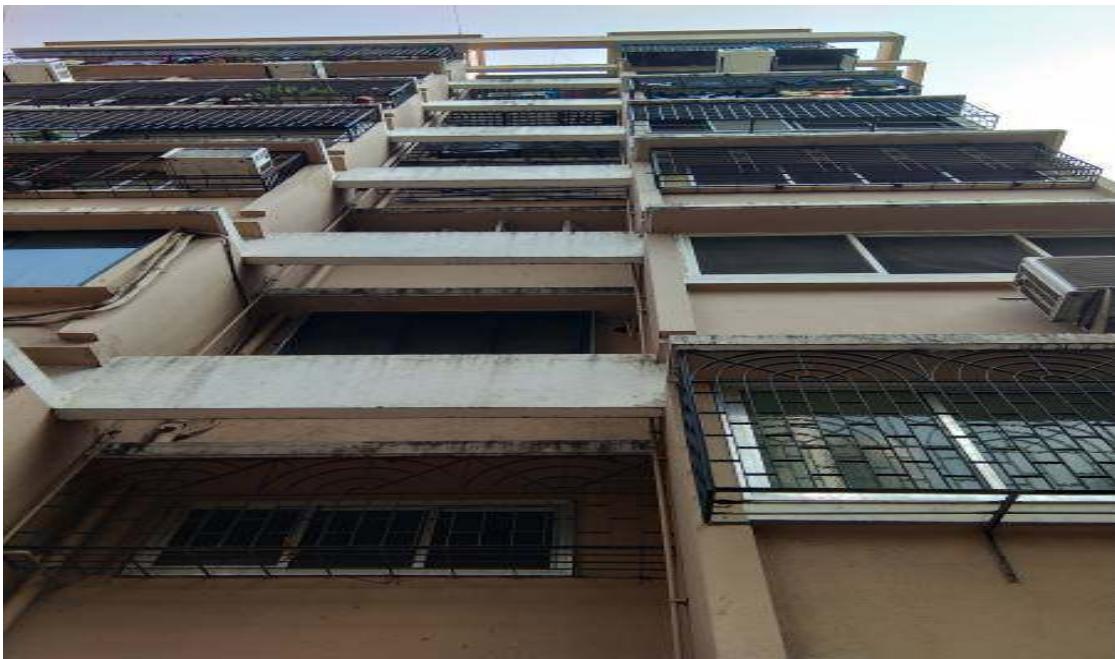
**A, B, C, WING EXTERNAL**

Building external photo view.

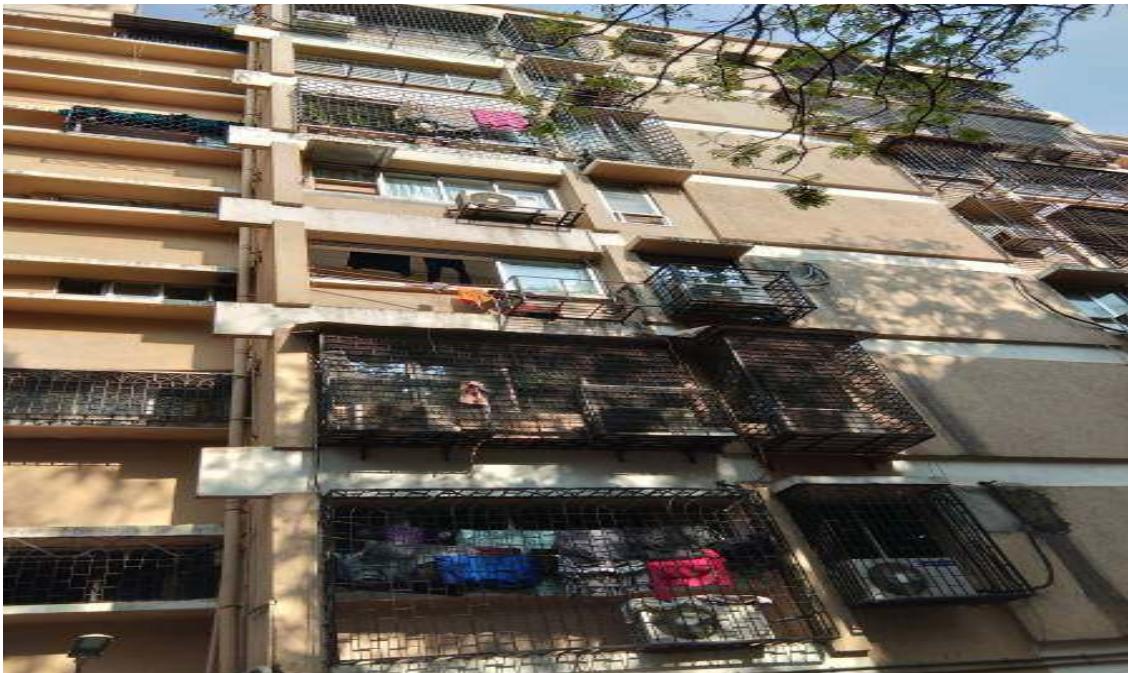
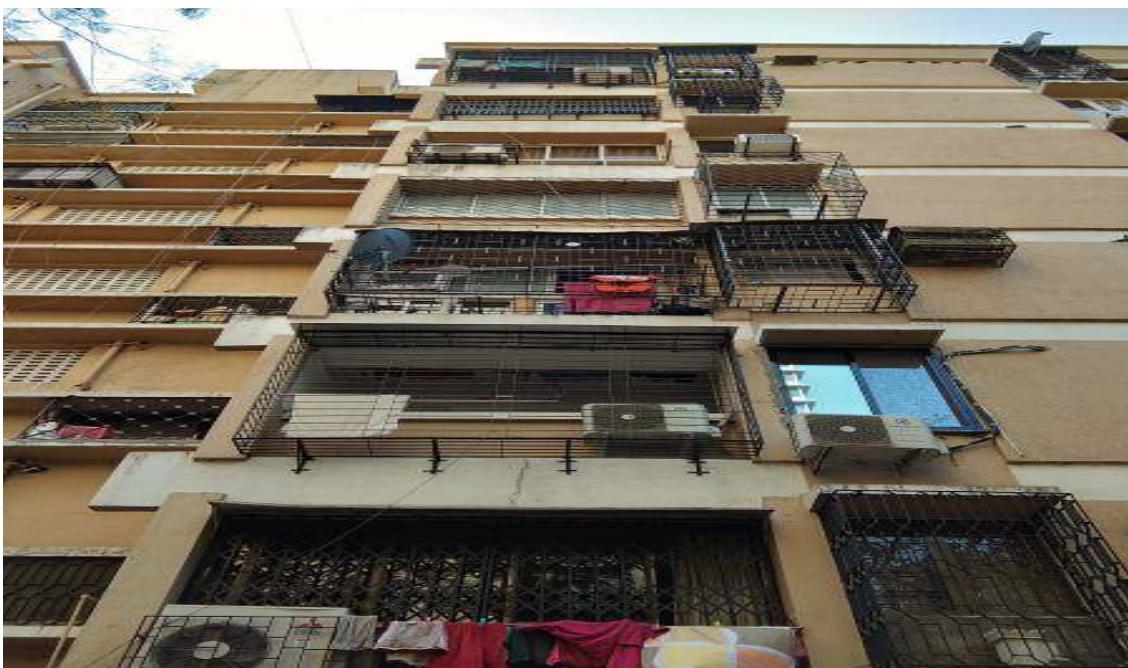
**A, B, C, WING EXTERNAL**

Building external photo view.

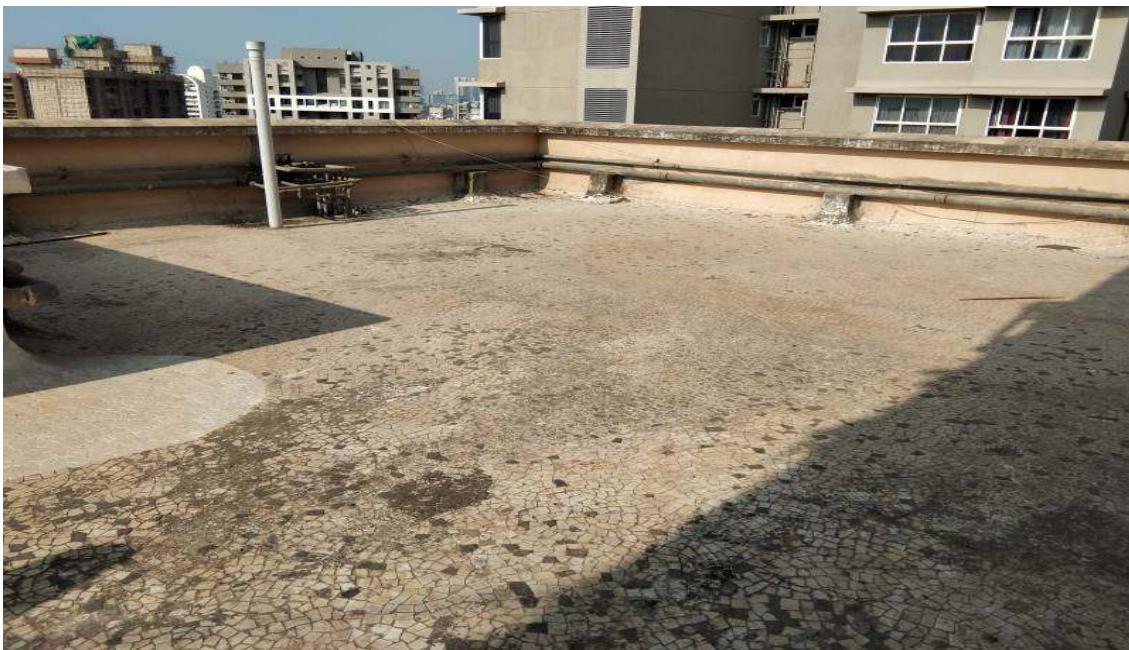
**EXTERNAL TOWER**

Terrace view

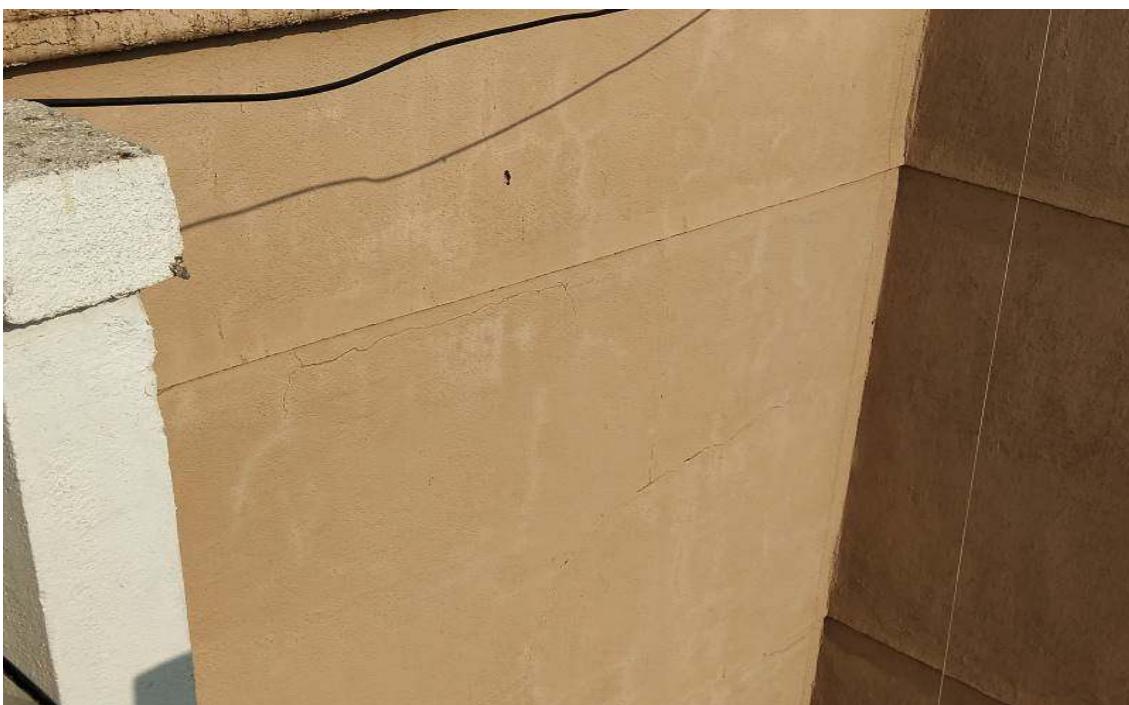
**EXTERNAL TOWER**

Beam is having structural cracks

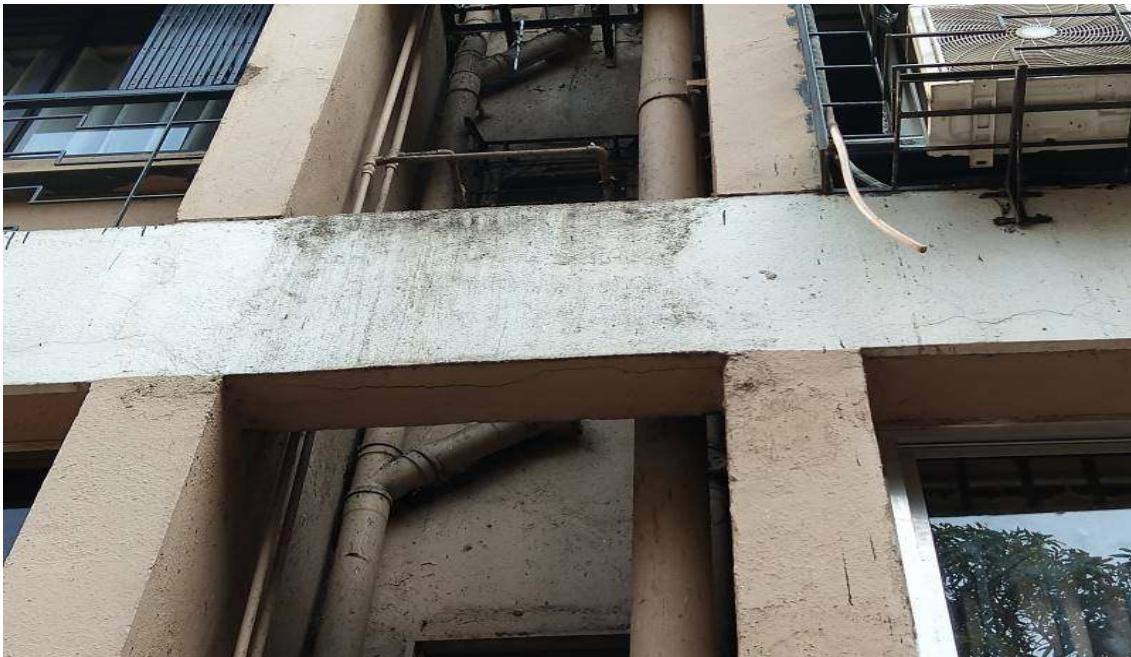
### EXTERNAL TOWER

2<sup>nd</sup> floor beam bottom is having structural crack

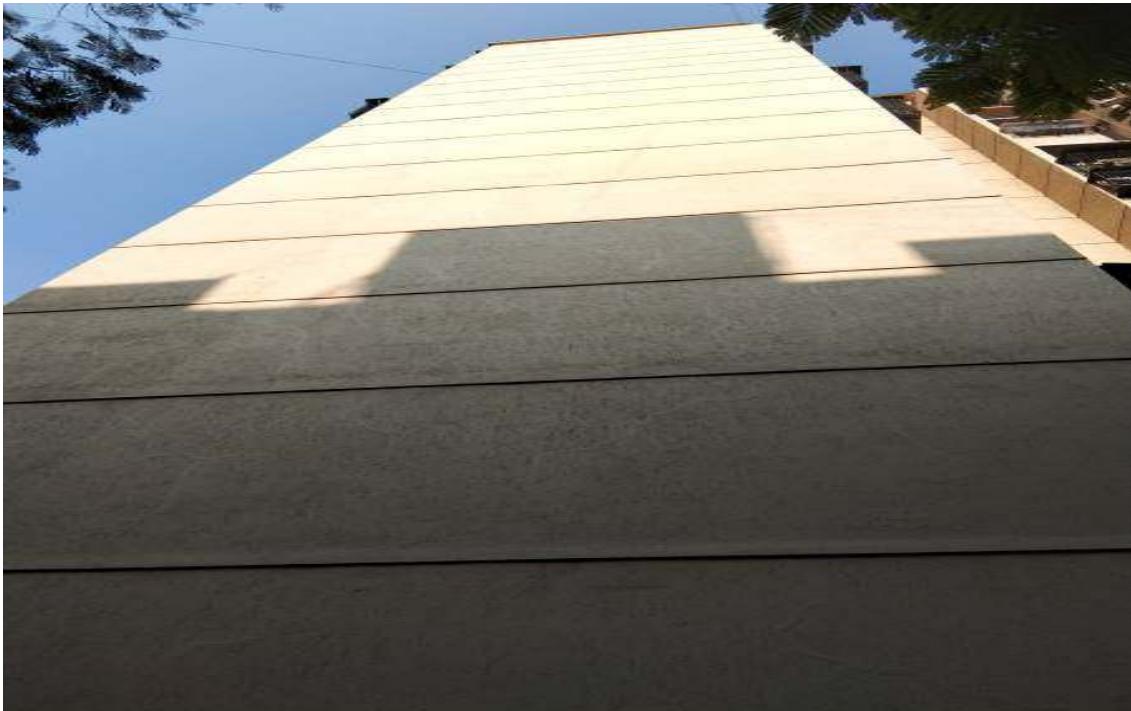
### EXTERNAL TOWER

South side view

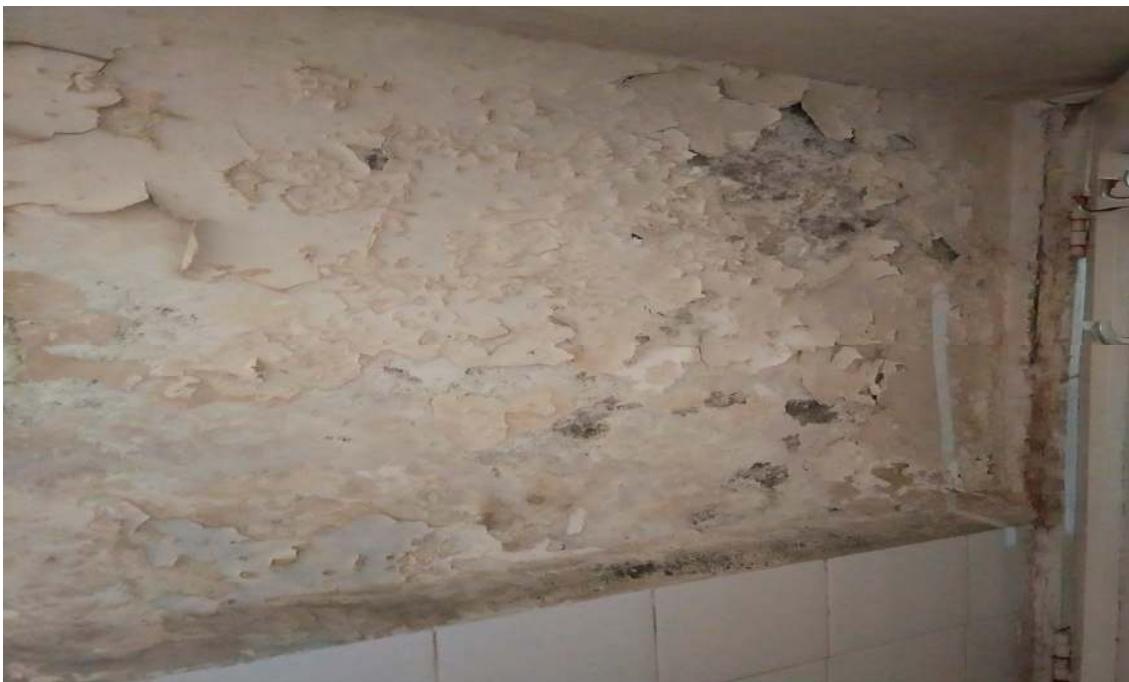
**FLAT NO. A/703**

Kitchen beam paint is peeled off.

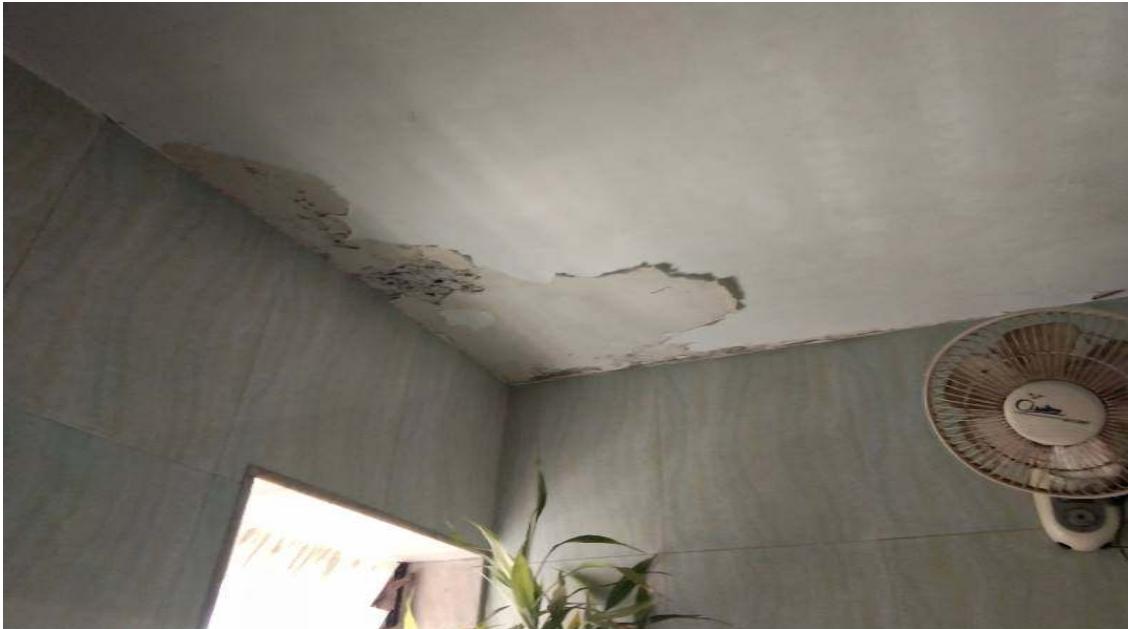
**FLAT NO. A/601**

Bathroom ceiling is having monsoon related leakages; concrete is also deboned and bulged

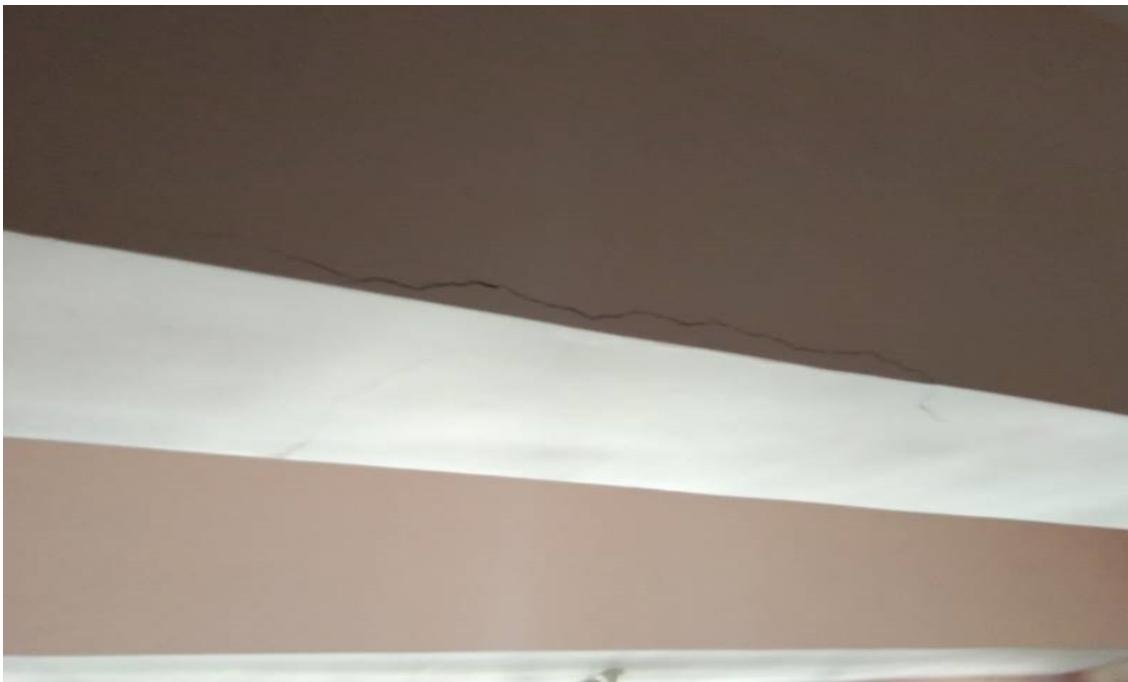
**FLAT NO. A/501**

Bedroom beam edge is having structural cracks

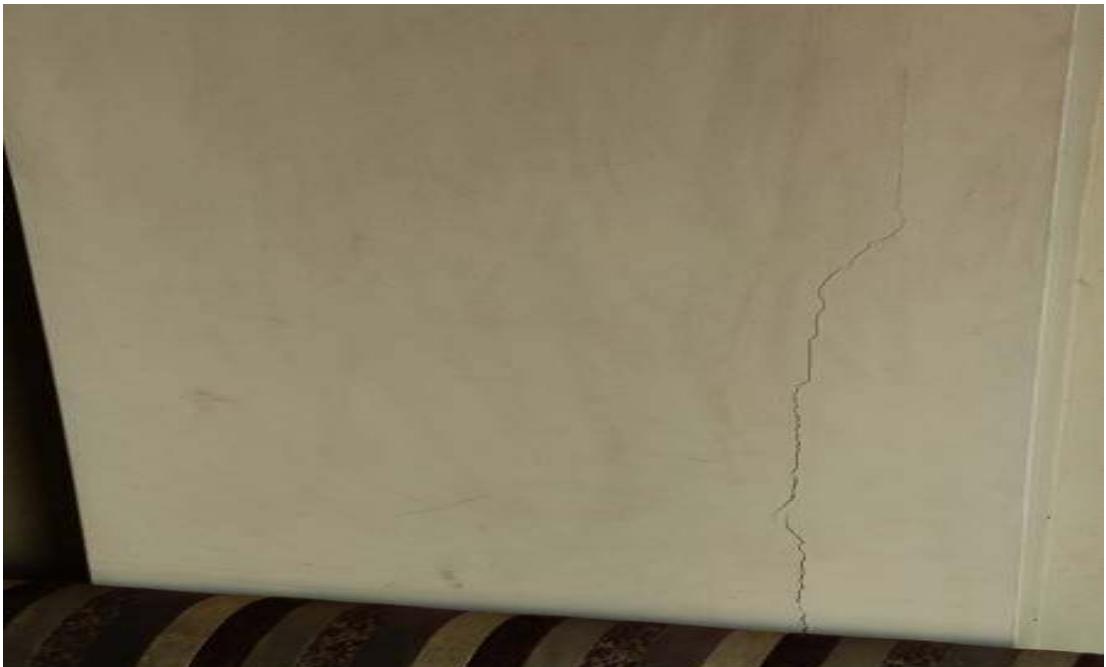
**FLAT NO. A/501**

Bedroom beam is having structural cracks

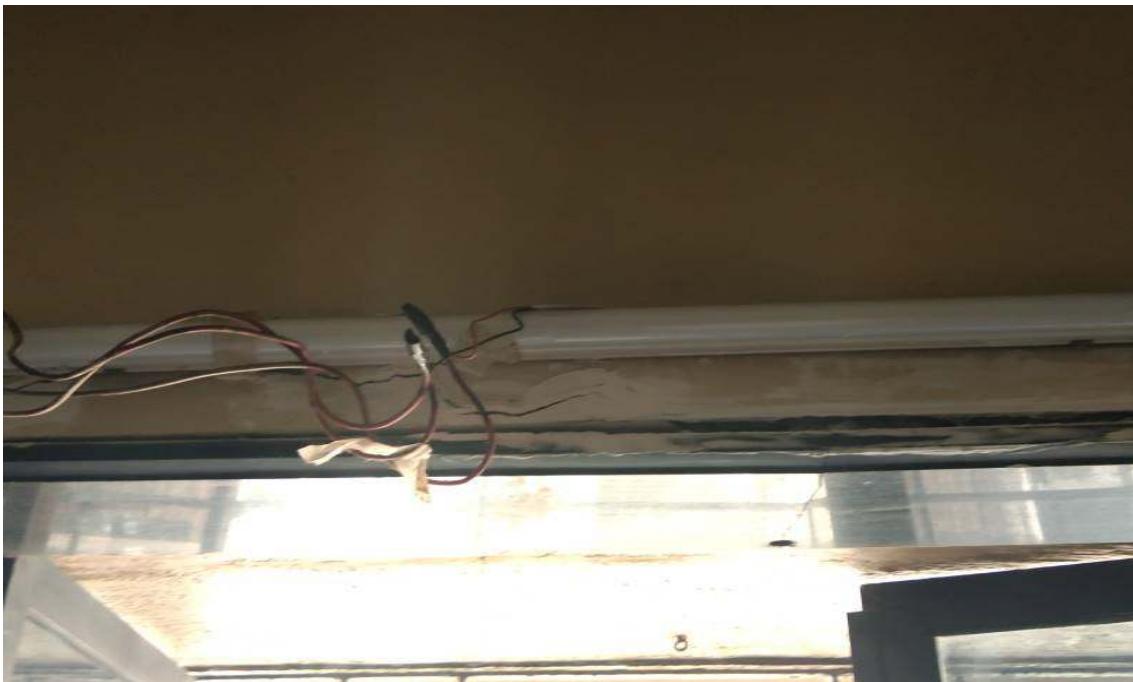
**FLAT NO. A/501**

Kitchen window beam has structural cracks, granite is also loosened

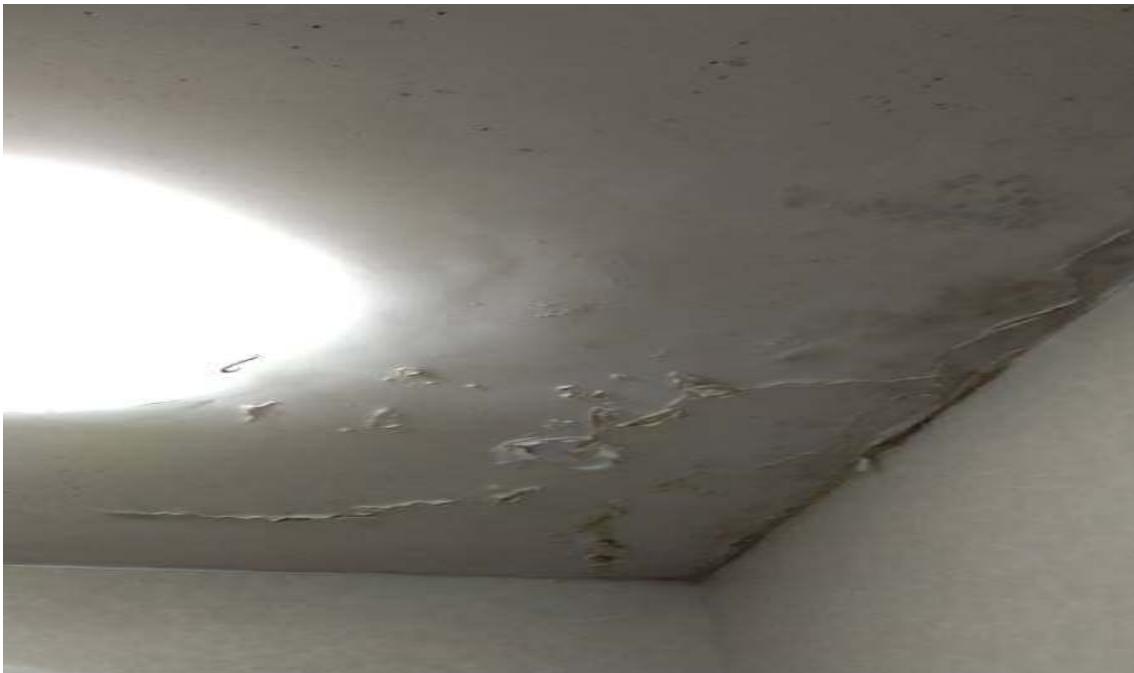
**FLAT NO. A/201**

Bathroom ceiling has leakage from upper flats at present found dry.

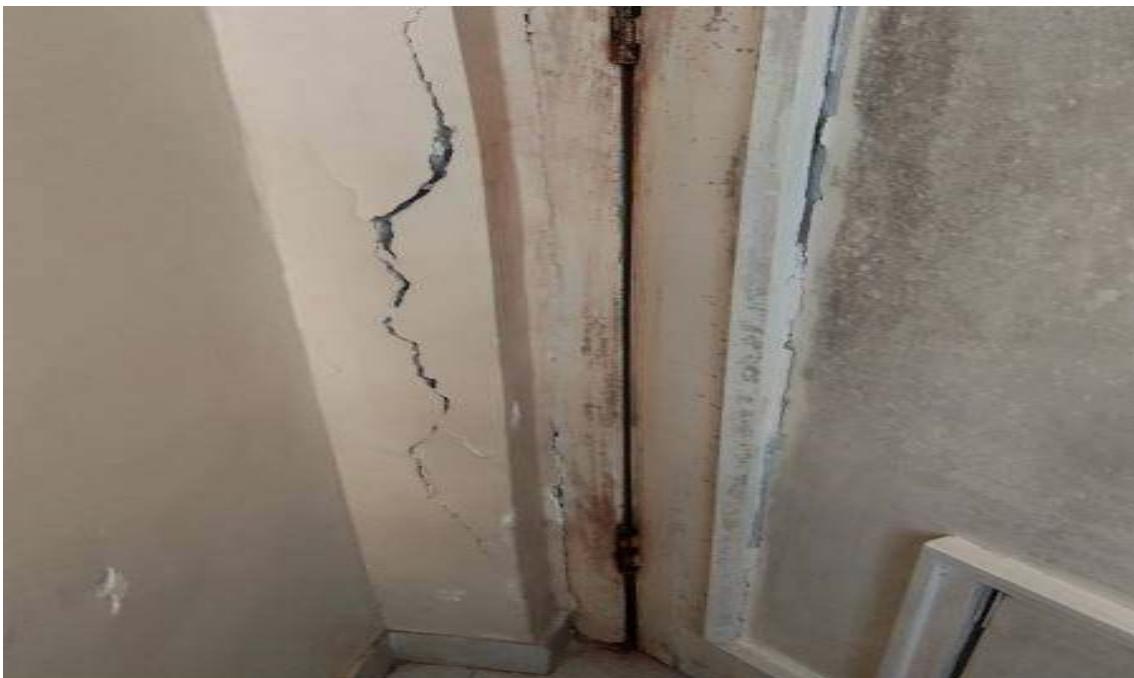
**FLAT NO. A/201**

Bedroom balcony column has major wide structural cracks.

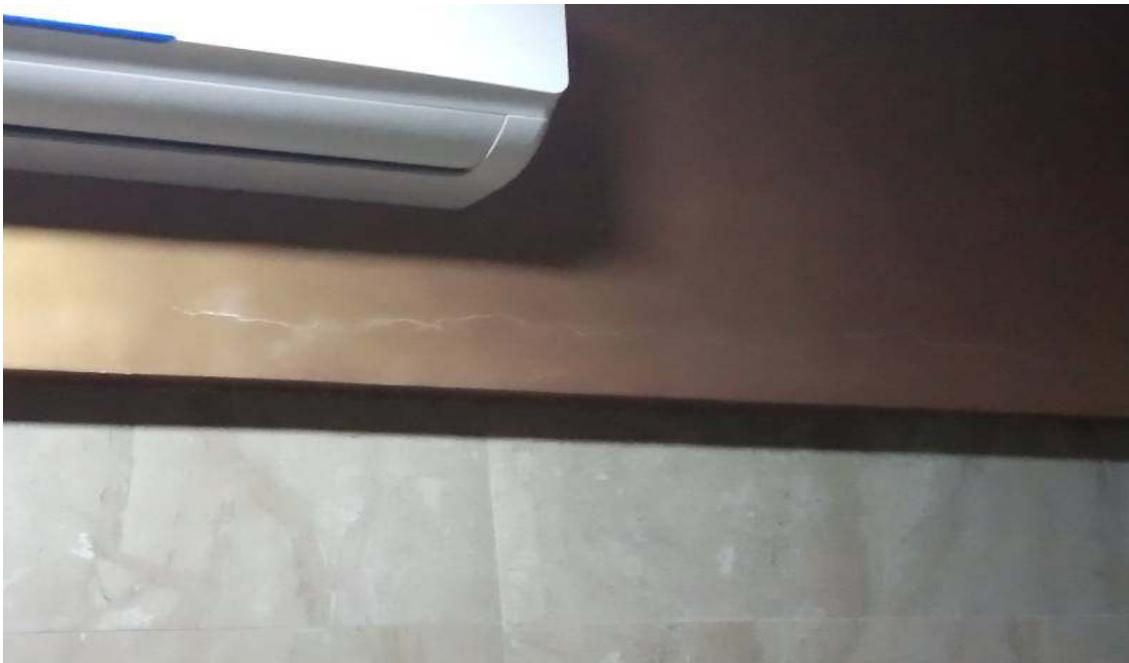
**FLAT NO. A/102-103**

Bedroom beam has structural cracks.

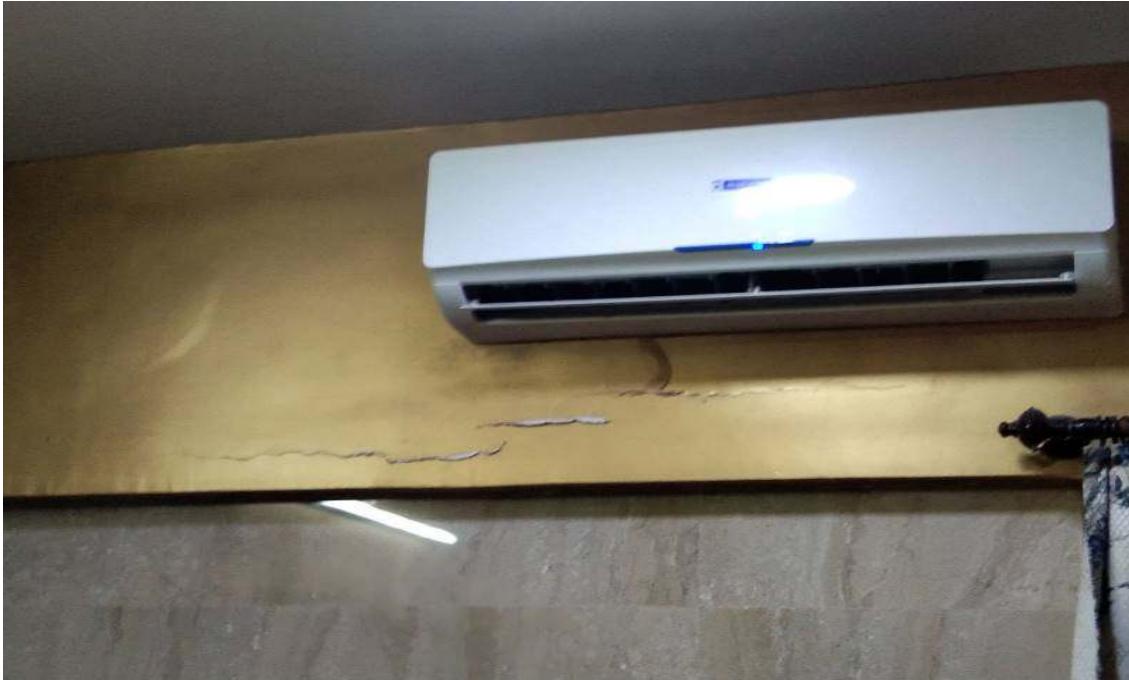
**FLAT NO. A/102-103**

Bedroom beam has multiple structural cracks.

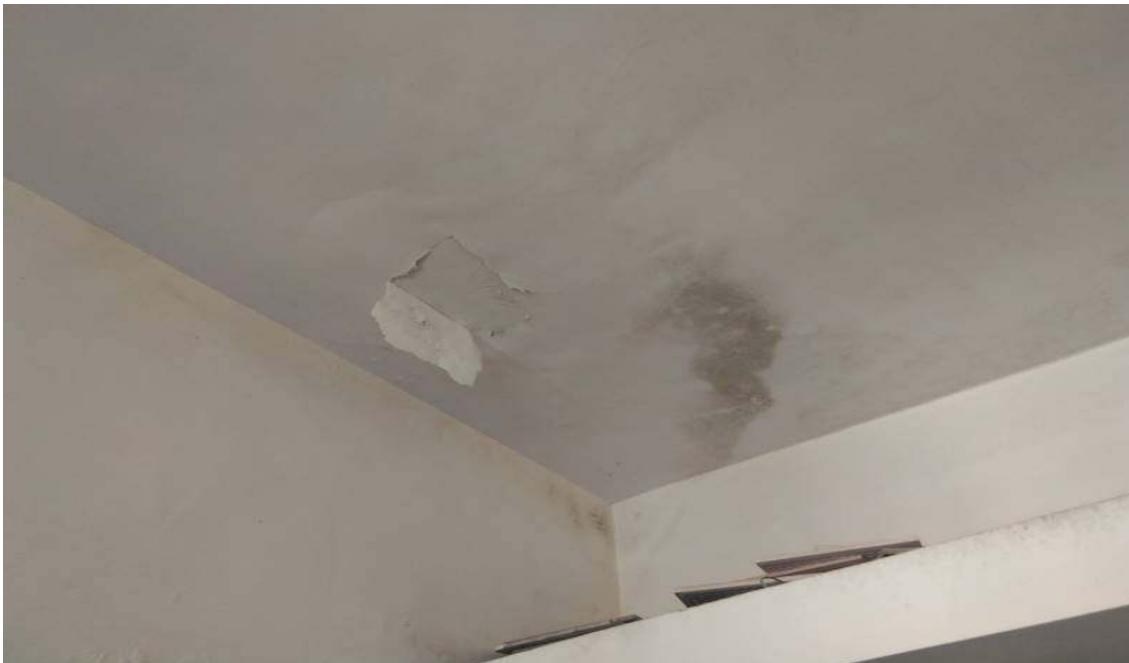
**FLAT NO. B/702**

Kitchen ceiling has leakage from upper flat at present found dry.

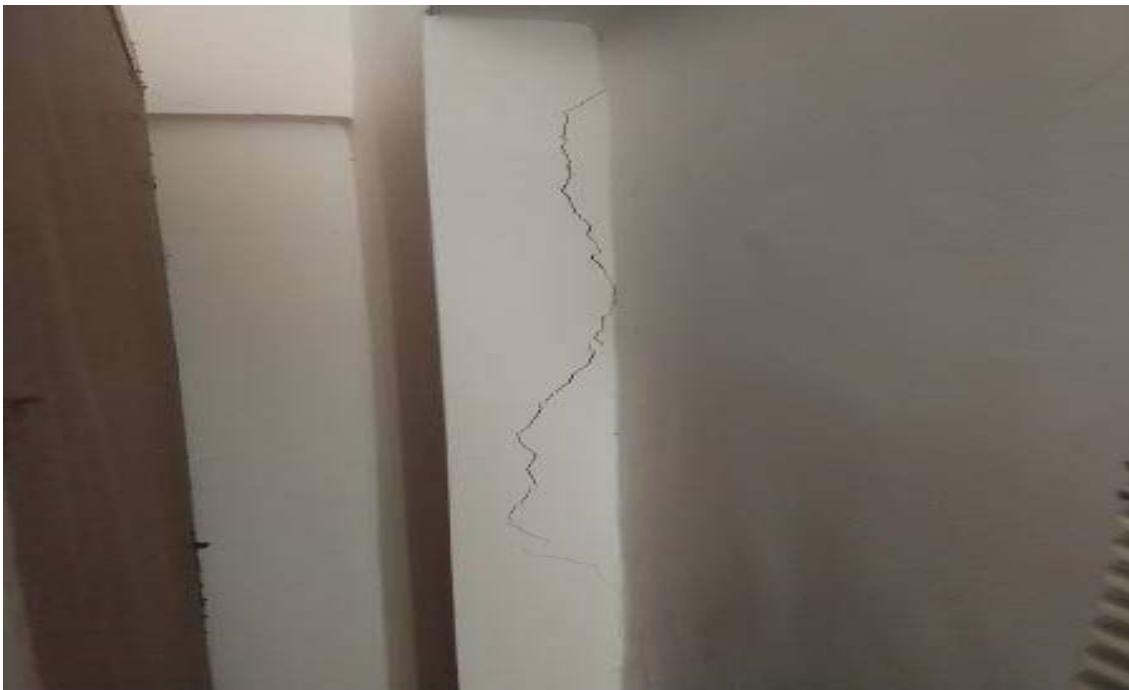
**FLAT NO. B/702**

Bedroom column has major structural cracks.

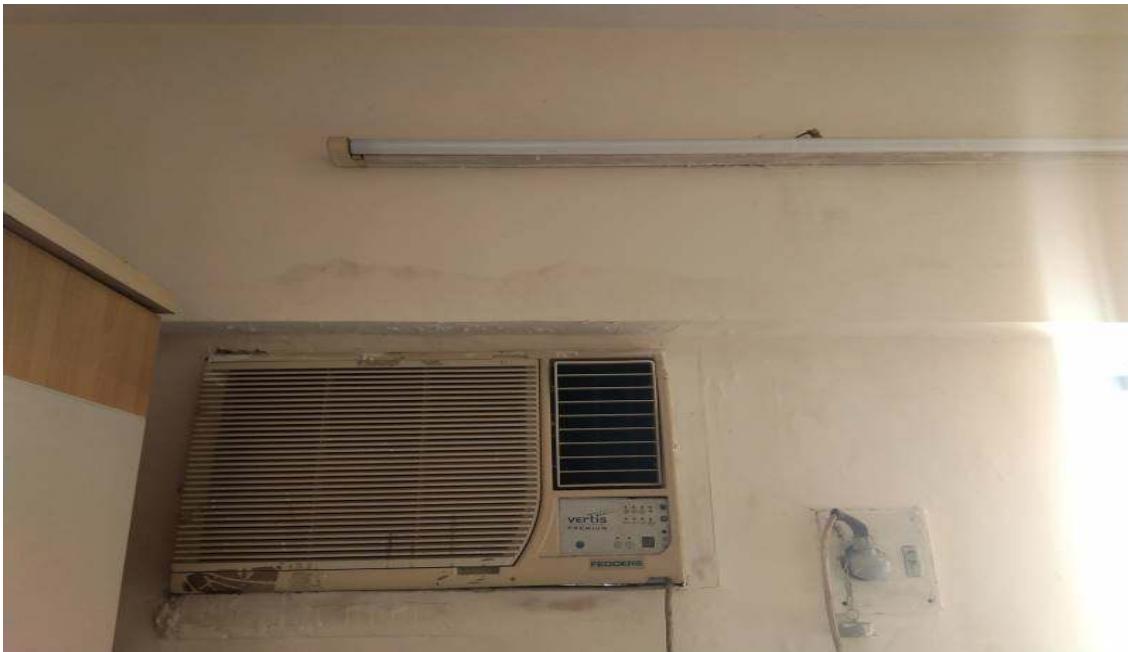
**FLAT NO. B/702**

Bedroom window wall has monsoon related leakages from external wall.

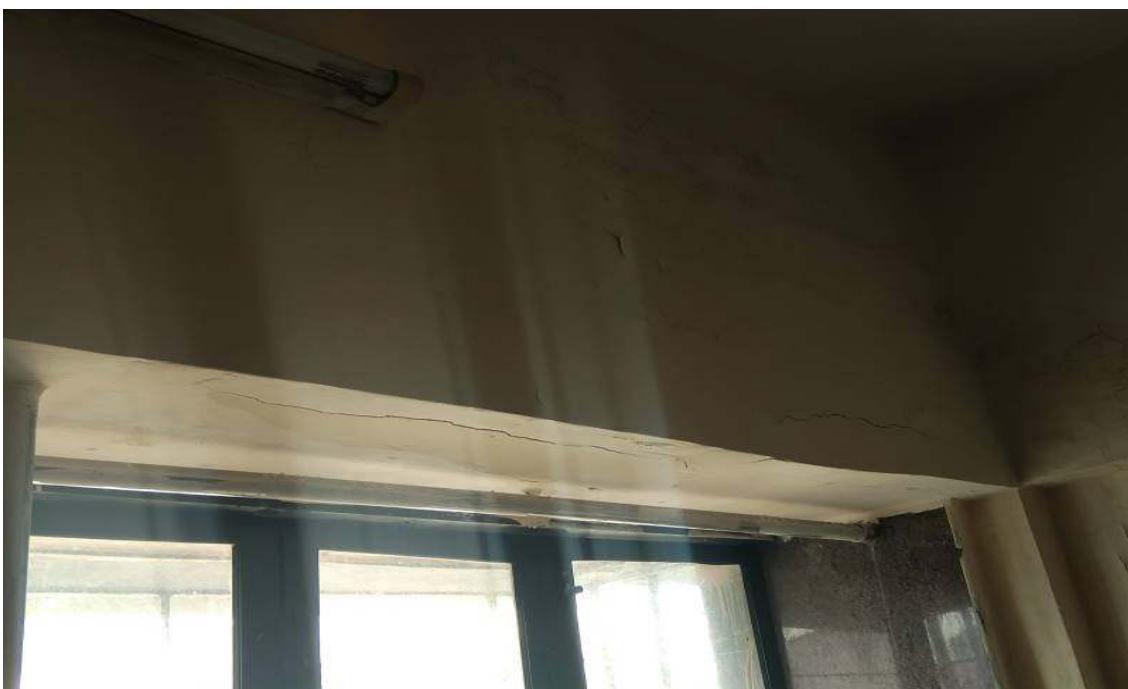
**FLAT NO. B/702**

Bedroom window beam bottom has structural cracks.

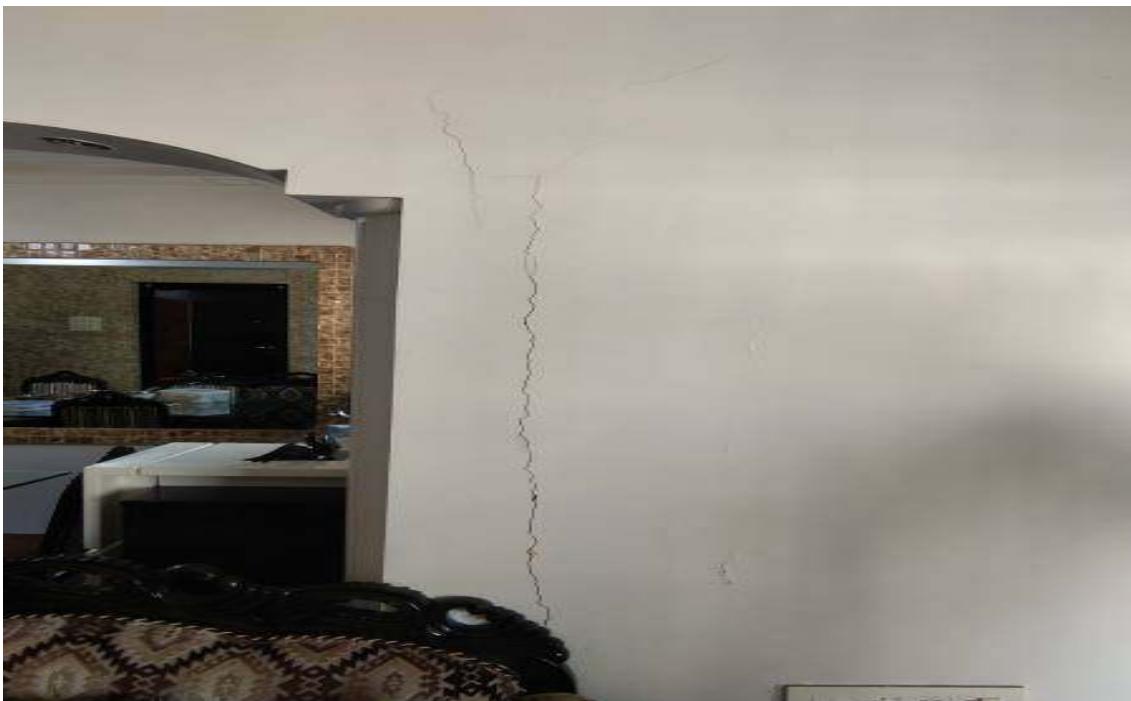
**FLAT NO. B/703**

Hall column has vertical separation cracks.

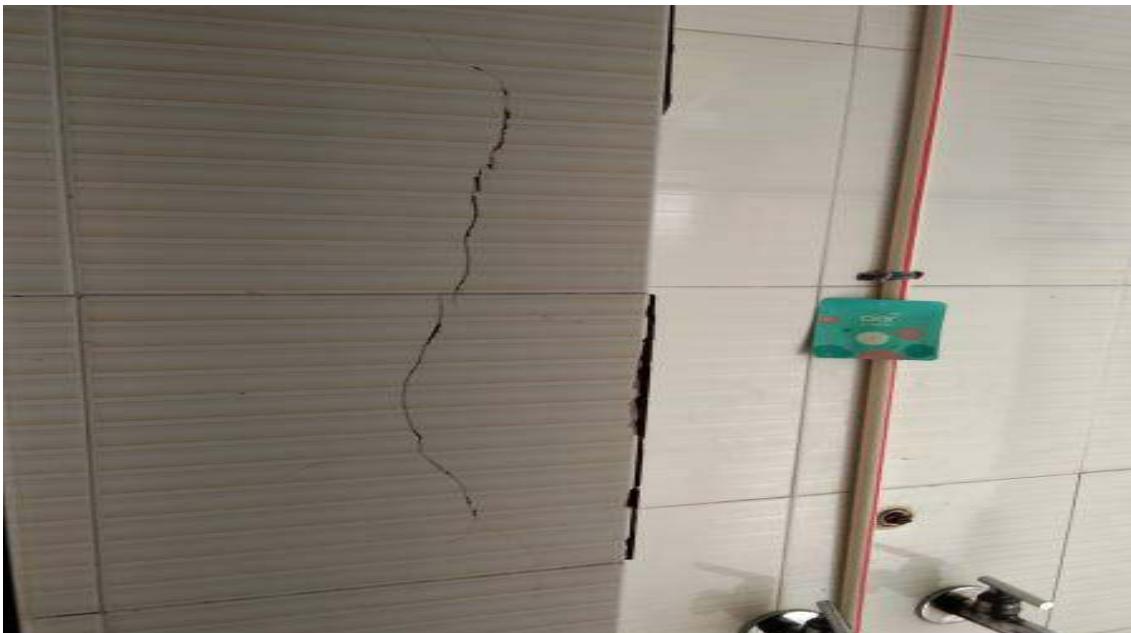
**FLAT NO. B/601**

W.C column has structural cracks including tiles.
