# **STRUCTURAL SURVEY REPORT**

**SUMAN TULSIANI  
C.H.S. LTD.**

**3rd Cross Road, Lokhandwala Complex,  
Andheri (West), Mumbai - 400 053**

**28.02.2020**

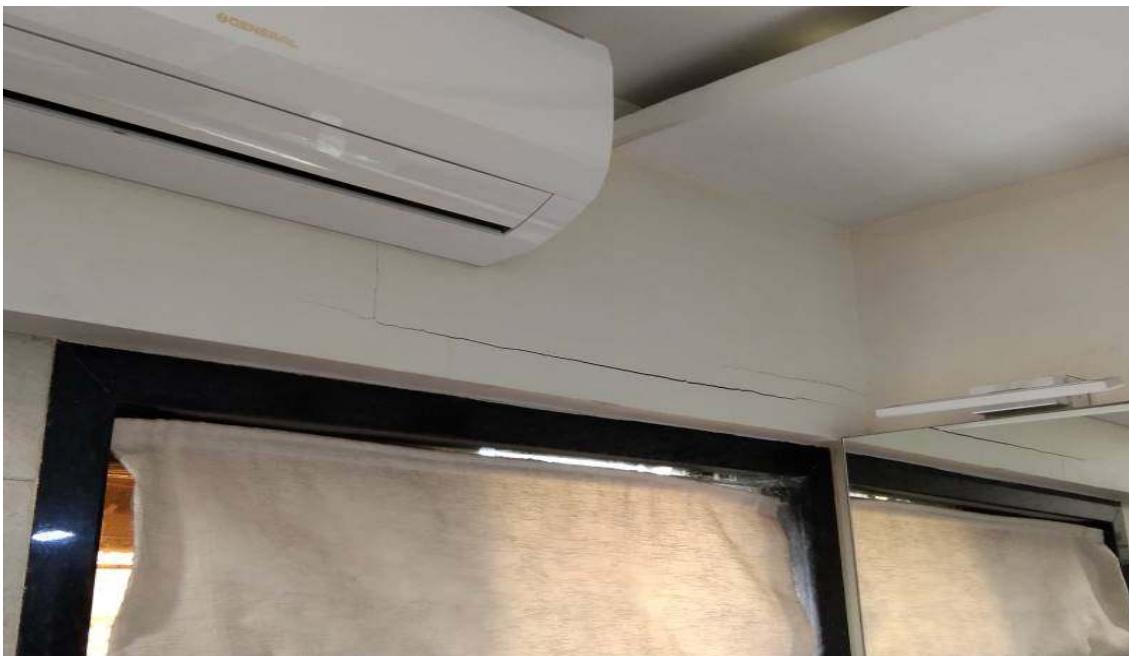
**FLAT NO. B/602**

Bedroom window beam has cracks.

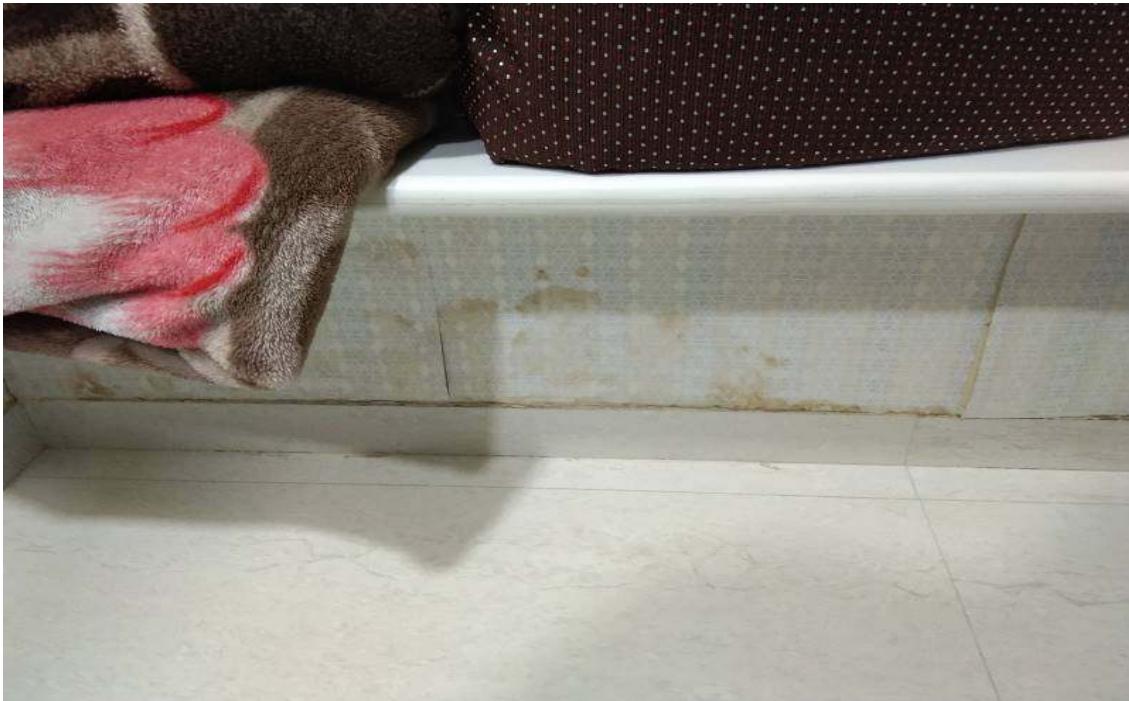
**FLAT NO. B/603**

Bedroom wall has monsoon related leakages from external wall.

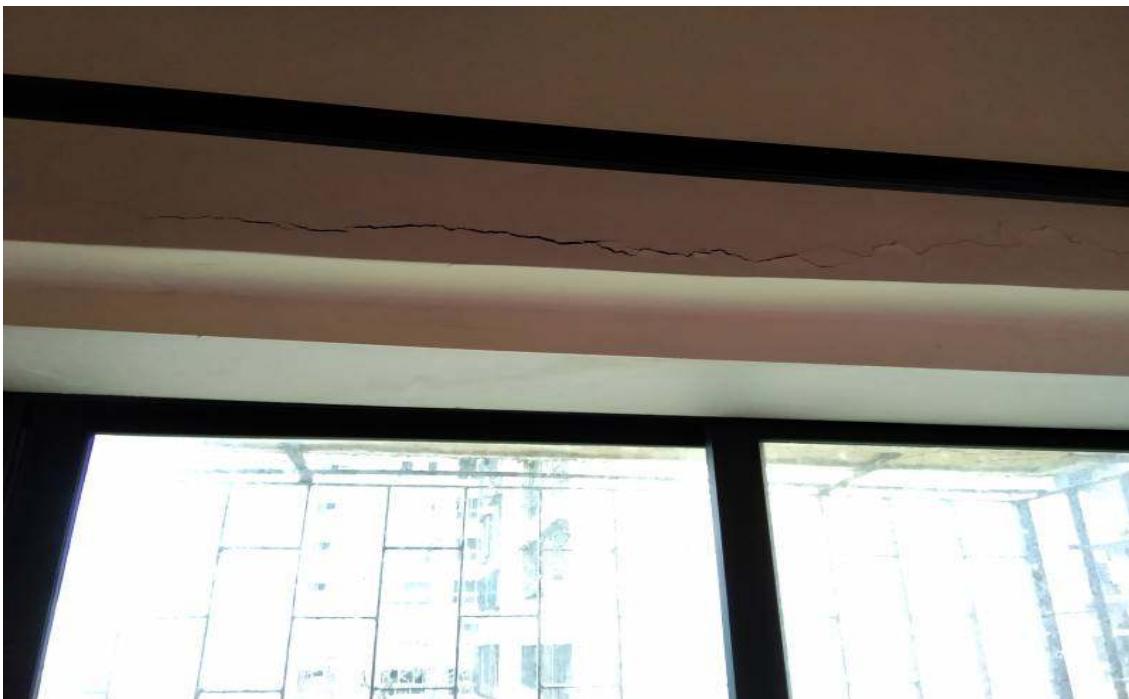
**FLAT NO. B/604**

Bedroom window beam has structural cracks.

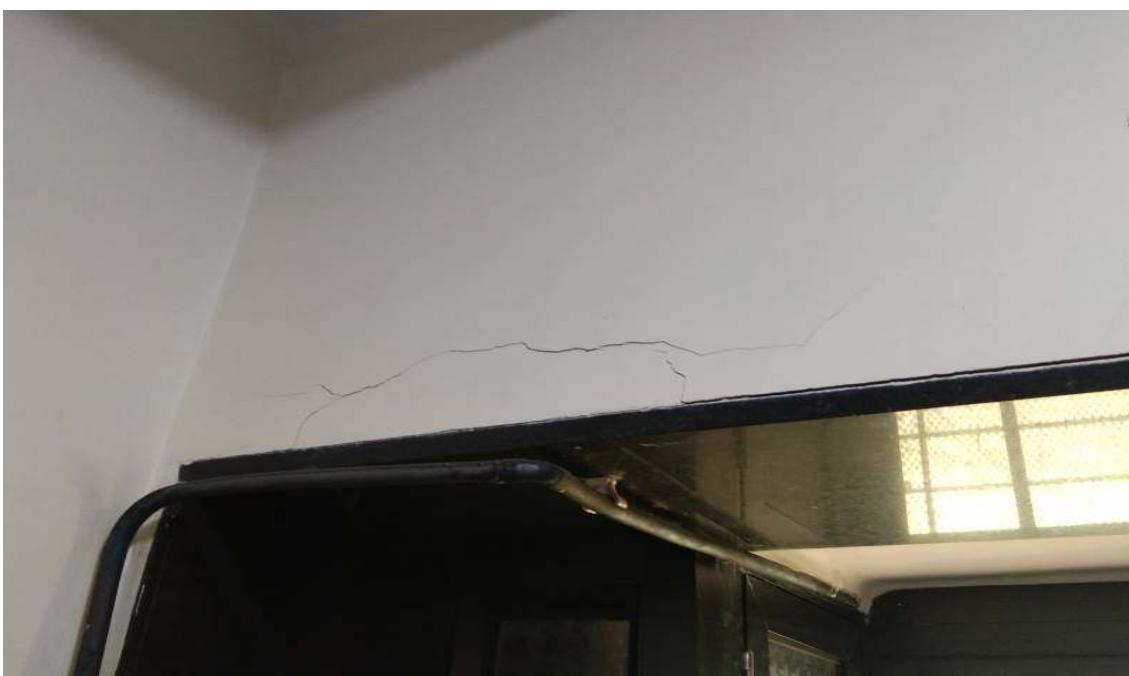
**FLAT NO. B/501-502**

Kitchen beam has structural cracks.

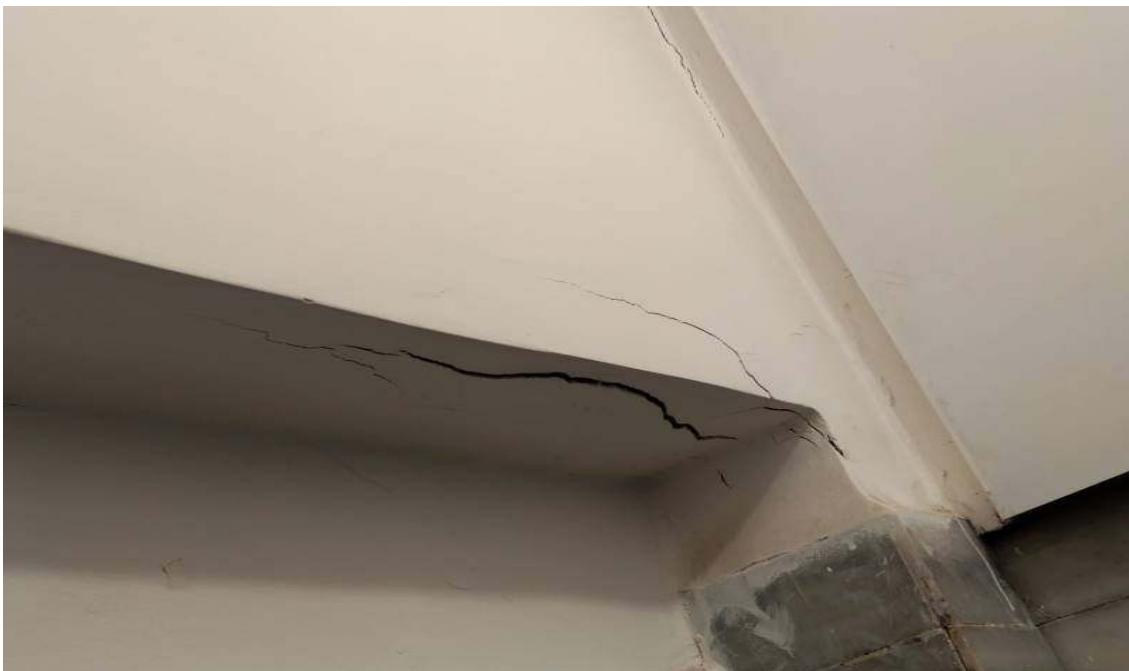
**FLAT NO. B/501-502**

Bathroom beam bottom has structural cracks.

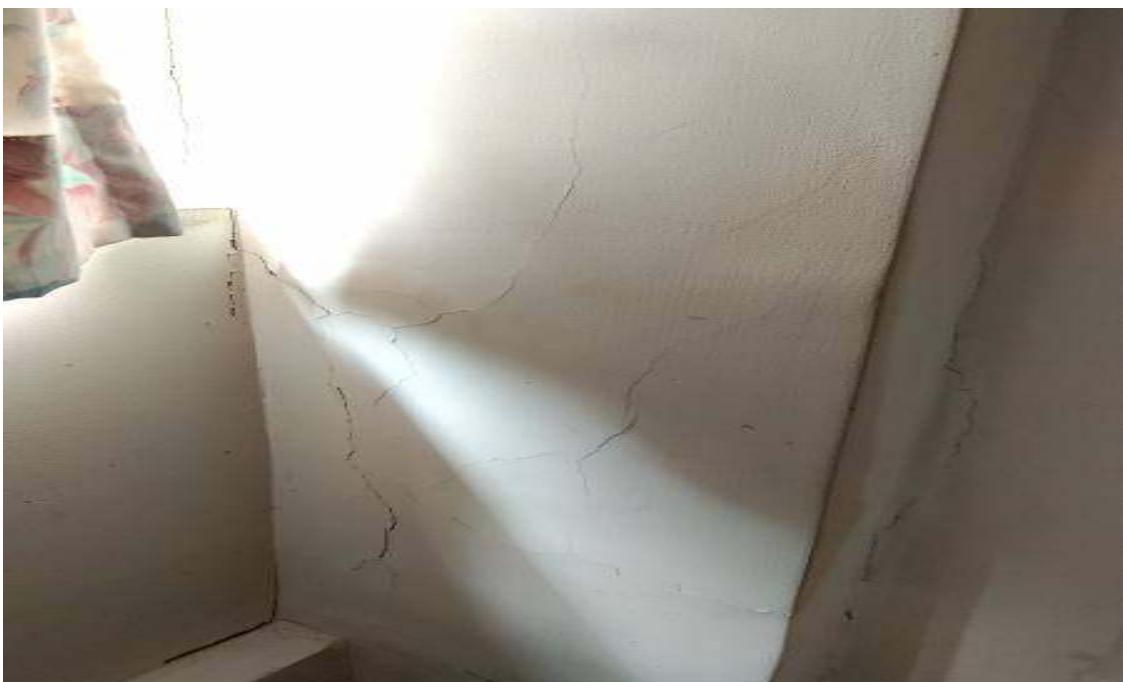
**FLAT NO. B/501-502**

Bedroom column has structural cracks.

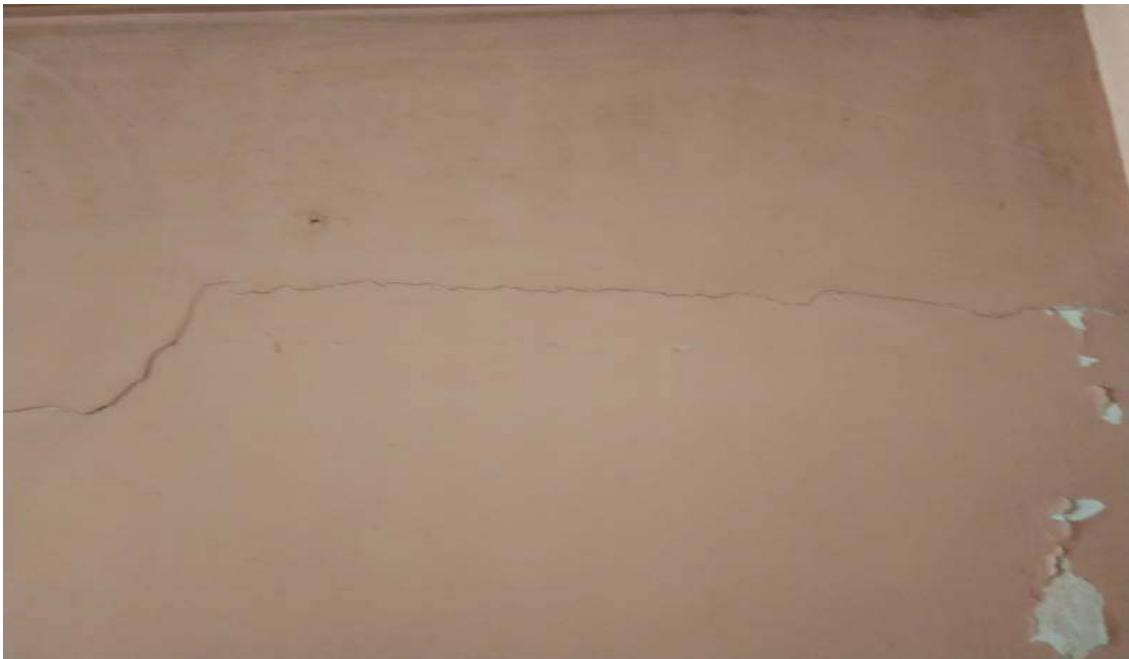
**FLAT NO. B/401**

Hall wall & beam has separation cracks.

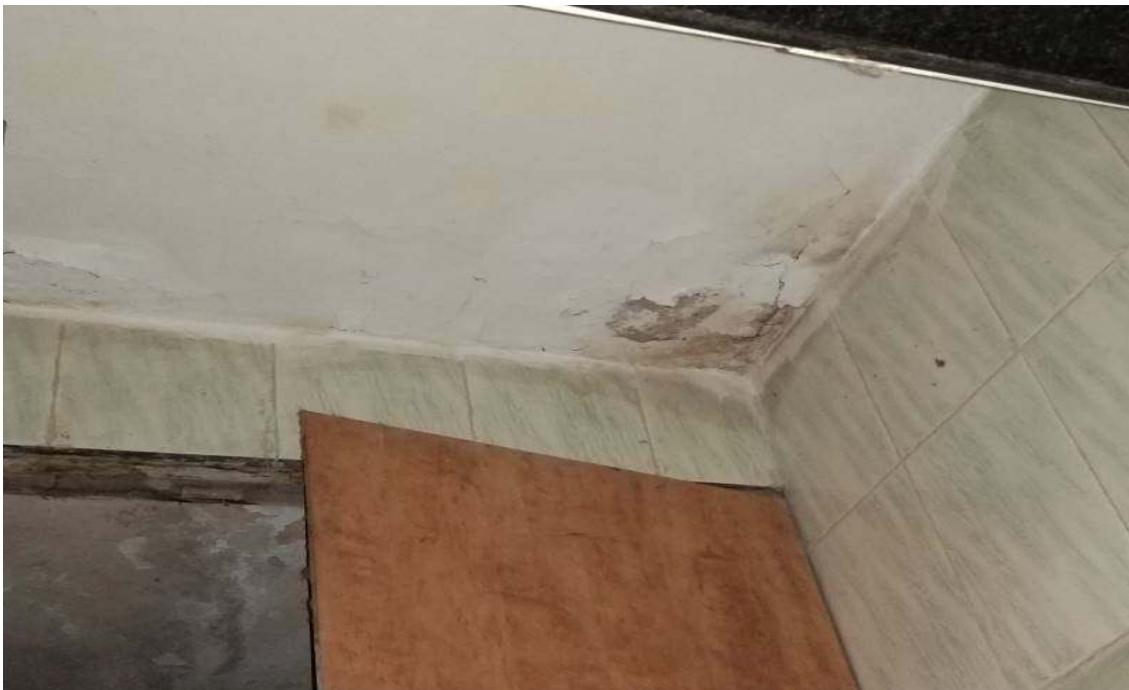
**FLAT NO. B/401**

Passage ceiling has monsoon related leakages from external wall.

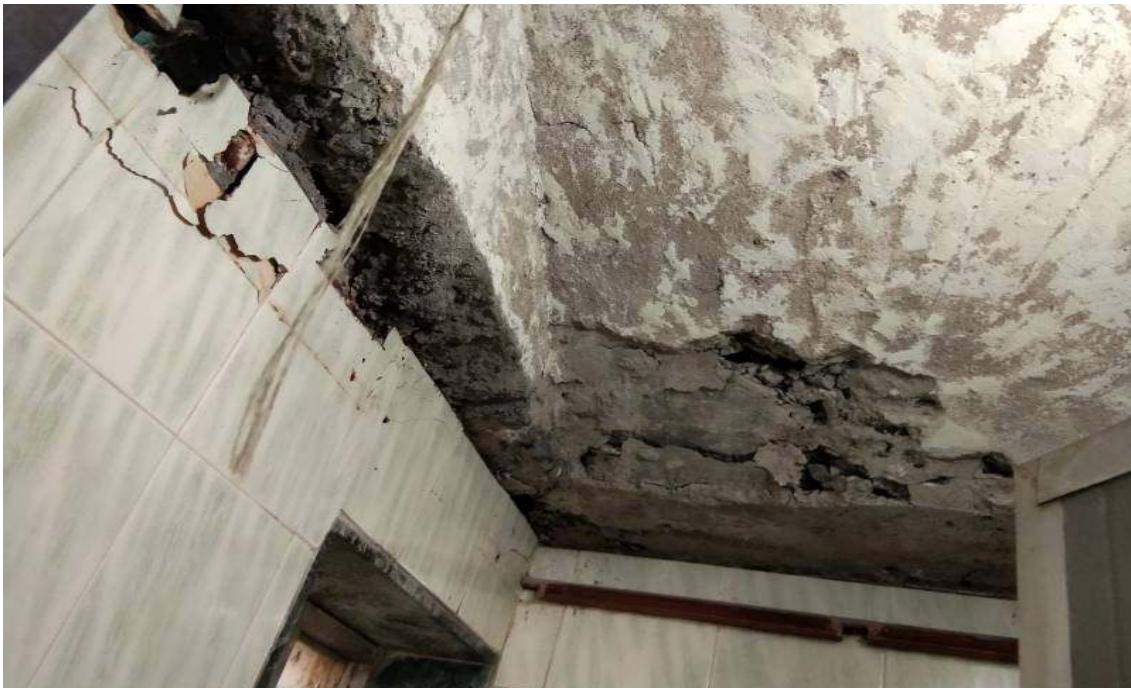
**FLAT NO. B/401**

W.C ceiling cover concrete is fallen down & steel is also visible. **Needs urgent repairs**

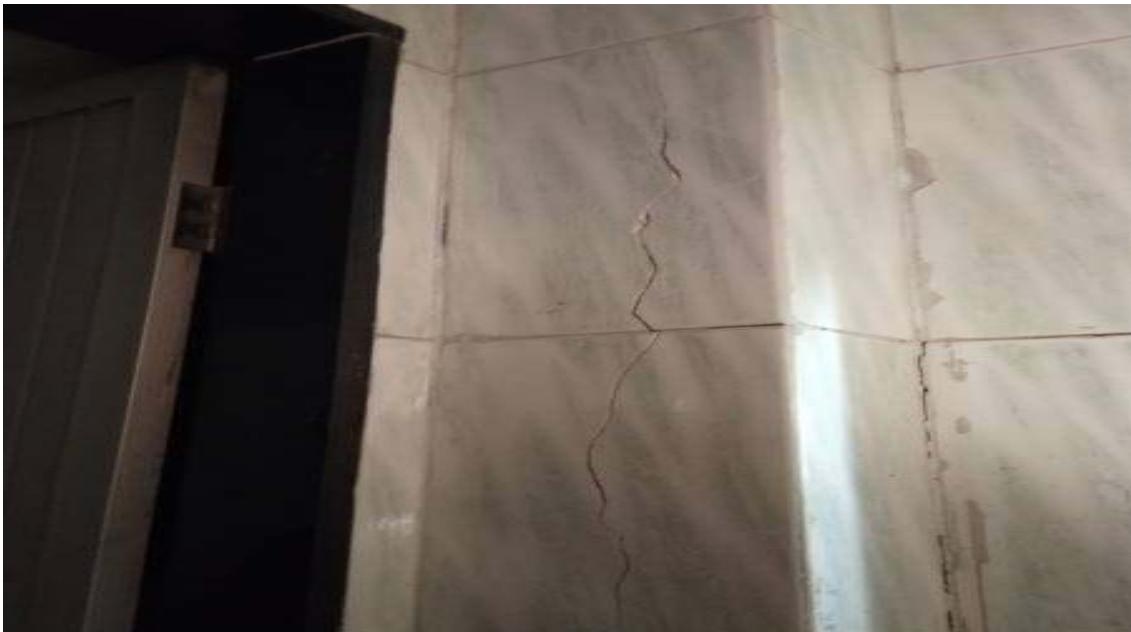
**FLAT NO. B/401**

W.C entrance column has structural cracks including tiles.

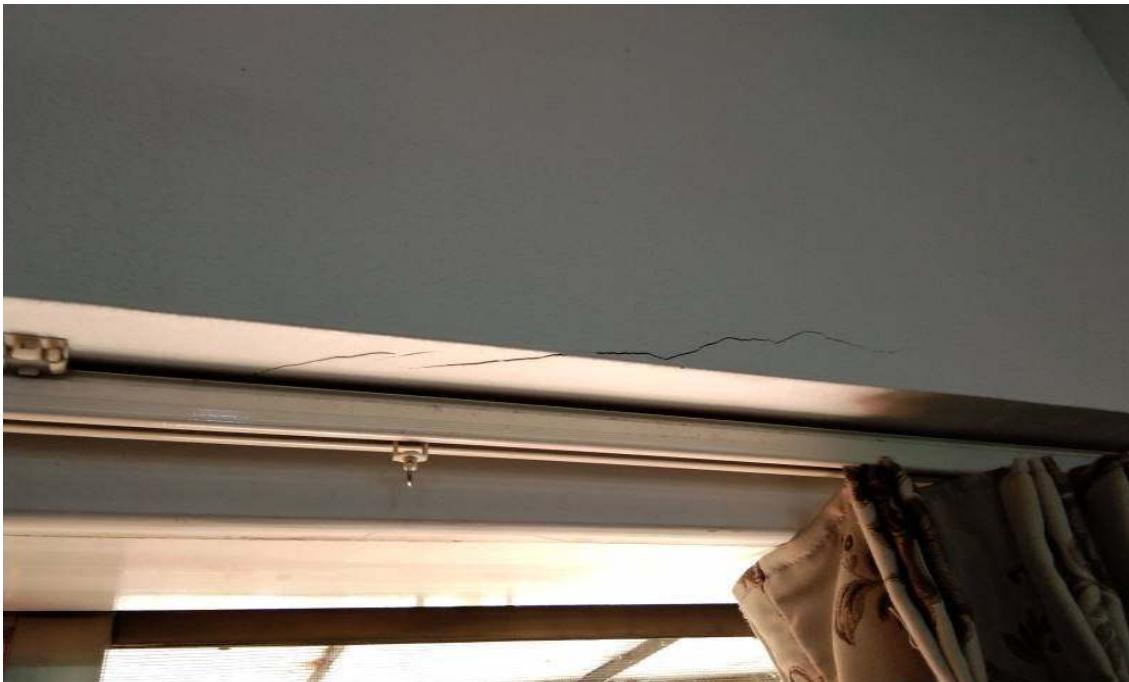
**FLAT NO. B/302**

Bedroom window beam has structural cracks.

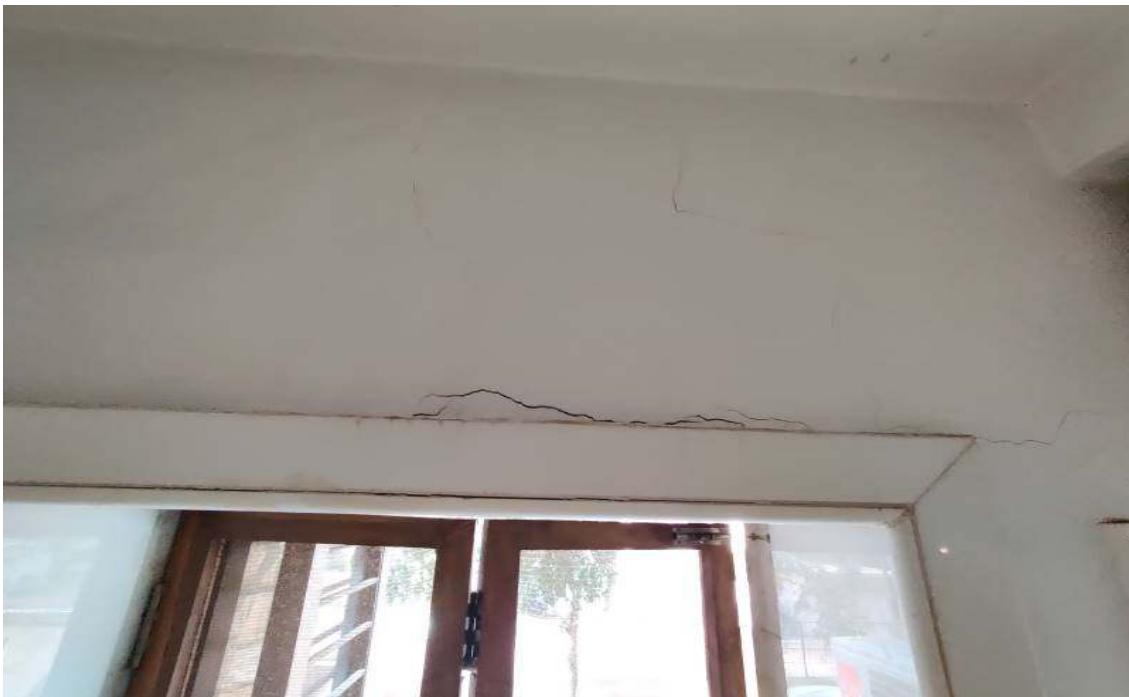
**FLAT NO. B/101-102**

Kitchen window beam has structural cracks

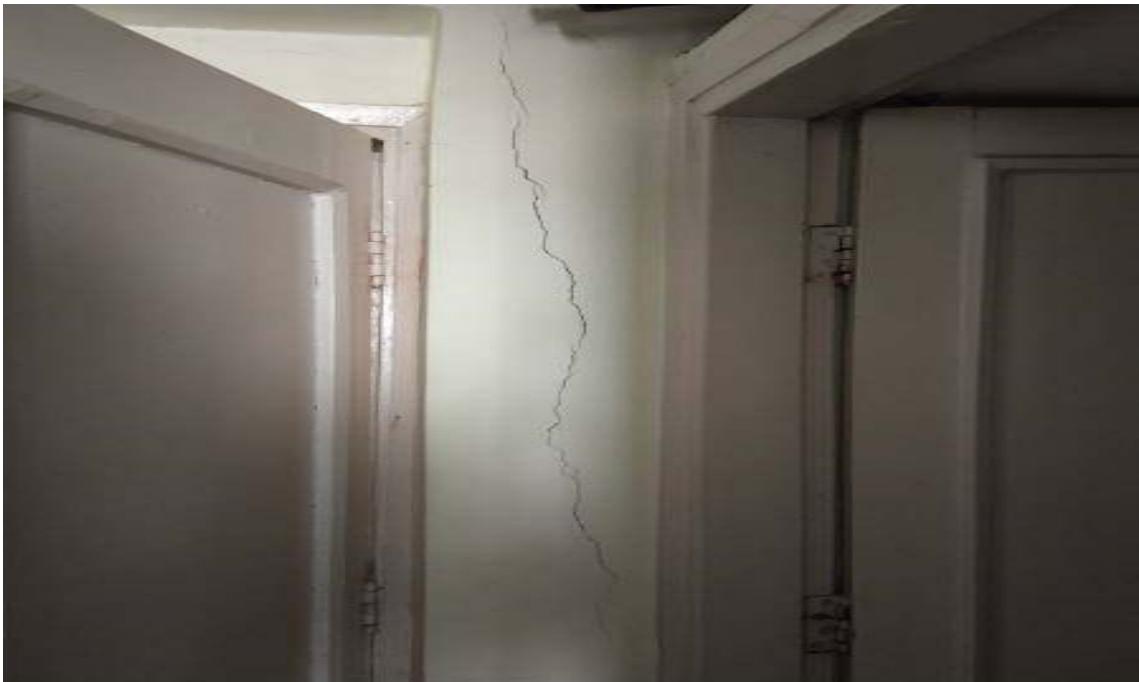
**FLAT NO. C/503**

Hall column has wide structural cracks.

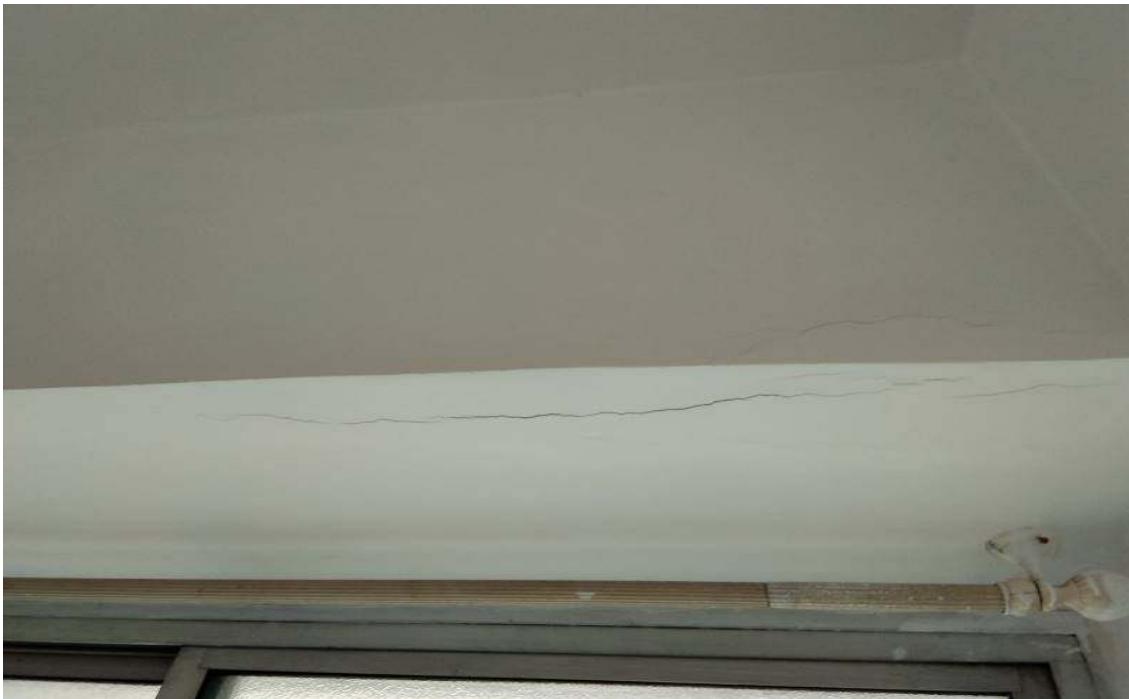
**FLAT NO. C/401**

Hall balcony beam has structural cracks.

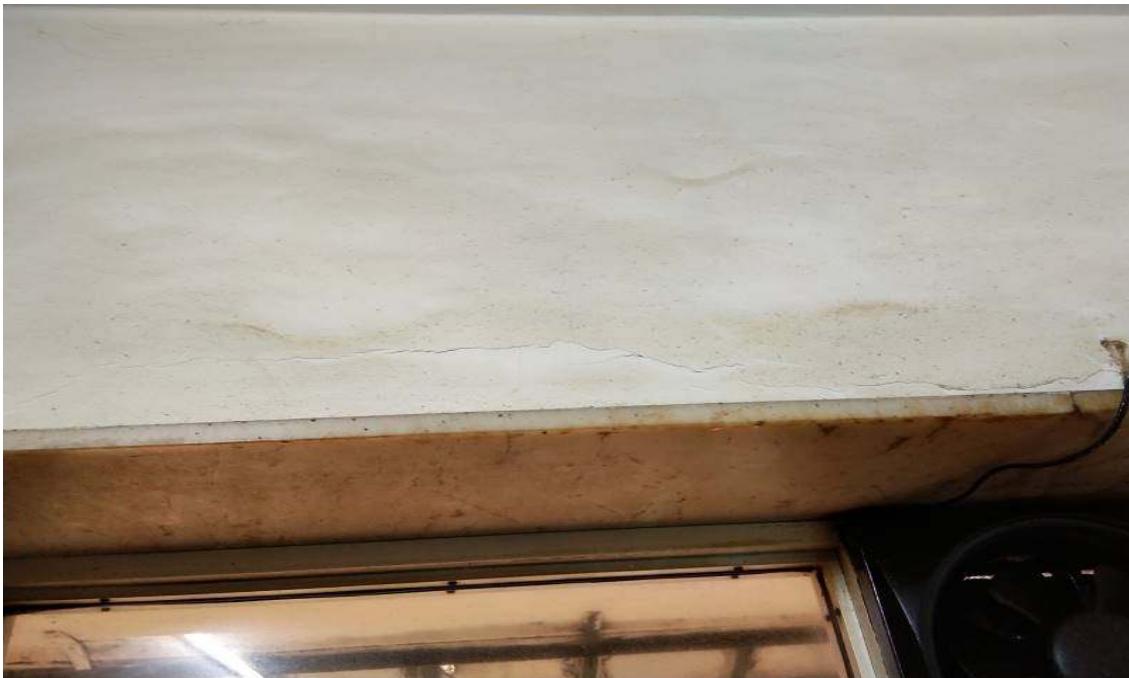
**FLAT NO. C/301**

Kitchen window beam has structural cracks.

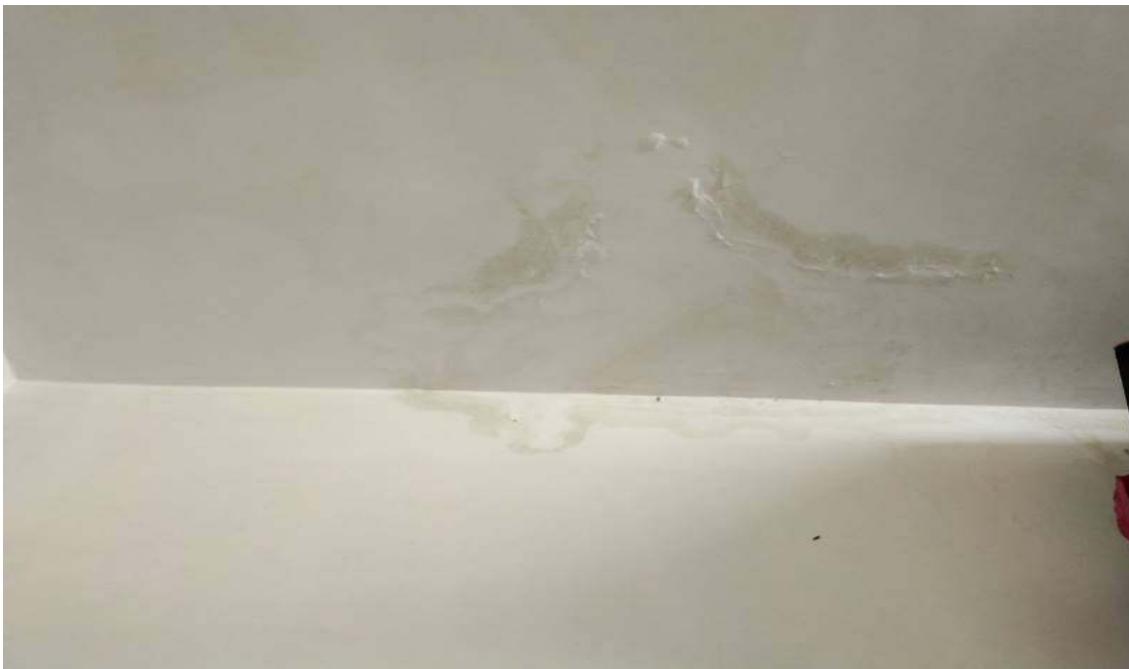
**FLAT NO. C/301**

Bedroom beam was having leakage from upper flat at present found dry.

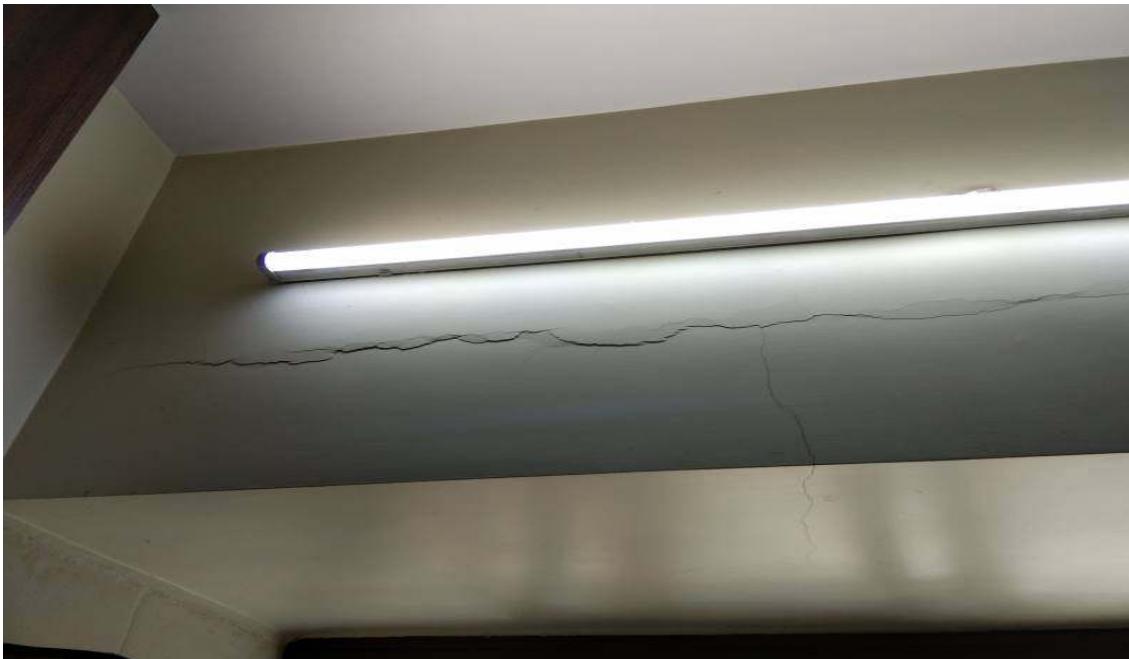
**FLAT NO. C/202-203**

Kitchen beam has horizontal structural / separation cracks.

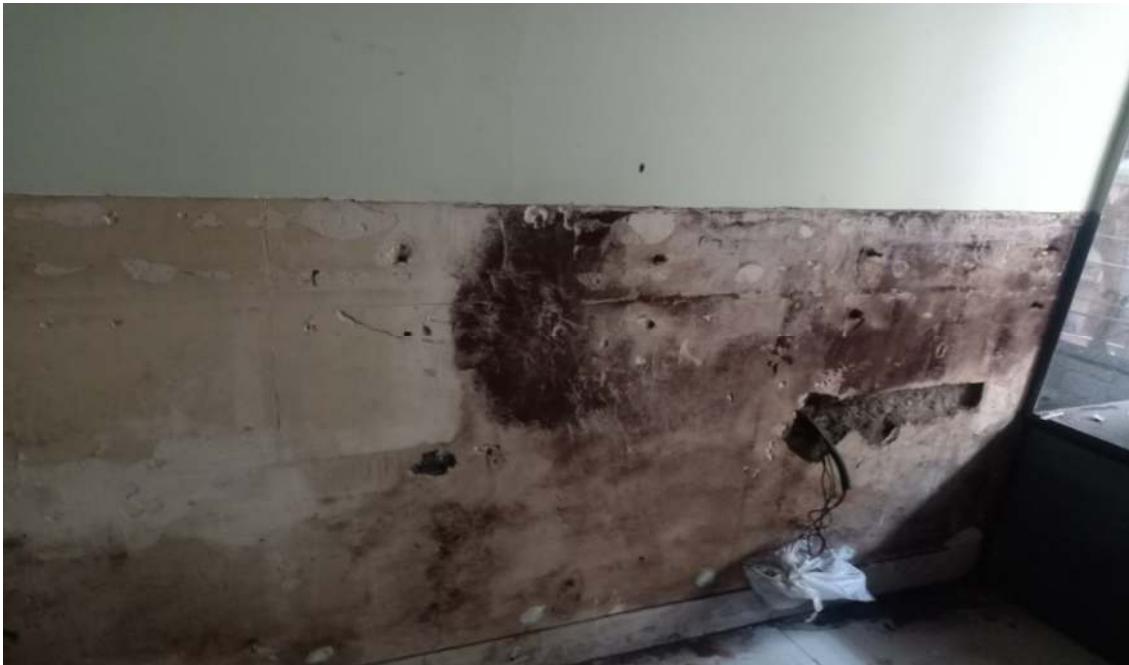
**FLAT NO. C/202-203**

Bedroom wall is having monsoon related leakages from external wall.
