BEFORE THE NEBRASKA DEPARTMENT OF ENVIRONMENT AND ENERGY

IN THE MATTER OF)
AltEn, LLC,) CASE NO. 3546
)
FID # 84069) EMERGENCY COMPLAINT
) AND ORDER
Respondent.)

DEPT. OF ENVIRONMENT AND ENERGY

Release of Thin Stillage and Cattle Manure from Digester at AltEn LLC, IIS #84069, RA
#021221-NH-0845

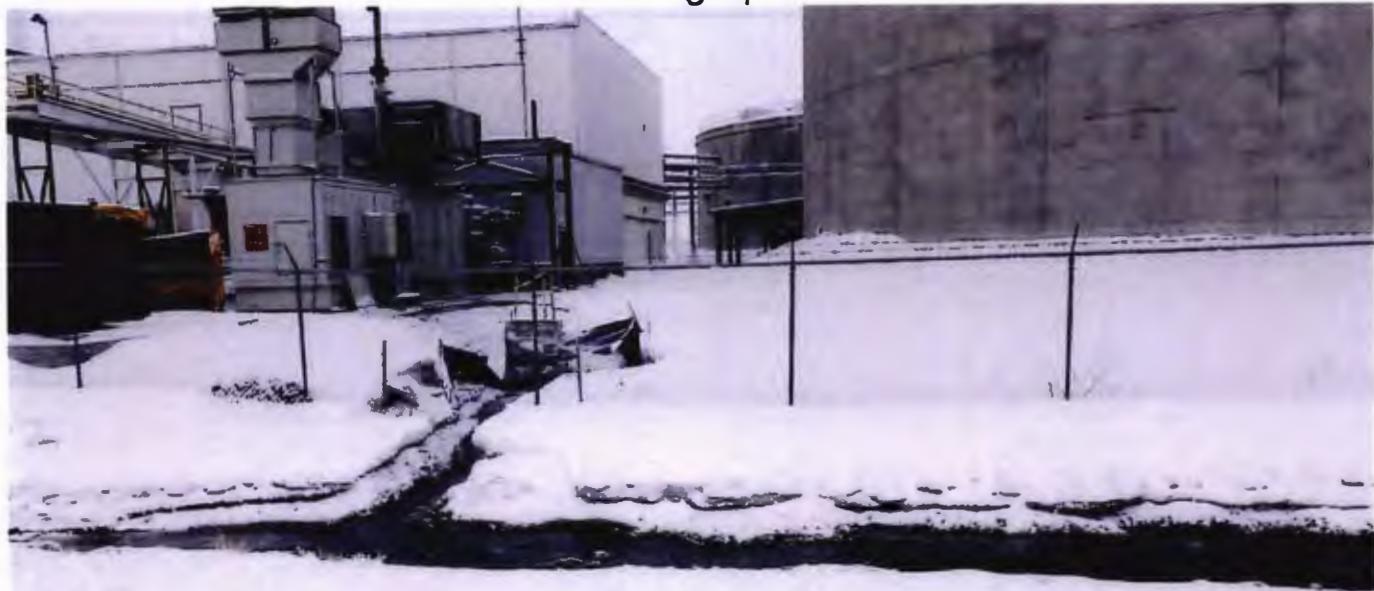
Photo 1

Mr. Peterson drove me to the digester. Upon arrival I observed wastewater conveying from the southwest side of the digester, photo 1. I asked Mr. Peterson if the break is located on the southwest side. Mr. Peterson stated no and drove to the southeast corner. There is heavy flow cascading over the hill into the adjacent ditch, photos 2 and 3. We then exited the truck and walked to the digester. The ruptured pipe is located on the east side splashing and spraying against the digester, photo 4. The surrounding area east, west and north are filled with wastewater, photos 5 and 6. I asked Mr. Peterson if the tank was full. Mr. Peterson confirmed the tank contained four million gallons. I asked what containment activities have been employed. Mr. Peterson stated the break is below ground. The water pressure and break area are making management difficult. Mr. Peterson stated they installed two trash pumps, photos 7 and 8.

Description: This photo depicts water flow from the storm water conveyance system. Water is entering the ditch flowing east along the south side of the digester.

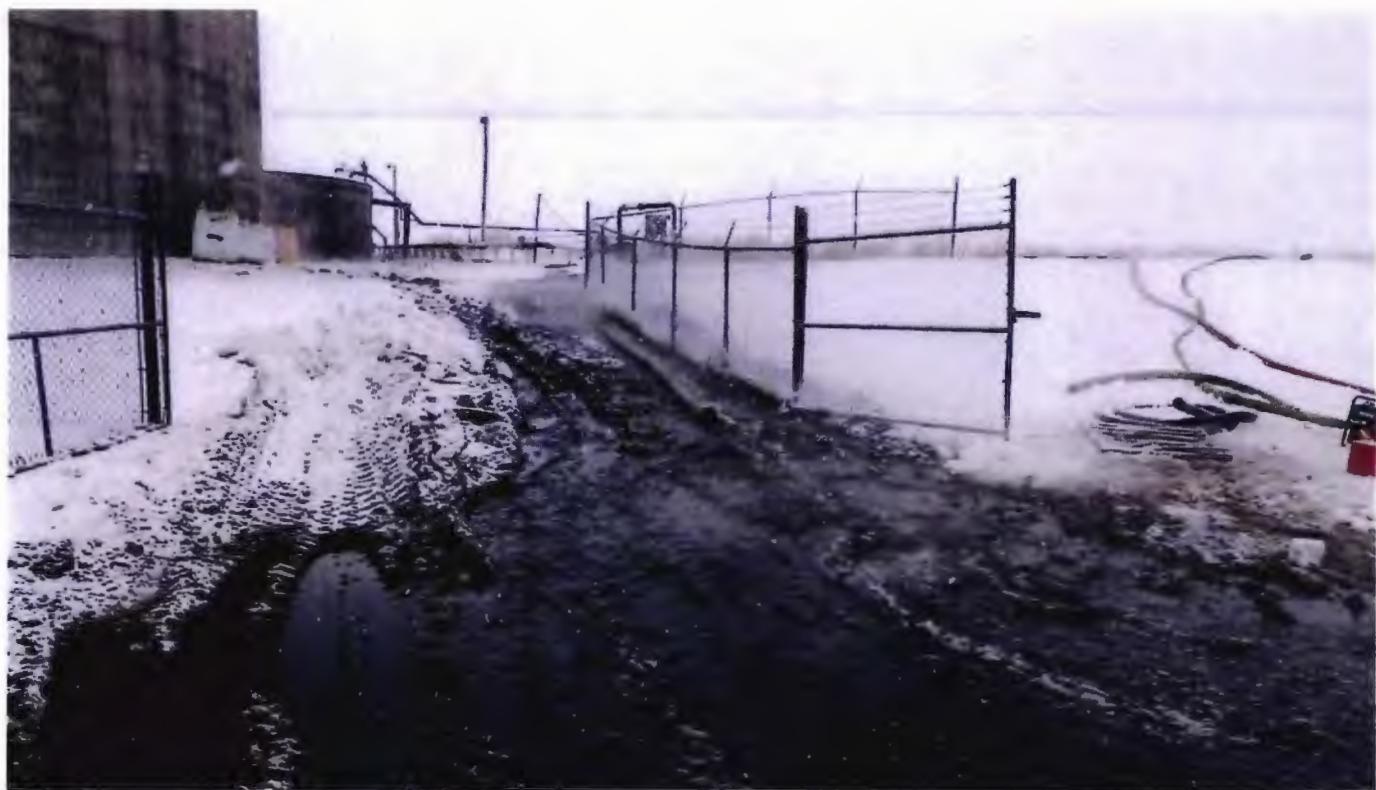
Photo 2

Description: This photo depicts cascading water exiting the southeast side of the digester.

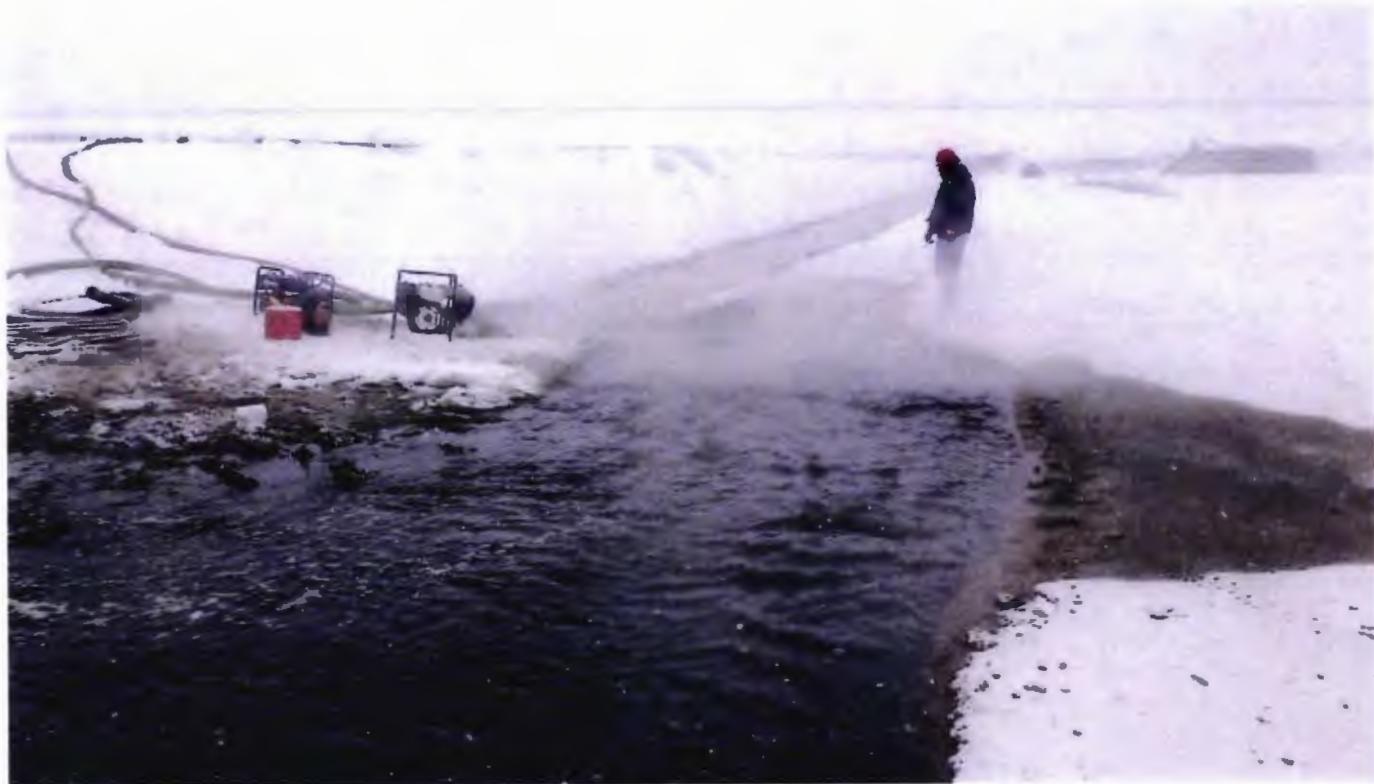
Photo 3

Description: This photo depicts water entering the ditch and flowing along the emergency lagoons. Also depicted is the trash pumps installed to transport water into the emergency lagoon.

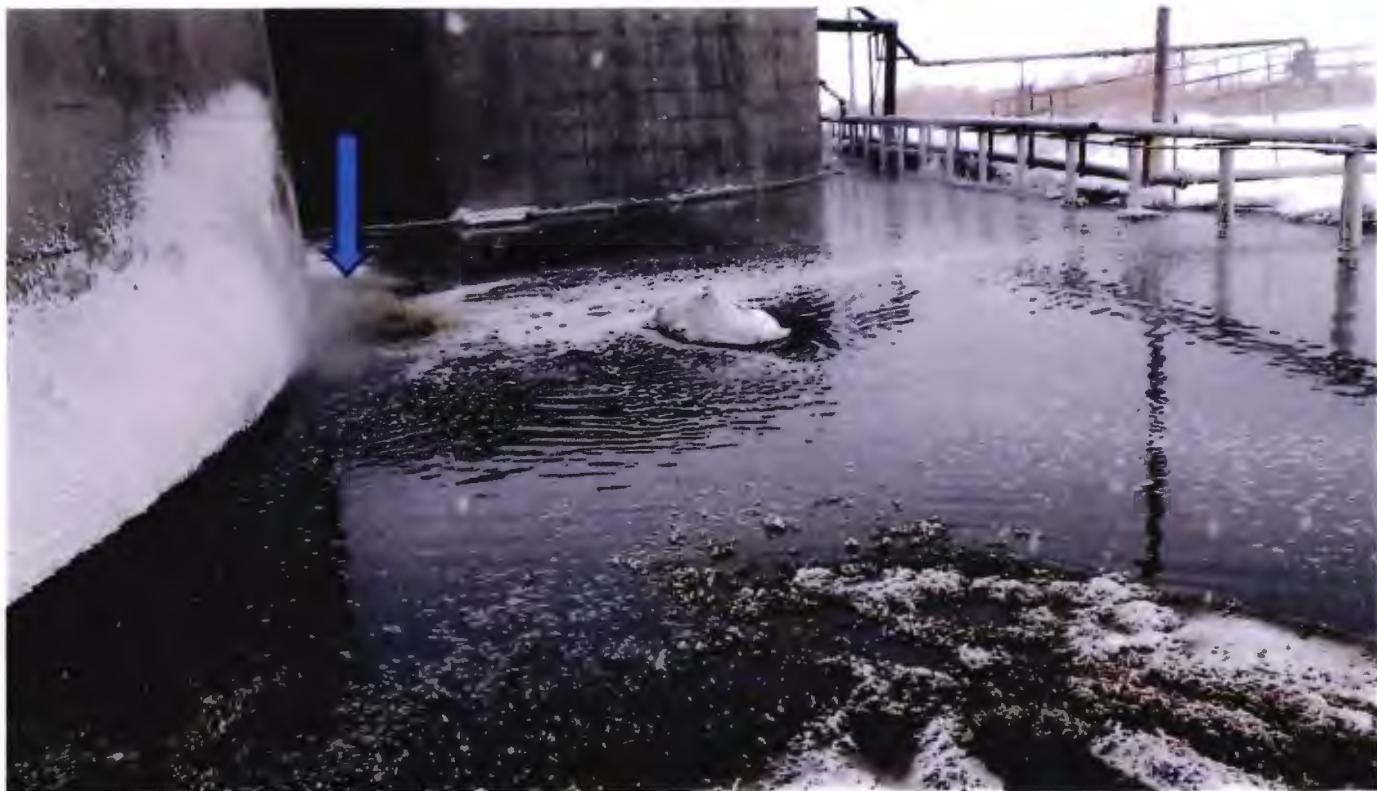
Photo 4

Description: This photo depicts the damaged area (arrow). Water is quickly exiting the digester creating ponding and discharge.

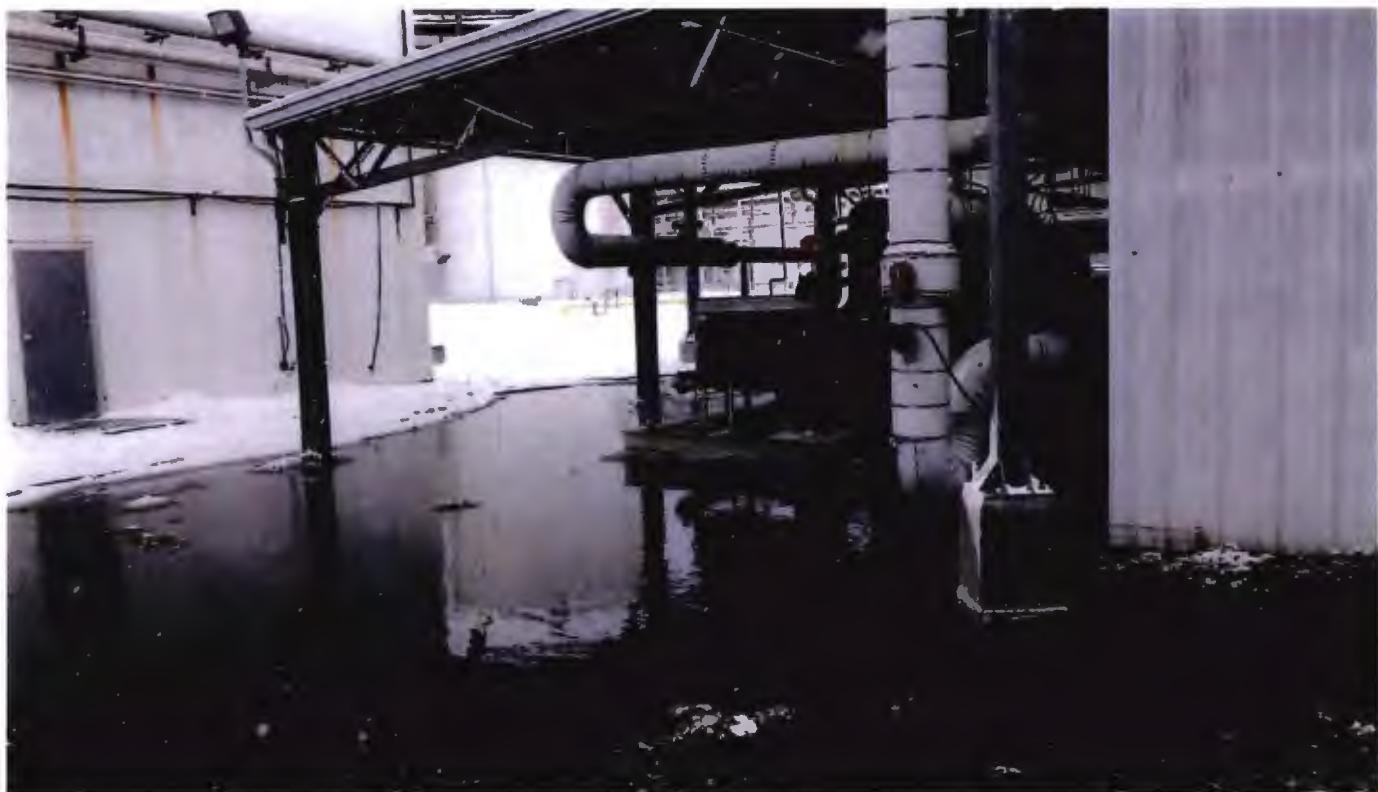
Photo 6

Description: This photo is pooled water west of the digester.

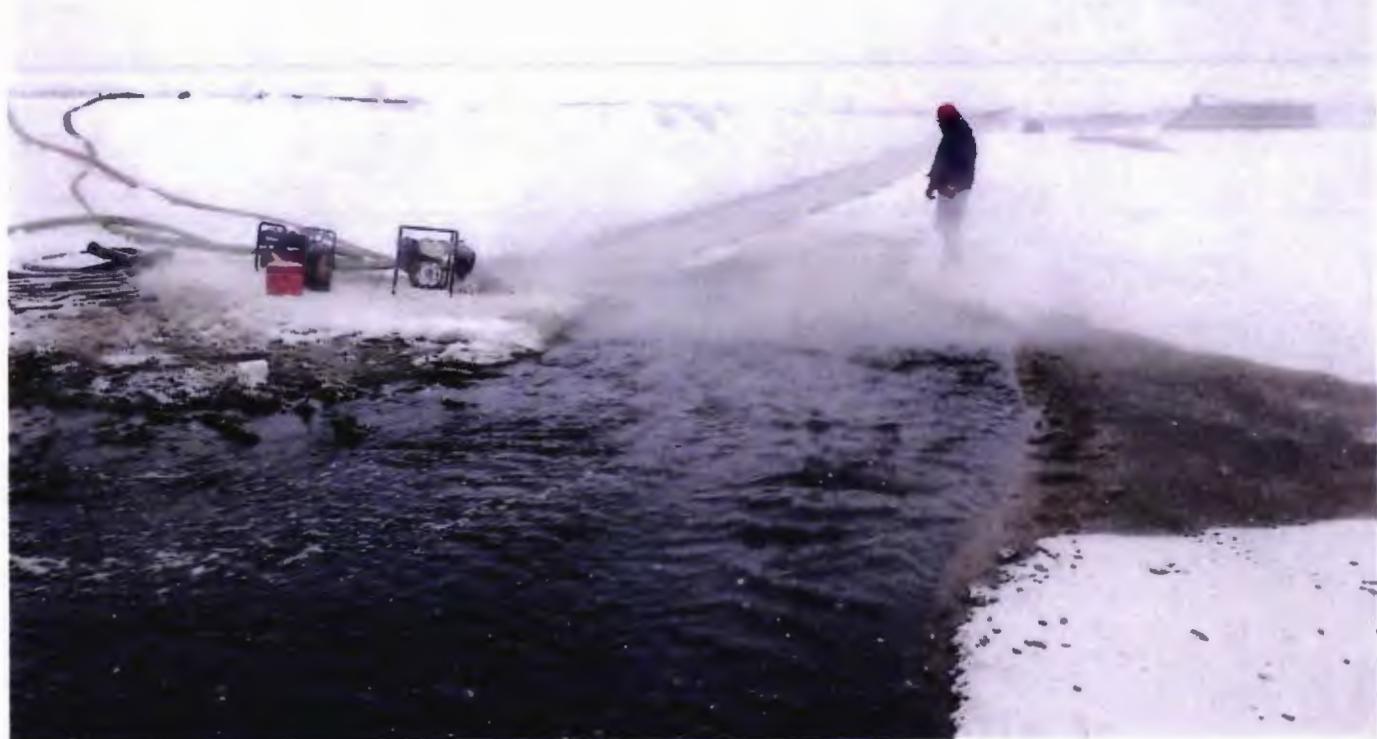
Photo 7

Description: This photo depicts the trash pumps used to transport water into the emergency lagoon.

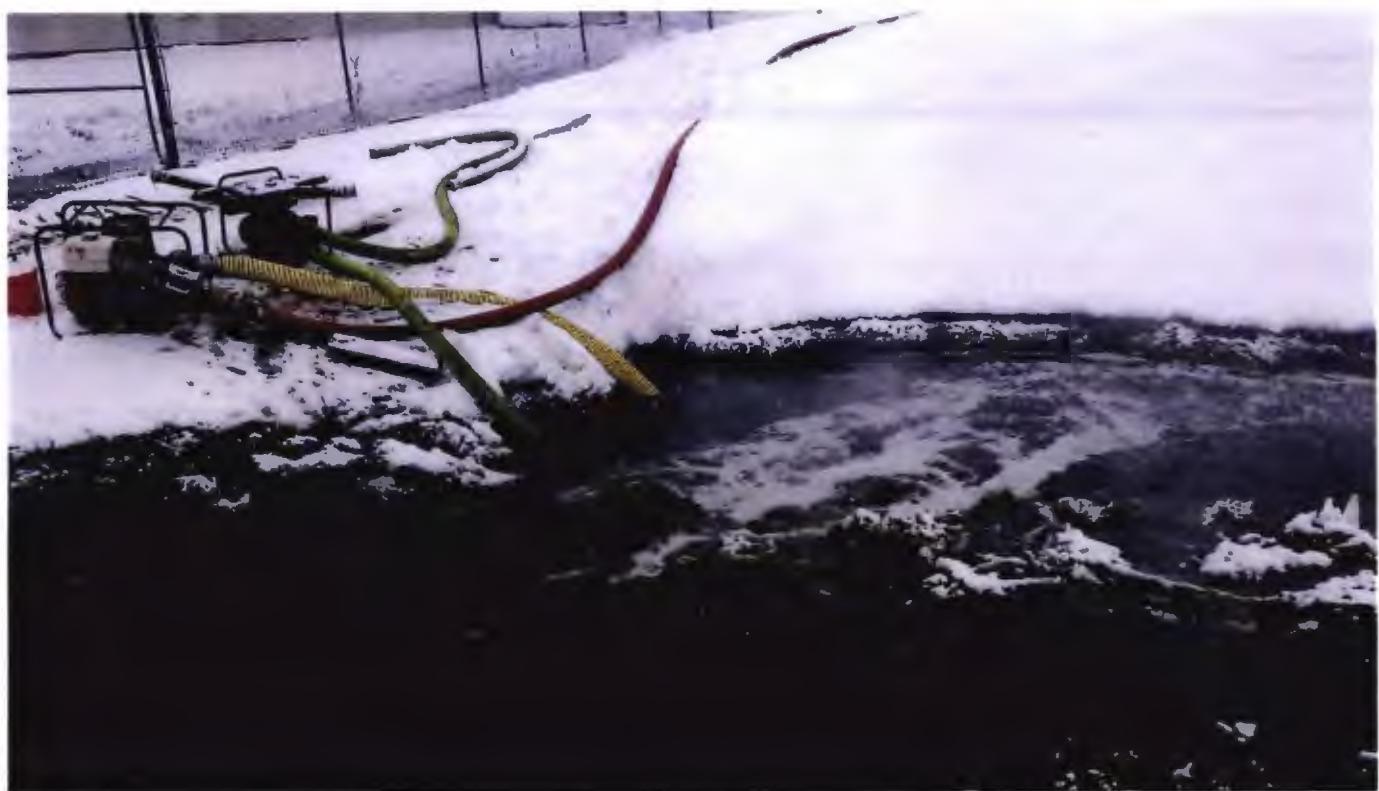
Photo 8

Description: This photo depicts the trash pumps used to transport water into the emergency lagoon.

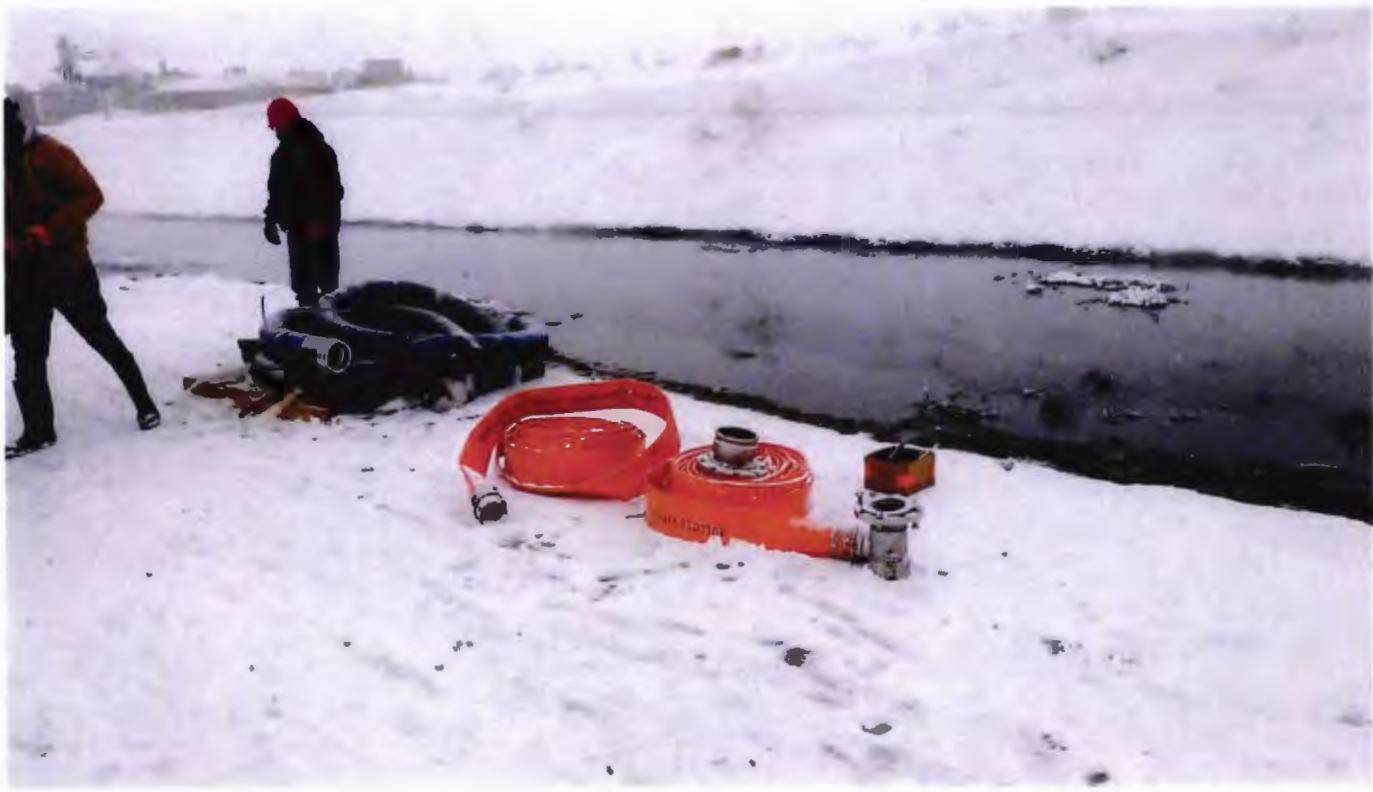
Photo 9

Description: This photo depicts AltEn personnel working to install an additional trash pump. The pump is being installed approximately 100 yards east of the pumps depicted in photo 8.

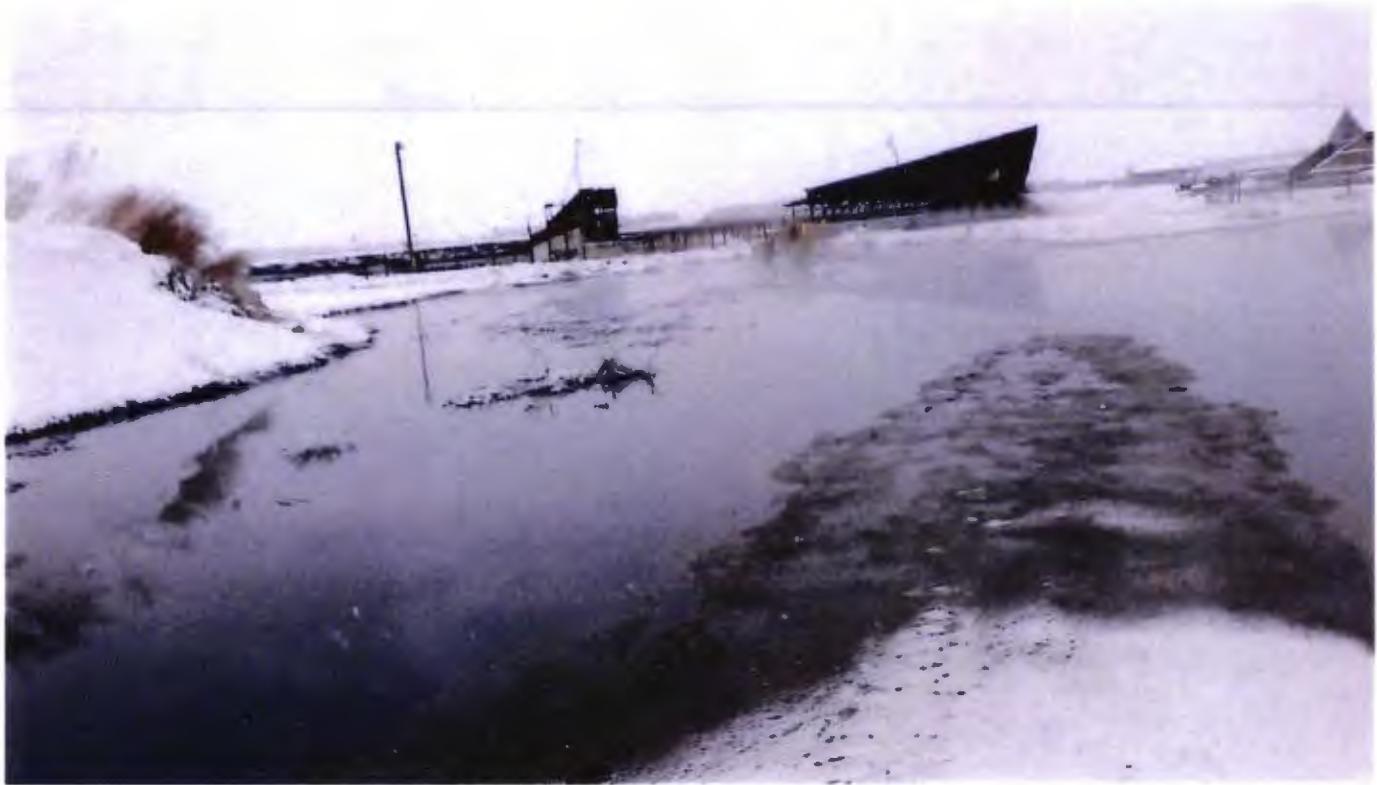
Photo 10

Description: This photo depicts the creek flooding the road entering Mead Cattle.

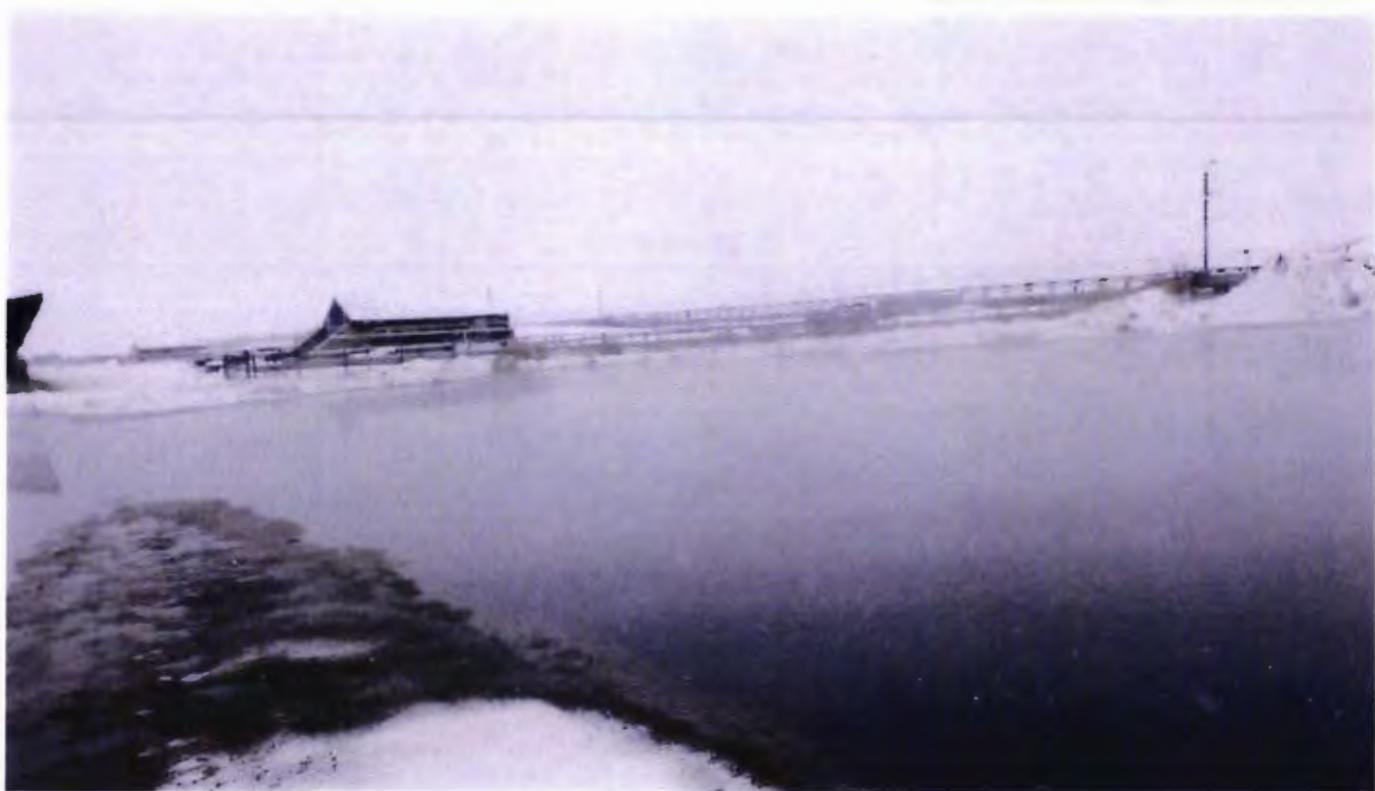
Photo 11

Description: This photo depicts water flooding the road and ponding on the south side.

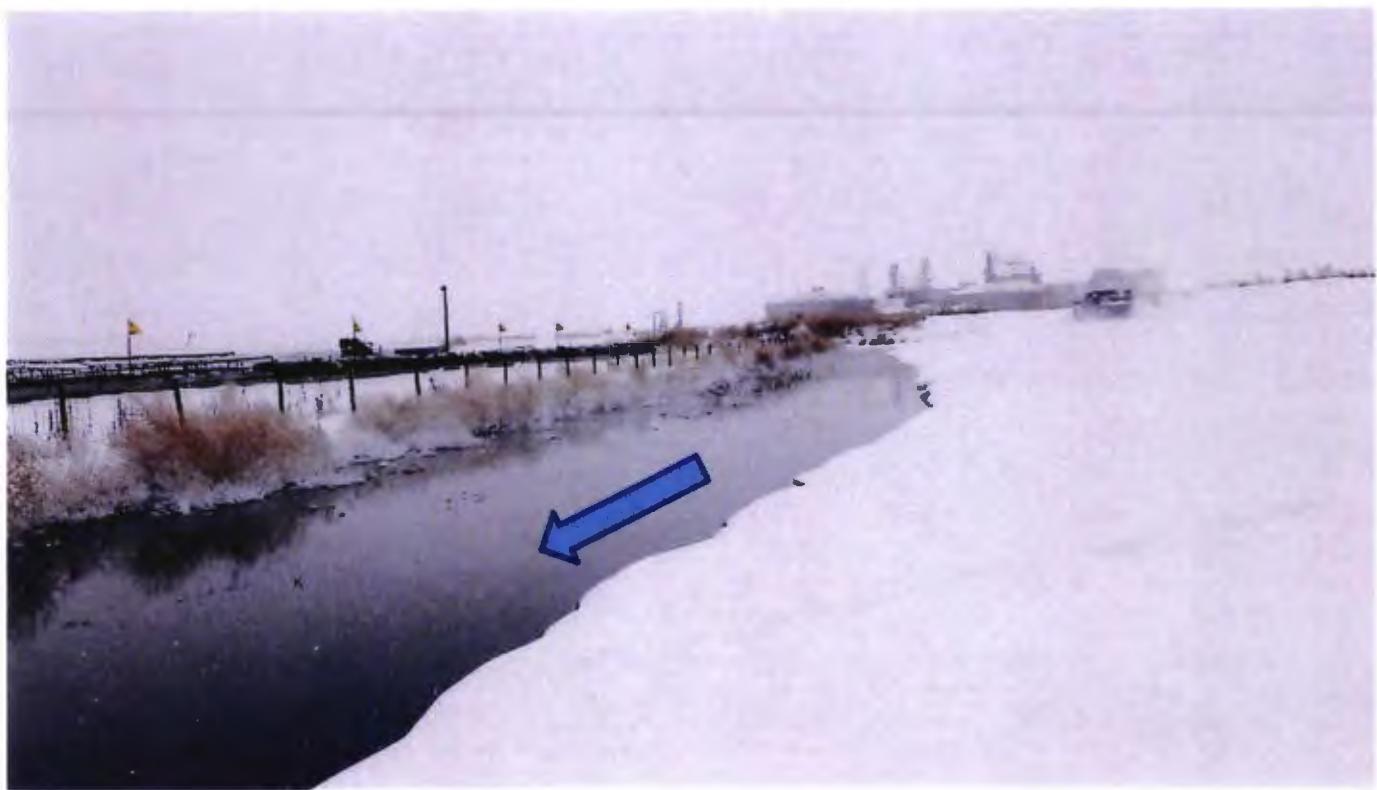
Photo 12

Description: This photo depicts wastewater flowing east along Mead Cattle. The arrow depicts flow direction.

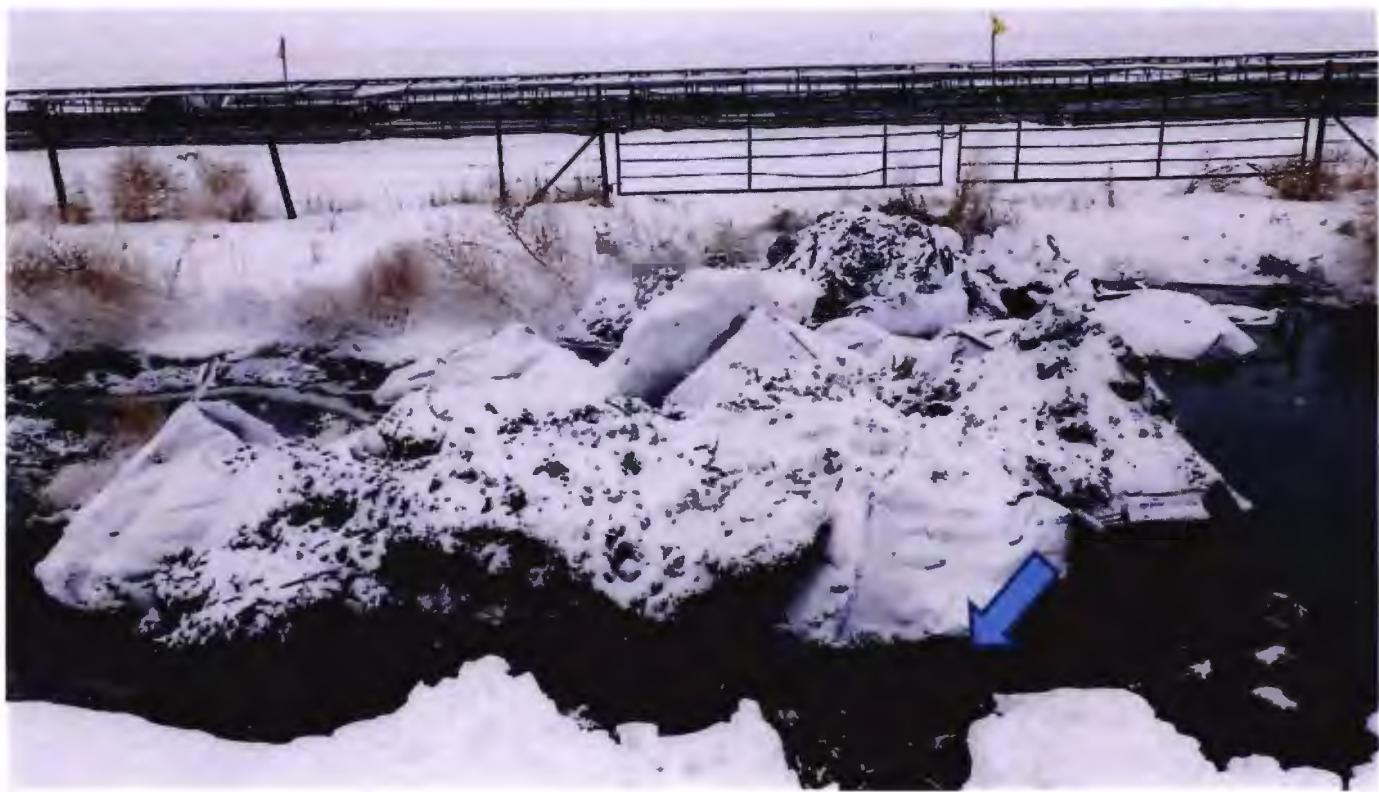
Photo 13

Description: This photo depicts a makeshift dam made of biochar supersacks. This photo also depicts the breach that occurred on the north side (arrow)

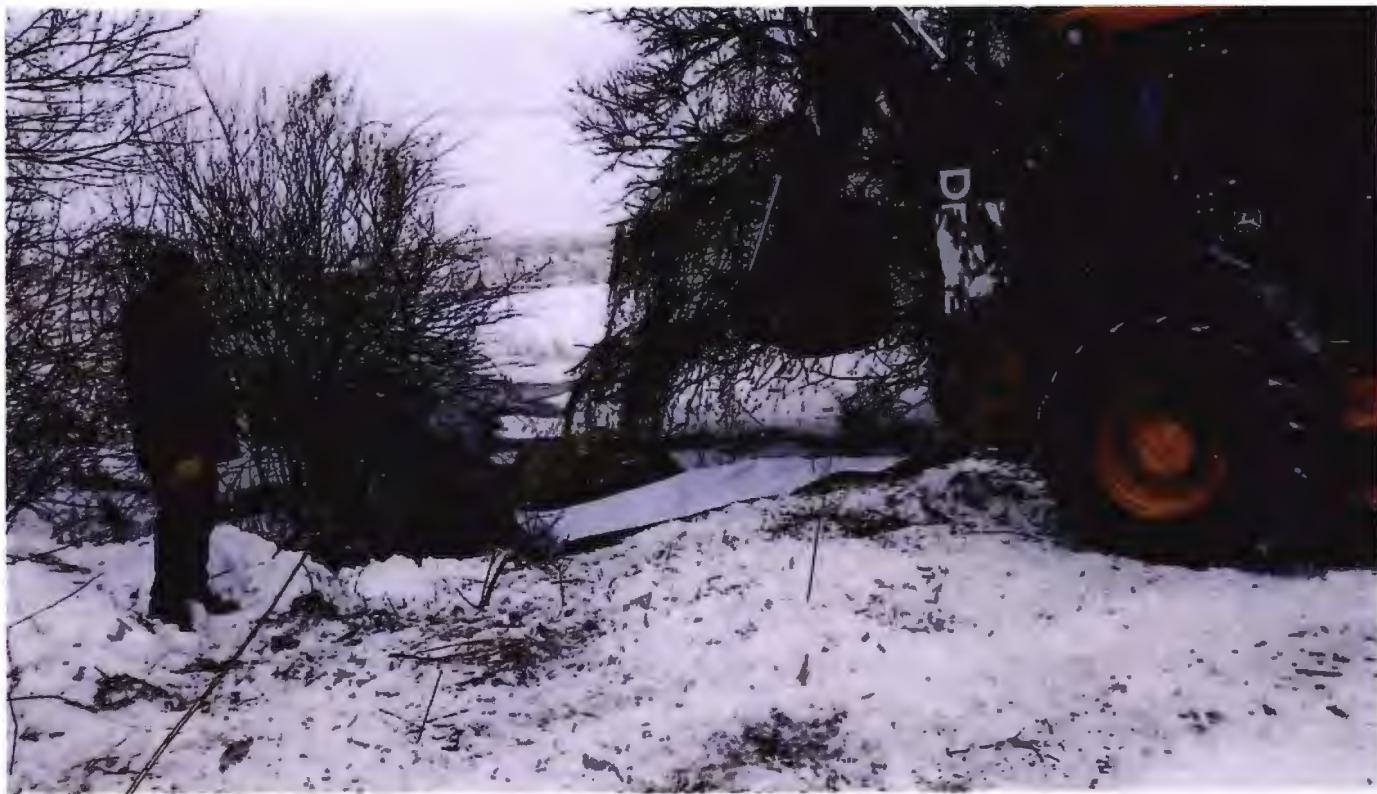
Photo 14

I then drove to the culvert that exits the facility. The culvert is located on the southeast side of the property. When I arrived, I met representatives from the University of Nebraska – Lincoln (UNL). I observed UNL installing plastic, bales and cement (rip-rap) in attempt to hold back the flow, photos 14 and 15.

Description: This photo depicts UNL personal installing plastic and bales to dam the culvert.

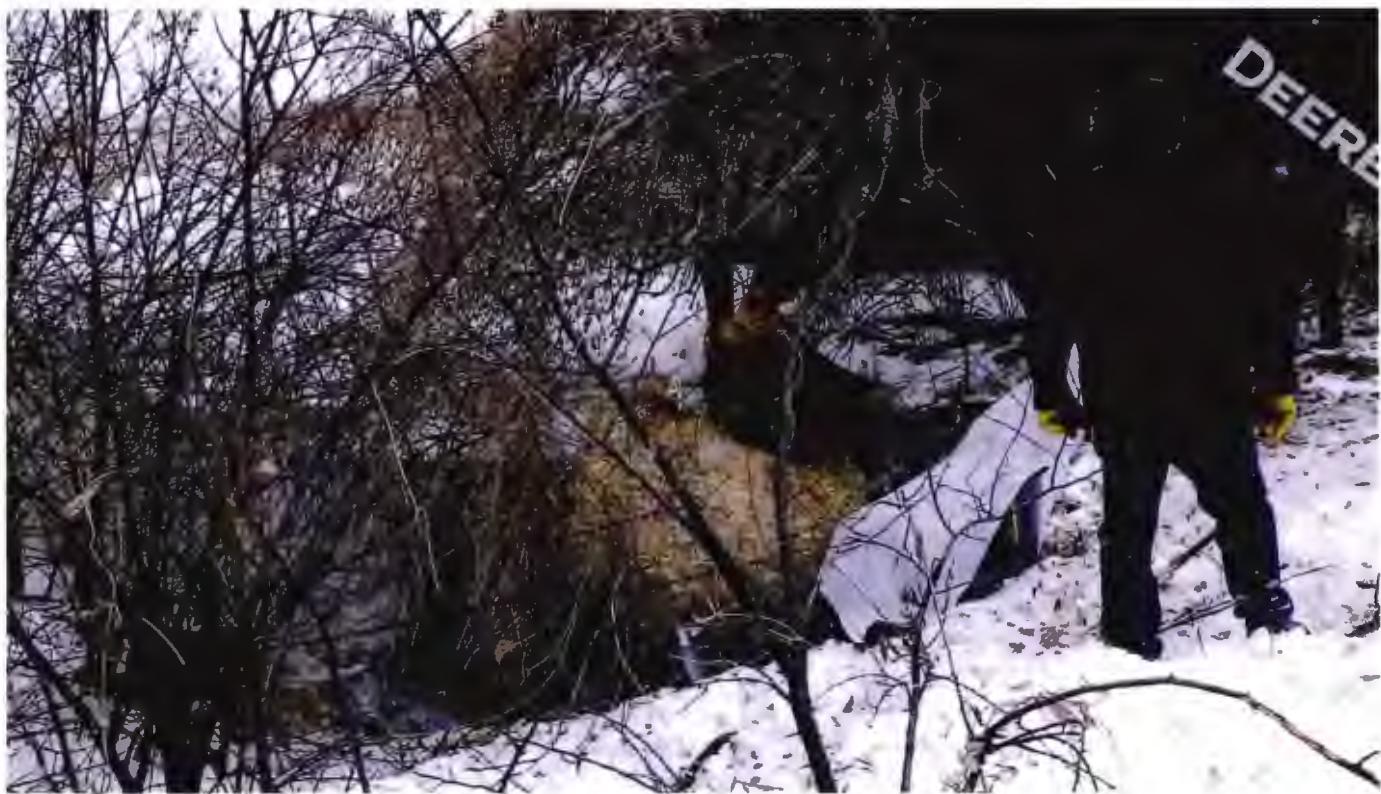
Photo 15

Description: This photo depicts UNL using a backhoe to push a bale and plastic into place.

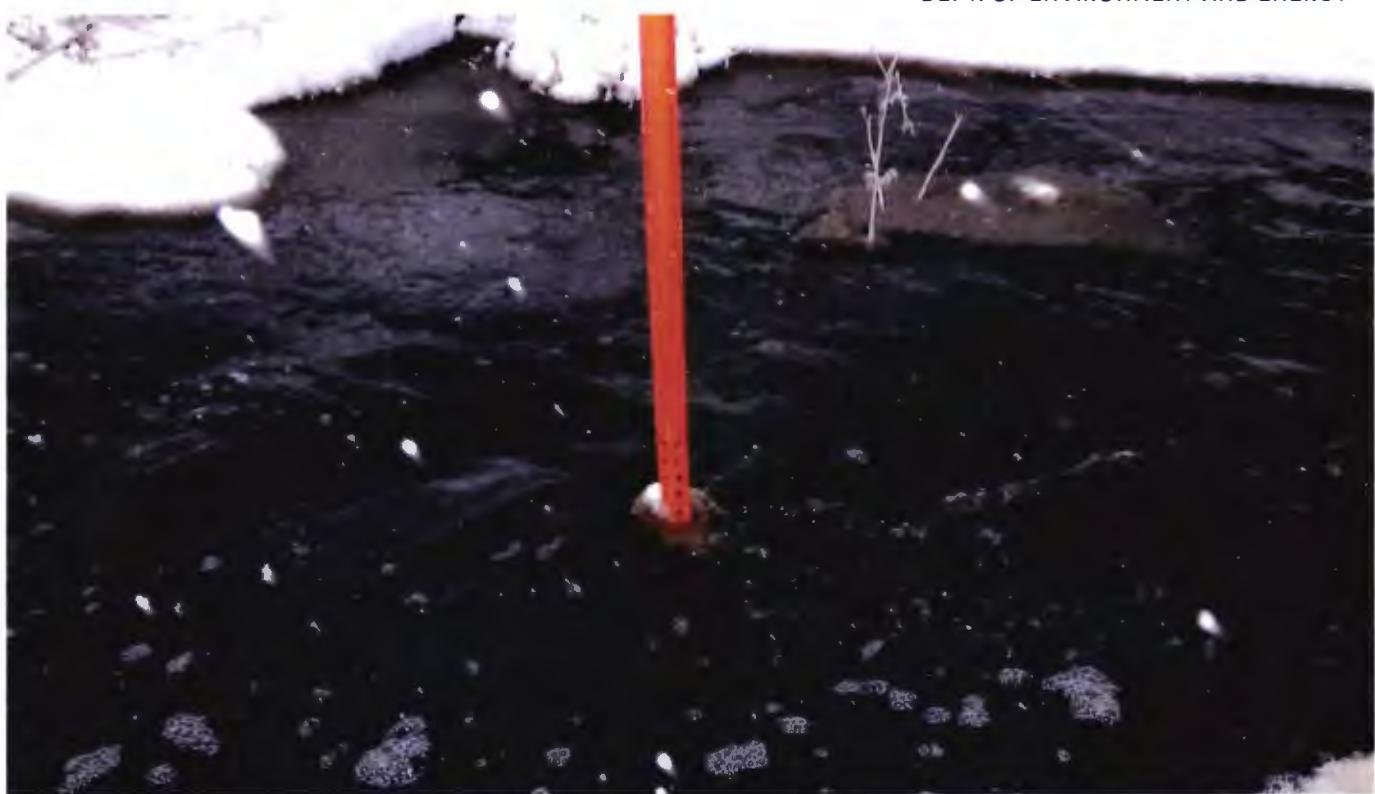
Photo 16

Description: This photo depicts UNL property adjacent county road 9. This photo is a depth finder that UNL installed to measure flow. Mr. Brummel (UNL) stated that water depth had been rising 2 inches per hour.

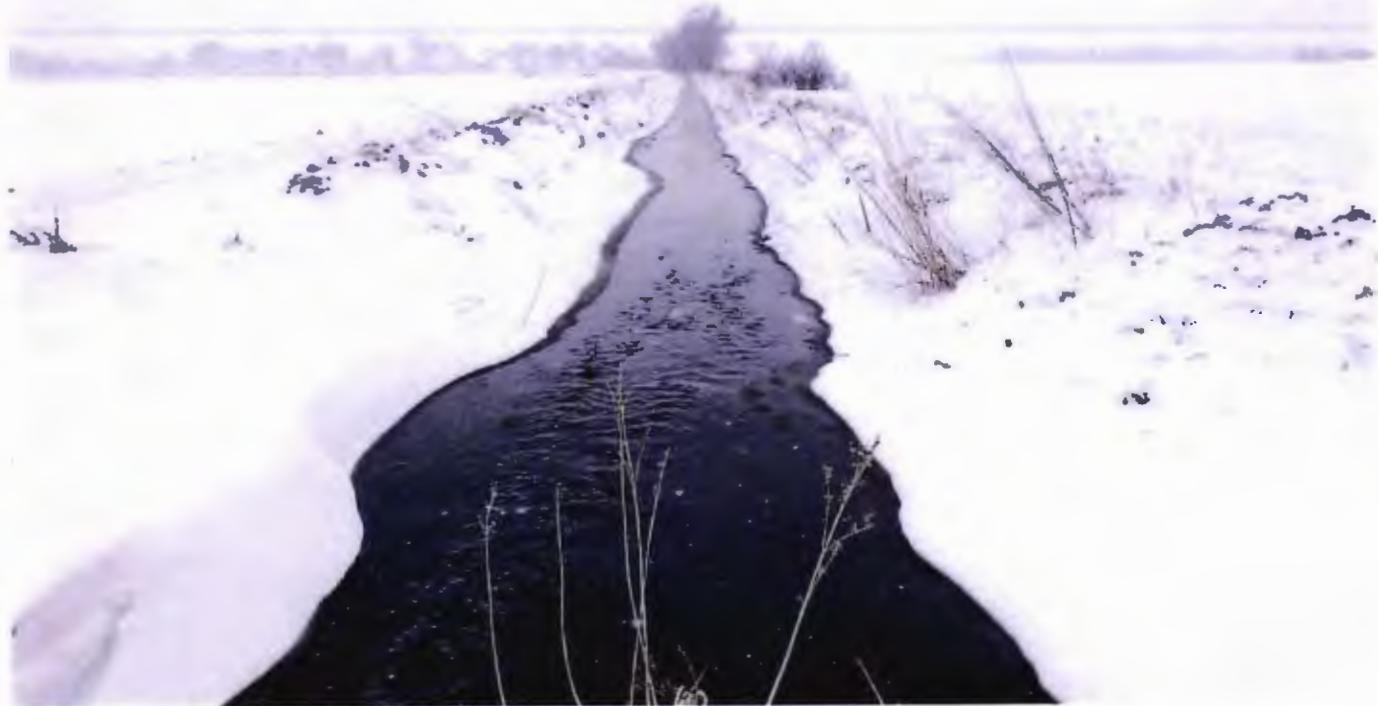
Photo 17

The flow continued through the culvert and then entered UNL property. Prior to investigating UNL property, I met with Sheldon Brummel (UNL). Mr. Brummel agreed to escort me to various locations to document flow. Mr. Brummel provide access to the first culvert site. I observed dark colored water and odor near a depth finder. Mr. Brummel stated that they have sampled the location all day and the depth has steadily increased, photo 16. I took photos from this area documenting the flow and dark colored water, photo 17.

Description: This photo is from the same area as the above photo. This photo is facing south from onto the culvert. I observed dark water and odor at this location.

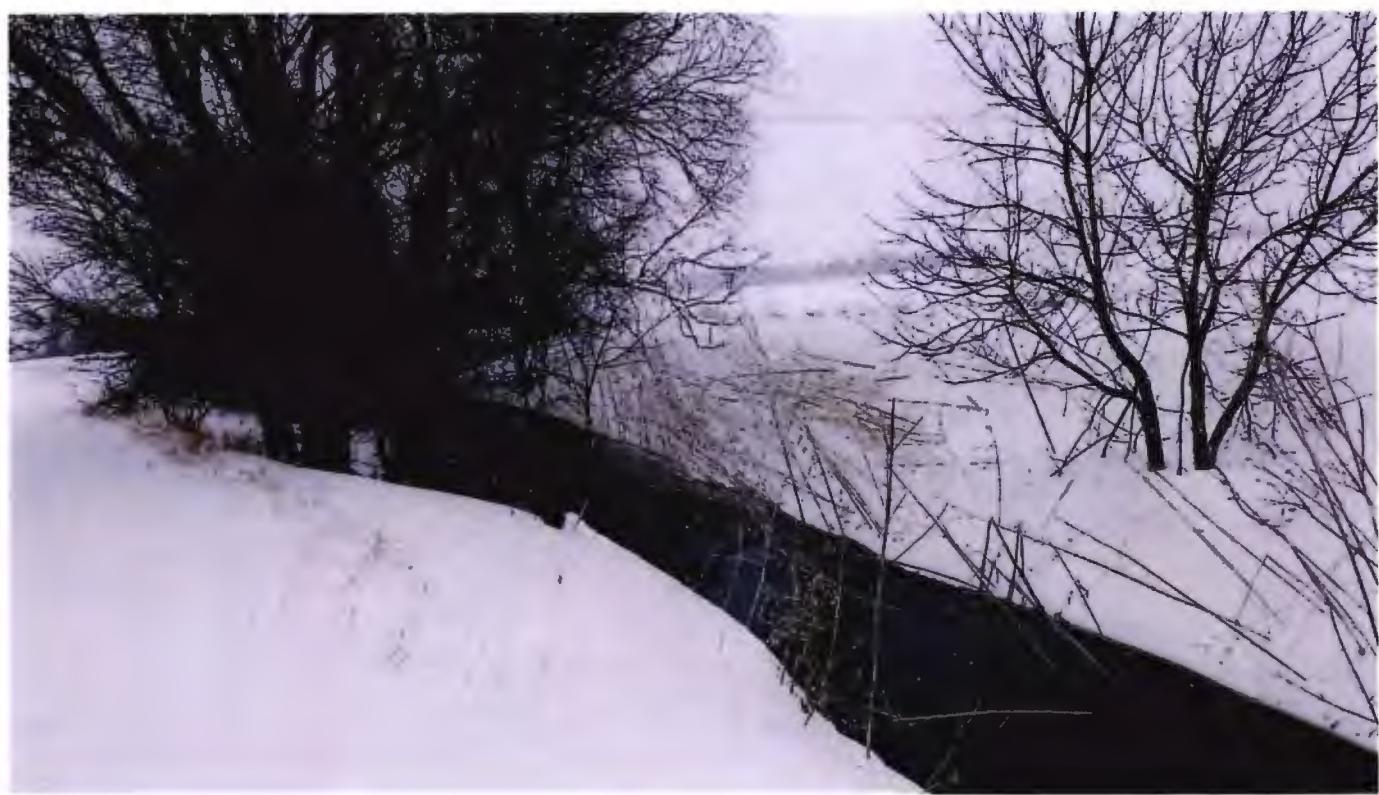
Photo 18

Mr. Brummel drove farther downstream. I again observed flow, dark colored water and noted odor, photo 18.

Description: This photo depicts an area deep into UNL property. I observed flow, dark water and odor.

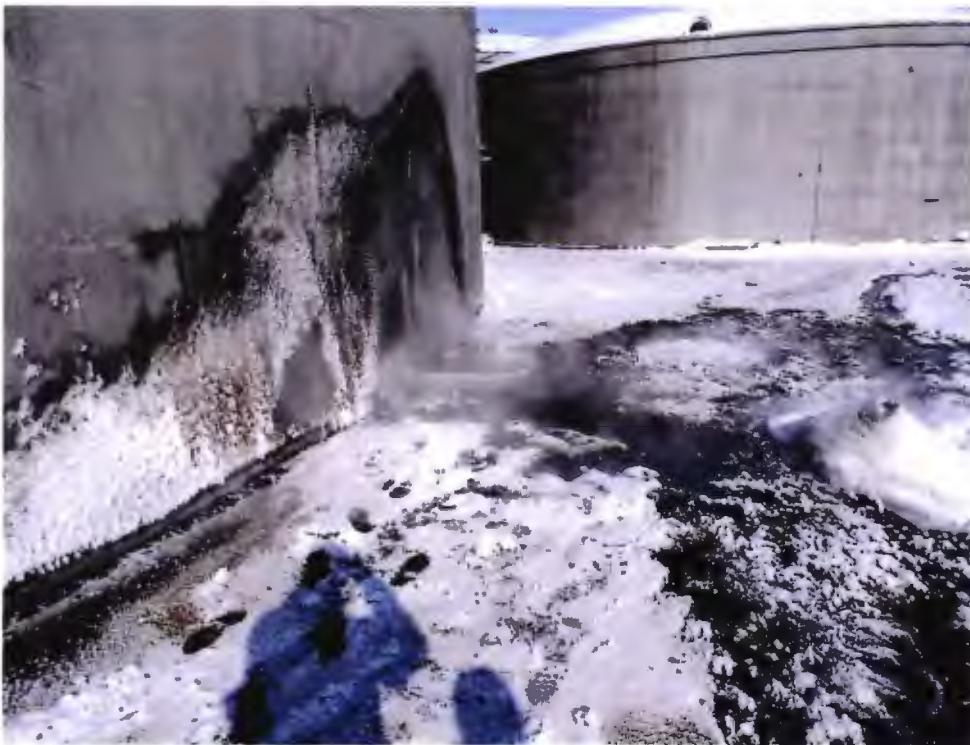
A digester containing thin stillage and cattle manure suffered a catastrophic failure due to a pipe connected to the floor of the digester bursting; reportedly due to freezing weather. An estimated

View north of piping vault where leak occurred

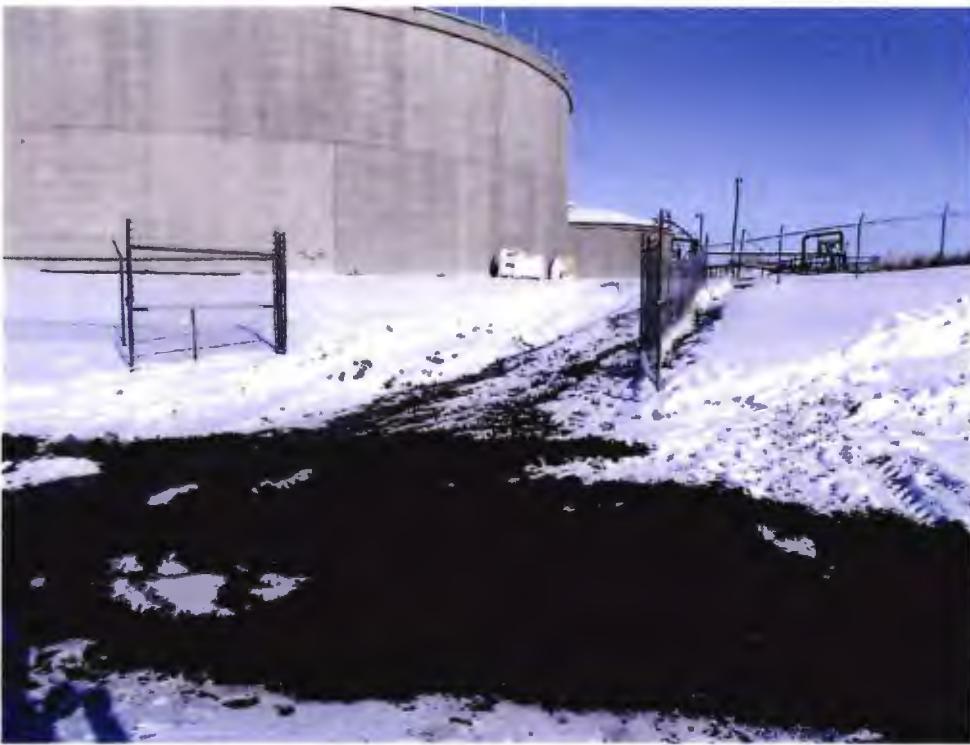
View north of digester where leak occurred

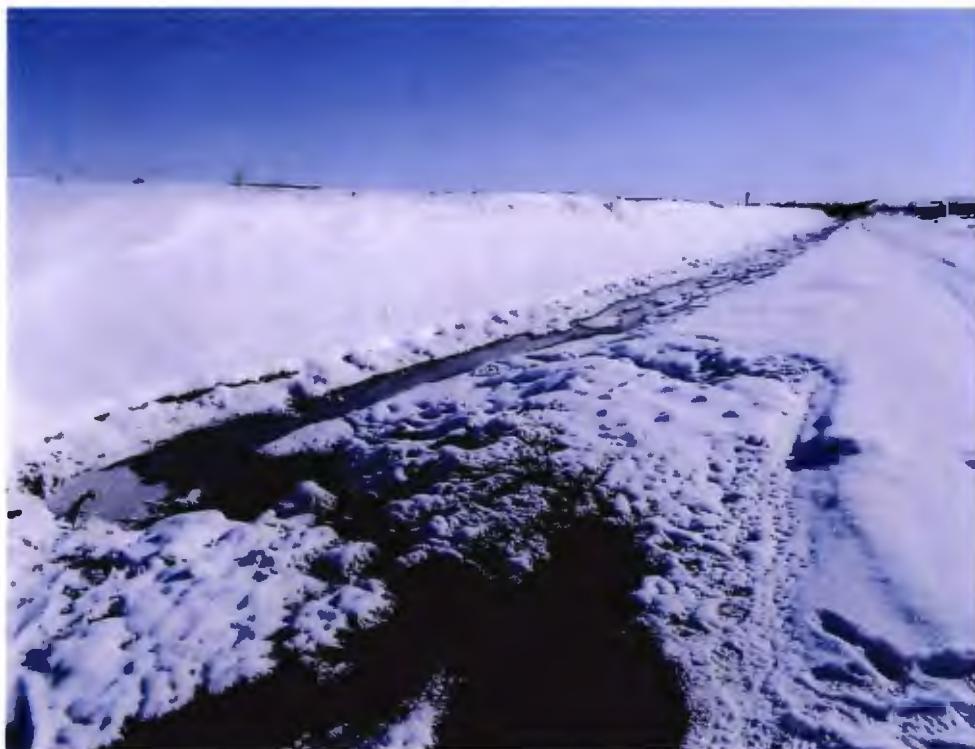
View east from near digester toward road ditch

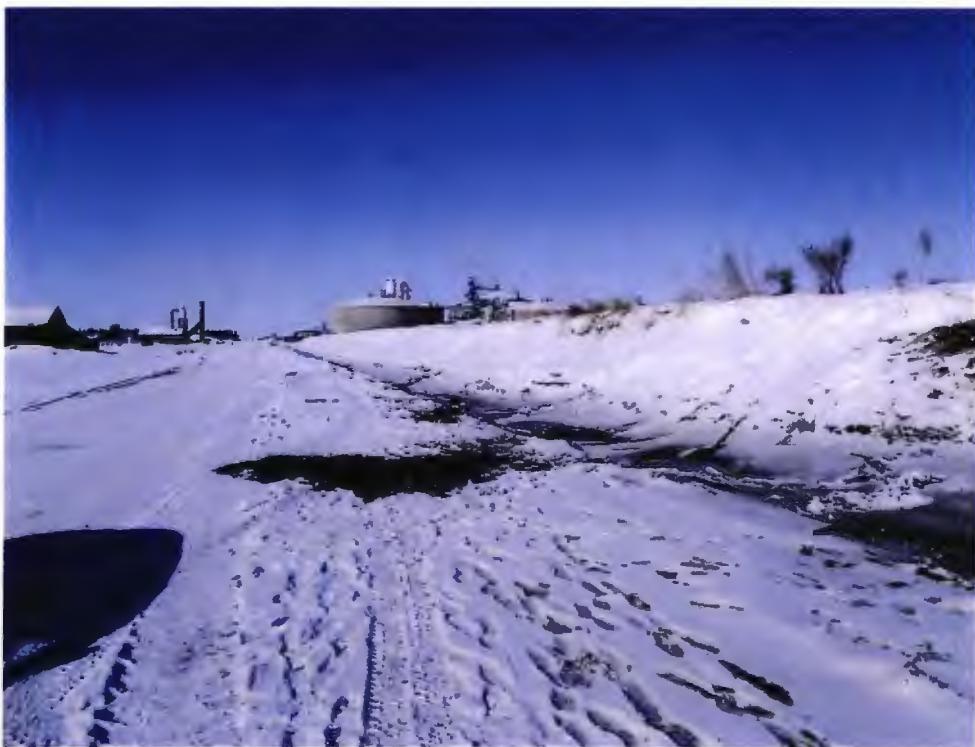
View west of road ditch with digester in background

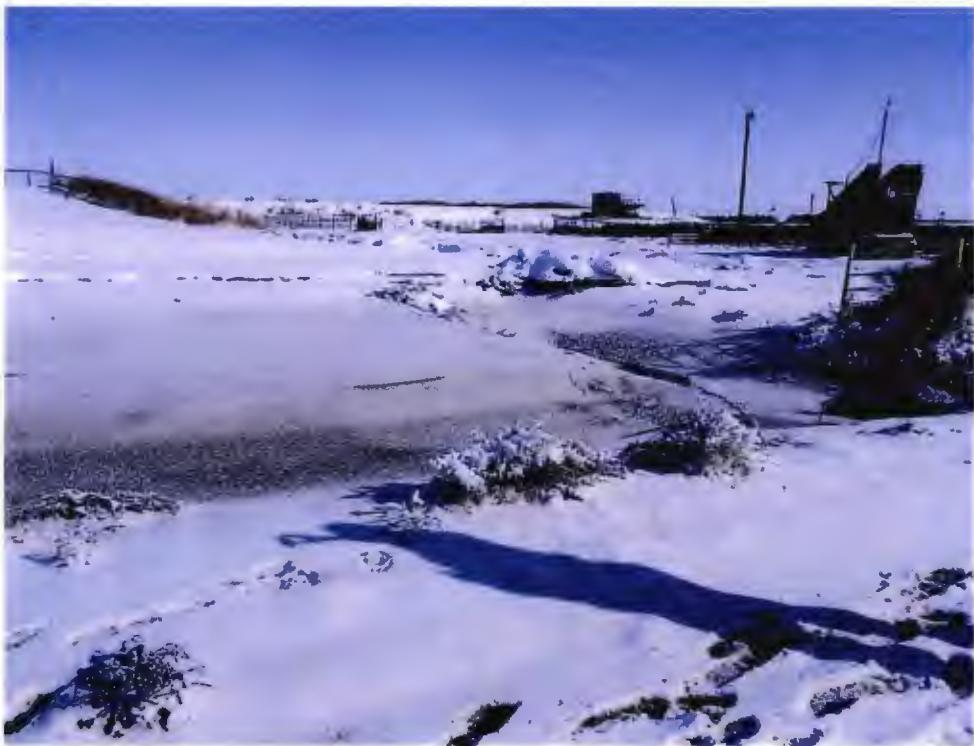
View NE of ditch near Mead Cattle Company
