BEFORE THE NEBRASKA DEPARTMENT OF ENVIRONMENT AND ENERGY

IN THE MATTER OF)
AltEn, LLC,) CASE NO. 3546
)
FID # 84069) EMERGENCY COMPLAINT
) AND ORDER
Respondent.)

DEPT. OF ENVIRONMENT AND ENERGY

Release of Thin Stillage and Cattle Manure from Digester at AltEn LLC, IIS #84069, RA
#021221-NH-0845

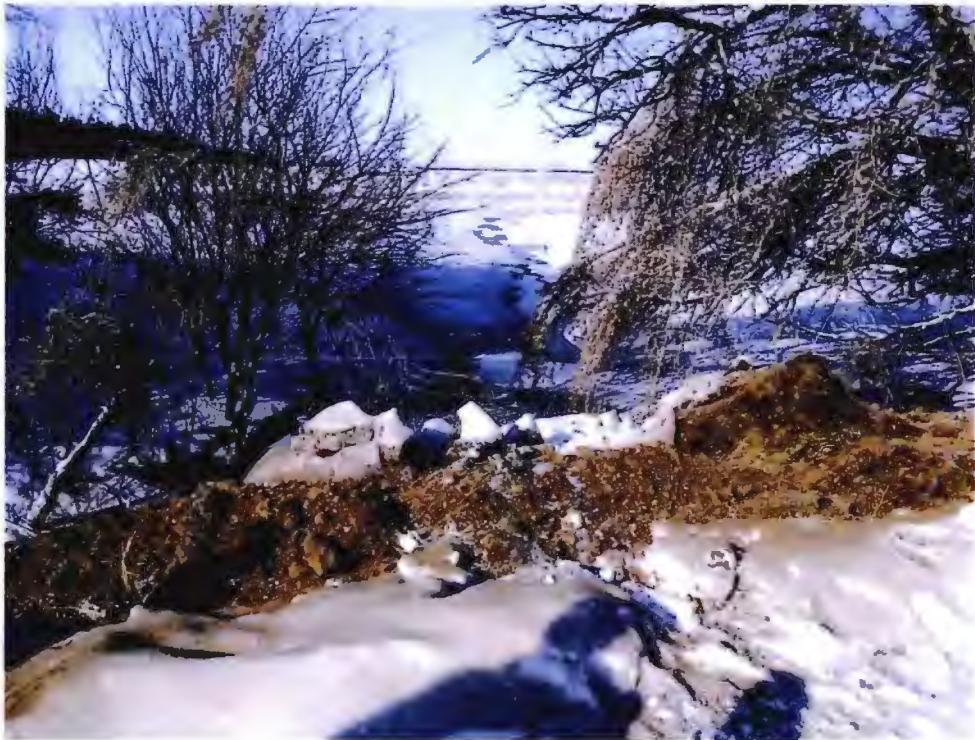
View WNW of dam upstream of culvert A

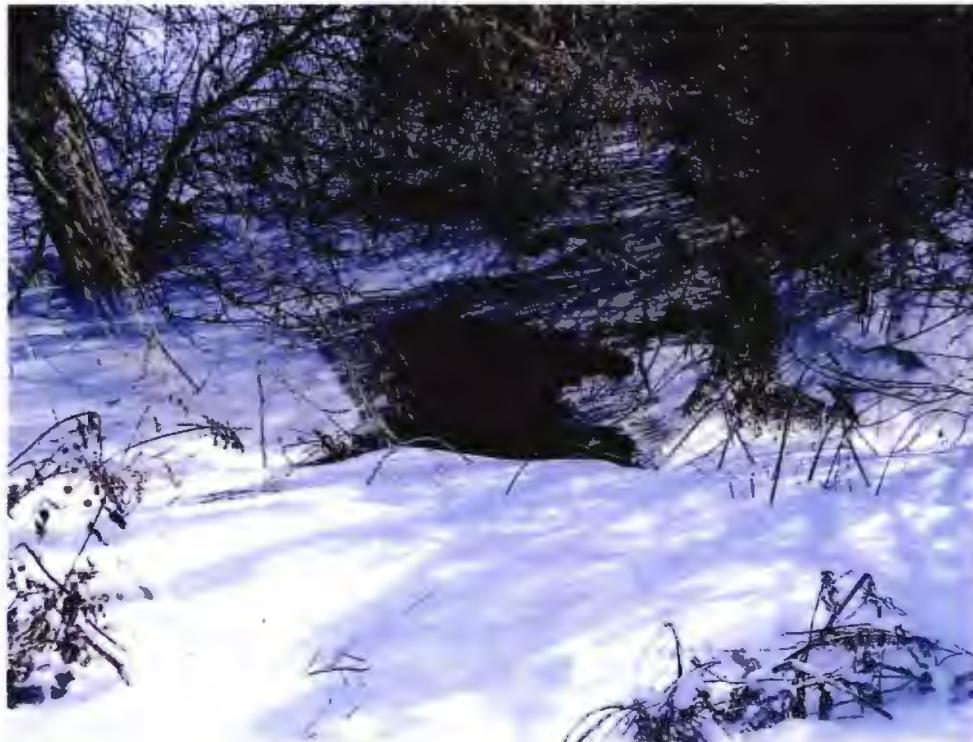
View east of ditch downstream from culvert A

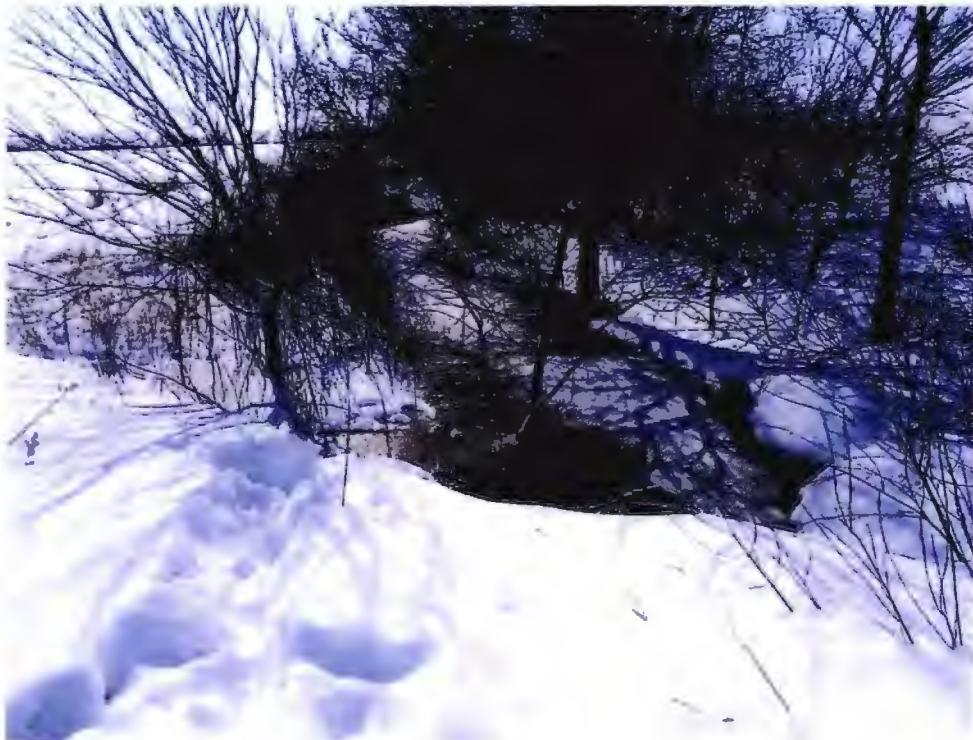
View north of ditch upstream from culvert B

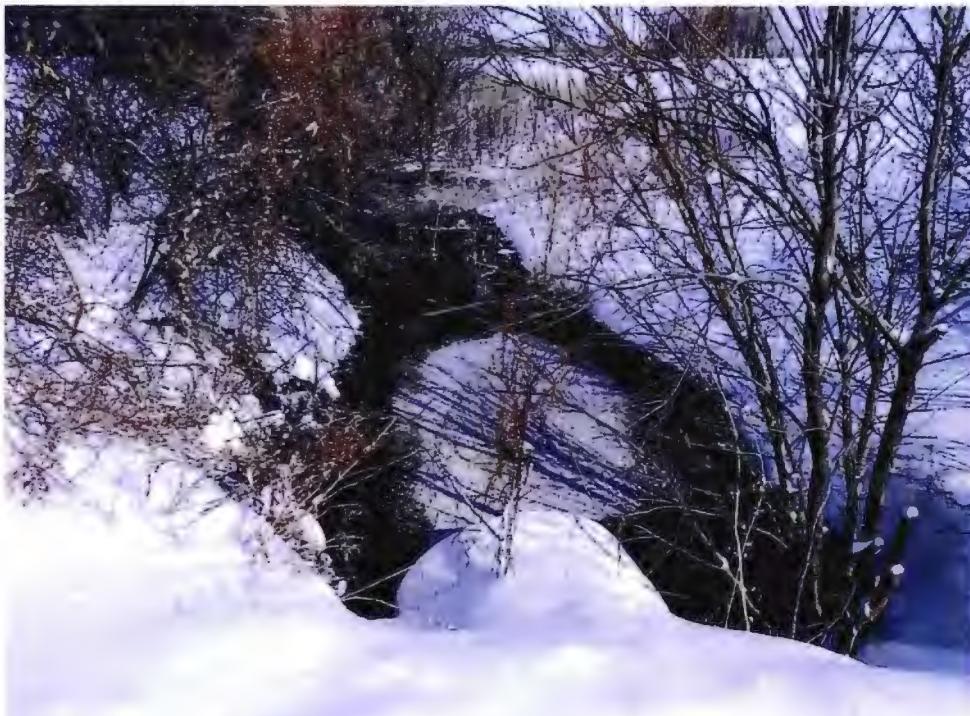
View south of ditch downstream of culvert B

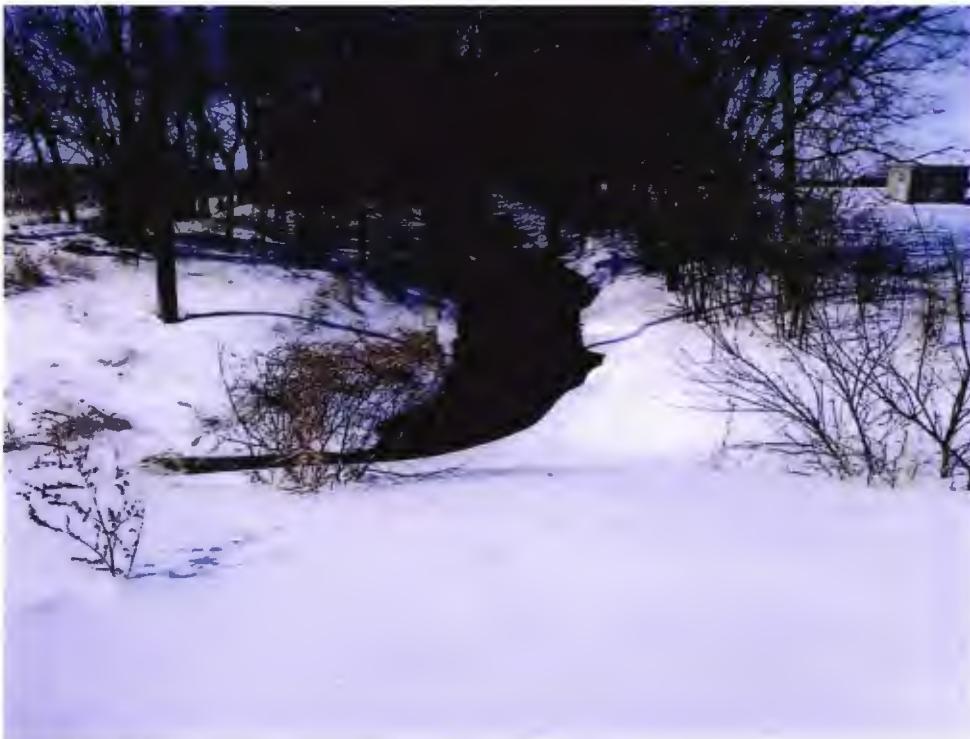
View north of ditch upstream from culvert C

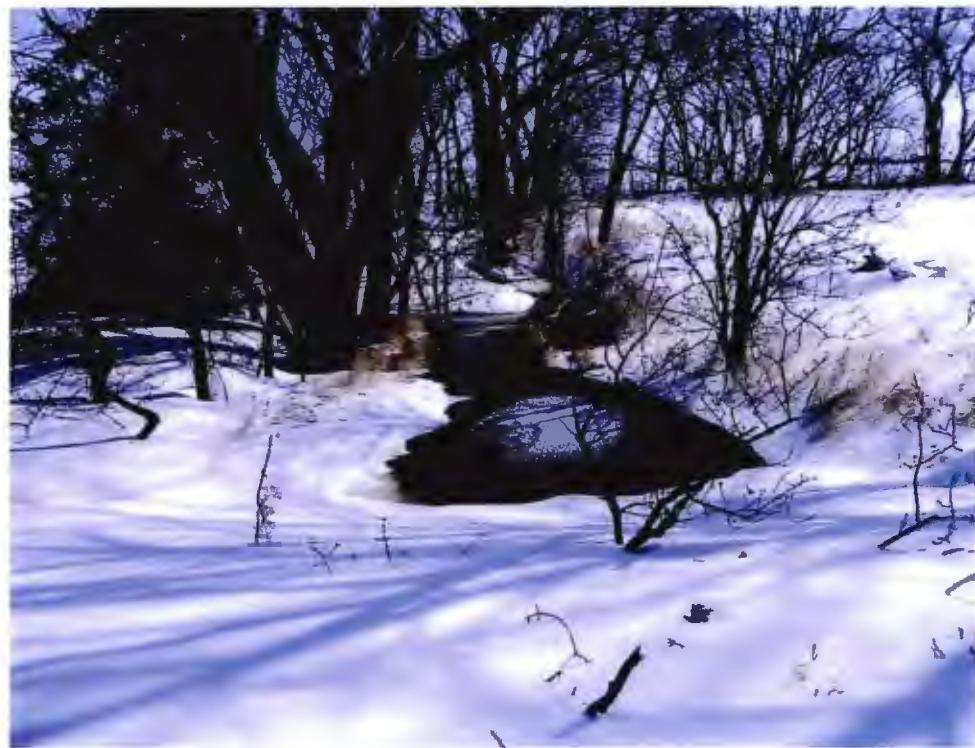
View south of ditch downstream from culvert C

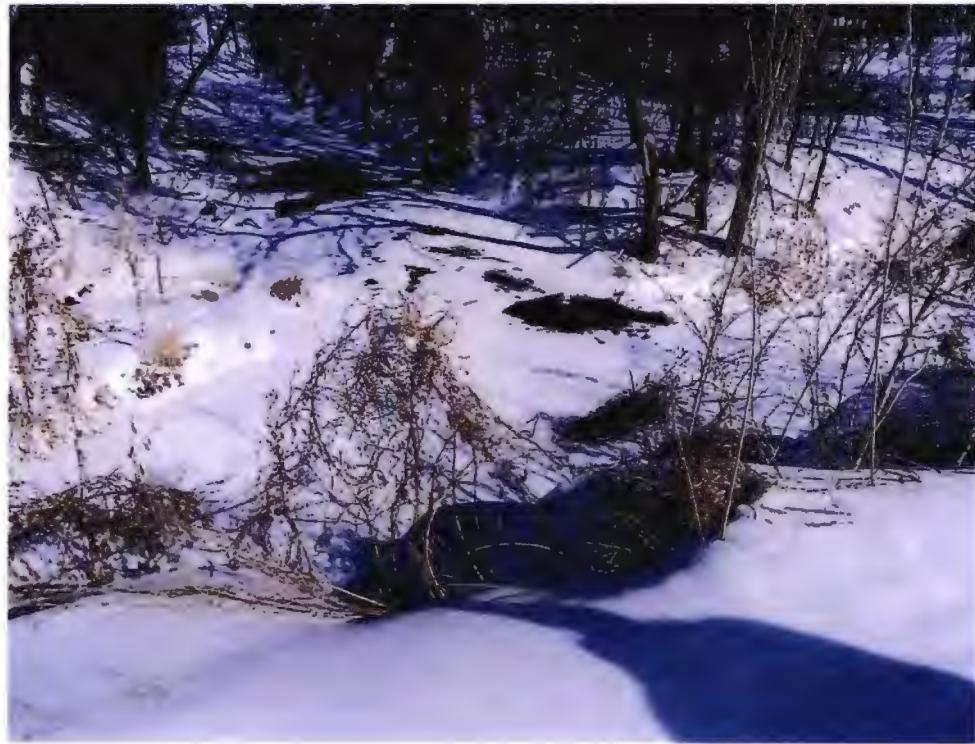
View north of ditch upstream from culvert D

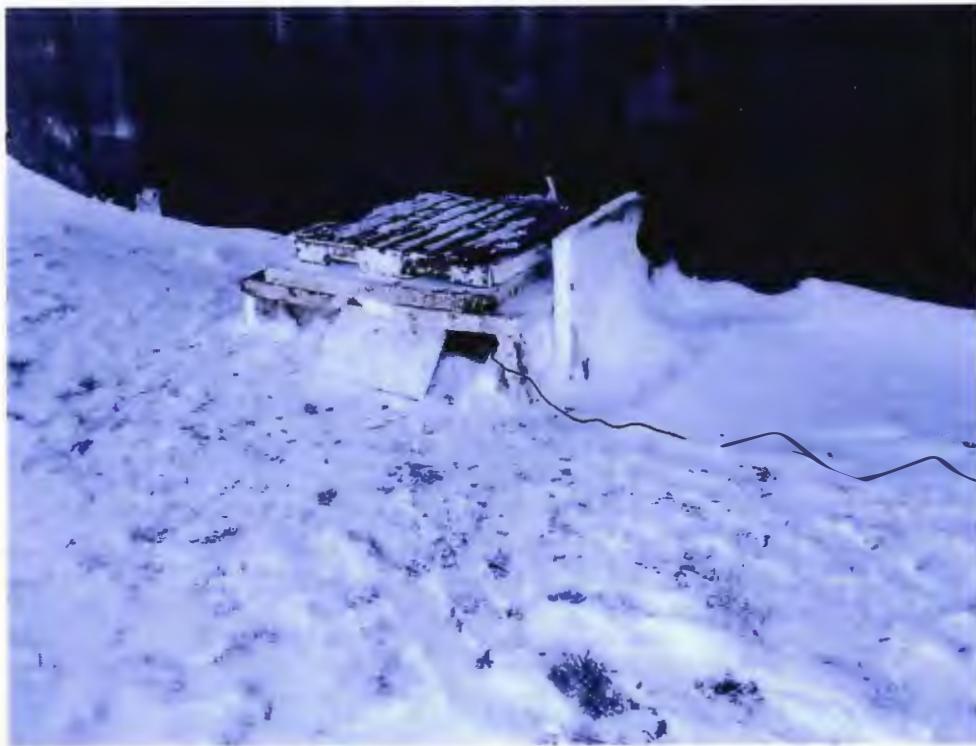
Insulation over piping vault on digester without leak

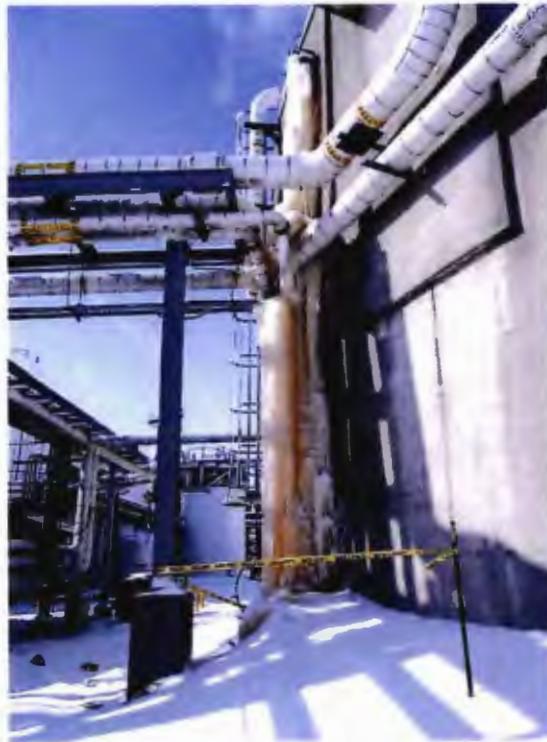
Spilling and leaking liquid from digester without leak

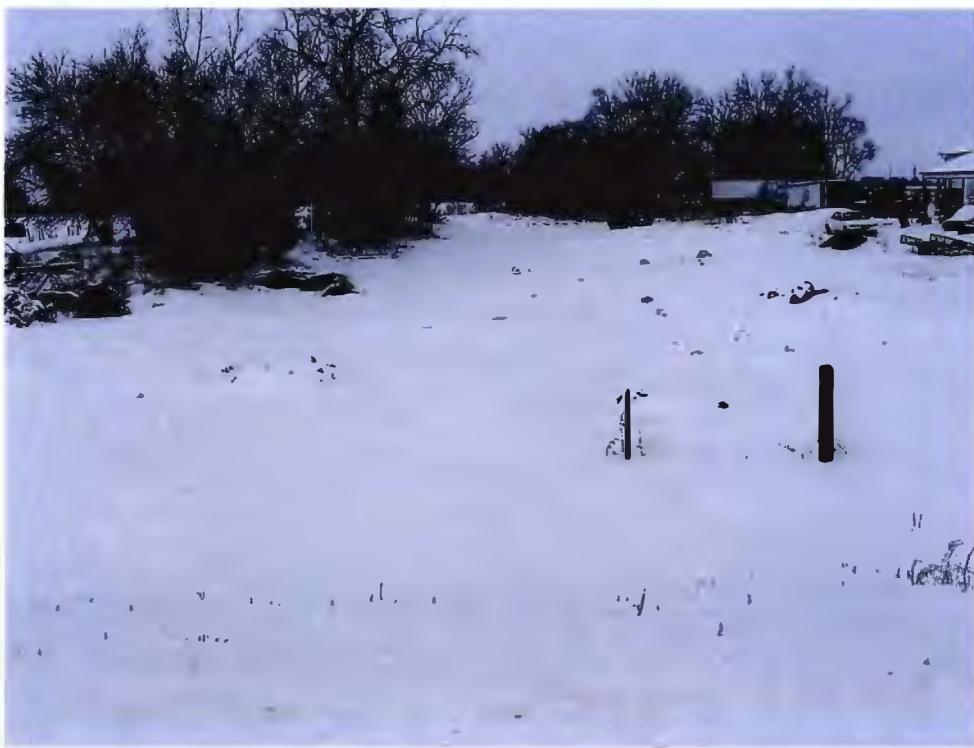
View north of ditch upstream from Stop #1

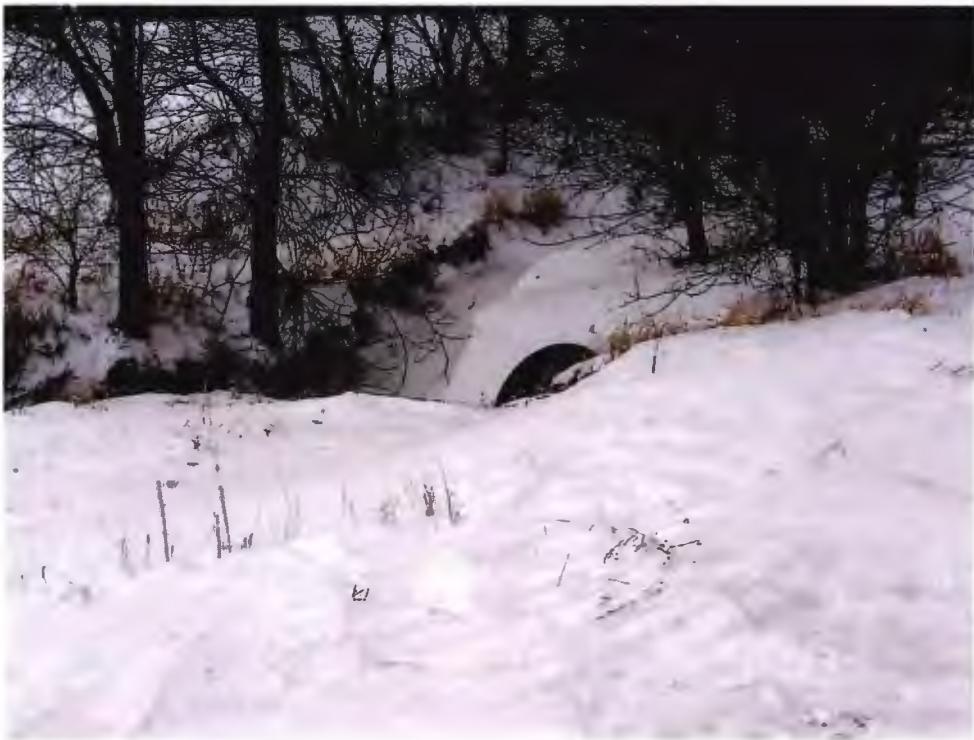
View west of ditch upstream from Stop #2

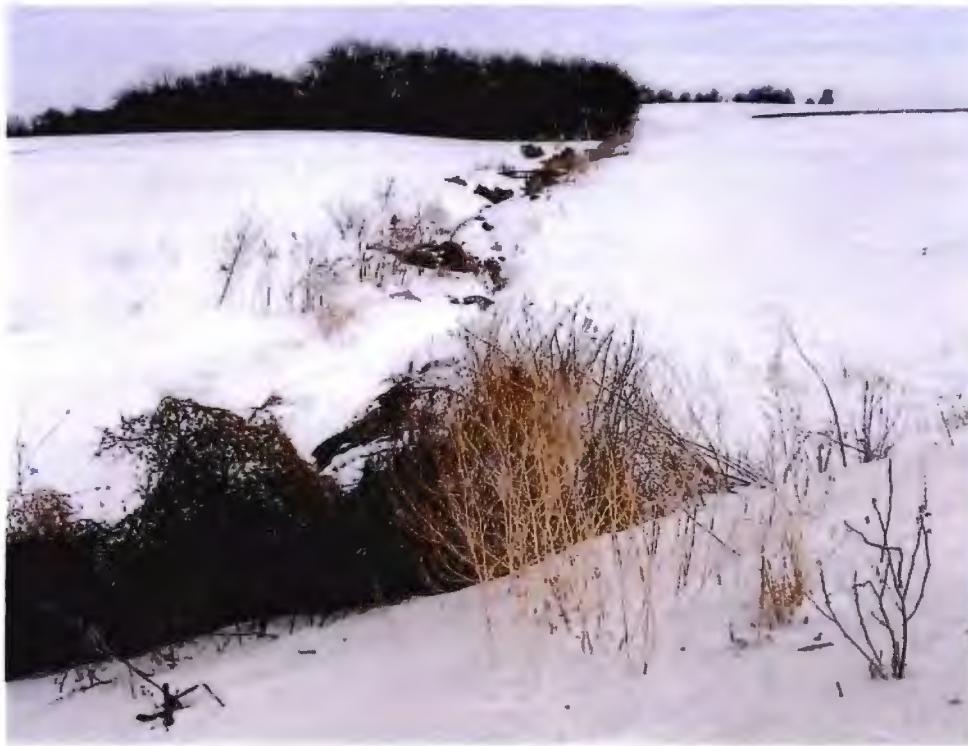
View east of ditch downstream from Stop #2

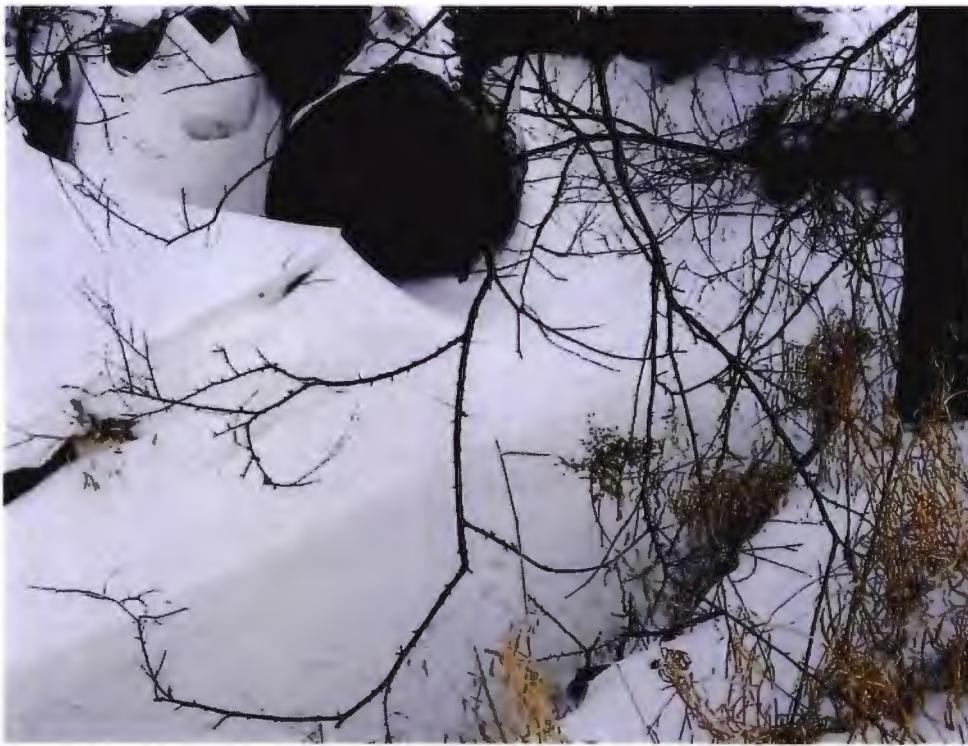
View east of upstream culvert inlet at Stop #2

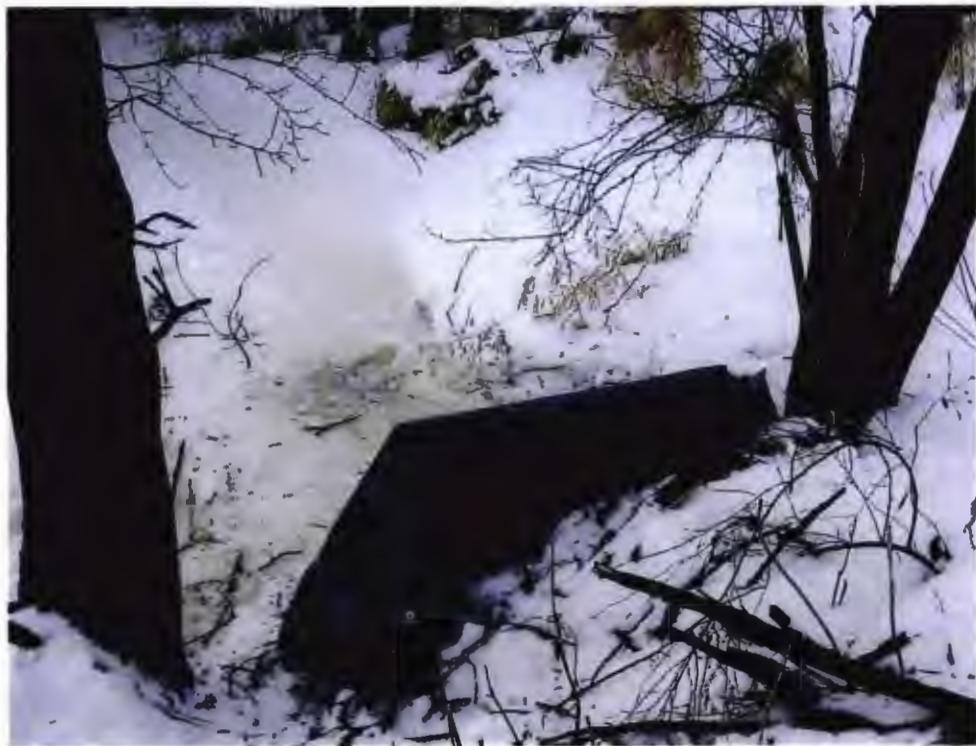
View west of ditch upstream from Stop #3

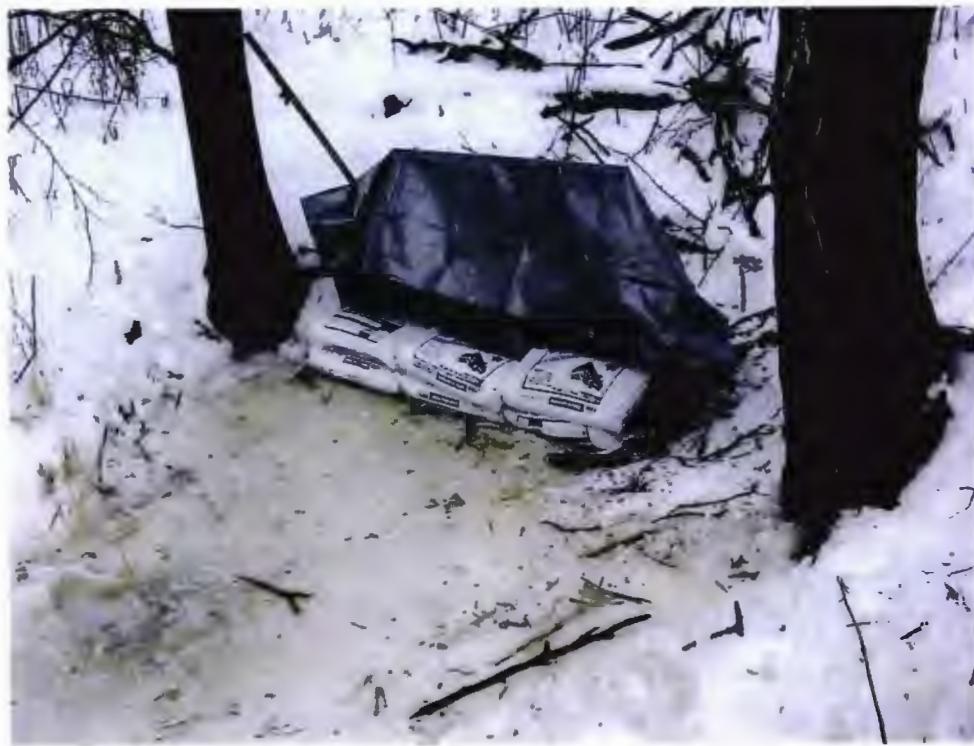
Containment structure in culvert inlet at Stop #3

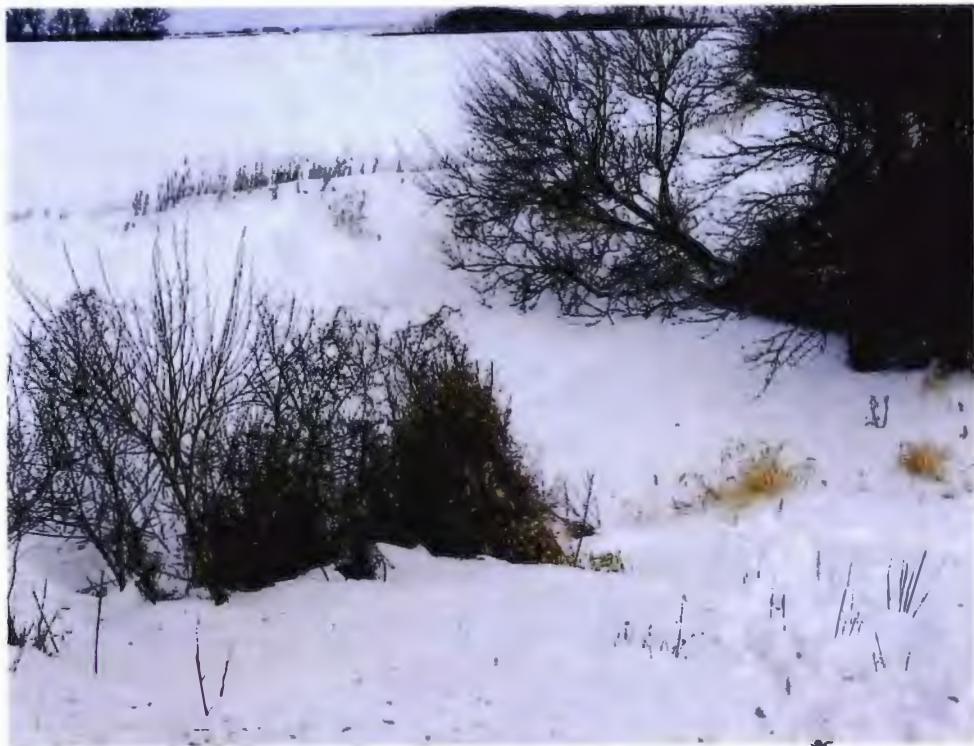
View east of ditch downstream from Stop #3

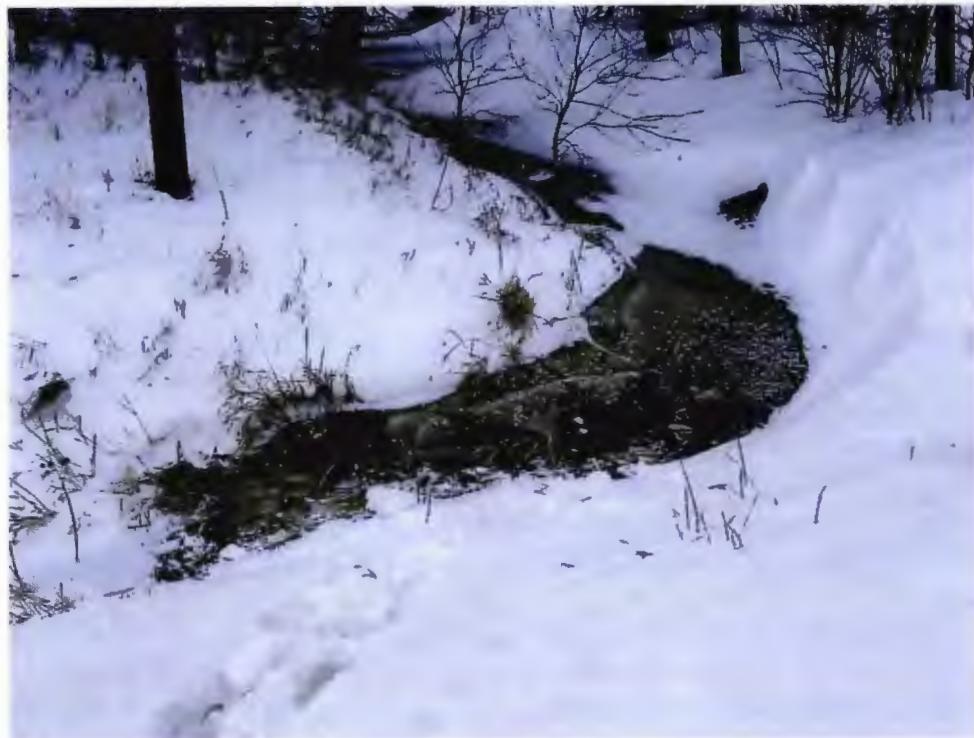
View west of ditch upstream from Stop #4

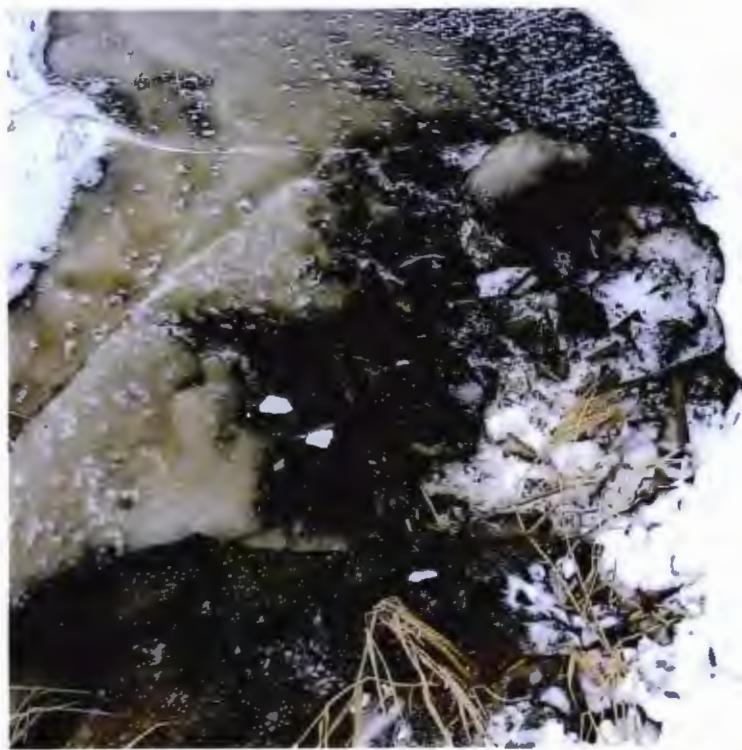
Broken crust of ice at culvert inlet at Stop #4

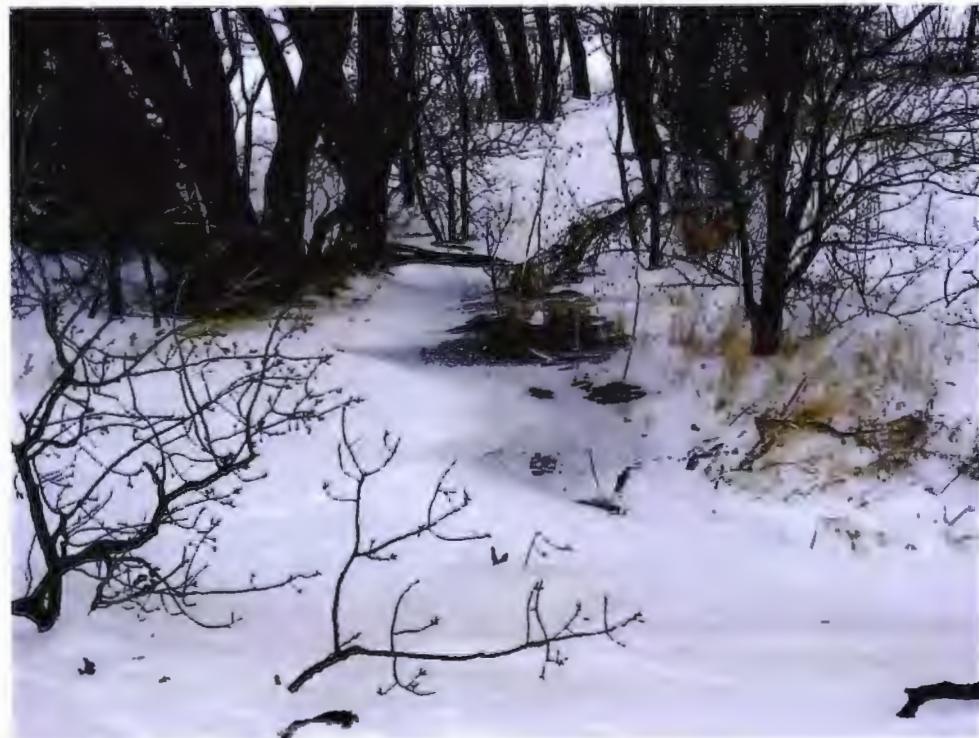
View east of ditch downstream from Stop #4

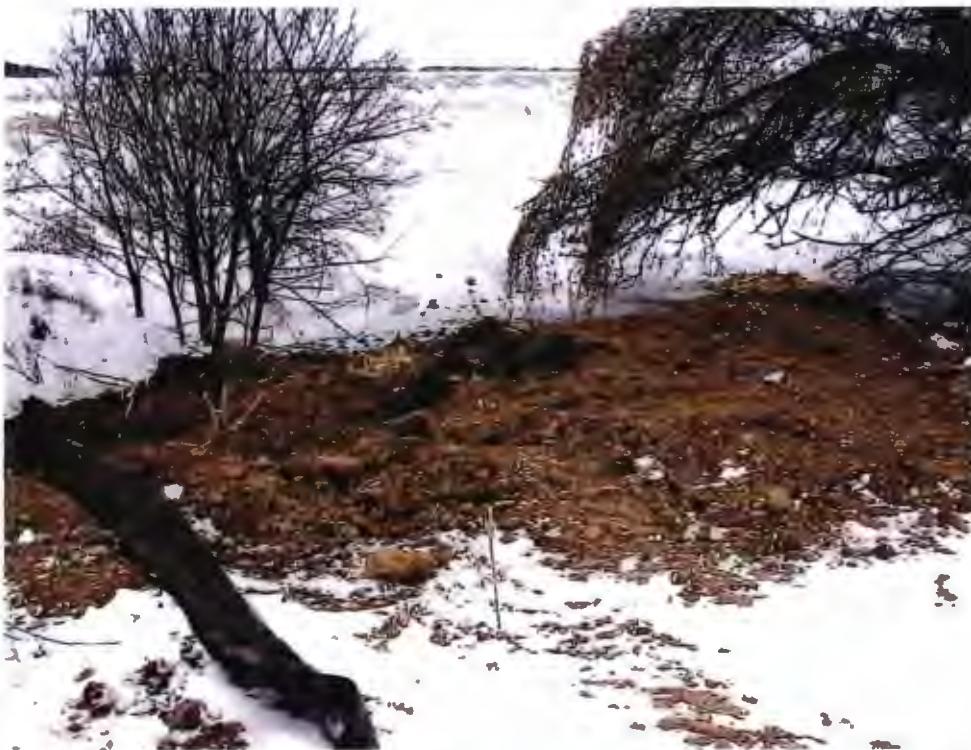
View west of dam upstream of Stop #5

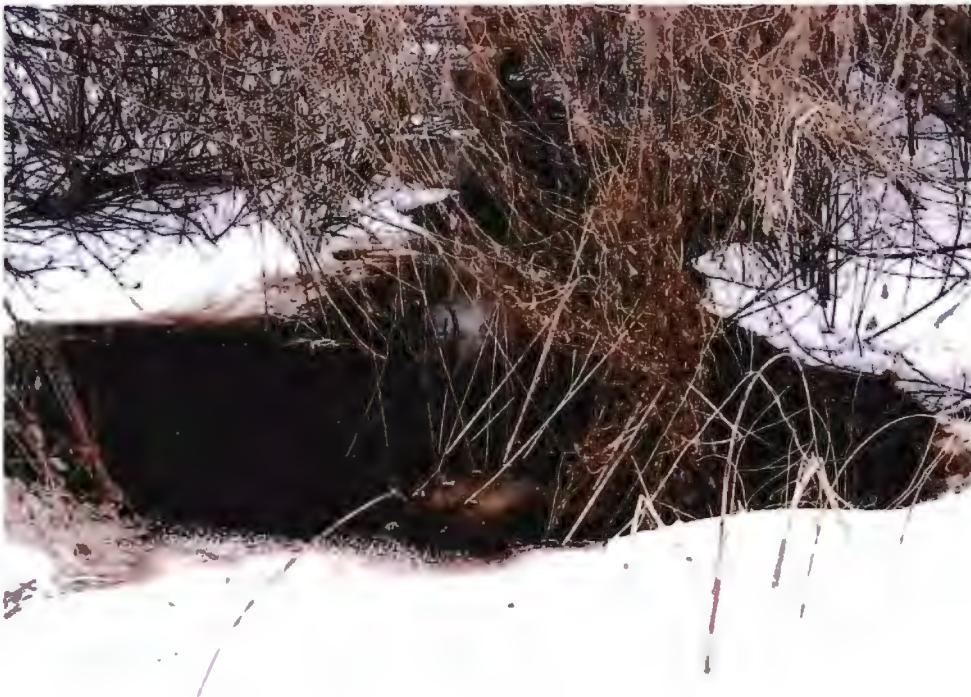
View east of ditch downstream from Stop #5

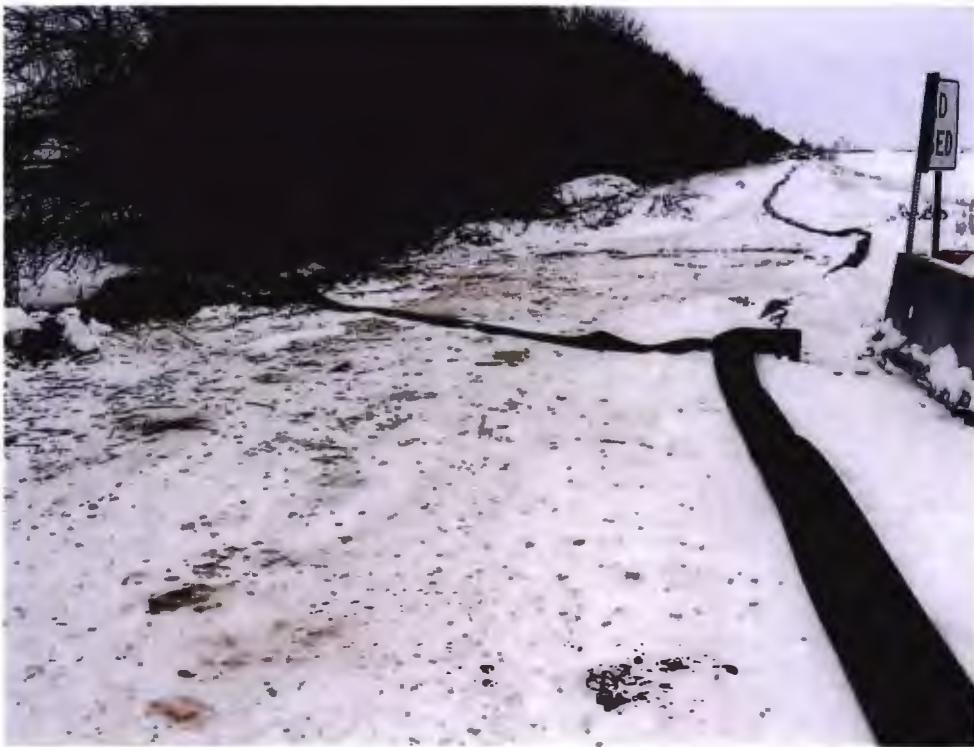
View north of piping laid out at Stop #5

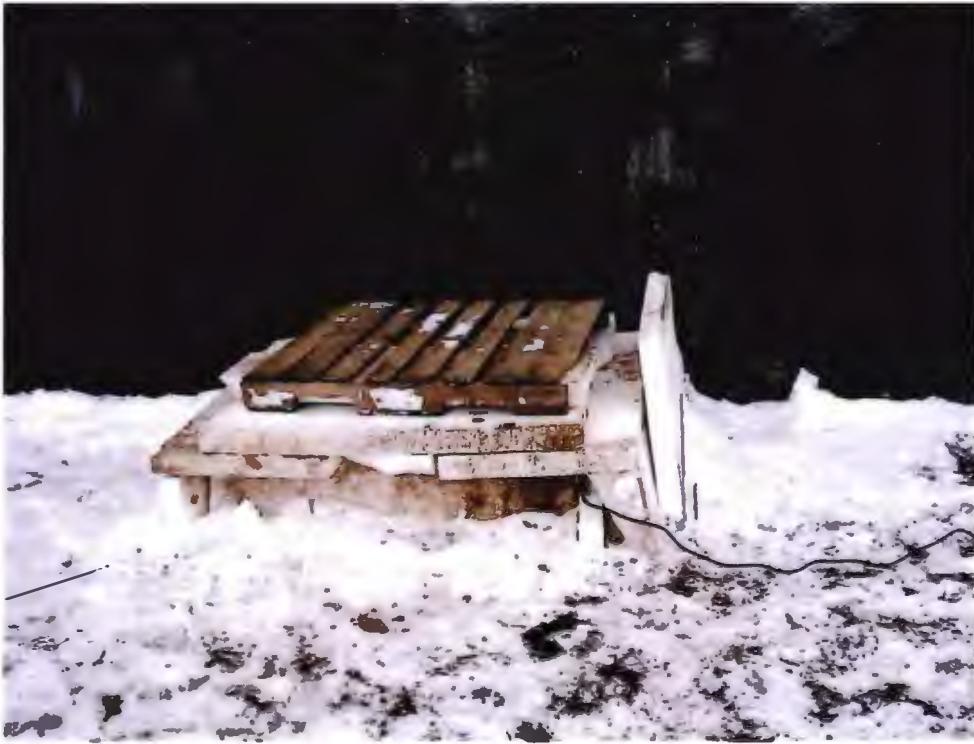
Insulation over piping well on digester w/out leak

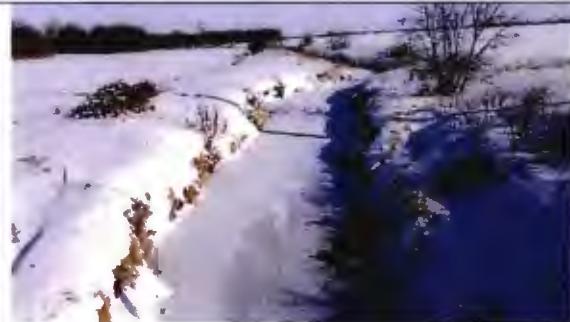
Clear Creek at this location was 99% ice/snow covered. There was a couple of open water areas, but site is currently not impacted from the AltEn LLC thin stillage discharge. Photo is looking north (upstream).

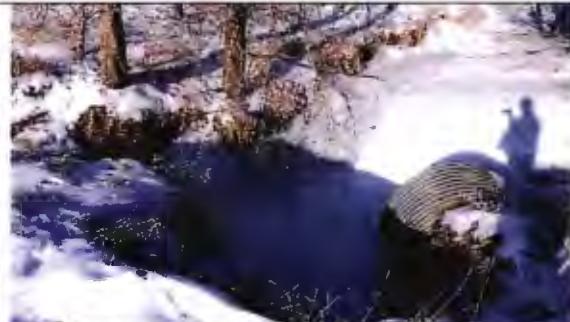
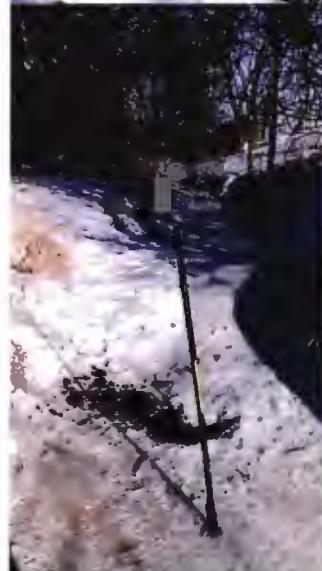
STOP 2 – North of the Intersection of COUNTY ROADS 6 & F

I found no evidence of the AltEn LLC thin stillage discharge reaching this location. I chopped a hole in the ice (~10 inches thick) to the channel's substrate. It was completely frozen, with no water below the ice. Photos were taken looking west/northwest (upstream).

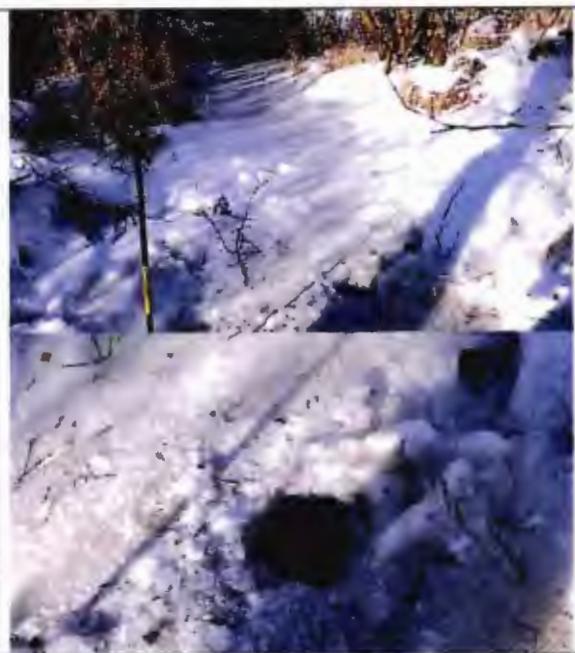
STOP 3 – Road 7/Highway 66

I found no evidence of the AltEn LLC thin stillage discharge reaching this location. I chopped a hole in the ice (~12 inches thick) to the channel's substrate. It was completely frozen, with no water below the ice. Photos were taken looking west/northwest (upstream).

The berm/dam located here made up of a tarp and sand bags appears to have constructed on top of the channel's ice surface in front the culvert. It would seem prudent to chip the ice away and lower the entire structure.

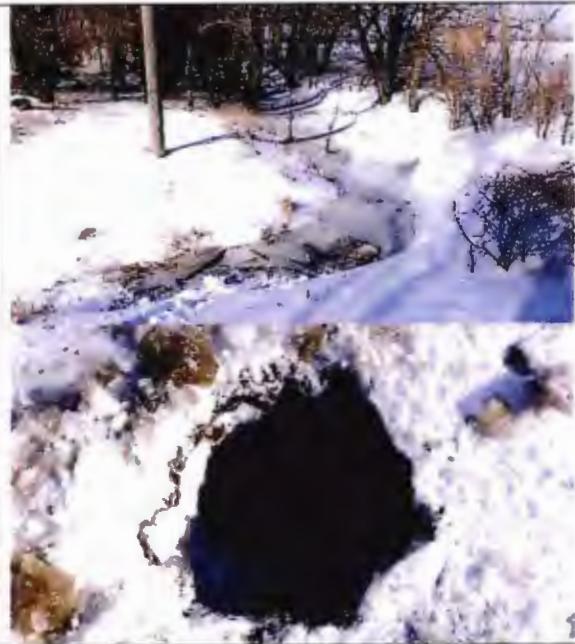
STOP 4 – County Road 8, North of Road H

The AltEn LLC thin stillage discharge water remains as a frozen layer on top of the original ice layer that existed prior to the thin stillage release. The frozen waste water ice is much darker in appearance than the snow and original ice in the channel. The darker, frozen top layer was easily broken by walking on it. I did chop a hole through the channel's original ice layer (~12 inches thick) and found water underneath at this location. I do not believe the water to be the thin stillage waste, as there was no pressure from below that filled the hole I had opened. However, I did not have a meter with me to confirm to be true.

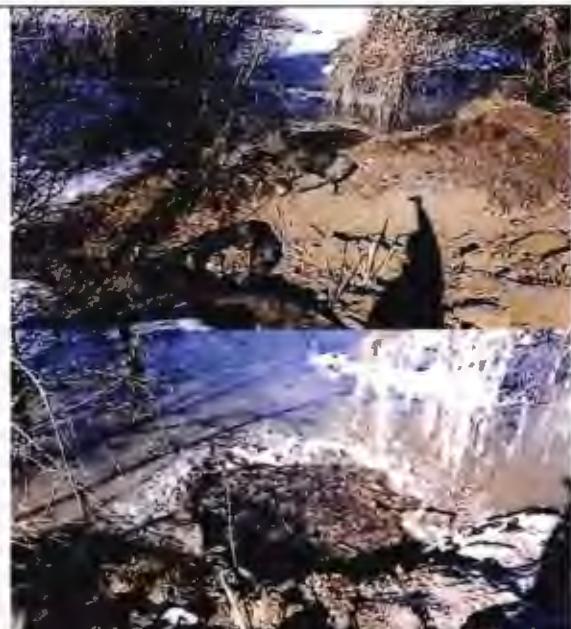
The AltEn LLC thin stillage discharge water remains as a large pooled area behind the make-shift dam constructed on the upstream (west) side at this location. Ken Peterson (AltEn Plant Manager) showed up while I was at this location. He told me they had placed additional earthen material here to stop the seepage through the culverts. He also said they planned to start pumping the liquid from this location back into a lagoon yet today. A hose was stretched out in this area, but no pump was in place when I was there.

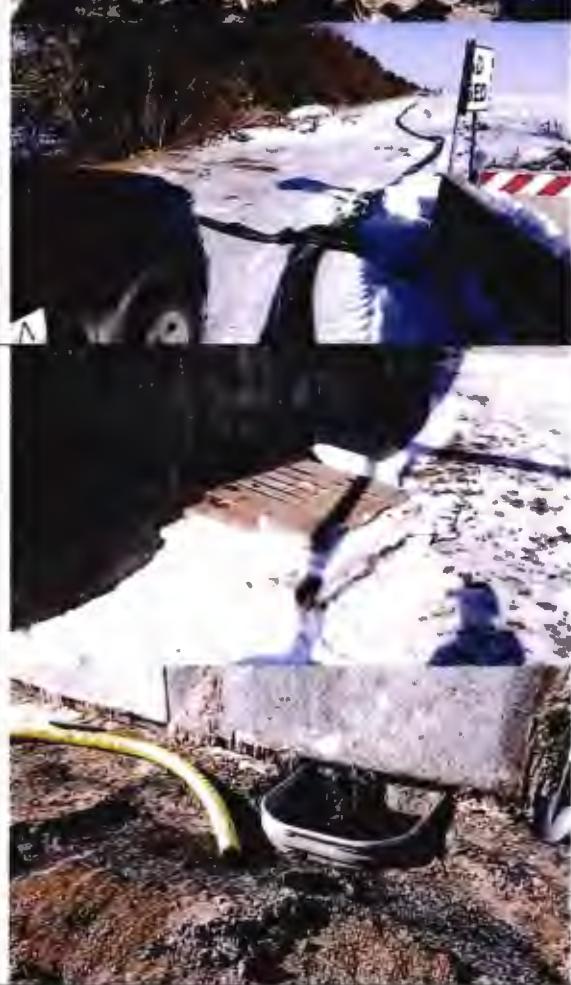
STOP 6 – ALTEN LLC FACILITY DIGESTERS

Ken Peterson (AltEn Plant Manager) led me to the digesters and gave me a quick tour. I did not observe any discharges from either the north or south stillage tank. The top photo is the covered pipe/valve housing on the north tank and the bottom photo is of the one that failed on the south tank.

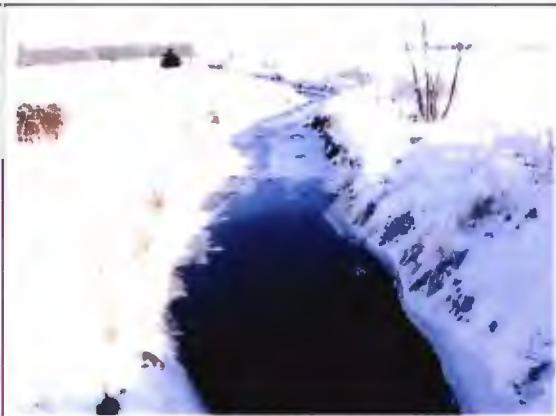
Nothing to see here other than water and ice;
no apparent impacts.

Photo looking north from Highway 66 bridge.

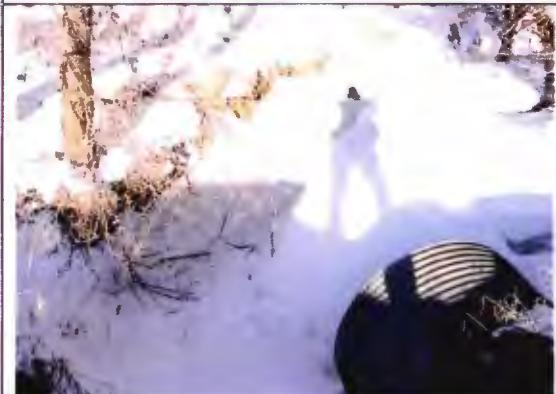
**STOP 2 – North of the Intersection of
COUNTY ROADS 6 & F – 0845 hrs.**

No apparent contamination; same as
described by Greg Michl 2-18-21.

Photo looking west.

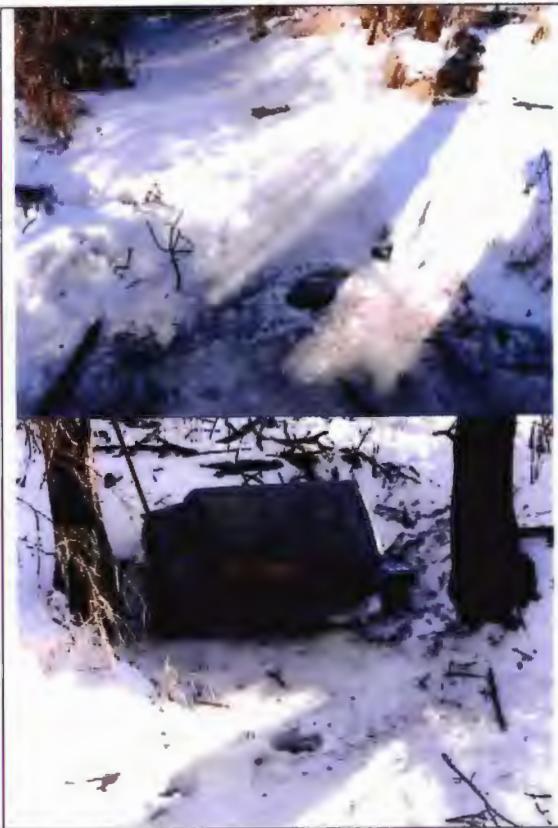
Top photo looking west.

Bottom photo looking east at containment structure.

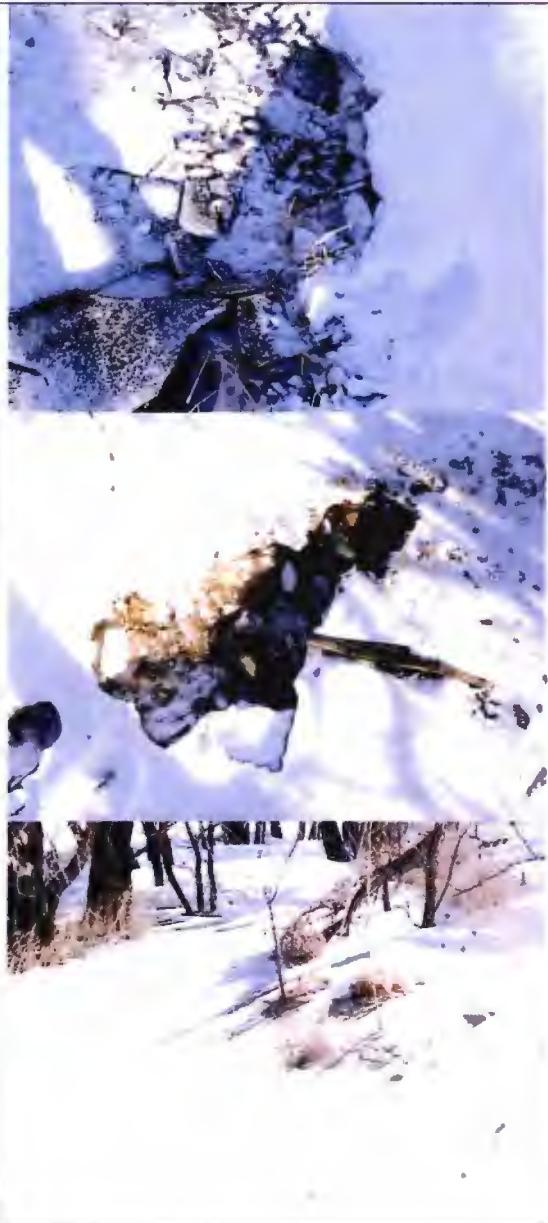
Top two photos looking down at frozen contamination on west side of county road.

Bottom photo looking east from east side of county road.

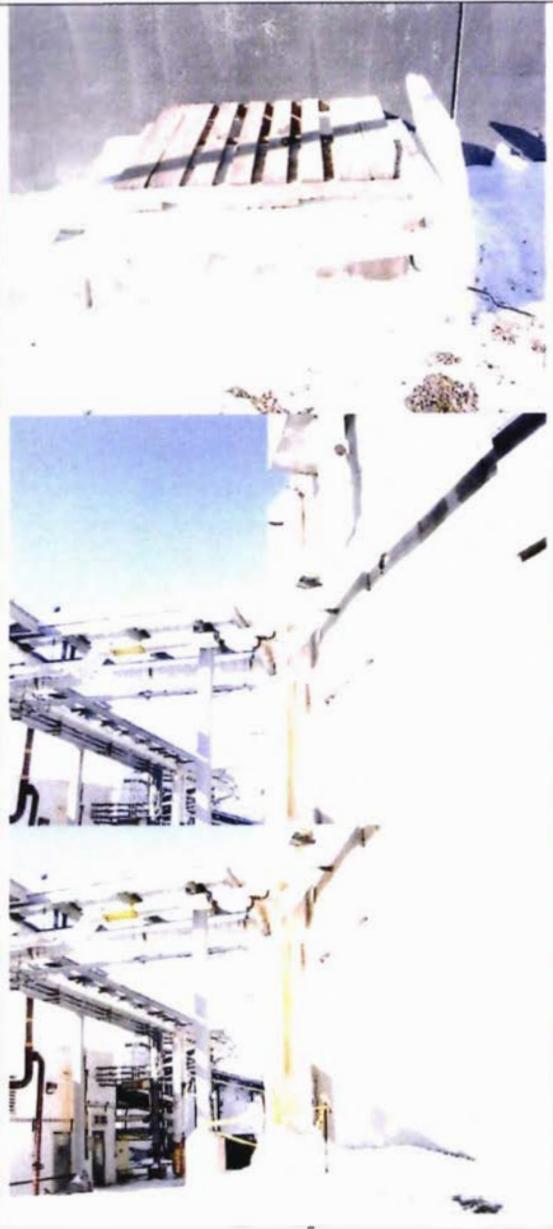
**STOP 6 – ALTEN LLC FACILITY
DIGESTERS – 0932 hrs.**

Same observed by Greg Michl 2-18-21.

Top photo. Looking at piping well associated with north digester. Chord on right side leading into well is associated with heating lamp for piping.

Bottom two photos. Looking at ice accumulation on side of north digester.

AltEn added additional insulation along with an external heat source around the pipe on the second (north) digester. If material from the second (north) digester were to be discharged, efforts similar to what was performed with the first (south) digester spill would be made to contain the spill on AltEn's property. Given the fact no secondary containment is able to be constructed, AltEn believes it should drain the second (north) digester into its lagoon system in order to best protect the environment from any additional accidental leaks or spills and with NDEE's approval, would do so. With the plant shut down and thus no heat source for the digesters, the draining of the liquids from the digester will eliminate the risk of future freeze related pipe breaks and leaks from the digester.

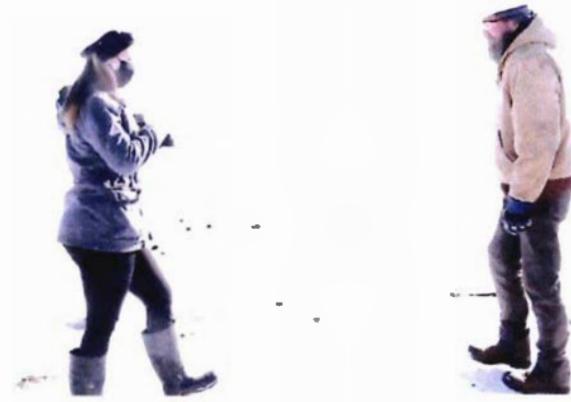
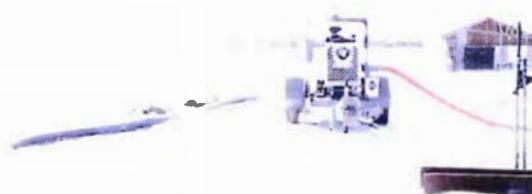
Facility pumping water from emergency lagoon to active wastewater lagoons in preparation for pumping material from north digester. NDEE Inspector Hillary Stoll on-site for inspection of emergency lagoon (see Photos below). Top photo looking east across "emergency lagoon." Bottom photo (looking south) shows water from "emergency lagoon" being pumped north to site wastewater lagoons.
