**SITE NAME: ENGEN FOURWAYS GARDENS**

**PROJECT NAME: MINOR BUILDING WORKS**

**CONTRACTOR: ORANGE CIRCLE CONSTRUCTION**

09 December 2025

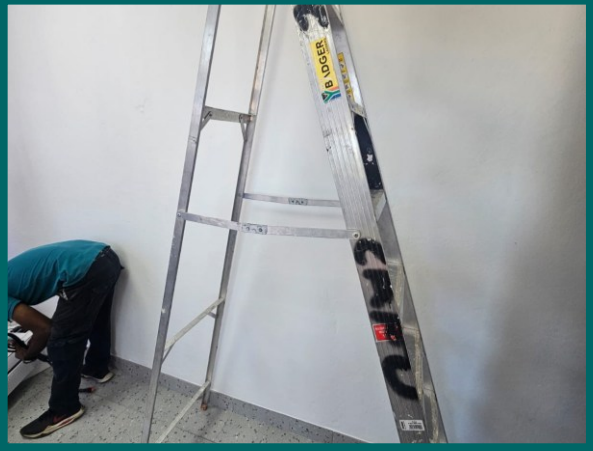
| VISUAL COMPLIANCE ITEM | DESCRIPTION OF COMPLIANCE ITEM |
|---|---|
| | <p>All ladders on site were in good condition.</p> <p><b>GENERAL SAFETY REGULATIONS 13 – LADDERS:</b></p> <p>13A (1) An employee shall ensure that every ladder is constructed of sound material and is suitable for the purpose for which it is used, and –</p> <p>(a) is fitted with non-skid devices at the bottom ends and hooks or similar devices at the upper ends of the stiles which shall ensure the stability of the ladder during normal use;</p> |

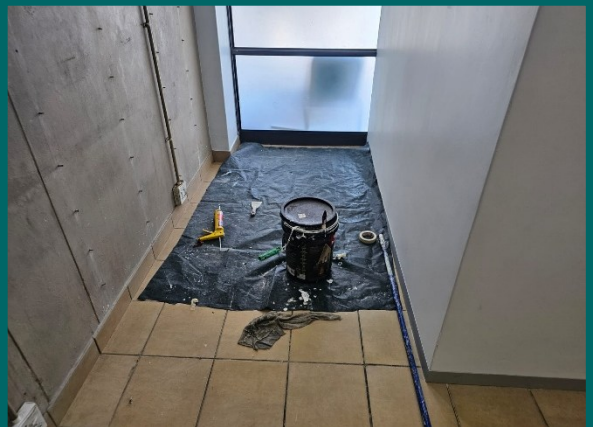
| VISUAL COMPLIANCE ITEM | DESCRIPTION OF COMPLIANCE ITEM |
|---|---|
| | <p>Drop sheets was used by the contractor to ensure no paint spillage on site.</p> |

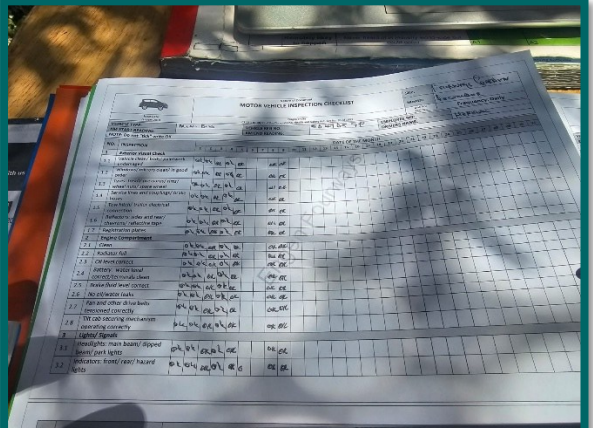
| VISUAL COMPLIANCE ITEM | DESCRIPTION OF COMPLIANCE ITEM |
|---|---|
| | <p>All completed checklists, registers, toolbox talks &amp; DSTI's was available in the safety file.</p> |

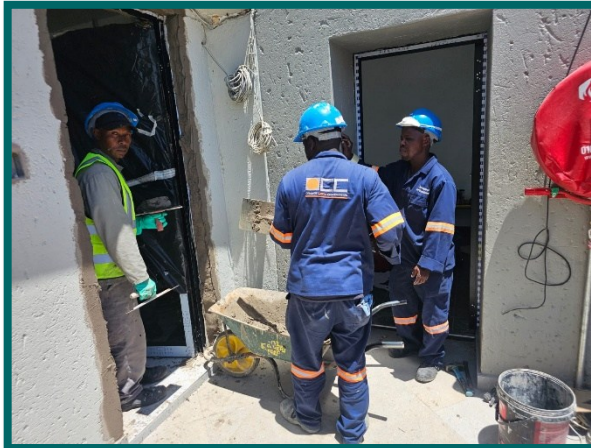
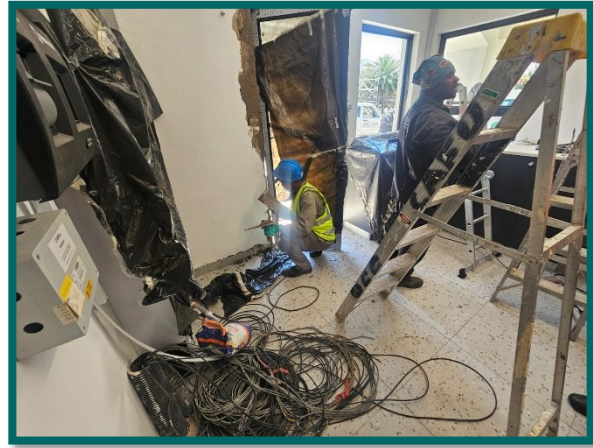
Not all employees on site were complying with the PPE requirements set out by Engen.

**ENGEN RETAIL SPECIFICATIONS – 4.12 PERSONAL PROTECTIVE EQUIPMENT (PPE) AND CLOTHING:**

All Contractors shall ensure PPE needs are analysed and that all workers are issued and wear hard hats. All contractor employees are to wear yellow, high-visibility vests while on site.

5. PERSONAL PROTECTIVE EQUIPMENT (PPE):
  - All persons (including visitors) on site must wear hard hats.
  - Reflective vests are to be worn when working in the vicinity of traffic.

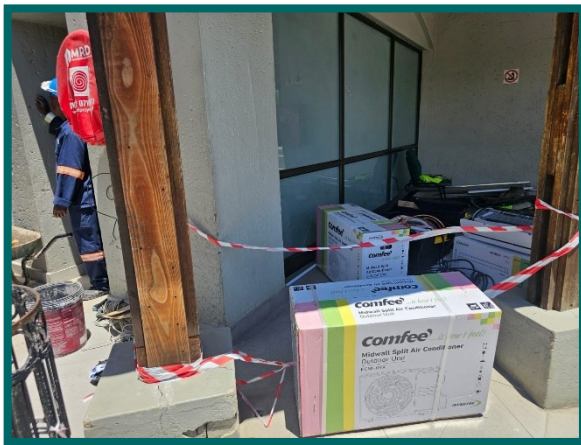
Danger Tape has been used as barricading on site.

**SPECIFICATION FOR TEMPORARY HOARDING & BARRICADING AT RETAIL SITES 3.1 - HOARDING AND BARRICADE TYPES:**

The hoarding is to be a minimum 1,8 metres high with a maximum 50mm gap and may be in the form of wire mesh fencing, corrugated iron, structurally supported shade cloth, solid steel interlocking panels, steel fencing, plywood or suitable alternatives.

Note: Orange road cones, hazard tape or flashing lights are considered a form of signage and do not constitute barricading.

4. PUBLIC SAFETY:
  - Sufficient safeguarding must be in place to prohibit the public from entering the site (Fencing off.) - Sections of the site barricading has been done with danger tape and danger tape does not comply with the Engen requirements.
