DRAFT - Bulkley River and Morice River Watershed Groups Fish Passage Restoration Planning

Prepared for
Habitat Conservation Trust Fund
BC Fish Passage Remediation Program
Canadian Wildlife Federation

Prepared by
Al Irvine, B.Sc., R.P.Bio.
New Graph Environment
6 Regent St
Nelson, BC V1L 2P1

DRaFT - Version 0.0.5
2021-03-11

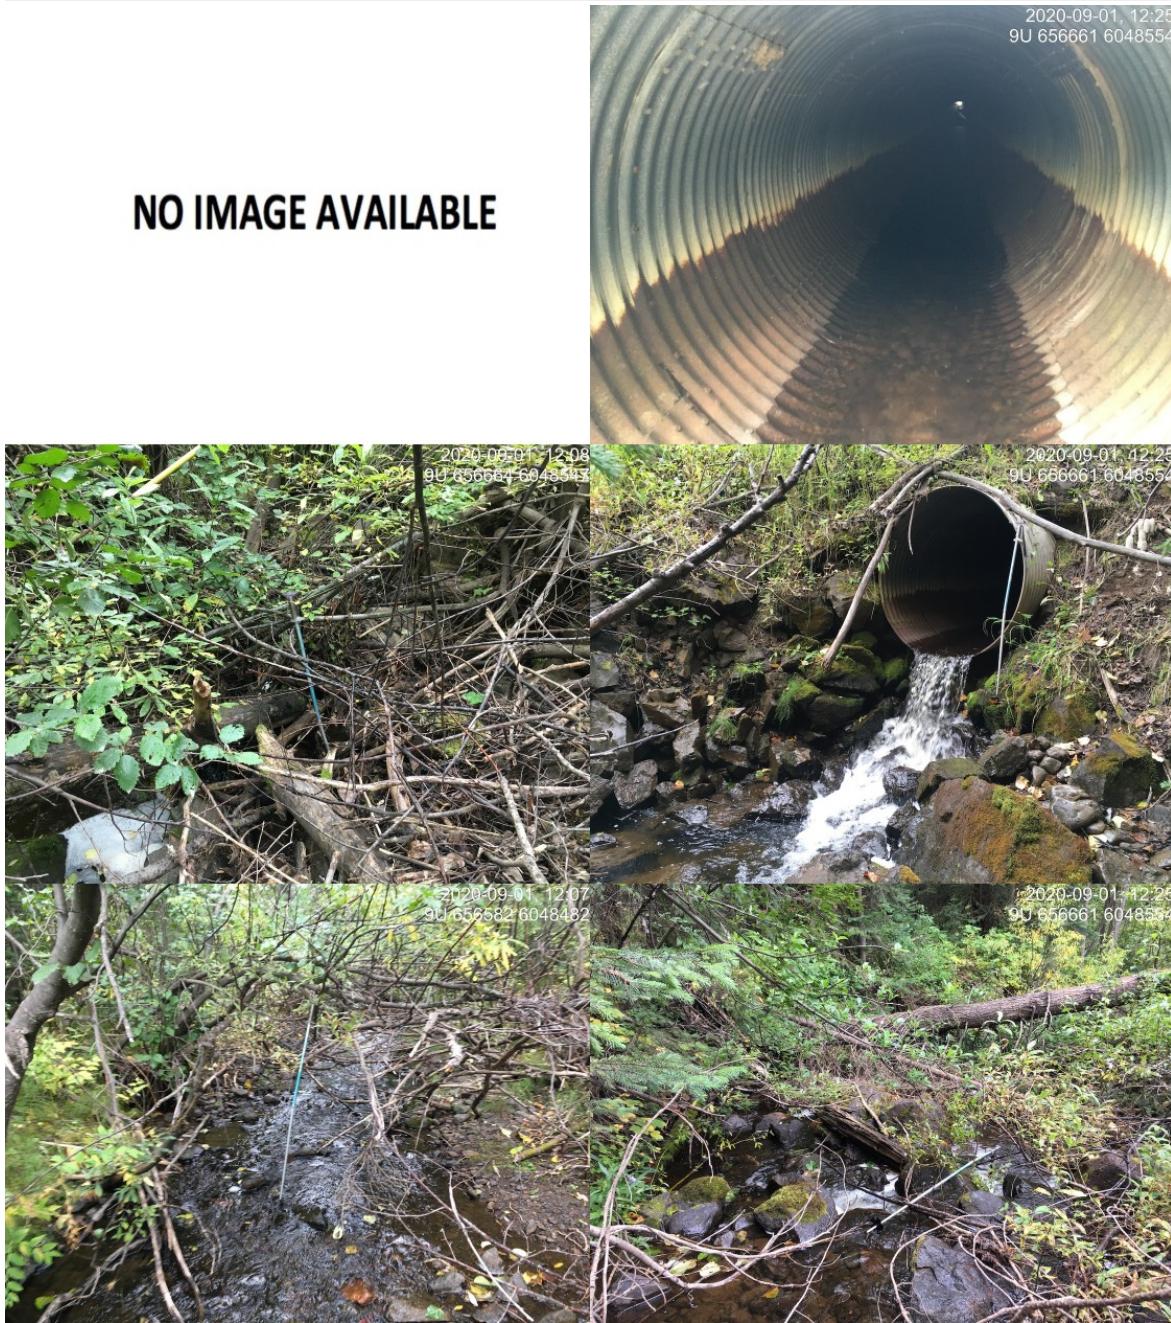
Comments: Inlet plugged with small and large woody debris. Fry and juvenile fish observed upstream.

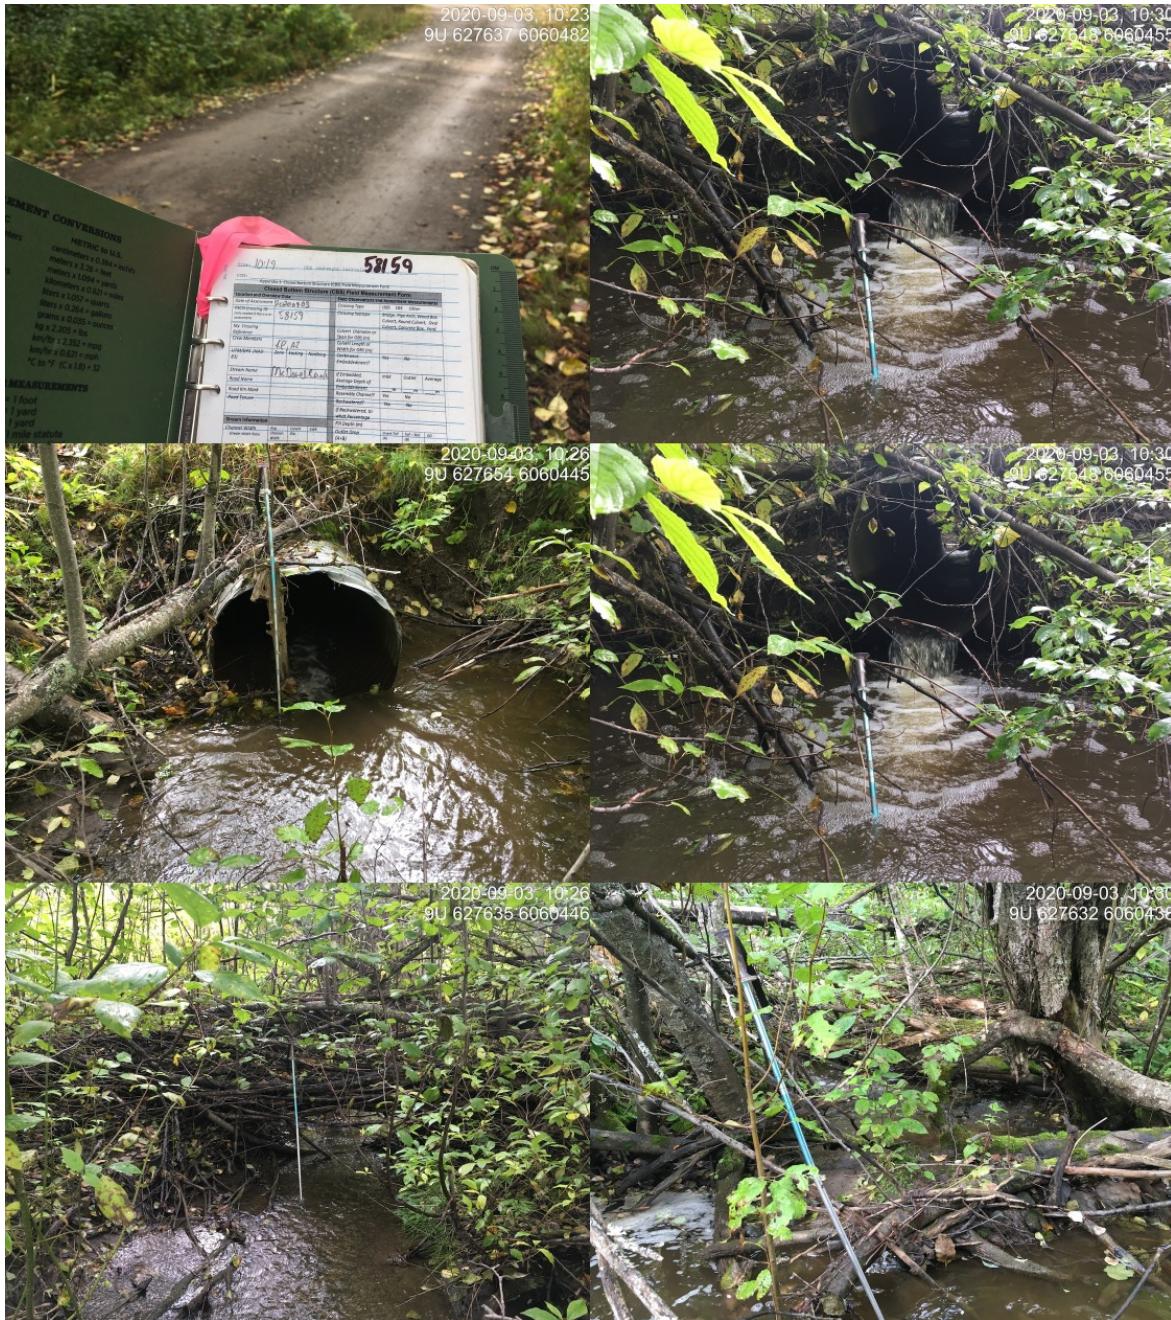
Comments: Stream flows through the Woodmere Nursery from small culvert on burn pile access road to the Highway. Electrofishing conducted. Abundant cover available primarily as overhanging vegetation and cobbles. Upstream culvert under Highway 16 has been recently replaced by horizontal drilling. Baffles at upstream crossing. Coho fry captured below the Highway crossing.

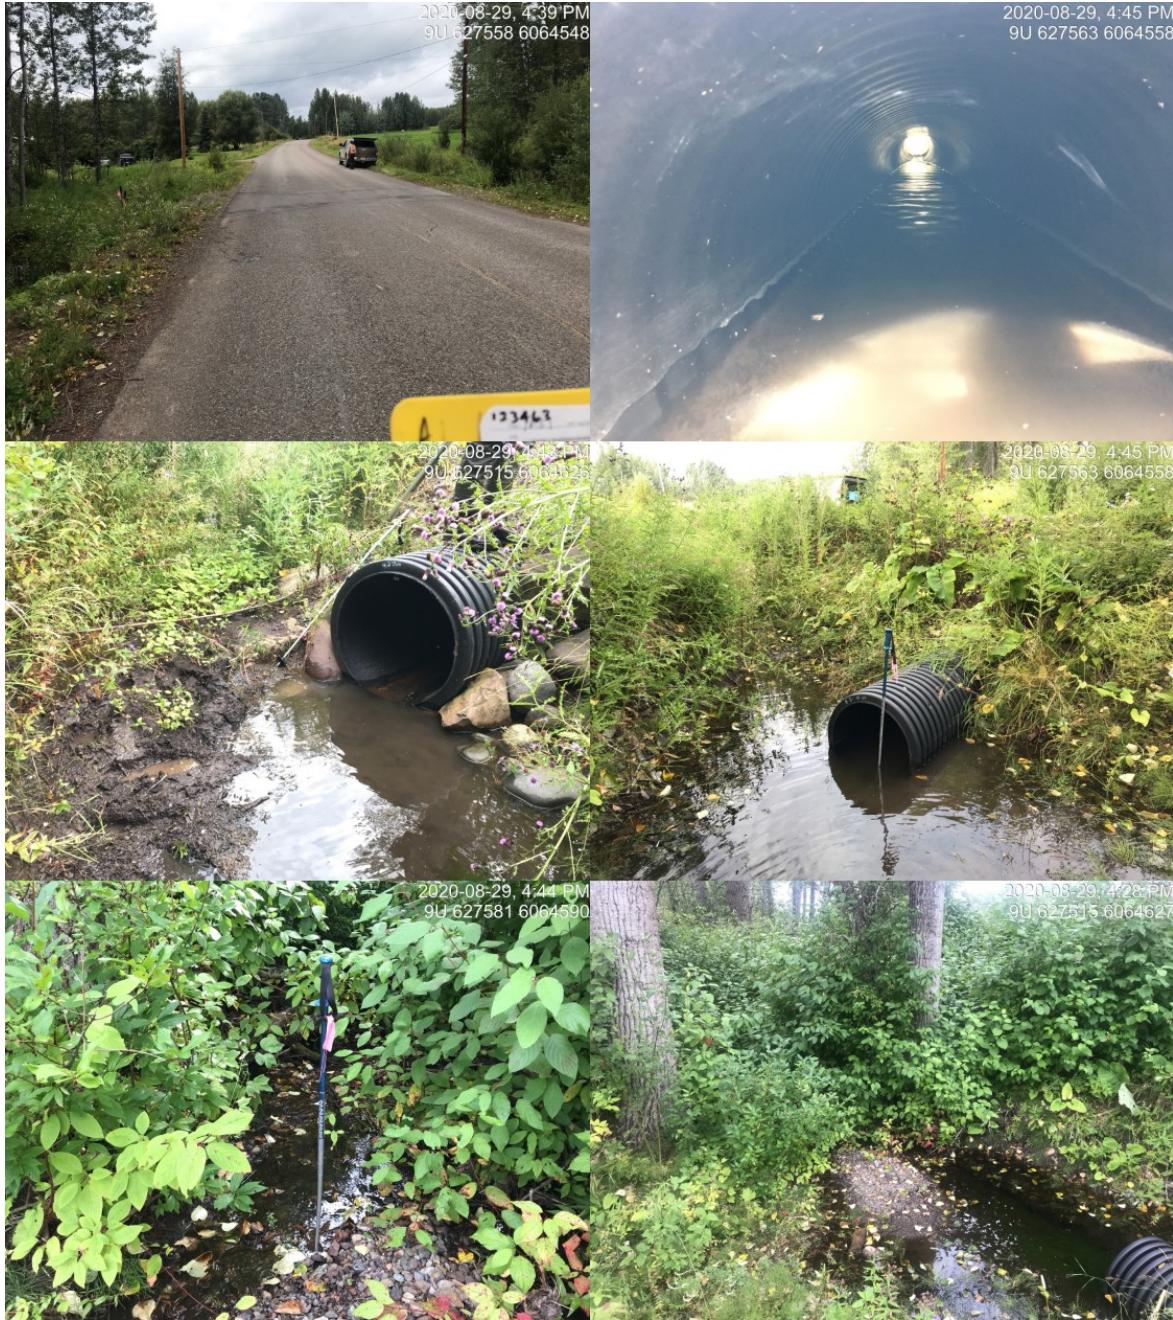
Comments: No habitat confirmation conducted in 2020. Newly replaced crossing. ID# 8 21 18 01 .

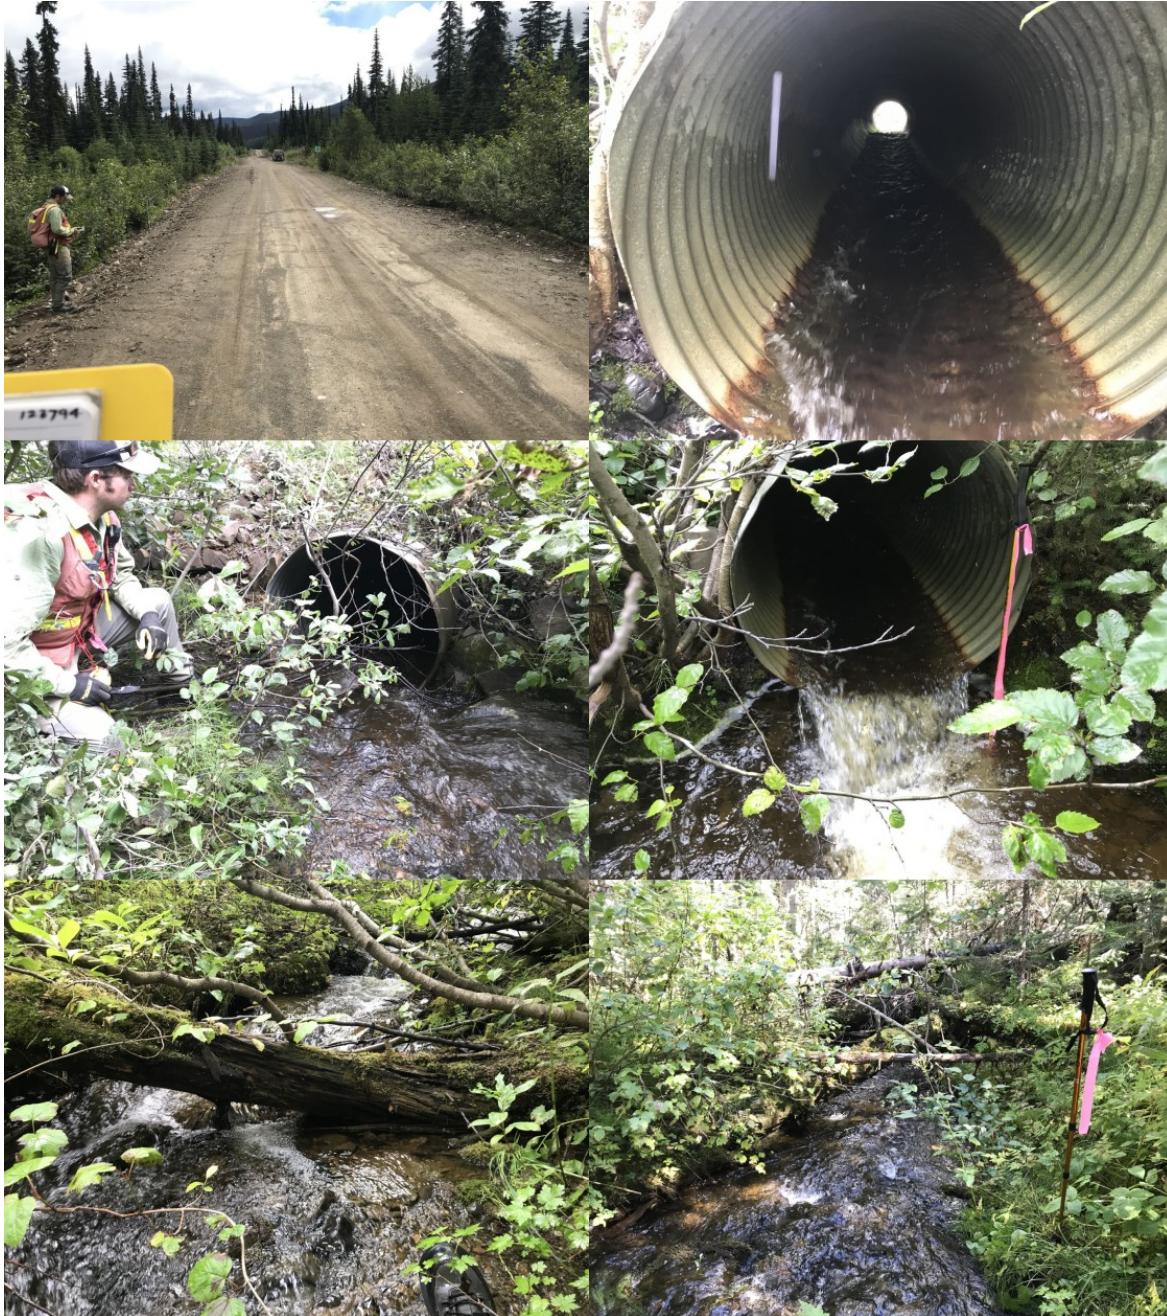
Comments: Smaller stream with good flow. Salmon points noted in adjacent stream. Recommend sampling upstream and downstream and habitat assessment of stream at associated PSCIS crossing 123785.

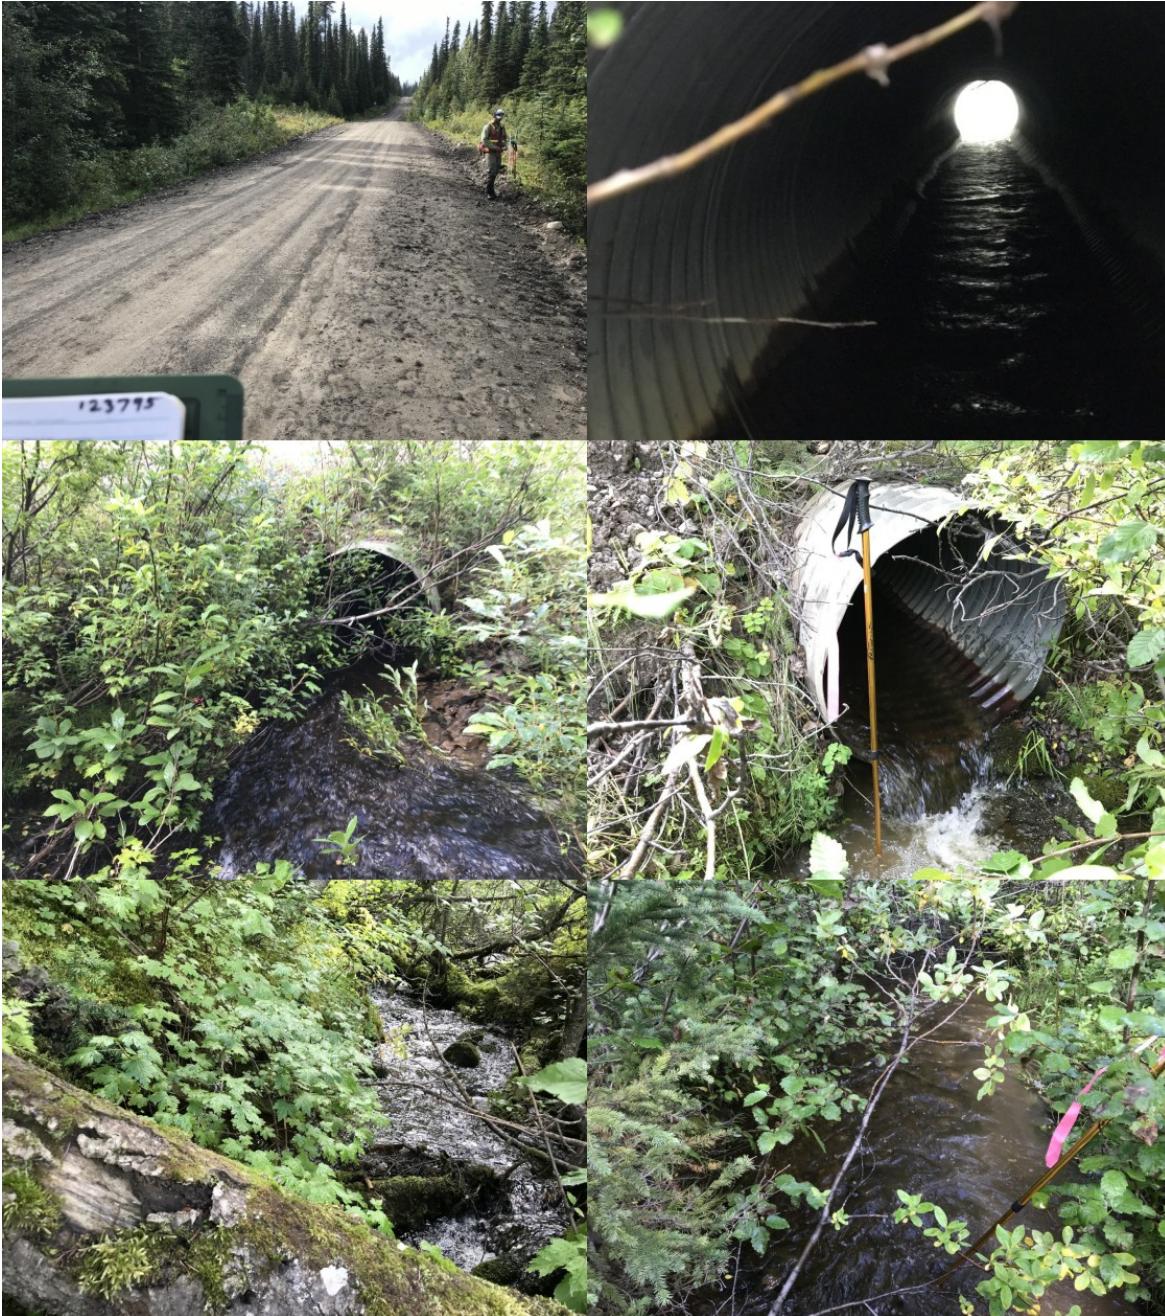
Comments: Smaller stream with good flow. Salmon point (juvenile) noted upstream. Recommend sampling upstream and downstream and habitat assessment of stream at associated PSCIS crossing 123785.

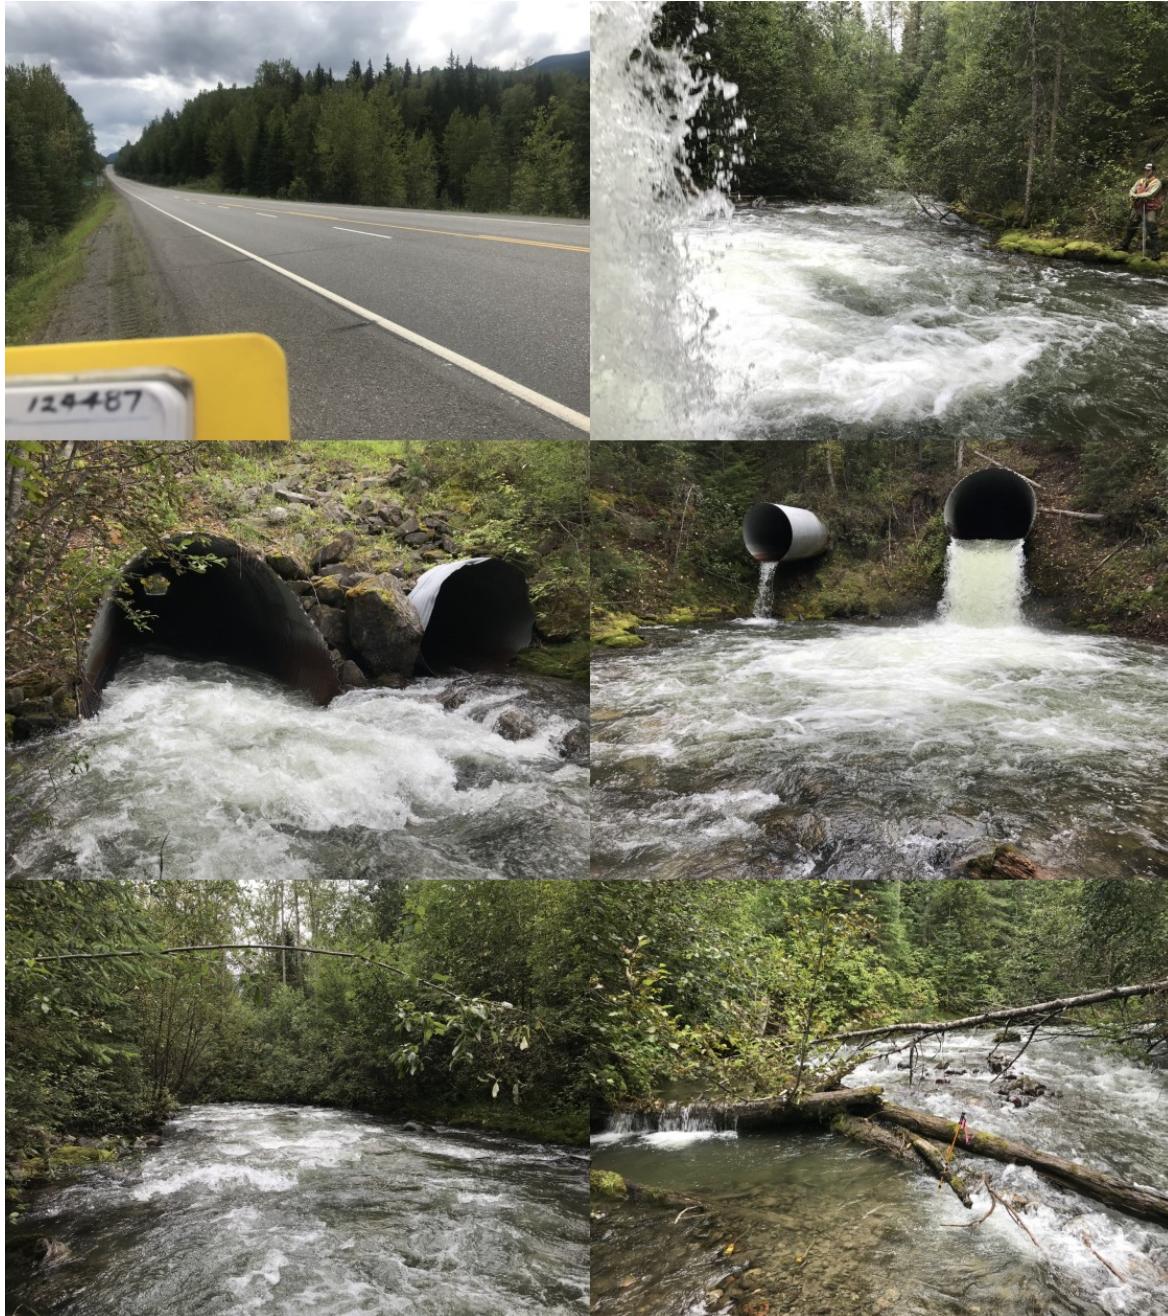
Comments: Unpassable to all life stages and species. Fill depth is approximately 35m. Salomid (50cm) observed trying to ascend to outlet of main pipe.

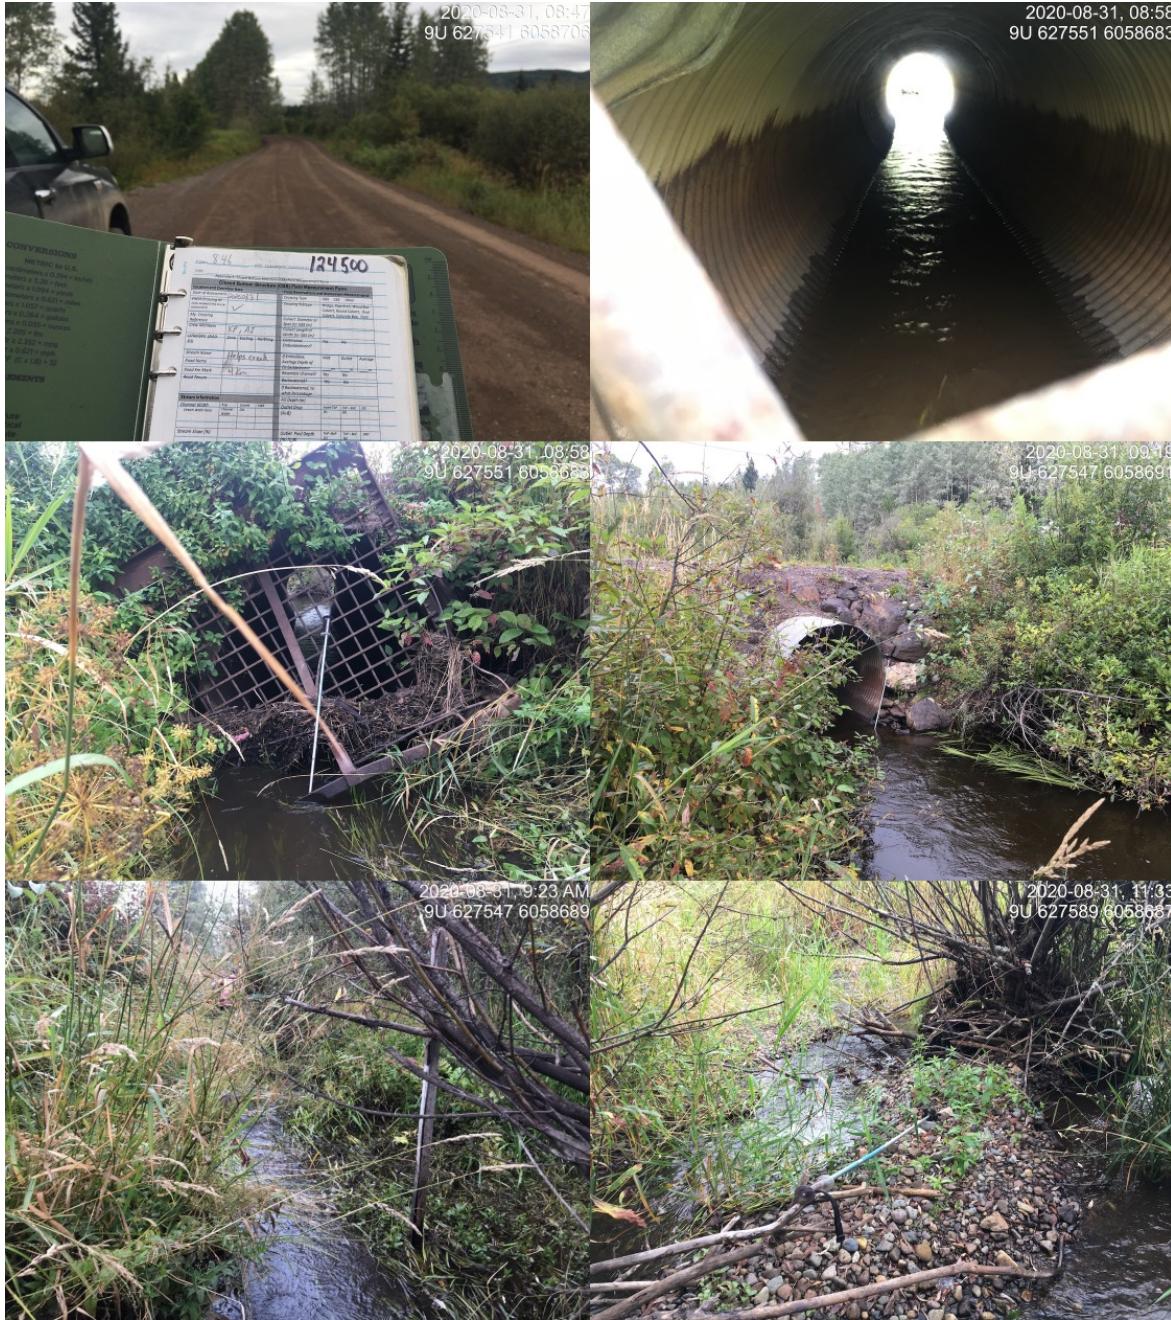
Comments: Wetland type habitat upstream with stream channel containing abundant gravels downstream.

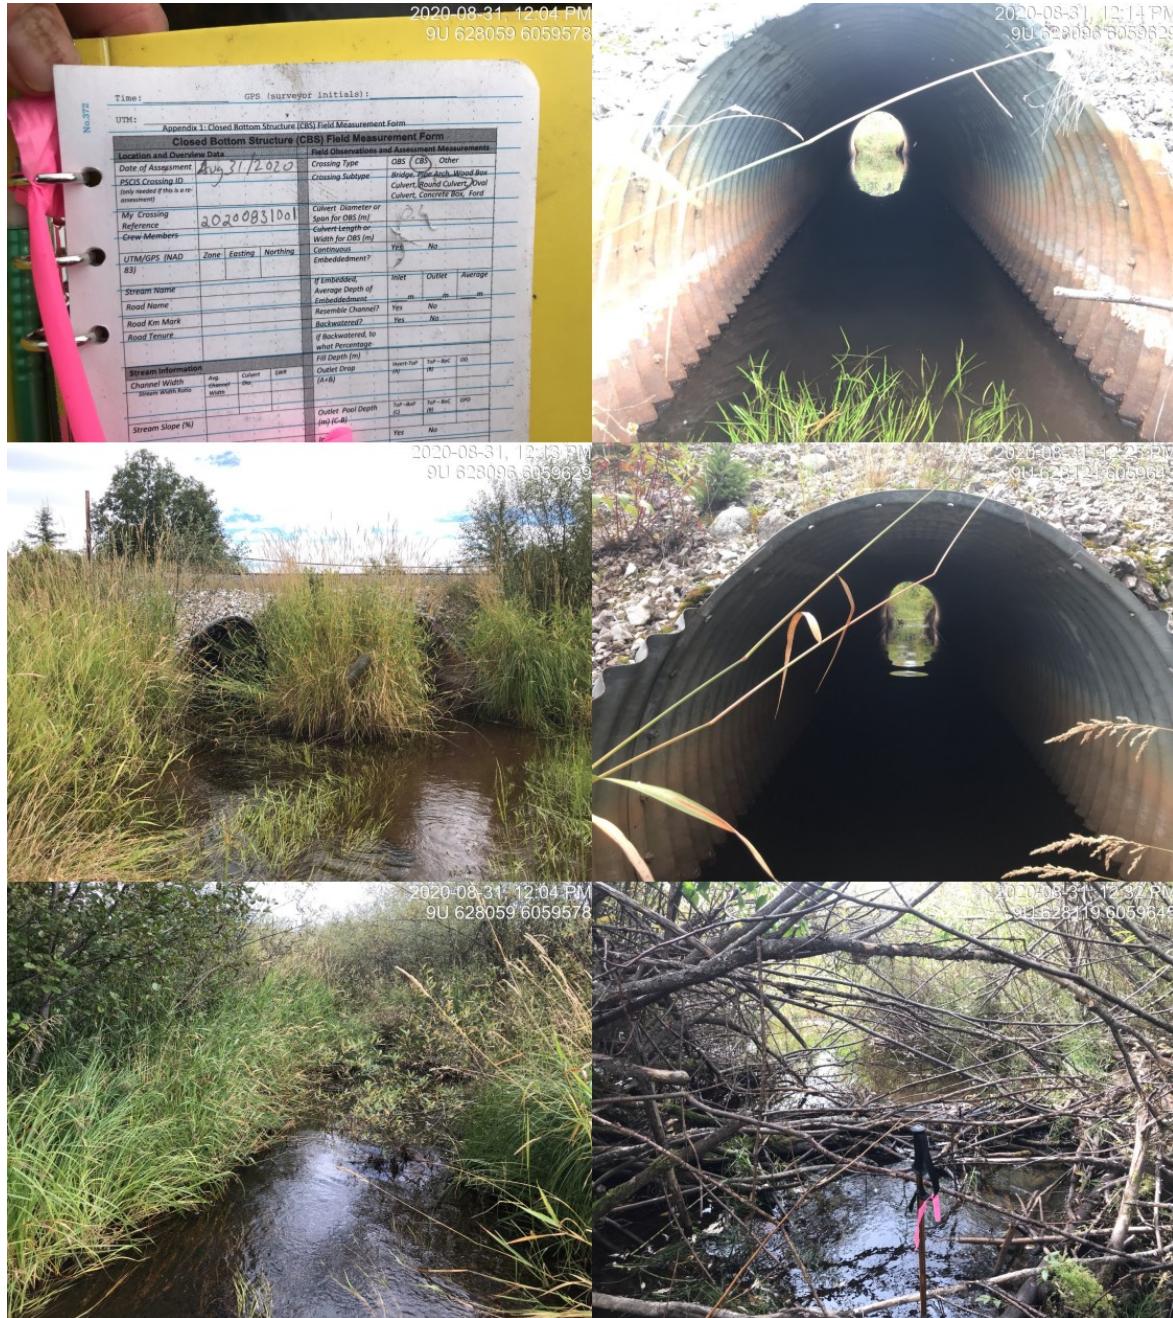
Comments: Passable and fully backwatered structure. Landowner reports that lamprey (~40cm x 20) at crossing inside of the culvert in the past.

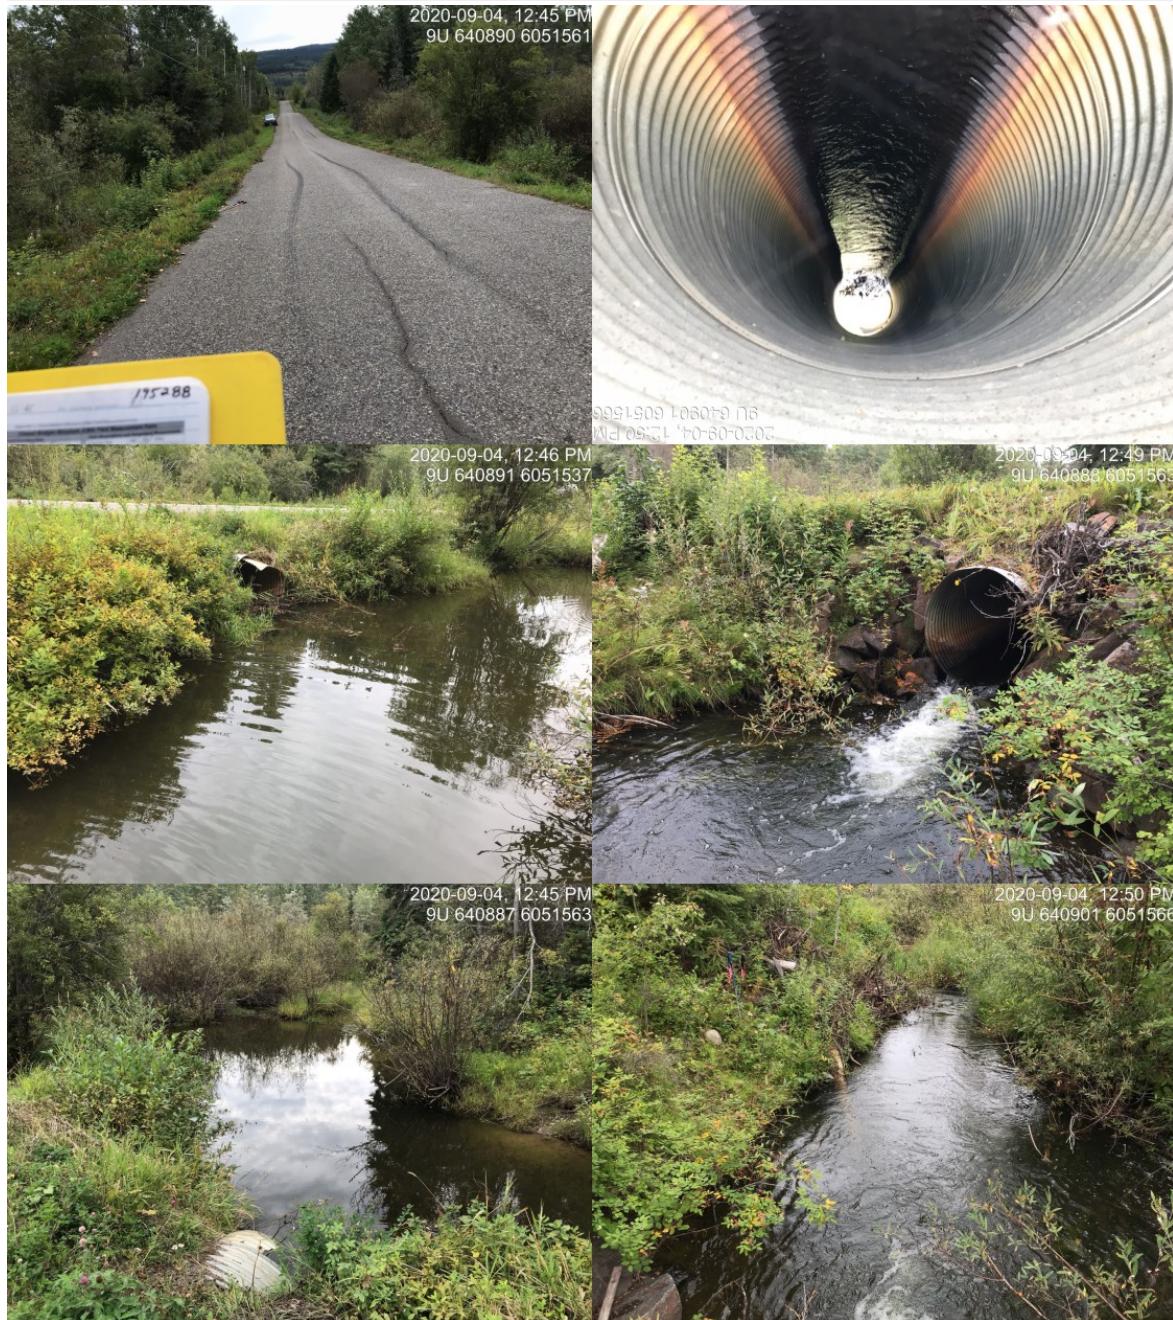
Comments: Wetland type habitat upstream and downstream. Drone flight conducted upstream to map immediate area upstream.

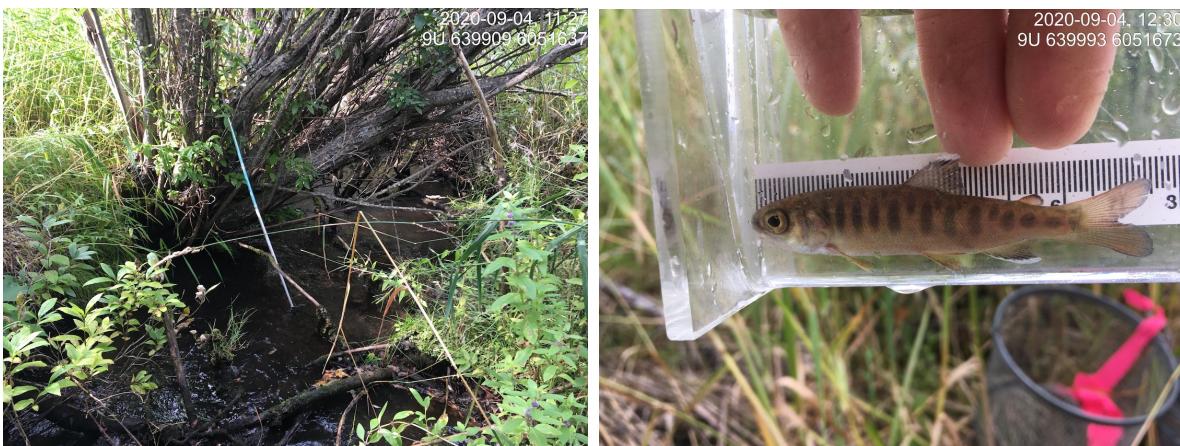
Figure 5.18: Left: Typical habitat downstream of PSCIS crossing 195290. Right: Coho captured downstream of PSCIS crossing 195290.

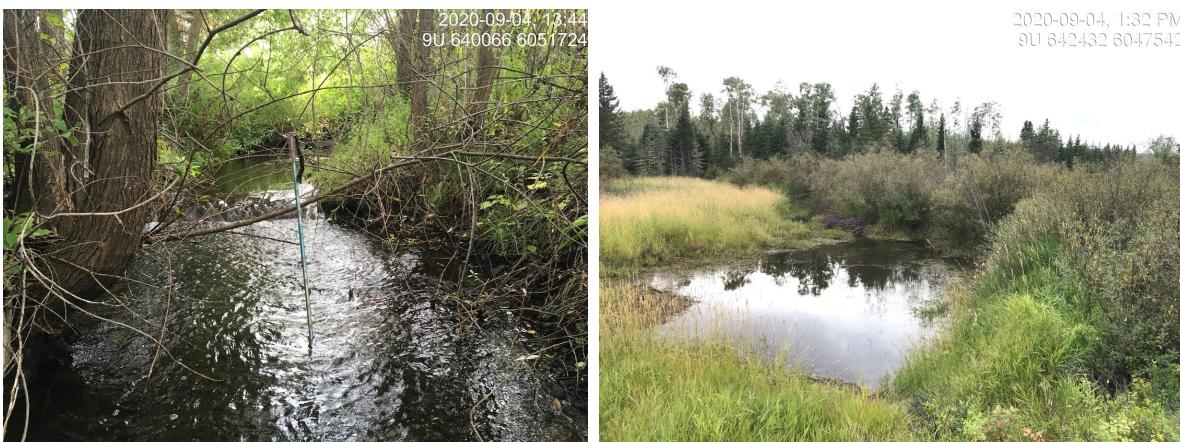
Figure 5.19: Left: Typical habitat upstream of PSCIS crossing 195290. Right: Wetland habitat upstream of PSCIS crossing 195290.

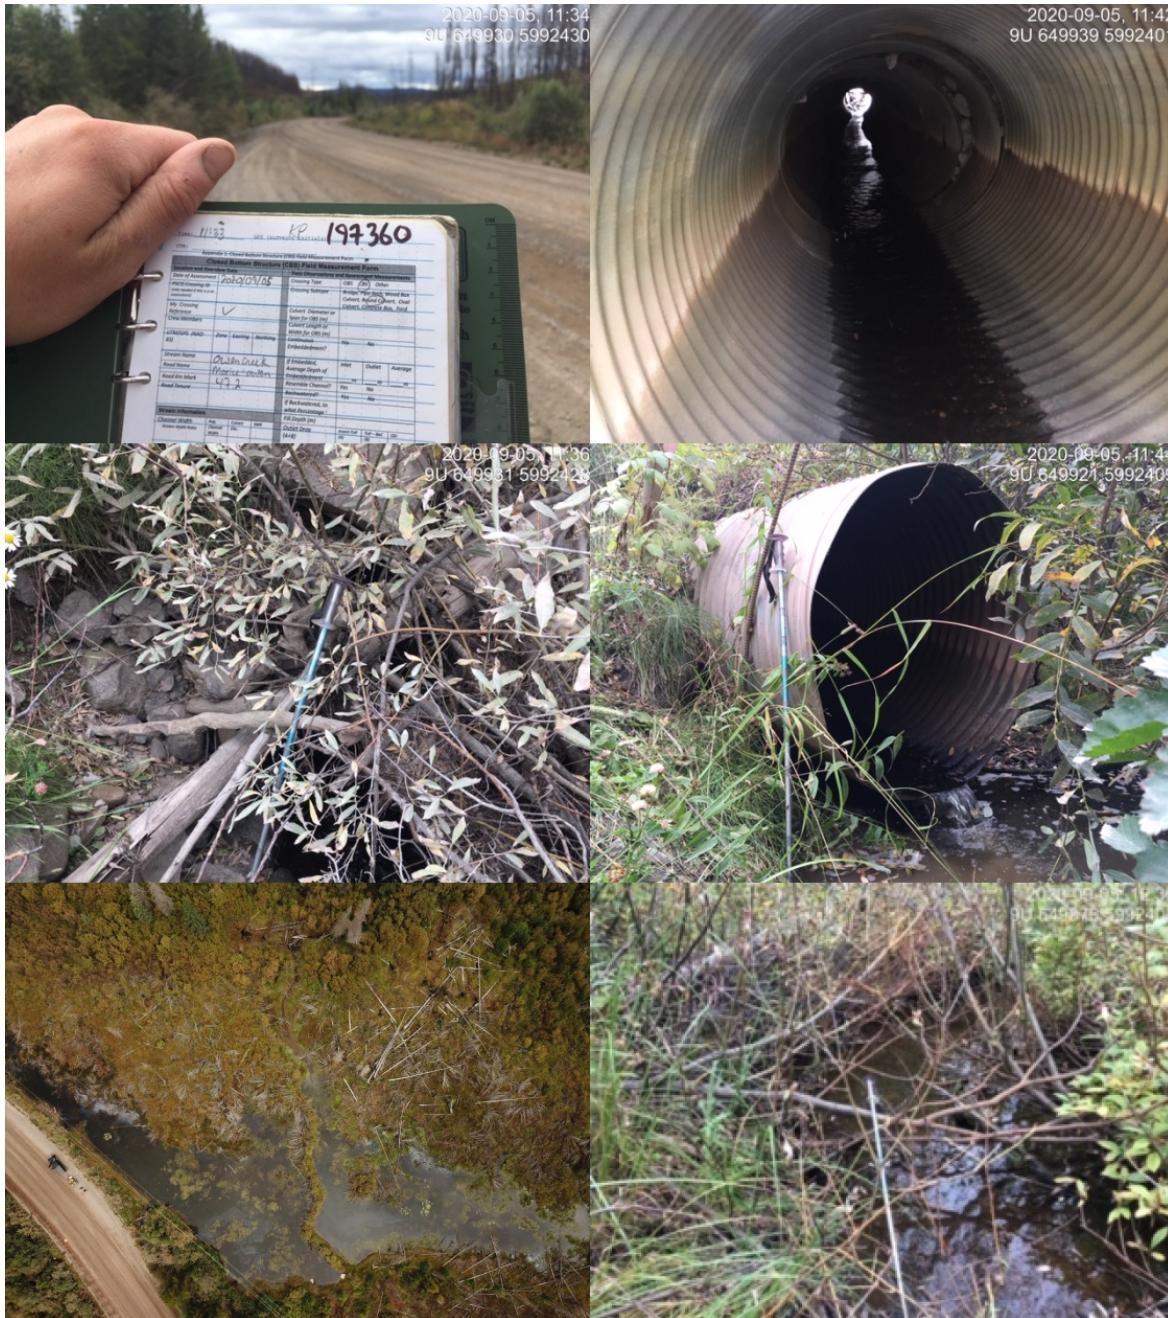
Comments: Wetland type habitat for first 300m upstream then 3m wide channel with cover available in all forms with pools suitable for juvenile RB and CO overwintering. Abundant gravels and small cobbles throughout suitable for CO or RB/ST spawning.

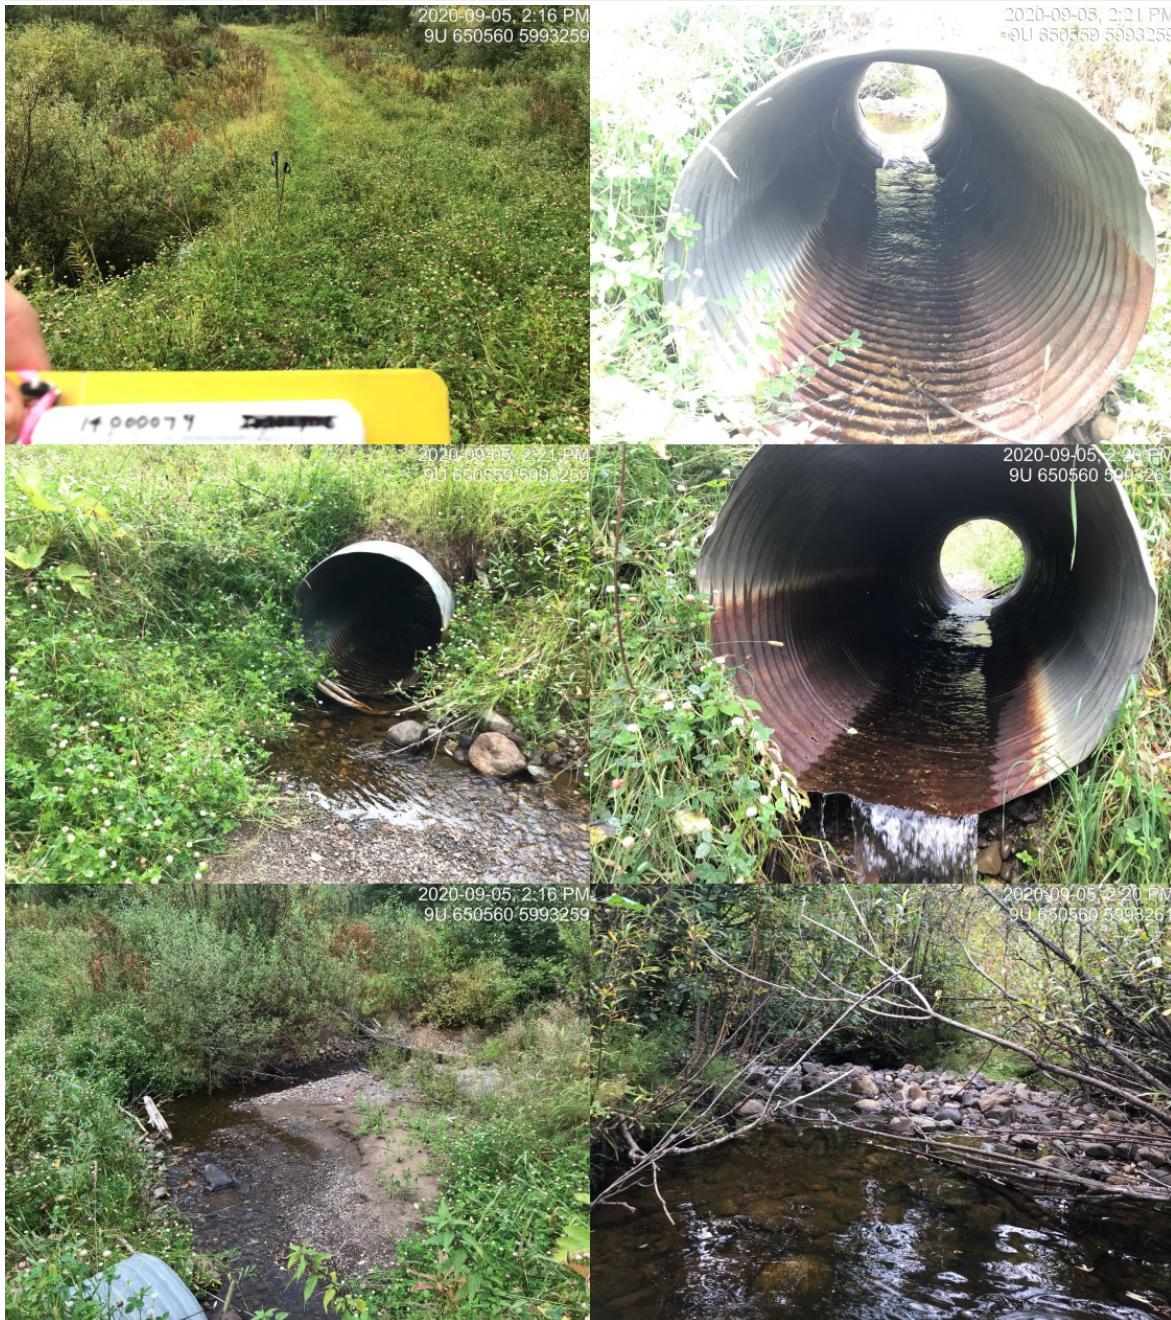
Comments: Extensive rearing habitat and gravels suitable for spawning. Stream eventually flows into top end of Owen Lake.

Structure replacement with a bridge (10m span) is recommended to provide access to the habitat located upstream of PSCIS crossing 197360. In addition to not facilitating high velocities and erosion due resulting from flow constriction, structures with large openings in relation to stream channel size have been demonstrated to reduce the likelihood of structure blockage due to beaver (Jensen et al. 2001). The cost of the work is estimated at \$125,000 for a cost benefit of 9.6 linear m/\$1000 and 31.7m²/\$1000.

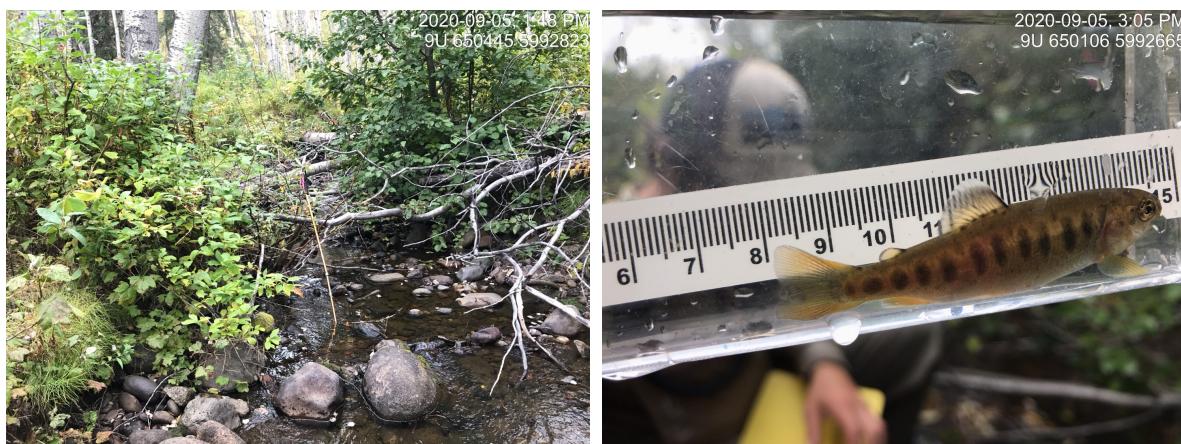
Figure 5.23: Left: Typical habitat upstream of PSCIS crossing 197360. Right: Rainbow trout captured upstream of PSCIS crossing 197360.

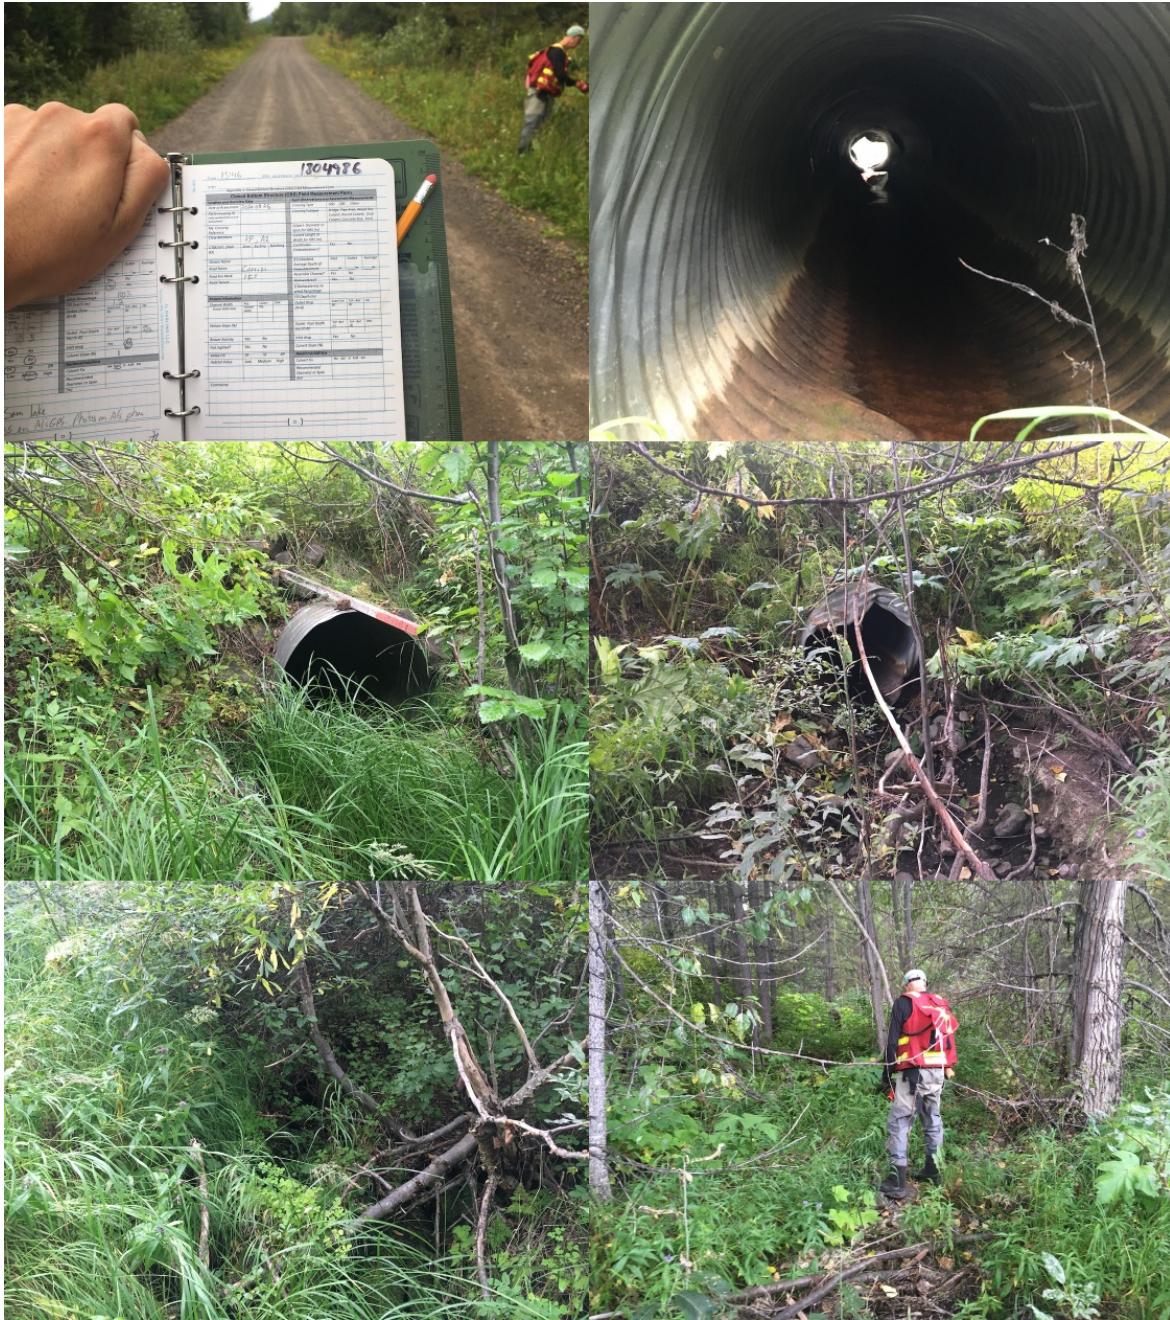
Comments: Suspect no fish. Multiple fish survey sites located downstream. Dry at time of survey.

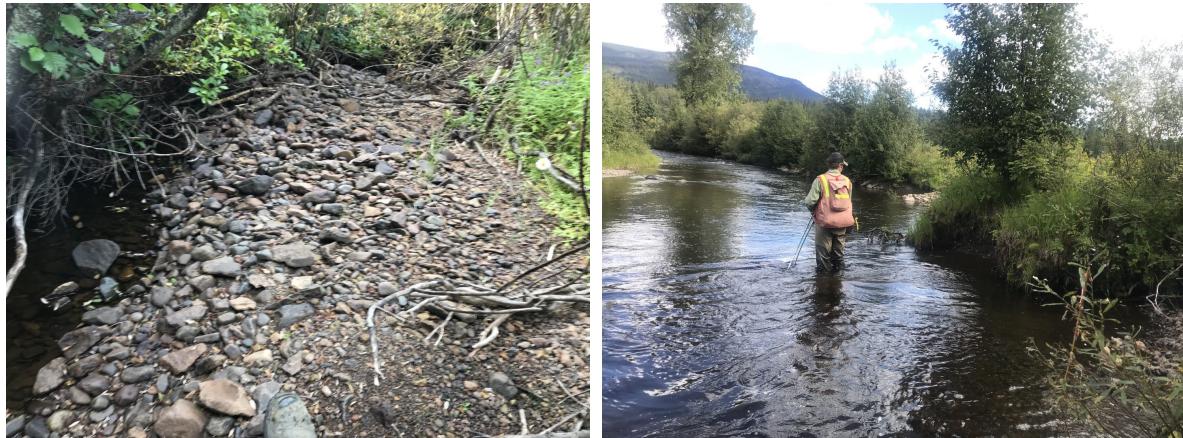
The stream was surveyed downstream from the culvert for 70m to the confluence with Buck Creek (Figure [??](#)). Total cover amount was rated as moderate with undercut banks dominant. Cover was also present as small woody debris, large woody debris, and overhanging vegetation (Table [5.42](#)). The average channel width was 4.6m, the average wetted width was 2.5m and the average gradient was 3%. The dominant substrate was gravels with cobbles subdominant. A fish (130mm) was observed in the culvert outlet pool and a substance suspected to be didymo was noted on the substrate. The habitat was rated as moderate value as it was considered an important migration corridor with habitat of moderate rearing potential for fry and juvenile salmonids.

Figure 5.24: Left: Habitat downstream of PSCIS crossing 197640. Right: Habitat downstream of crossing 197640 at the confluence with Buck Creek.

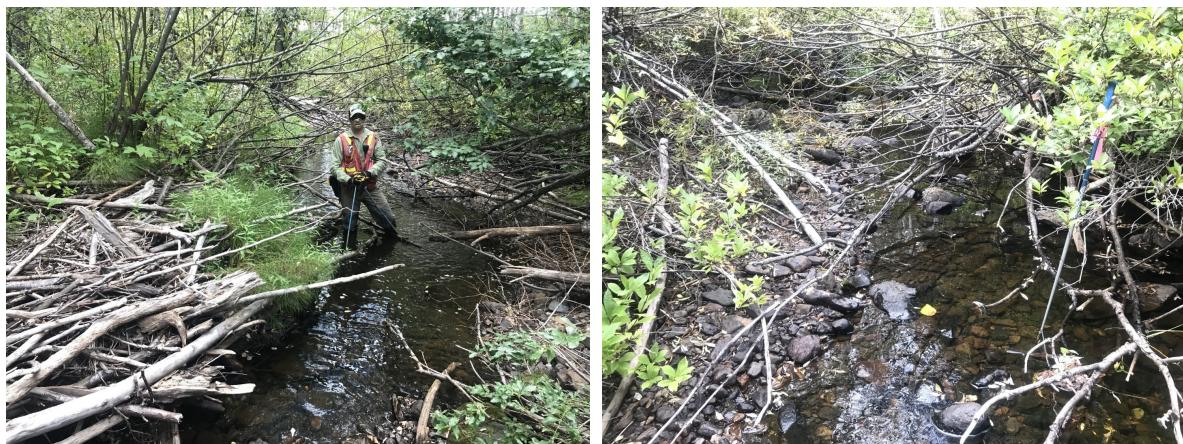
The stream was surveyed immediately upstream from 197640 for approximately 535m (Figure [??](#)). Within the area surveyed, total cover amount was rated as moderate with undercut banks dominant. Cover was also present as small woody debris, large woody debris, boulders, deep pools, and overhanging vegetation (Table [5.42](#)). The average channel width was 4.4m, the average wetted width was 2.2m and the average gradient was 2.5%. The dominant substrate was cobbles with boulders subdominant. Rare pockets of gravel suitable for spawning resident, fluvial and anadromous salmonids were noted. The stream appeared to be aggraded with side bars common. One salmonid (110mm - unidentified species) was observed just upstream of Buck Flats Road. Habitat value was rated as moderate value with moderate rearing potential for fry and juvenile salmonids.

Figure 5.25: Left: Habitat upstream of PSCIS crossing 197640. Right: Habitat upstream of PSCIS crossing 197640.

Replacement of PSCIS crossing 197640 with a bridge (10m span) is recommended. The cost of the work is estimated at \$NA for a cost benefit of NA linear m/\$1000 and NAm²/\$1000.
