DRAFT - Bulkley River and Morice River Watershed Groups Fish Passage Restoration Planning

Prepared for
Habitat Conservation Trust Fund
BC Fish Passage Remediation Program
Canadian Wildlife Federation

Prepared by
Al Irvine, B.Sc., R.P.Bio.
New Graph Environment
6 Regent St
Nelson, BC V1L 2P1

DRaFT - Version 0.0.5
2021-03-11

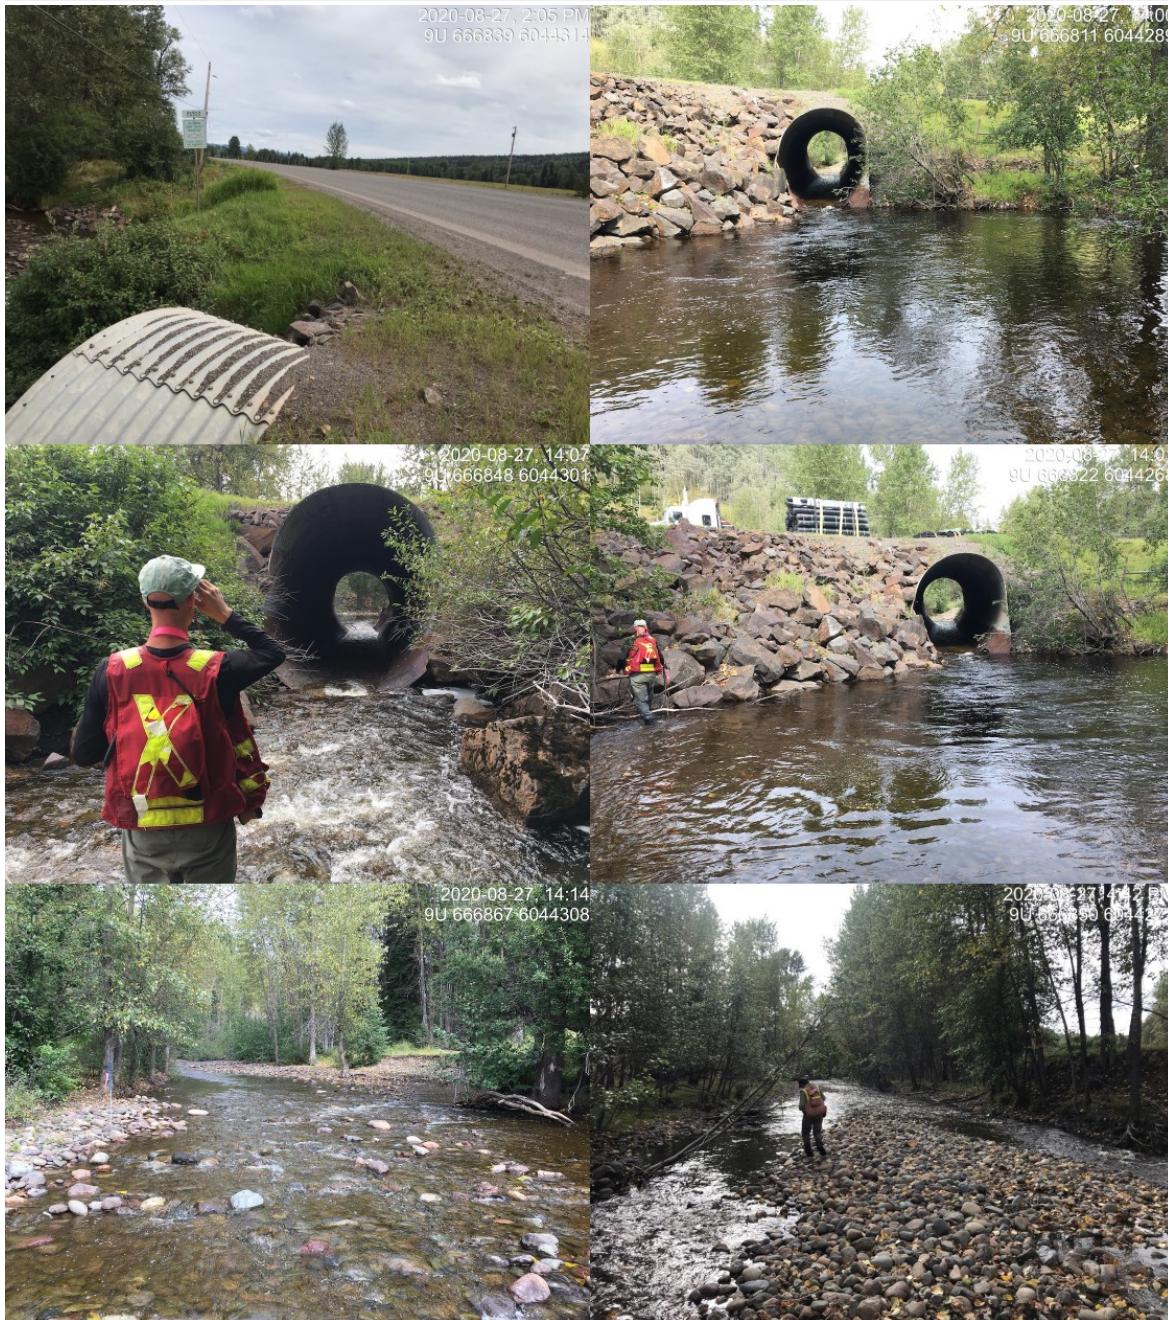
Comments: Culvert is likely as passable for most species and life stages at most non-peak and non-lowest flows. Streamkeepers have observed fry moving through culvert in overwintering studies.

Structure replacement with a bridge (15.1m span) is recommended to provide access to the habitat located upstream of PSCIS crossing 197658. The cost of the work is estimated at \$7,550,000 for a cost benefit of 0.8 linear m/\$1000 and $10.3\text{m}^2/\$1000$.

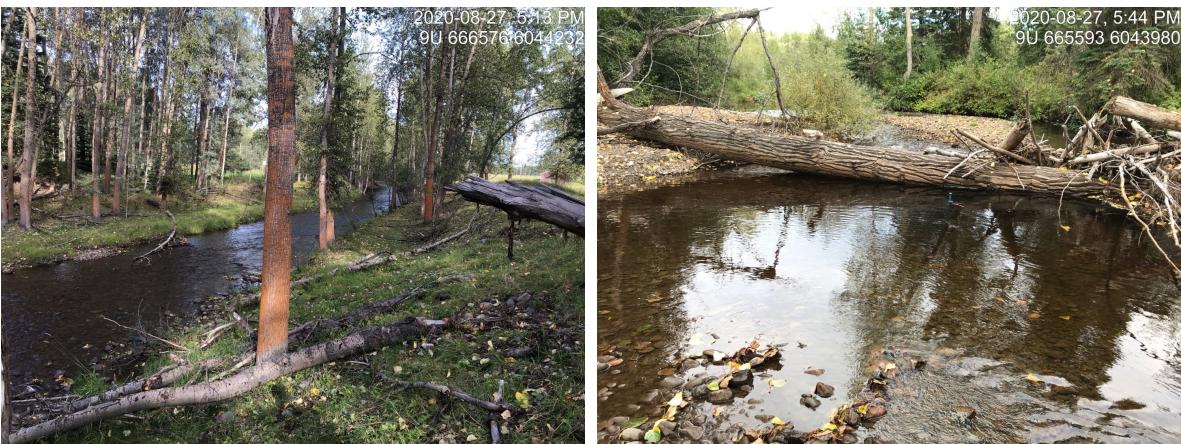
Below the railway bridge, the habitat was noted as far more complex than the area immediately below the highway culvert. Total cover amount was rated as abundant with overhanging vegetation dominant. Cover was also present as small woody debris, large woody debris, undercut banks, and deep pools. The average channel width was 8.6m, the average wetted width was 7.5m and the average gradient was 0.8%. The dominant substrate was cobbles with gravels subdominant. There were extensive sections of channel with deep glides (50-70 cm deep at the time of survey) with well developed riparian vegetation creating good structure for all species and life stages of salmonids. An algae layer was noted on the substrate. There were abundant large gravels and small cobbles present suitable for salmon spawning.

Figure 5.26: Left: Typical habitat immediately downstream of PSCIS crossing 197658. Right: Typical habitat downstream of crossing 197658 below the railway bridge and adjacent to the Bulkley River mainstem.

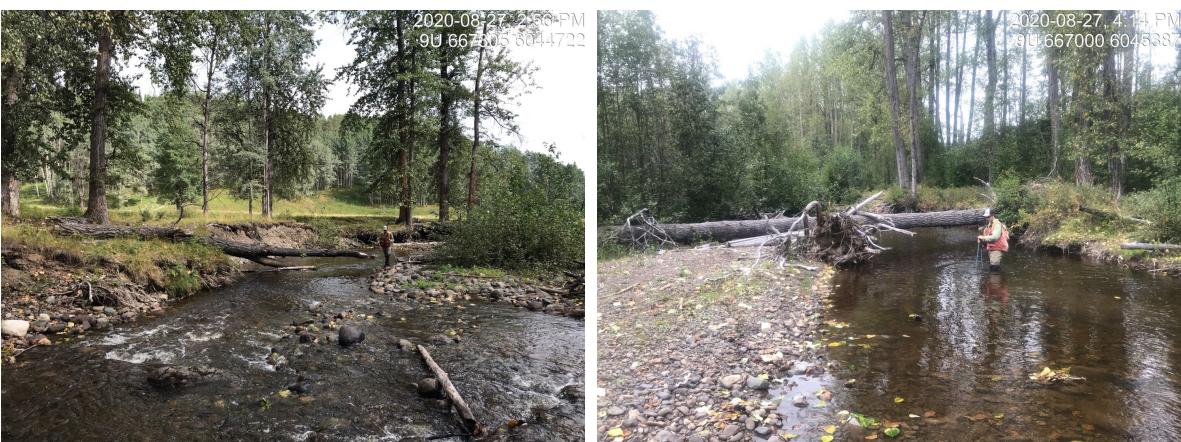
The stream was surveyed upstream from 197658 for 1400m (Figure 5.27). Within the area surveyed, total cover amount was rated as moderate with deep pools dominant. Cover was also present as small woody debris, large woody debris, boulders, undercut banks, and overhanging vegetation (Table 5.45). The average channel width was 12.9m, the average wetted width was 7.9m and the average gradient was 2.1%. The dominant substrate was cobbles with boulders subdominant. Within the area surveyed, riparian areas adjacent to both banks were used as rangeland with several cattle access points on the stream and evidence of understory shrub degradation from cattle grazing. The large stream had high habitat complexity including numerous pools up to 2m deep and frequent glide sections to 1m deep throughout. There were extensive areas of gravel suitable for spawning for resident and anadromous salmonid species. Habitat value was rated as high for resident and anadromous salmonid rearing and spawning.

Figure 5.27: Left: habitat upstream of PSCIS crossing 197658. Right: Habitat upstream of PSCIS crossing 197658.

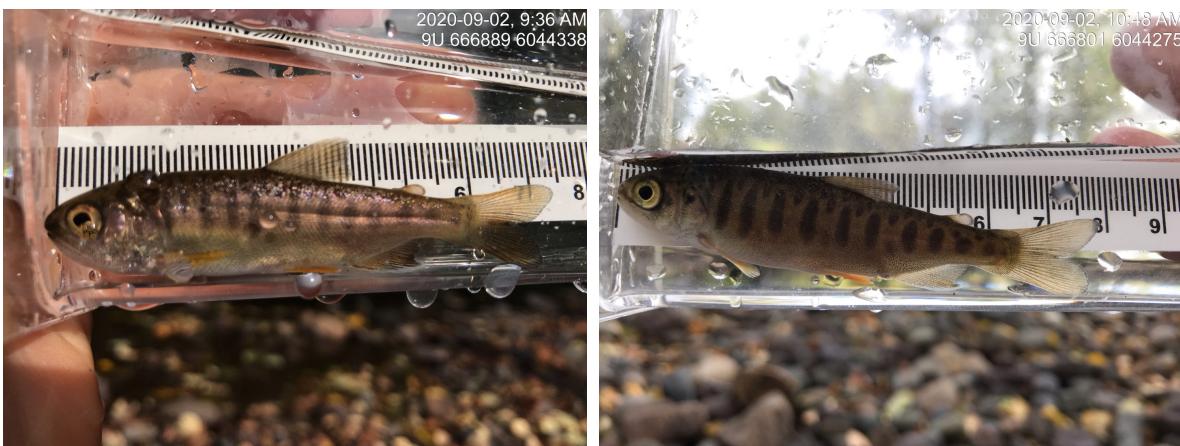
Minnowtrapping was conducted with three traps set overnight upstream as well as downstream of the crossing. A total of 5 coho and 6 rainbow trout were captured downstream with 1 coho and 9 rainbow trout captured upstream (Table 5.47 and (Figure 5.28).

Figure 5.28: Left: Coho captured downstream of PSCIS crossing 197658. Right: Coho captured upstream of PSCIS crossing 197658.

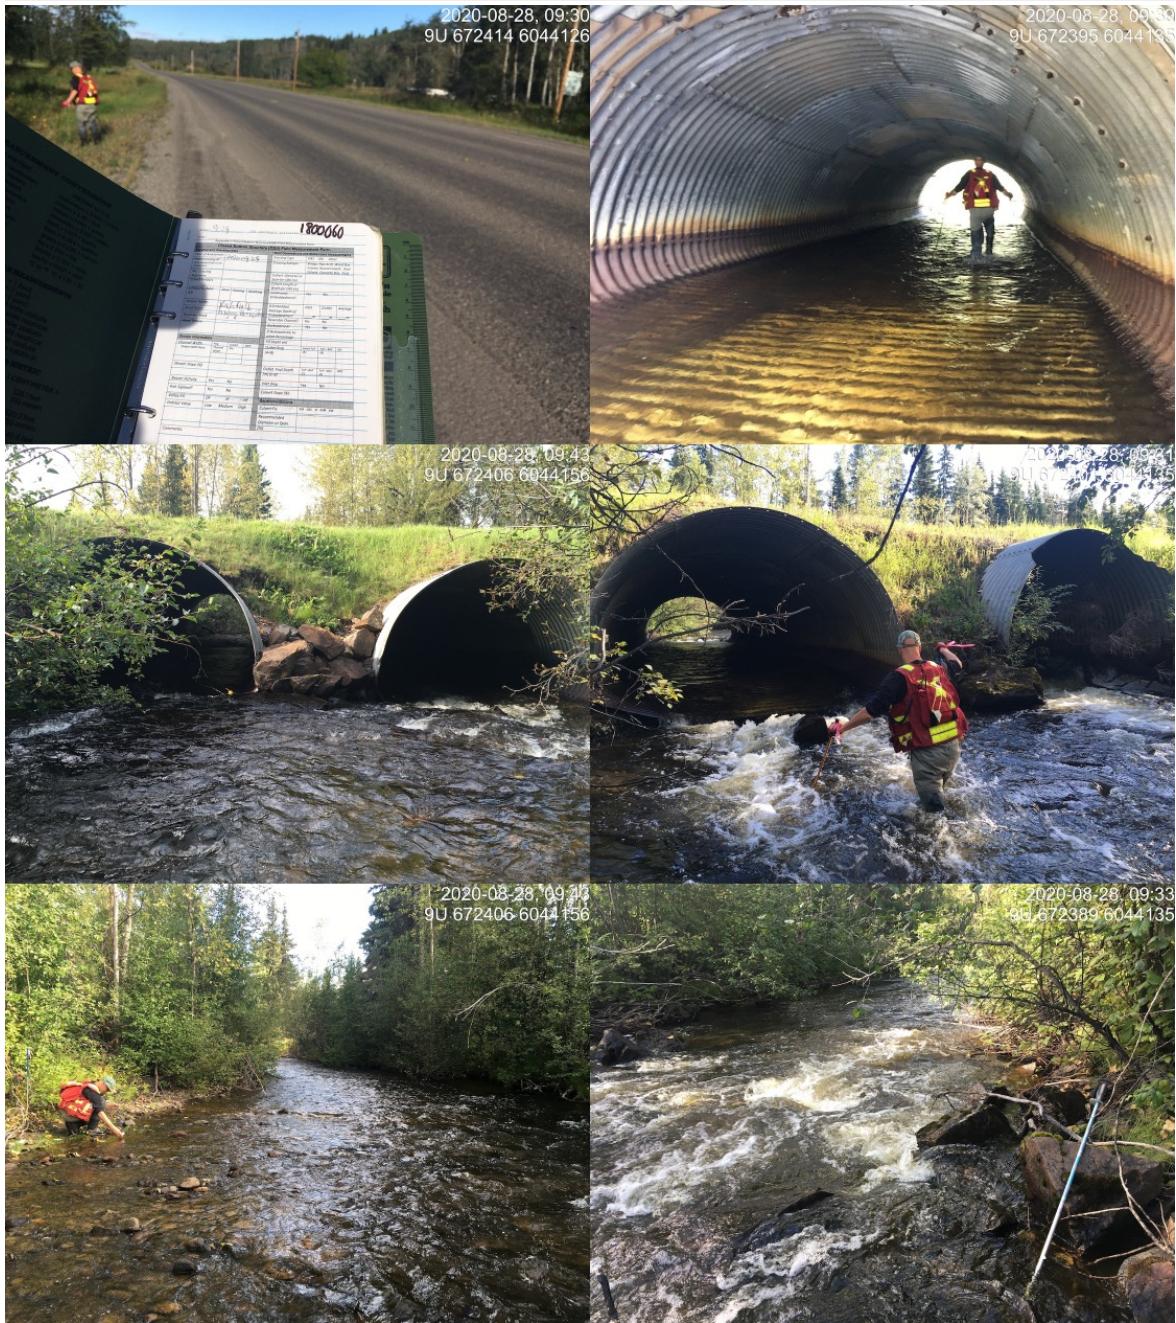
Comments: Habitat confirmation and minnowtrapping completed.

Structure replacement with a bridge (16.5m span) is recommended to provide access to the habitat located upstream of PSCIS crossing 197662. The cost of the work is estimated at \$8,250,000 for a cost benefit of 0.2 linear m/\$1000 and 3.2m²/\$1000.

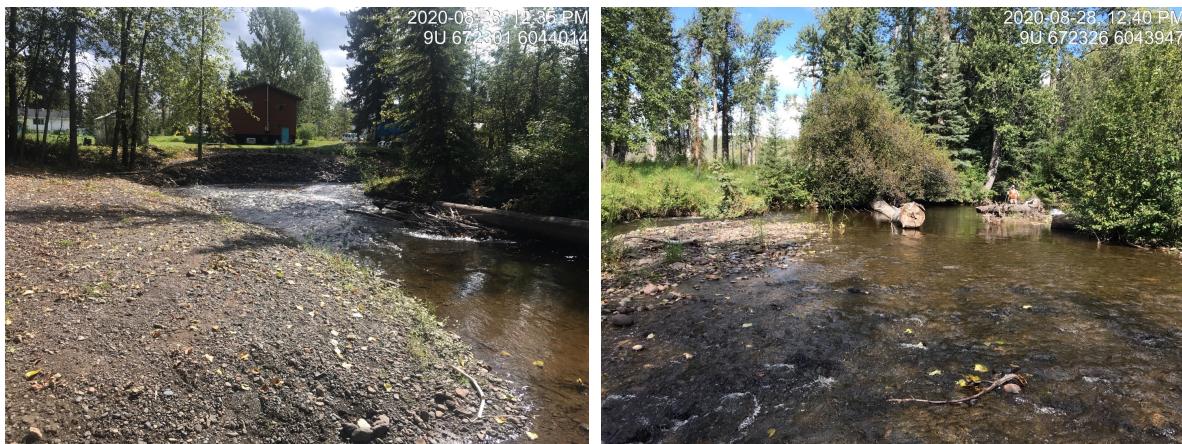
Figure 5.29: Left: Typical habitat downstream of PSCIS crossing 197662. Right: Typical habitat downstream of PSCIS crossing 197662.

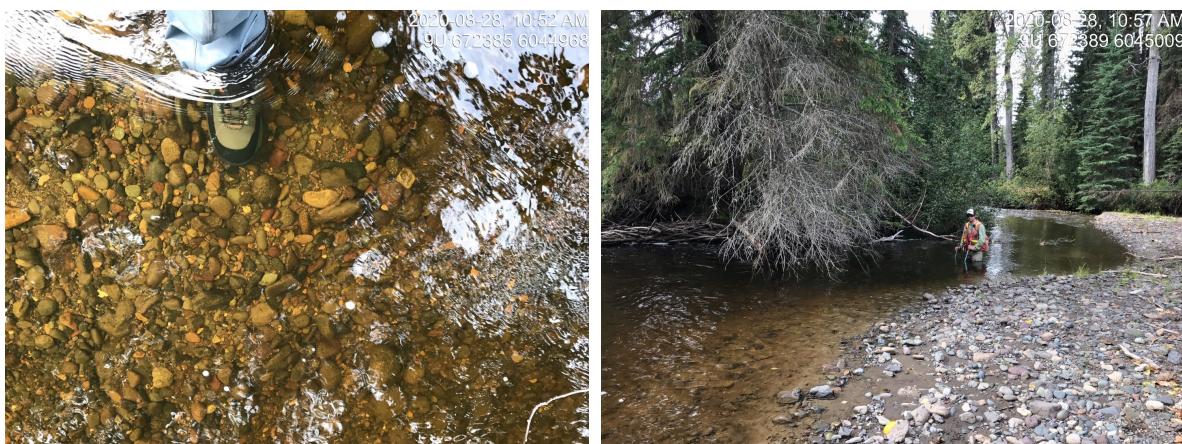
Figure 5.30: Left: Gravel and cobble substrate upstream of PSCIS crossing 197662. Right: Typical habitat upstream of PSCIS crossing 197662.

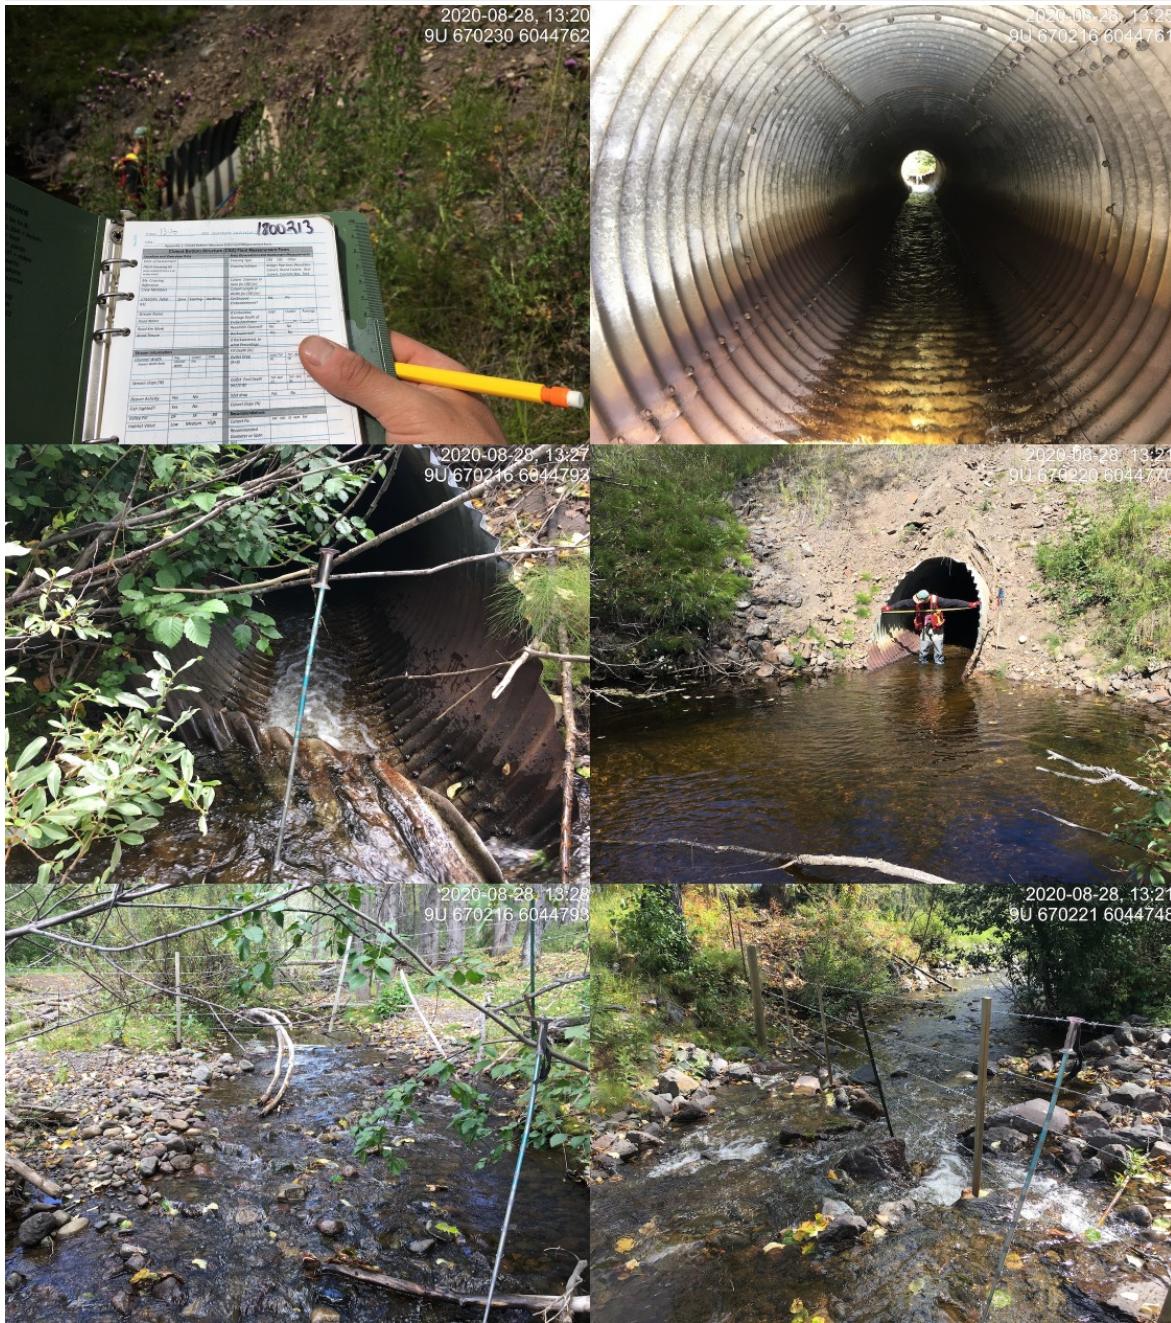
At the time of the survey, the 197663 on Highway 16 was un-embedded, non-backwatered and considered a barrier to upstream fish passage according to the provincial protocol. The pipe was 1.75m in diameter with a length of 25m, a culvert slope of 2%, a stream width ratio of 3.6 and an outlet drop of 0m (Table [5.52](#)). The inlet of the culvert was damaged with the metal folded up by incoming debris. Water temperature was 11°C, pH was 8.1 and conductivity was 186uS/cm.

Comments: Habitat confirmation and sampling completed.

Wilson and Rabnett (2007) recommended that PSCIS crossing 197663 be a high priority for remedial works to backwater the crossing by establishing a series of pools to step up to the outfall pool. A rehabilitation design was prescribed by Gaboury and Smith (2016). Smith (2018) reported that in 2017, the Wet'suwet'en First Nation - Yinka Dene Economic Development Limited Partnership Inc. and LGL Limited constructed three rock riffles and berms on both banks to backwater the stream and raise the outlet pool water level to above the elevation of the base of the culvert.

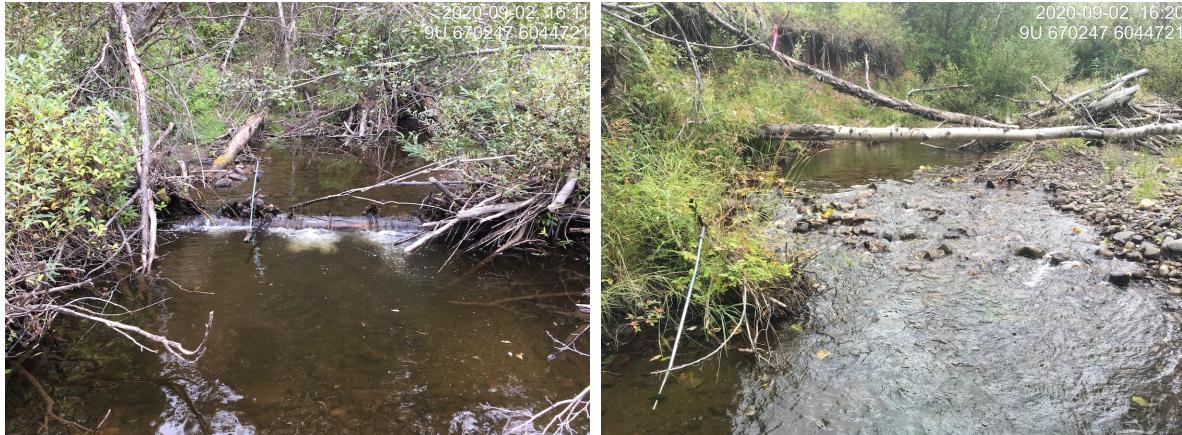
Figure 5.33: Left: Typical habitat downstream of PSCIS crossing 197663. Right: Typical habitat downstream of PSCIS crossing 197663.

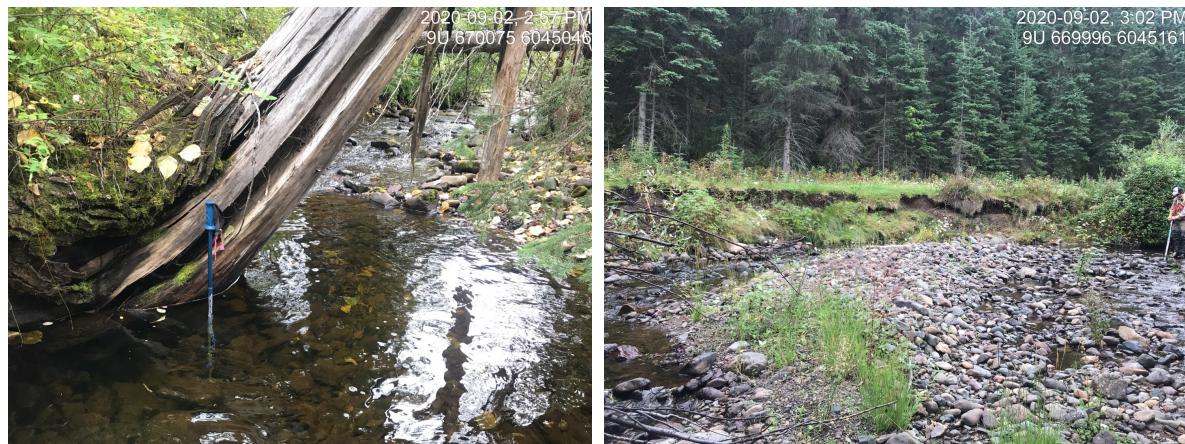
Figure 5.34: Left: Habitat upstream of PSCIS crossing 197663. Right: Habitat upstream of PSCIS crossing 197663.

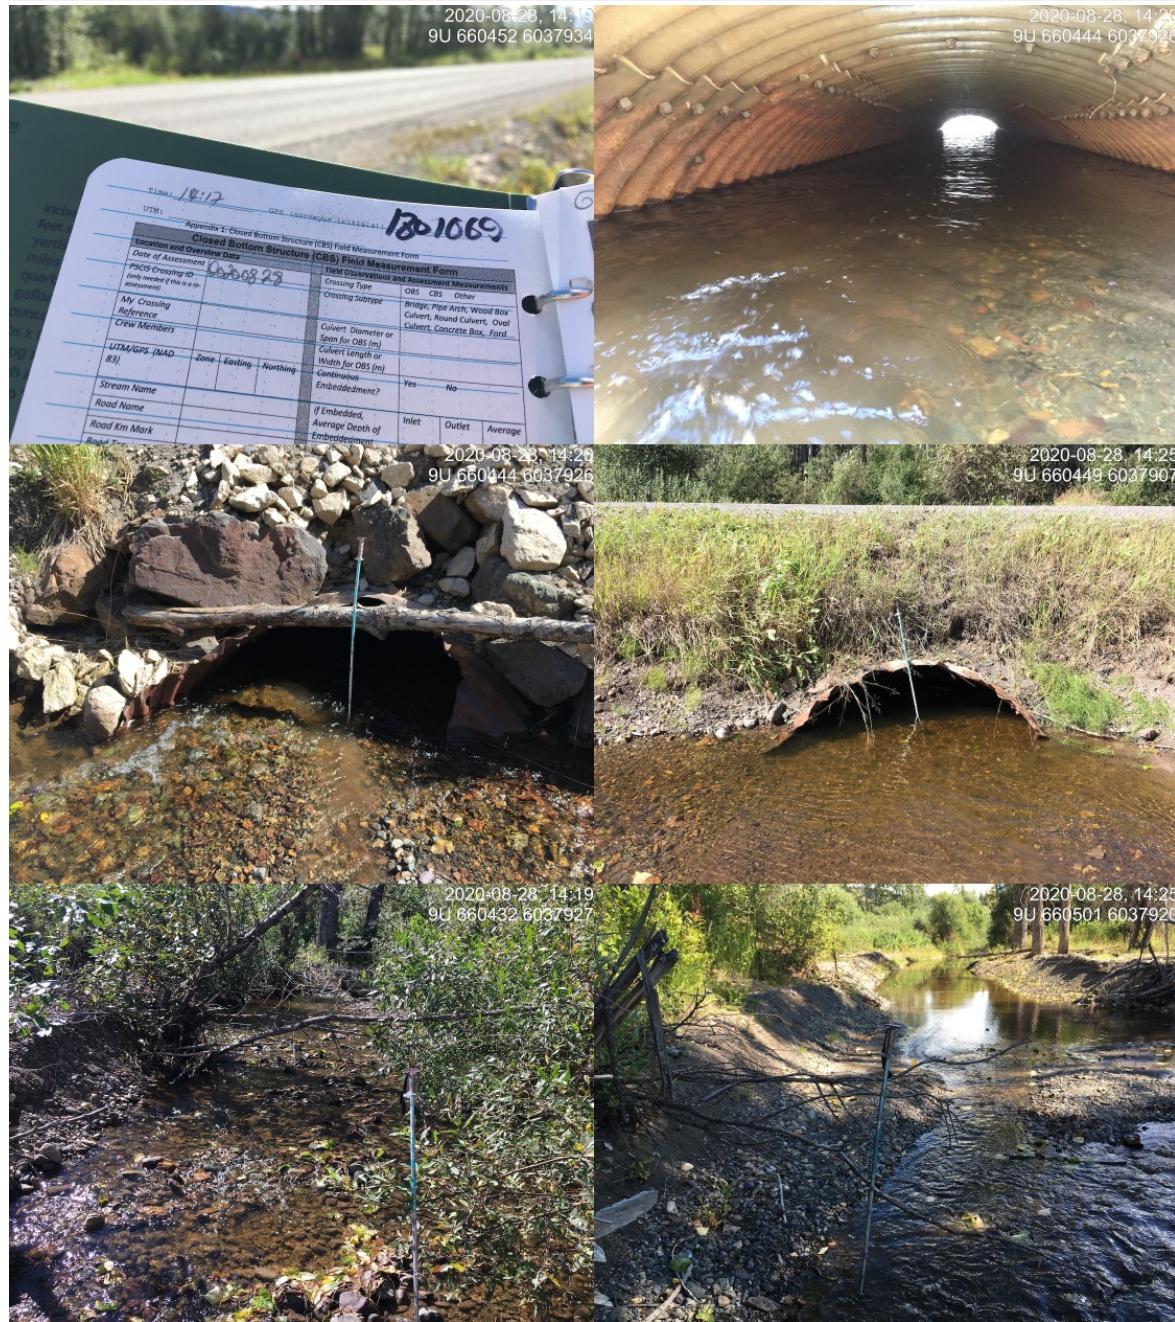
Comments: Targeted for habitat confirmation due to aggradation and dredging associated impacts on coho.

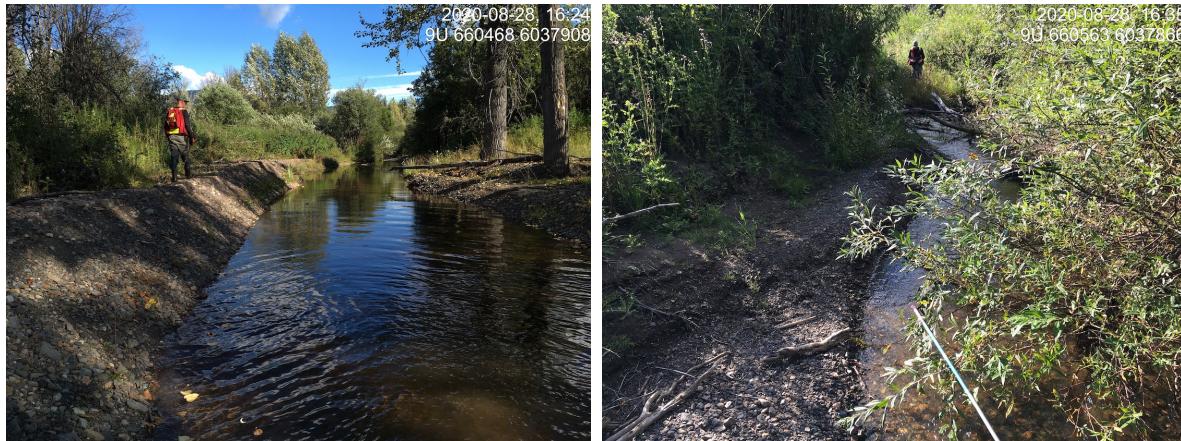
The stream was surveyed upstream from 197665 for 100m to Highway 16 (Figure 5.37). Within the area surveyed, total cover amount was rated as moderate with overhanging vegetation dominant. Cover was also present as small woody debris (Table 5.62). The average channel width was 4.7m, the average wetted width was 2.7m and the average gradient was 1.8%. Abundant gravels and small cobbles suitable for resident, fluvial, adfluvial and anadromous salmonid spawning were present throughout the area surveyed. Habitat was rated as moderate value with habitat present suitable for resident and anadromous fry/juvenile salmonid rearing and spawning.

Figure 5.37: Left: Typical habitat downstream of PSCIS crossing 197664. Right: Typical habitat downstream of PSCIS crossing 197664.

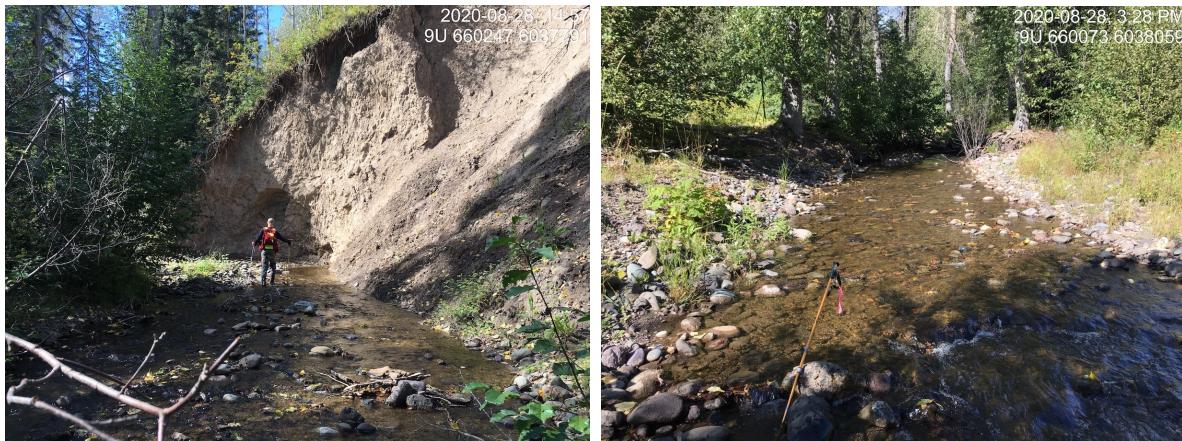
Barren Creek was surveyed upstream from 197664 for 800m (Figure 5.38). Within the area surveyed, total cover amount was rated as moderate with undercut banks dominant. Cover was also present as small woody debris, large woody debris, and overhanging vegetation (Table 5.62). The average channel width was 7.2m, the average wetted width was 4.7m and the average gradient

Figure 5.38: Left: Habitat upstream of PSCIS crossing 197664 and location of cutslope. Right: Habitat upstream of PSCIS crossing 197664.

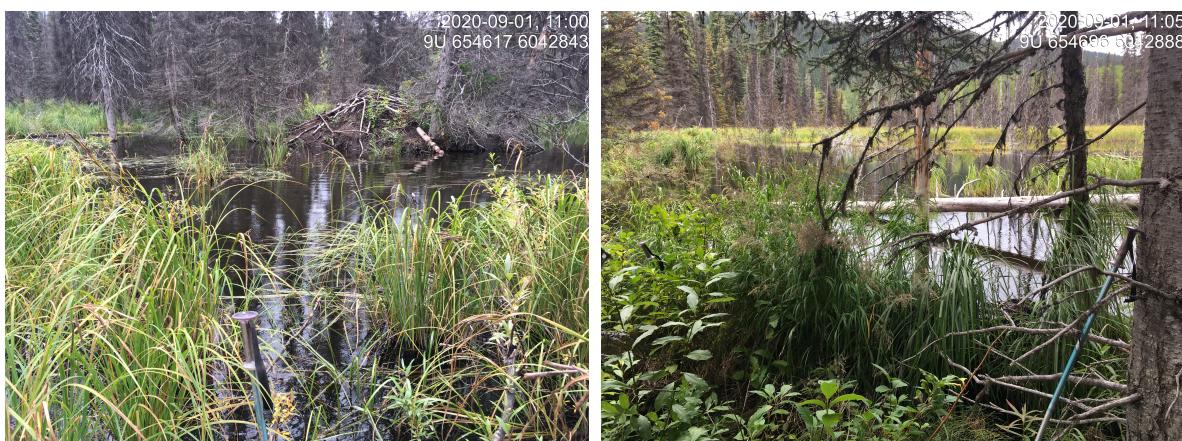
Figure 5.39: Left: Habitat downstream of PSCIS crossing 3042. Right: Habitat downstream of PSCIS crossing 3042.

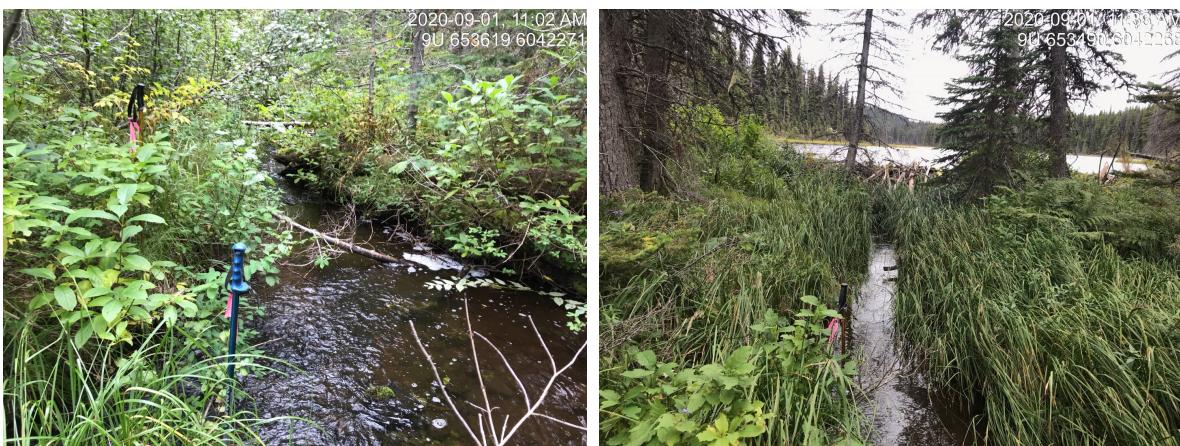
There is 1.7km of mainstem habitat upstream of crossing 3042 including an estimated 4ha of wetland and 4ha of lake. Habitat in the areas surveyed upstream was rated as moderate value for salmonid rearing/spawning. Wilson Falls is located downstream of the crossing, so restoration of passage at Barren Creek FSR could benefit resident rainbow trout only. The crossing was ranked as a low priority for proceeding to design for replacement.

Figure 5.40: Left: Habitat upstream of PSCIS crossing 3042. Right: Habitat upstream of PSCIS crossing 3042.

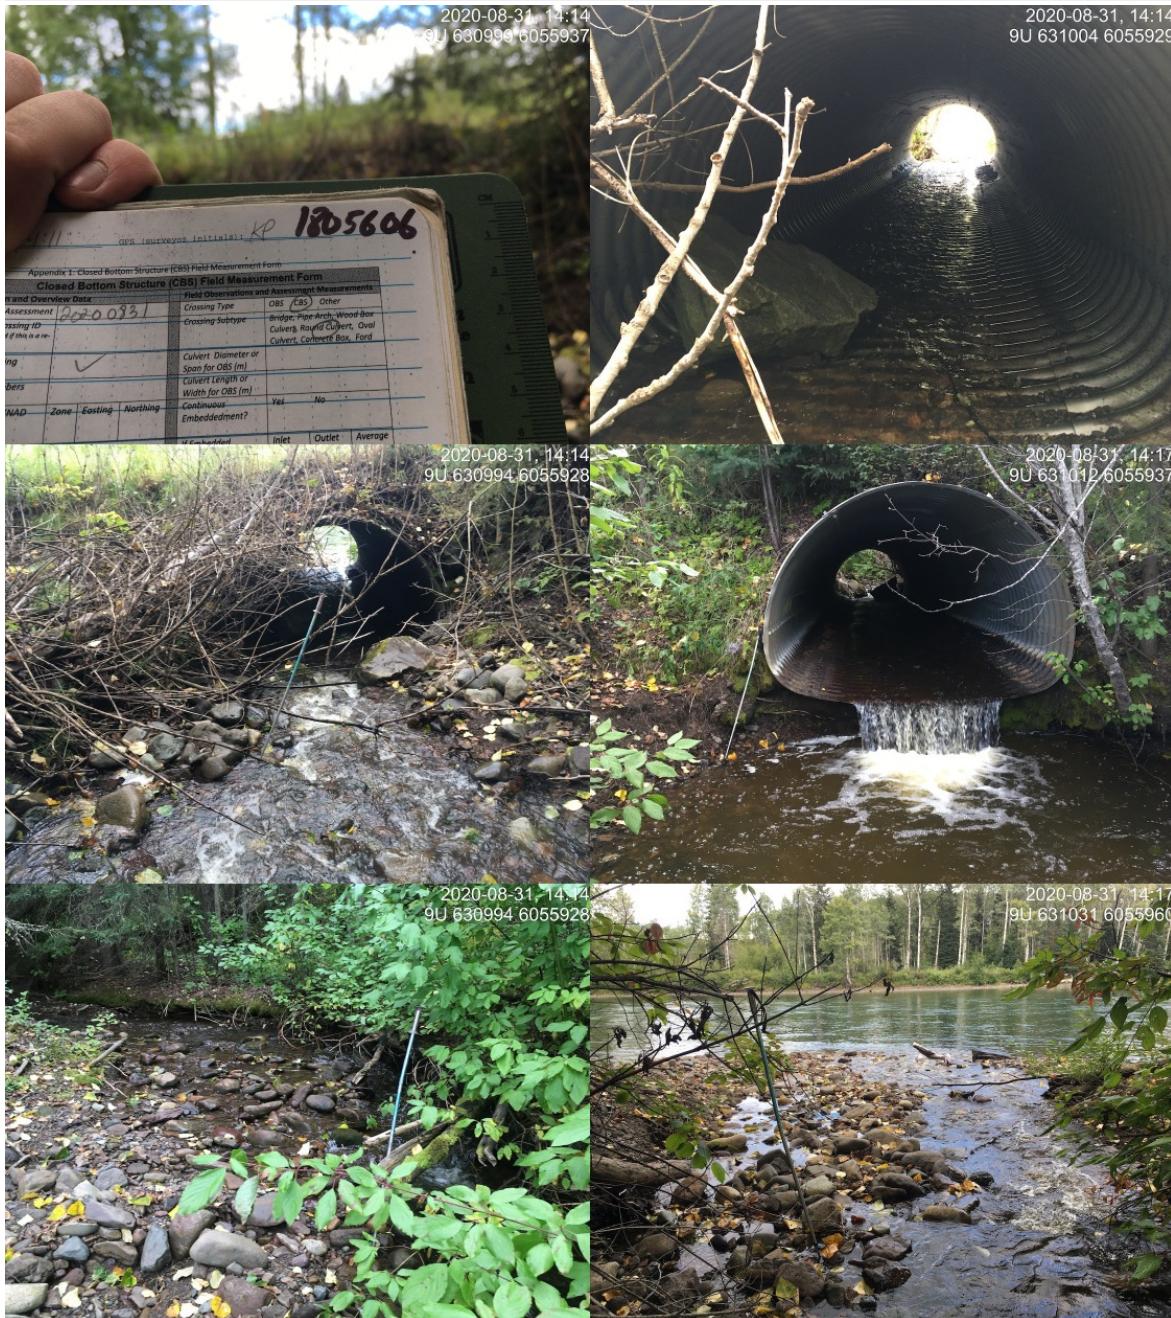
Photos: From top left clockwise: Road/Site Card, Barrel, Outlet, Downstream, Upstream, Inlet.

Comments: Approximately 17m from the outlet to the Bulkley River.

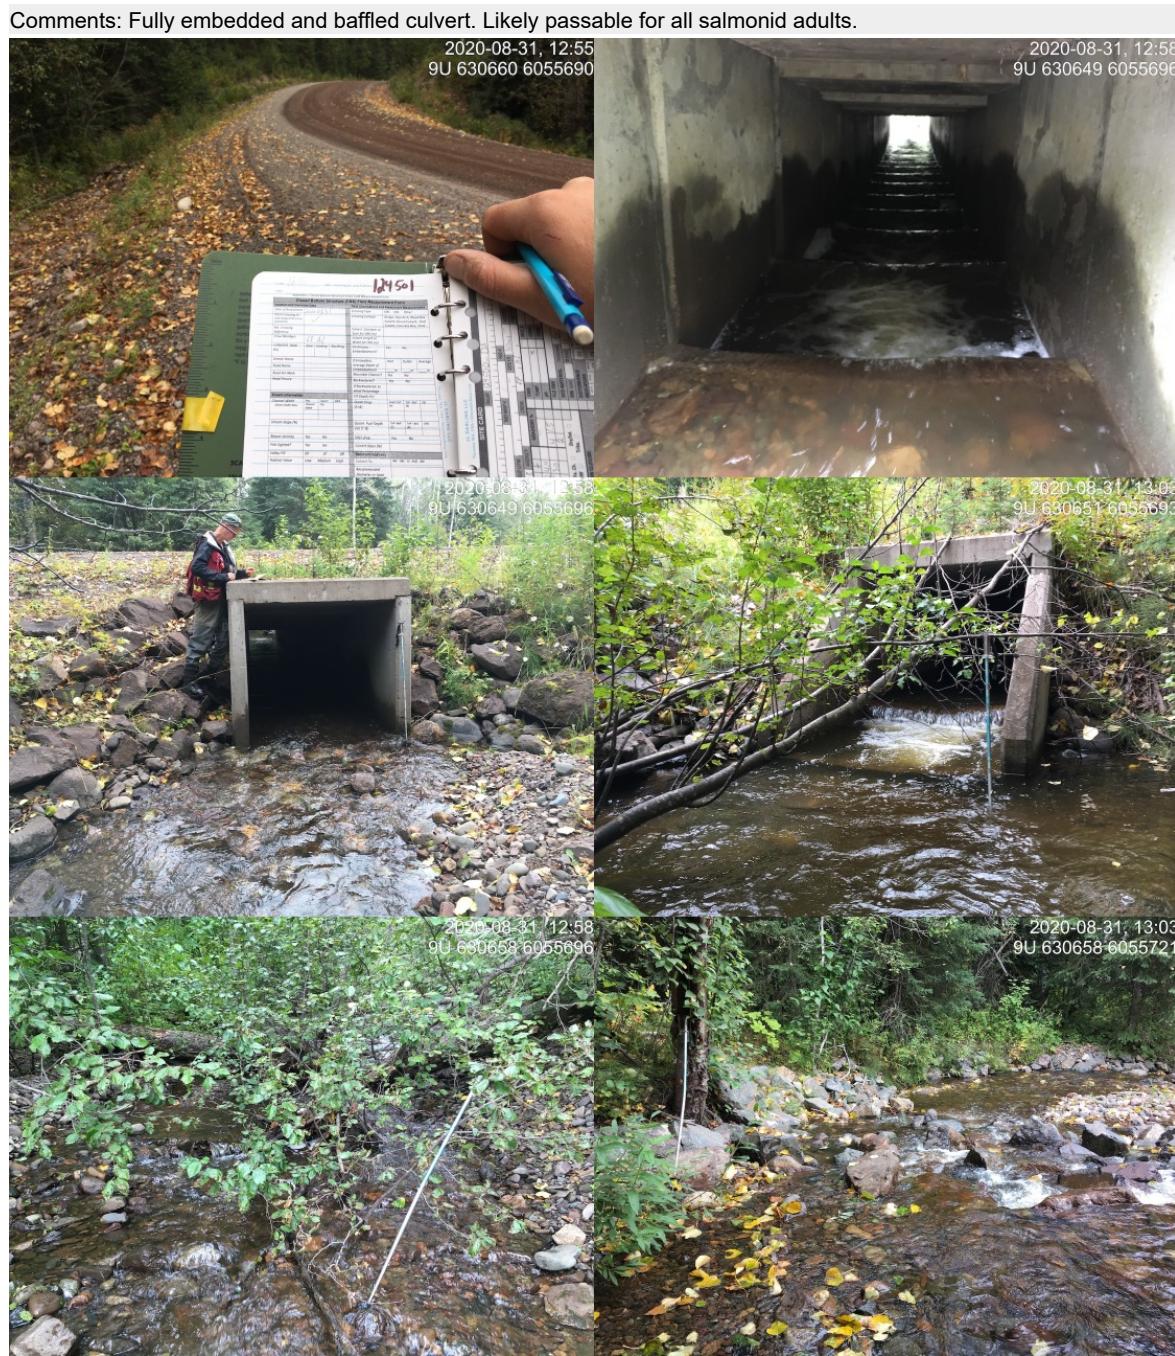
Table 5.65: Summary of fish passage assessment for PSCIS crossing 124501.

PSCIS ID	124501	Diameter (m)	1.6
External ID	–	Length (m)	25
Crew	KP, AI	Embedded	Yes
UTM Zone	9	Depth Embedded (m)	0.15
Easting	630661	Resemble Channel	Yes
Northing	6055713	Backwatered	No
Stream	Moan Creek	Percent Backwatered	–
Road	Lawson Road	Fill Depth (m)	1
Road Tenure	MoTi resource	Outlet Drop (m)	0.3
Channel Width (m)	4.5	Outlet Pool Depth (m)	0.7
Stream Slope (%)	4.5	Inlet Drop	No
Beaver Activity	No	Slope (%)	6
Habitat Value	High	Valley Fill	Deep Fill
Final score	34	Barrier Result	Barrier
Fix type	Replace with New Open Bottom Structure	Fix Span / Diameter	10

Photos: From top left clockwise: Road/Site Card, Barrel, Outlet, Downstream, Upstream, Inlet.

A cost estimate for replacing 197667 with a bridge (10m span) is \$5,000,000, resulting in cost benefits of 0.7 linear m/\$1000 and 3m²/\$1000. Although 124501 on Lawson Road was considered passable for most species/life stages during most flows, an estimate of cost for replacement (10m span) is \$500,000 resulting in cost benefits of 5.6 linear m/\$1000 and 26.9m²/\$1000.

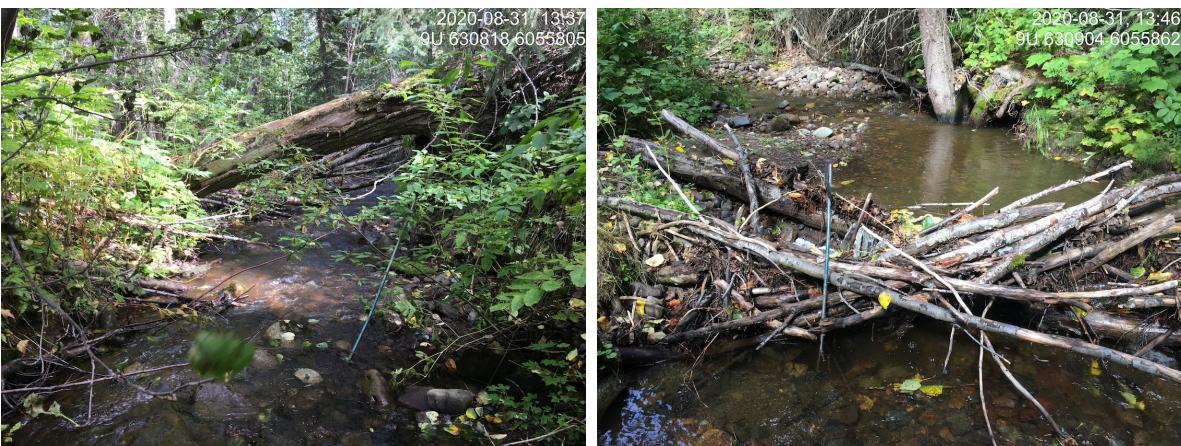
Figure 5.41: Left: Typical habitat upstream of PSCIS crossing 197667. Right: Typical habitat upstream of PSCIS crossing 197667.

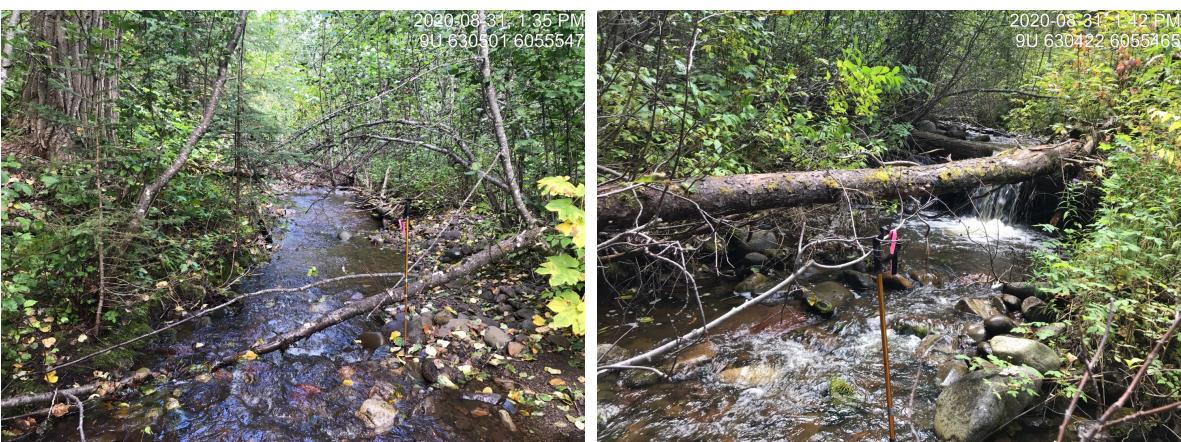
Moan Creek was surveyed upstream from 124501 for 520m (Figure [5.42](#)). Within the area surveyed, total cover amount was rated as moderate with deep pools dominant. Cover was also present as small woody debris, large woody debris, boulders, undercut banks, and overhanging vegetation (Table [5.66](#)). The average channel width was 4.8m, the average wetted width was 3.1m and the average gradient was 6.3%. There were multiple debris jams present upstream from 350m above Larson Road with heights ranging from 0.4 - 1m high. Habitat was noted as complex with abundant gravels suitable for resident, fluvial and anadromous salmonid spawning. Habitat was rated as high value.

Figure 5.42: Left: Habitat upstream of PSCIS crossing 124501. Right: Habitat upstream of PSCIS crossing 124501.

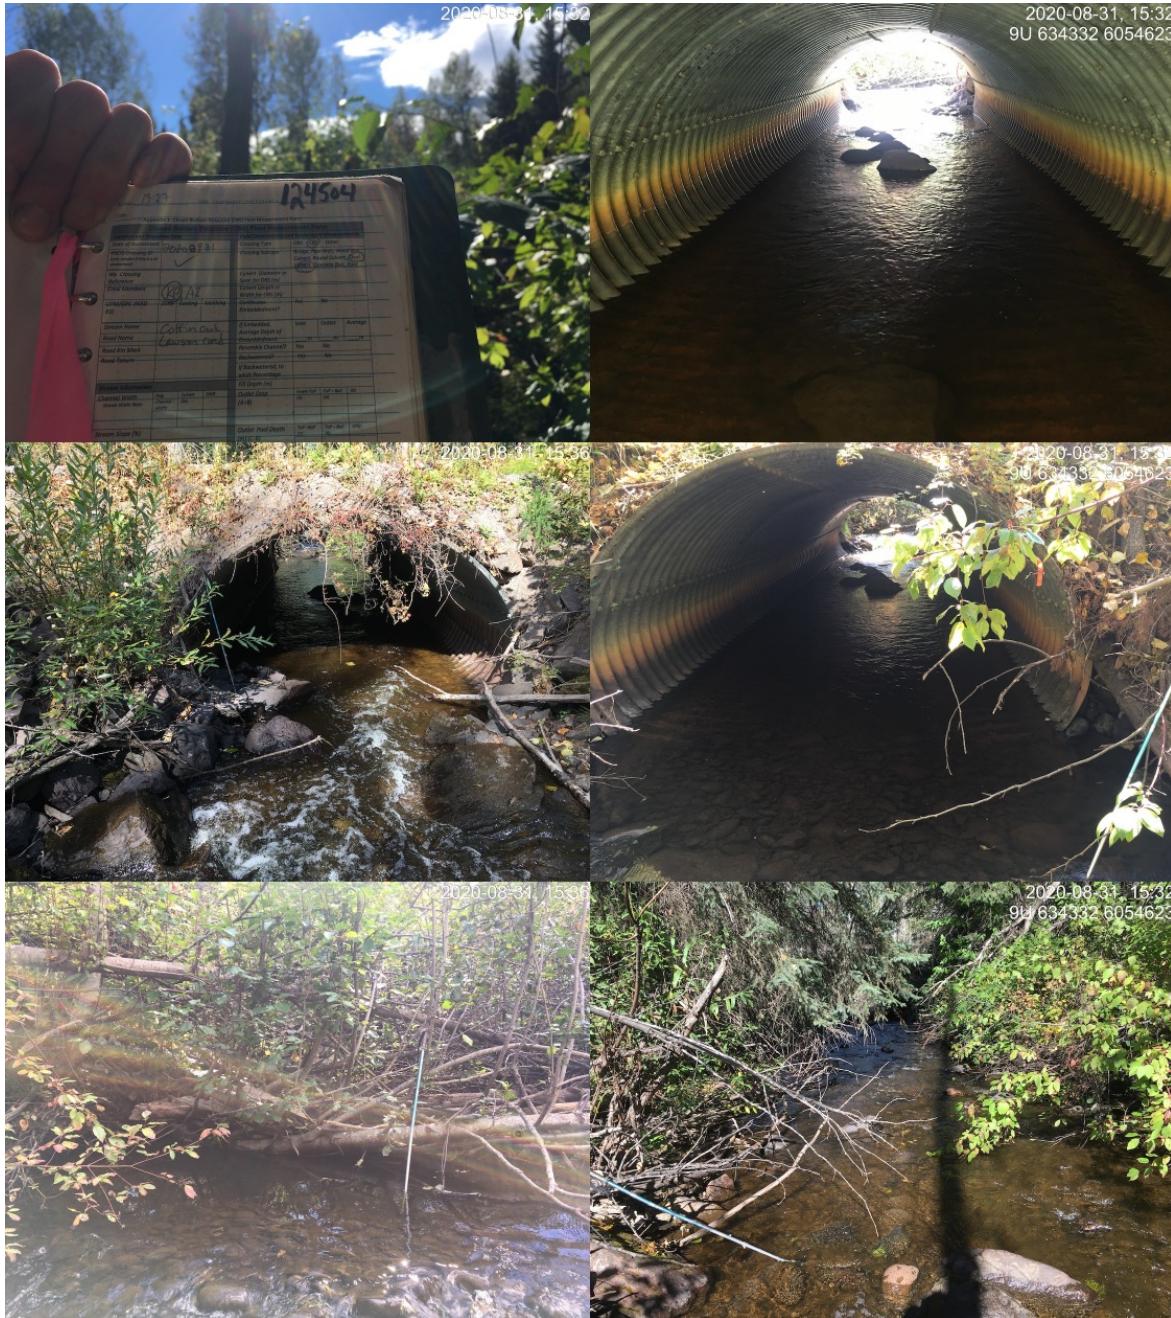
Table 5.70: Summary of fish passage assessment for PSCIS crossing 124504.

Date	2020-08-31	Crossing Sub Type	Round Culvert
PSCIS ID	124504	Diameter (m)	3
External ID	–	Length (m)	16
Crew	KP, AI	Embedded	Yes
UTM Zone	9	Depth Embedded (m)	0.15
Easting	634323	Resemble Channel	Yes
Northing	6054587	Backwatered	No
Stream	Coffin Creek	Percent Backwatered	–
Road	Lawson Road	Fill Depth (m)	0.5
Road Tenure	MoTi resource	Outlet Drop (m)	0.2
Channel Width (m)	5.3	Outlet Pool Depth (m)	0.1
Stream Slope (%)	2	Inlet Drop	No
Beaver Activity	No	Slope (%)	1
Habitat Value	High	Valley Fill	Deep Fill
Final score	24	Barrier Result	Barrier
Fix type	Replace with New Open Bottom Structure	Fix Span / Diameter	10
Photos: From top left clockwise: Road/Site Card, Barrel, Outlet, Downstream, Upstream, Inlet.

Comments: Partially embedded with several large boulders (30 - 50cm) in culvert. No outlet drop at the time of survey but there may be at lowest flow levels.

Replacement with bridges for 197668 (10m span) and 124504 (10m span) are recommended to provide unimpeded access to the habitat located upstream. An estimate of cost for replacement of 197668 is \$5,000,000 resulting in cost benefits of 0.8 linear m/\$1000 and $4.2\text{m}^2/\$1000$. An estimate of cost for replacement of 124504 is \$500,000 resulting in cost benefits of 8 linear m/\$1000 and $46.4\text{m}^2/\$1000$.

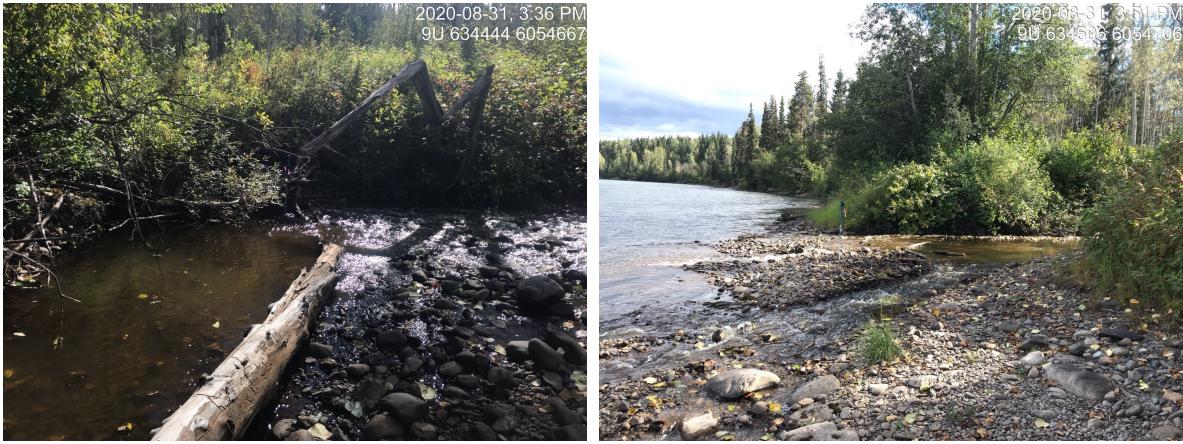
Figure 5.43: Left: Typical habitat downstream of PSCIS crossing 197668. Right: Coffin Creek downstream of PSCIS crossing 197668 at confluence with the Bulkley River.

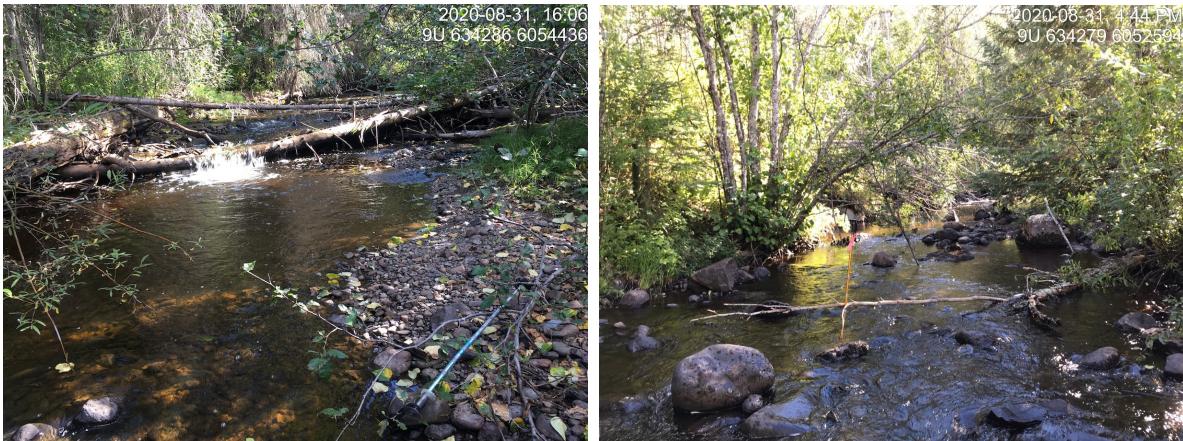
Coffin Creek was surveyed upstream from 124504 for 415m and again upstream approximately 2.2km at a powerline ford crossing (Figure [5.44](#)). Within the area surveyed, total cover amount was rated as moderate with undercut banks dominant. Cover was also present as small woody debris, large woody debris, boulders, deep pools, and overhanging vegetation (Table [5.71](#)). The average channel width was 5.8m, the average wetted width was 3.5m and the average gradient was 2.3%. The stream in the areas surveyed was noted as having high complexity with occasional patches of gravels suitable for spawning present. Habitat value was rated as high for younger life stages of resident and anadromous salmonid rearing and resident adult salmonid spawning.

Figure 5.44: Left: Habitat upstream of PSCIS crossing 124504. Right: Habitat 2.1km upstream of PSCIS crossing 124504.
