## **ELK RIVER WATERSHED GROUP FISH PASSAGE RESTORATION PLANNING**

December 31, 2020

Version 0.0.4

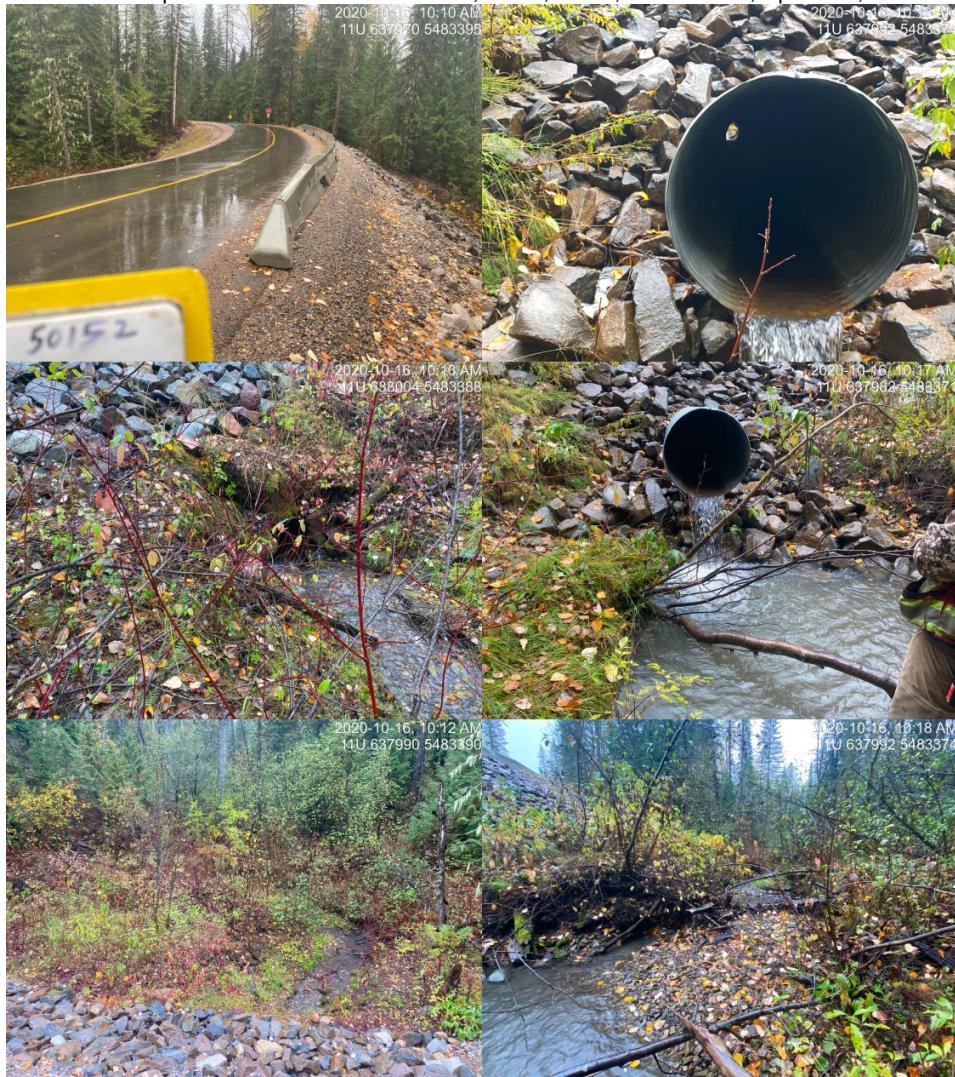
Photos: From top left clockwise: Road/Site Card, Barrel, Outlet, Downstream, Upstream, Inlet.

As noted, the culvert located at PSCIS 50152 appeared to have been replaced in 2020 with fresh rock, road fill and pavement present. At the time of the survey, the un-embedded and non-backwatered 0.9m diameter crossing was considered a barrier to upstream fish passage with a pipe length of 30m, a culvert slope of 1.5%, a stream width ratio of 2.9 and an outlet drop of 0.9m (Table [5.1](#)). Water temperature was 5°C, pH was 8.5 and conductivity was 286uS/cm.

Structure replacement with an open bottomed structure is recommended to provide access to the habitat located upstream of PSCIS crossing 50152. The cost of the work is estimated at \$438000 for a cost benefit of \$6200/linear m and \$8000/m<sup>2</sup>.

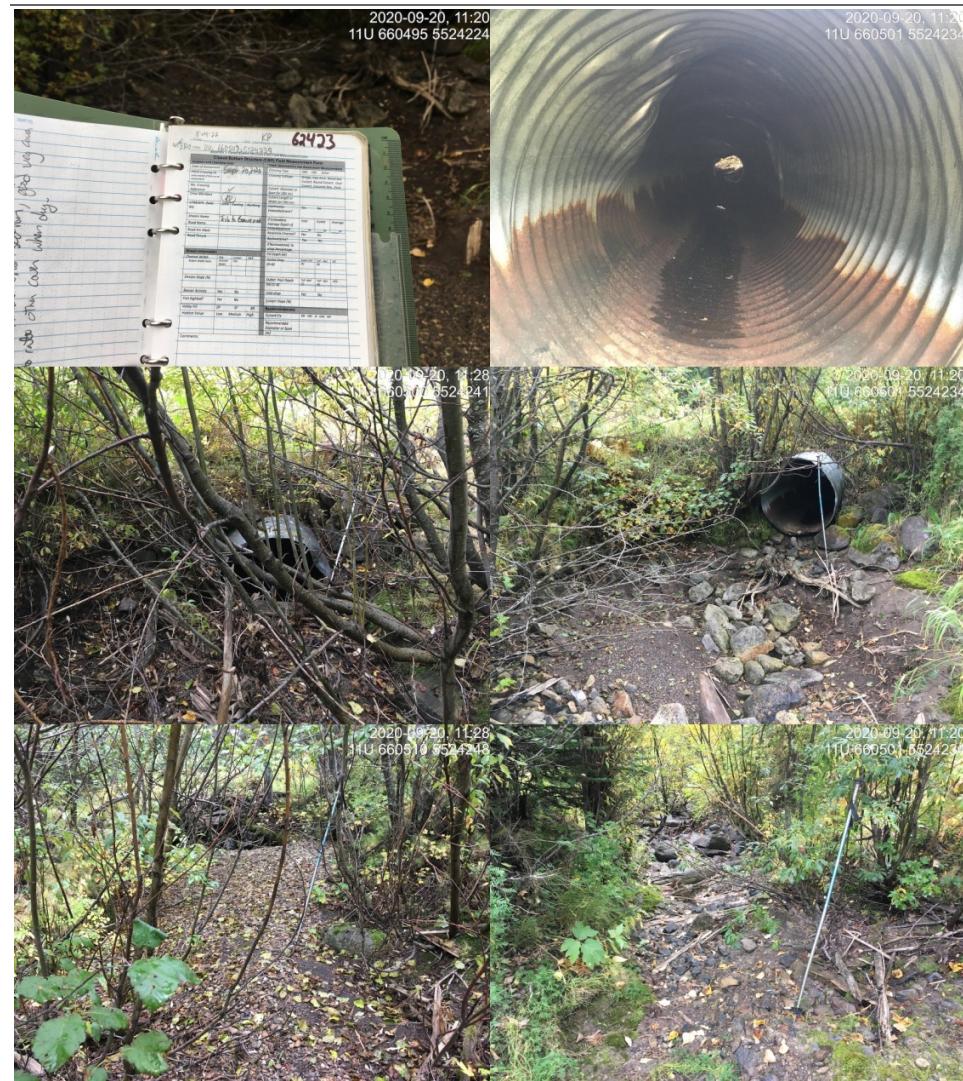
<b>Location and Stream Data</b>		<b>Crossing Characteristics</b>	
Date	2020-09-20	Crossing Sub Type	Round Culvert
PSCIS ID	62423	Diameter (m)	0.9
External ID	NA	Length (m)	12
Crew	KP, AI	Embedded	No
UTM Zone	11	Depth Embedded (m)	NA
Easting	660508	Resemble Channel	No
Northing	5524239	Backwatered	No
Stream	Harriet Lake Creek	Percent Backwatered	NA
Road	Grave Creek FSR	Fill Depth (m)	0.3
Road Tenure	Unknown	Outlet Drop (m)	0.18
Channel Width (m)	1.44	Outlet Pool Depth (m)	0.6
Stream Slope (%)	4	Inlet Drop	Yes
Beaver Activity	No	Slope (%)	0.5
Habitat Value	Low	Valley Fill	Deep Fill

Photos: From top left clockwise: Road/Site Card, Barrel, Outlet, Downstream, Upstream, Inlet.

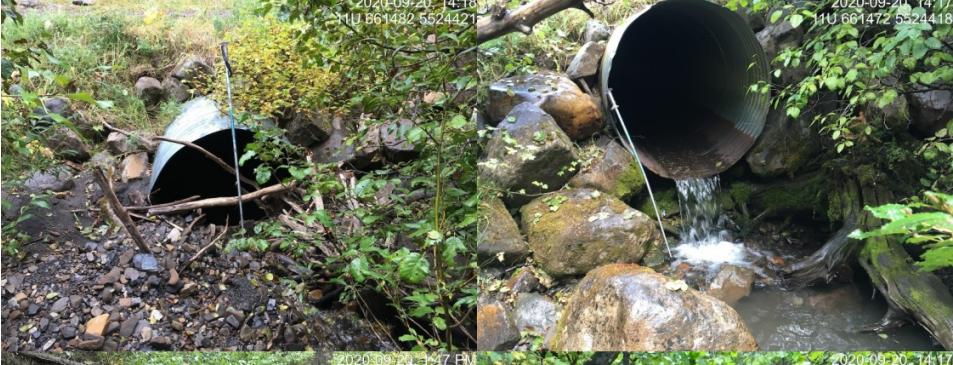
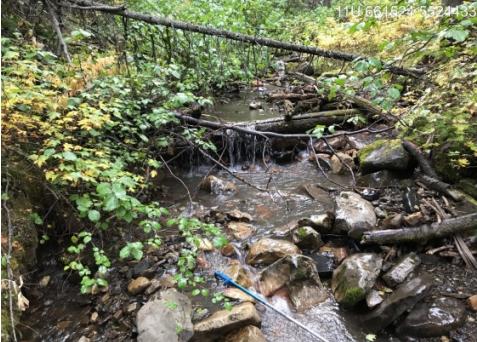
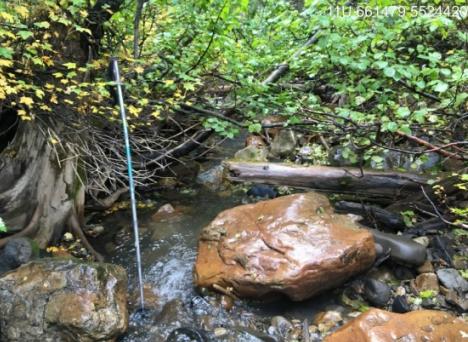
<b>Location and Stream Data</b>		<b>Crossing Characteristics –</b>	
Date	2020-09-20	Crossing Sub Type	Round Culvert
PSCIS ID	62425	Diameter (m)	1.2
External ID	NA	Length (m)	12
Crew	KP, AI	Embedded	No
UTM Zone	11	Depth Embedded (m)	NA
Easting	661486	Resemble Channel	No
Northing	5524426	Backwatered	No
Stream	Grave Creek	Percent Backwatered	NA
Road	Spur	Fill Depth (m)	1
Road Tenure	Canfor R08362	Outlet Drop (m)	0.47
Channel Width (m)	3.7	Outlet Pool Depth (m)	0.38
Stream Slope (%)	7.5	Inlet Drop	Yes
Beaver Activity	No	Slope (%)	7.5

Habitat Value	Medium	Valley Fill	Deep Fill
Photos: From top left clockwise: Road/Site Card, Barrel, Outlet, Downstream, Upstream, Inlet.			
	2020-09-20 14:16 11U 661487 5524433	2020-09-20 14:17 11U 661472 5524418

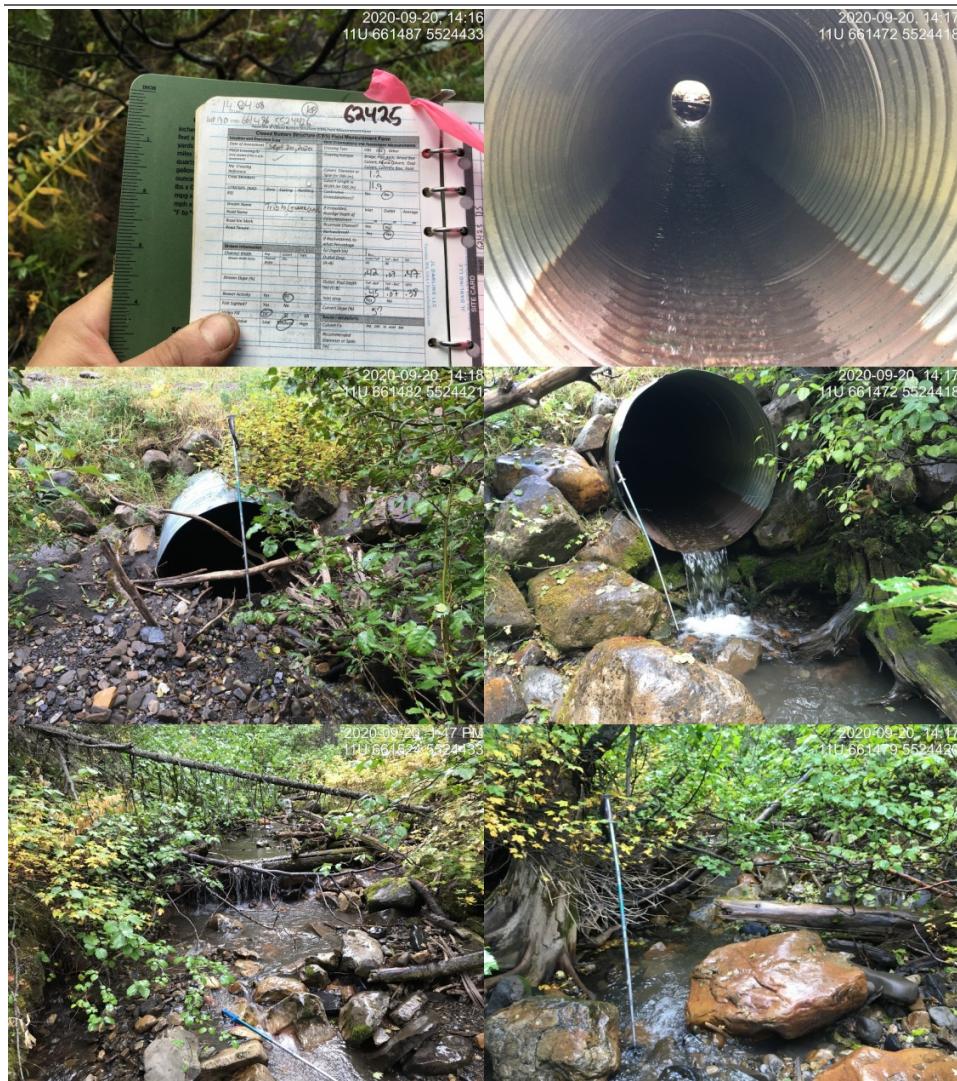
Location and Stream Data	.	Crossing Characteristics	-
Date	2020-09-20	Crossing Sub Type	Round Culvert
PSCIS ID	62426	Diameter (m)	1.2
External ID	NA	Length (m)	12
Crew	KP, AI	Embedded	No
UTM Zone	11	Depth Embedded (m)	NA
Easting	661611	Resemble Channel	No
Northing	5524460	Backwatered	No
Stream	Grave Creek	Percent Backwatered	NA
Road	Spur	Fill Depth (m)	1
Road Tenure	Canfor R08362	Outlet Drop (m)	0.25
Channel Width (m)	3.5	Outlet Pool Depth (m)	0.65
Stream Slope (%)	6	Inlet Drop	Yes
Beaver Activity	No	Slope (%)	5
Habitat Value	Medium	Valley Fill	Deep Fill

Photos: From top left clockwise: Road/Site Card, Barrel, Outlet, Downstream, Upstream, Inlet.

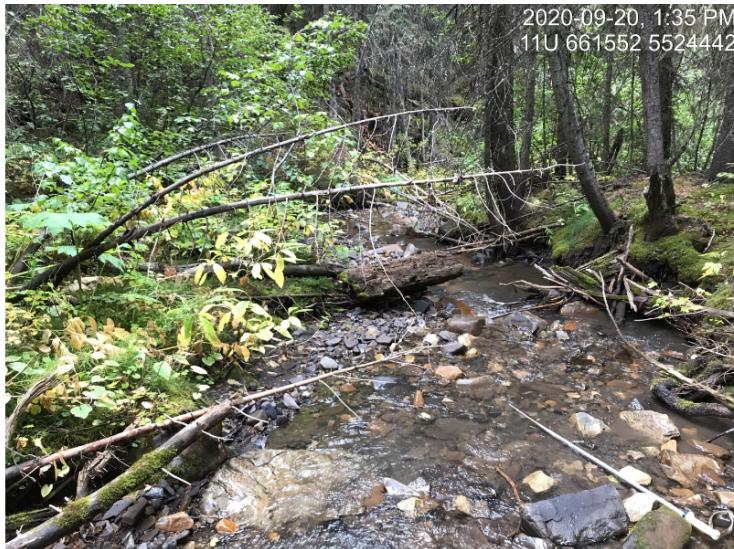
The stream was surveyed upstream from 62425 for 170m to 62426. Overall, total cover amount was rated as moderate with deep pools dominant. Cover was also present as large woody debris and boulders (Table 5.23, Figure 5.22). The average channel width was 3.5m, the average wetted width was 2.1m and the average gradient was 5%. There were abundant gravels suitable for resident westslope cutthroat trout spawning throughout (Figure 5.23). Some debris jam steps to 0.8m in height were observed and there were approximately 15 westslope cutthroat trout (approximately 170mm long) in the outlet pool for crossing 62426. Habitat value was rated as high for fry/juvenile salmonid rearing.

Figure 5.22: Typical habitat upstream of PSCIS crossing 62425 and downstream of PSCIS crossing 62426.

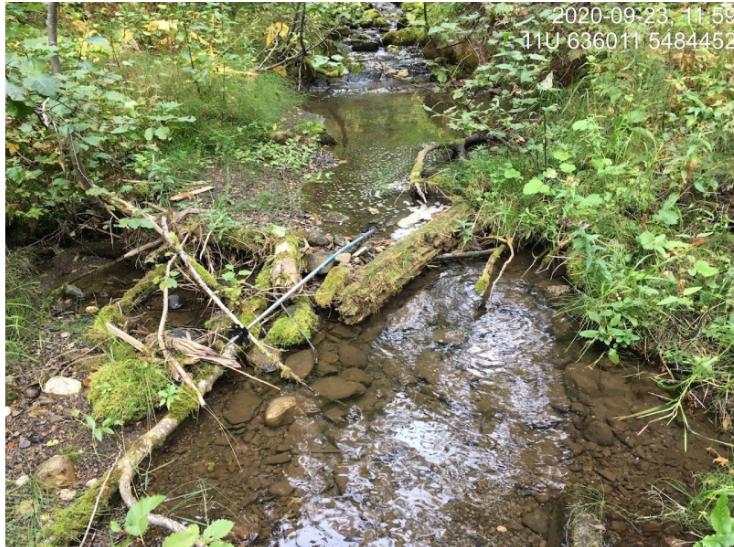
overhanging vegetation (Table 5.25, Figure 5.24). The average channel width was 2m, the average wetted width was 1.3m and the average gradient was 7.6%. There were abundant gravels suitable for resident westslope cutthroat trout spawning throughout (Figure 5.24). Fry were observed within the area surveyed to 540m upstream of the culvert where gradients increased to >20% for a distance of approximately 15m. Although no sampling was conducted, no fish were observed above this high gradient section. Habitat value was rated as high for fry/juvenile salmonid rearing.

Figure 5.25: Typical habitat upstream of PSCIS crossing 62516.

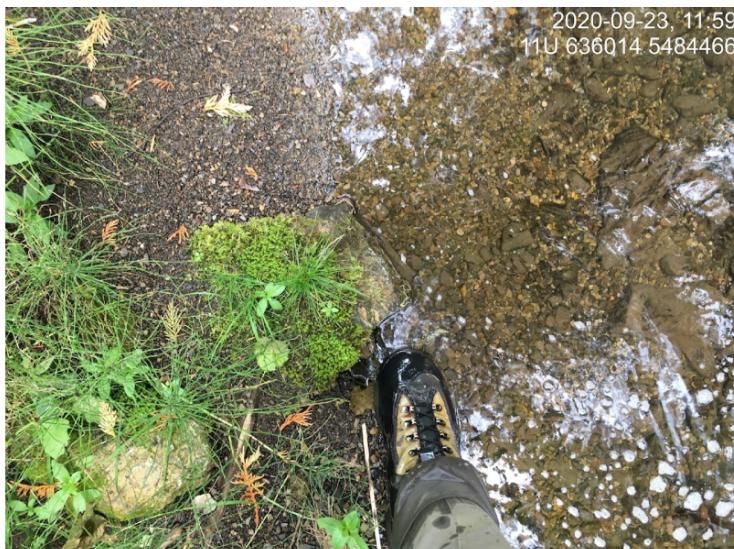
Figure 5.26: Gravels suitable for spawning upstream of PSCIS crossing 62516.

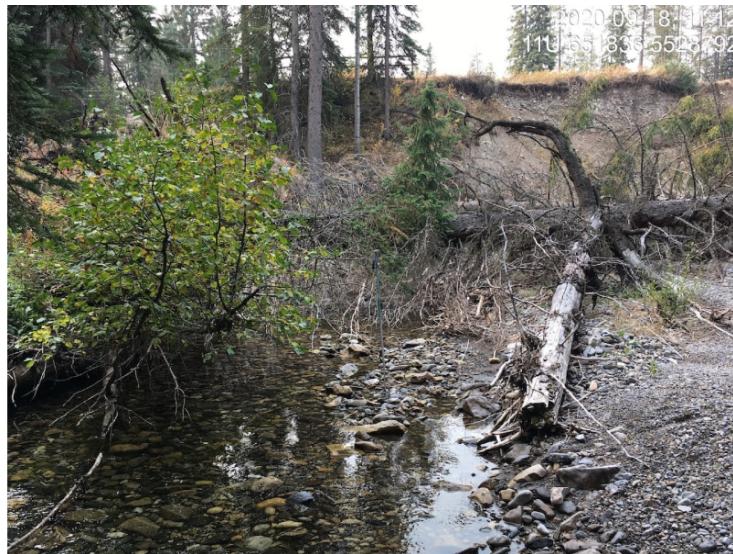
Figure 5.27: Typical habitat downstream of PSCIS crossing 197533.

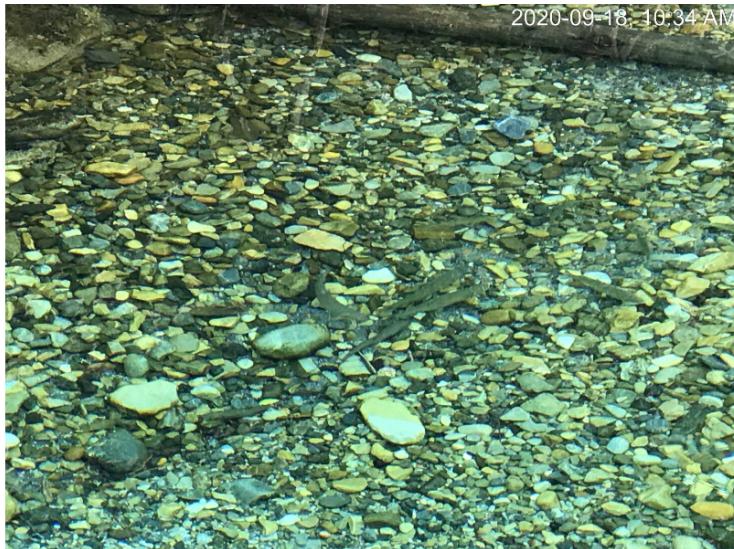
Figure 5.29: Westslope cutthroat trout in outlet pool downstream of PSCIS crossing 197559.

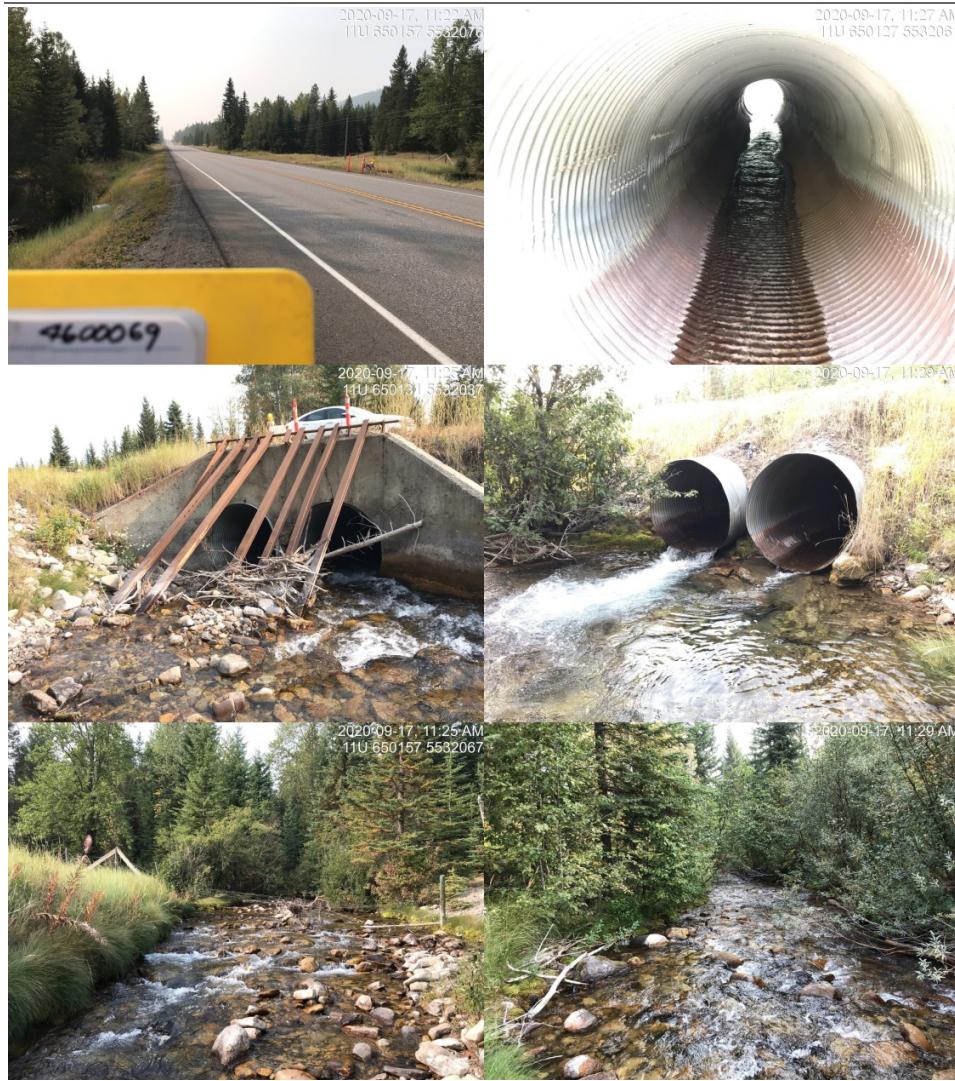
Photos: From top left clockwise: Road/Site Card, Barrel, Outlet, Downstream, Upstream, Inlet.

Location and Stream Data	.	Crossing Characteristics	-
Date	2020-09-17	Crossing Sub Type	Round Culvert
PSCIS ID	197534	Diameter (m)	3.2
External ID	NA	Length (m)	18
Crew	AI, KP	Embedded	No
UTM Zone	11	Depth Embedded (m)	NA
Easting	650144	Resemble Channel	No
Northing	5532055	Backwatered	No
Stream	Weigart Creek	Percent Backwatered	NA
Road	Highway 43	Fill Depth (m)	1.3
Road Tenure	MoTi highway	Outlet Drop (m)	0.15
Channel Width (m)	4.3	Outlet Pool Depth (m)	0.6
Stream Slope (%)	2	Inlet Drop	Yes
Beaver Activity	No	Slope (%)	3.4
Habitat Value	High	Valley Fill	Deep Fill

Structure replacement with an open bottomed structure is recommended to provide access to the habitat located upstream of PSCIS crossing 197534. The cost of the work is estimated at \$2500000 for a cost benefit of \$4600/linear m and \$10000/m<sup>2</sup>.

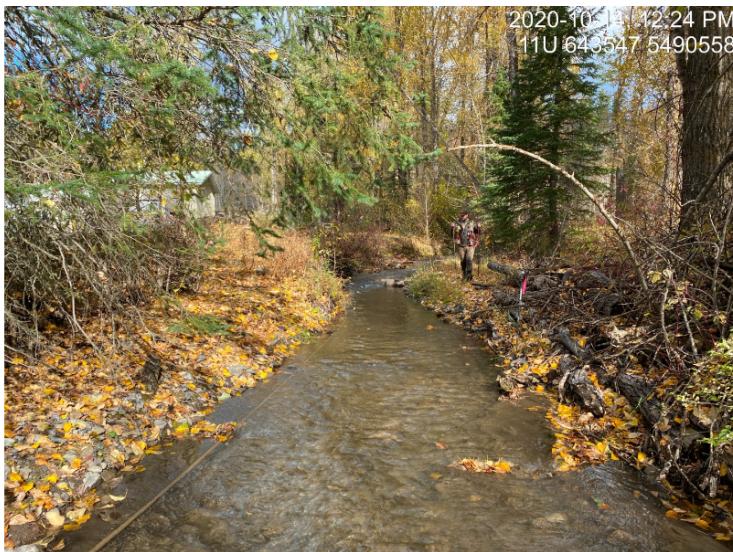
**Figure 5.35: Typical habitat downstream of PSCIS crossing 197542.**

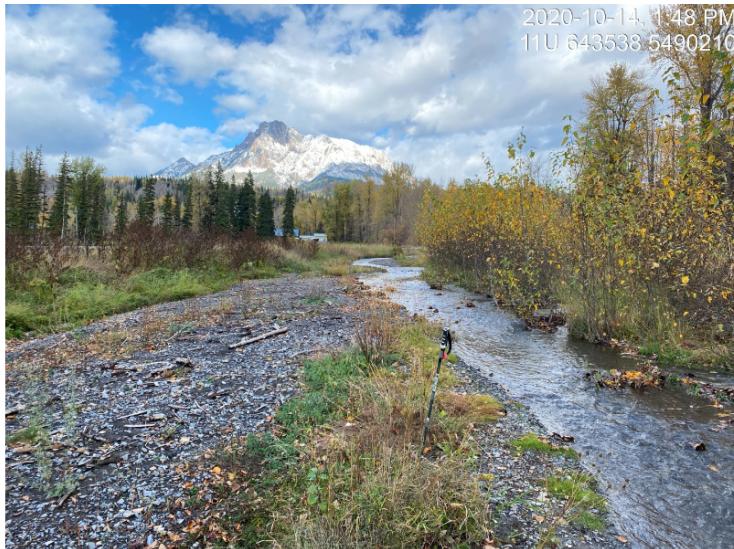
Figure 5.36: Typical habitat downstream of PSCIS crossing 197582.
