DRAFT - Bulkley River and Morice River Watershed Groups Fish Passage Restoration Planning

Prepared for
Habitat Conservation Trust Fund
BC Fish Passage Remediation Program
Canadian Wildlife Federation

Prepared by
Al Irvine, B.Sc., R.P.Bio.
New Graph Environment
6 Regent St
Nelson, BC V1L 2P1

DRaFT - Version 0.0.3
2021-03-02

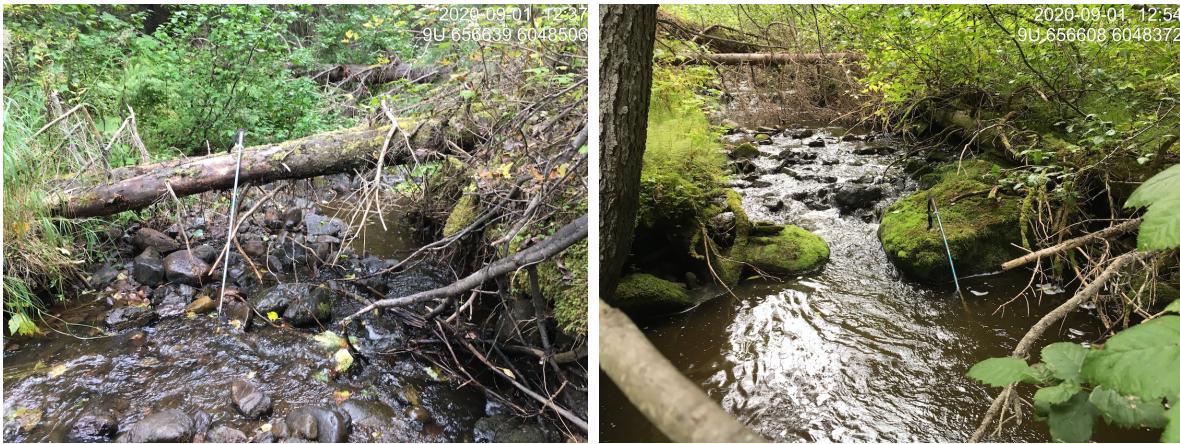
Figure 5.1: Left: Habitat downstream of PSCIS crossing 3139. Right: Habitat downstream of crossing 3139.

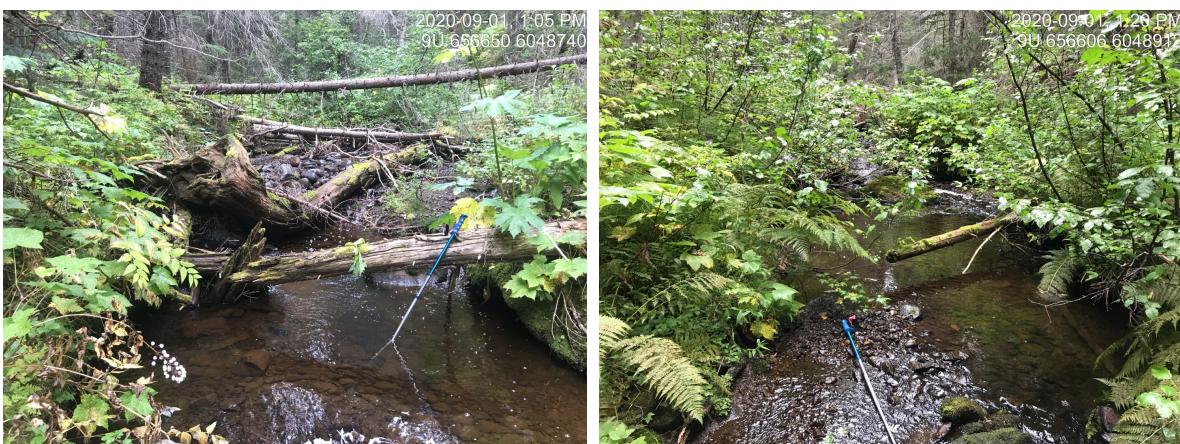
Figure 5.2: Left: Habitat upstream of PSCIS crossing 3139. Right: Habitat upstream of PSCIS crossing 3139.

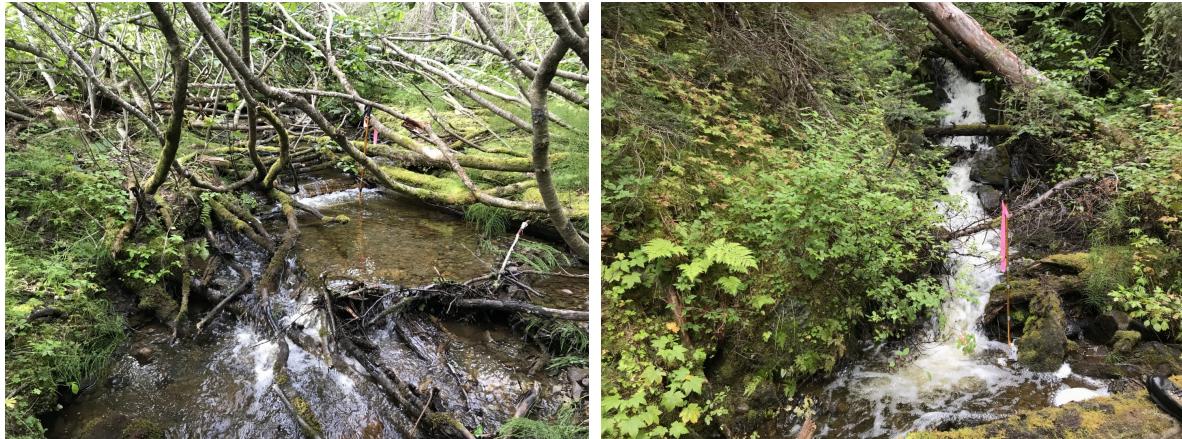
Figure 5.10: Left: Habitat upstream of PSCIS crossing 123794. Right: Cascade upstream of PSCIS crossing 123794.

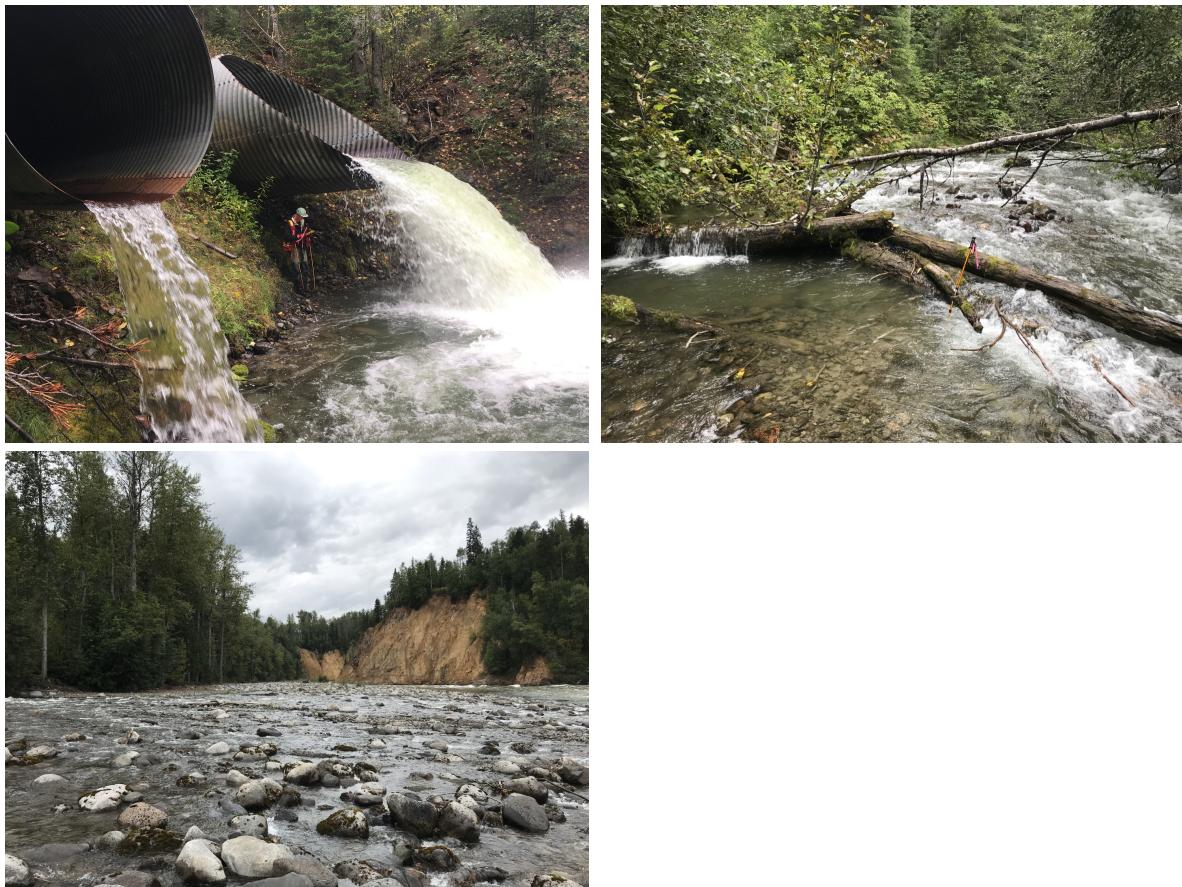
Comments: Unpassable to all life stages and species. Fill depth is approximately 35m. Salomid (50cm) observed trying to ascend to outlet of main pipe.

Figure 5.13: Left: Outlets of PSCIS crossing 124487. Right: Typical habitat downstream of crossing 124487 below the railway bridge and adjacent to the Bulkley River mainstem.

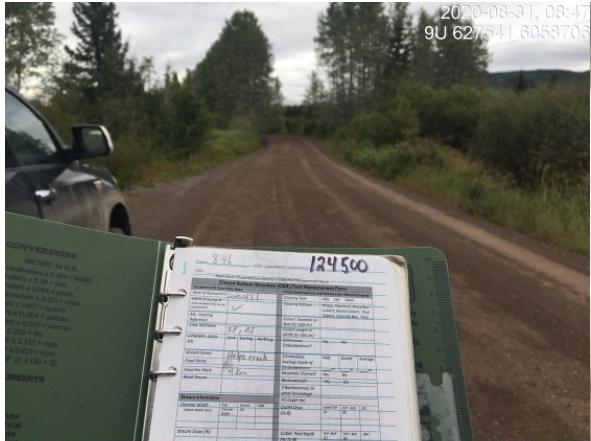
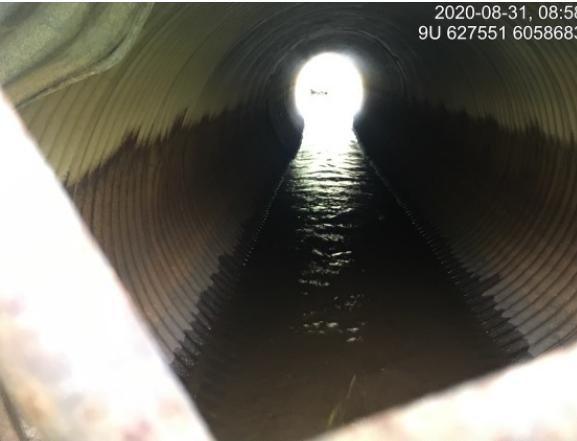
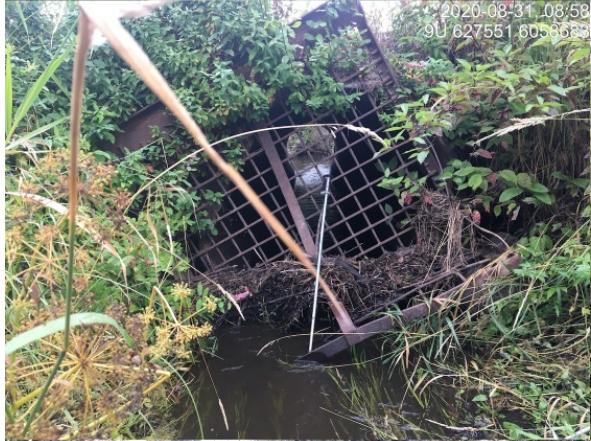
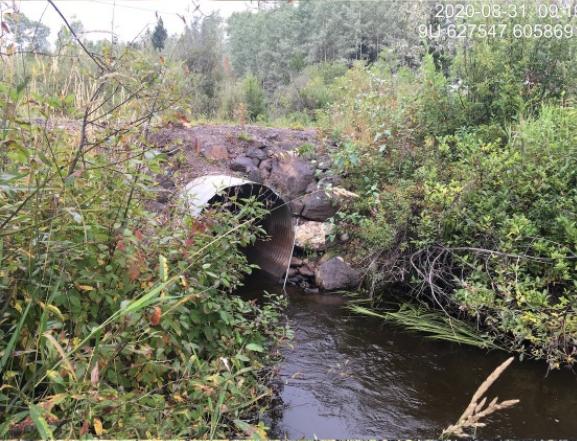
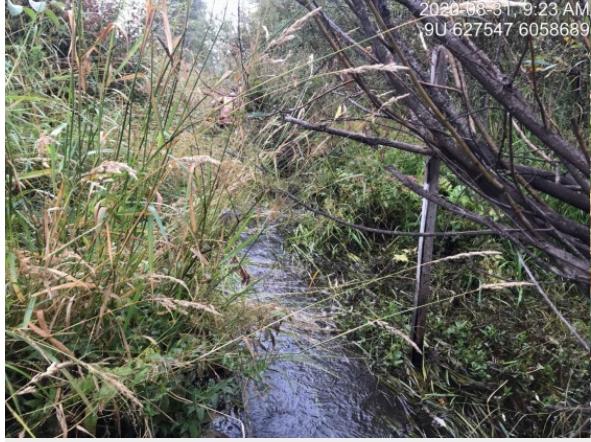
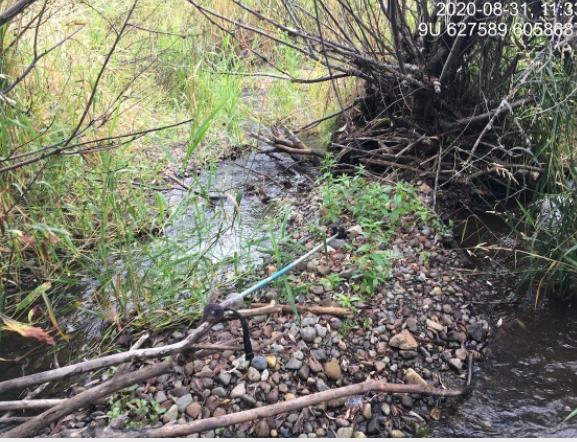
Comments: Wetland type habitat upstream with stream channel containing abundant gravels downstream.

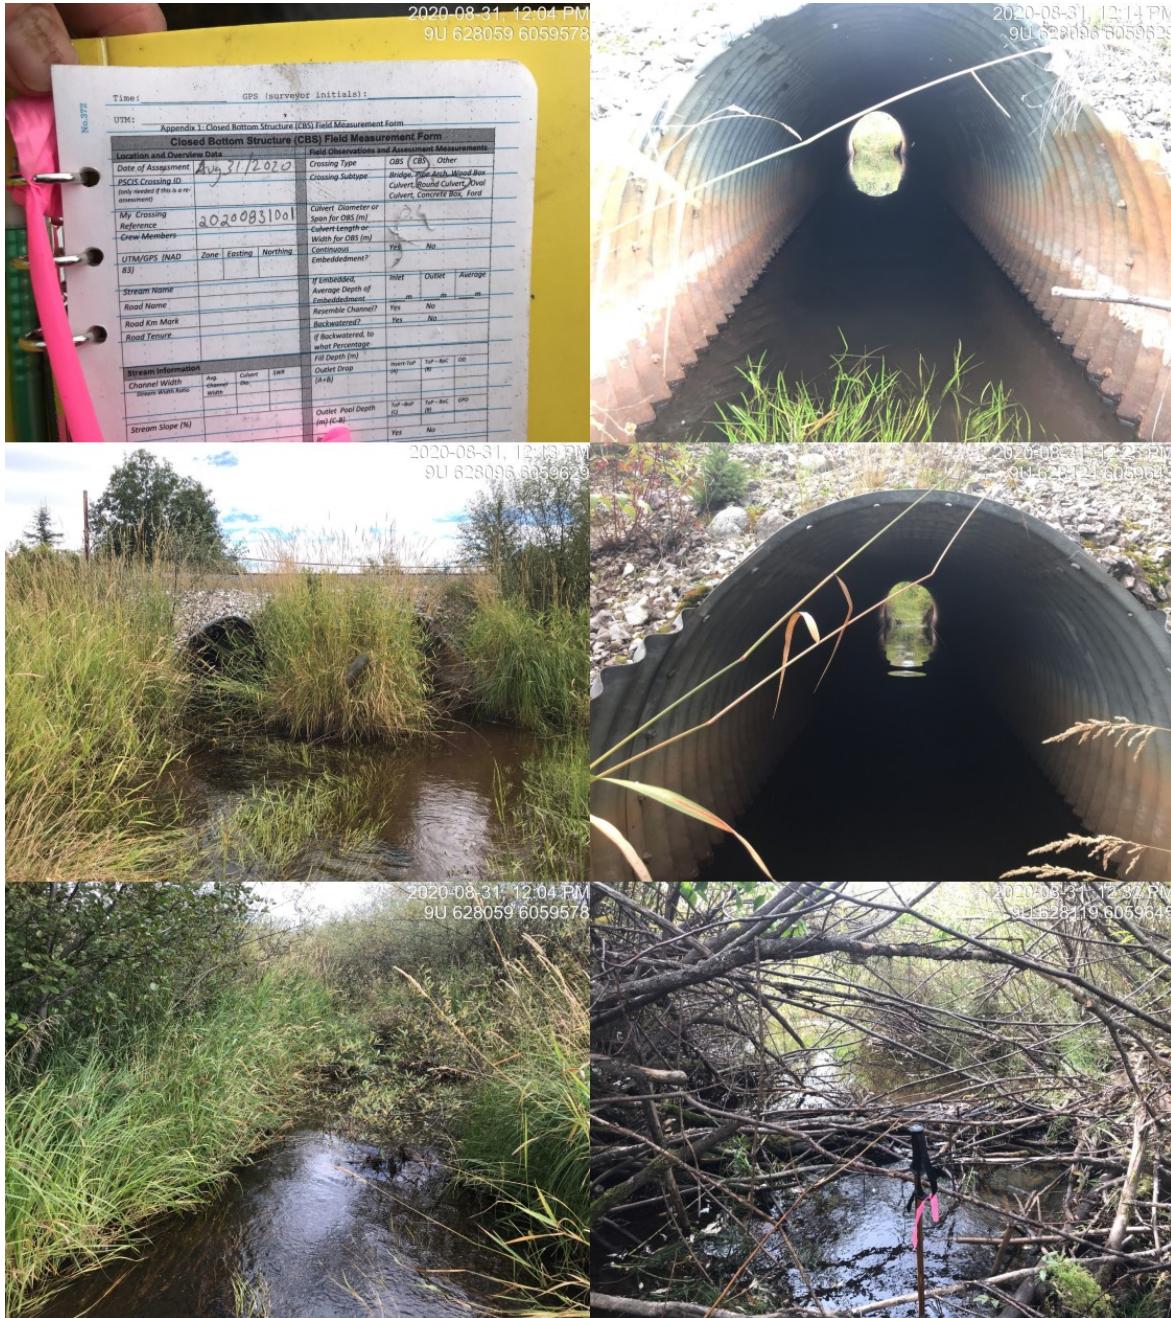
Comments: Passable and fully backwatered structure. Landowner reports that lamprey (~40cm x 20) at crossing inside of the culvert in the past.

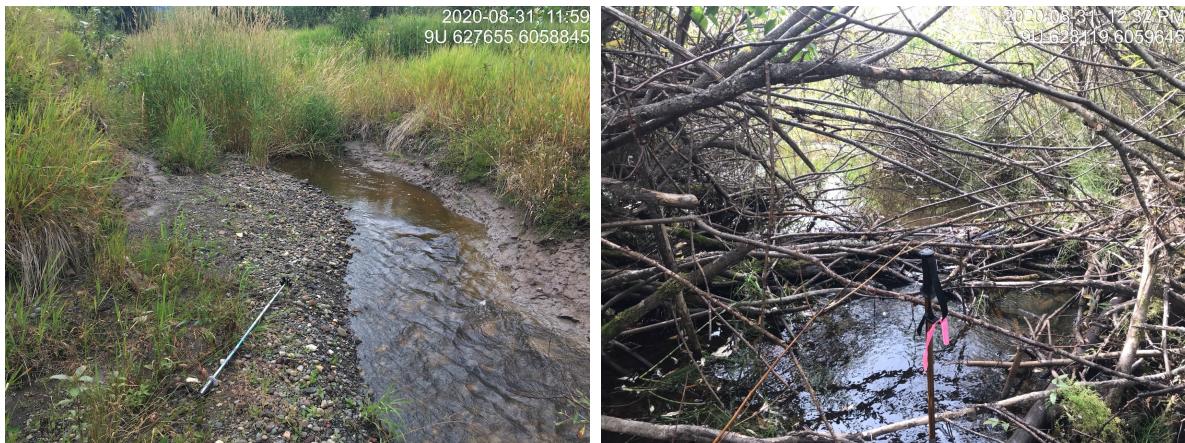
Figure 5.15: Left: Habitat downstream of PSCIS crossing 124500. Right: Habitat downstream of crossing 124500 below the railway culverts.

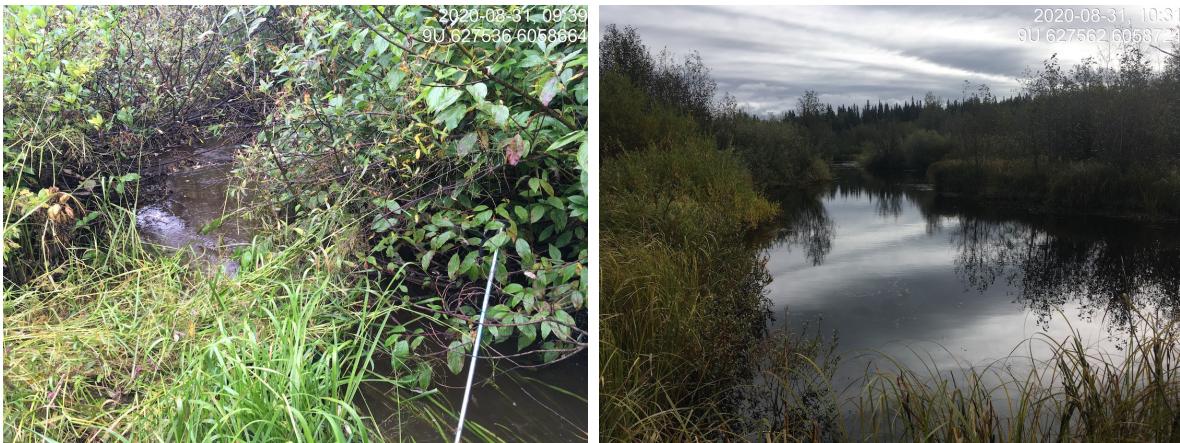
The stream was surveyed immediately upstream from 124500 for approximately 200m then an adjacent road was walked to access the stream 1100m upstream of the crossing within an area comprised of swamp ([Figure 5.16](#)). Within the area immediately upstream of Lawson Road, the stream had multiple braided channels flowing within beaver influenced wetland areas. Within the area surveyed, total cover amount was rated as moderate with small woody debris dominant. Cover was also present as large woody debris, undercut banks, deep pools, overhanging vegetation, and instream vegetation ([Table 5.25](#)). The average channel width was 4.8m, the average wetted width was 4.1m and the average gradient was 0.8%. The dominant substrate was fines with gravels subdominant. At top end of the site, the beaver ponds had wetted widths of approximately 12-14m wide and estimated depths of 1m. Habitat value was rated as moderate for salmonid rearing with habitat noted as suitable for coho and cutthroat rearing.

Figure 5.16: Left: Habitat upstream of PSCIS crossing 124500. Right: Habitat upstream of PSCIS crossing 124500.

Replacement of PSCIS crossing 124500 with a bridge (10m span) is recommended in the long term. The cost of the work is estimated at \$500,000 for a cost benefit of 18 linear m/\$1000 and 86.4m²/\$1000.

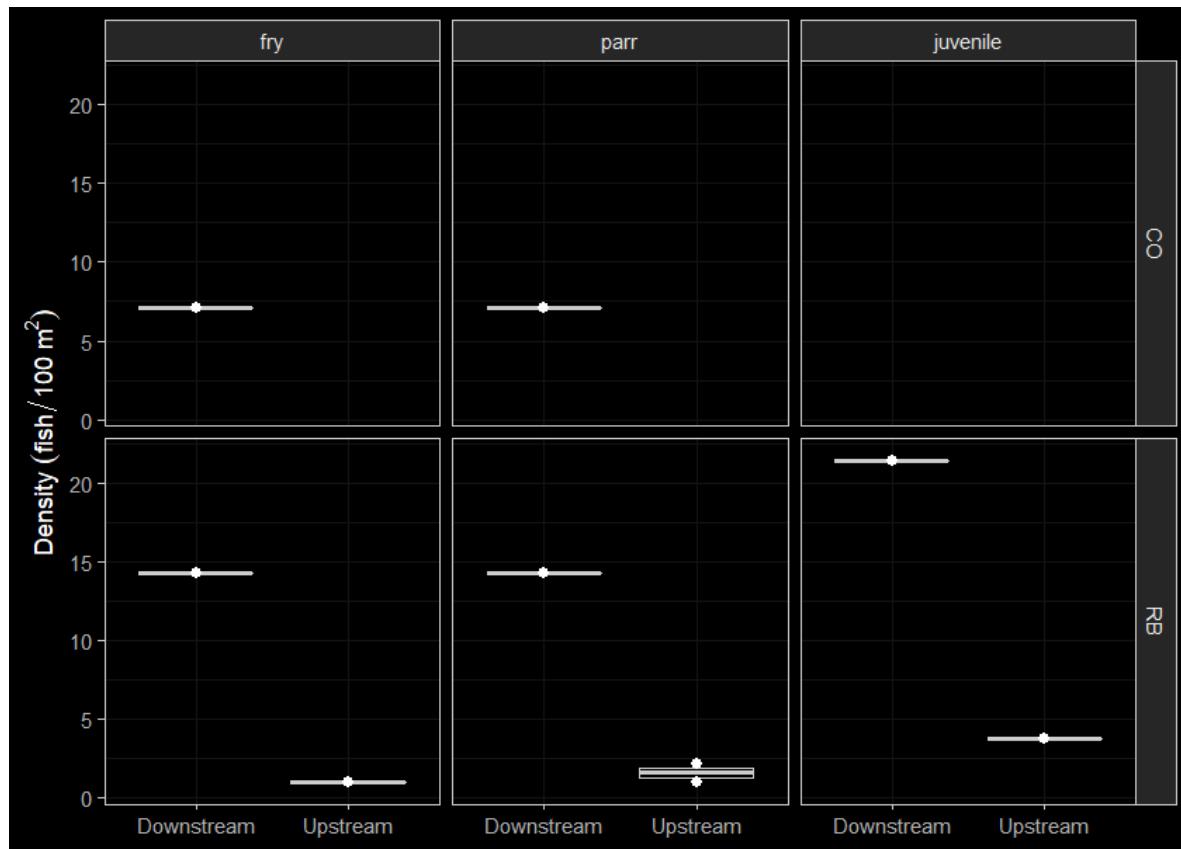
Site	Location	Species	Fry	Parr	Juvenile
51	Downstream	CO	7.1	7.1	0
51	Downstream	RB	14.3	14.3	21.4
50	Upstream	RB	1	1	3.8
52	Upstream	RB	0	2.2	0

Figure 5.17: Densities of fish (fish/100m²) capture upstream and downstream of PSCIS crossing 195290.

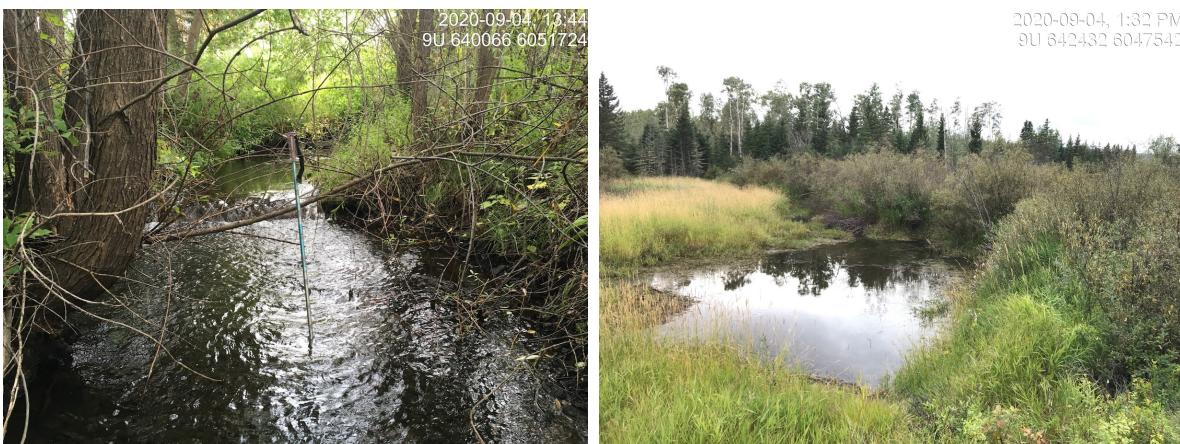
The stream was surveyed upstream from 195290 for 150m to where survey conditions because difficult due to the wetland type habitat (Figure [5.23](#)). Immediately upstream of the crossing for approximately 50m, the riparian area is dominated by well developed shrub and mature primarily deciduous forest. Upstream of this location the riparian area transitions to dense shrub and grass with a narrow and deep channel influenced by beaver activity. Within the area surveyed, total cover amount was rated as abundant with overhanging vegetation dominant. Cover was also present as small woody debris, large woody debris, undercut banks, deep pools, and instream vegetation (Table [5.29](#)). The average channel width was 2m, the average wetted width was 1.6m and the average gradient was 1.3%. Abundant gravels and small cobbles suitable for resident, fluvial, adfluvial and anadromous salmonid spawning were present throughout the area surveyed. Habitat value was rated as moderate for salmonid rearing and spawning.

Figure 5.19: Left: Typical habitat upstream of PSCIS crossing 195290. Right: Wetland habitat upstream of PSCIS crossing 195290.

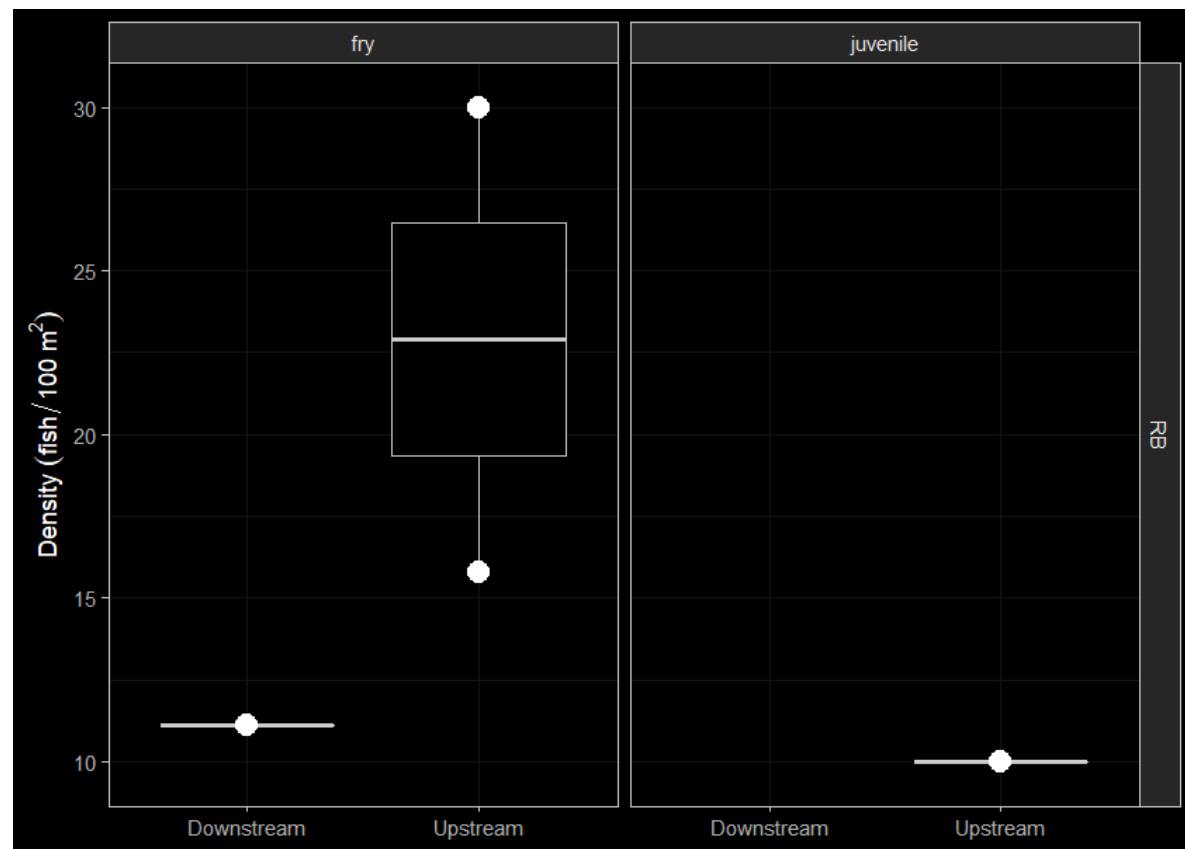
Site	Location	Species	Fry	Juvenile
57	Downstream	RB	11.1	0
55	Upstream	RB	15.8	0
56	Upstream	RB	30	10

Figure 5.21: Densities of rainbow trout (fish/100m²) capture upstream and downstream of PSCIS crossing 197360.

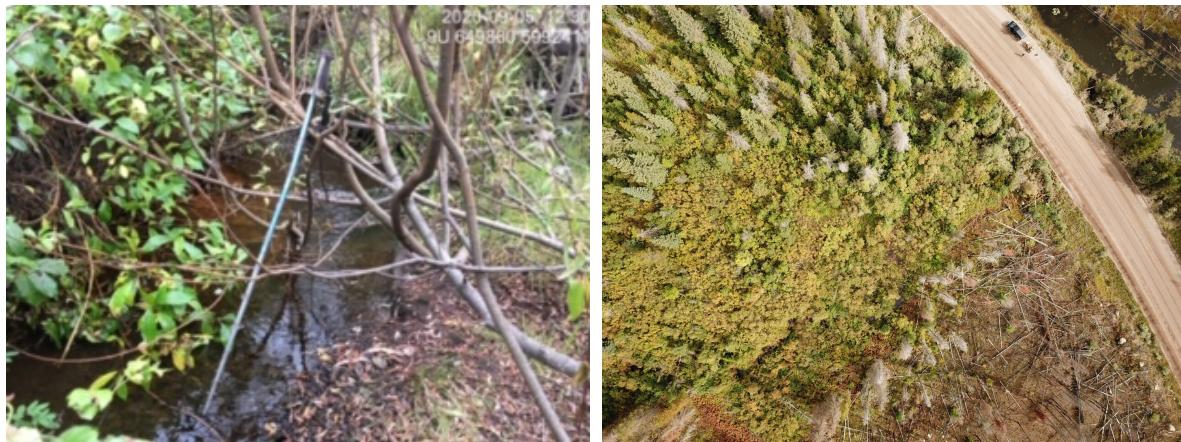
The stream was surveyed downstream from the culvert for 300m (Figure [5.22](#)). Overall, total cover amount was rated as moderate with overhanging vegetation dominant. Cover was also present as small woody debris, large woody debris, undercut banks, deep pools, and instream vegetation (Table [5.36](#)). The average channel width was 3.7m, the average wetted width was 3.2m and the average gradient was 1.1%. The dominant substrate was fines with gravels subdominant. A somewhat recent burn was noted within a forested area on left bank of stream. Habitat was rated as moderate as it was considered an important migration corridor with moderate value habitat for fry/juvenile salmonid rearing.

Figure 5.22: Left: Typical habitat downstream of PSCIS crossing 197360. Right: Aerial view of typical habitat downstream of PSCIS crossing 197360.

Structure replacement with a bridge (10m span) is recommended to provide access to the habitat located upstream of PSCIS crossing 197360. In addition to not facilitating high velocities and erosion due resulting from flow constriction, structures with large openings in relation to stream channel size have been demonstrated to reduce the likelihood of structure blockage due to beaver (Jensen et al. 2001). The cost of the work is estimated at \$125,000 for a cost benefit of 9.6 linear m/\$1000 and 31.7m²/\$1000.

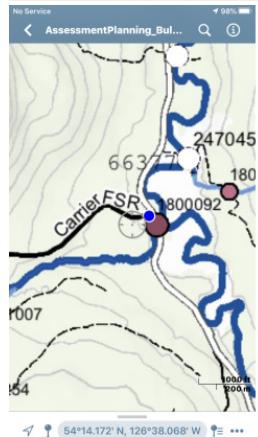
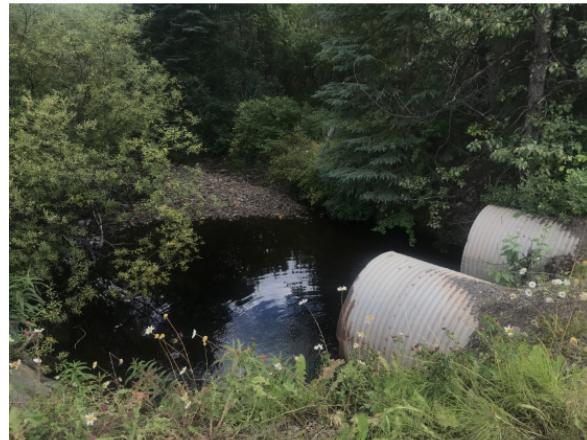
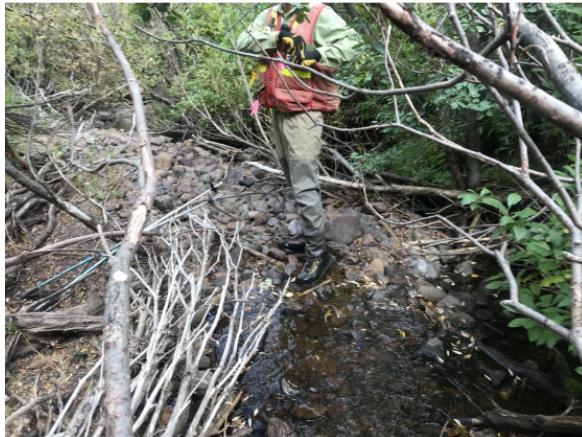
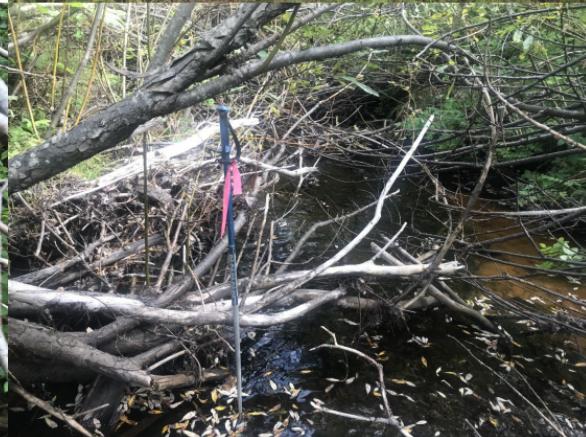
Location and Stream Data	•	Crossing Characteristics –	
Date	2020-09-26	Crossing Sub Type	Round Culvert
PSCIS ID	197640	Diameter (m)	1.5
External ID	–	Length (m)	12
Crew	AI, KP	Embedded	No
UTM Zone	9	Depth Embedded (m)	–
Easting	654312	Resemble Channel	No
Northing	6012383	Backwatered	No
Stream	Tributary to Buck Creek	Percent Backwatered	–
Road	Buck Flats Road	Fill Depth (m)	1
Road Tenure	MoTi local	Outlet Drop (m)	0.4
Channel Width (m)	5.1	Outlet Pool Depth (m)	1.2
Stream Slope (%)	3	Inlet Drop	No
Beaver Activity	No	Slope (%)	1.5
Habitat Value	High	Valley Fill	Deep Fill
Final score	31	Barrier Result	Barrier
Fix type	Replace with New Open Bottom Structure	Fix Span / Diameter	10
Photos: From top left clockwise: Road/Site Card, Barrel, Outlet, Downstream, Upstream, Inlet.

Comments: Large tributary on section of tributary connected to salmon bearing Buck Creek. Fish rising in outlet pool (estimated 130mm). Some cattle access points downstream.

Replacement of PSCIS crossing 197640 with a bridge (10m span) is recommended. The cost of the work is estimated at \$NA for a cost benefit of NA linear m/\$1000 and NAm²/\$1000.

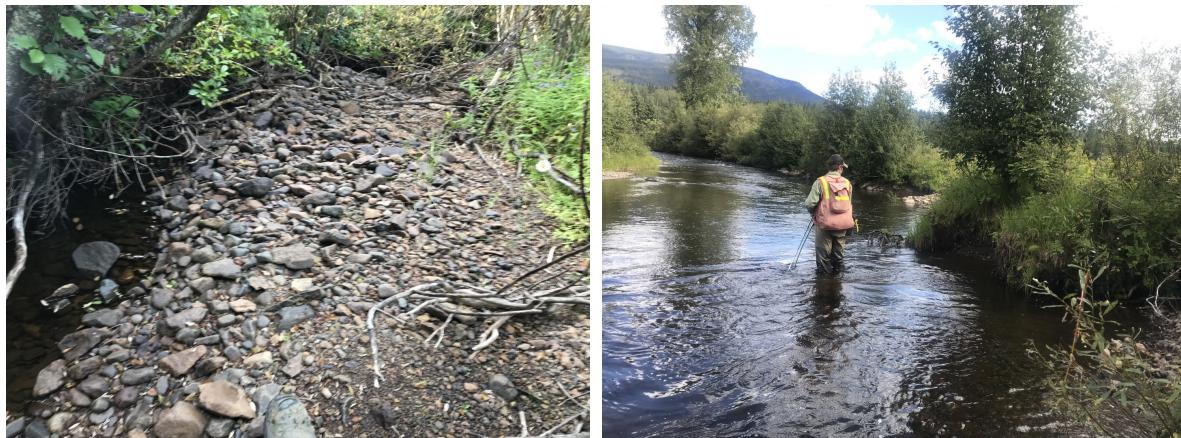
The stream was surveyed downstream from the culvert for 70m to the confluence with Buck Creek (Figure [??](#)). Total cover amount was rated as moderate with undercut banks dominant. Cover was also present as small woody debris, large woody debris, and overhanging vegetation (Table [5.42](#)). The average channel width was 4.6m, the average wetted width was 2.5m and the average gradient was 3%. The dominant substrate was gravels with cobbles subdominant. A fish (130mm) was observed in the culvert outlet pool and a substance suspected to be didymo was noted on the substrate. The habitat was rated as moderate value as it was considered an important migration corridor with habitat of moderate rearing potential for fry and juvenile salmonids.

Figure 5.24: Left: Habitat downstream of PSCIS crossing 197640. Right: Habitat downstream of crossing 197640 at the confluence with Buck Creek.

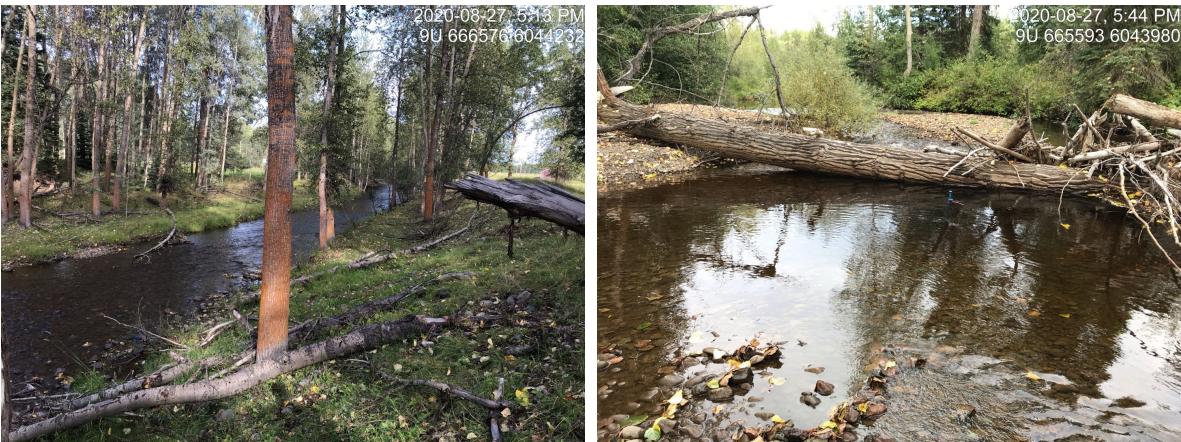
Below the railway bridge, the habitat was noted as far more complex than the area immediately below the highway culvert. Total cover amount was rated as abundant with overhanging vegetation dominant. Cover was also present as small woody debris, large woody debris, undercut banks, and deep pools. The average channel width was 8.6m, the average wetted width was 7.5m and the average gradient was 0.8%. The dominant substrate was cobbles with gravels subdominant. There were extensive sections of channel with deep glides (50-70 cm deep at the time of survey) with well developed riparian vegetation creating good structure for all species and life stages of salmonids. An algae layer was noted on the substrate. There were abundant large gravels and small cobbles present suitable for salmon spawning.

Figure 5.26: Left: Typical habitat immediately downstream of PSCIS crossing 197658. Right: Typical habitat downstream of crossing 197658 below the railway bridge and adjacent to the Bulkley River mainstem.

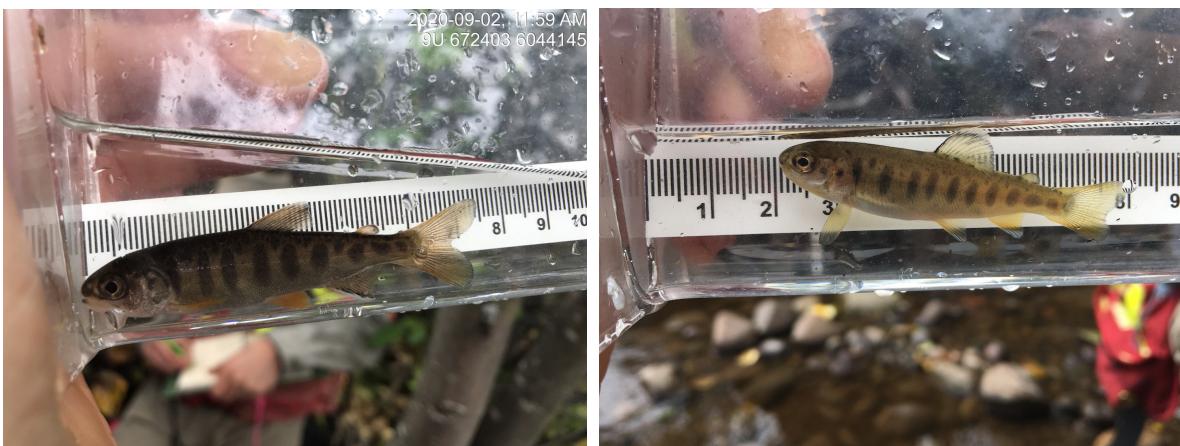
Figure 5.31: Left: Coho captured downstream of PSCIS crossing 197662. Right: Rainbow trout captured upstream of PSCIS crossing 197662.

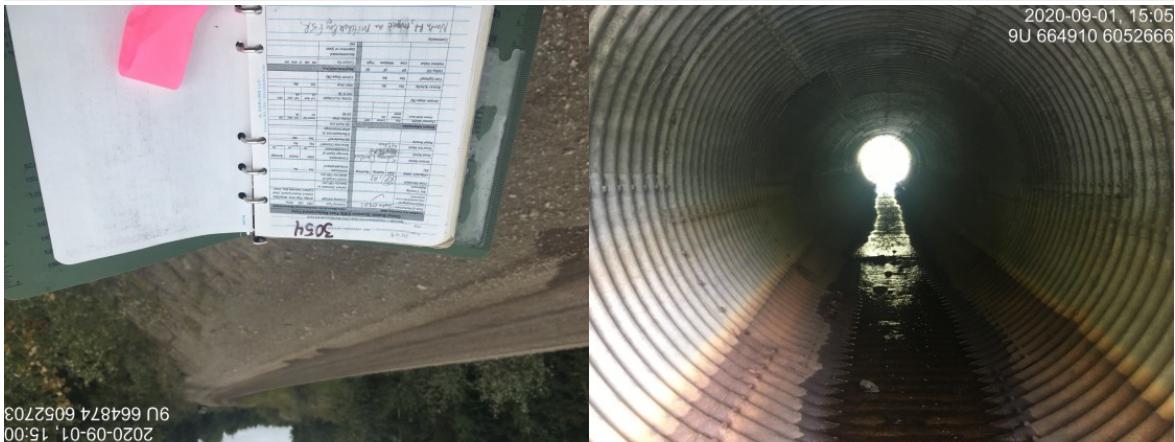
PSCIS ID	3054	Diameter (m)	3
External ID	–	Length (m)	40
Crew	KP, AI	Embedded	No
UTM Zone	9	Depth Embedded (m)	–
Easting	664881	Resemble Channel	No
Northing	6052688	Backwatered	No
Stream	Johnny David Creek	Percent Backwatered	–
Road	North road	Fill Depth (m)	9.99
Road Tenure	MoTi local	Outlet Drop (m)	0.76
Channel Width (m)	3.5	Outlet Pool Depth (m)	0.8
Stream Slope (%)	3.3	Inlet Drop	No
Beaver Activity	Yes	Slope (%)	2
Habitat Value	Medium	Valley Fill	Deep Fill
Final score	34	Barrier Result	Barrier
Fix type	Replace with New Open Bottom Structure	Fix Span / Diameter	31
Photos: From top left clockwise: Road/Site Card, Barrel, Outlet, Downstream, Upstream, Inlet.

Comments: Fill depth approximatley 12m. Fish observed upstream of crossing.

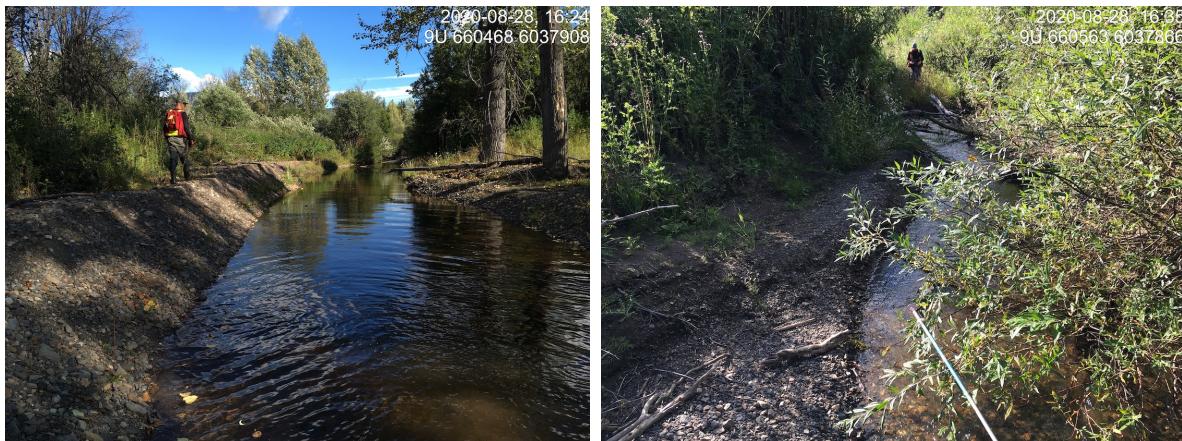
was 3%. An active cut was noted approximately 100m upstream of culvert. It is suspected that this area is constantly depositing gravels into stream. There extensive areas of gravels suitable for CO spawning. Riparian vegetation consisted of a mature cottonwood forest with right bank armouring and riparian removal along the adjacent private road. Habitat was rated as high value for resident and anadromous salmonid rearing and spawning.

Figure 5.37: Left: Typical habitat downstream of PSCIS crossing 197664. Right: Typical habitat downstream of PSCIS crossing 197664.

Costs to replace 197665 and 197664 with bridges are estimated at \$5,000,000 per crossing. Structure replacement with an embedded culvert is recommended for 3042 (streambed simulation - 3m span) with an estimated cost of \$25,000 resulting in cost benefits of 68 linear m/\$1000 and 156.4m²/\$1000.

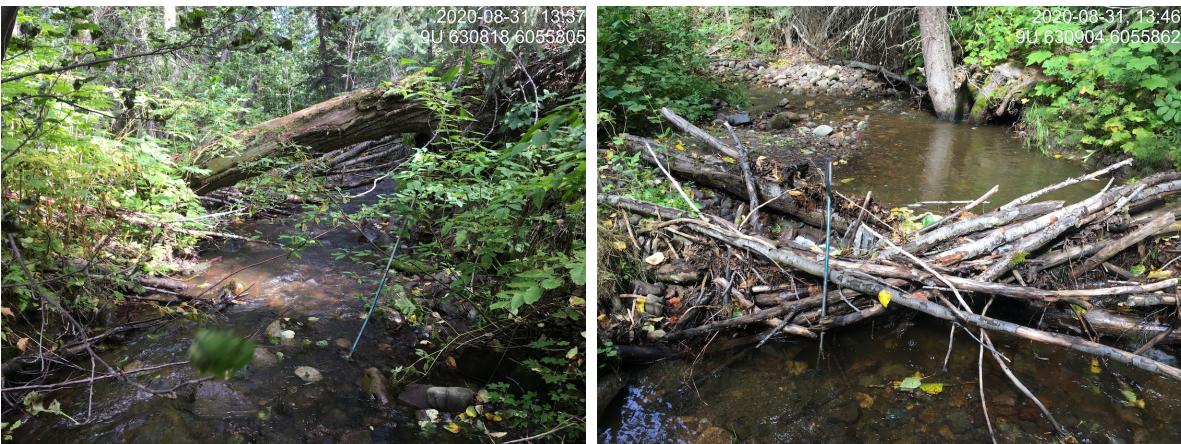
There is 3.3km of habitat upstream of crossing 197667 and below 124501. Upstream of Lawson Road there is an additional 2.8km of habitat modelled. Habitat in the areas surveyed upstream of 197667 and 124501 was rated as high value for salmonid rearing with some habitat also suitable for spawning in both areas. Crossing 197667 on the railway was ranked as a high priority for proceeding to design for replacement. Although not quantified with current assessment protocols, the low depth of water in 197667 during moderate to low flows (such as those observed during the 2020 survey) could prevent upstream migration (particularly for larger fish such as coho and chinook salmon). Although classified as a “barrier” according to provincial metrics, crossing 124501 is embedded, baffled and without a significant outlet drop. As such, we suspect that provided conditions at the site do not change substantially from those observed during surveys, the crossing will remain passable to adult salmonids migrating upstream during most flows. The crossing was assessed as a low priority for proceeding to design for replacement.

Figure 5.41: Left: Typical habitat upstream of PSCIS crossing 197667. Right: Typical habitat upstream of PSCIS crossing 197667.

A cost estimate for replacing 197667 with a bridge (10m span) is \$5,000,000, resulting in cost benefits of 0.7 linear m/\$1000 and $3\text{m}^2/\$1000$. Although 124501 on Lawson Road was considered passable for most species/life stages during most flows, an estimate of cost for replacement (10m span) is \$500,000 resulting in cost benefits of 5.6 linear m/\$1000 and $26.9\text{m}^2/\$1000$.

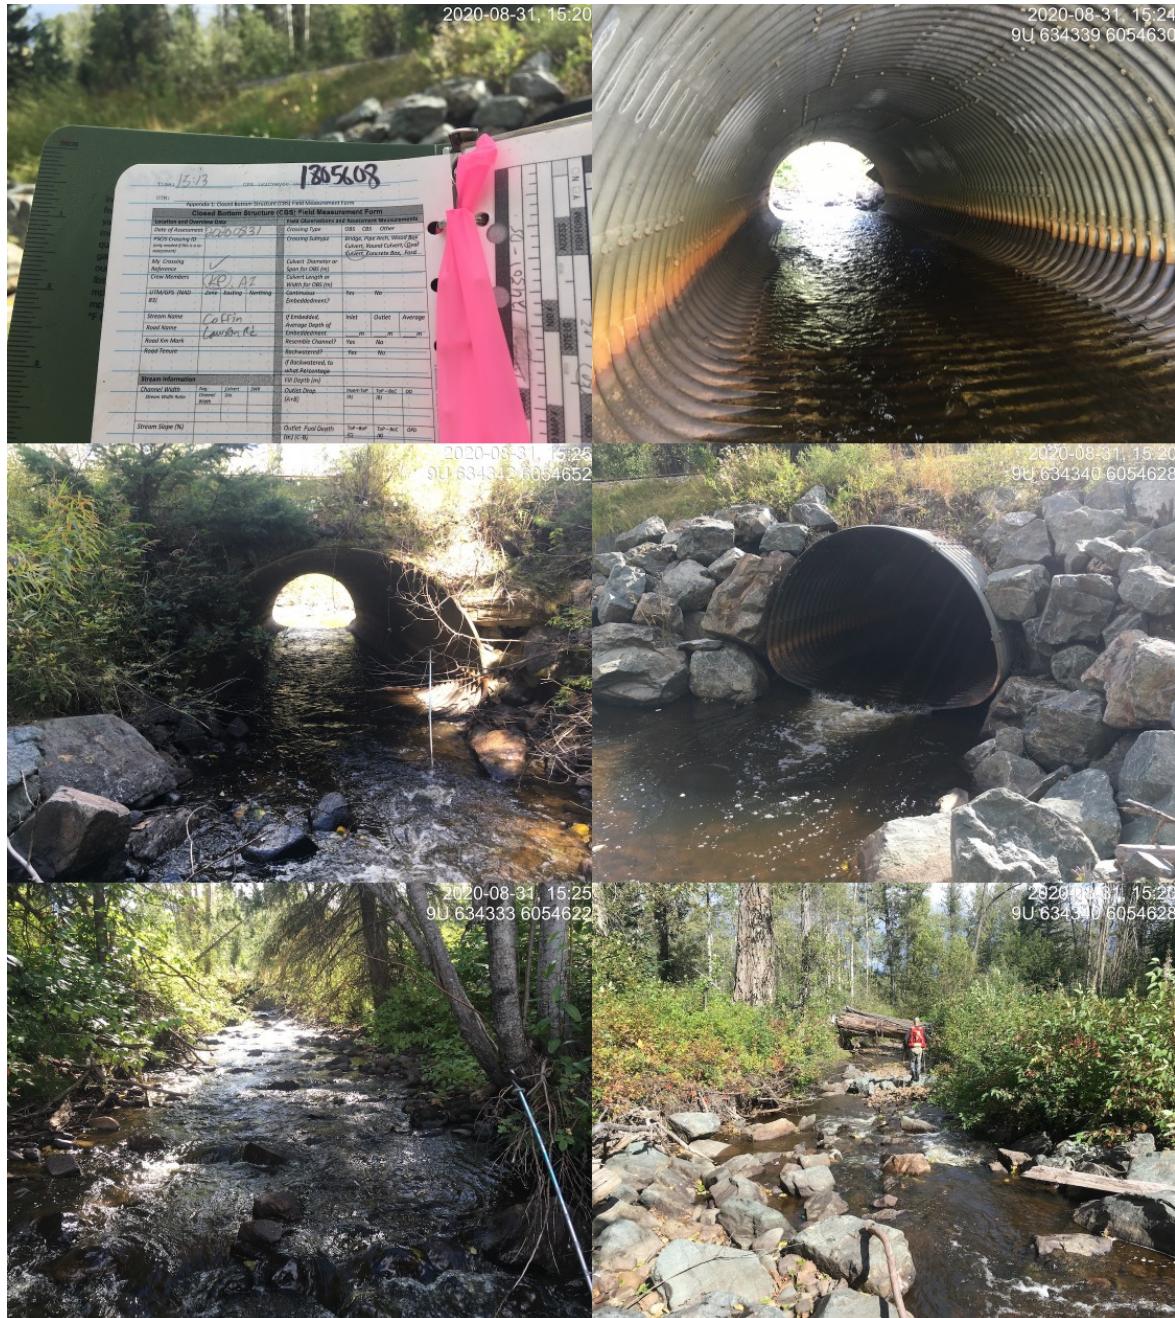
Table 5.70: Summary of fish passage assessment for PSCIS crossing 124504.

Date	2020-08-31	Crossing Sub Type	Round Culvert
PSCIS ID	124504	Diameter (m)	3
External ID	–	Length (m)	16
Crew	KP, AI	Embedded	Yes
UTM Zone	9	Depth Embedded (m)	0.15
Easting	634323	Resemble Channel	Yes
Northing	6054587	Backwatered	No
Stream	Coffin Creek	Percent Backwatered	–
Road	Lawson Road	Fill Depth (m)	0.5
Road Tenure	MoTi resource	Outlet Drop (m)	0.2
Channel Width (m)	5.3	Outlet Pool Depth (m)	0.1
Stream Slope (%)	2	Inlet Drop	No
Beaver Activity	No	Slope (%)	1
Habitat Value	High	Valley Fill	Deep Fill
Final score	24	Barrier Result	Barrier
Fix type	Replace with New Open Bottom Structure	Fix Span / Diameter	10
Photos: From top left clockwise: Road/Site Card, Barrel, Outlet, Downstream, Upstream, Inlet.

Comments: Partially embedded with several large boulders (30 - 50cm) in culvert. No outlet drop at the time of survey but there may be at lowest flow levels.

Replacement with bridges for 197668 (10m span) and 124504 (10m span) are recommended to provide unimpeded access to the habitat located upstream. An estimate of cost for replacement of 197668 is \$5,000,000 resulting in cost benefits of 0.8 linear m/\$1000 and $4.2\text{m}^2/\$1000$. An estimate of cost for replacement of 124504 is \$500,000 resulting in cost benefits of 8 linear m/\$1000 and $46.4\text{m}^2/\$1000$.

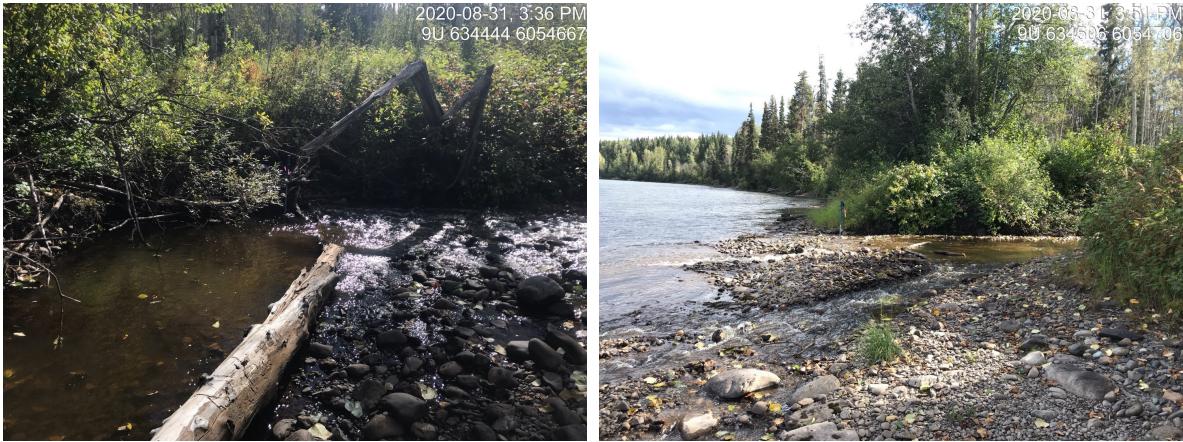
Figure 5.43: Left: Typical habitat downstream of PSCIS crossing 197668. Right: Coffin Creek downstream of PSCIS crossing 197668 at confluence with the Bulkley River.
