Elk River Fish Passage

Al Irvine, R.P.Bio.

2020-12-14

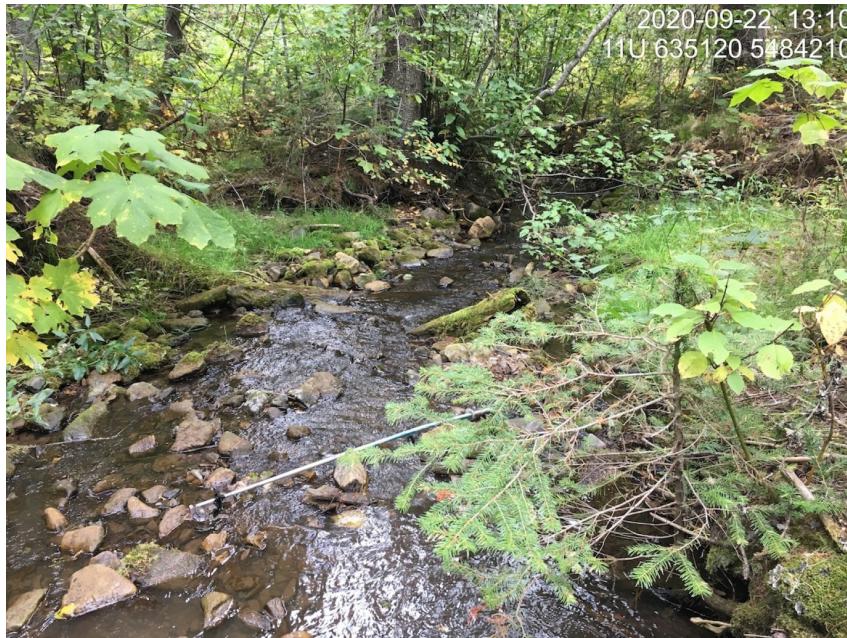
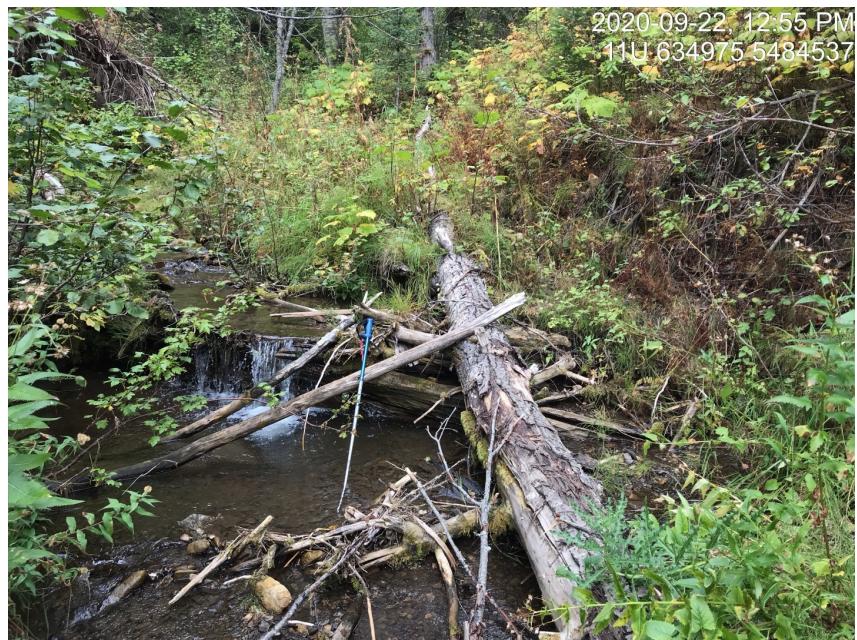
Figure 5.2: Typical habitat upstream of PSCIS crossing 50155.

Electrofished upstream and downstream with abundant WCT fry and juveniles throughout. EB also present.
