DRAFT - Bulkley River and Morice River Watershed Groups Fish Passage Restoration Planning

Prepared for
Habitat Conservation Trust Fund
BC Fish Passage Remediation Program
Canadian Wildlife Federation

Prepared by
Al Irvine, B.Sc., R.P.Bio.
New Graph Environment
6 Regent St
Nelson, BC V1L 2P1

DRaFT - Version 0.0.1
2021-02-20

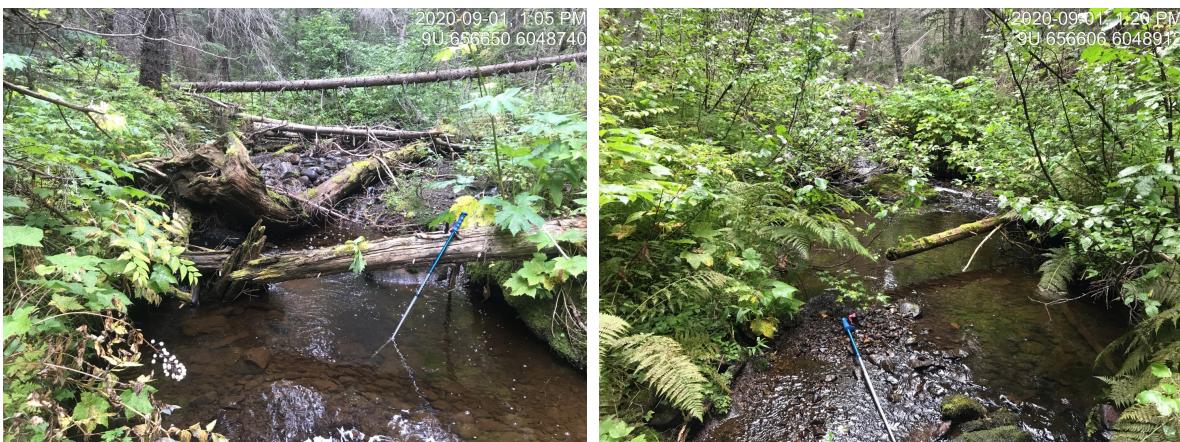
and fry were observed throughout the surveyed area. Habitat value was rated as high value resident salmonid rearing and spawning.

Figure 4.2: Left: Habitat upstream of PSCIS crossing 3139. Right: Habitat upstream of PSCIS crossing 3139.

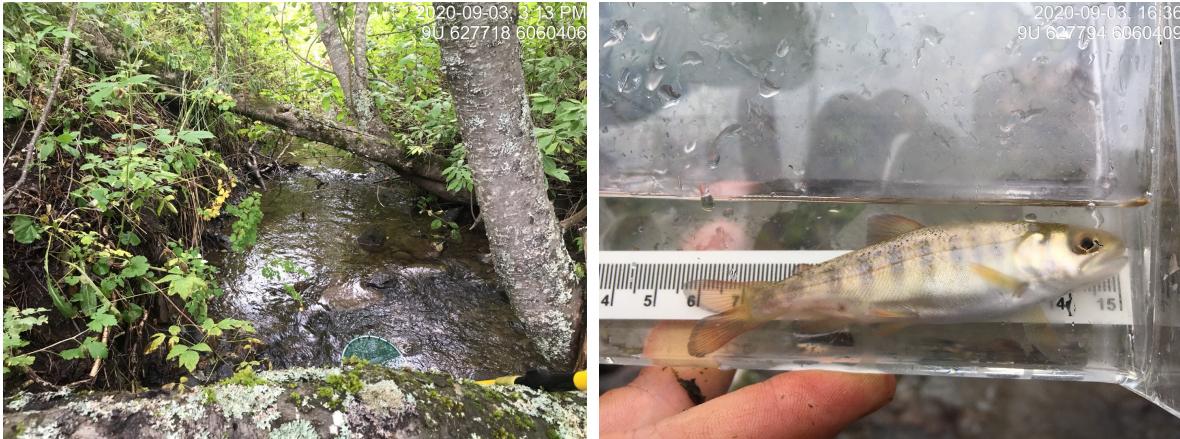
There is 0.8km of habitat upstream of crossing 58159. Habitat in this area was rated as moderate value for salmonid rearing/spawning. Woodmere Nursery Road is on private land owned by the Woodmere Nursery. The crossing was ranked as a high priority for proceeding to design for replacement.

Figure 4.4: Left: Typical habitat upstream of PSCIS crossing 58159. Right: Coho captured upstream of PSCIS crossing 58159.

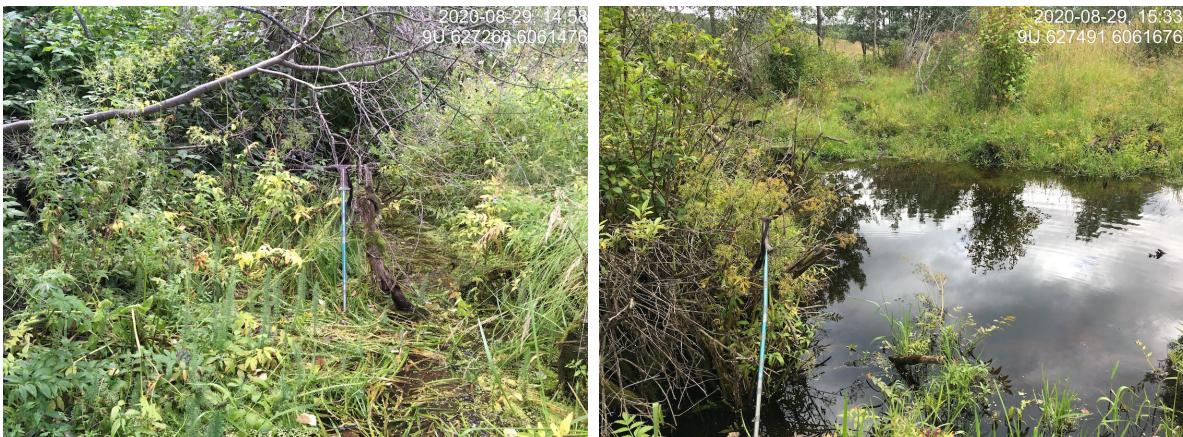
The stream was surveyed from 123445 for 540m to 123446(Figure [??](#)). Within the area surveyed, total cover amount was rated as moderate with overhanging vegetation dominant. Cover was also present as small woody debris, large woody debris, undercut banks, and instream vegetation (Table [4.16](#)). The average channel width was 2.1m, the average wetted width was 1.6m and the average gradient was 0.5%. Water within the narrow channel was noted as often stagnant with aquatic vegetation present throughout. Some riparian disturbance by adjacent livestock was also noted. Although, habitat value was considered of low value for rearing and spawning it was rated as moderate overall as it was considered an important migration corridor providing access to the lake.

Figure 4.7: Left: Habitat upstream of PSCIS crossing 123445. Right: Habitat upstream of PSCIS crossing 123445.

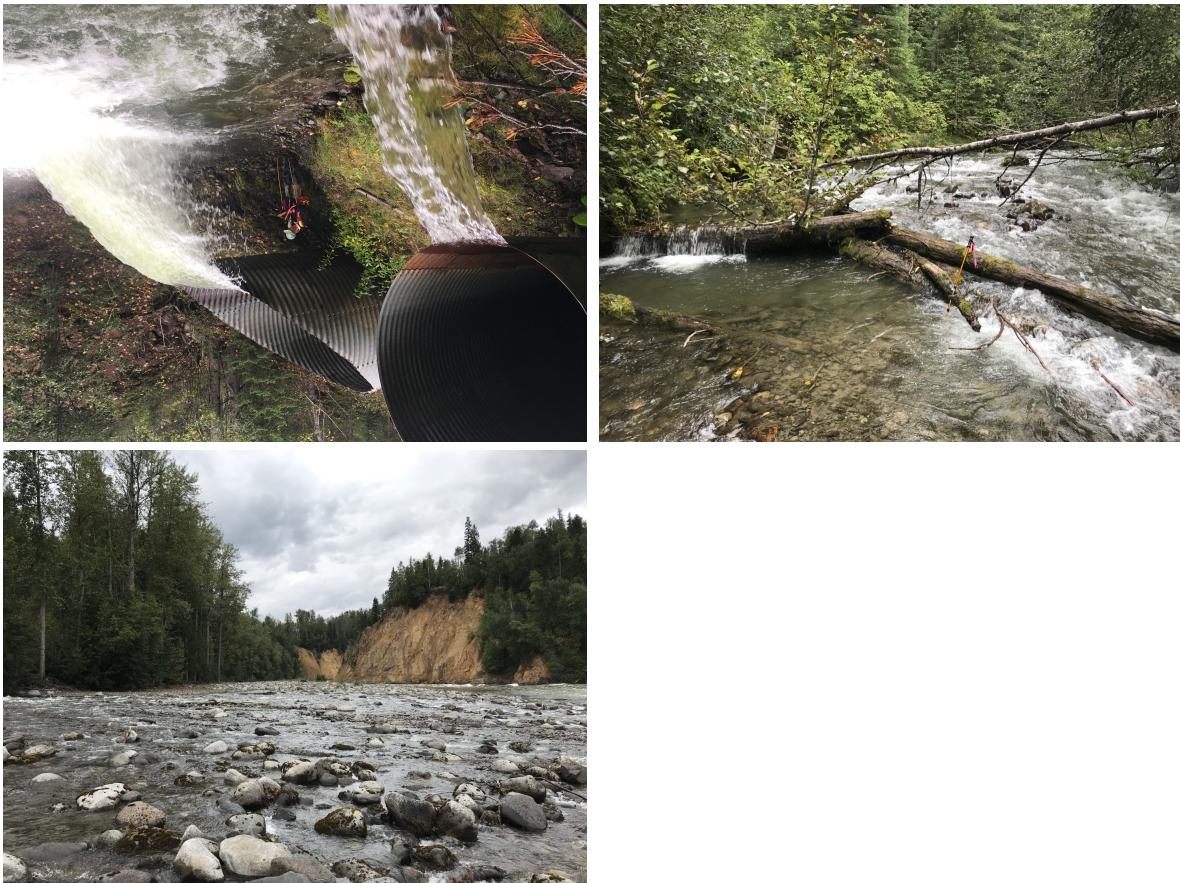
Comments: Unpassable to all life stages and species. Fill depth is approximately 35m. Salomid (50cm) observed trying to ascend to outlet of main pipe.

Figure 4.11: Left: Outlets of PSCIS crossing 124487. Right: Typical habitat downstream of crossing 124487 below the railway bridge and adjacent to the Bulkley River mainstem.

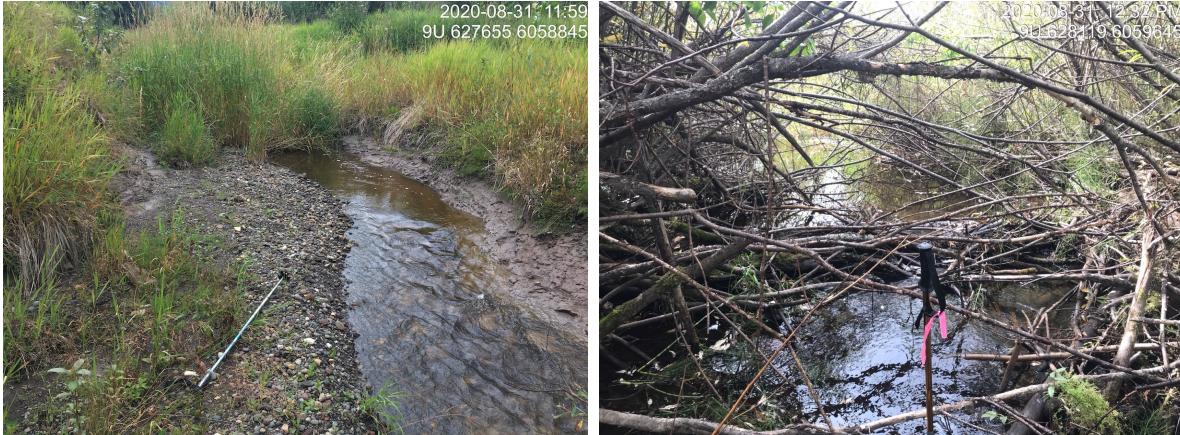
Figure 4.13: Left: Habitat downstream of PSCIS crossing 124500. Right: Habitat downstream of crossing 124500 below the railway culverts.

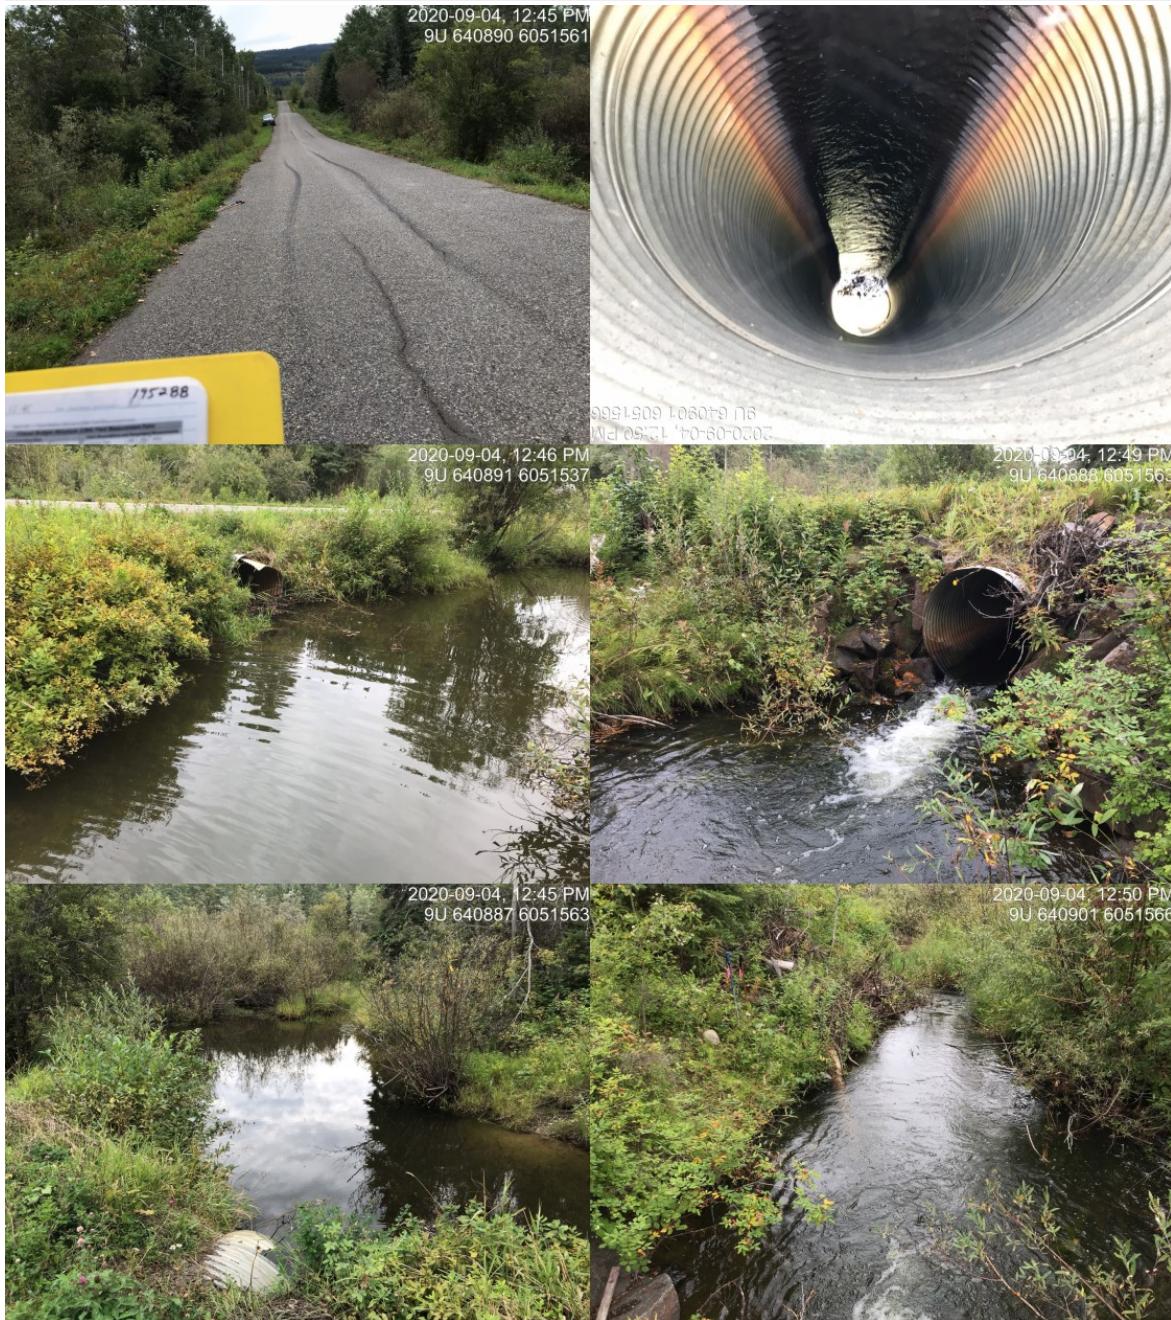
Comments: Wetland type habitat upstream and downstream. Drone flight conducted upstream to map immediate area upstream.

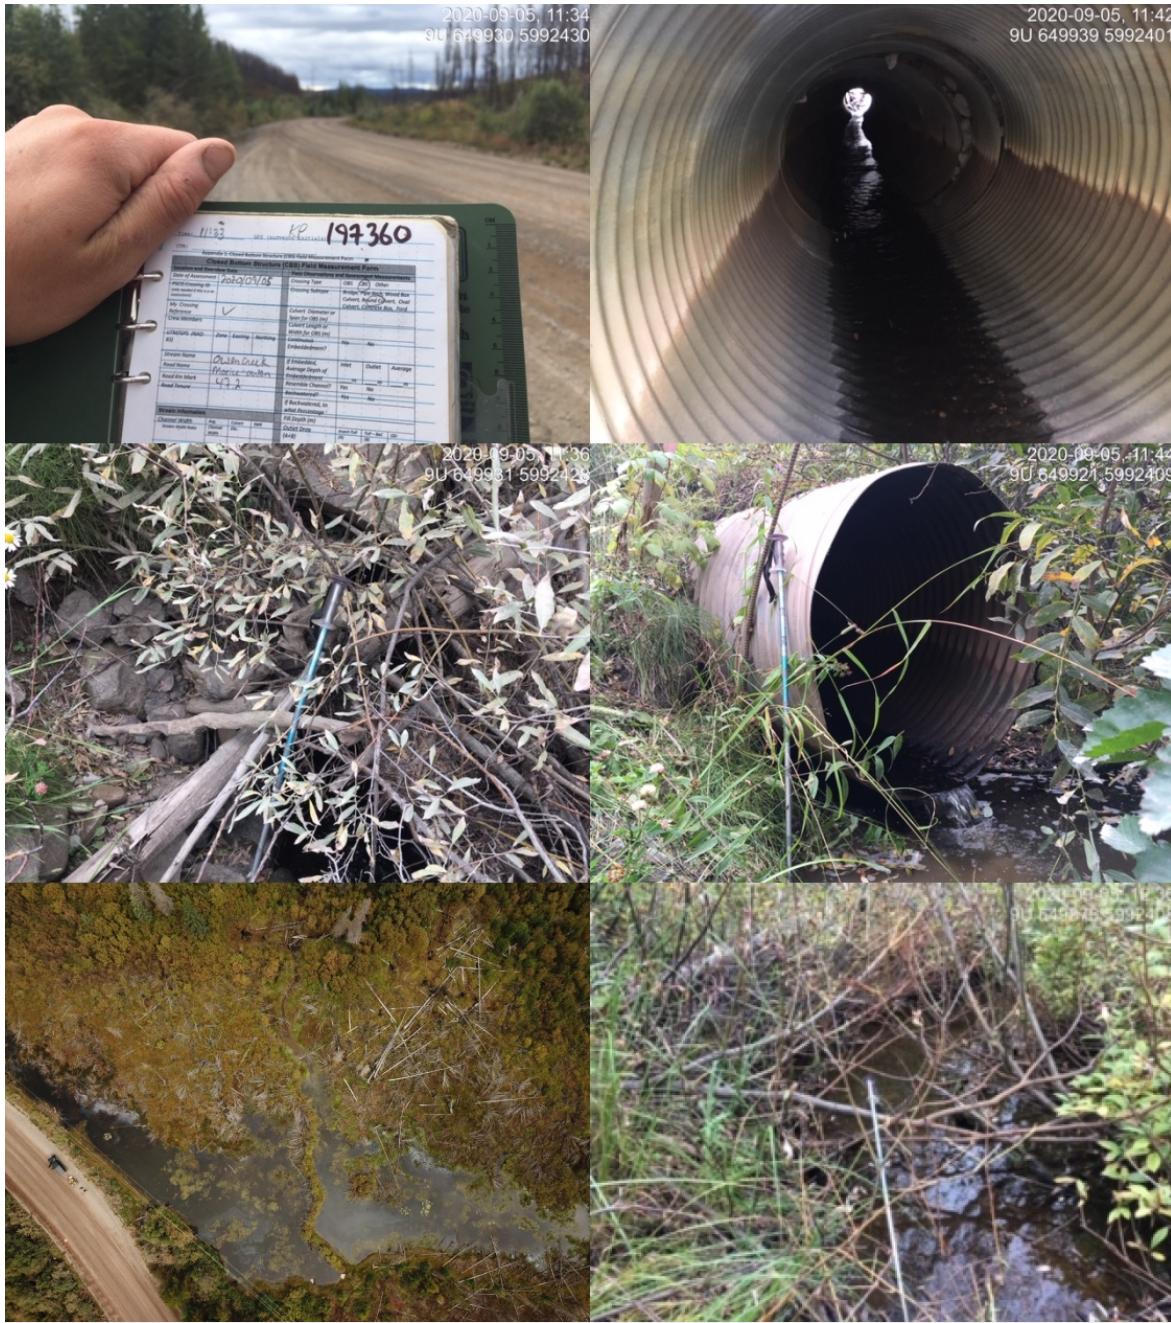
Comments: Wetland type habitat for first 300m upstream then 3m wide channel with cover available in all forms with pools suitable for juvenile RB and CO overwintering. Abundant gravels and small cobbles throughout suitable for CO or RB/ST spawning.

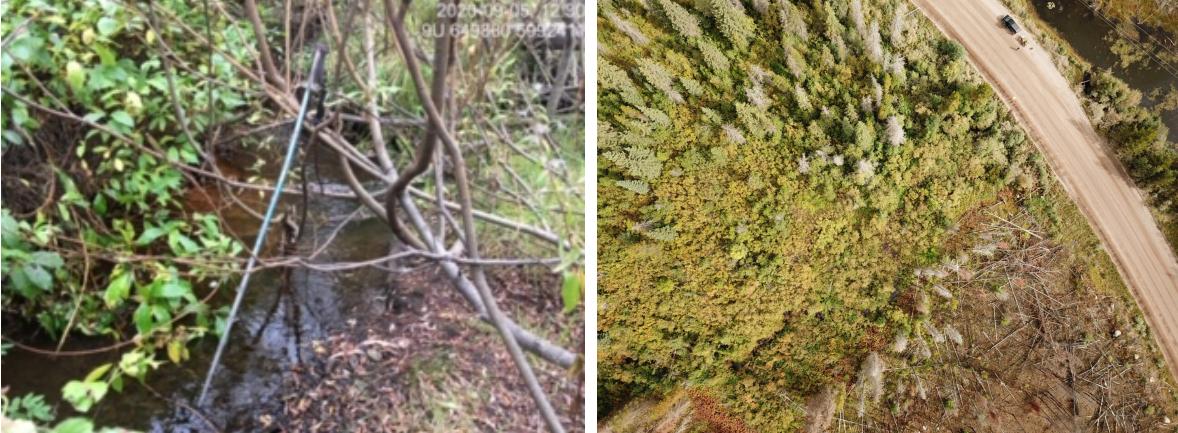
Figure 4.21: Left: Typical habitat downstream of PSCIS crossing 197360. Right: Aerial view of typical habitat downstream of PSCIS crossing 197360.

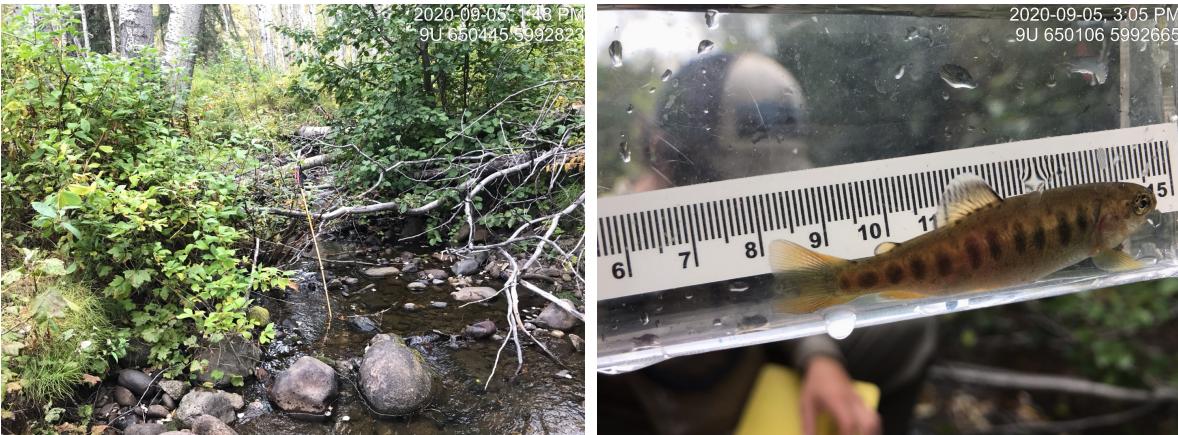
Figure 4.22: Left: Typical habitat upstream of PSCIS crossing 197360. Right: Rainbow trout captured upstream of PSCIS crossing 197360.

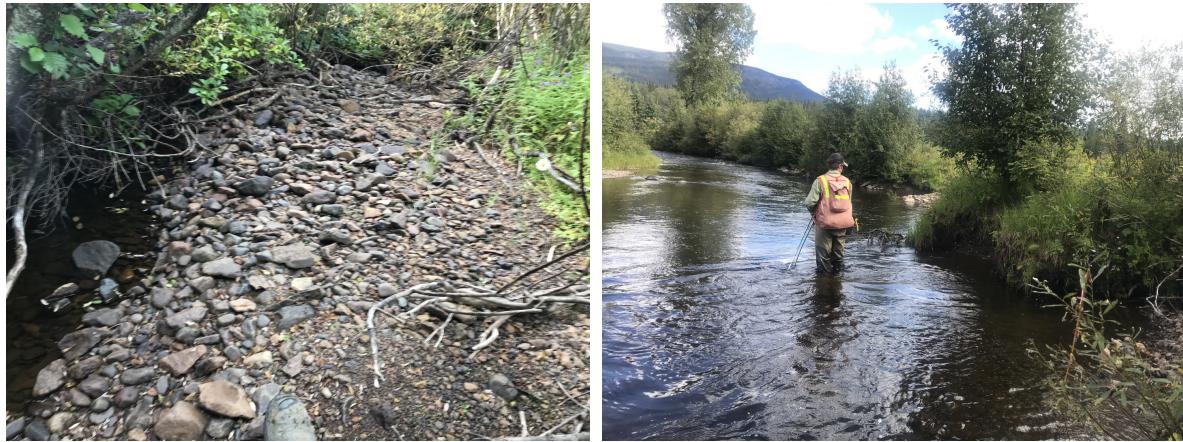
Figure 4.24: Left: Habitat downstream of PSCIS crossing 197640. Right: Habitat downstream of crossing 197640 at the confluence with Buck Creek.

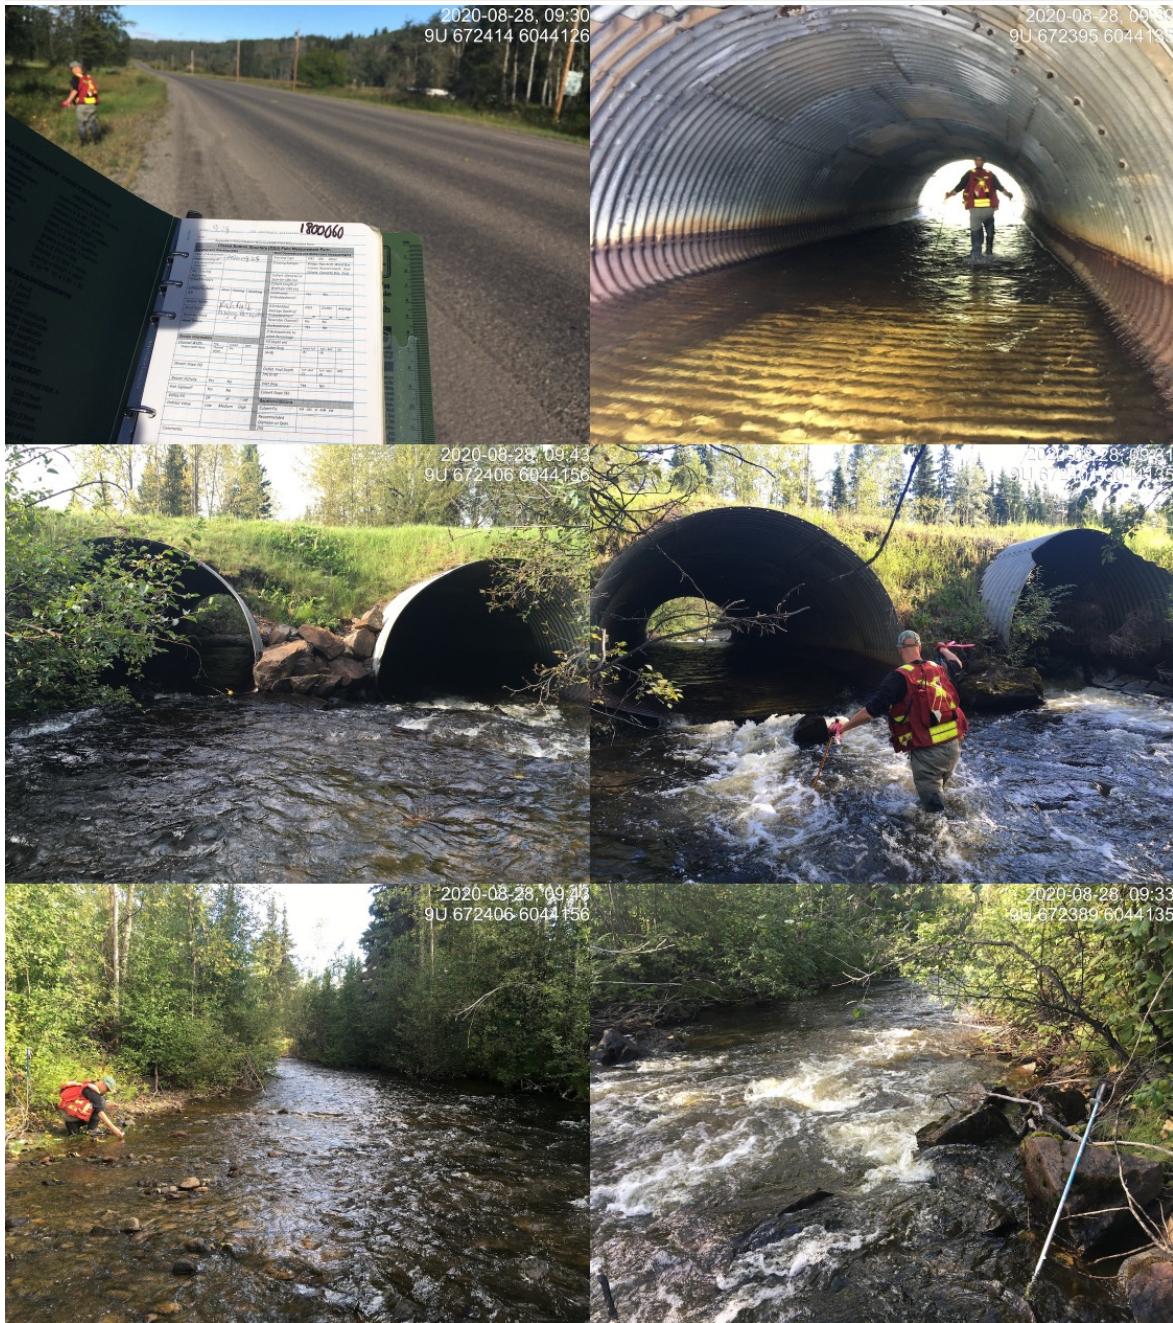
Comments: Habitat confirmation and minnowtrapping completed.

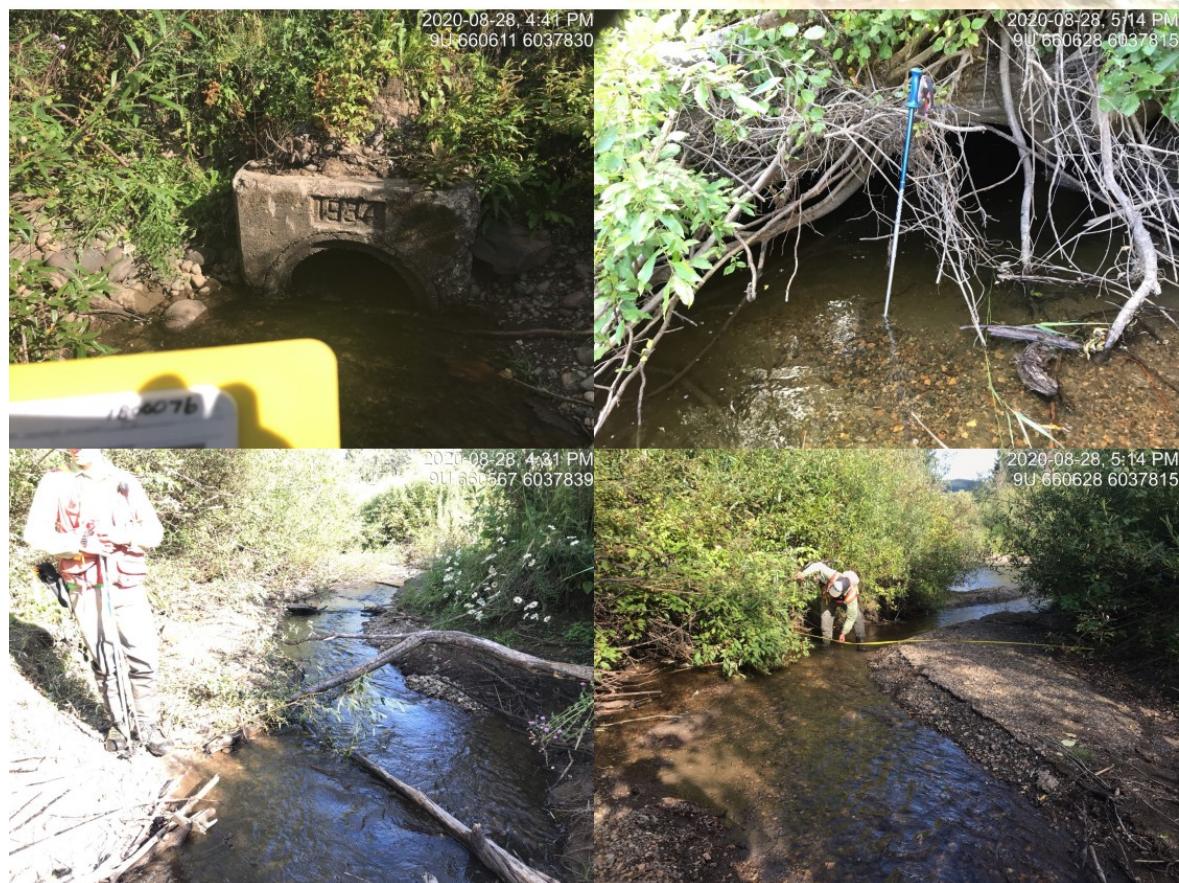
Table 4.51: Summary of fish passage assessment for PSCIS crossing 197664.

Comments: Targeted for habitat confirmation due to aggradation and dredging associated impacts on coho.

Costs to replace 197665 and 197664 with bridges are estimated at \$5,000,000 per crossing. Structure replacement with an embedded culvert is recommended for 3042 (5m span) with an estimated cost of \$25,000 resulting in cost benefits of 68 linear m/\$1000 and $156.4\text{m}^2/\$1000$.

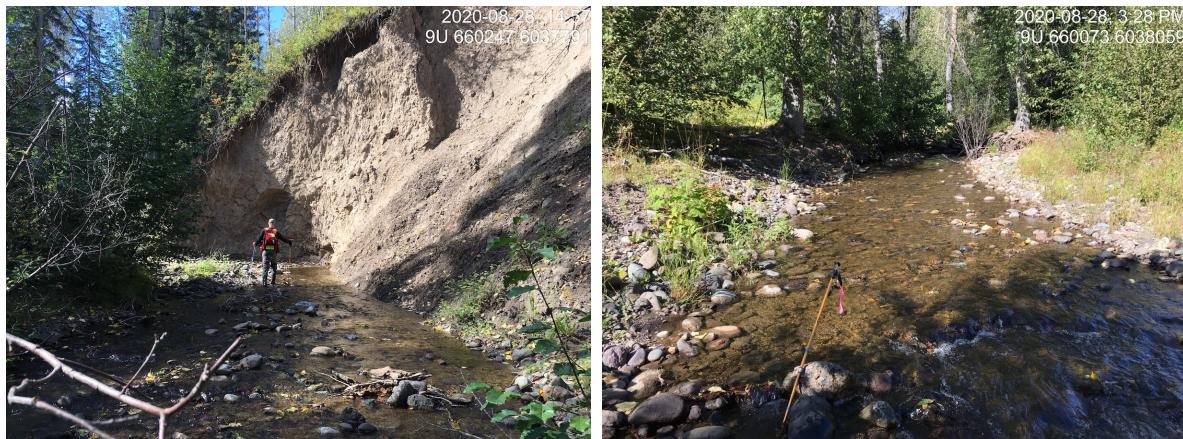
Figure 4.38: Left: Habitat upstream of PSCIS crossing 197664 and location of cutslope. Right: Habitat upstream of PSCIS crossing 197664.

Barren Creek was surveyed upstream from 197664 for 800m (Figure [??](#)). Within the area surveyed, total cover amount was rated as moderate with undercut banks dominant. Cover was also present as small woody debris, large woody debris, and overhanging vegetation (Table [4.53](#)). The average channel width was 7.2m, the average wetted width was 4.7m and the average gradient was 3%. An active cut was noted approximately 100m upstream of culvert. It is suspected that this area is constantly depositing gravels into stream. There extensive areas of gravels suitable for CO spawning. Riparian vegetation consisted of a mature cottonwood forest with right bank armouring and riparian removal along the adjacent private road. Habitat was rated as high value for resident and anadromous salmonid rearing and spawning.
