ELK RIVER WATERSHED GROUP FISH PASSAGE RESTORATION PLANNING

December 31, 2020

Version 0.0.4

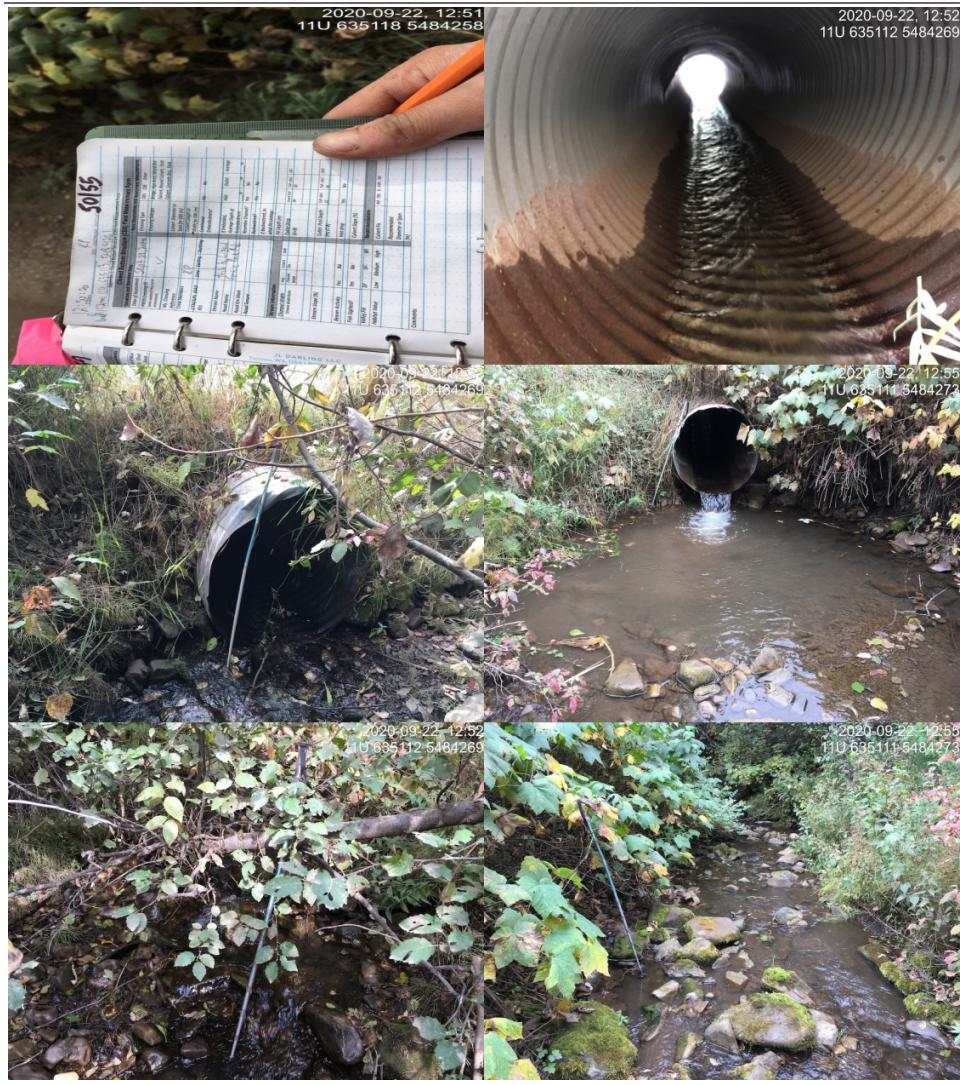
Photos: From top left clockwise: Road/Site Card, Barrel, Outlet, Downstream, Upstream, Inlet.

Structure replacement with an open bottomed culvert is recommended to provide unconstrained access to the habitat located upstream of PSCIS crossing 50155. The cost for work is estimated at \$125000 for a cost benefit of \$14400/linear m and \$16200/m².

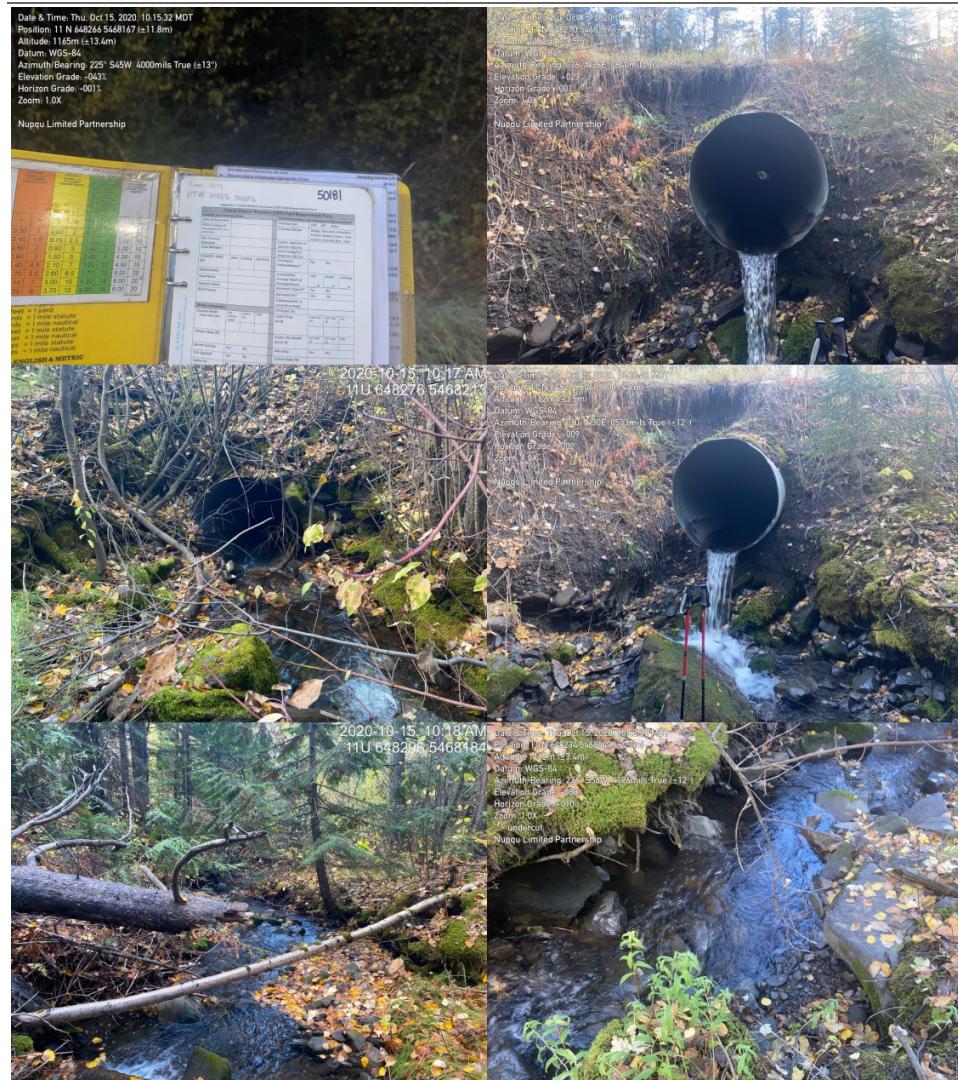
Photos: From top left clockwise: Road/Site Card, Barrel, Outlet, Downstream, Upstream, Inlet.

Structure replacement with an open bottomed structure is recommended to provide access to the habitat located upstream of PSCIS crossing 50181. The cost of the work is estimated at \$125000 for a cost benefit of \$4100/linear m and \$5400/m².

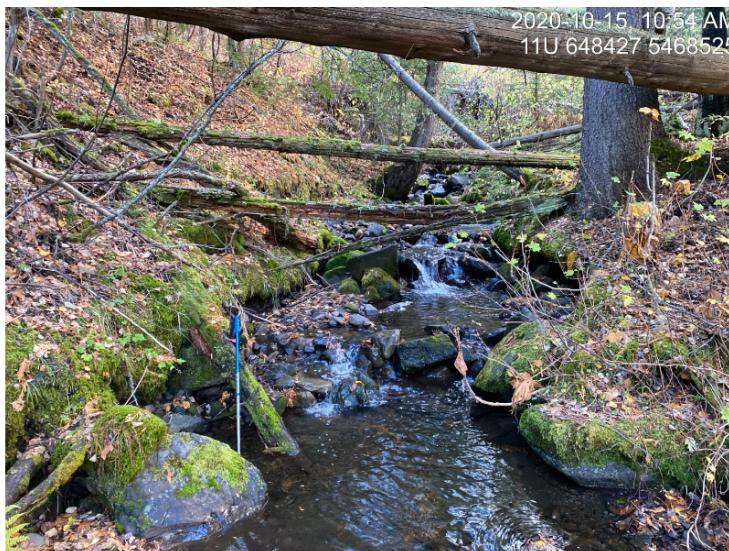
The stream was surveyed upstream from the culvert for 515m. Overall, total cover amount was rated as moderate with boulders dominant. Cover was also present as small woody debris, large woody debris, undercut banks, and overhanging vegetation (Table [5.10](#), Figure [5.10](#)). The average channel width was 2.9m, the average wetted width was 2.2m and the average gradient was 12.4%. The dominant substrate was cobbles with boulders subdominant. Good flows were present and some pockets of gravels suitable for spawning were observed throughout. There were steps ranging from 0.5 - 0.8m due to large woody debris jams but no permanent migration barriers were observed until a cascade at the top end of the survey area (24% for >50m). Habitat was rated as medium value for fry and juvenile westslope cutthroat trout rearing.

Figure 5.10: Typical habitat upstream of PSCIS crossing 50181.

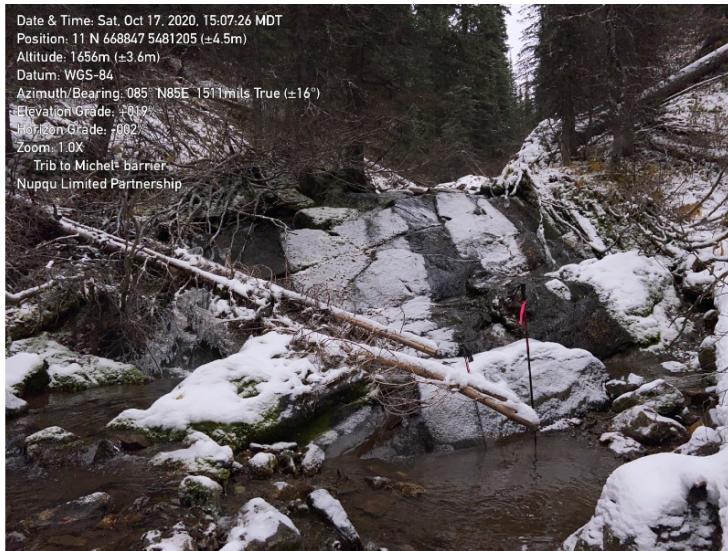
Figure 5.17: Chute barrier located 200 downstream of PSCIS crossing 50261.

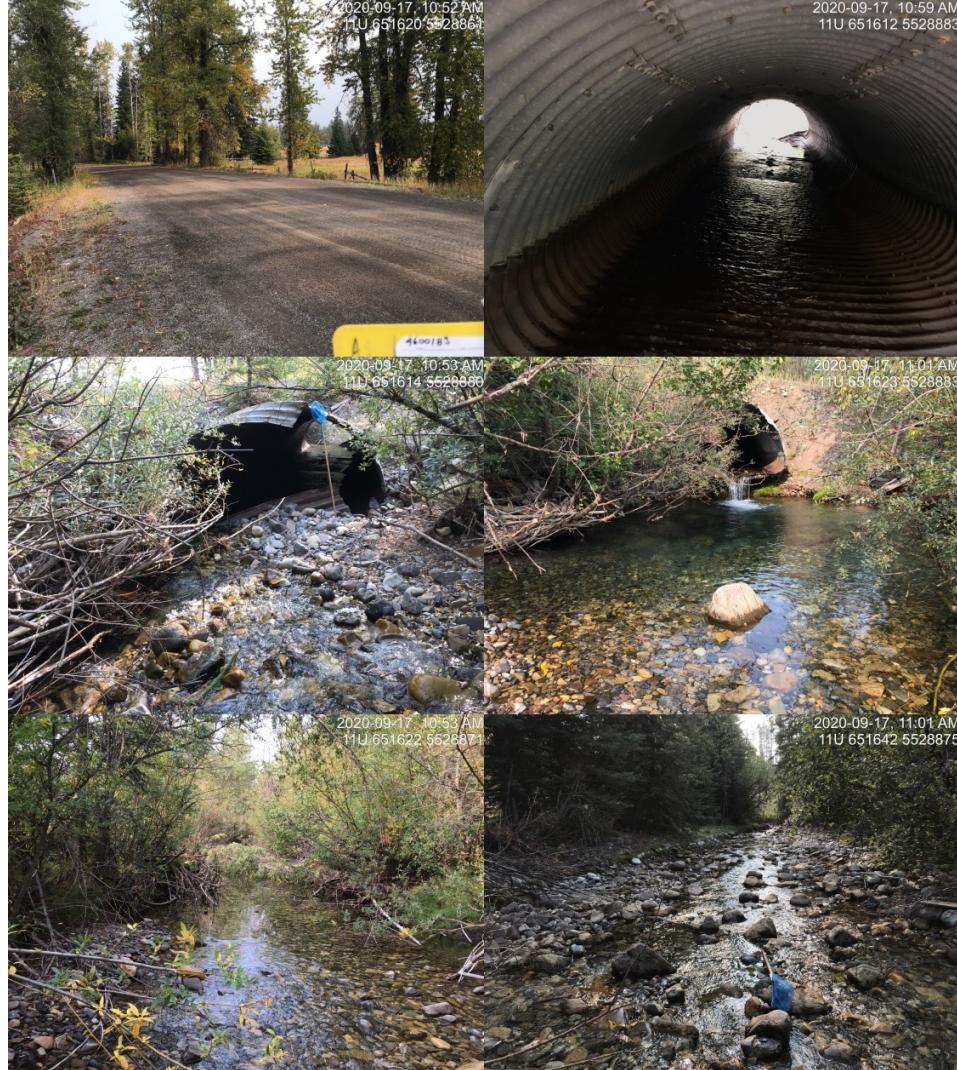
Photos: From top left clockwise: Road/Site Card, Barrel, Outlet, Downstream, Upstream, Inlet.

Stream Slope (%)	2	Inlet Drop	Yes
Beaver Activity	No	Slope (%)	4
Habitat Value	High	Valley Fill	Deep Fill

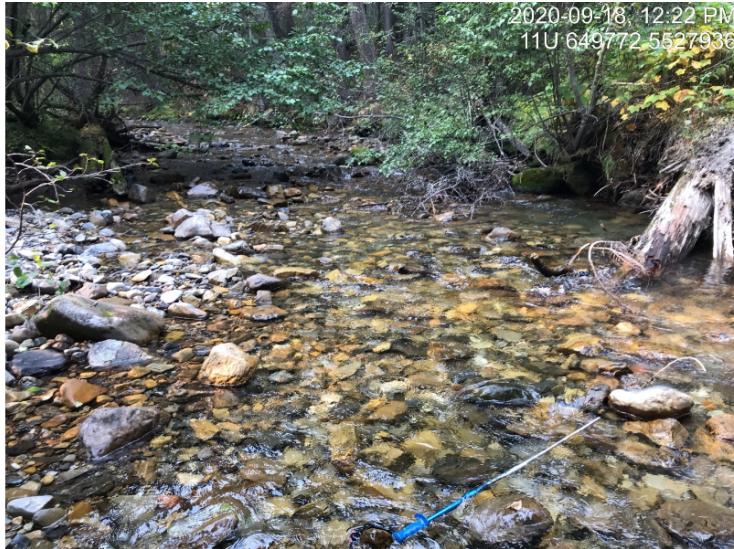
The stream was surveyed immediately upstream from 197559 for 1200m and then another 600m beginning at the ford (PSCIS 197536) 2km upstream for a total of 1600m. The channel was dewatered immediately upstream of Highway 43 with intermittent pools only to a distance approximately 670 m upstream. Upstream of the dewatered area, stream flows increased with increasing upstream distance. Overall, total cover amount was rated as moderate with deep pools dominant. Cover was also present as boulders and undercut banks (Table 5.28, Figure 5.28). The average channel width was 5.5m, the average wetted width was 2.3m and the average gradient was 3.5%. Overall, habitat upstream of 197559 was rated as high value habitat present suitable for resident and fluvial salmonid rearing and spawning.

Figure 5.31: Typical habitat above dewatered area upstream of PSCIS crossing 197533.

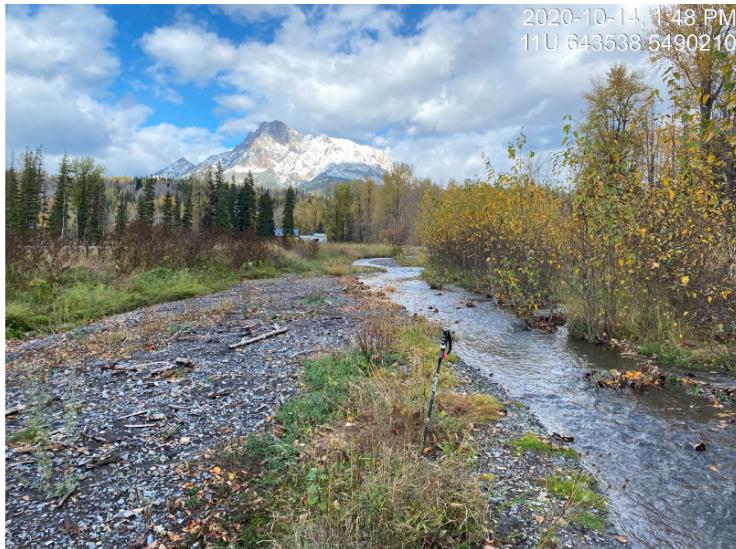
Figure 5.36: Typical habitat downstream of PSCIS crossing 197582.

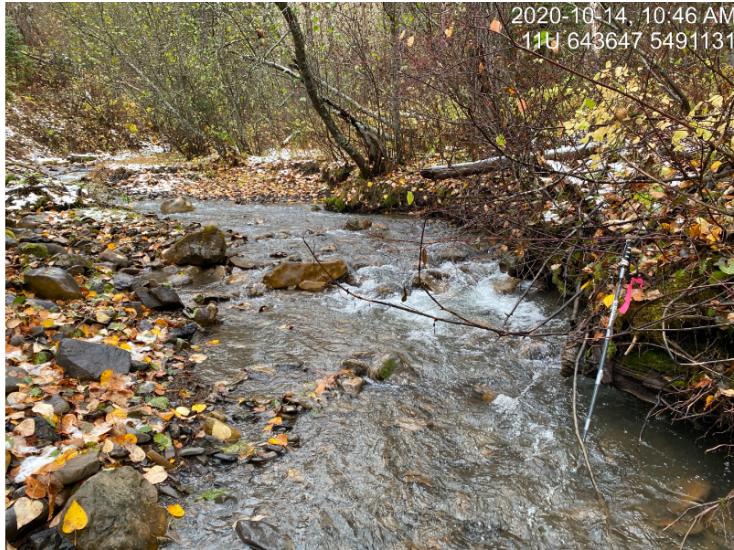
and may present an obstruction to upstream fish passage for fry and juvenile salmonids at some flows. Overall, total cover amount was rated as moderate with dominant. Cover was also present as small woody debris, undercut banks, deep pools, and overhanging vegetation (Table 5.33, Figure 5.38). The average channel width was 6.1m, the average wetted width was 3.8m and the average gradient was 3.5%. The dominant substrate was cobbles with gravels subdominant. There were frequent pools formed by small and large woody debris ranging from 0.3 - 0.7m in depth with a debris jam near top of site (11U 643668 5491243) measured at 1.2m in height. Pockets of gravels suitable for resident and fluvial salmonids were present and there were areas of erosion notable on the right bank of the stream.

Figure 5.38: Typical habitat upstream of PSCIS crossing 197542.

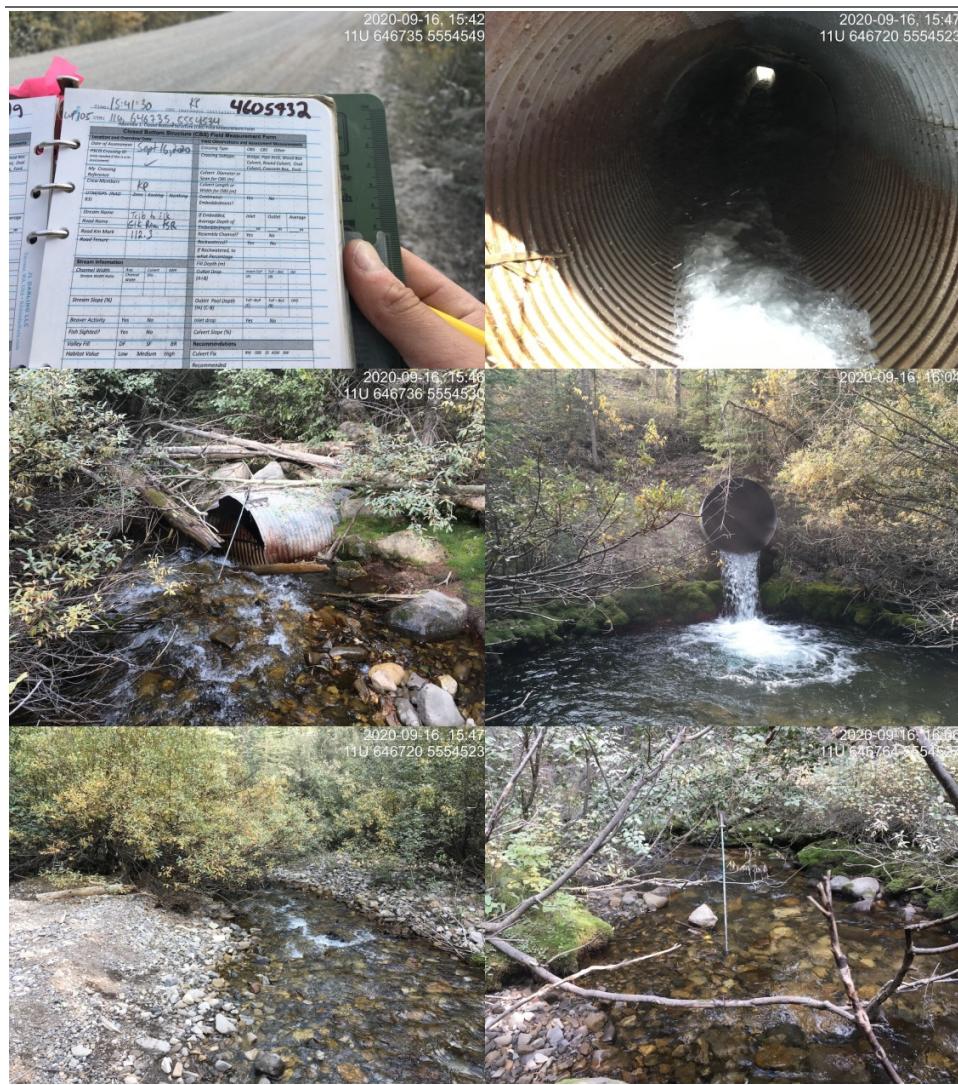
Table 5.34: Summary of fish passage reassessment for PSCIS crossing 197555.

Location and Stream Data		Crossing Characteristics –	
Date	2020-09-16	Crossing Sub Type	Round Culvert
PSCIS ID	197555	Diameter (m)	1.5
External ID	NA	Length (m)	49
Crew	KP, AI	Embedded	No
UTM Zone	11	Depth Embedded (m)	NA
Easting	646735	Resemble Channel	No
Northing	5554534	Backwatered	No
Stream	Tributary to Elk River	Percent Backwatered	NA
Road	Elk River FSR	Fill Depth (m)	8
Road Tenure	FLNR 0103	Outlet Drop (m)	1.48
Channel Width (m)	3.5	Outlet Pool Depth (m)	1.3
Stream Slope (%)	1.5	Inlet Drop	Yes
Beaver Activity	No	Slope (%)	3.5
Habitat Value	High	Valley Fill	Deep Fill
Photos: From top left clockwise: Road/Site Card, Barrel, Outlet, Downstream, Upstream, Inlet.

Structure replacement with an open bottomed culvert is recommended to provide access to the habitat located upstream of PSCIS crossing 197555. Due to the large amount of fill on the road (8) the size of a replacement bridge was estimated at 25m. The cost for work is estimated at \$312000 for a cost benefit of \$19200/linear m and \$33700/m².
