Elk River Watershed Group Fish Passage Restoration Planning

Prepared for Canadian Wildlife Federation

New Graph Environment

2020-12-22 DRaft

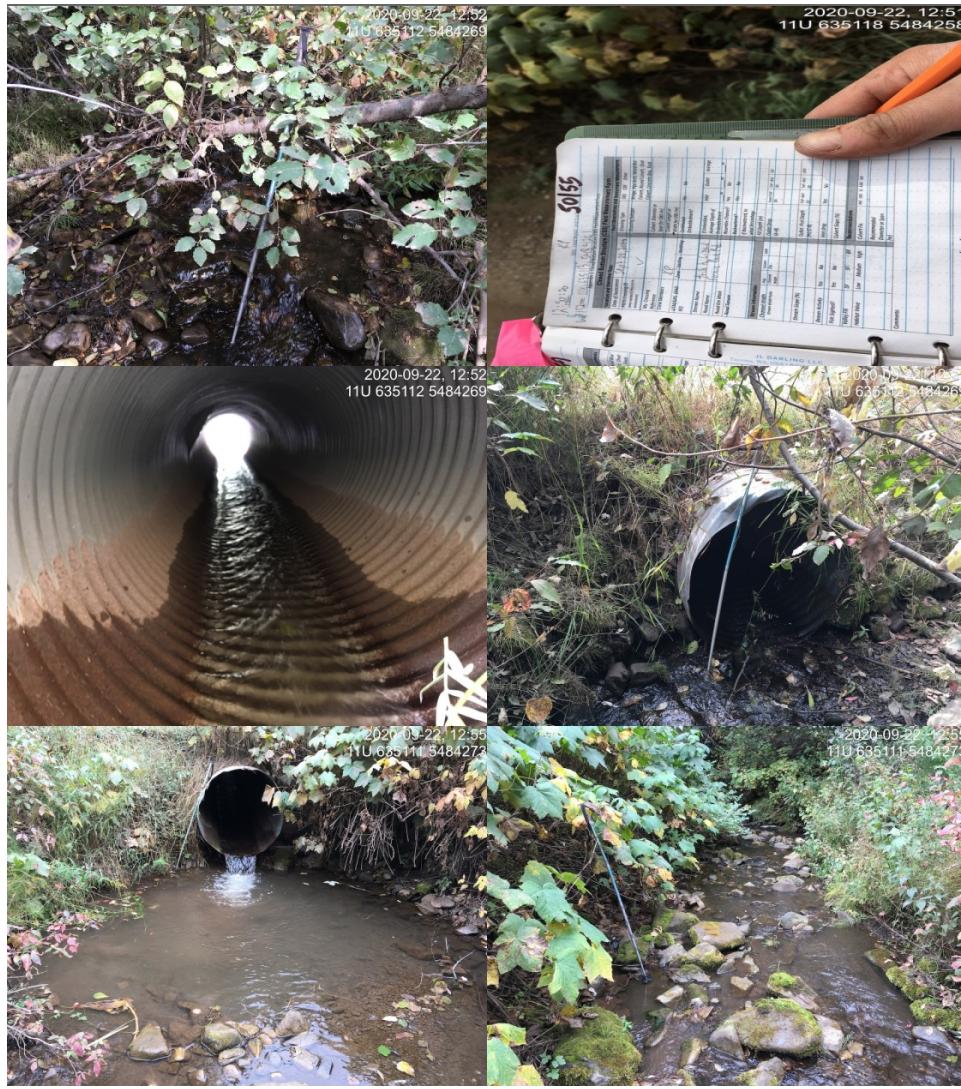
Table 5.2: Summary of habitat details for PSCIS crossing 50155.

Structure replacement with an open bottomed culvert is recommended to provide unconstrained access to the habitat located upstream of PSCIS crossing 50155. The cost for work is estimated at \$125000 for a cost benefit of \$8700/linear m and \$9700/m².

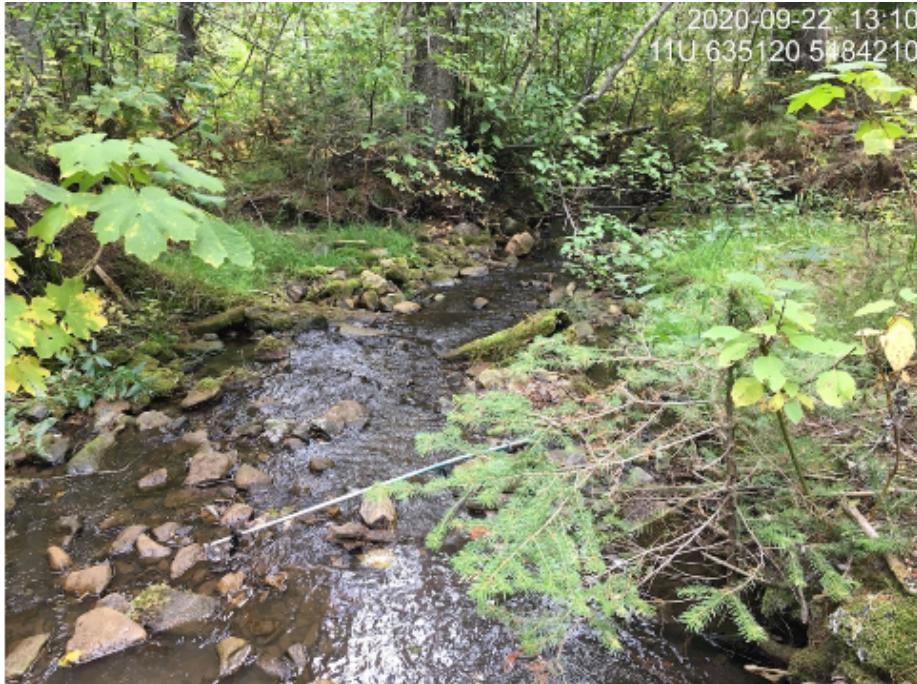
Figure 5.2: Typical habitat downstream of PSCIS crossing 50155.

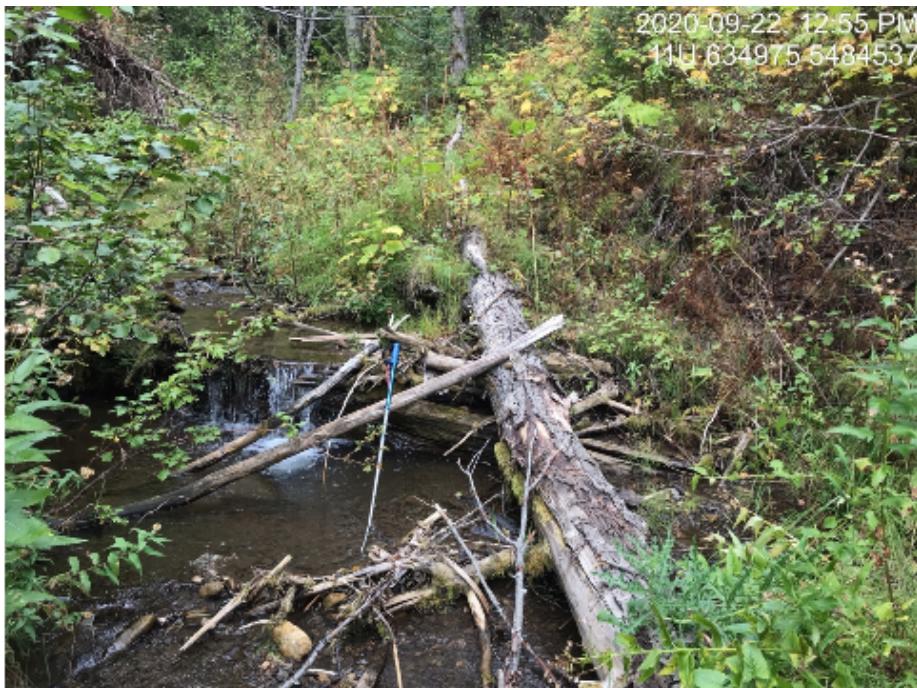
Figure 5.3: Typical habitat upstream of PSCIS crossing 50155.

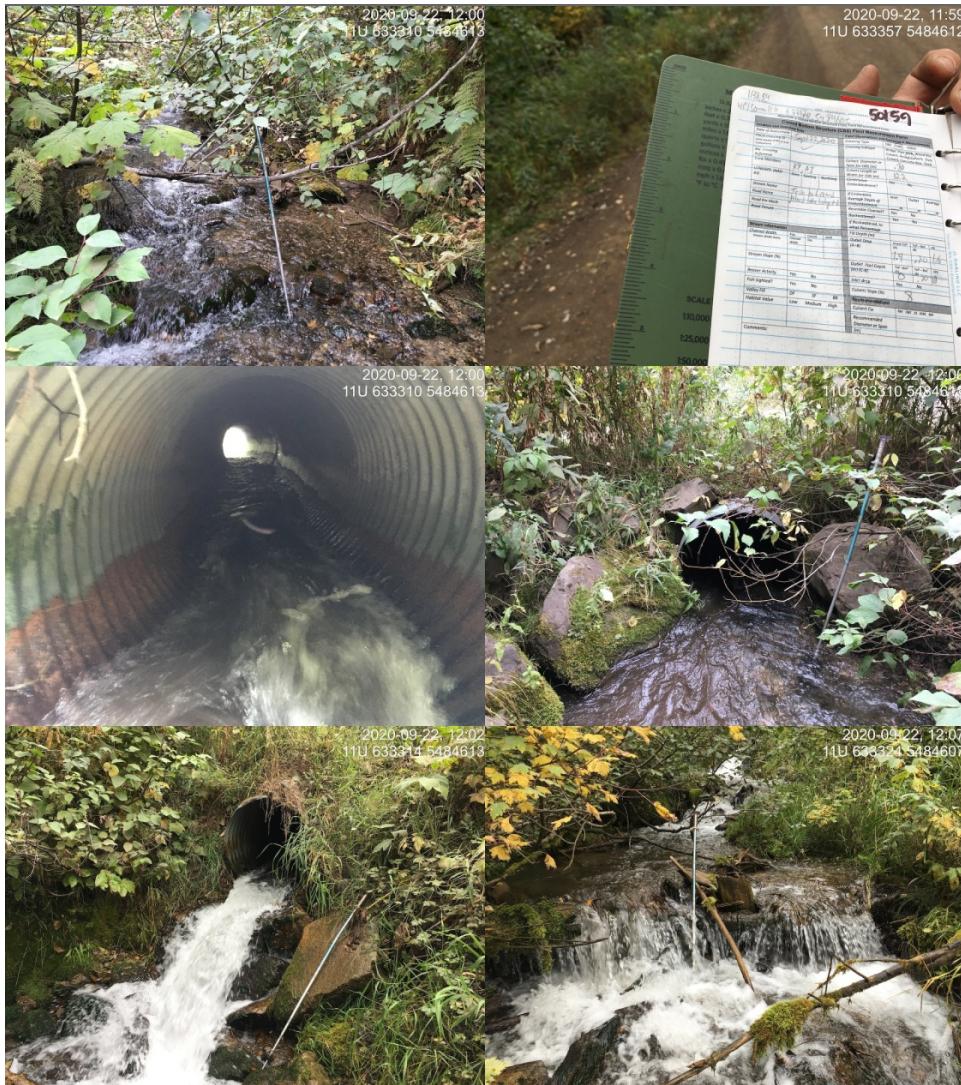
There is 0.3km of mainstem habitat upstream of crossing 50159 with habitat in the areas surveyed upstream of the crossing rated as high value for fry and juvenile salmonid rearing. The road may be part of the Island Lake Recreational tenure or solely the responsibility of the Ministry of Forests, Lands, Natural Resource Operations & Rural Development. The crossing was ranked as a high priority for proceeding to design for replacement with an open bottomed structure.

Table 5.6: Summary of habitat details for PSCIS crossing 50159.

Structure replacement with a bridge is recommended to provide access to the habitat located upstream of PSCIS crossing 50159. The cost for the work is estimated at \$125000 for a cost benefit of \$0/linear m and \$0/m².

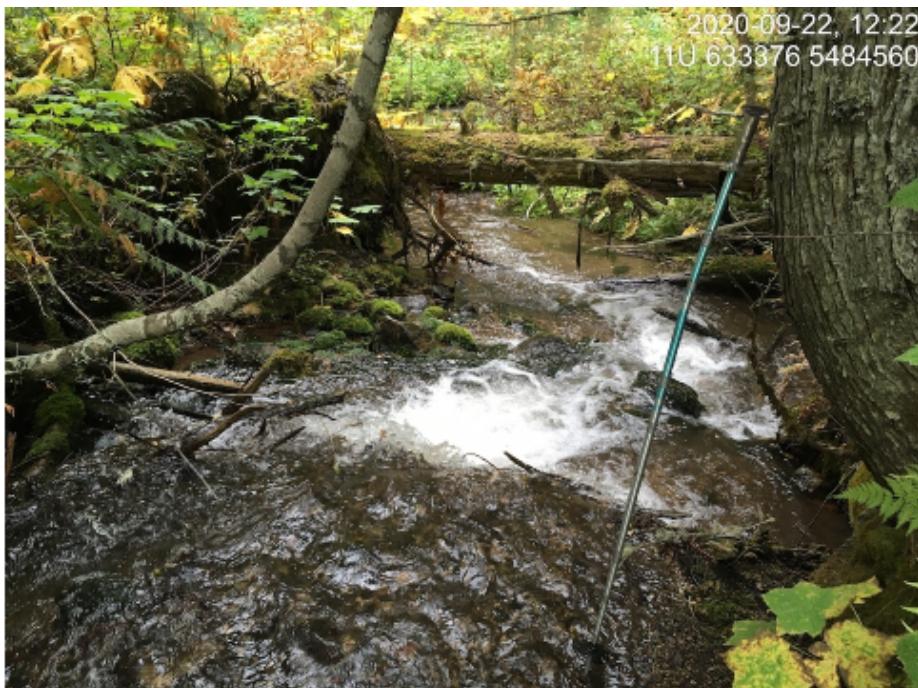
Figure 5.4: Typical habitat downstream of PSCIS crossing 50159.

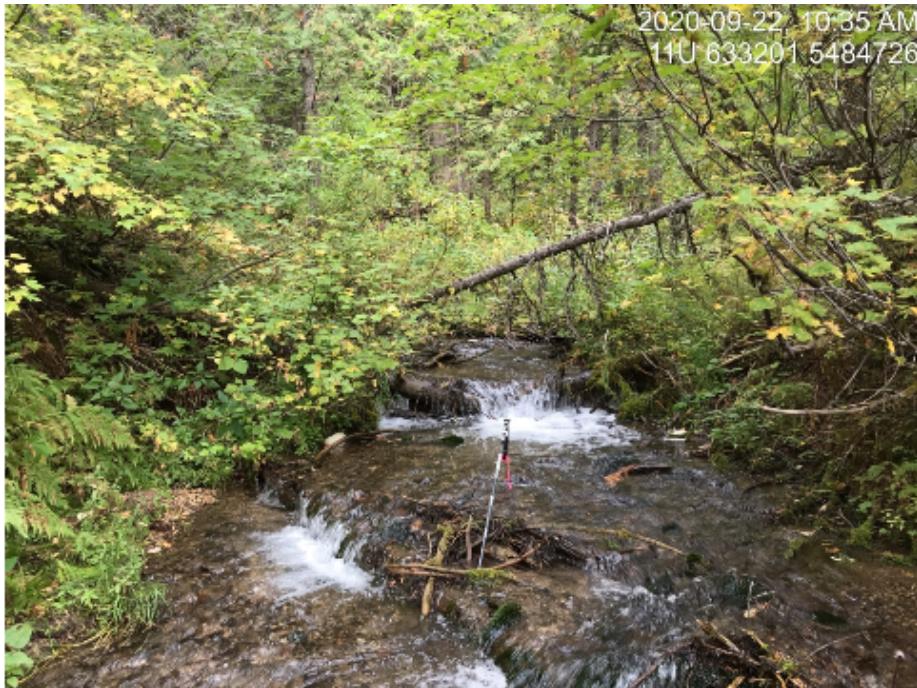
Figure 5.5: Typical habitat upstream of PSCIS crossing 50159.

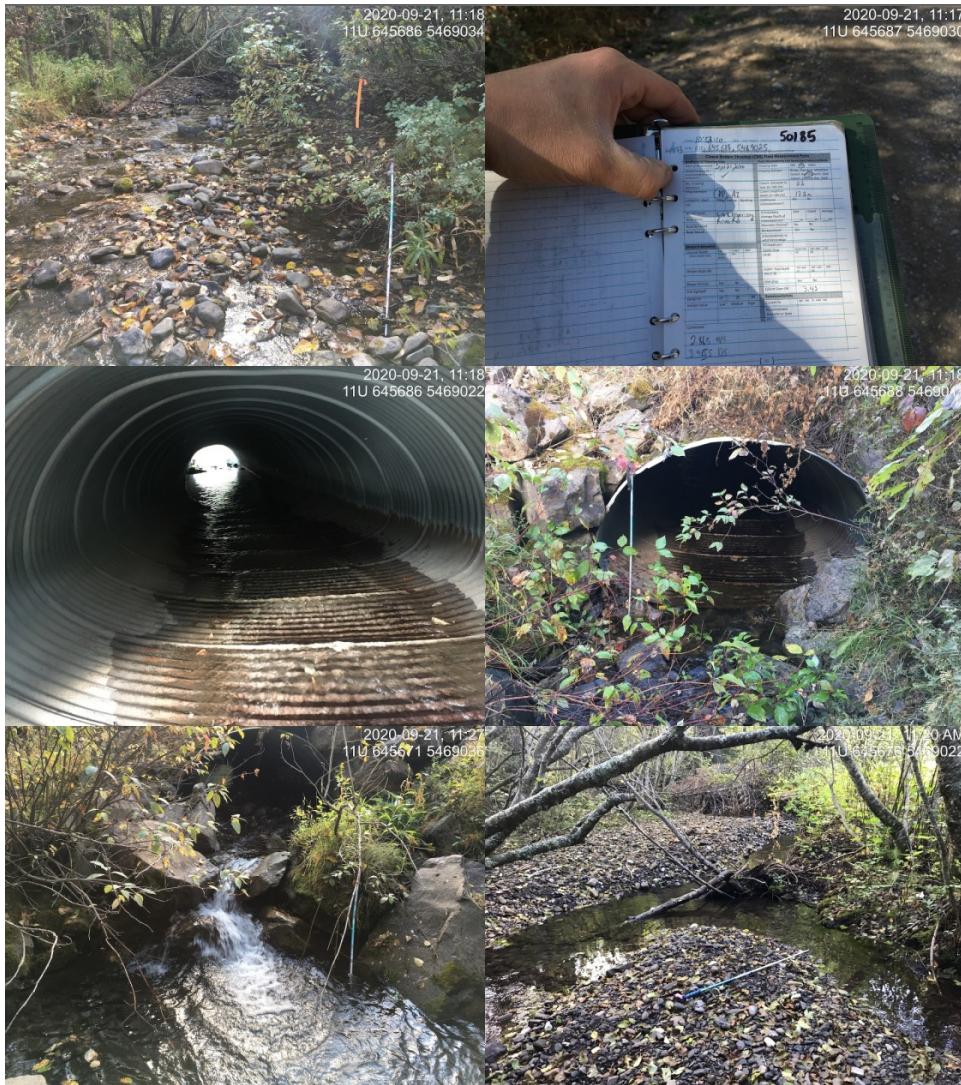
Table 5.8: Summary of habitat details for PSCIS crossing 50185.

Structure replacement with an open bottomed structure is recommended to provide access to the habitat located upstream of PSCIS crossing 50185. The cost of the work is estimated at \$125000 for a cost benefit of \$14400/linear m and \$30900/m².

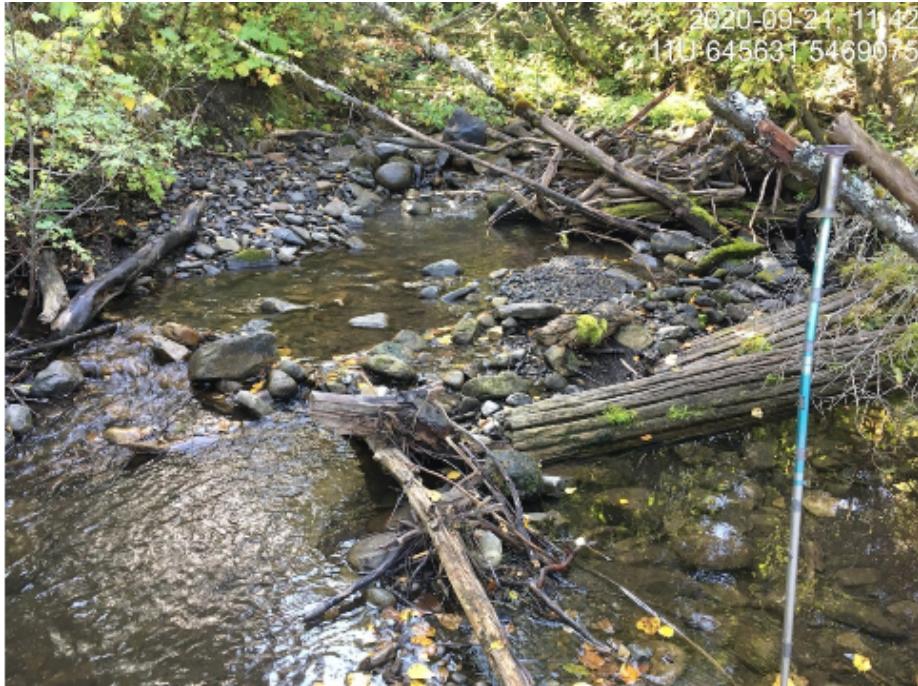
The stream was surveyed downstream from the culvert for 255m to the confluence with Morrissey Creek. The mouth of the stream is located approximately 500m upstream from the confluence of Morrissey Creek and the Elk River. Overall, total cover amount was rated as moderate with small woody debris dominant. Cover was also present as large woody debris, undercut banks, deep pools, and overhanging vegetation (Table [5.8](#), Figure [5.7](#)). The average channel width was 4.3m, the average wetted width was 2.7m and the average gradient was 4.2%. The dominant substrate was cobbles with gravels subdominant. There were frequent pools formed by small and large woody debris ranging from 0.3 - 0.75m in depth (average residual depth = 0.4m). Pockets of small gravels suitable for resident salmonid spawning were also present. Habitat value was rated as high with good potential for fry/juvenile salmonid rearing.

Figure 5.7: Typical habitat downstream of PSCIS crossing 50185.

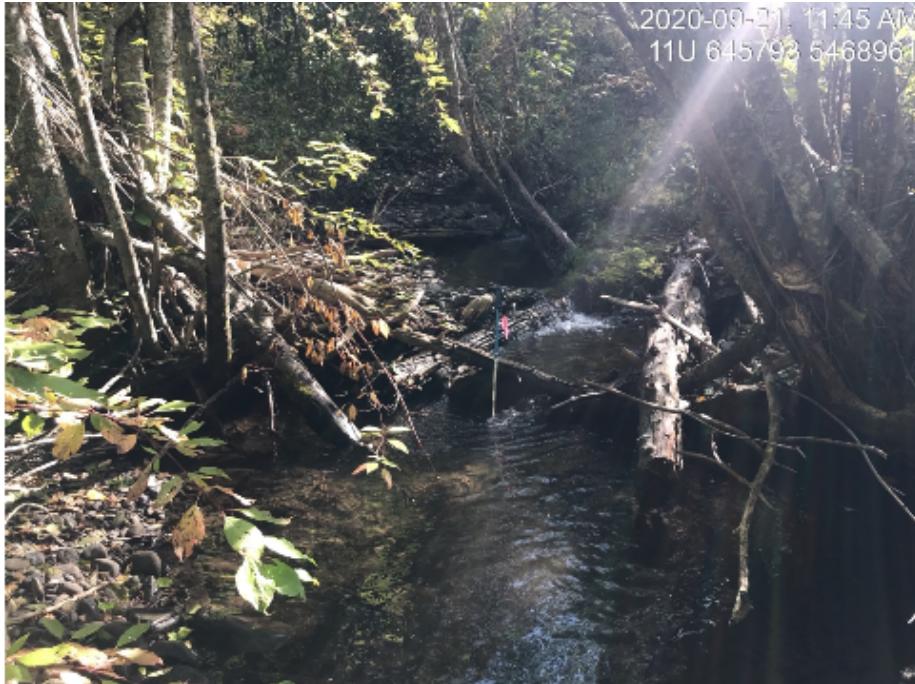
flows with fry observed throughout the area surveyed. Pools to 0.6m deep (average residual depth =0.4m) were present with pockets of gravel suitable for spawning throughout. Infrequent large woody debris jams to 0.5m high were also observed. There were frequent areas of gravels suitable for resident westslope cutthroat trout spawning. Habitat value was rated as high for fry and juvenile westslope cutthroat trout rearing.

Figure 5.8: Typical habitat upstream of PSCIS crossing 50185.

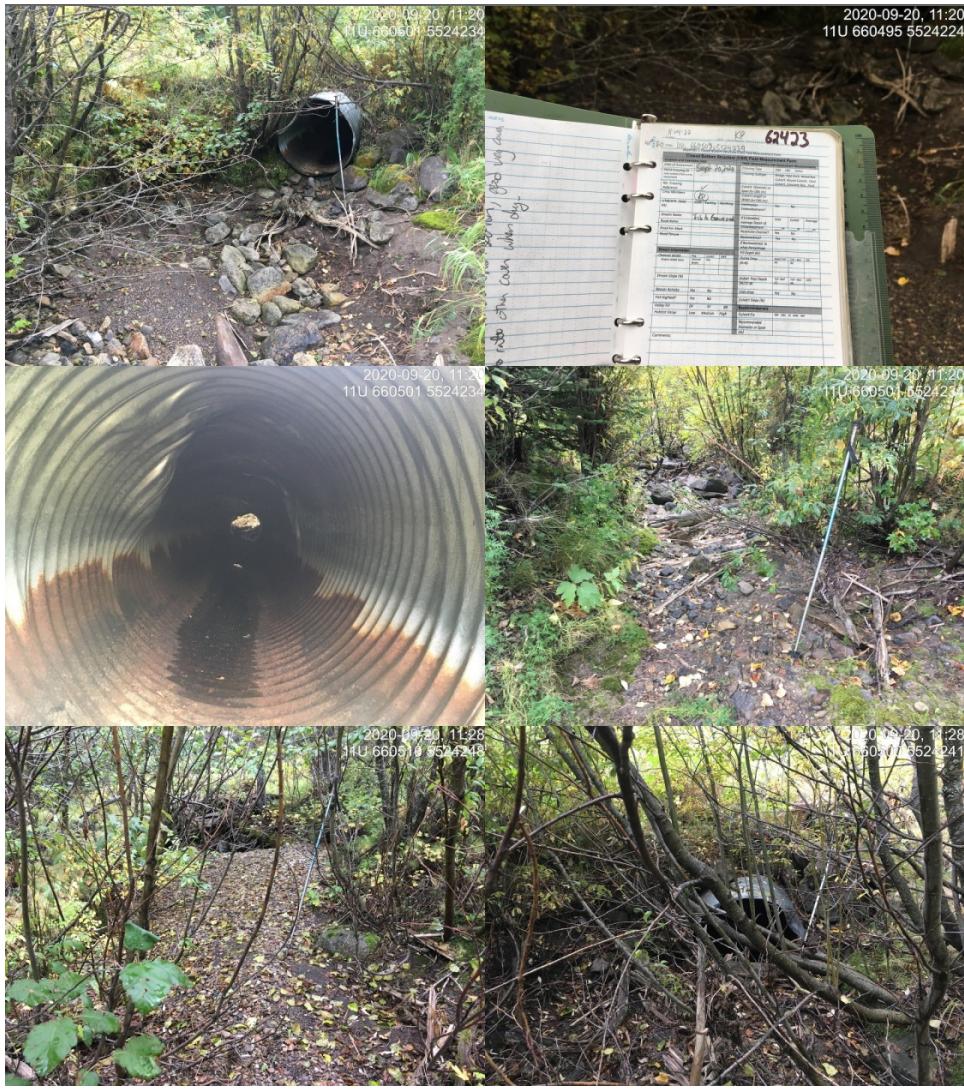
There is 2.4km of mainstem habitat upstream of crossing 62423 with habitat in the areas surveyed upstream of the crossing rated as medium value. Although the provincial forest tenure road layer does not include Grave Creek FSR, it is likely that it is a tenure road under the responsibility of the Ministry of Forests, Lands, Natural Resource Operations and Rural Development. The crossing was ranked as a low priority for proceeding to design for replacement with an open bottomed structure.

Table 5.12: Summary of habitat details for PSCIS crossing 62423.

Structure replacement with an embedded culvert is recommended to provide access to the habitat located upstream of PSCIS crossing 62423. The cost for the work is estimated at \$25000 for a cost benefit of \$63100/linear m and \$45500/m².

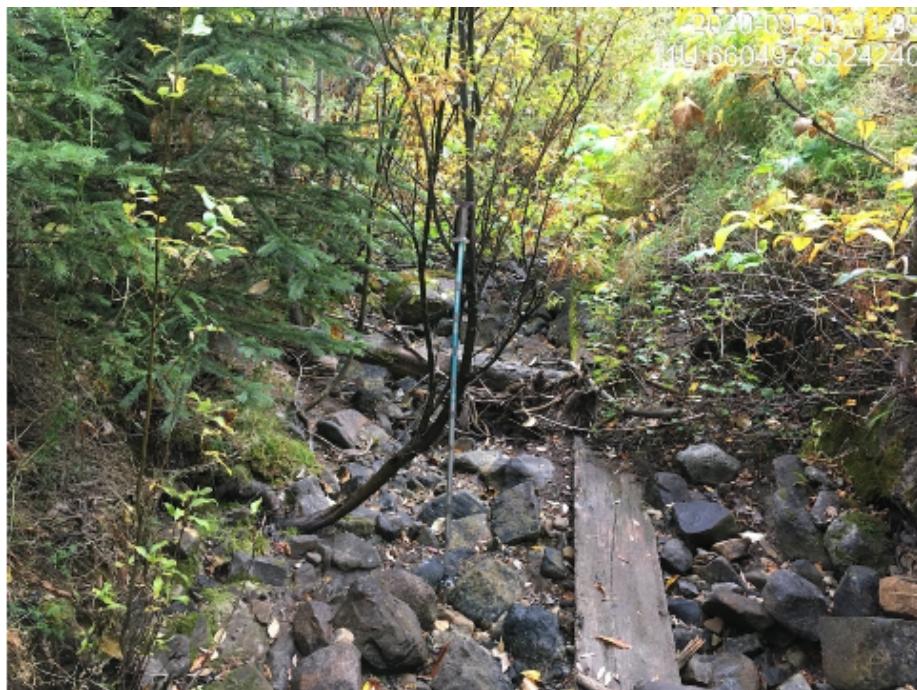
Figure 5.10: Typical habitat downstream of PSCIS crossing 62423.

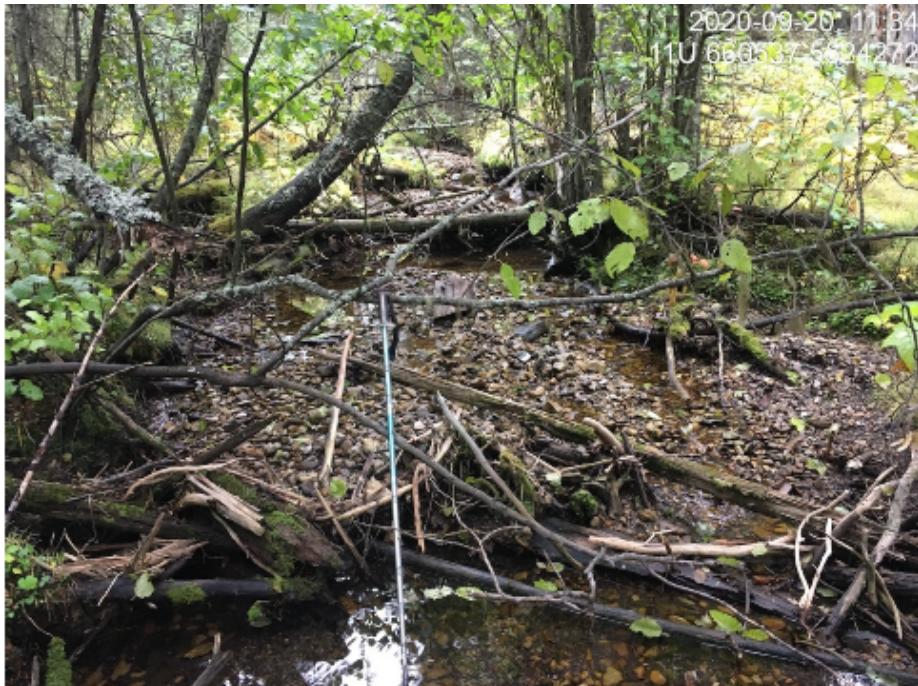
primarily fines above its confluence. There was however, a visible channel in this location with a ford (PSCIS 197563) located approximately 600m upstream of PSCSIS 62423. Overall, total cover amount was rated as moderate with undercut banks dominant. Cover was also present as small woody debris, large woody debris, and boulders (Table 5.12, Figure 5.10). The average channel width was 1.2m, the average wetted width was 0.8m and the average gradient was 4.4%. Harriet Lake Creek gradients modelled at 19% just upstream of the bridge located 1km upstream and too steep for upstream westslope cutthroat passage (>20%) at 2.2km. Habitat value was rated as medium for fry and juvenile westslope cutthroat rearing in Harriet Creek and low in the unnamed tributary mapped as Grave Creek due to a lack of flow.

Figure 5.11: Typical habitat upstream of PSCIS crossing 62423.

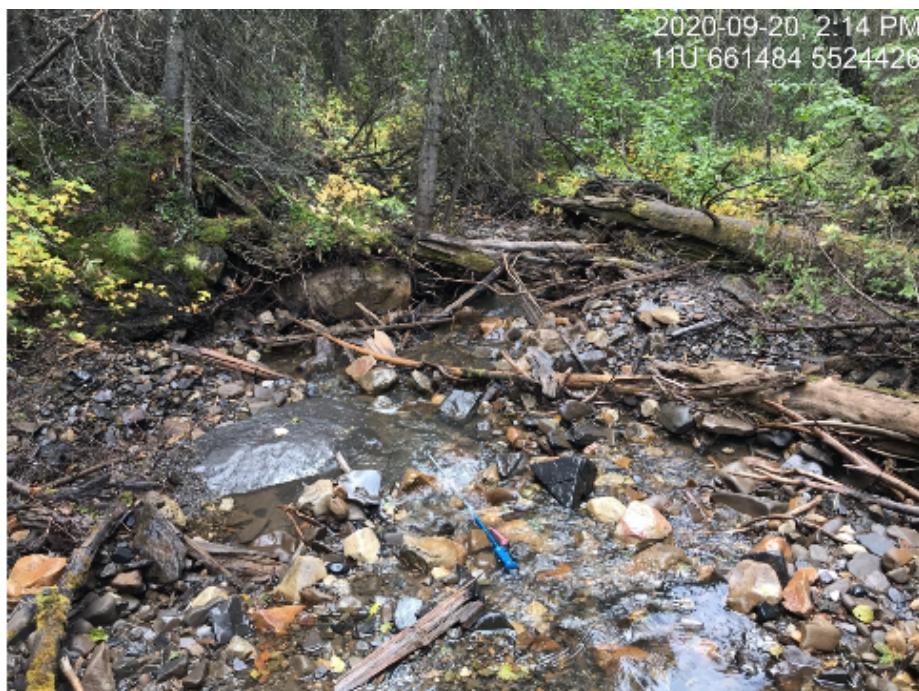
Figure 5.12: Typical habitat downstream of PSCIS crossing 62425.

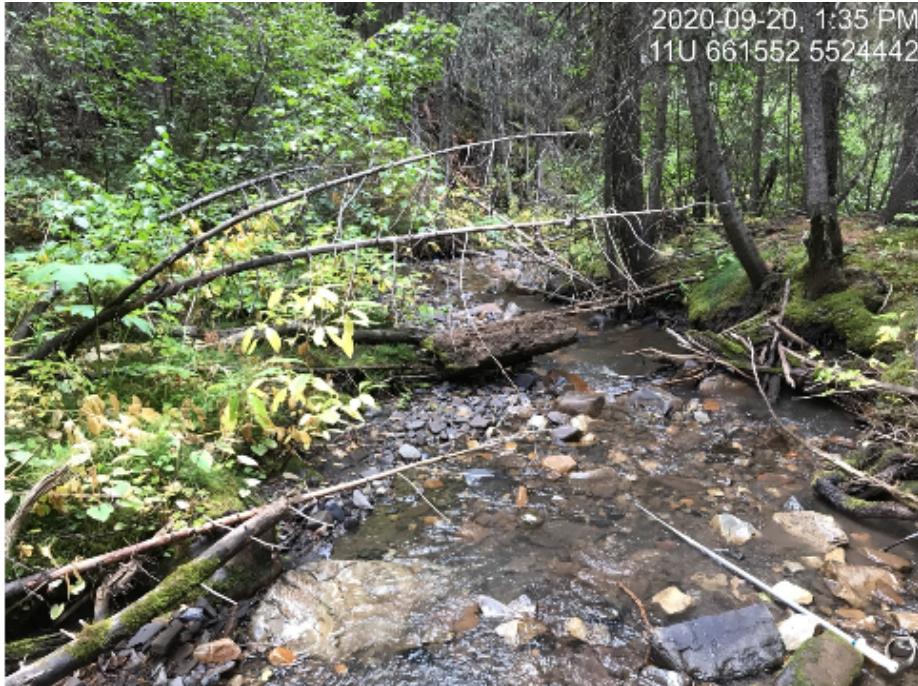
The stream was surveyed upstream from 62425 for 170m to 62426. Overall, total cover amount was rated as moderate with deep pools dominant. Cover was also present as large woody debris and boulders (Table 5.15, Figure 5.13). The average channel width was 3.5m, the average wetted width was 2.1m and the average gradient was 5%. There were abundant gravels suitable for resident westslope cutthroat trout spawning throughout (Figure 5.14). Some debris jam steps to 0.8m in height were observed and there were approximately 15 westslope cutthroat trout (approximately 170mm long) in the outlet pool for crossing 62426. Habitat value was rated as high for fry/juvenile salmonid rearing.

The stream was surveyed upstream from 62426 for 650m. Overall, total cover amount was rated as moderate with deep pools dominant. Cover was also present as boulders (Table 5.15, Figure 5.13). The average channel width was 3.5m, the average wetted width was 1.6m and the average gradient was 11.9%. This stream channel showed evidence of recent disturbance with eroding banks, multiple channels and aggraded sections throughout. Steps (0.6 - 0.9m in height) due to large woody debris debris jams were frequent throughout surveyed area and at a point approximately 200 m upstream of the road-stream crossing to the top end of the area surveyed, cover was limited to sporadic pools up to 0.3m deep. As mentioned previously, the historic channel was abandoned at 175m upstream of 62426 (UTM: 11 U 661748 5524558, Figure 5.14) with no flow observed within its banks. One of the tributaries that enters Grave Creek approximately 250m upstream of 62426 was accessed off of an adjacent spur road with a rapid assessment conducted 250m upstream from the confluence with Grave Creek (UTM: 11U 662083 5524708). The average channel width at this location was 1.9m and the average gradient was 9%. Immediately upstream, the gradient in this tributary was 20% representing grades not likely passable for westslope cutthroat trout migrating upstream. Overall, habitat value upstream of 62426 within the mainstem of Grave Creek was rated as medium with moderate rearing potential for fry/juvenile westslope cutthroat trout.

Figure 5.13: Typical habitat upstream of PSCIS crossing 62425 and downstream of PSCIS crossing 62426.

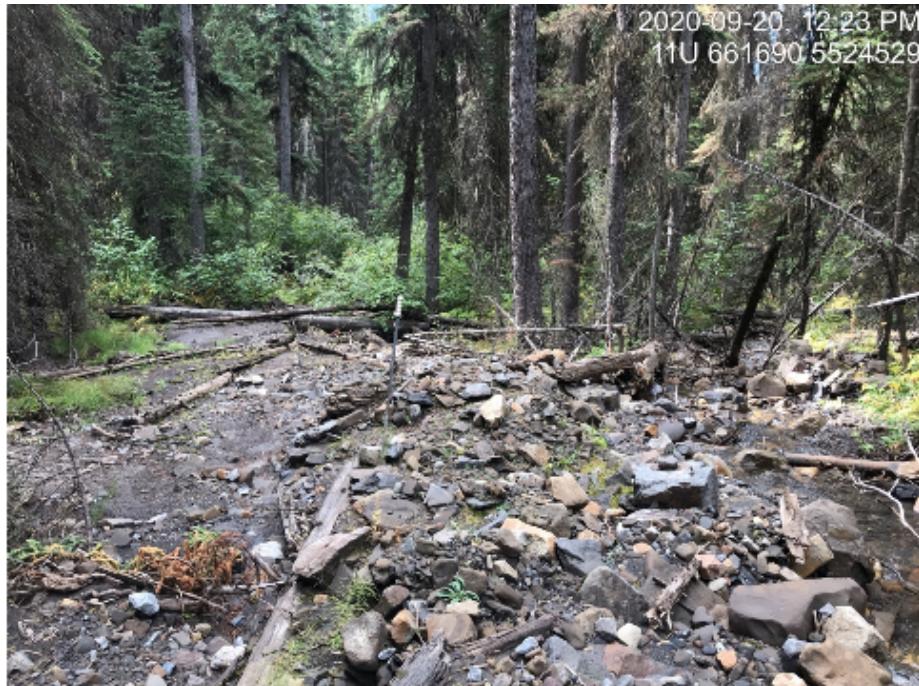
Figure 5.14: Grave Creek redirection out of historic channel located upstream of PSCIS crossing 62426.

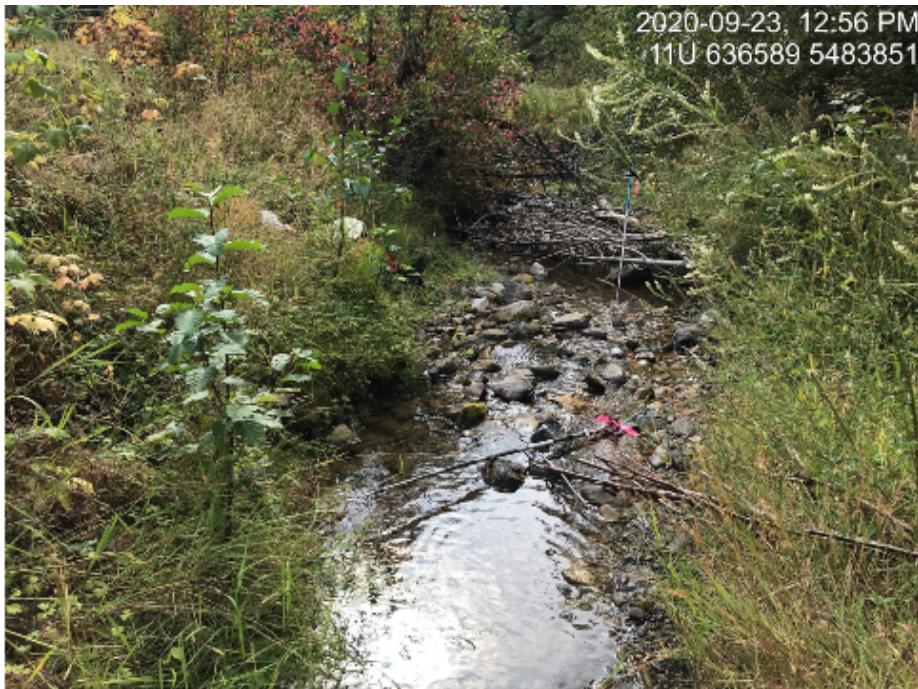
spawning throughout (Figure 5.15). Fry were observed within the area surveyed to 540m upstream of the culvert where gradients increased to >20% for a distance of approximately 15m. Although no sampling was conducted, no fish were observed above this high gradient section. Habitat value was rated as high for fry/juvenile salmonid rearing.

Figure 5.15: Typical habitat downstream of PSCIS crossing 62516.

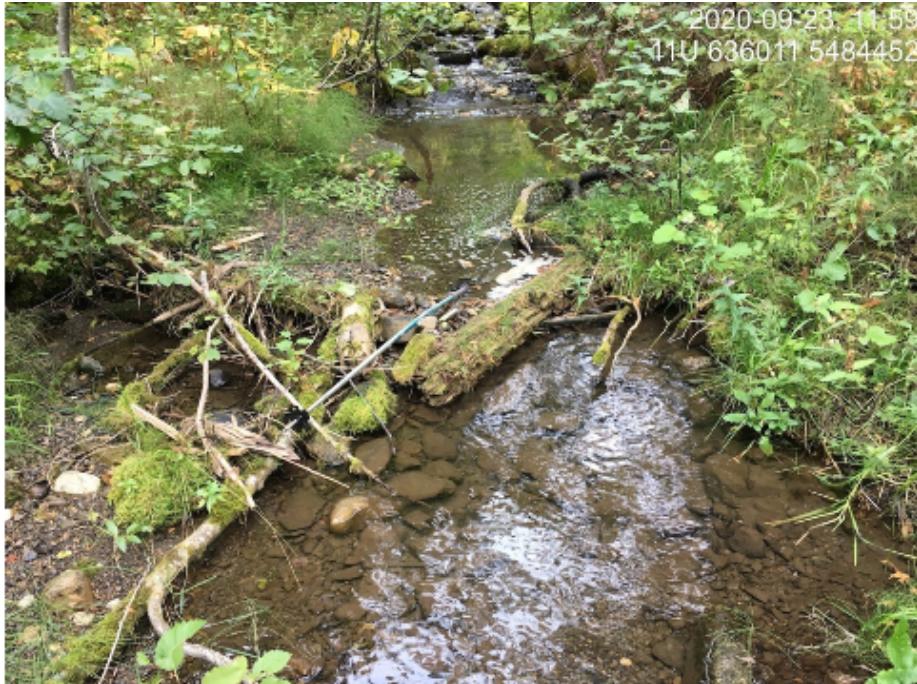
Figure 5.16: Typical habitat upstream of PSCIS crossing 62516.

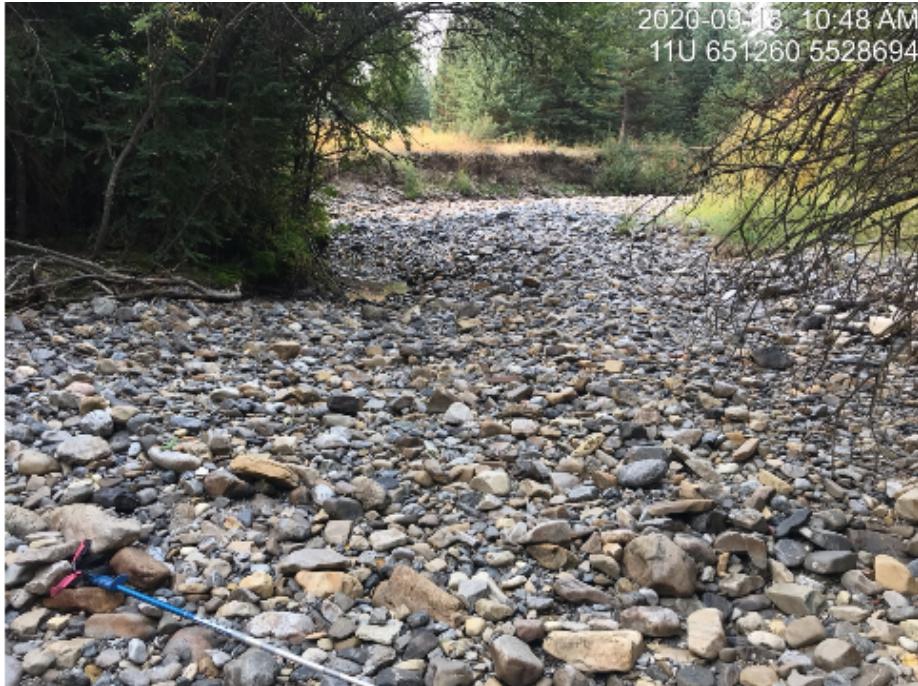
The stream was surveyed immediately upstream from 197559 for 1200m and then another 600m beginning at the ford (PSCIS 197536) 2km upstream for a total of 1600m. The channel was dewatered immediately upstream of Highway 43 with intermittent pools only to a distance approximately 670 m upstream. Upstream of the dewatered area, stream flows increased with increasing upstream distance. Overall, total cover amount was rated as moderate with deep pools dominant. Cover was also present as boulders and undercut banks (Table 5.20, Figure 5.19). The average channel width was 5.5m, the average wetted width was 2.3m and the average gradient was 3.5%. Overall, habitat upstream of 197559 was rated as high value habitat present suitable for resident and fluvial salmonid rearing and spawning.

Figure 5.21: Subsurface flow area upstream of PSCIS crossing 197559.

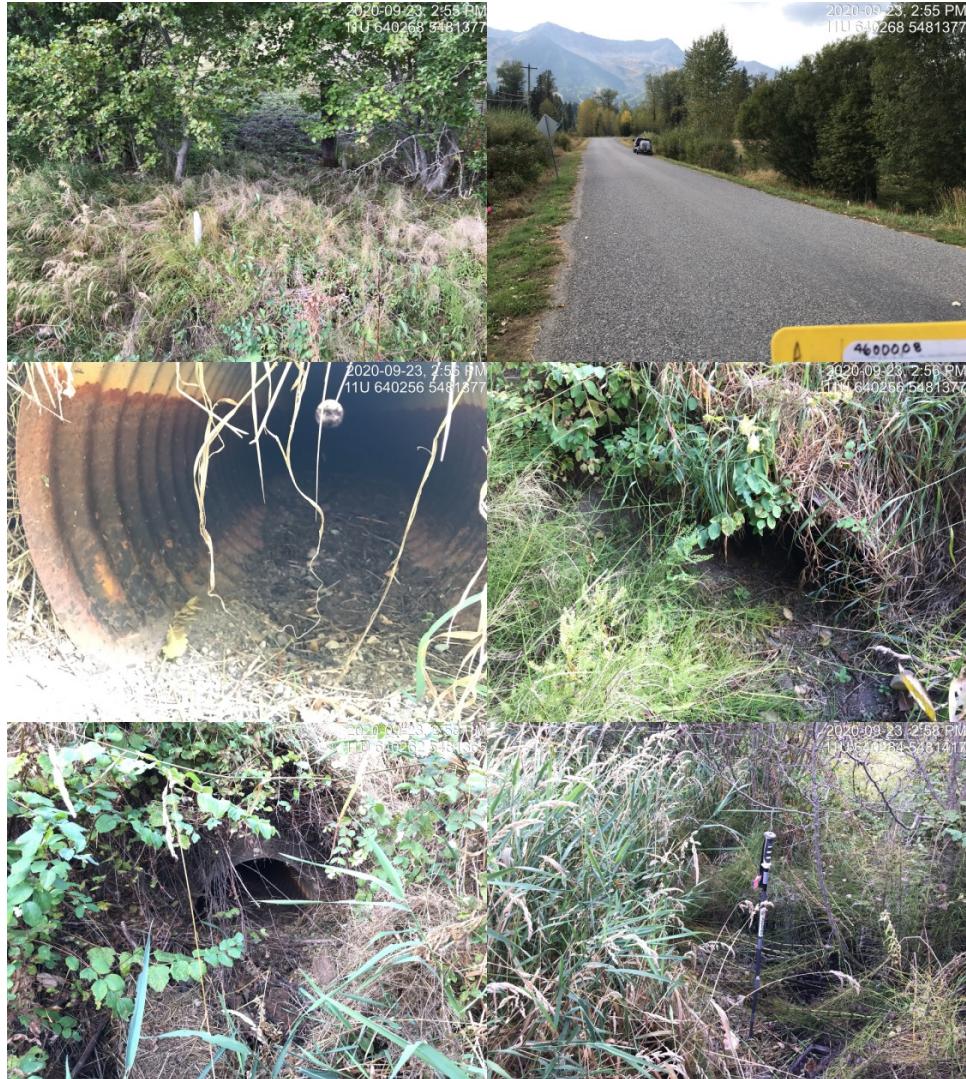
Photos: 4600008

Comments: Dry mostly vegetated channel. Not likely fish habitat.

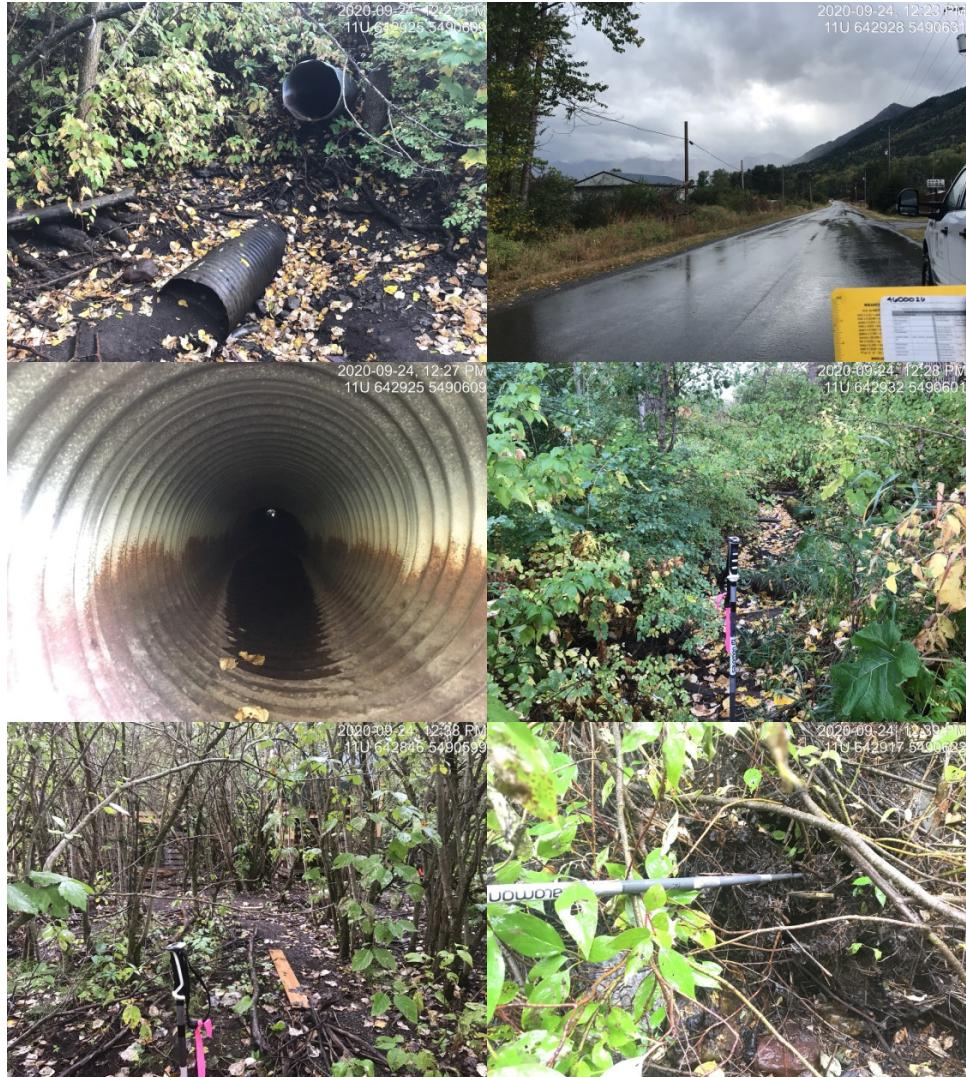
Photos: 4600026

Comments: Stream dry at time of survey. Children's fort in upstream channel indicating that flows are likely very minimal year round.

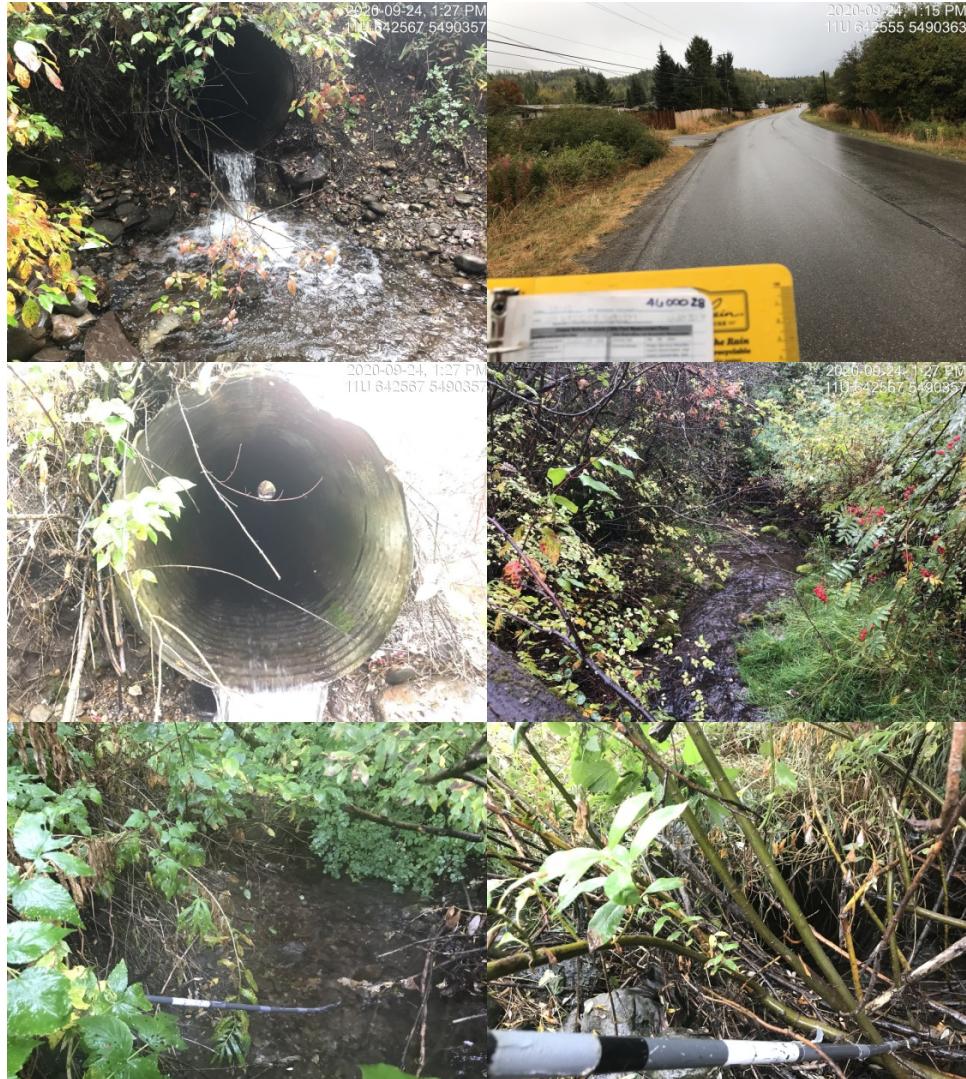
Photos: 4600028

Comments: Multiple fish observed in outlet pool (~190mm). Some gravels suitable for spawning located upstream.

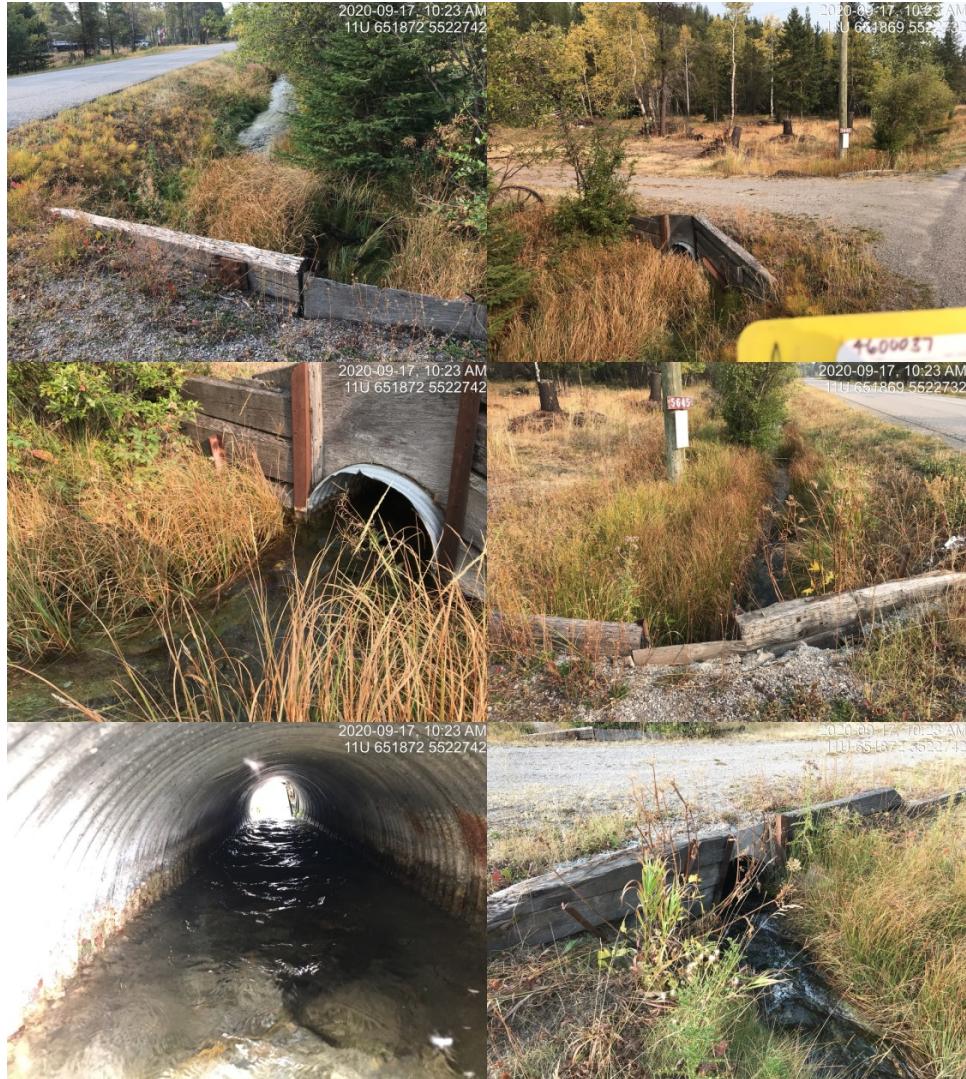
Photos: 4600037

Comments: Embedded culvert on private driveway. EB known upstream. Culvert does not appear likely to be significantly impacting upstream fish passage for juvenile or adult WCT at time of survey.

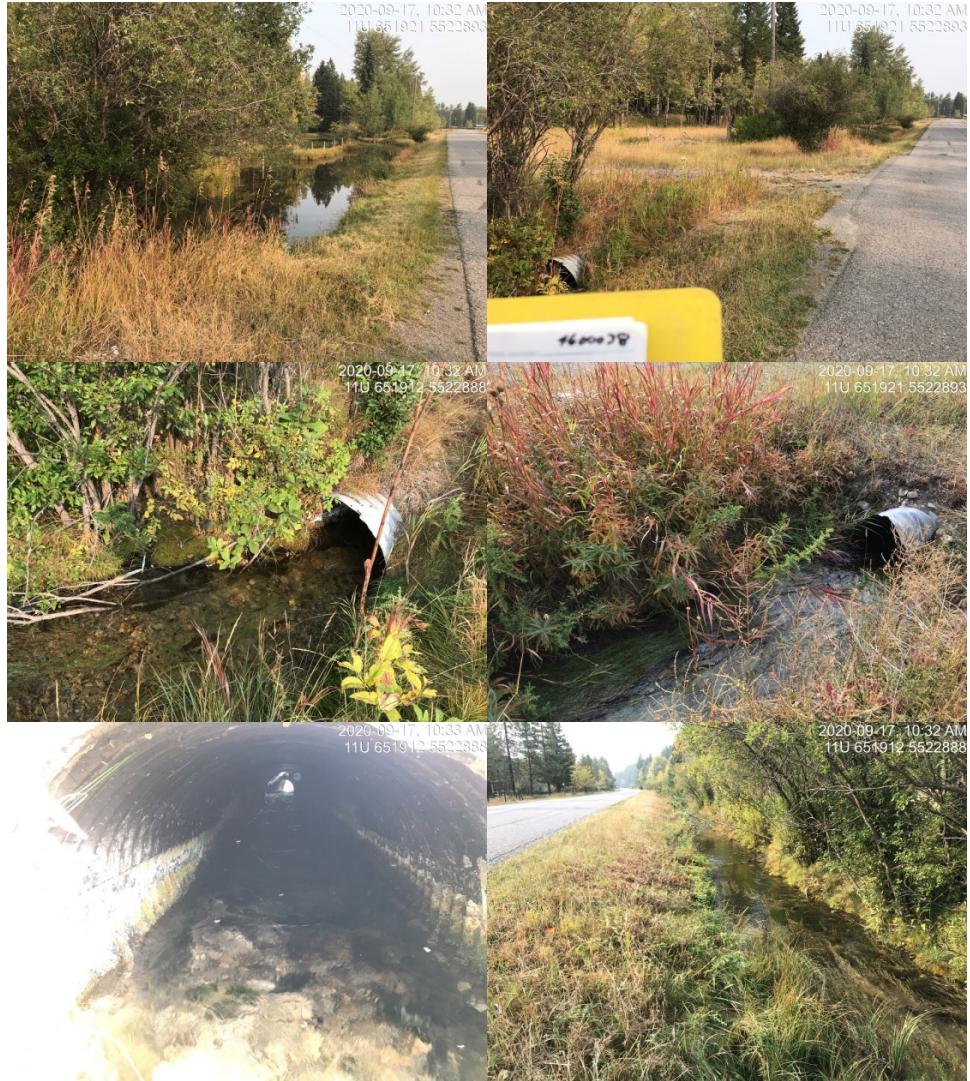
Photos: 4600038

Comments: Culvert collapsing in the middle. Private residence driveway. Wetland type habitat upstream. Culvert does not appear likely to be significantly impacting upstream fish passage for juvenile or adult WCT at time of survey.

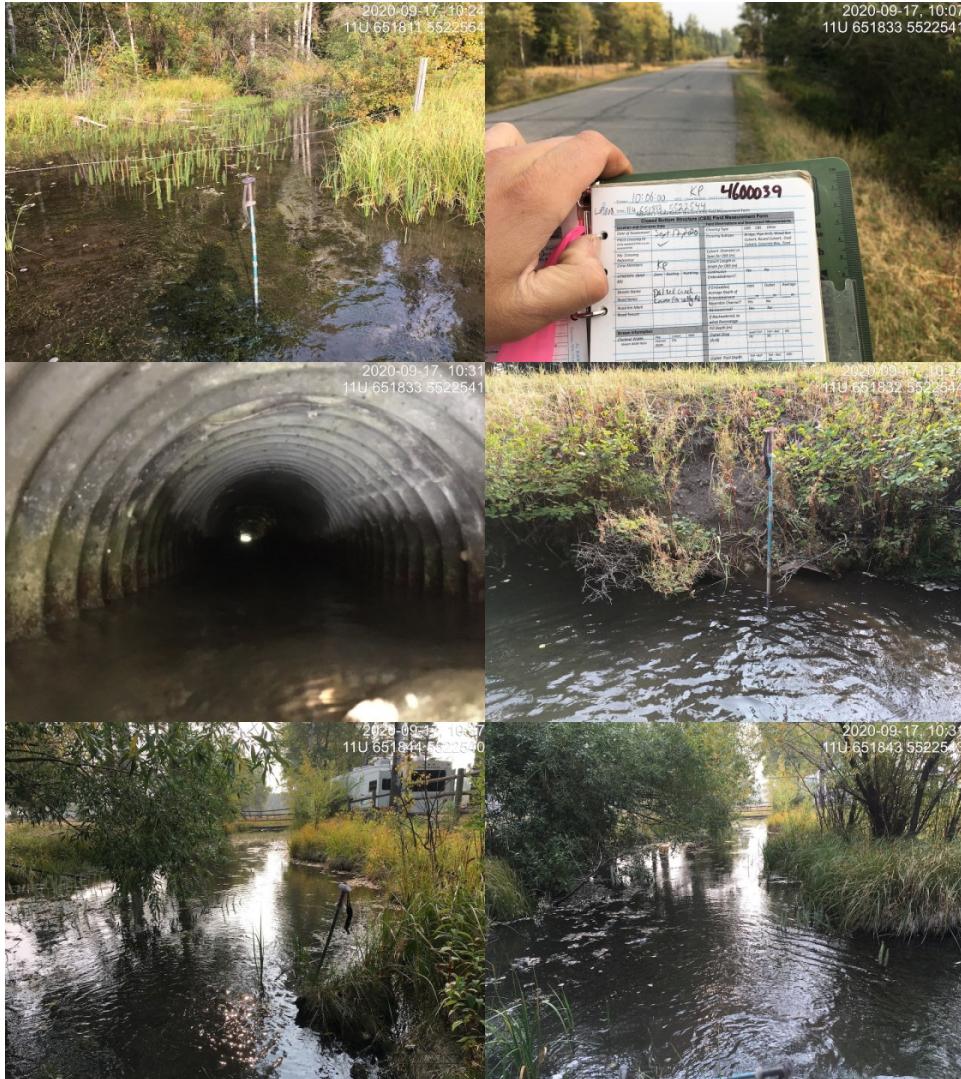
Photos: 4600039

Comments: Three barrels (.45m each). Two of the three have water flowing through them. Upstream and downstream channel widens out, slow flow through vegetated channel. Highly manipulated banks. Deep fine substrate on both sides of crossing. Upstream resembles a wetland. Crossing does not appear likely to be significantly impacting upstream fish passage for juvenile or adult WCT at time of survey.

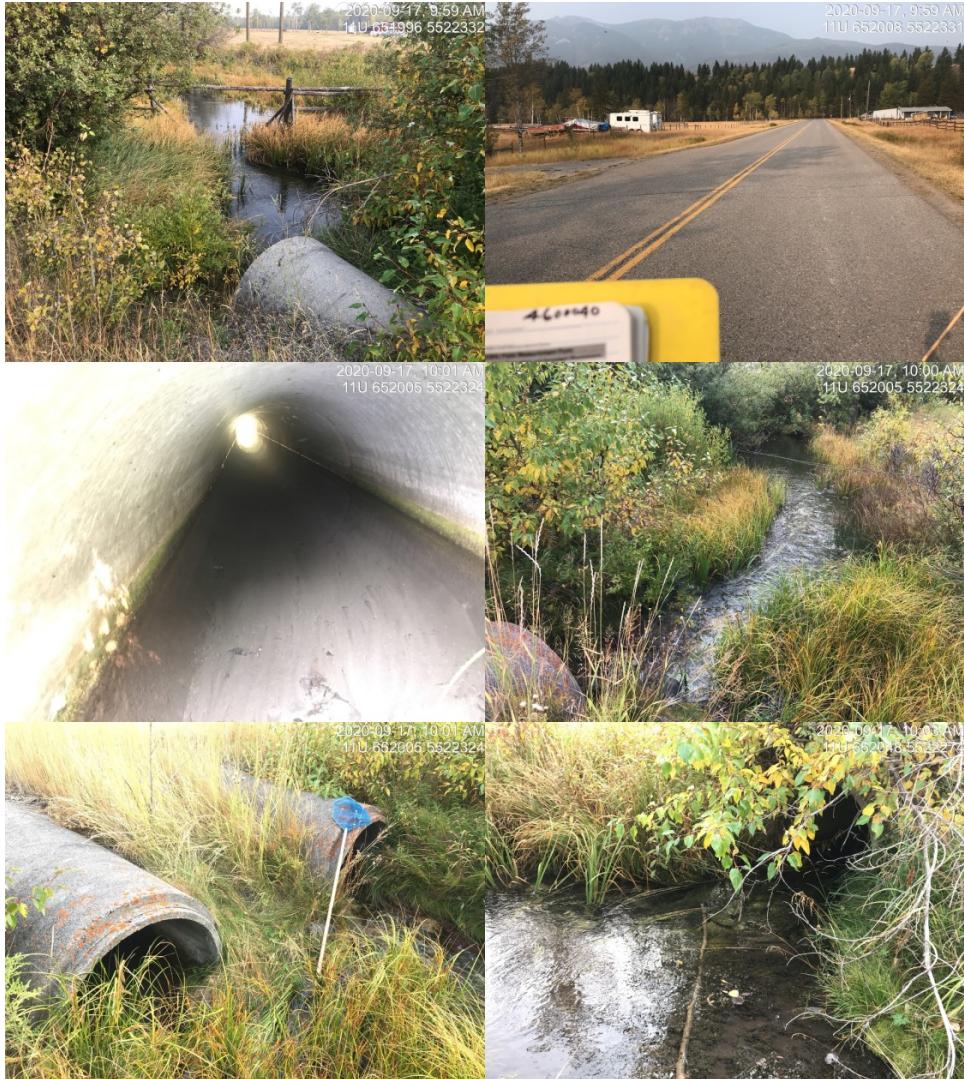
Photos: 4600040

Comments: Fenced private land upstream and downstream. Wetland area downstream. Culvert does not appear likely to be significantly impacting upstream fish passage for juvenile or adult WCT at time of survey.
