Elk River Watershed Group Fish Passage Restoration Planning

Prepared for Canadian Wildlife Federation

New Graph Environment

2020-12-22 DRaft

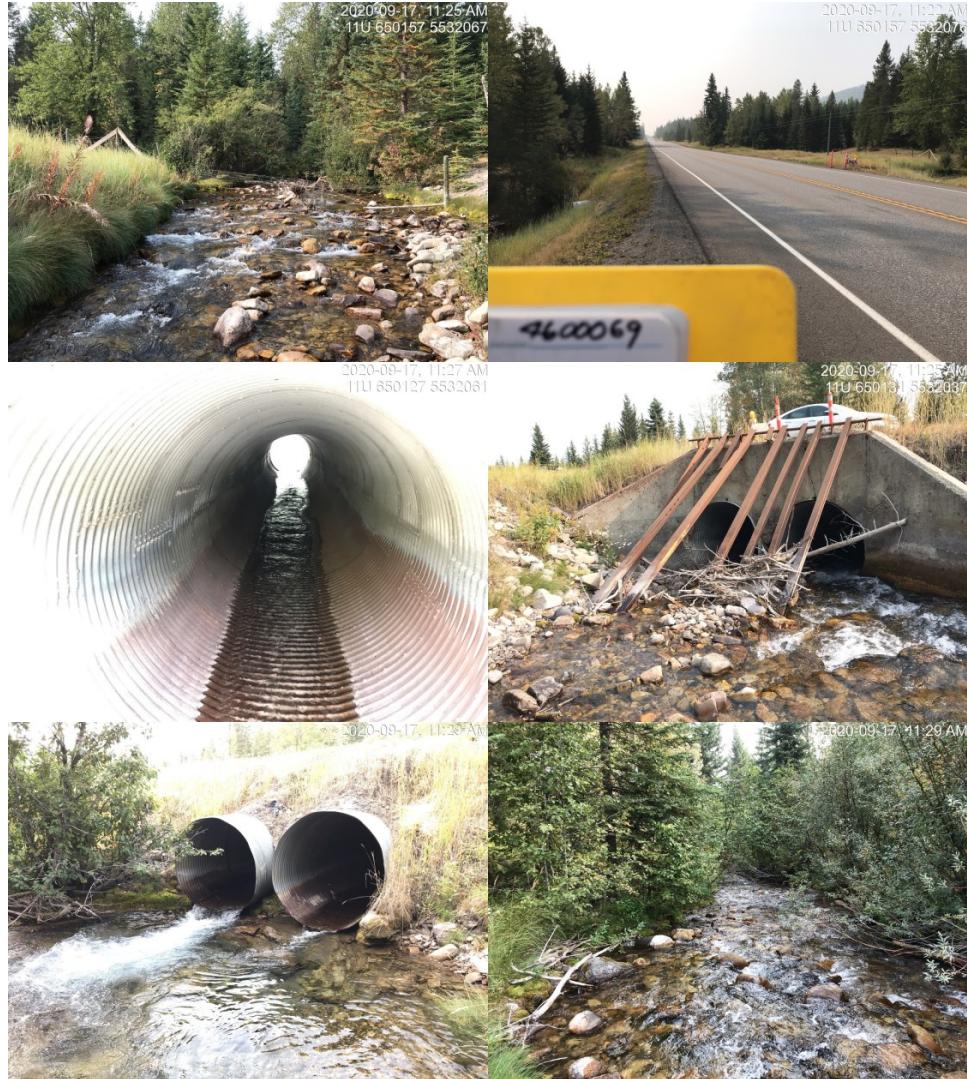
Photos: 4600069

Comments: Large stream with good flow. Flows currently mostly through south culvert which has slightly higher outlet drop. Similar elevation outlets so added together for width. Lazer level used for culvert slope. Cobble/boulder substrate. Boulder cover.

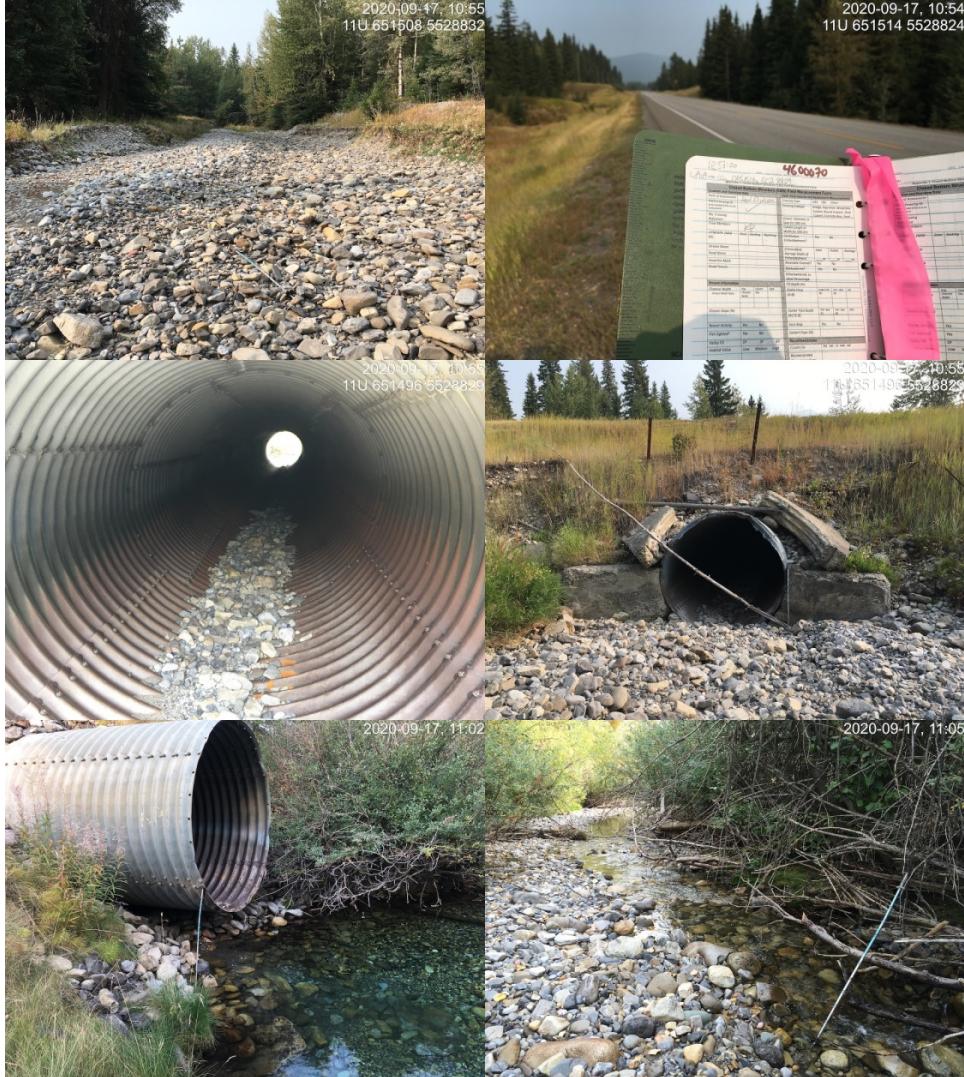
Photos: 4600070

Comments: Dewatered upstream of highway for 600m. Deep pool present downstream fed subsurface from northside of culvert. Approximately 9 WCT in outlet pool. Four fish ~300mm and 5 fish ~200 mm. High confidence that the larger fish were WCT as easy to recognize spotted backs from bank.

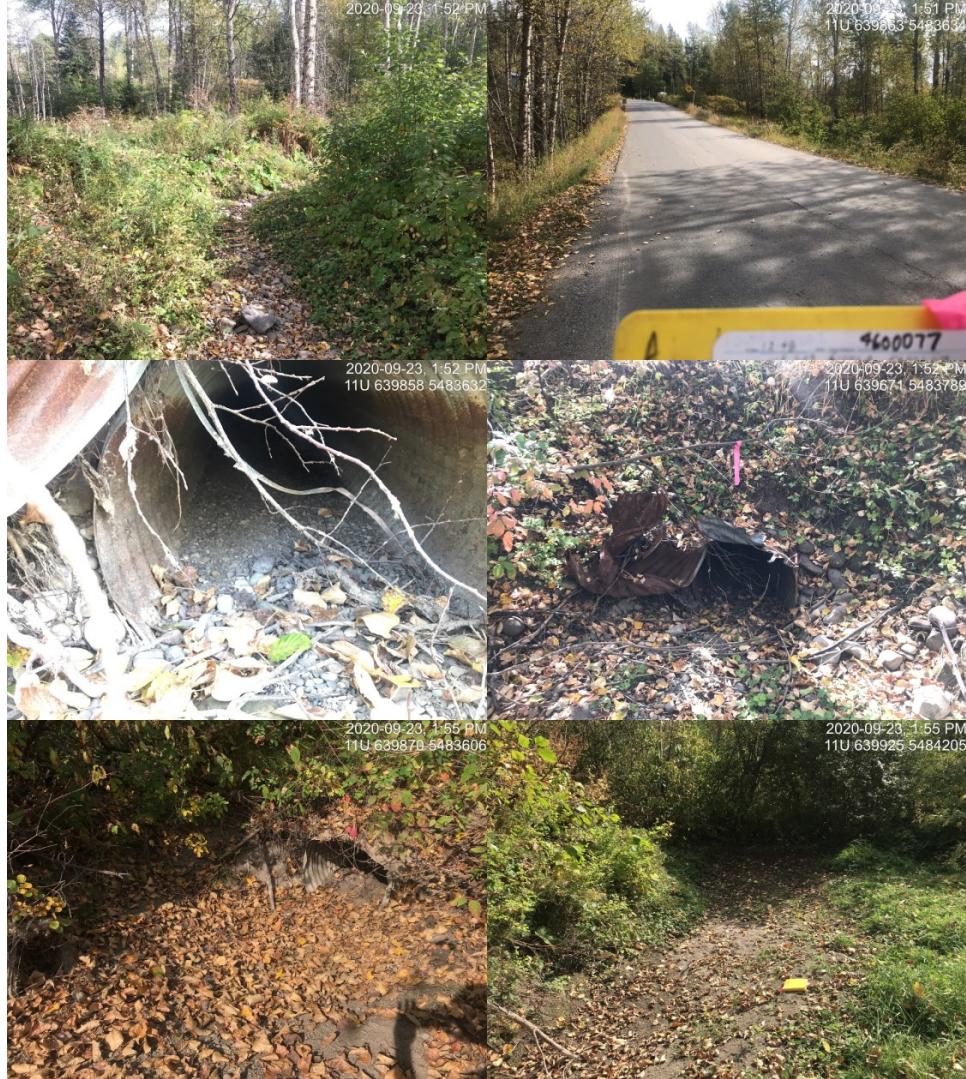
Photos: 4600077

Comments: Dry channel. Culvert is embedded.

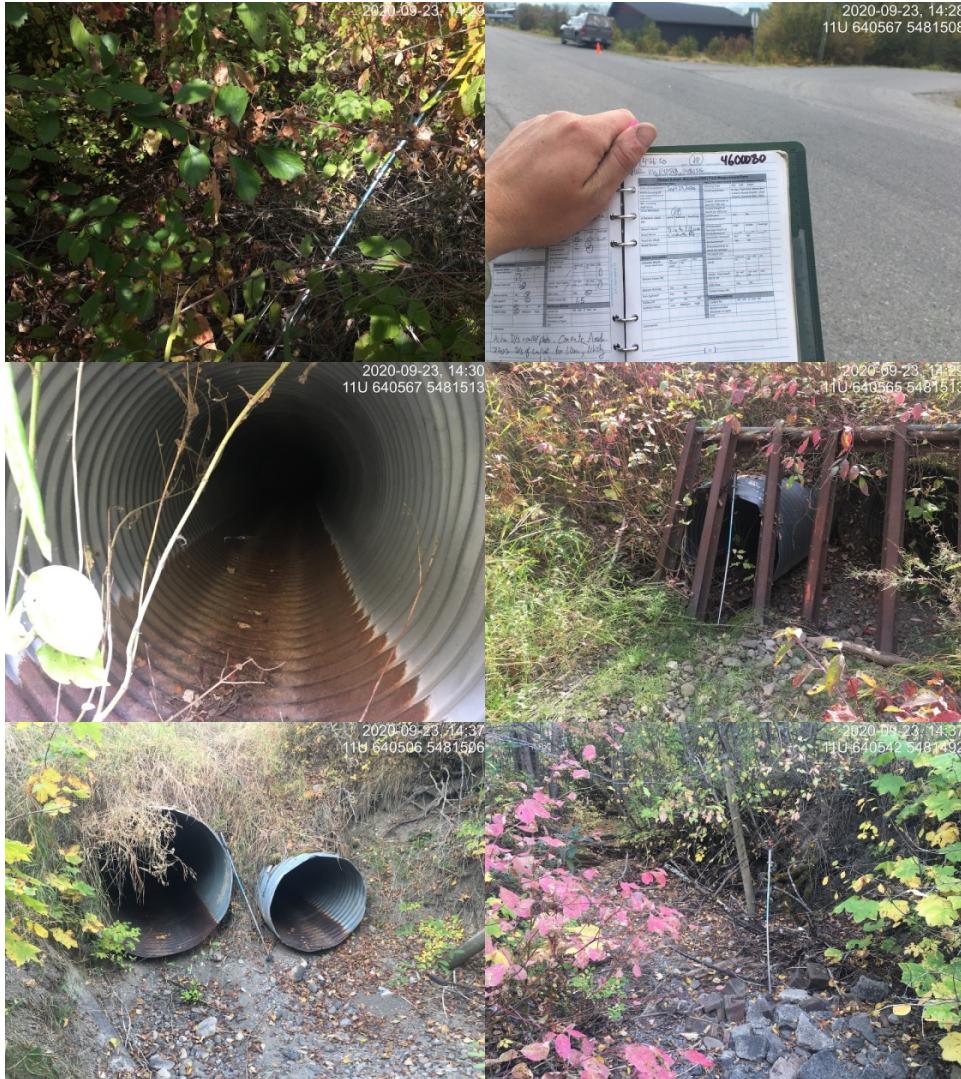
Photos: 4600080

Comments: 2 barrels, 0.90 and 1.1m. Debris rack on inlet. Stream dry at time of survey.

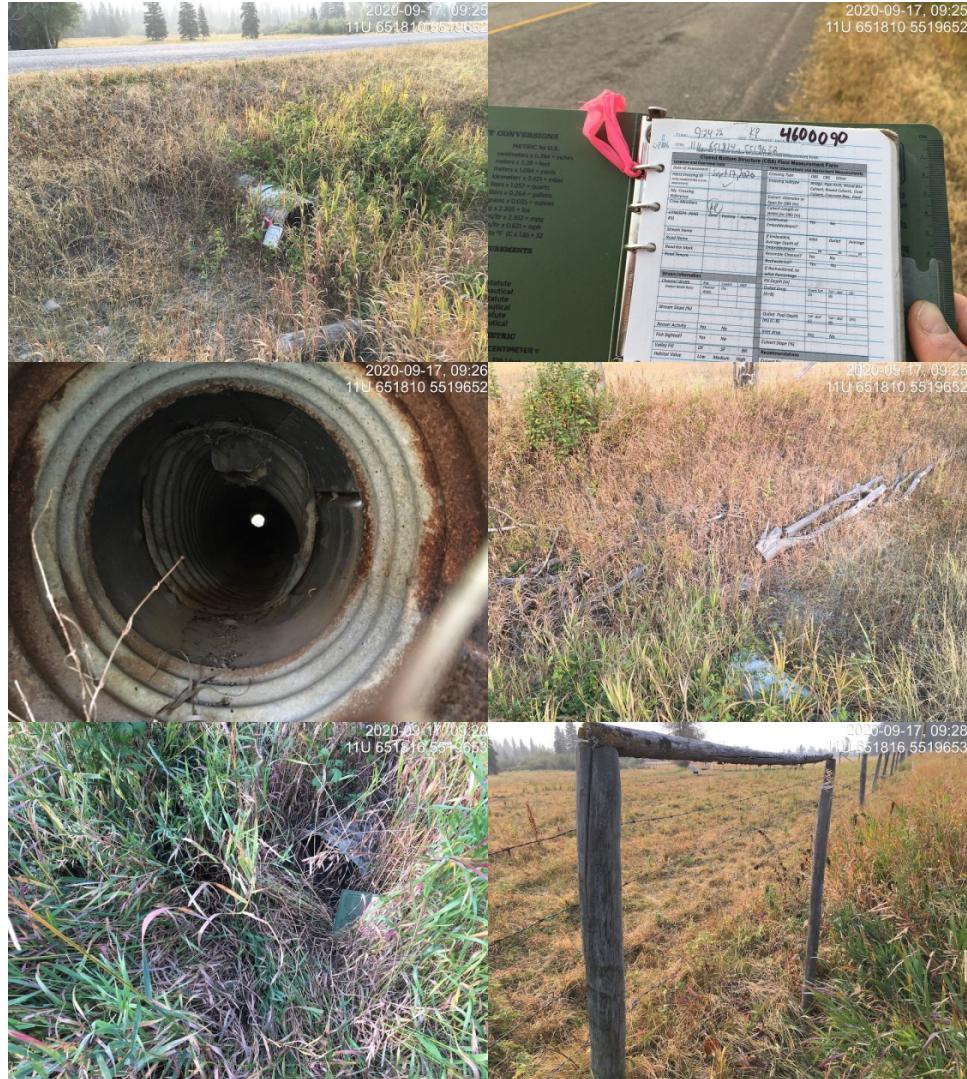
Photos: 4600090

Comments: No visible channel. Not likely fish habitat. Agricultural area.

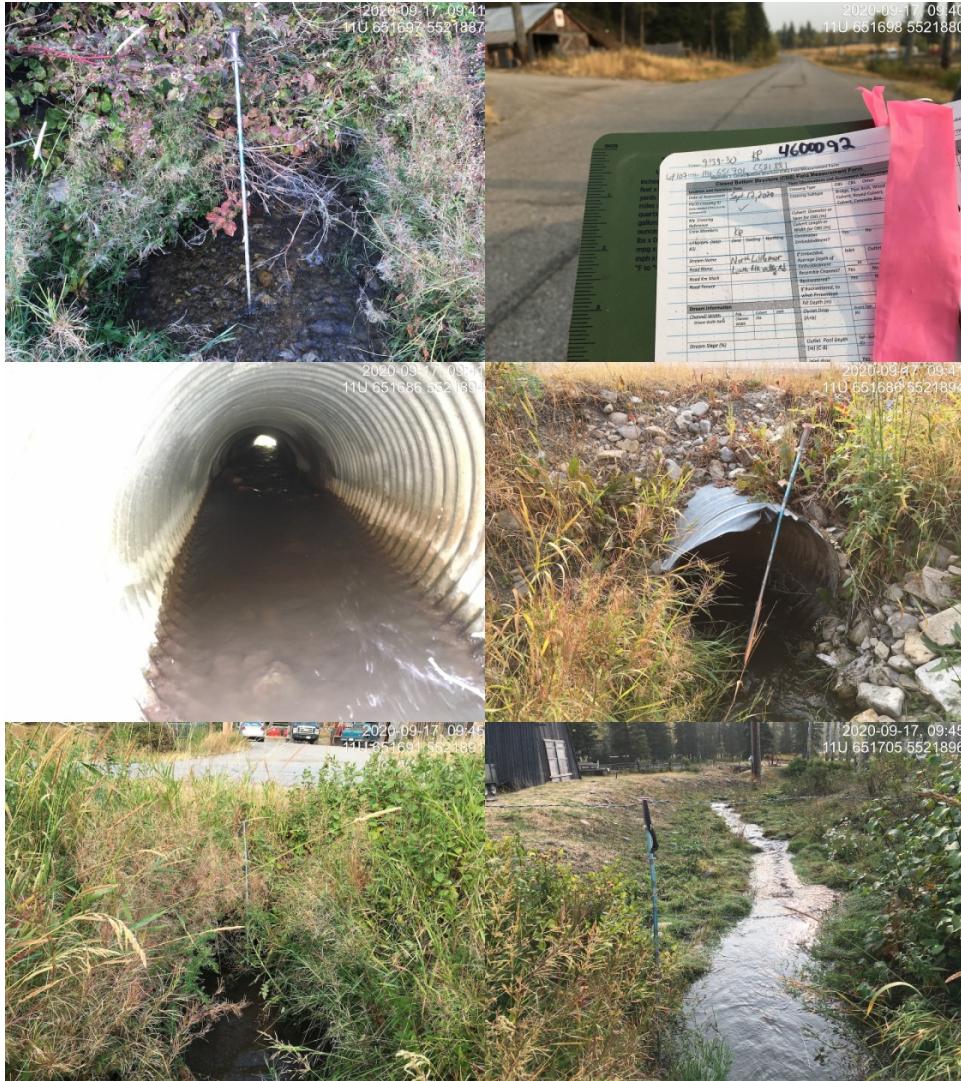
Photos: 4600092

Comments: Stream slope estimated due to fenced private land.

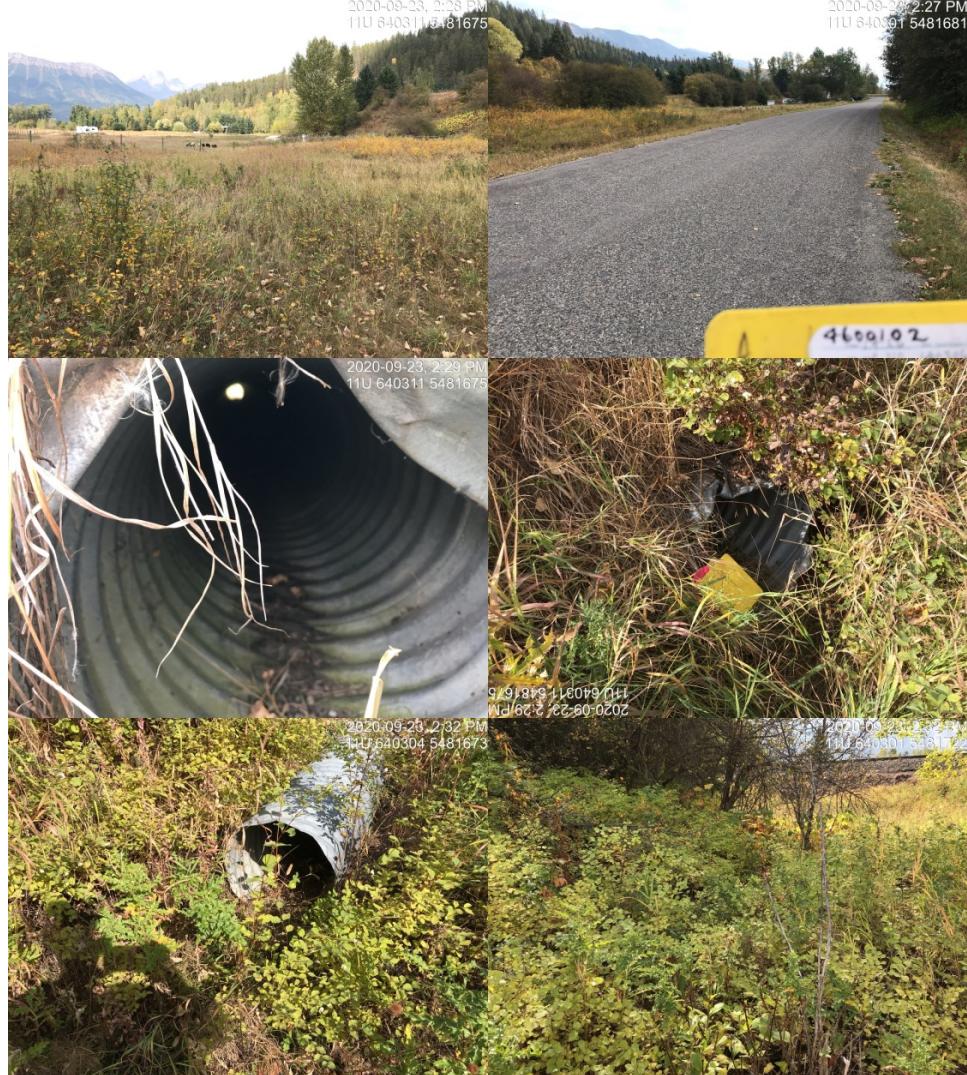
Comments: Vegetated channel. Not likely fish habitat.

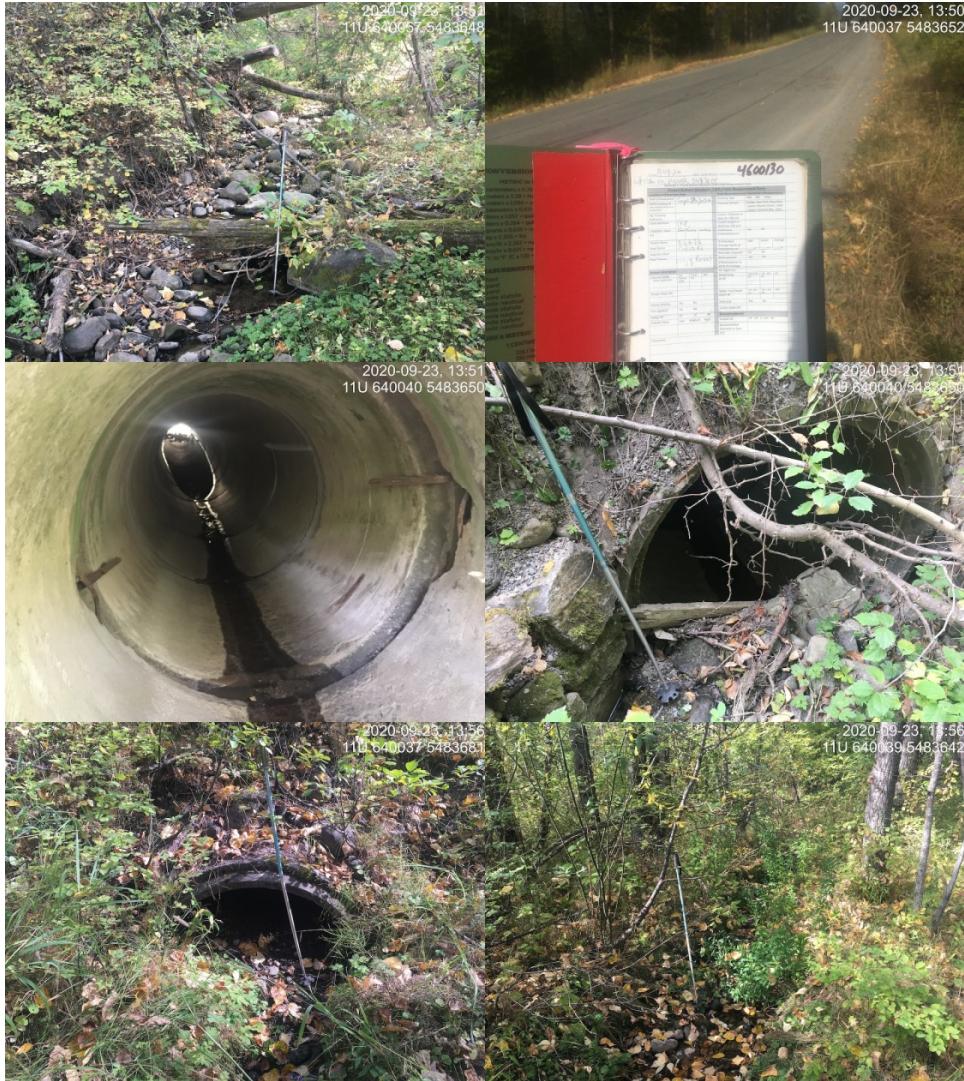
Comments: Very low flow at time of survey and 0.5m inlet drop from debris. Very steep culvert, possibly 2 sections with further upstream section being much steeper.

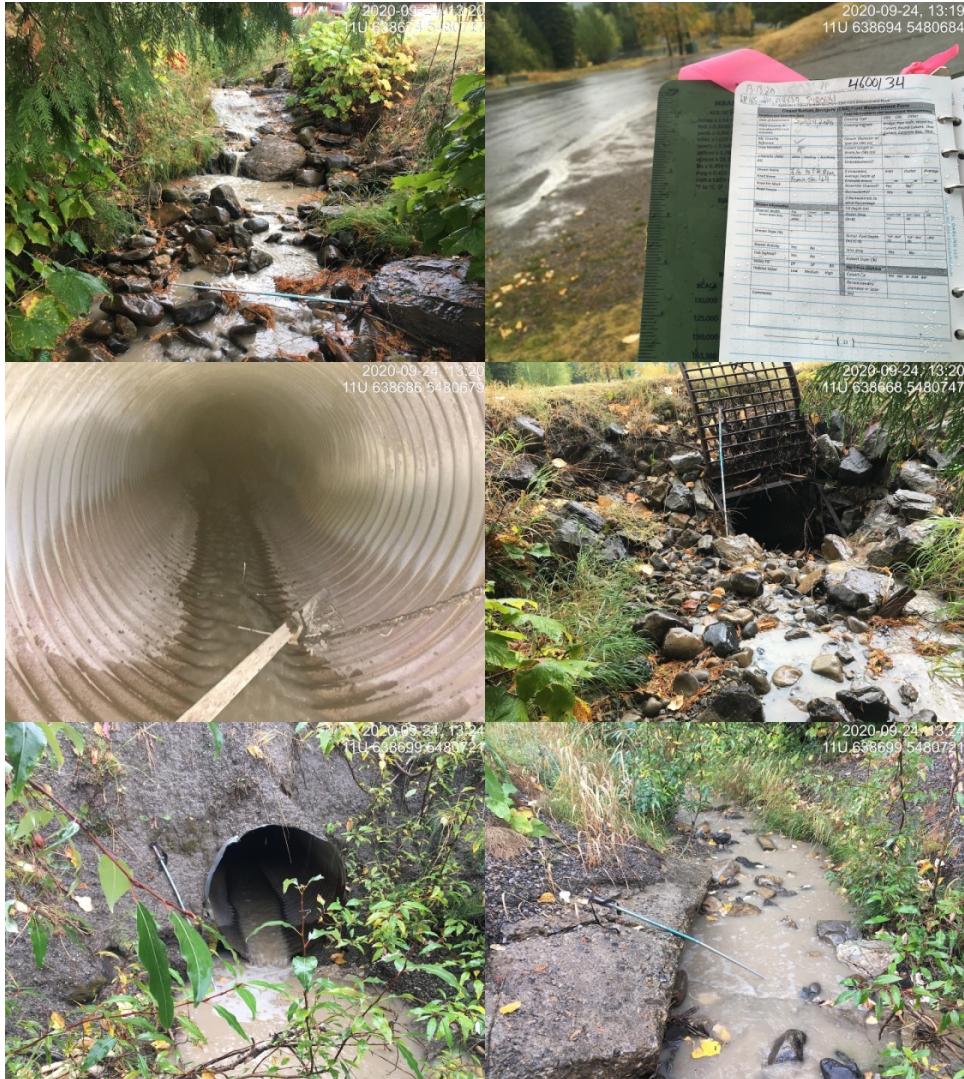
Comments: Debris guard on inlet. Unable to see through the culvert to other end. Highly manipulated banks, drains large parking area and ski hill. Steep with placed rocks (rip rap) in spots upstream. Stream goes under large turn around, paved area. Culvert likely >1 piece with slight angle. Armoured banks downstream, lots of sediment (sand) form pavement and parking area.

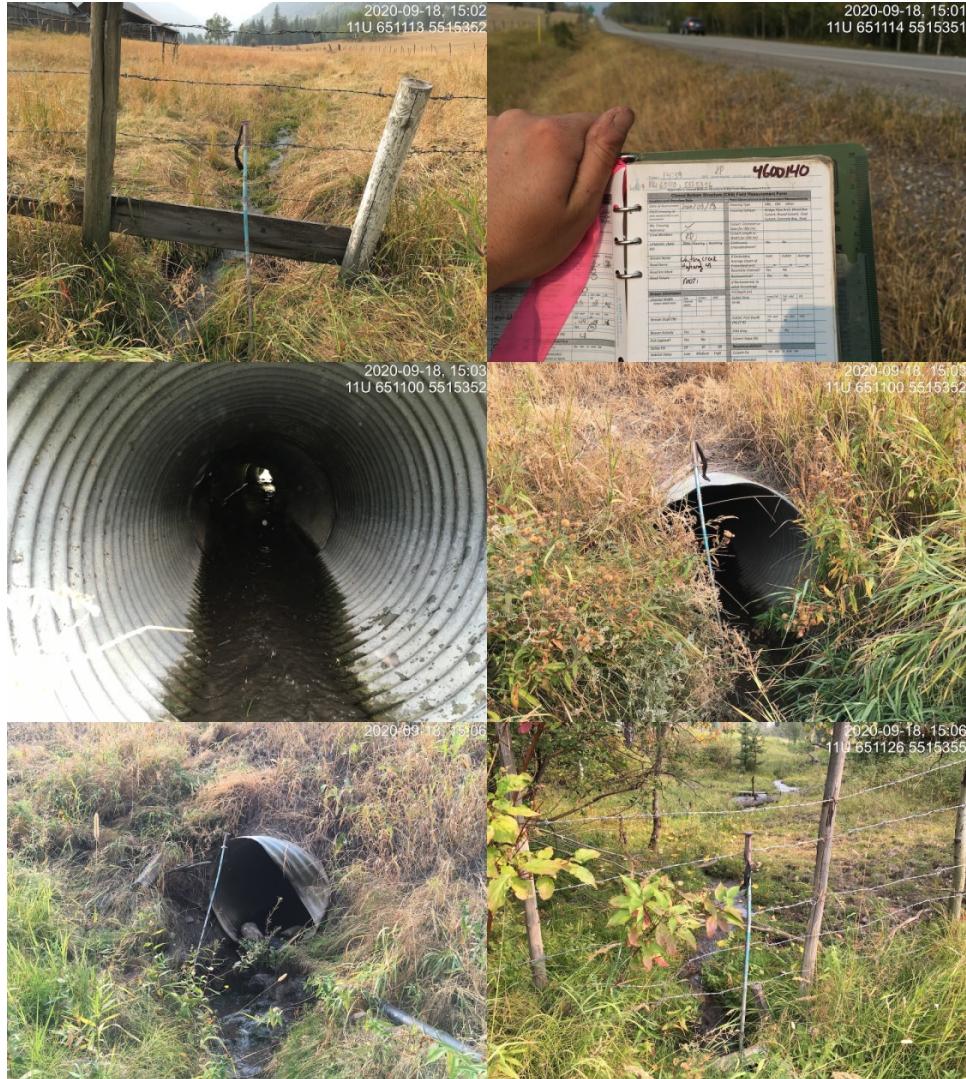
Comments: No access up or downstream due to fenced private land. Stream slope estimated.
Water pipe intake at the outlet.

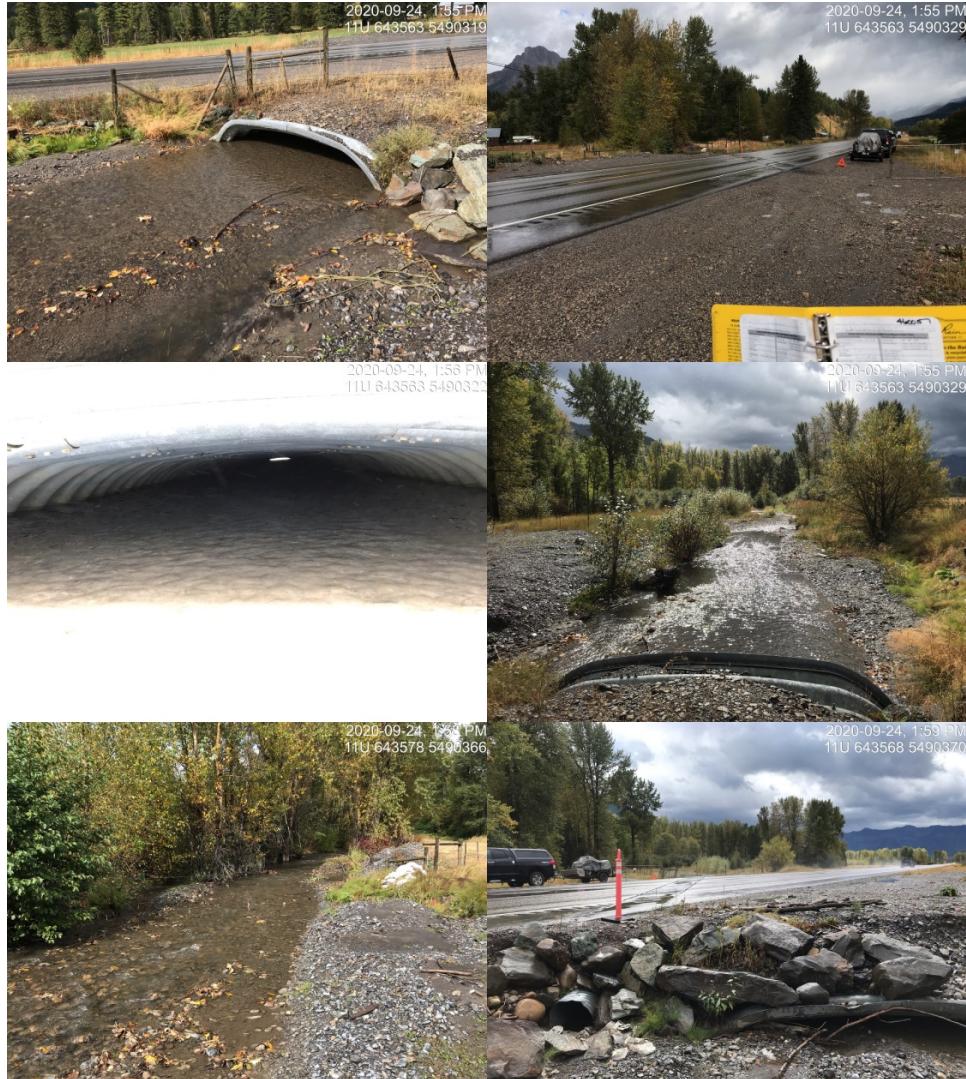
Comments: This crossing is very full of debris and has been recently dredges. Less than 30cm freeboard from top of aggraded gravels at inlet and top of pipe arch. Newly installed overflow pipe (0.55 diameter) on left bank.

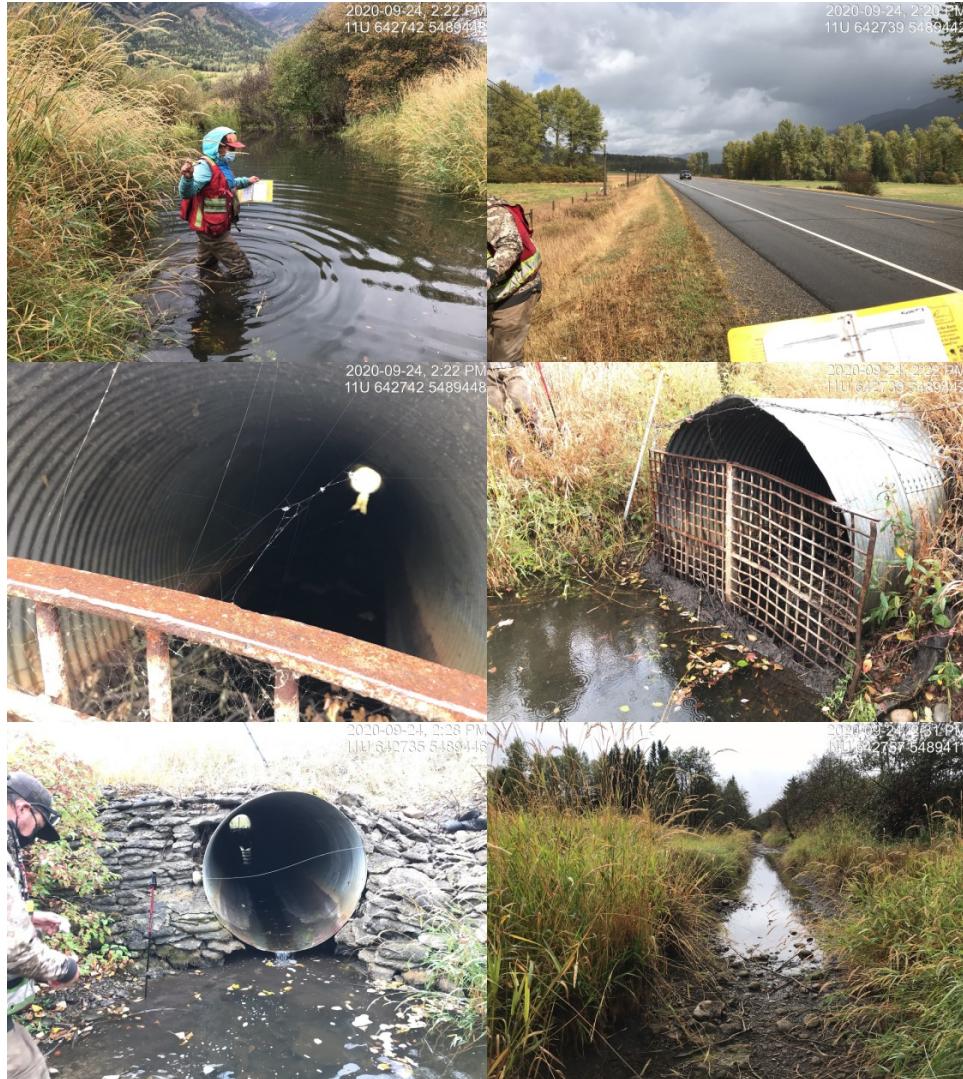
Comments: Fish observed at upstream crossing on Bean Rd. Grate on inlet may prevent passage off adult fish. Fill depth estimated from photos.

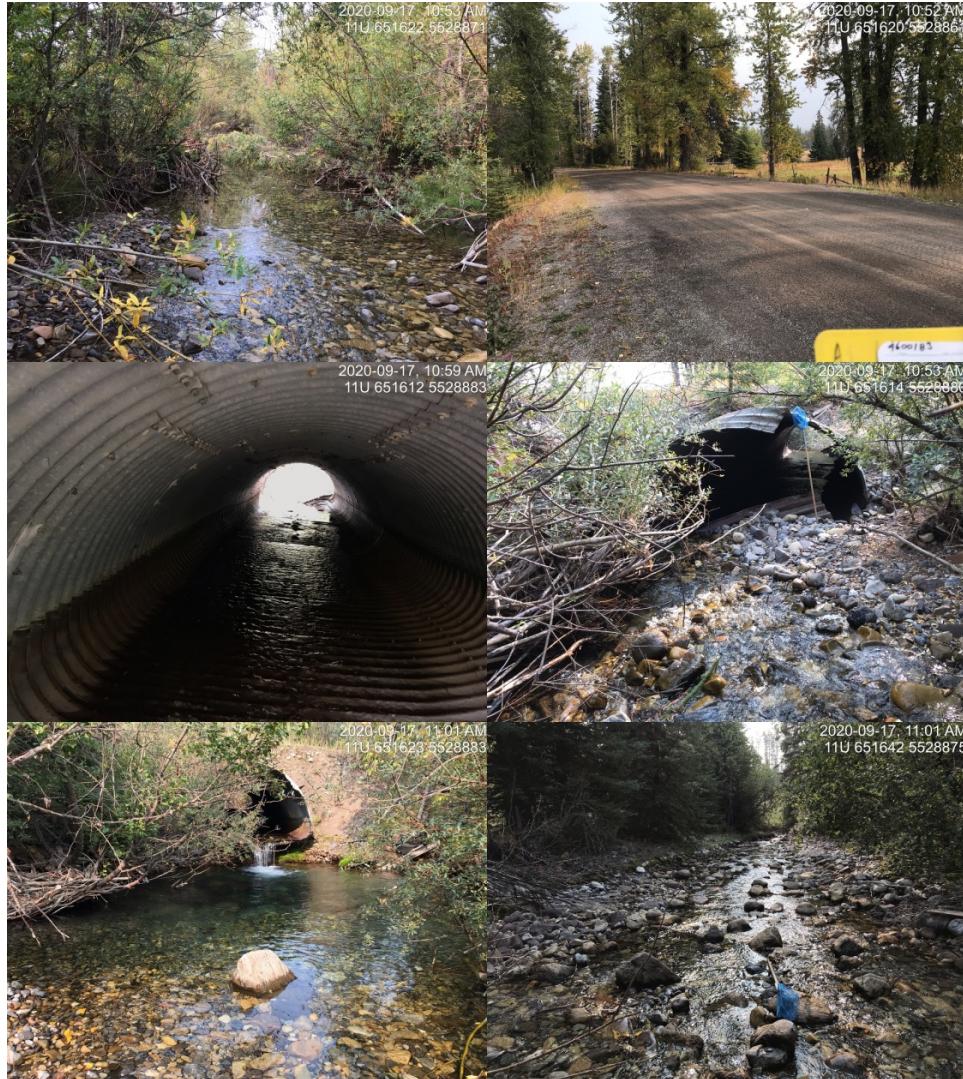
Comments: Large stream with good flow at this crossing. Culvert inlet is damaged and there is a large outlet drop. Upstream of highway the stream is subsurface for ~600m.

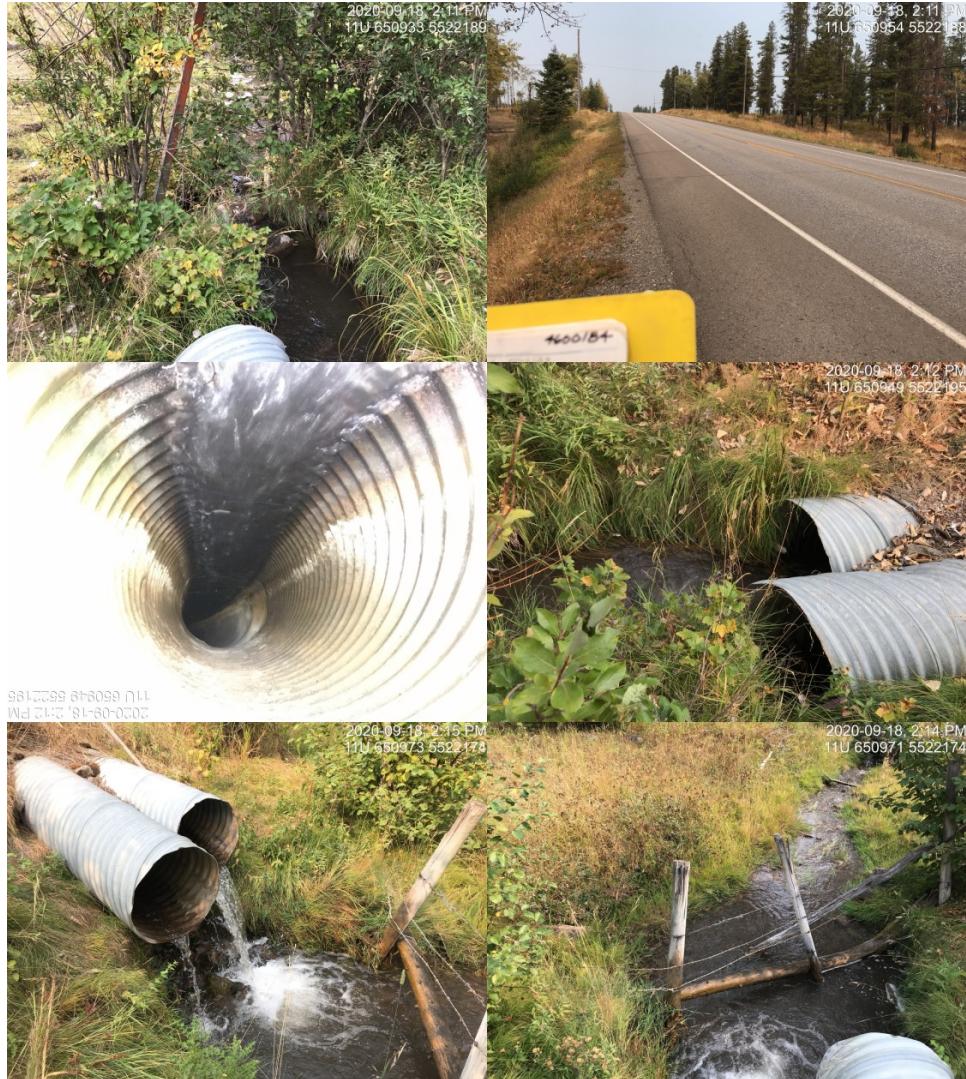
Comments: Small stream with good flow, EB known upstream. Fenced private land upstream and downstream. Stream measurements estimated due to fenced private land. Large outlet drop.

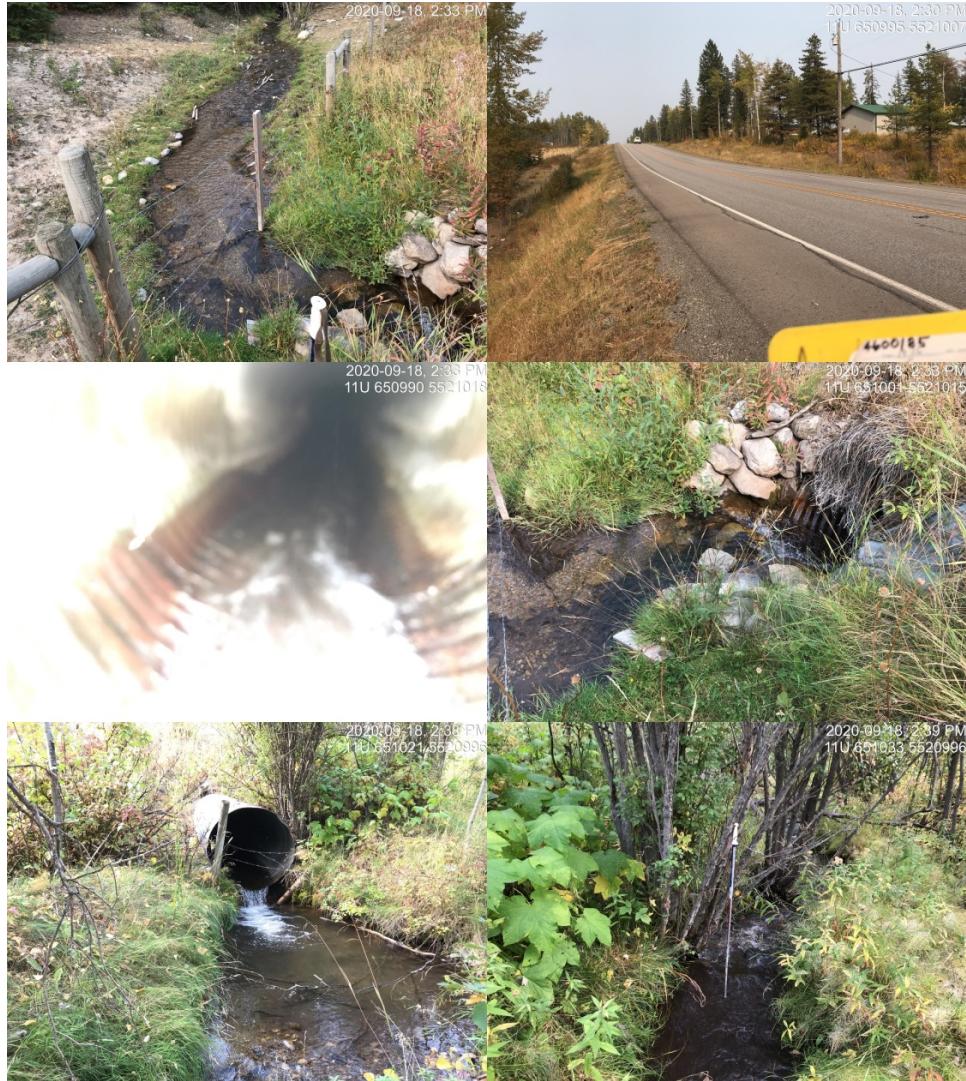
Comments: Culvert has extension with corner, small stream with good flow. WCT and EB documented upstream. Gravels present suitable for WCT and EB spawning.

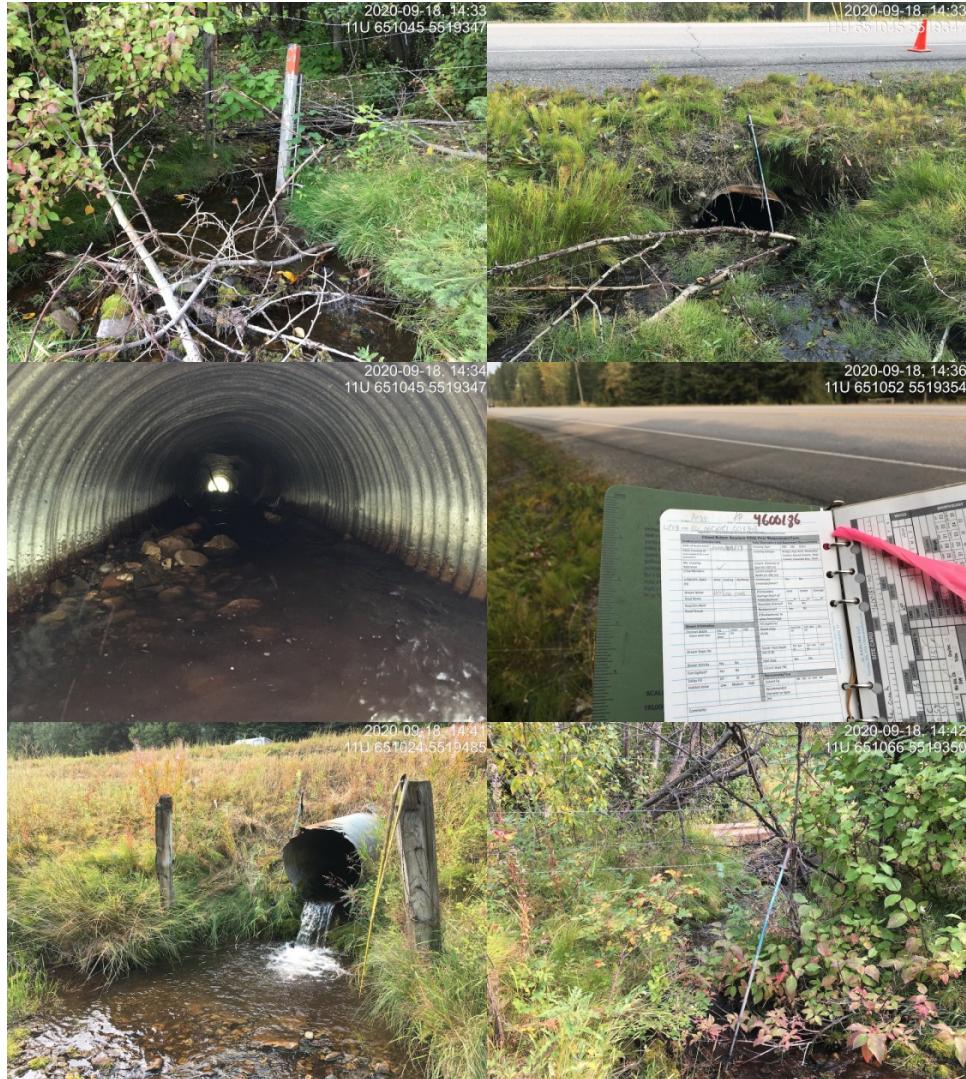
Comments: No access up or downstream due to fenced private land. Stream slope estimated.

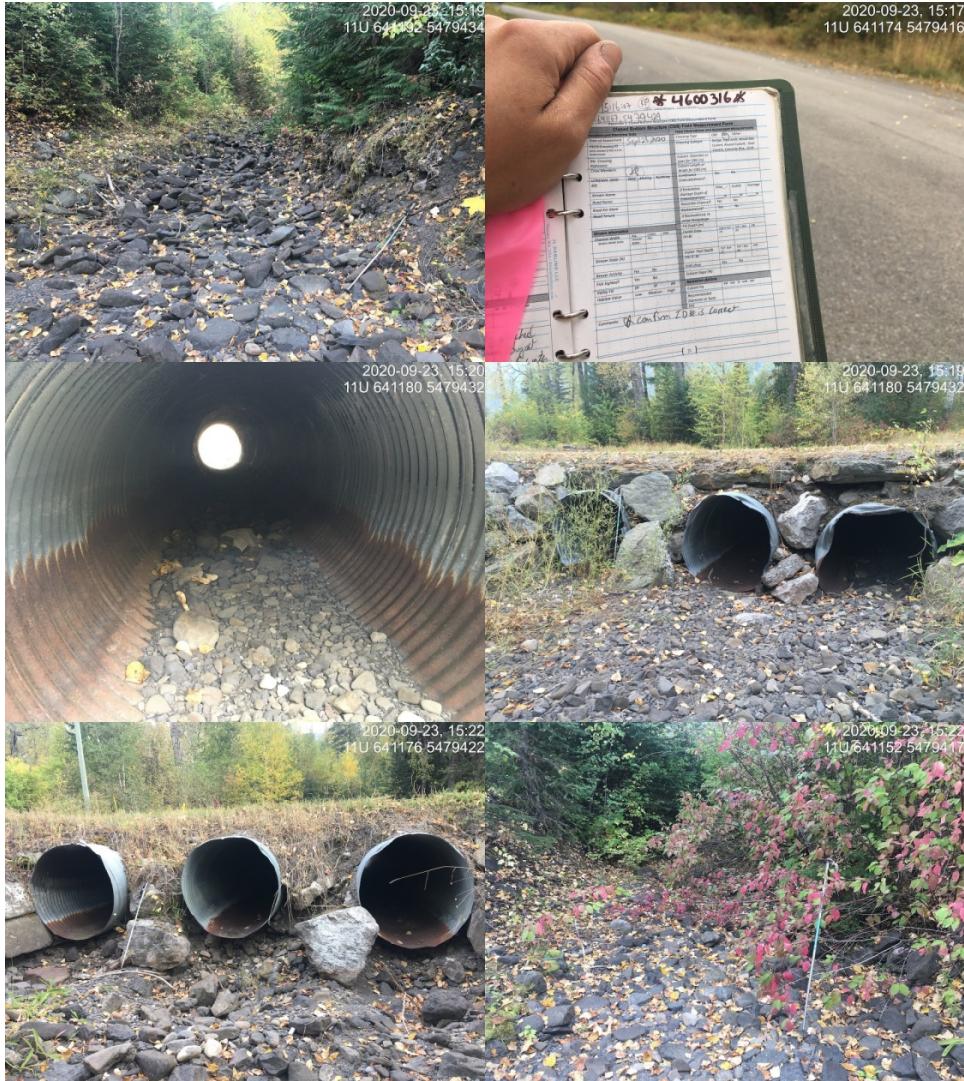
Comments: Stream dry at time of survey. Three barrels, 1.2m in diameter. All three very similar elevation, all perched .2-.50m above substrate.

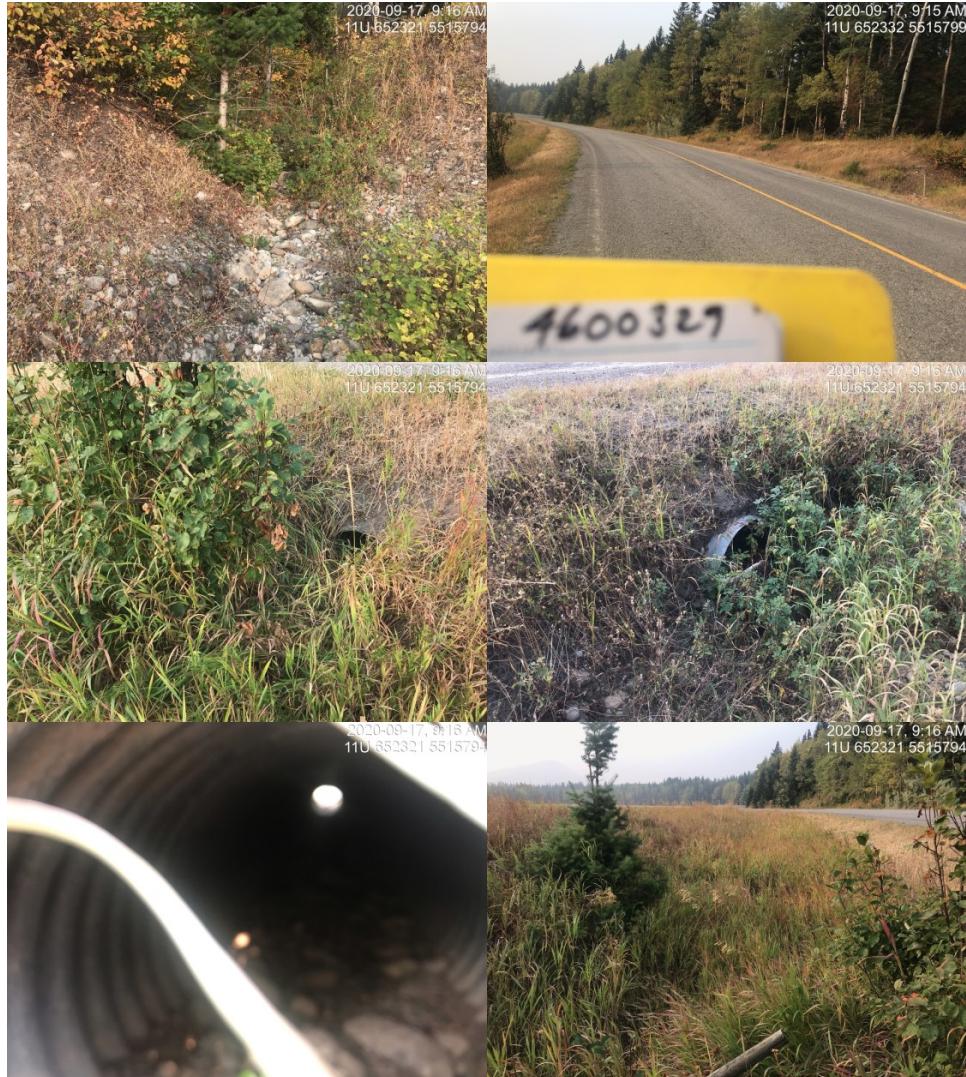
Comments: Whiting creek appeared to not be present through agricultural field downstream. This appeared to be only channel present for Whiting crossing this road although the main Whiting channel is present upstream. Dry, heavily vegetated channel downstream. Defined channel upstream but seems unlikely to be fish bearing.

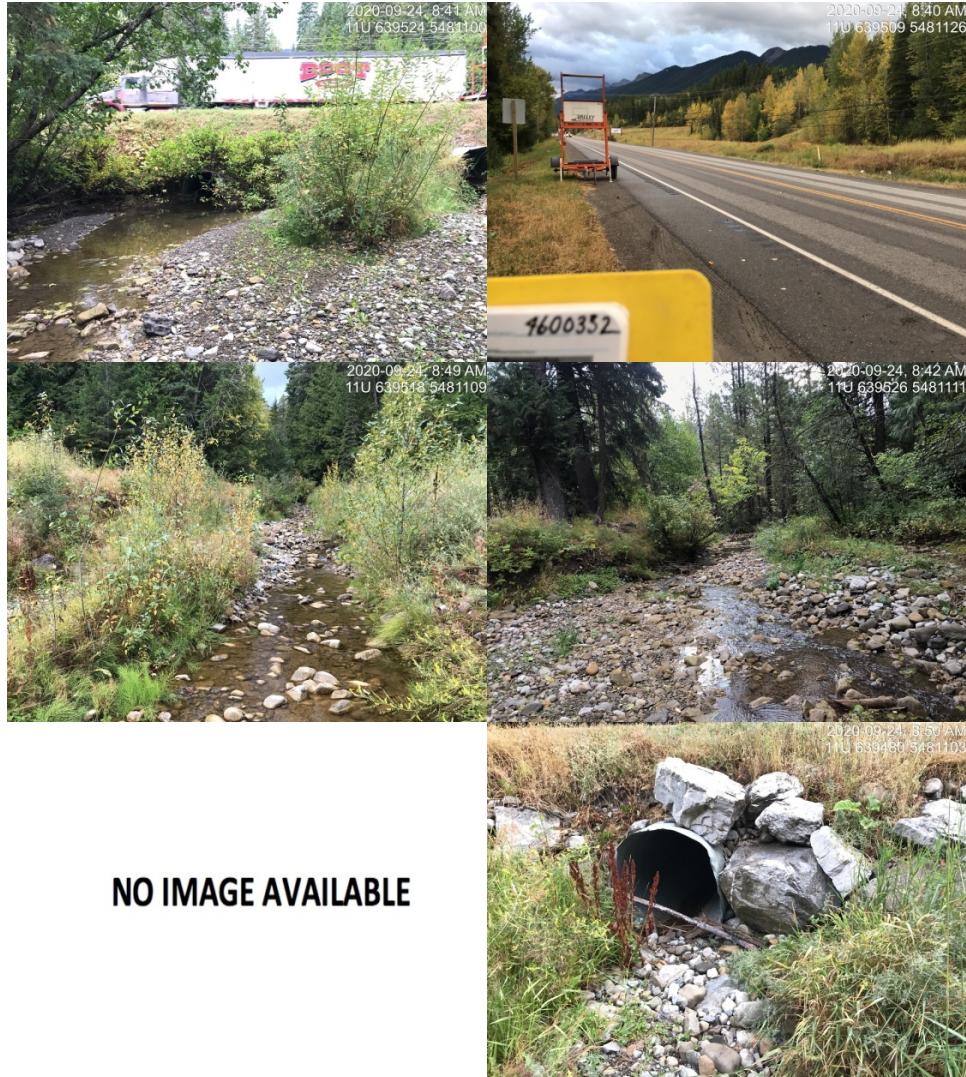
Comments: Fry observed at outlet pool. Inlet of active pipe mostly plugged with debris. Overflow pipe is 0.8m outlet drop with fry/juveniles stranded in outlet pool. Flows out of Fernie Ski Hill Road development area.

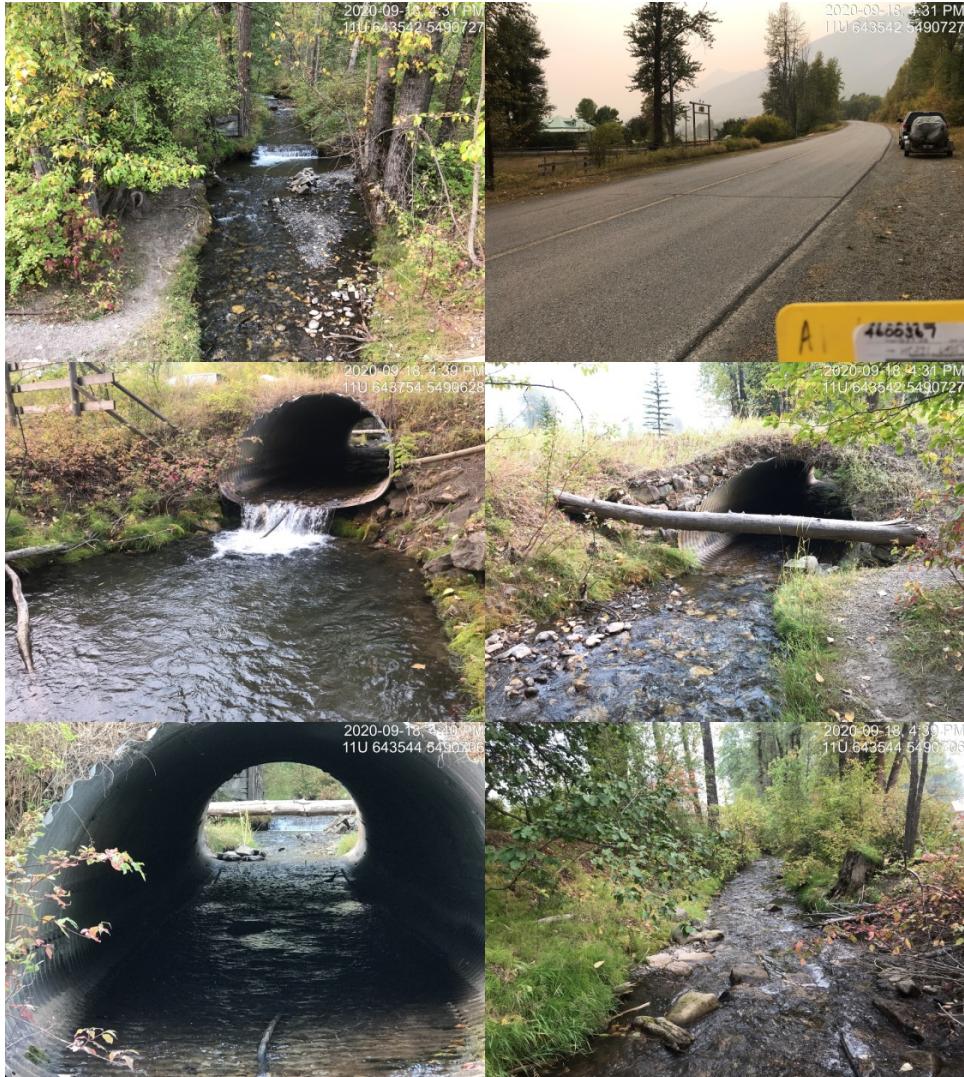
Photos: 4600367

Comments: Laser level used for culvert slope. WCT spawning system. See Management Plan for the Westslope Cutthroat Trout (*Oncorhynchus clarkii lewisi*) in British Columbia 2014
<http://a100.gov.bc.ca/pub/eirs/finishDownloadDocument.do?subdocumentId=9781>

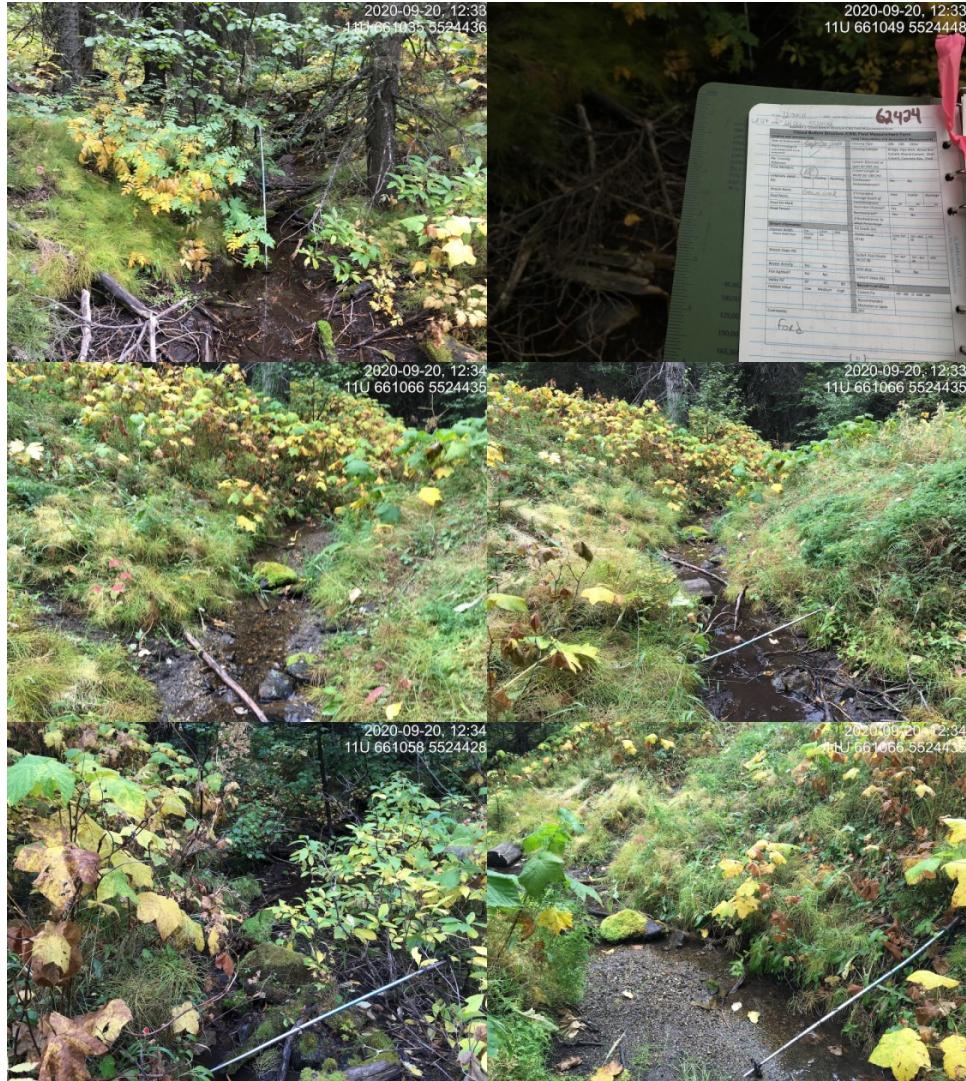
Photos: 4601129

Comments: Deactivated road. Ford.
