Elk River Watershed Group Fish Passage Restoration Planning

Prepared for Canadian Wildlife Federation

New Graph Environment

2020-12-22 DRaft

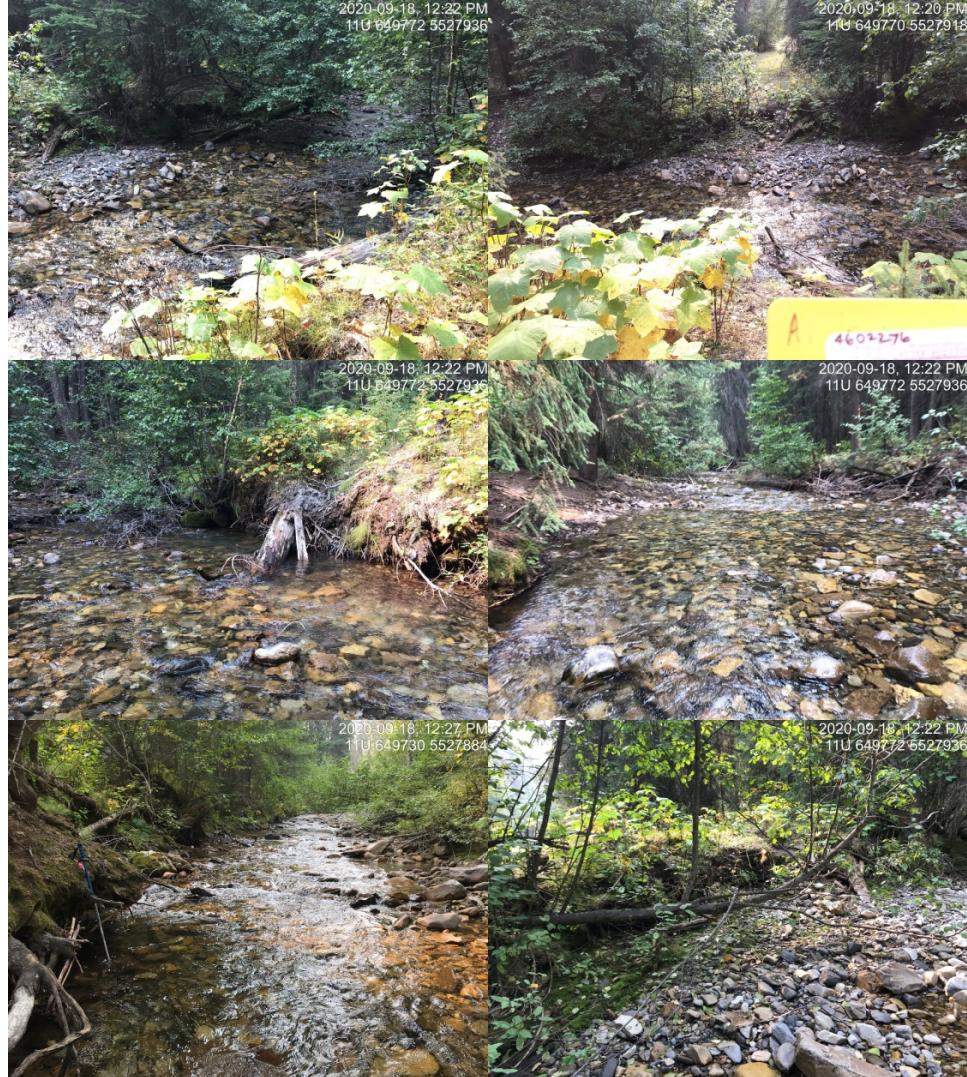
Photos: 4601205

Comments: Pulled crossing, no issues, is now a ford.

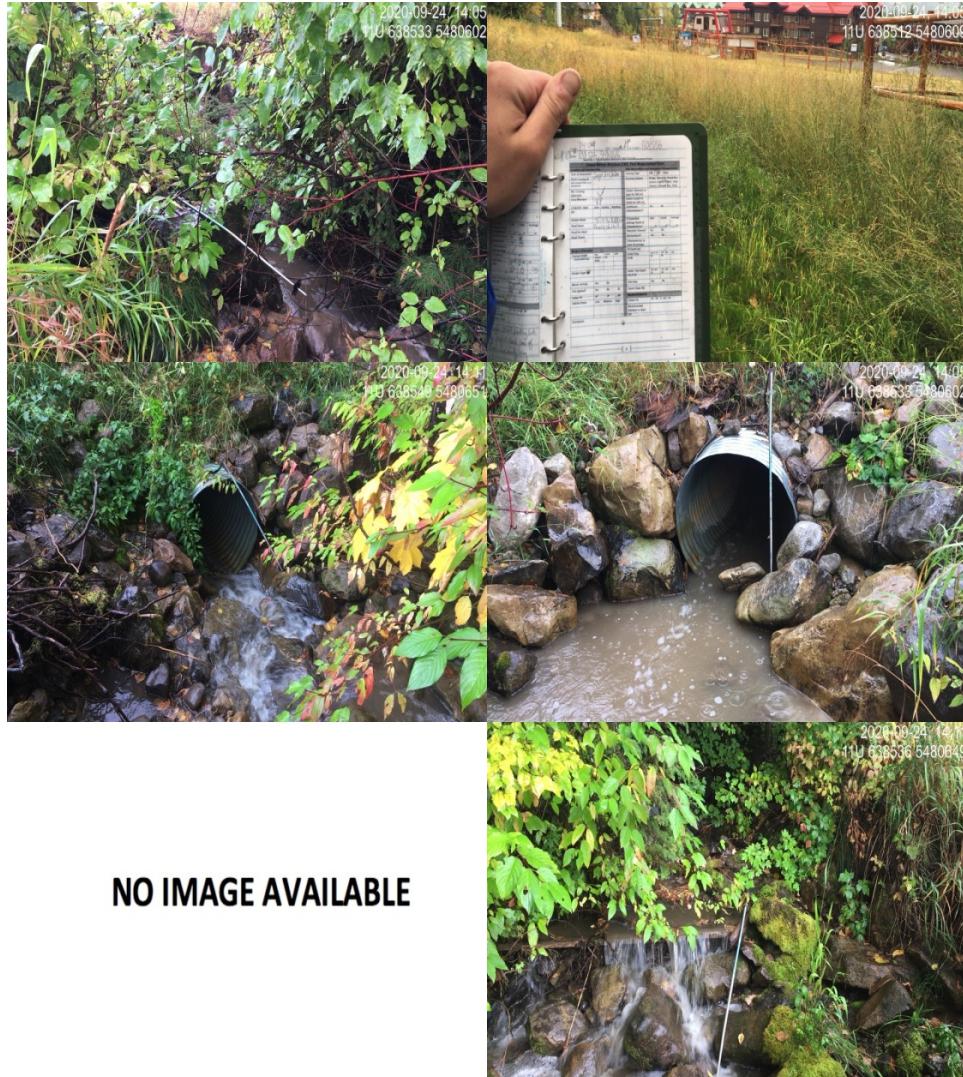
Photos: 4601556

Comments: Stream gradient immediately upstream of crossing is near 20%. Crossing is last of a series within close proximity to each other. The crossing downstream of this one is near 100m long. Likely more crossings upstream on ski hill infrastructure and access roads. Recent heavy rains.

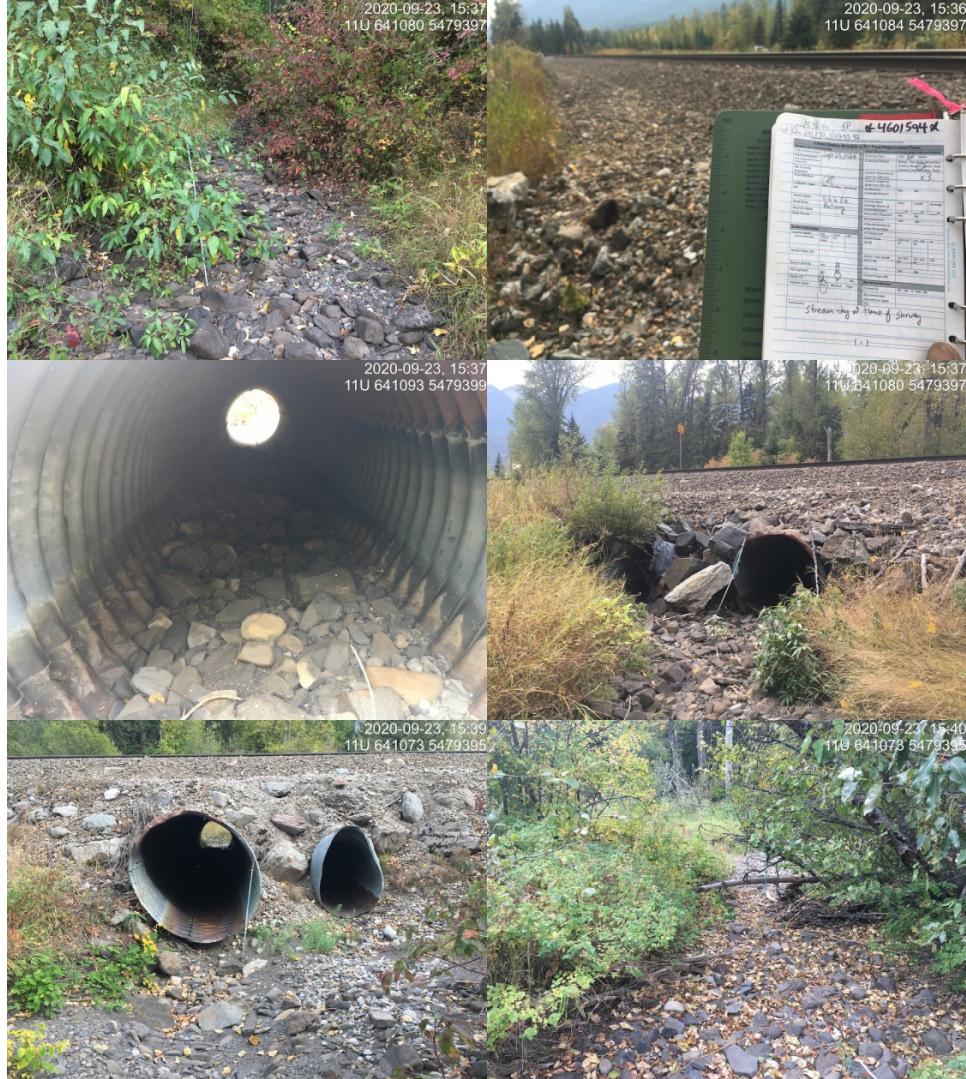
Comments: Stream dry at time of survey. 2 barrels (0.80 and 1.5m in diameter), similar heights but 1.5m slightly lower. Smaller barrel inlet damaged.

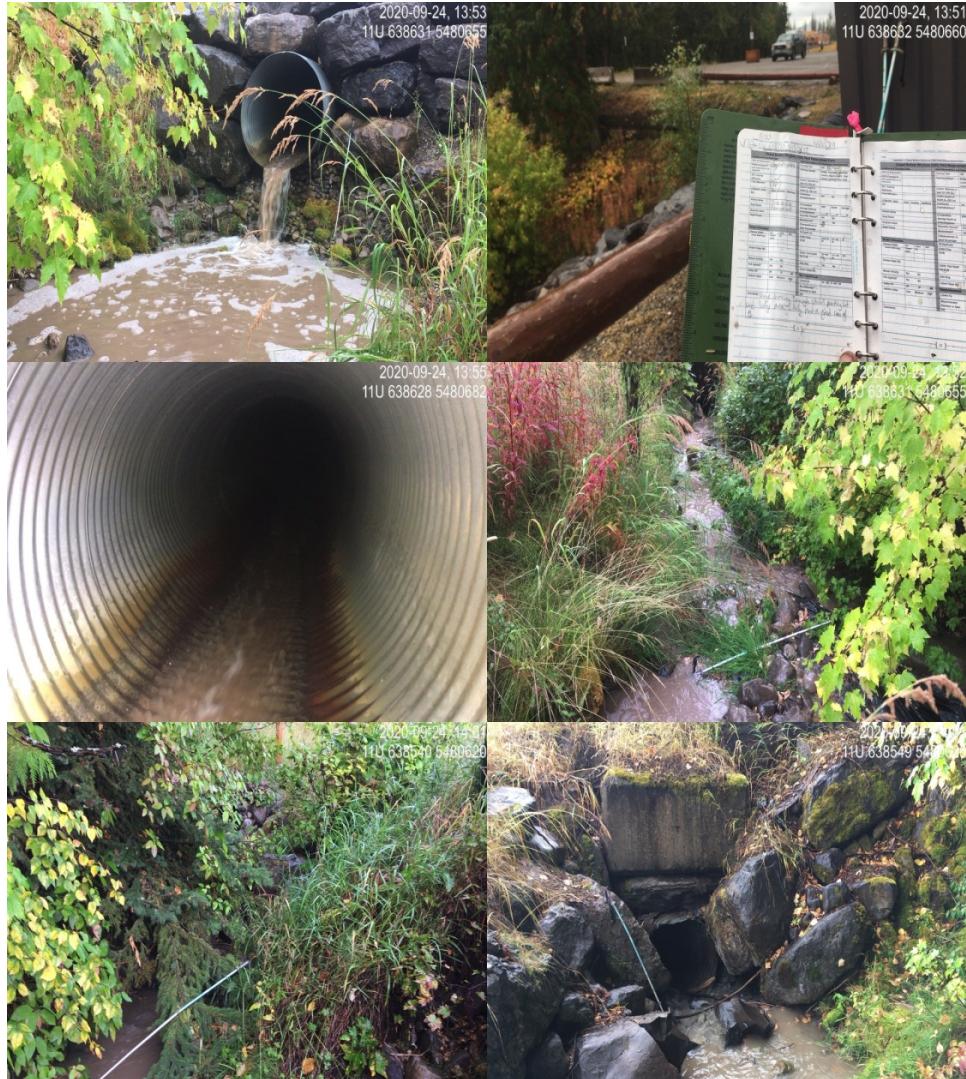
Comments: Huge crossing through the ski hill parking lot and lodge area. Large outlet drop and pool, extremely long culvert (close to 100m) tied in with other drainage infrastructure at the base of the Fernie ski hill. Inlet drop about .15m.

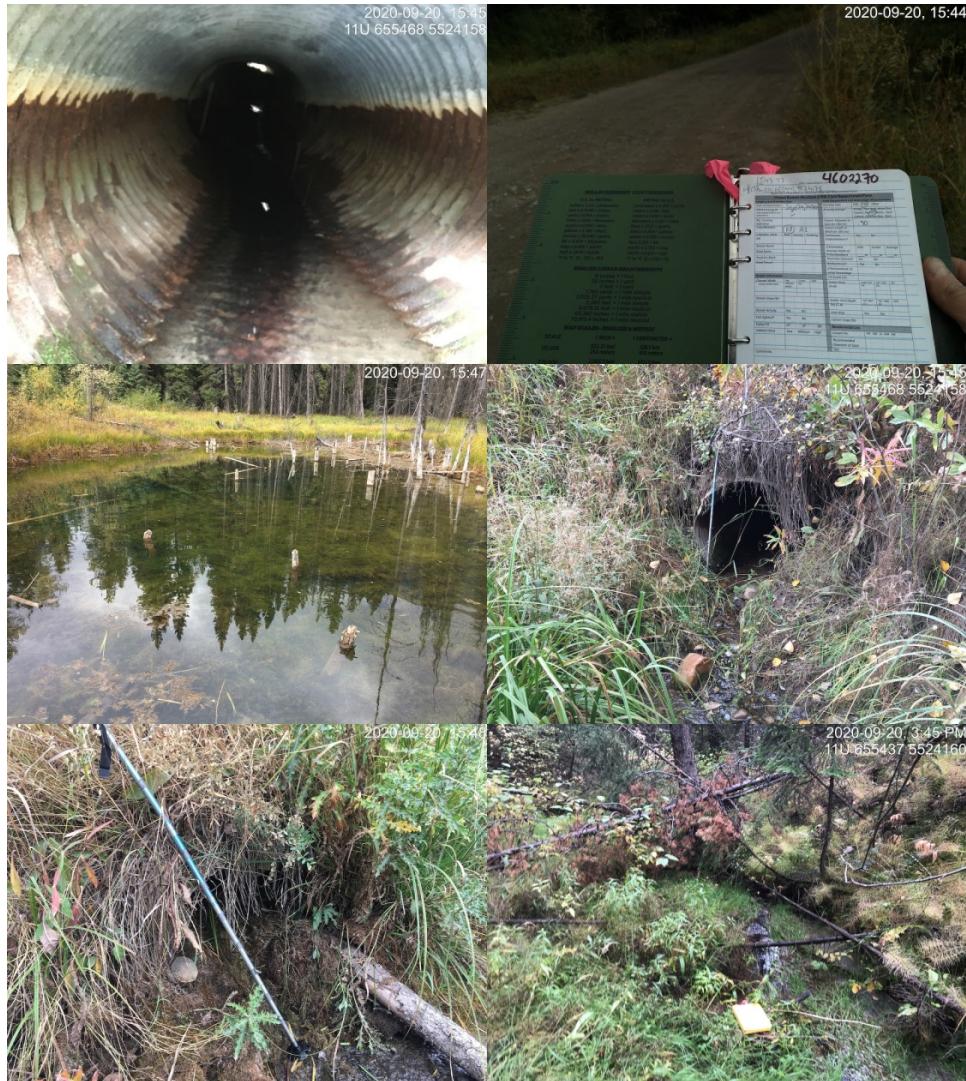
Comments: Inlet clogged with debris 3/4 of way up. Upstream area is wetland/pond.

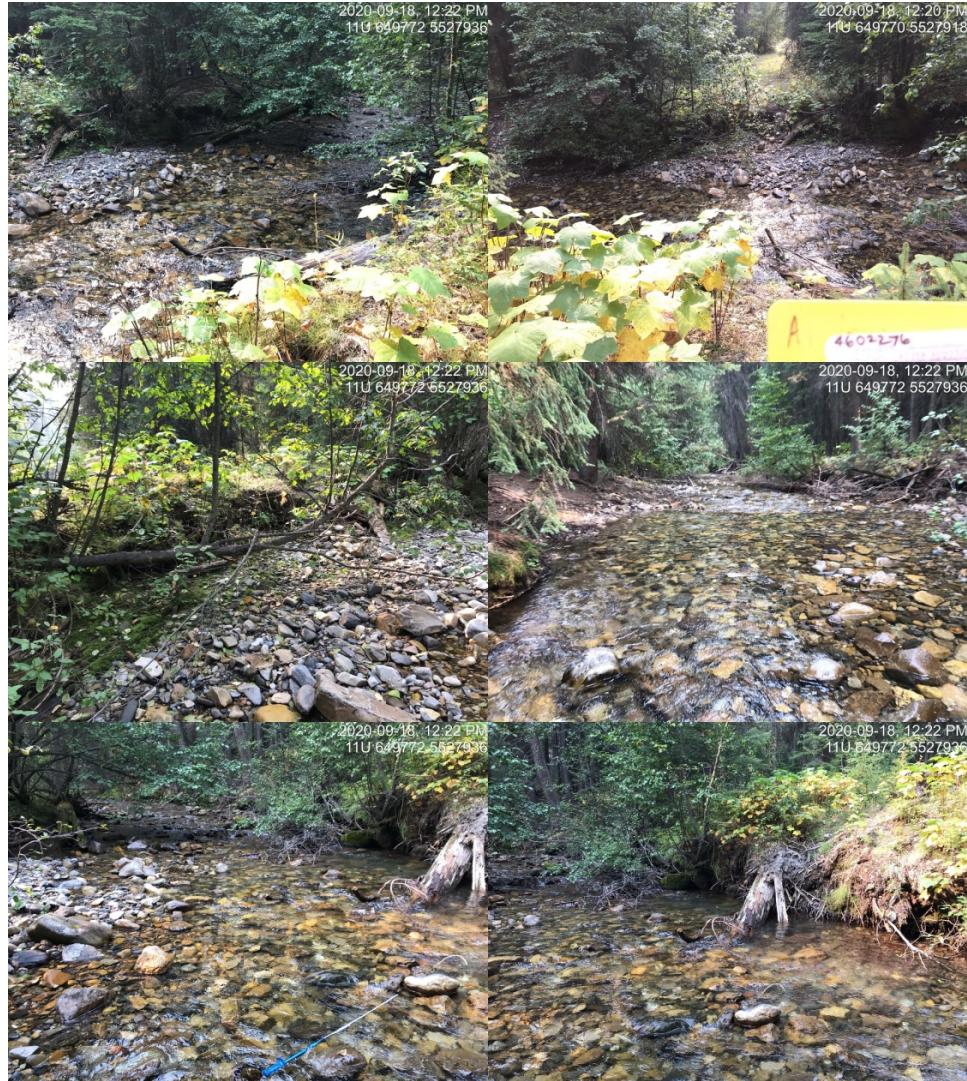
Photos: 4602276

Comments: Deactivated. Ford. no issues.

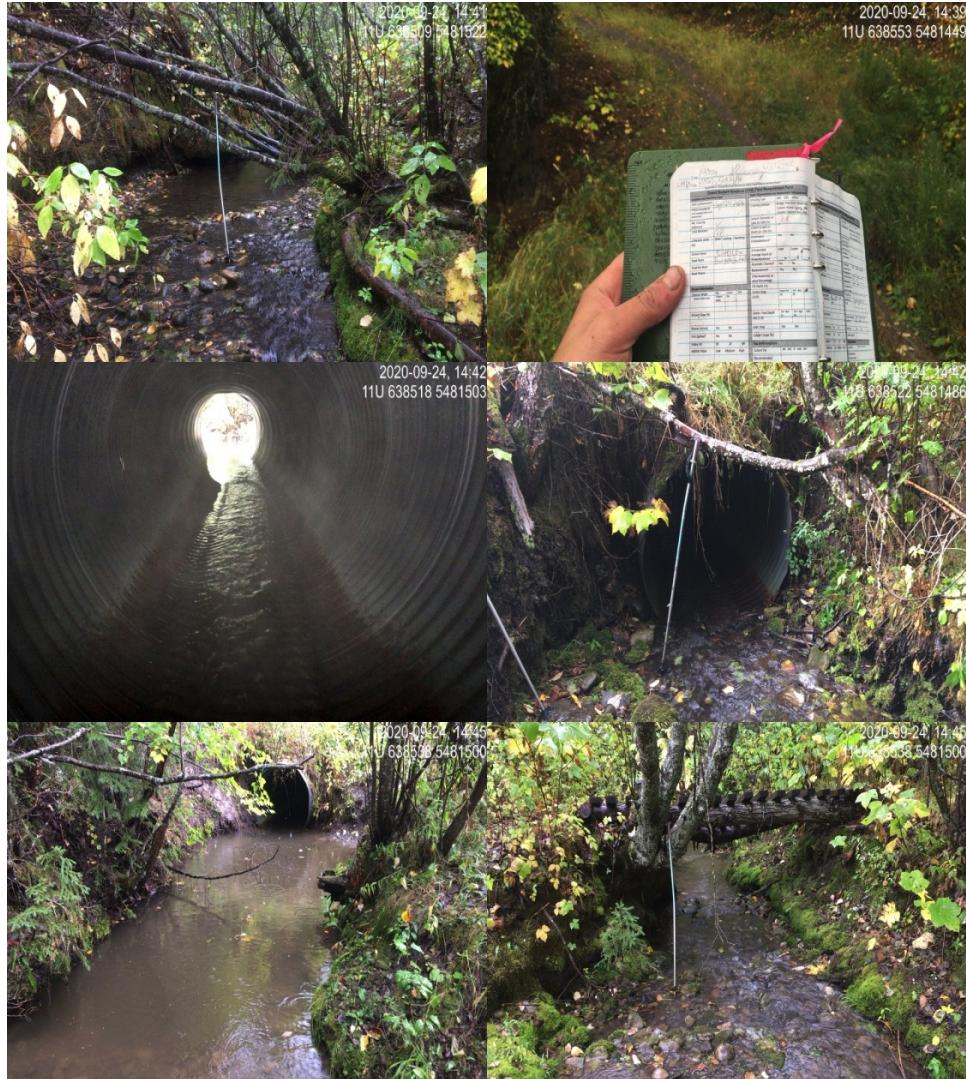
Comments: Outlet pool appears dredged, very deep, approximately 2m and 7-8m long. Nice stream, good flow.

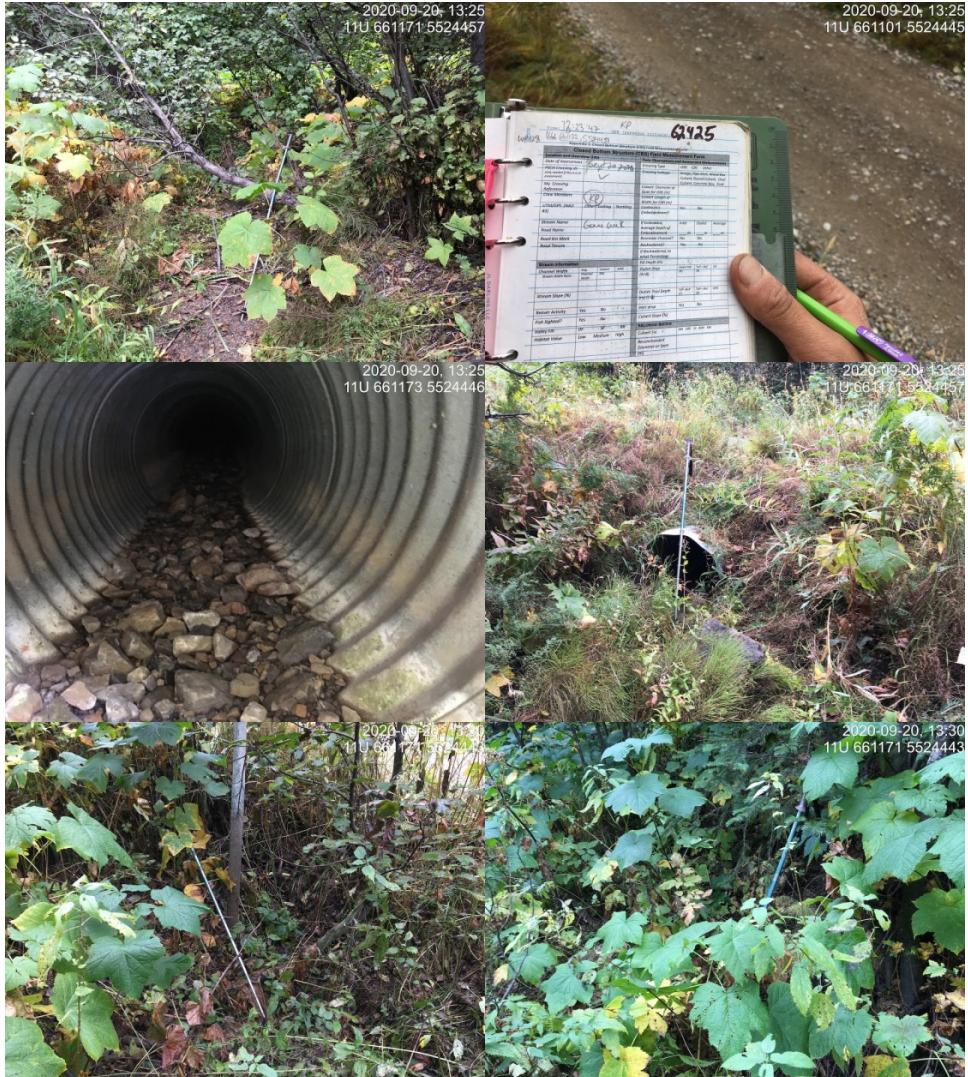
Comments: Stream dry at time of survey, channel not visible for about 40 downstream. Water and channel appear about 65m downstream of crossing. Upstream side of crossing inlet not visible, covered by road fill or deep organic debris. Channel upstream non-existent and dry. This system (labelled as Grave creek on the map) must be a side channel or remnant channel.

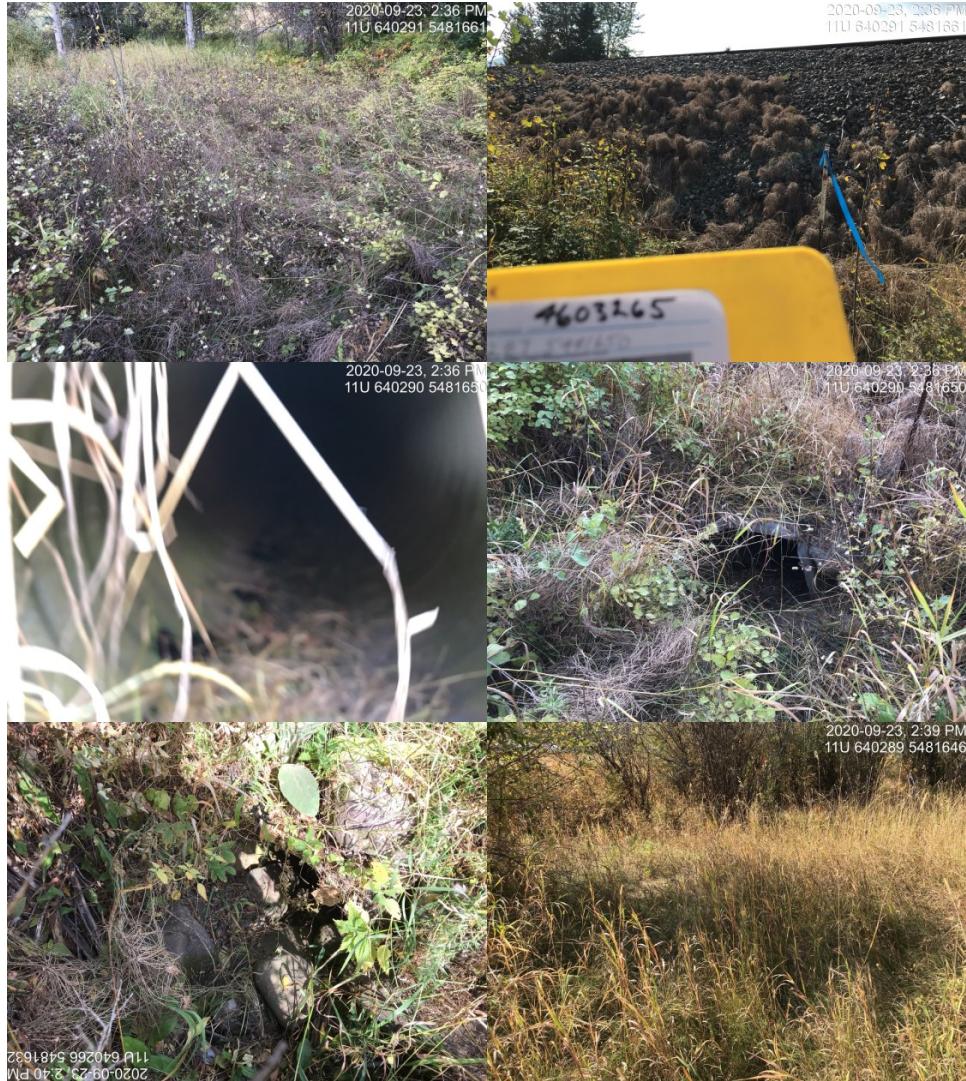
Photos: 4603265

Comments: Dry vegetated channel. Not likely fish habitat.

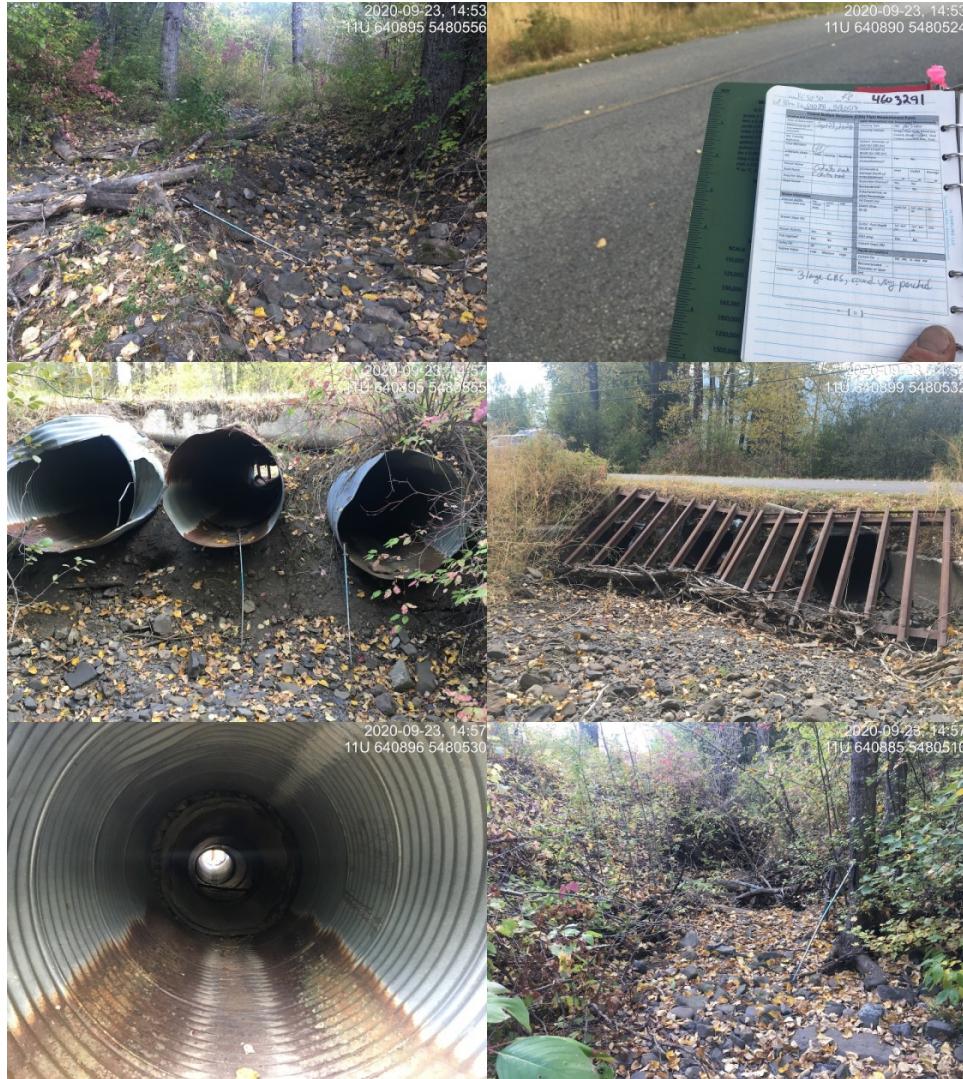
Comments: 3 large barrels (all 1.2m), very perched 0.7-1.3m above substrate. Stream dry at time of survey. Debris rack on upstream side of culvert. Note there is a slope change at the inlet of structure, much steeper short section possibly from damage.

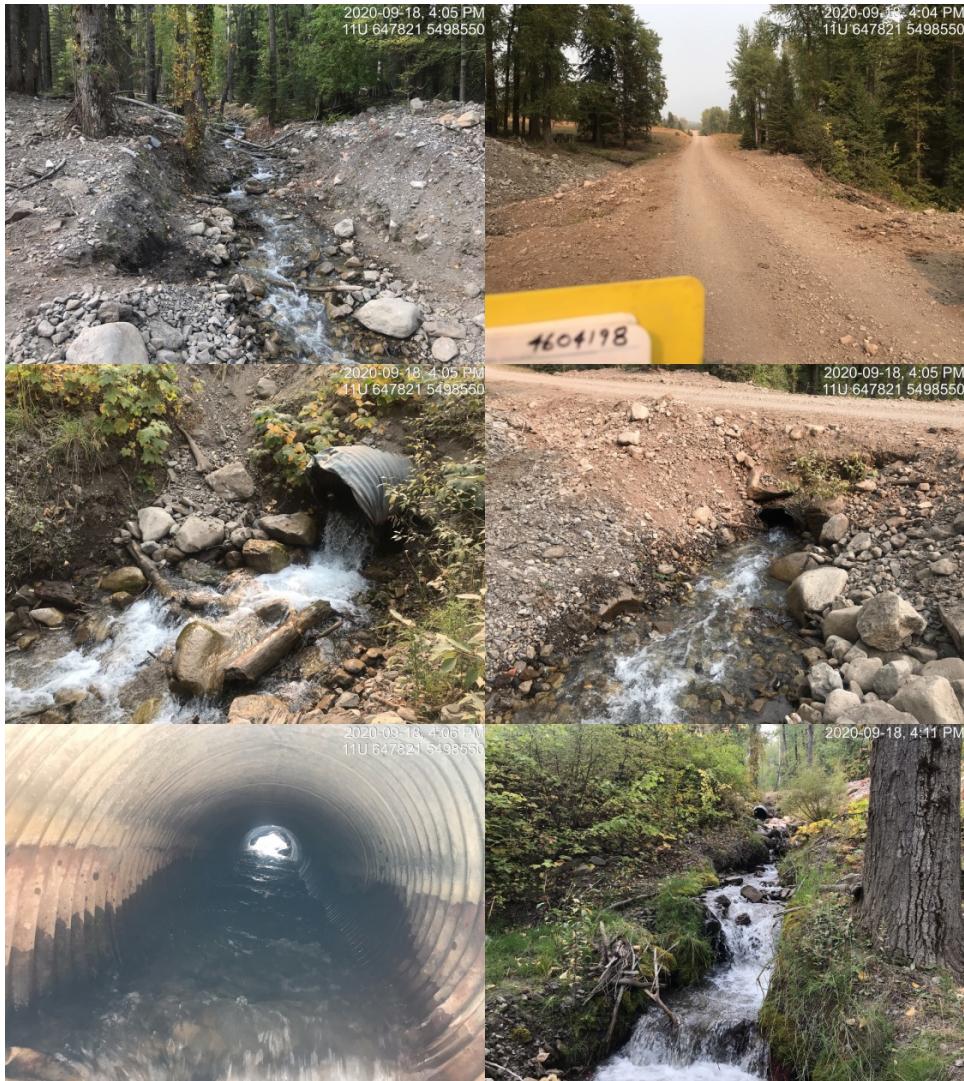
Photos: 4604198

Comments: Steep stream with good flow. FISS sample site 2593 near crossing location. Suspect too steep to be fish bearing.

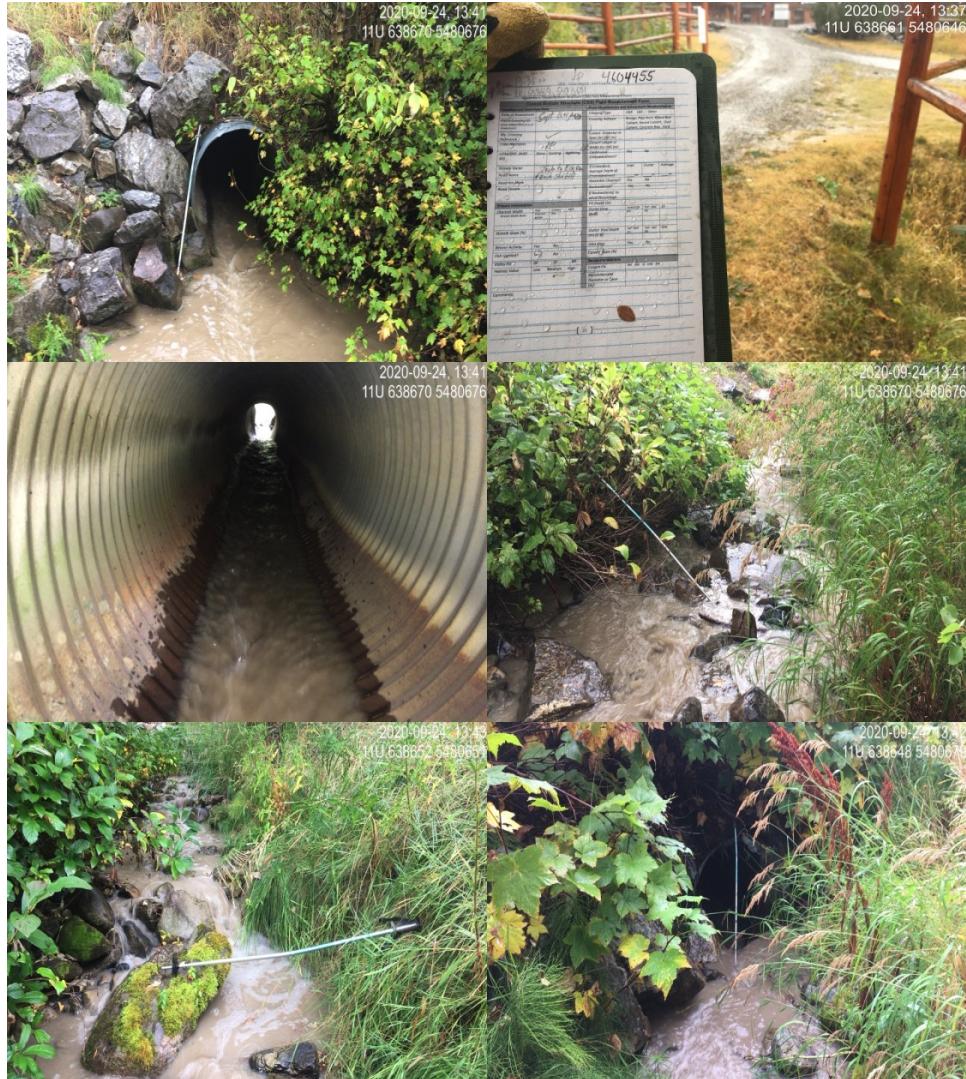
Comments: Inlet drop about .40m, significant and looks like increased barrier. Crossing is Fernie ski hill gravel road. Currently high and turbid due to heavy rain.

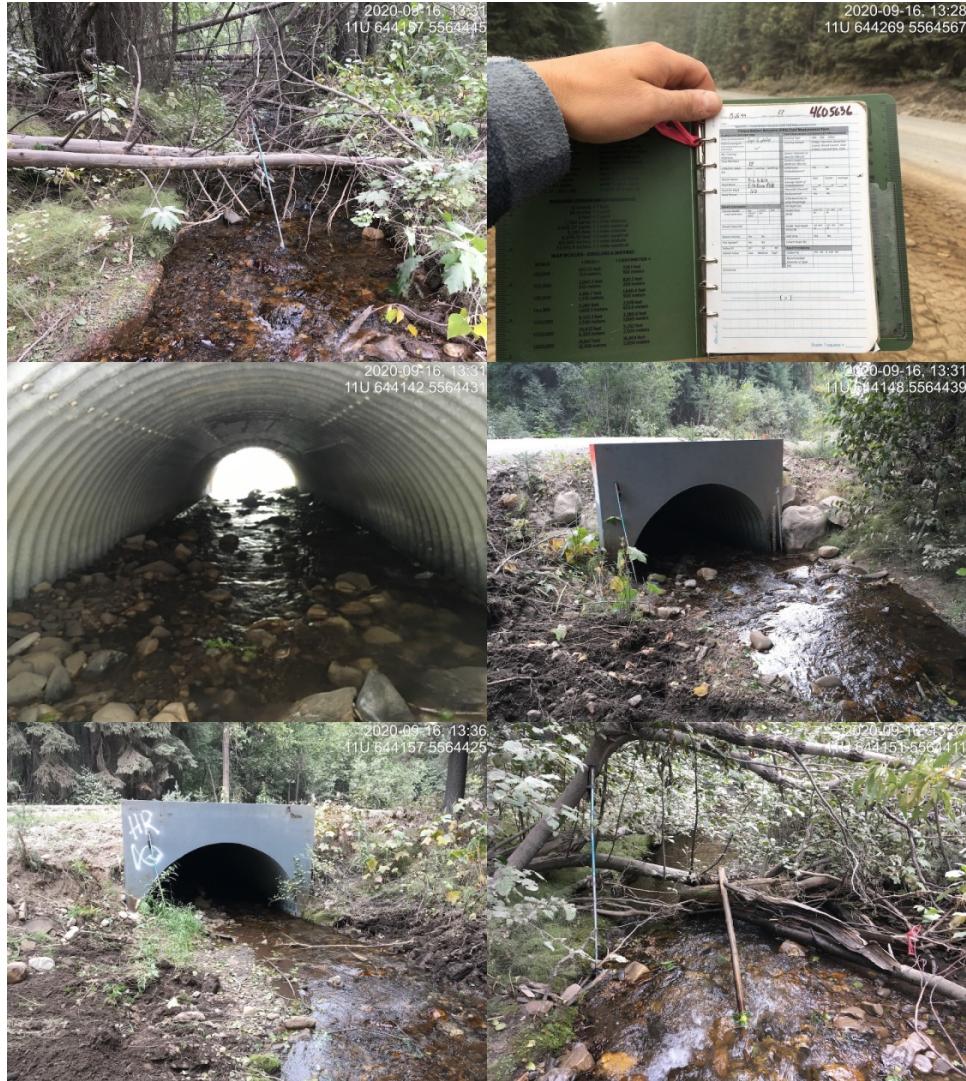
Photos: 4605636

Comments: Appears passable.

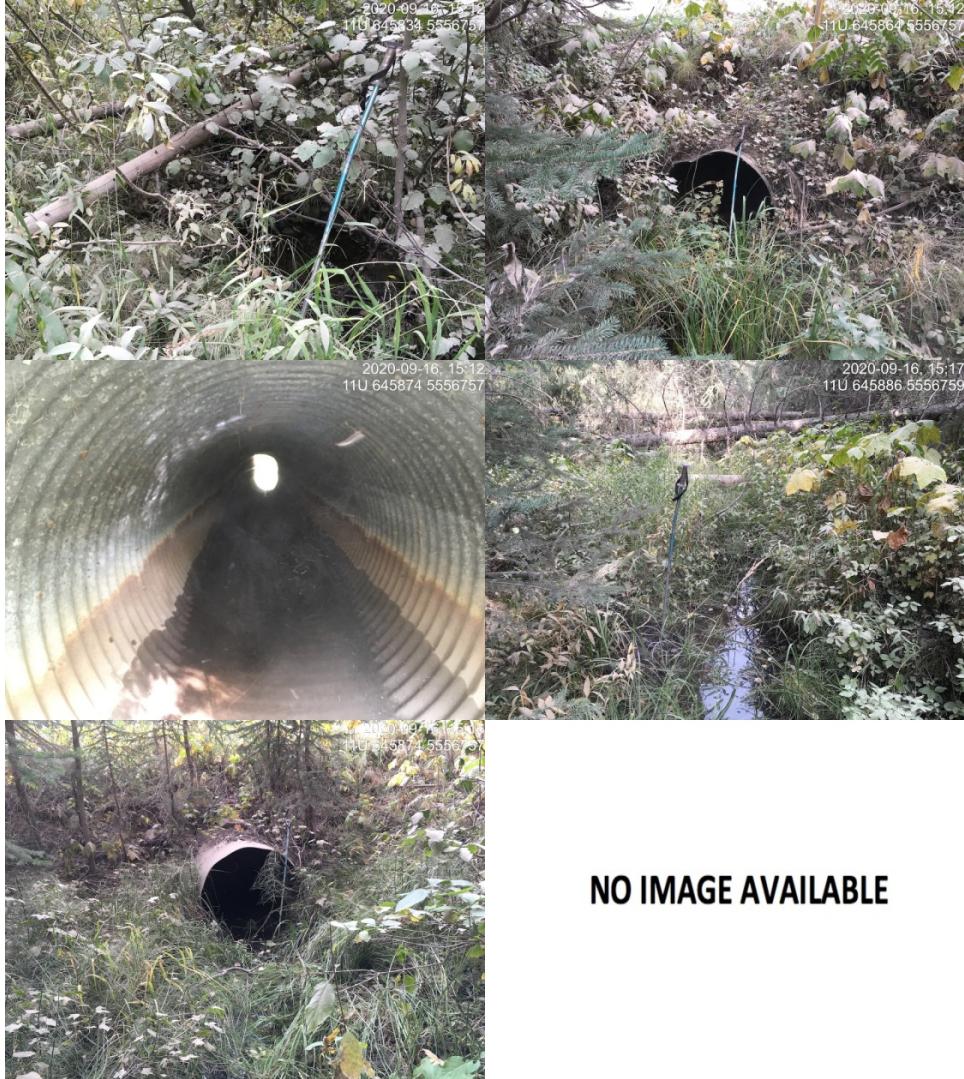
Photos: 4605649

Comments: Low, slow flow. Culvert completely backwatered.

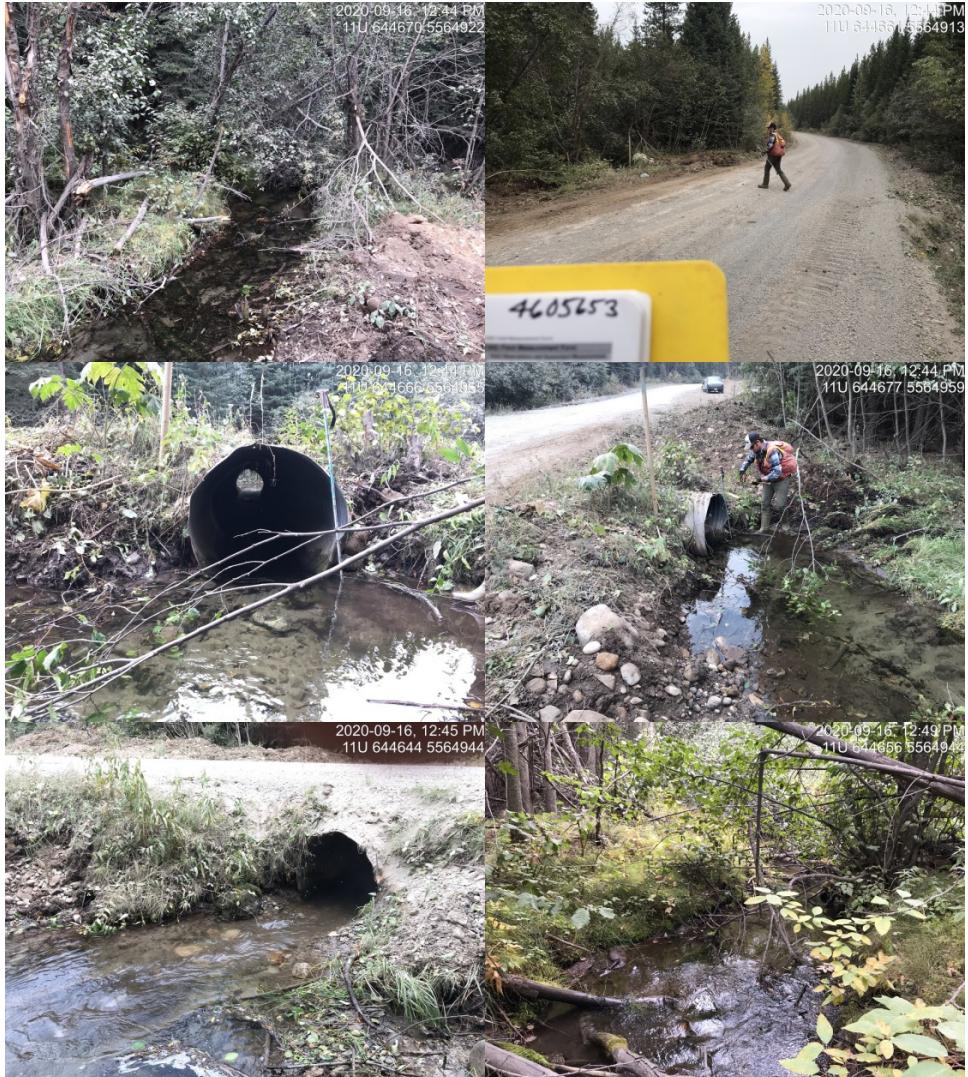
Photos: 4605653

Comments: Good habitat, habitat assessment (FHAP) conducted in 2016 (Masse Environmental Consultants Ltd.) for proposed coal mine EA (Bingay). Electrofished U/S and D/S, see provincial records and data submission file at <http://a100.gov.bc.ca/pub/acat/public/viewReport.do?reportId=52717>. Culvert does not appear to be barrier to any species at any life stage at time of survey. Could be barrier to small fish at high flows. EB and WCT recorded upstream.

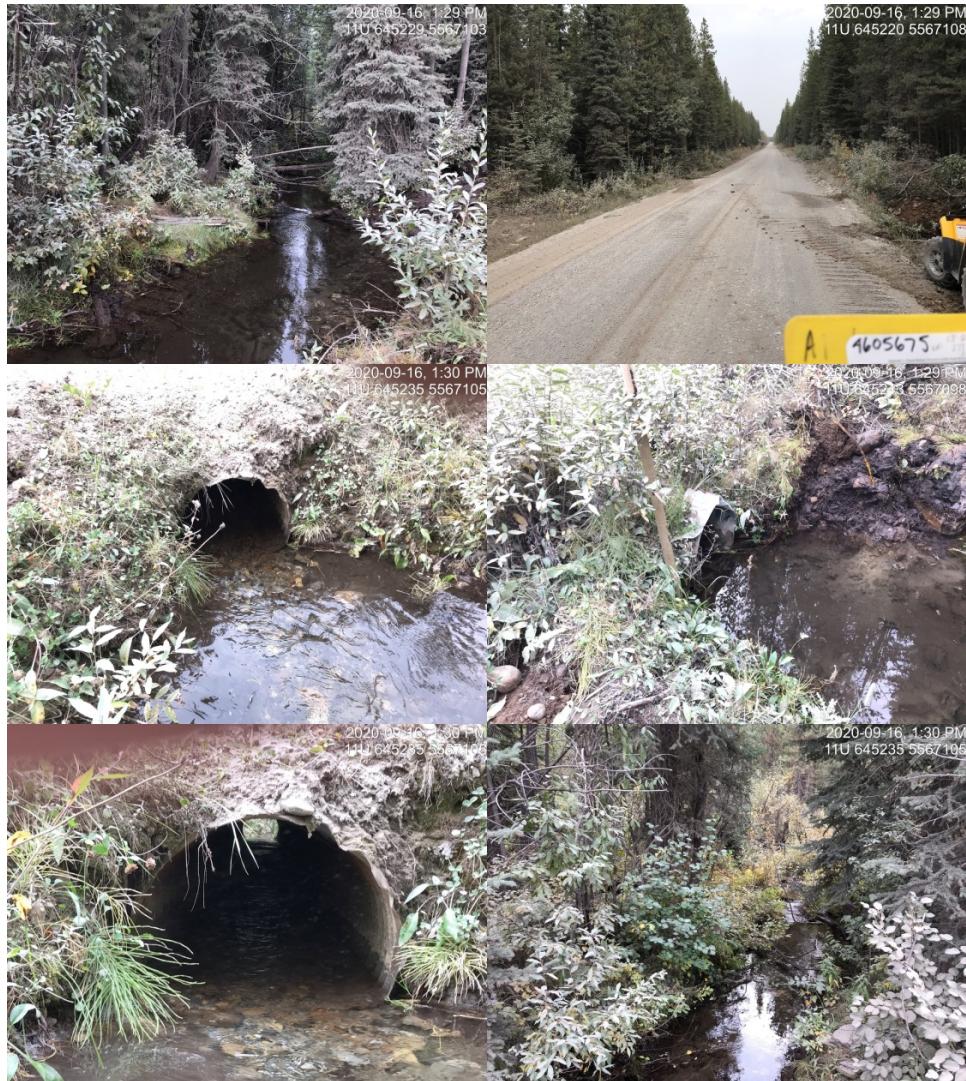
Comments: Culvert slope estimate. Stream dredged upstream to remove sediments. Flows are slow through culvert and unlikely barrier for fry/parr for much of year. Crossing 4606244 is on deactivated spur upstream so very likely a ford, about 300m upstream same thing for 4604099.

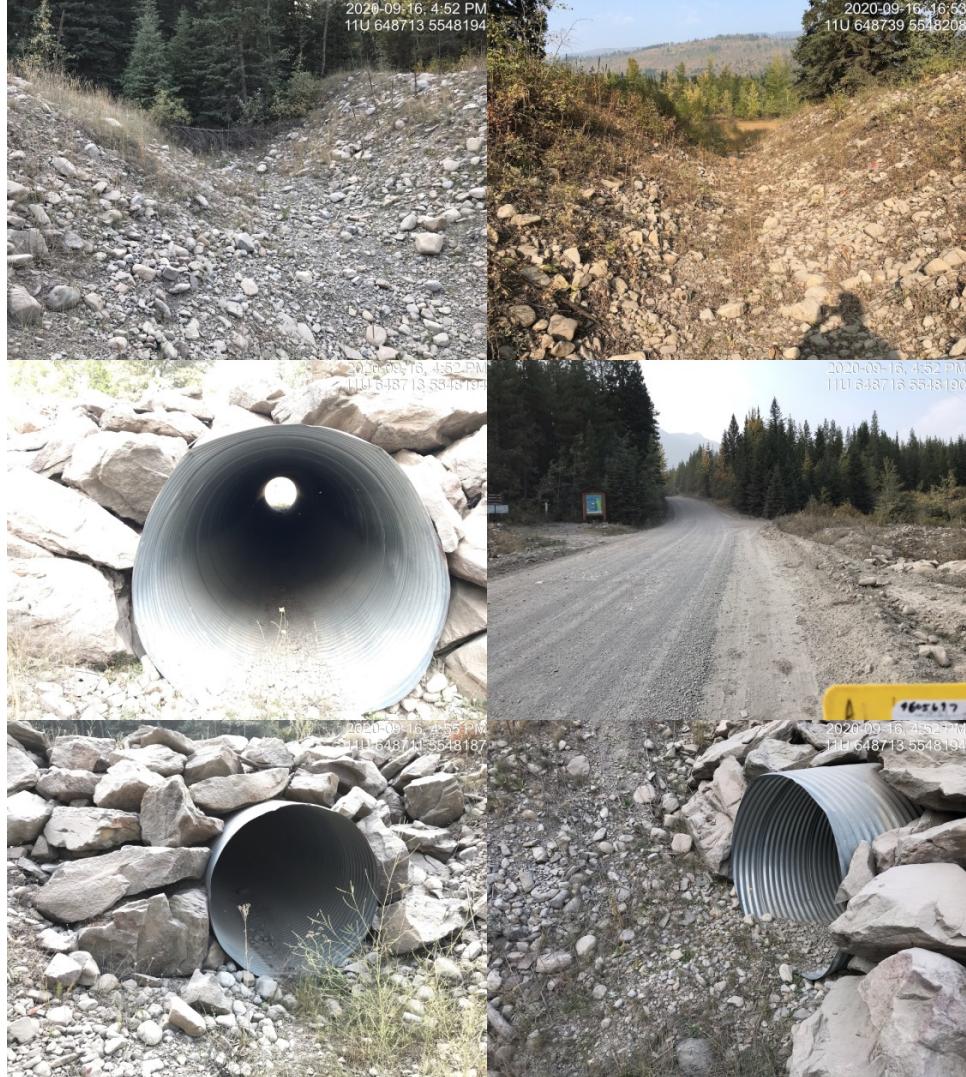
Photos: 4605697

Comments: Dry channel at time of survey, channel transitions to grass flats about 60 meters downstream.

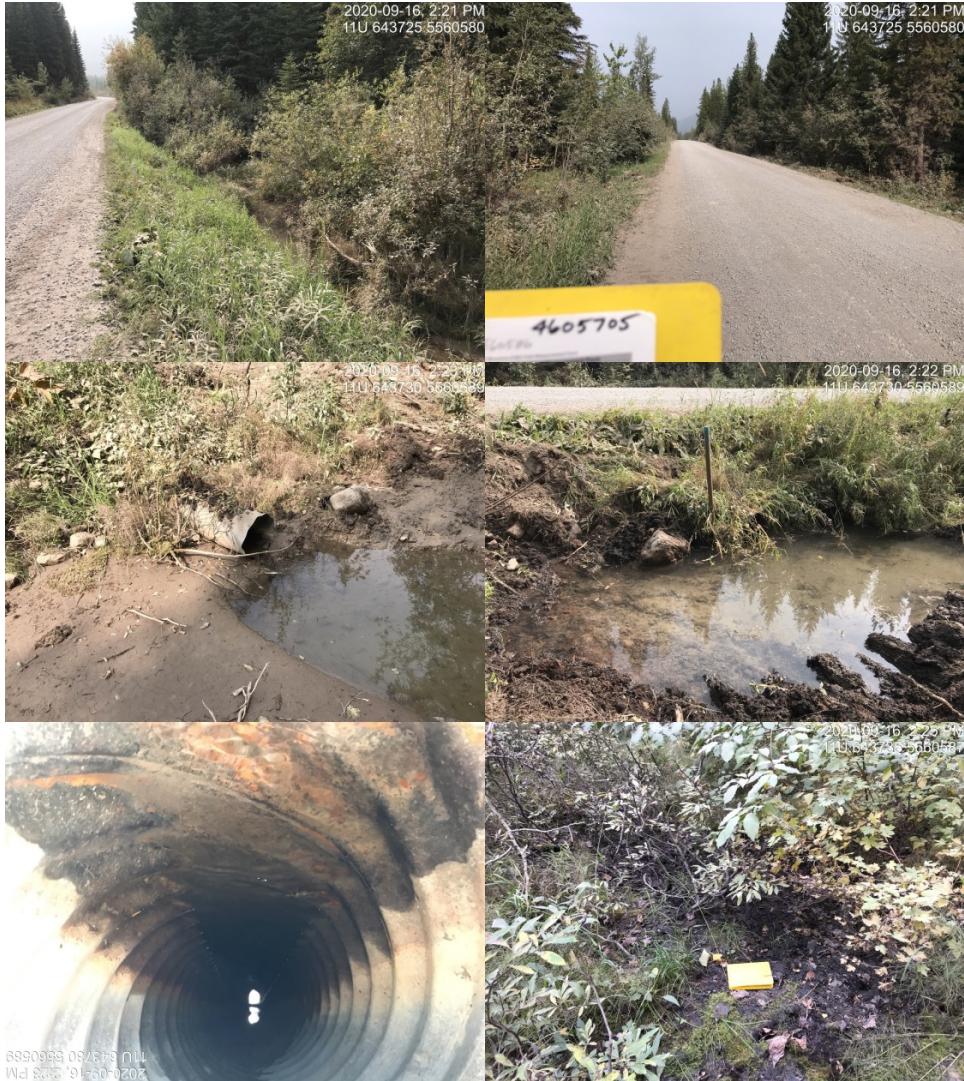
Photos: 4605705

Comments: Stream not located where mapped. Unlikely fish bearing. Flows into forest floor downstream of culvert.

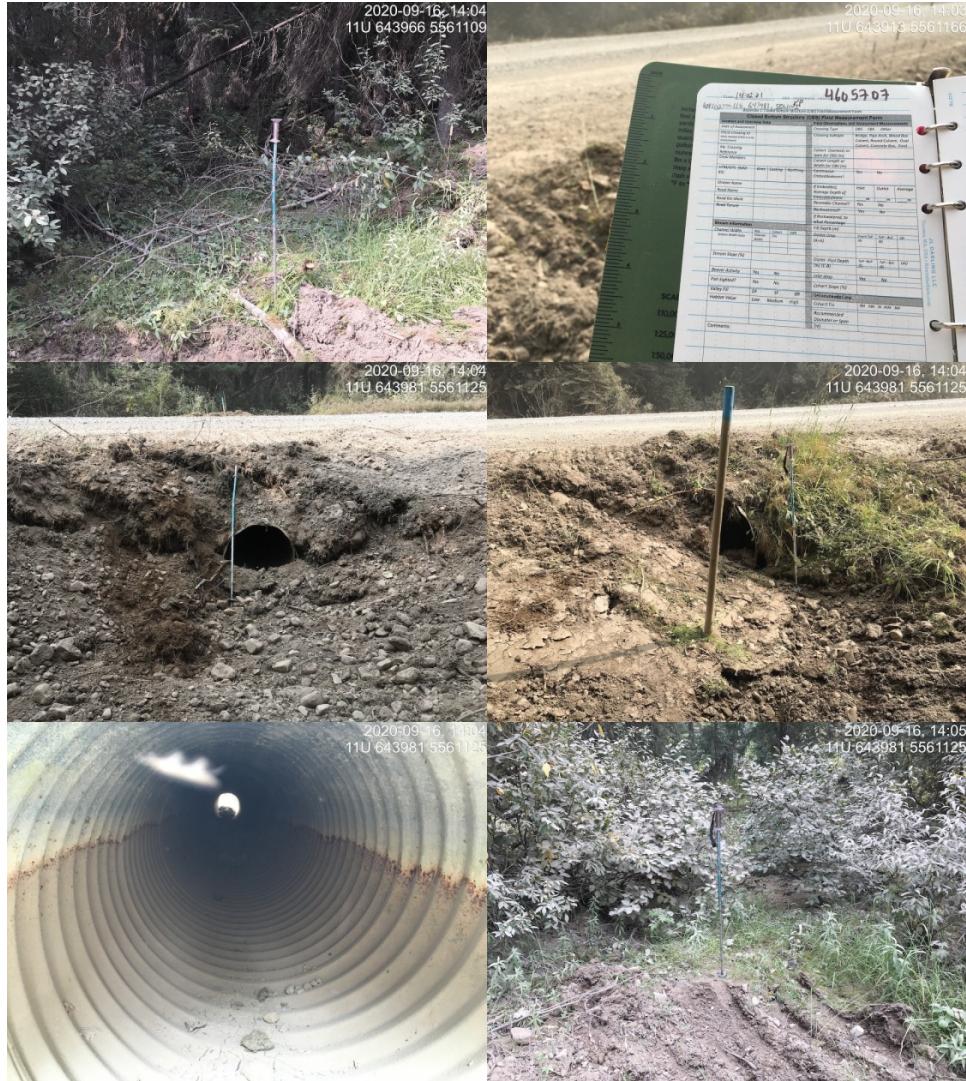
Comments: Stream dry at time of survey. Vegetated channel, loaded with sediment. Inlet of culvert damaged, partly bent. Inlet and outlet area dredged. Not likely fish habitat.

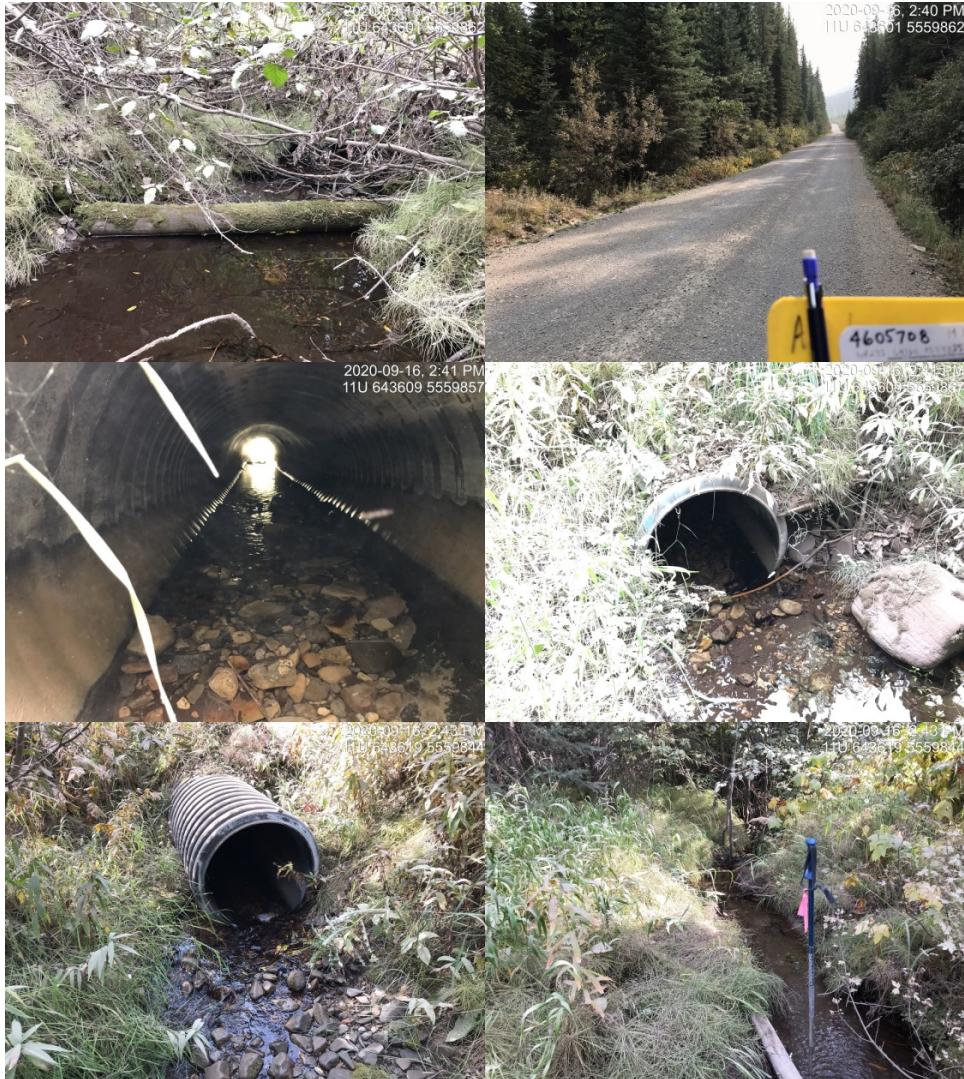
Comments: Channelized downstream due to dredging for about 30m. Small stream, substrate primarily fines but some gravel present.

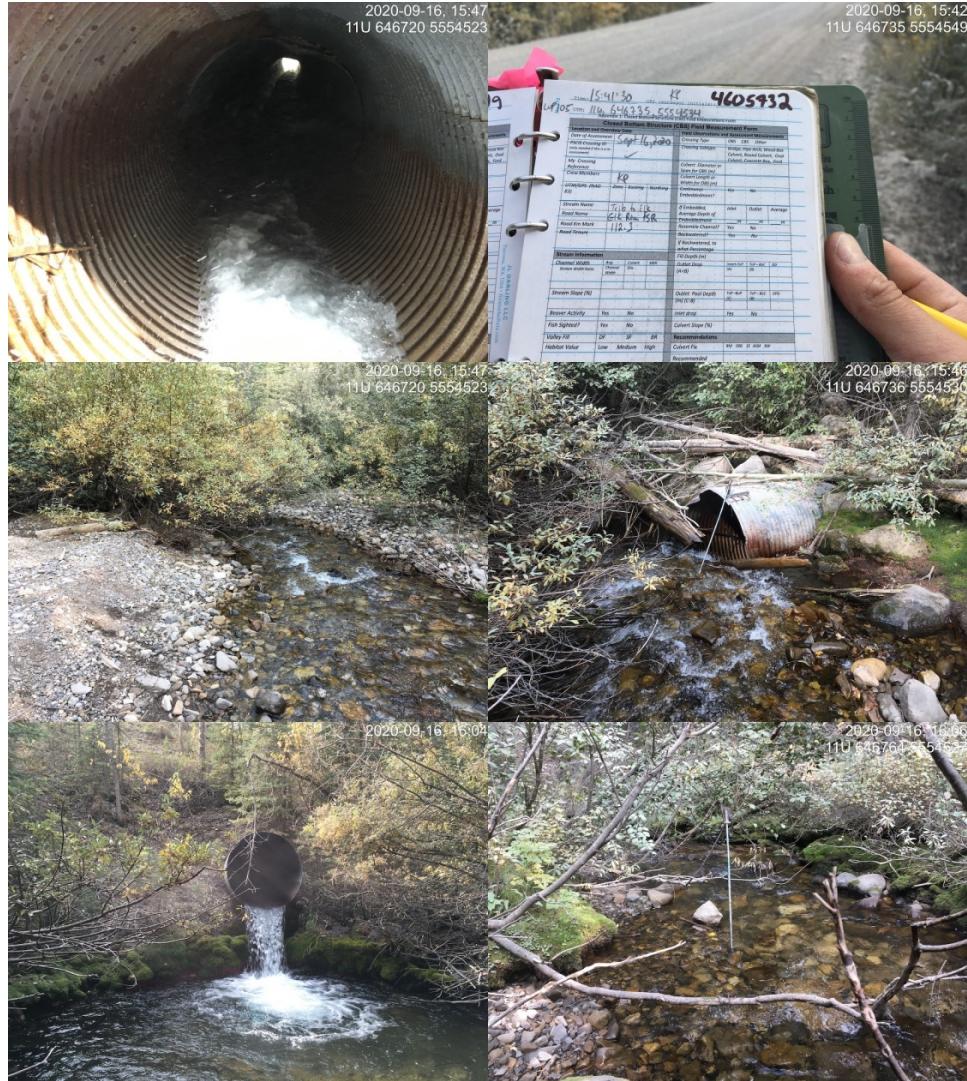
Comments: Large perched culvert. High value habitat. Habitat confirmation and sampling conducted.
