Elk River Watershed Group Fish Passage Restoration Planning

Prepared for Canadian Wildlife Federation

New Graph Environment

2020-12-22 DRaft

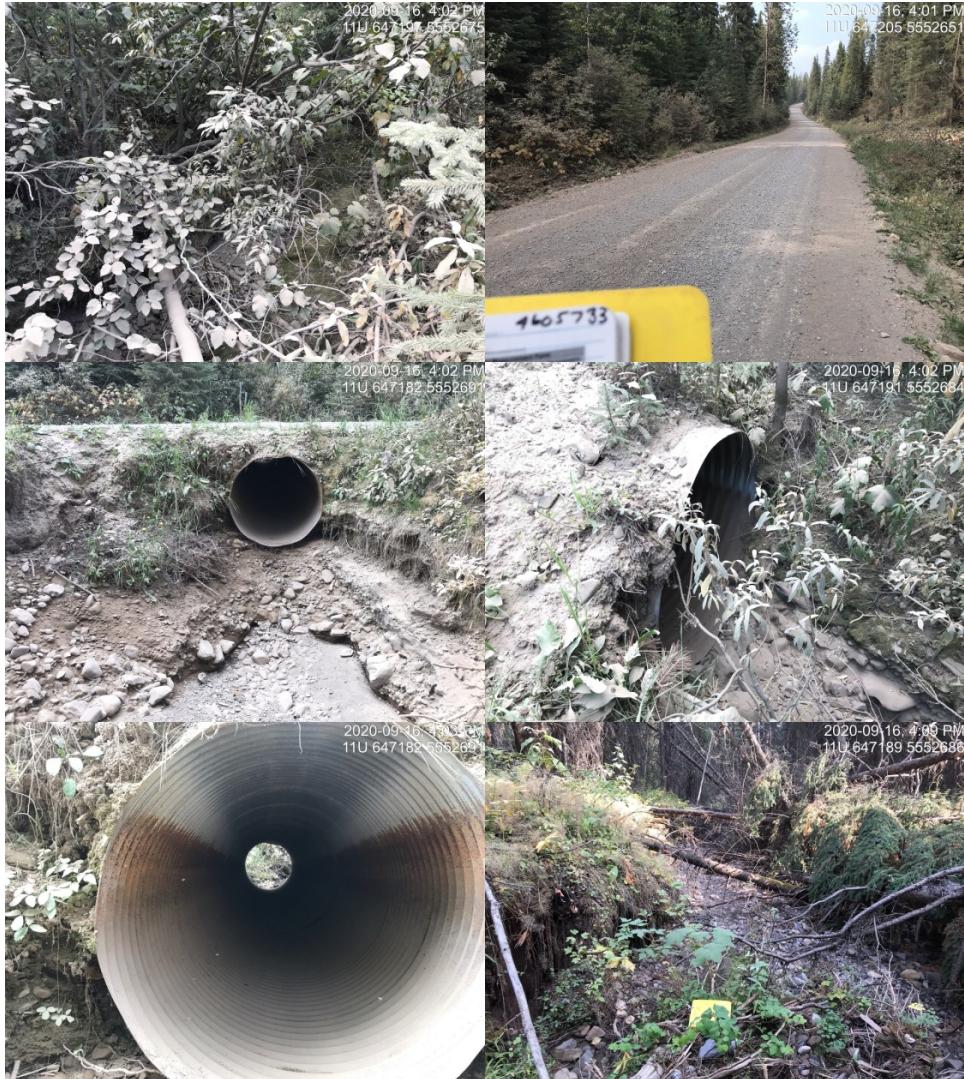
Comments: Freshly dredged. Dry. Dredging may extend well down channel. See photo from about 130m downstream.

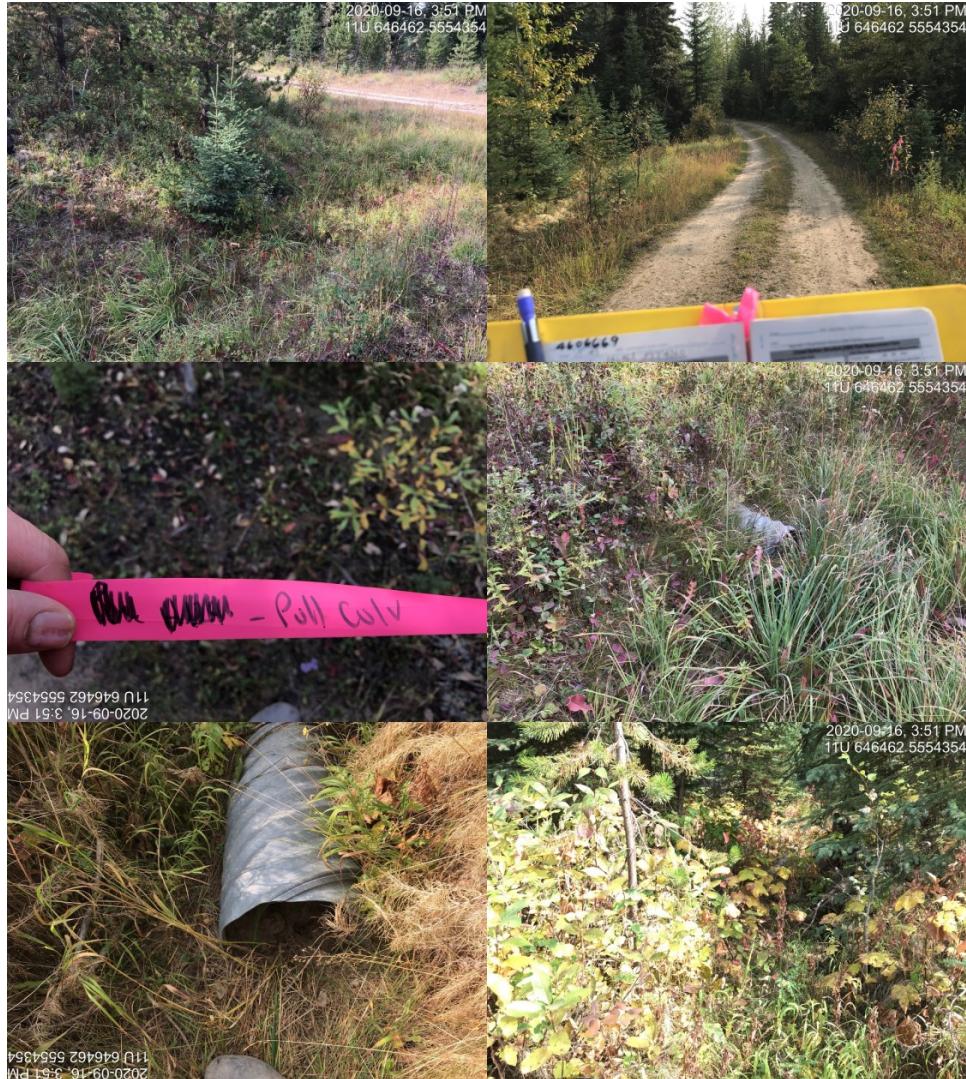
Photos: 4606669

Comments: Plan in place to deactivate entire network here (personal communication with local machinery operator). Dry, vegetated channel. Likely non-fish bearing.

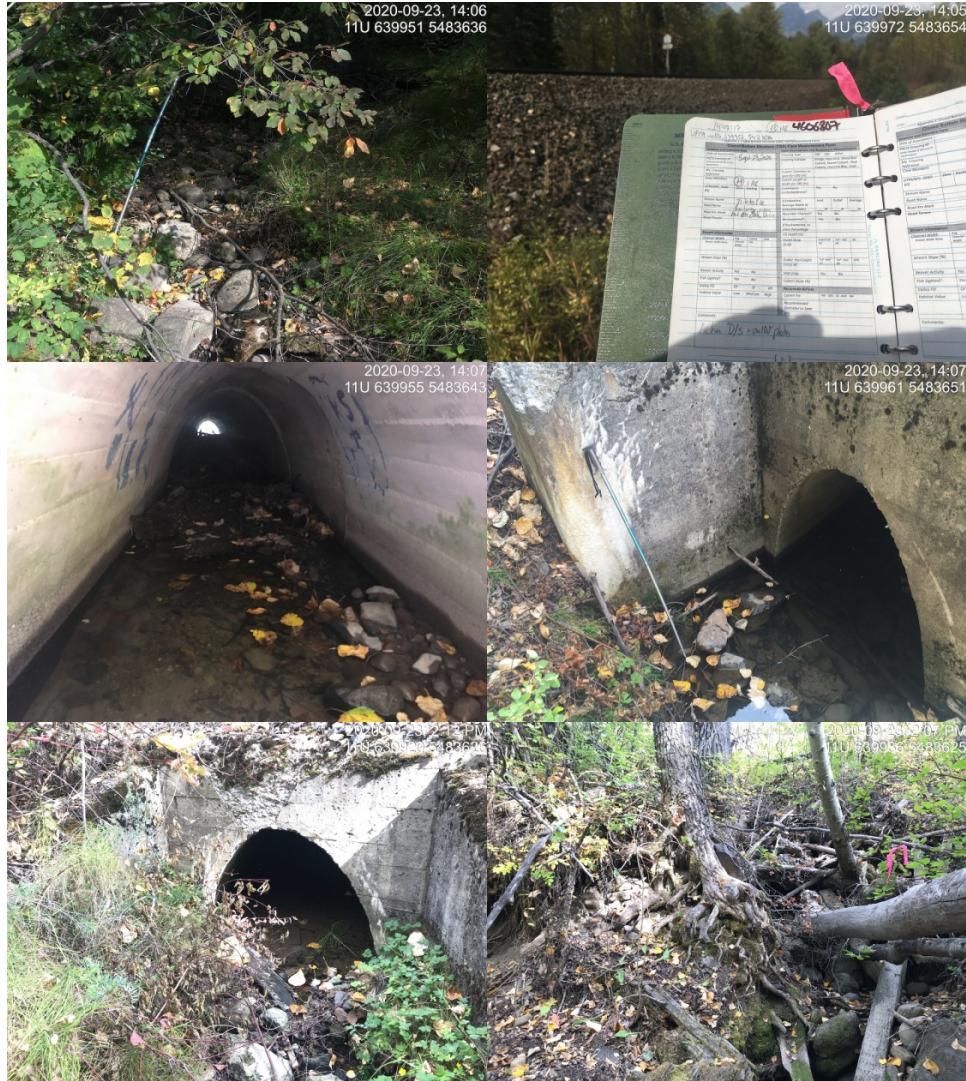
Comments: Concrete arch, >30% downstream of culvert for 10m likely from railway fill. Dry downstream with stagnant pools upstream.

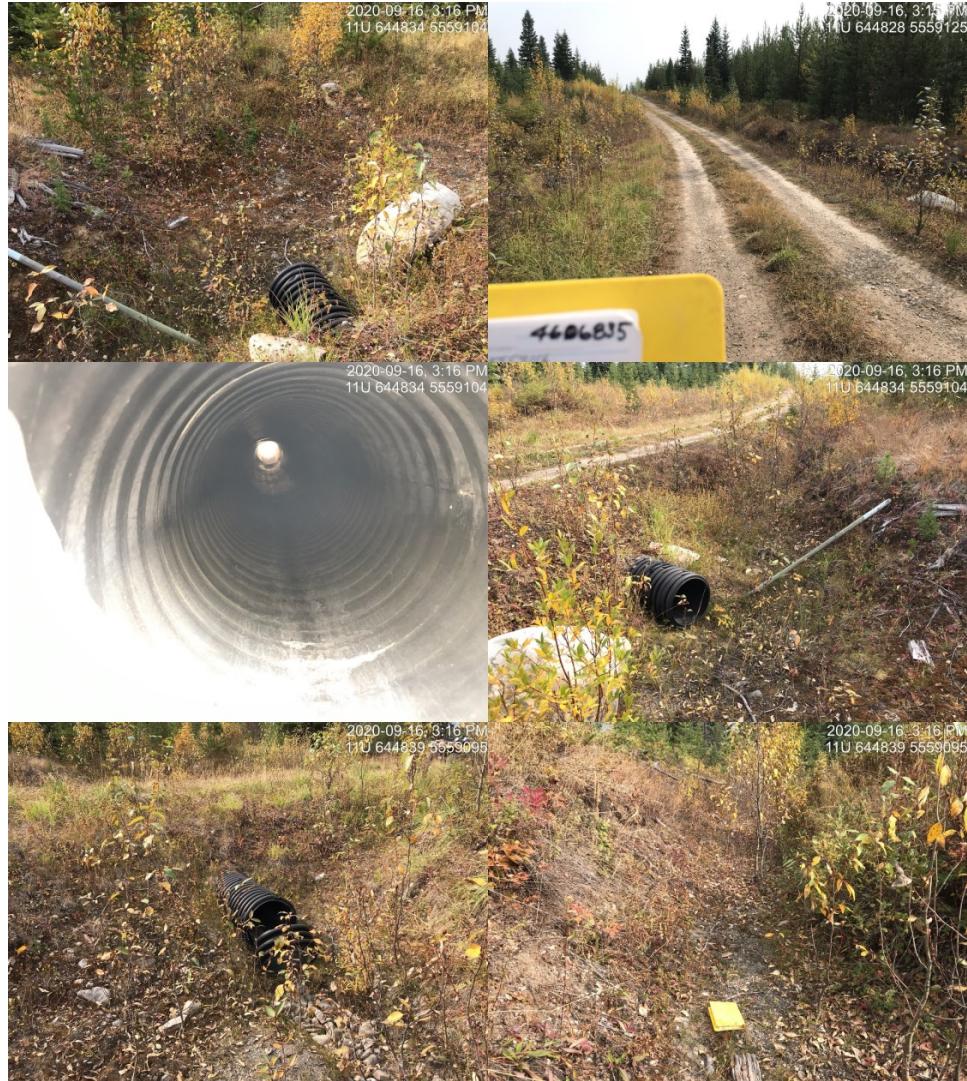
Photos: 4606835

Comments: Road is deactivated downstream so no crossings below (4607172, 4606929). Dry vegetated channel. Not likely fish bearing at this location.

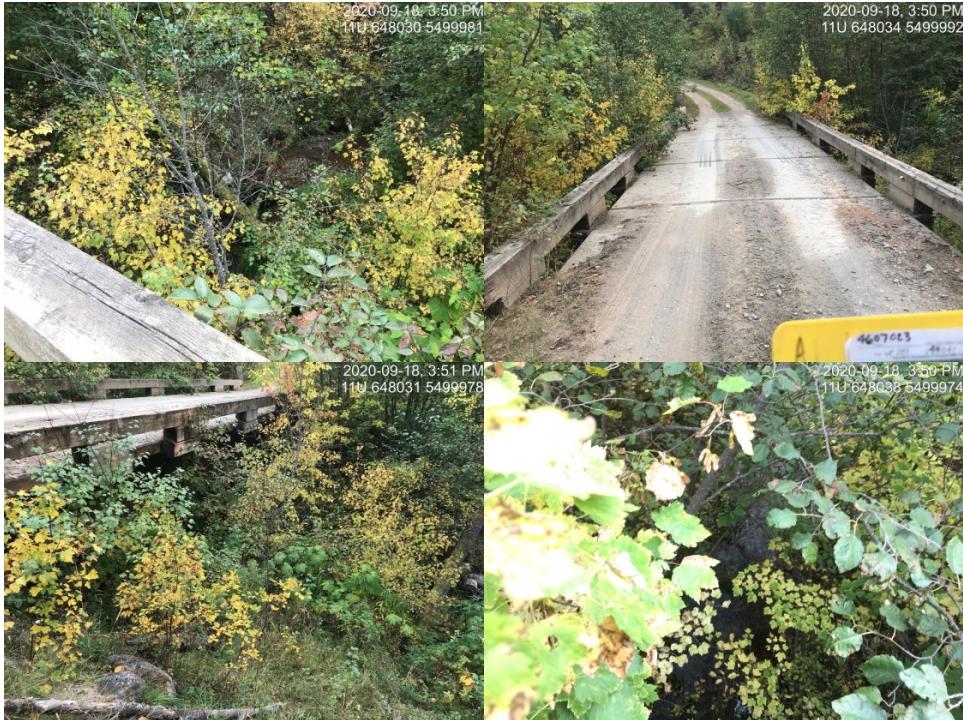
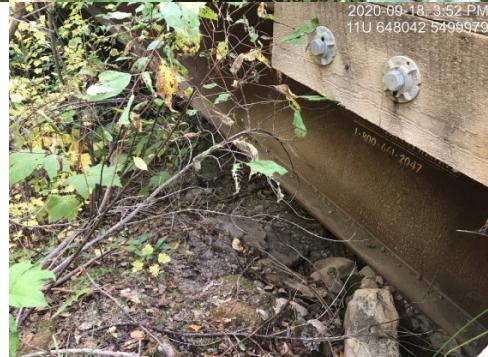
Photos: 4607023

Comments: Bridge.

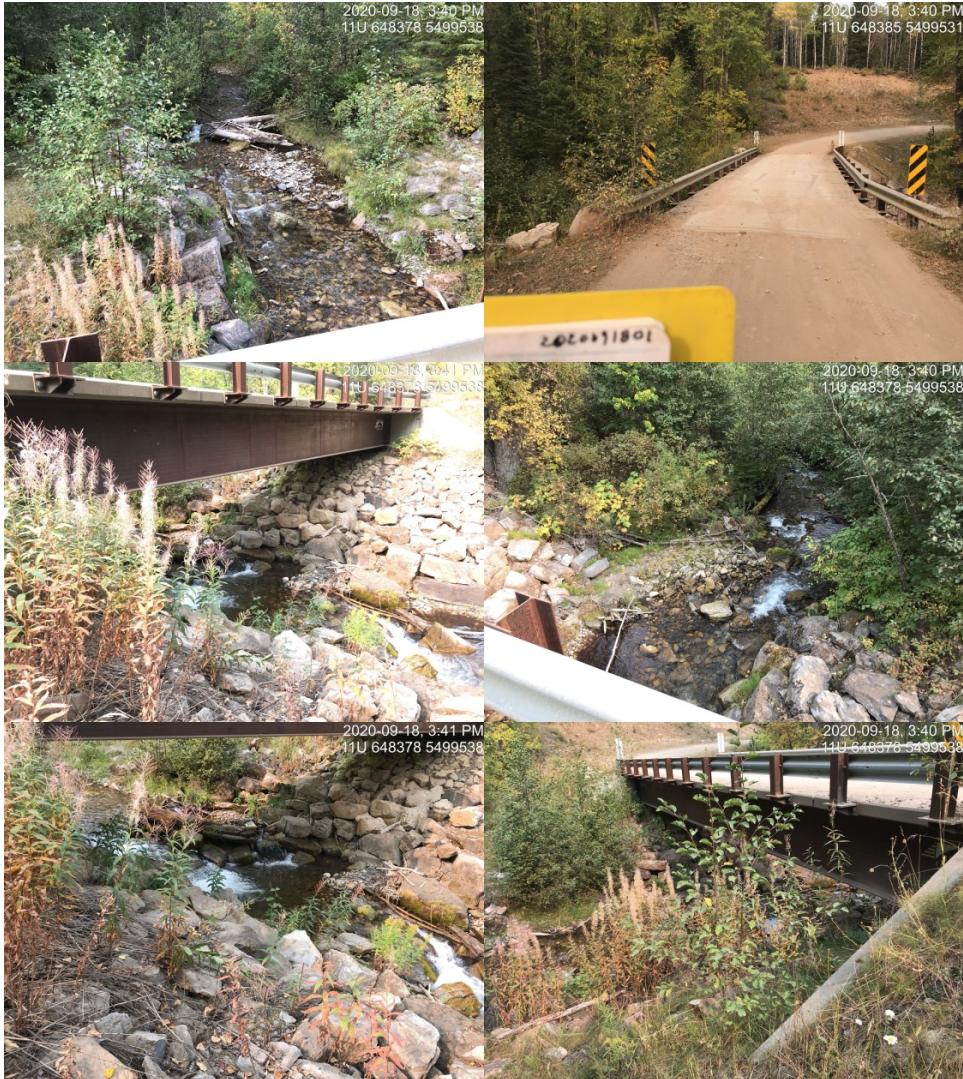
Photos: 2020091801

Comments: Bridge.

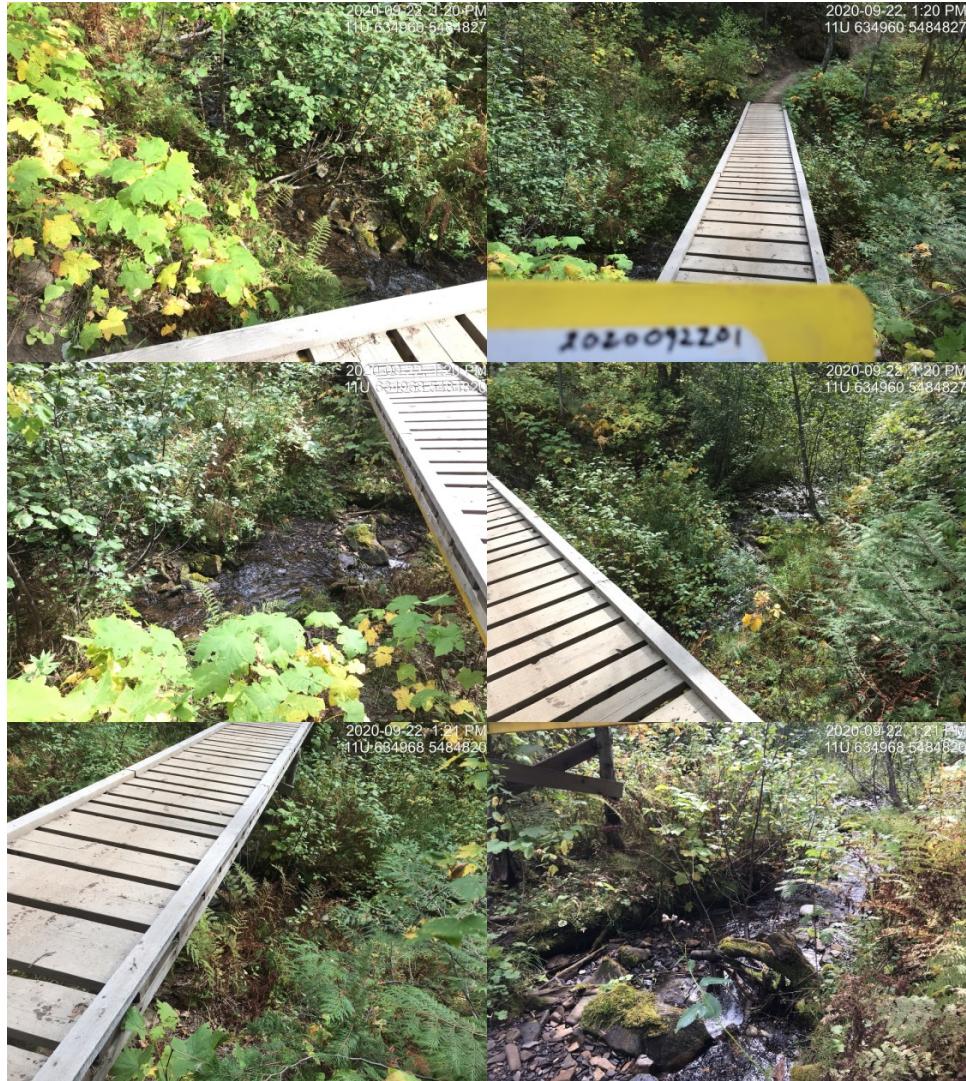
Photos: 2020092201

Comments: Bike trail.

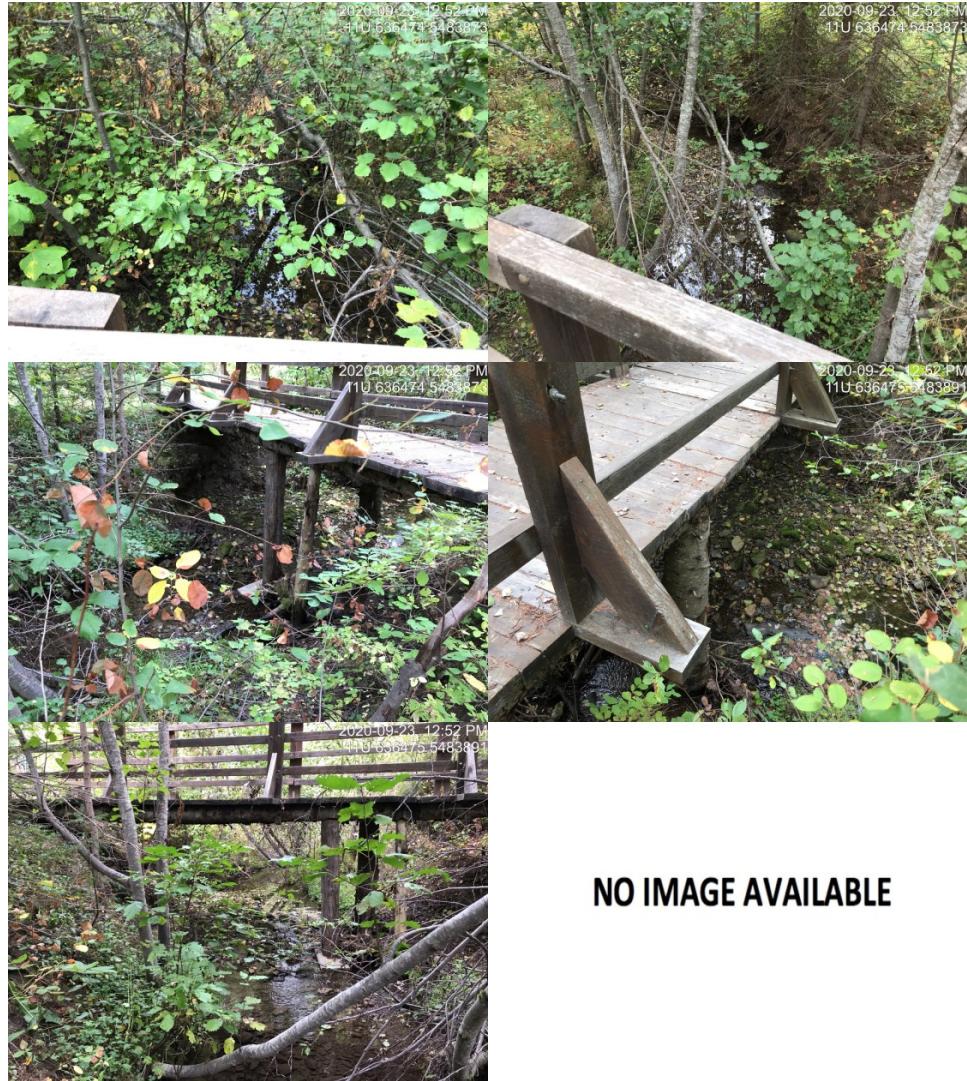
Photos: 2020092301

Comments: Trail. Stream has been diverted to beside the road.

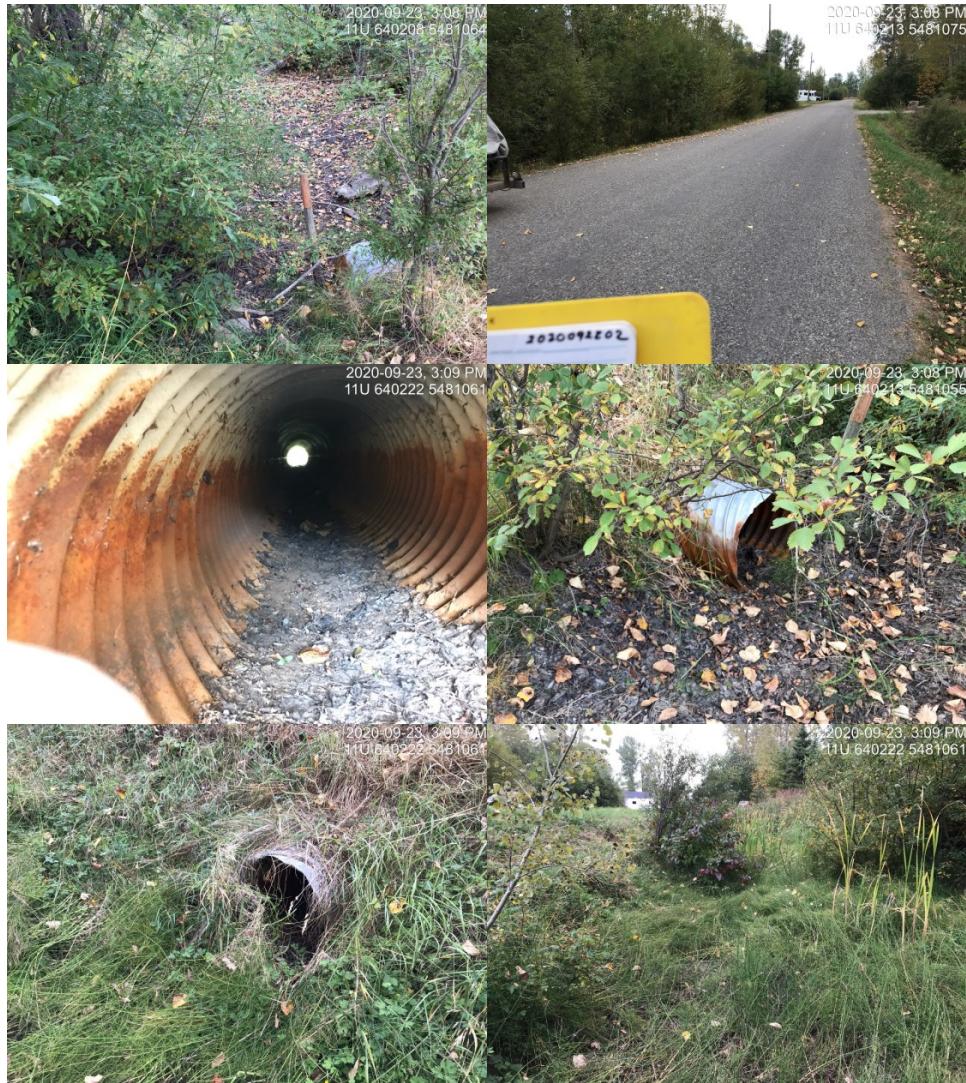
Photos: 2020092302

Comments: Dry vegetated channel. Not likely fish habitat.

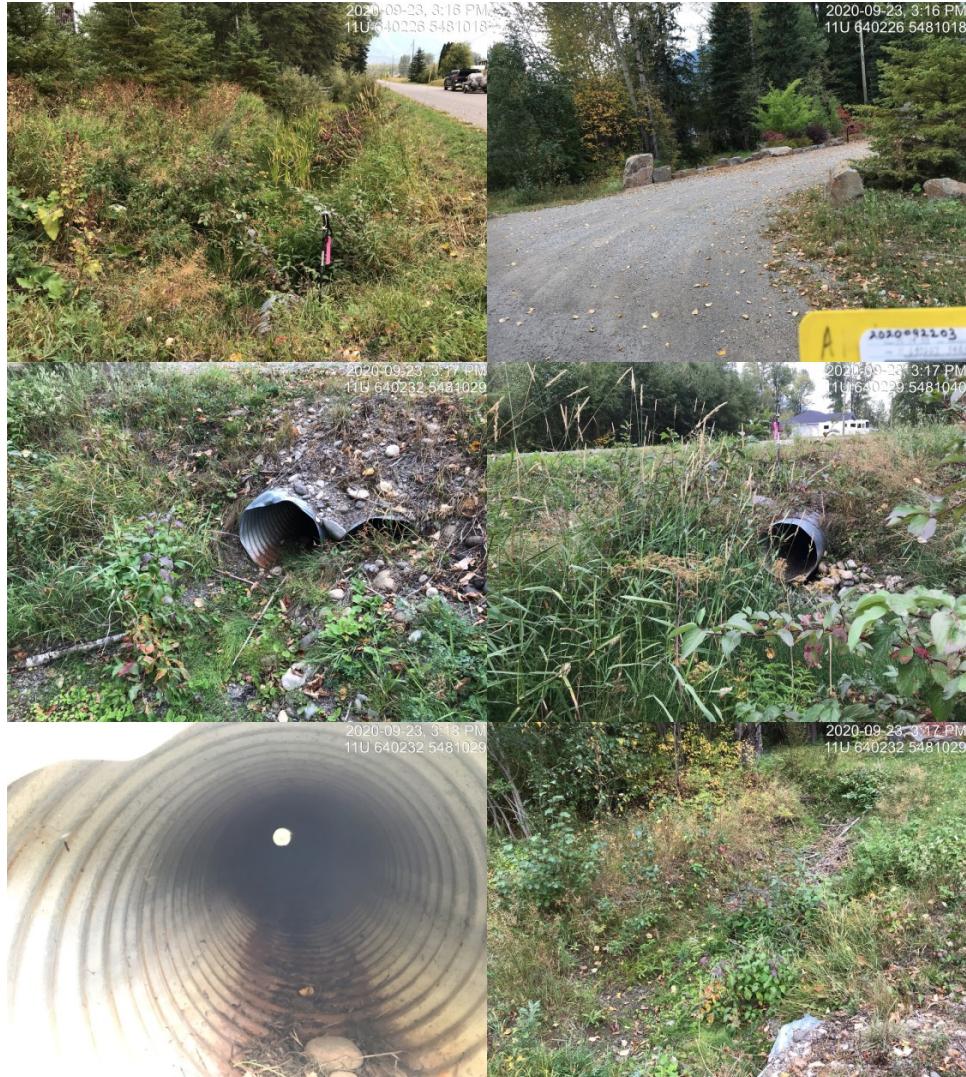
Comments: Dry, mostly vegetated channel. Not likely fish habitat. Two pipes, one buried by fill. Inlet elevated resulting in small area of wetland vegetation upstream.

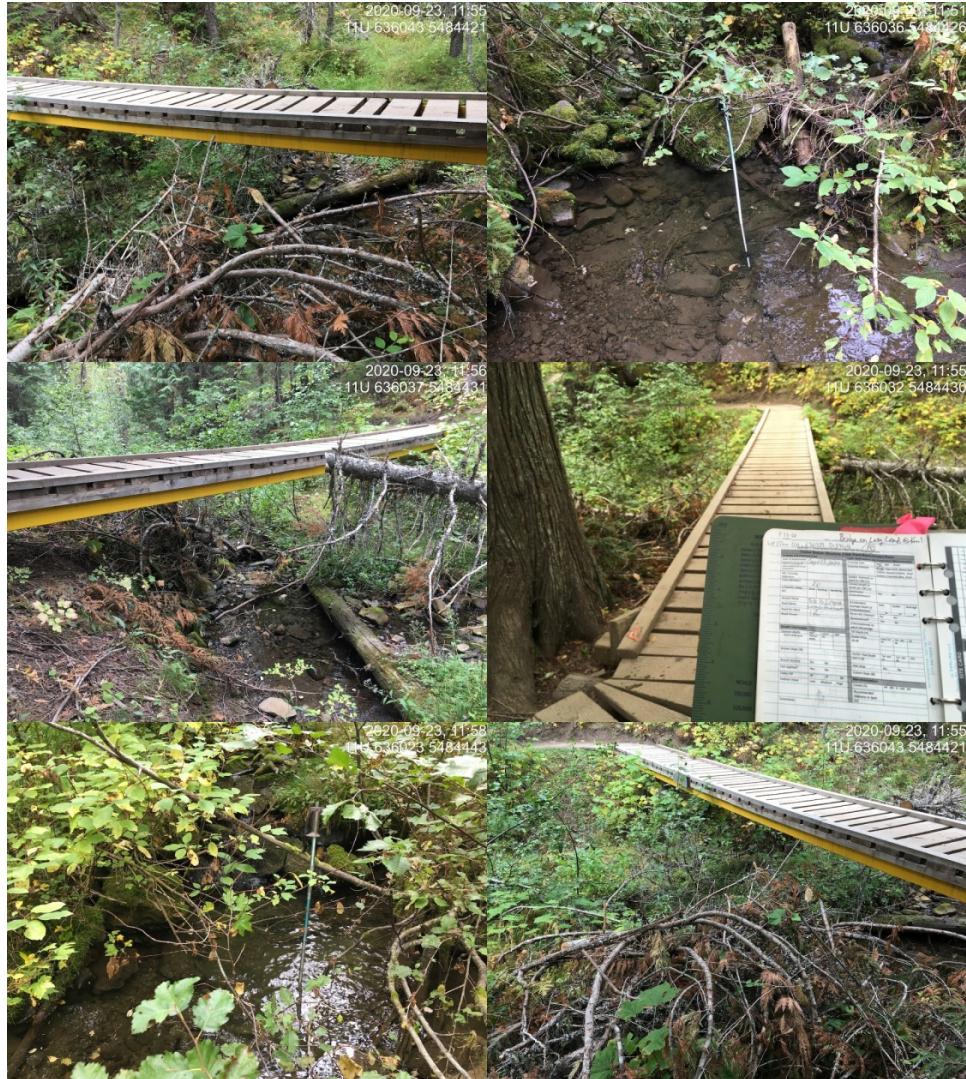
Photos: 2020092310

Comments: Nice wooden pedestrian/bike bridge for recreational use.
