Appendix - Phase 1 Fish Passage Assessment Data and Photos

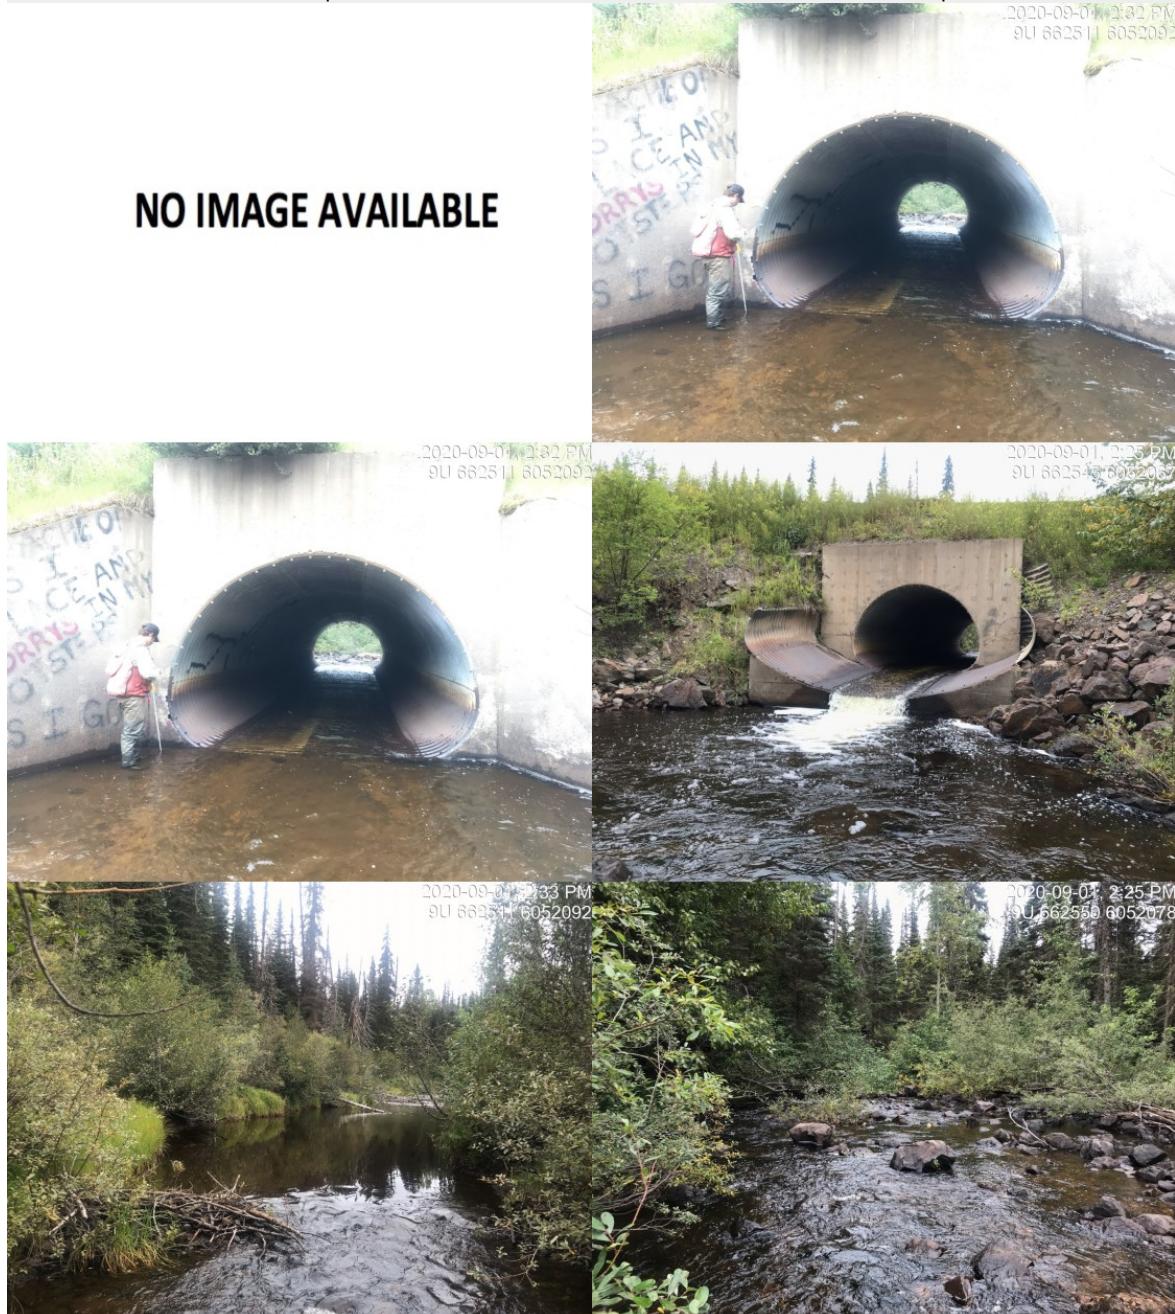
Photos: PSCIS ID 3067. From top left clockwise: Road/Site Card, Barrel, Outlet, Downstream, Upstream, Inlet.

Location and Stream Data		Crossing Characteristics –	
Date	2020-09-01	Crossing Sub Type	Oval Culvert
PSCIS ID	3067	Diameter (m)	4
External ID	–	Length (m)	25
Crew	KP, AI	Embedded	No
UTM Zone	9	Depth Embedded (m)	–
Easting	662522	Resemble Channel	No
Northing	6052094	Backwatered	No
Stream	Byman Creek	Percent Backwatered	–
Road	North Road	Fill Depth (m)	2
Road Tenure	FLNR Nadina 7543	Outlet Drop (m)	0.5
Channel Width (m)	9	Outlet Pool Depth (m)	1
Stream Slope (%)	5	Inlet Drop	No
Beaver Activity	No	Slope (%)	2
Habitat Value	High	Valley Fill	Deep Fill
Final score	34	Barrier Result	Barrier
Fix type	Replace with New Open Bottom Structure	Fix Span / Diameter	13

Comments: No habitat confirmation conducted in 2020. Fins 2009 reports 60% gradient for 50m located 200m downstream of crossing. Stream measurement estimated.

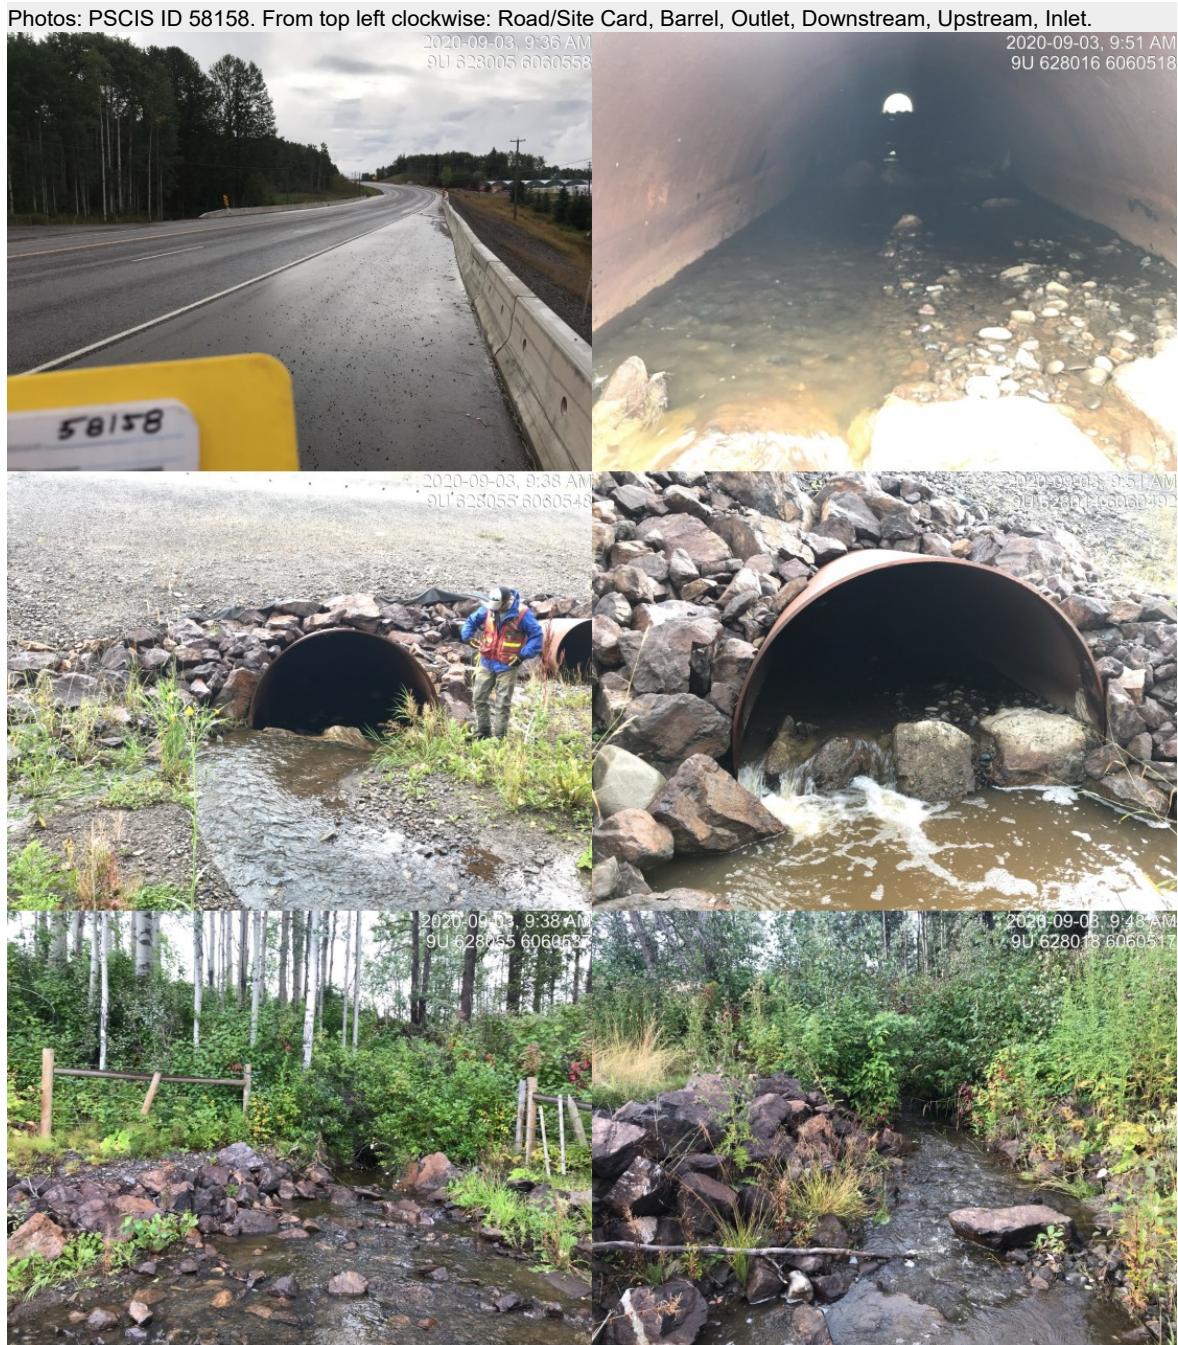
Location and Stream Data		Crossing Characteristics	
Date	2020-09-03	Crossing Sub Type	Round Culvert
PSCIS ID	58158	Diameter (m)	2.5
External ID	–	Length (m)	53
Crew	AI, KP	Embedded	Yes
UTM Zone	9	Depth Embedded (m)	0.5
Easting	628044	Resemble Channel	Yes
Northing	6060527	Backwatered	No
Stream	McDowell Creek	Percent Backwatered	–
Road	Highway 16	Fill Depth (m)	4
Road Tenure	MoTi highway	Outlet Drop (m)	0.36
Channel Width (m)	2.5	Outlet Pool Depth (m)	0.45
Stream Slope (%)	3	Inlet Drop	Yes
Beaver Activity	No	Slope (%)	5.5
Habitat Value	High	Valley Fill	Deep Fill
Final score	34	Barrier Result	Barrier
Fix type	Replace with New Open Bottom Structure	Fix Span / Diameter	13

Comments: New culvert horizontally drilled under highway in 2017. Structure has baffles made of oured concrete and boulders. Often deep pools up to 50cm before baffles. Baffles seem sharp and have potential to injure fish ascending?

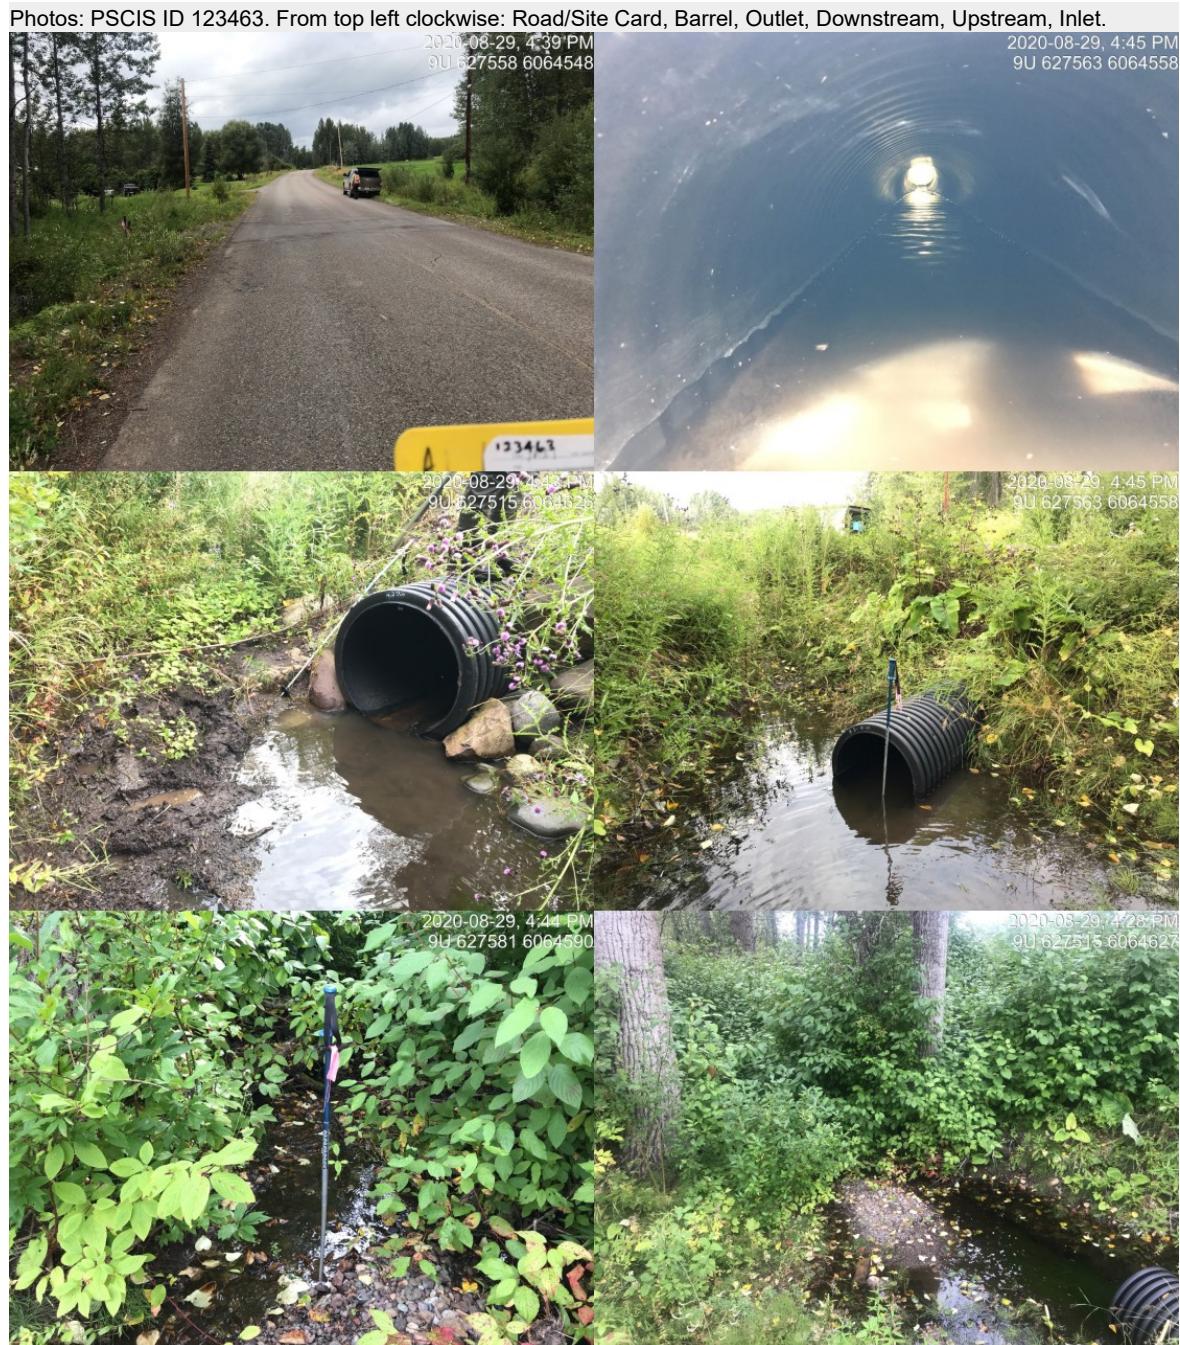
Location and Stream Data		Crossing Characteristics	
	•		-
Date	2020-08-29	Crossing Sub Type	Round Culvert
PSCIS ID	123463	Diameter (m)	0.6
External ID	-	Length (m)	18
Crew	AI, KP	Embedded	No
UTM Zone	9	Depth Embedded (m)	-
Easting	627570	Resemble Channel	No
Northing	6064562	Backwatered	Yes
Stream	Victor Creek	Percent Backwatered	30
Road	Tyee Lake Road	Fill Depth (m)	1
Road Tenure	MoTi local	Outlet Drop (m)	0
Channel Width (m)	1.8	Outlet Pool Depth (m)	0.3
Stream Slope (%)	1	Inlet Drop	No
Beaver Activity	No	Slope (%)	3
Habitat Value	Medium	Valley Fill	Deep Fill
Final score	29	Barrier Result	Barrier
Fix type	Replace Structure with Streambed Simulation CBS	Fix Span / Diameter	5

Comments: No habitat confirmation conducted in 2020. Newly replaced crossing. ID# 8 21 18 01 .

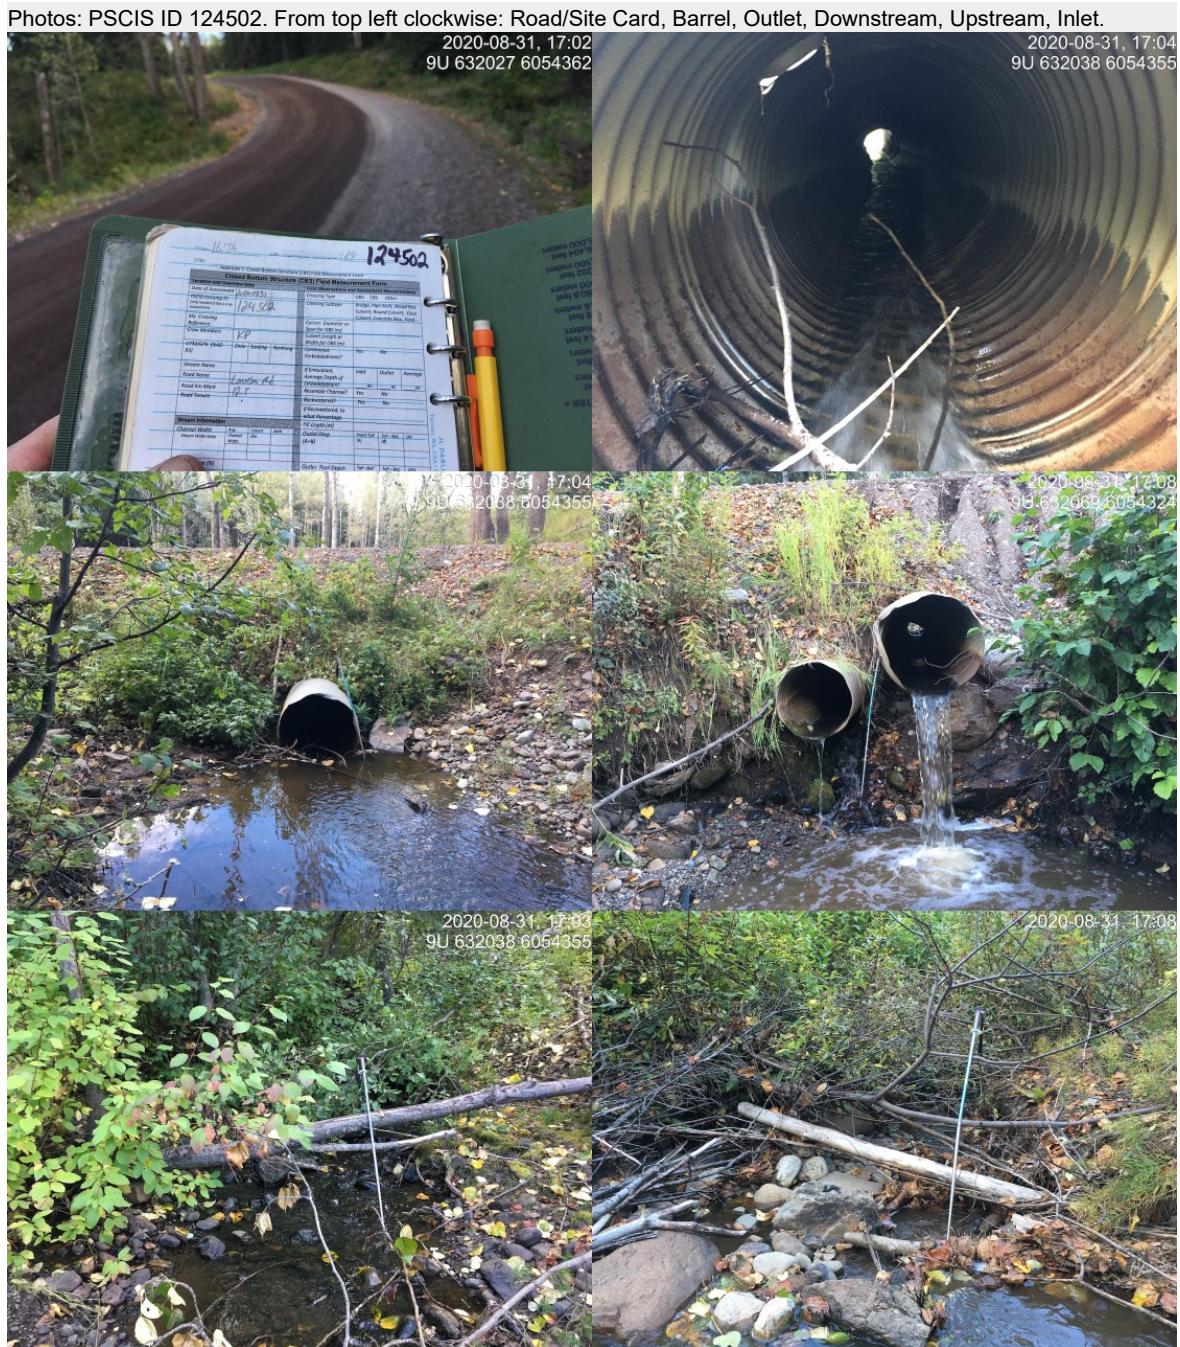
Location and Stream Data		Crossing Characteristics	
Date	2020-08-31	Crossing Sub Type	Round Culvert
PSCIS ID	124502	Diameter (m)	0.8
External ID	–	Length (m)	21
Crew	KP, AI	Embedded	No
UTM Zone	9	Depth Embedded (m)	–
Easting	632070	Resemble Channel	No
Northing	6054348	Backwatered	No
Stream	Tributary to Bulkley River	Percent Backwatered	–
Road	Lawson Road	Fill Depth (m)	2
Road Tenure	MoTi local	Outlet Drop (m)	1.2
Channel Width (m)	3.2	Outlet Pool Depth (m)	0.45
Stream Slope (%)	3.5	Inlet Drop	Yes
Beaver Activity	No	Slope (%)	5
Habitat Value	Medium	Valley Fill	Deep Fill
Final score	39	Barrier Result	Barrier
Fix type	Replace with New Open Bottom Structure	Fix Span / Diameter	10

Comments: No habitat confirmation conducted in 2020. Good flow. Adjacent land owner reports that this stream consistently flows year round and that the culvert under the railway has large outlet drop. This crossing and the crossing under the railway should be followed up in the future.

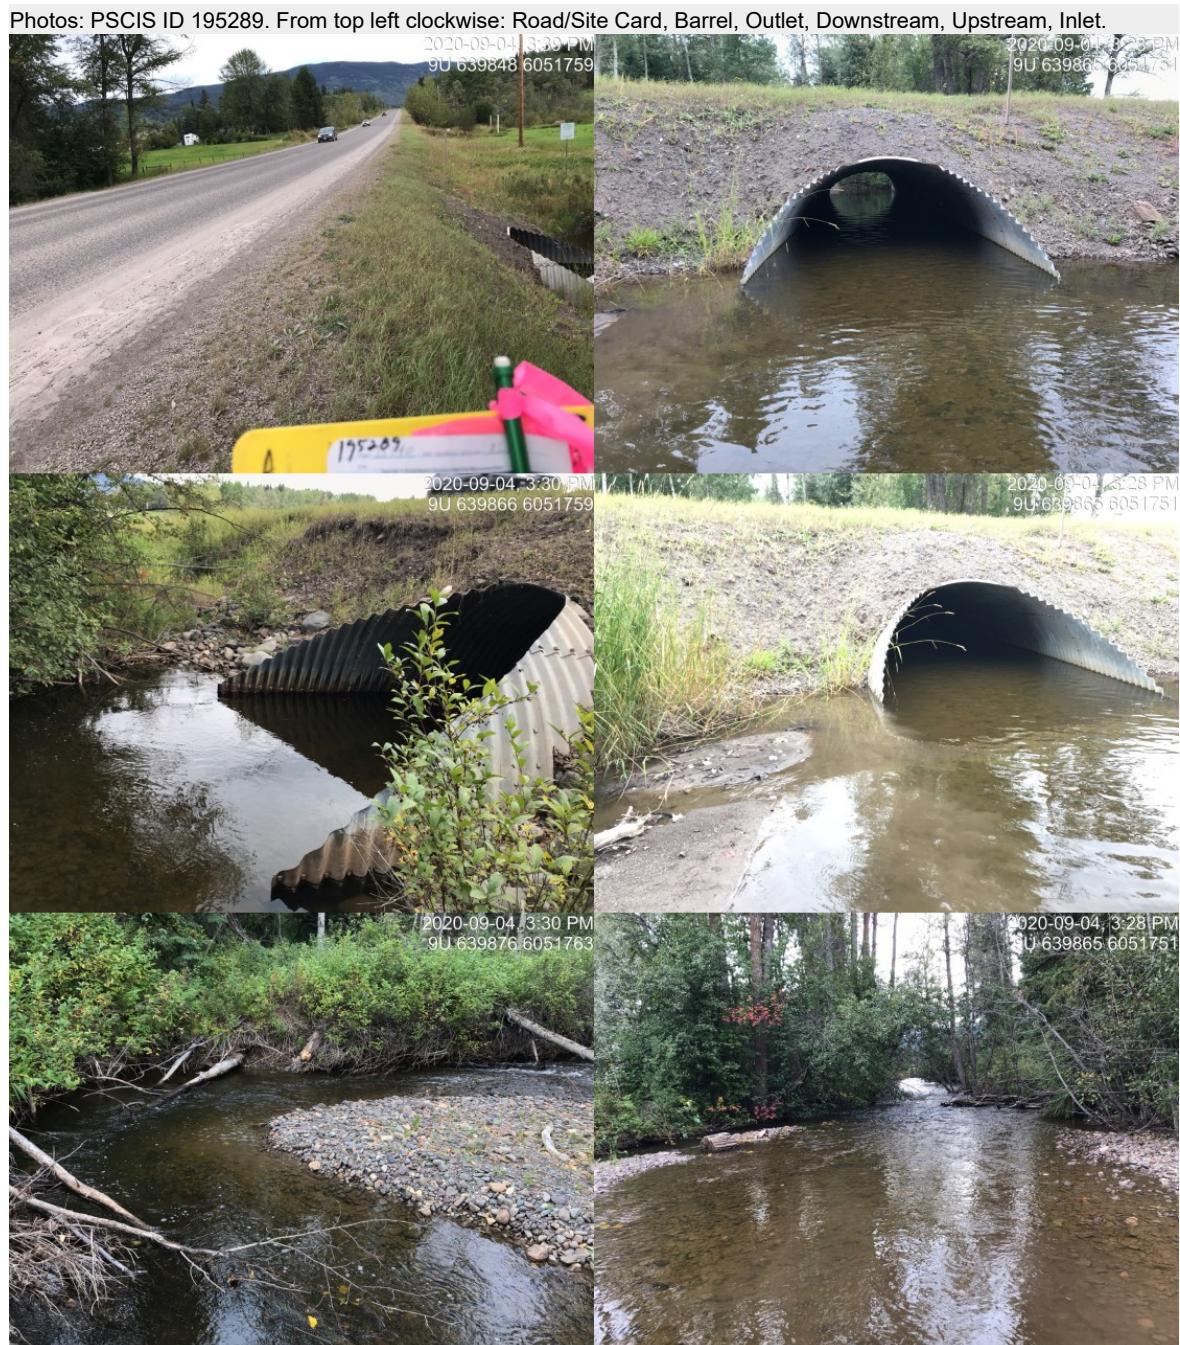
Location and Stream Data		.	Crossing Characteristics –	
Date	2020-09-04	Crossing Sub Type	Oval Culvert	
PSCIS ID	195289	Diameter (m)	4	
External ID	–	Length (m)	2	
Crew	AI, KP	Embedded	Yes	
UTM Zone	9	Depth Embedded (m)	0.55	
Easting	639869	Resemble Channel	No	
Northing	6051747	Backwatered	No	
Stream	Deep Creek	Percent Backwatered	–	
Road	Highway 16	Fill Depth (m)	1.5	
Road Tenure	MoTi highway	Outlet Drop (m)	0	
Channel Width (m)	14	Outlet Pool Depth (m)	0.3	
Stream Slope (%)	2	Inlet Drop	No	
Beaver Activity	No	Slope (%)	0.5	
Habitat Value	High	Valley Fill	Deep Fill	
Final score	11	Barrier Result	Passable	
Fix type	–	Fix Span / Diameter	–

Comments: No habitat confirmation in 2020. Culvert is now embedded where as it was not in 2014 surveys. Passable structure with no issues.

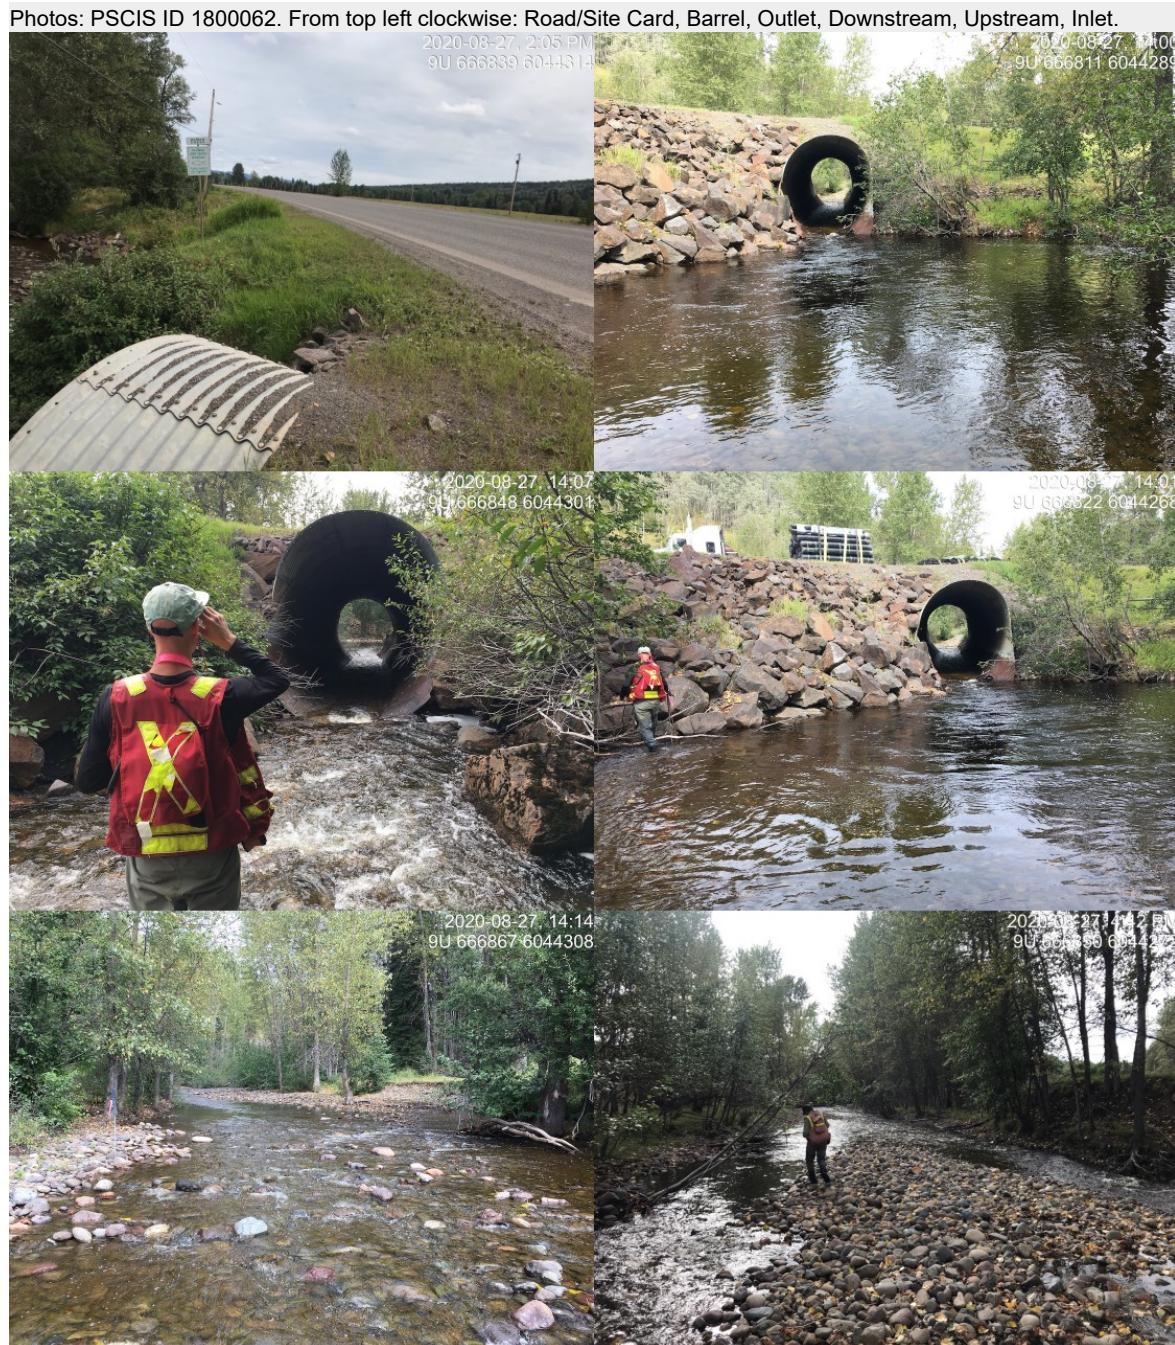
Comments: Newly constructed passable structure.

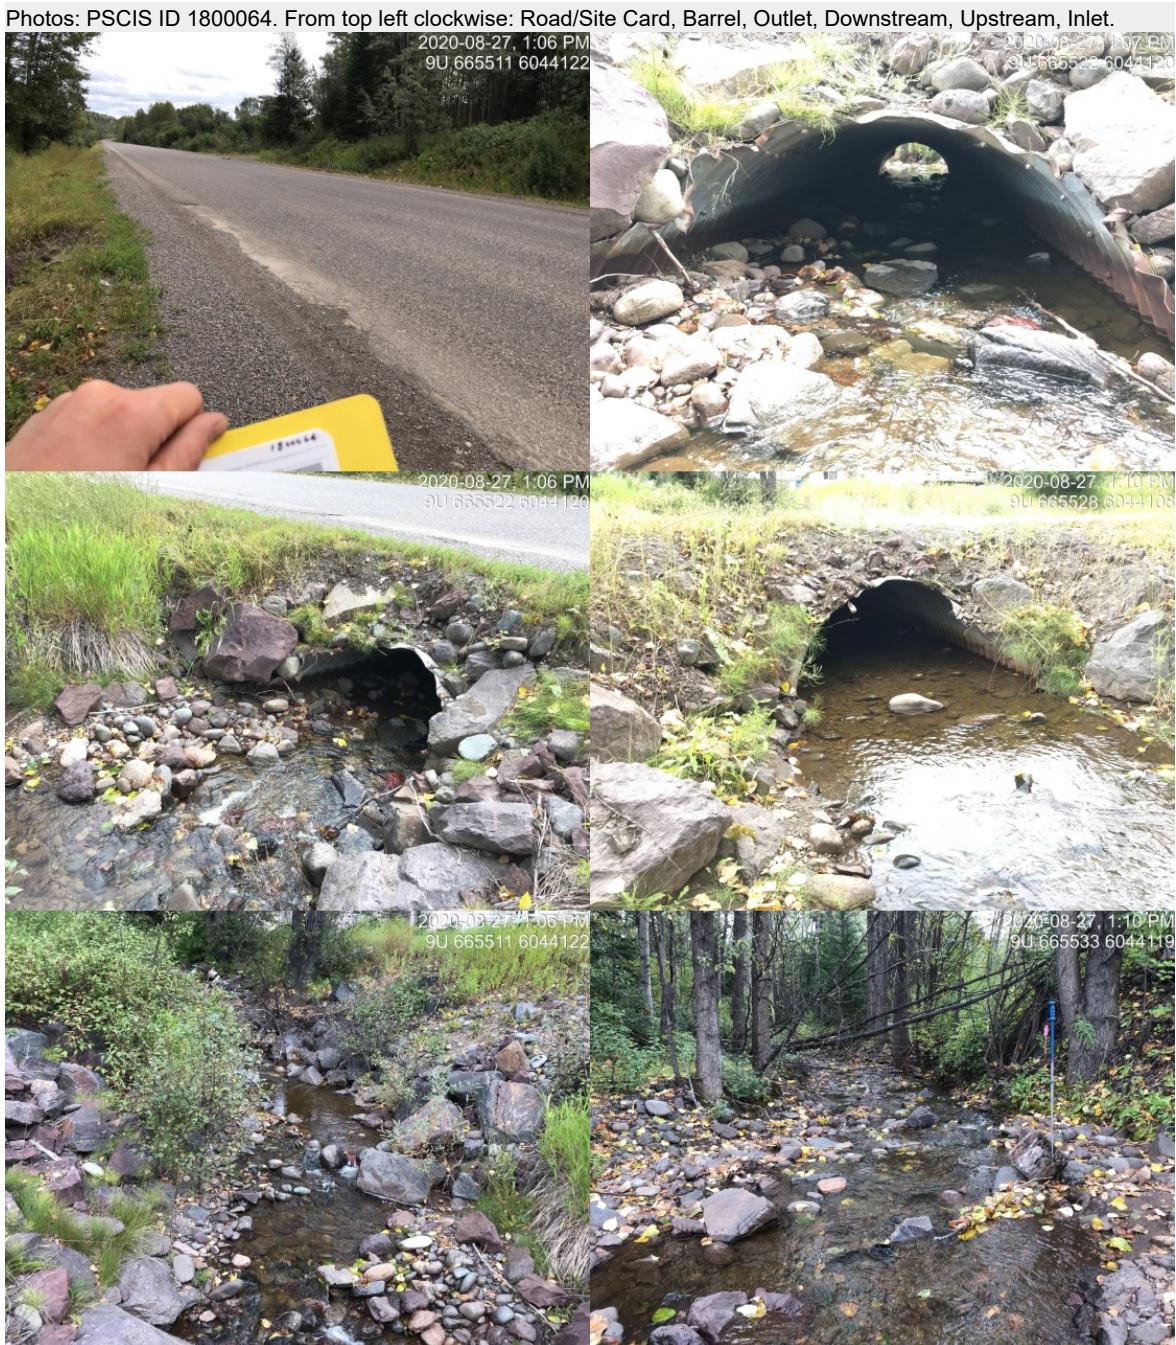
Comments: Ford. No issues.

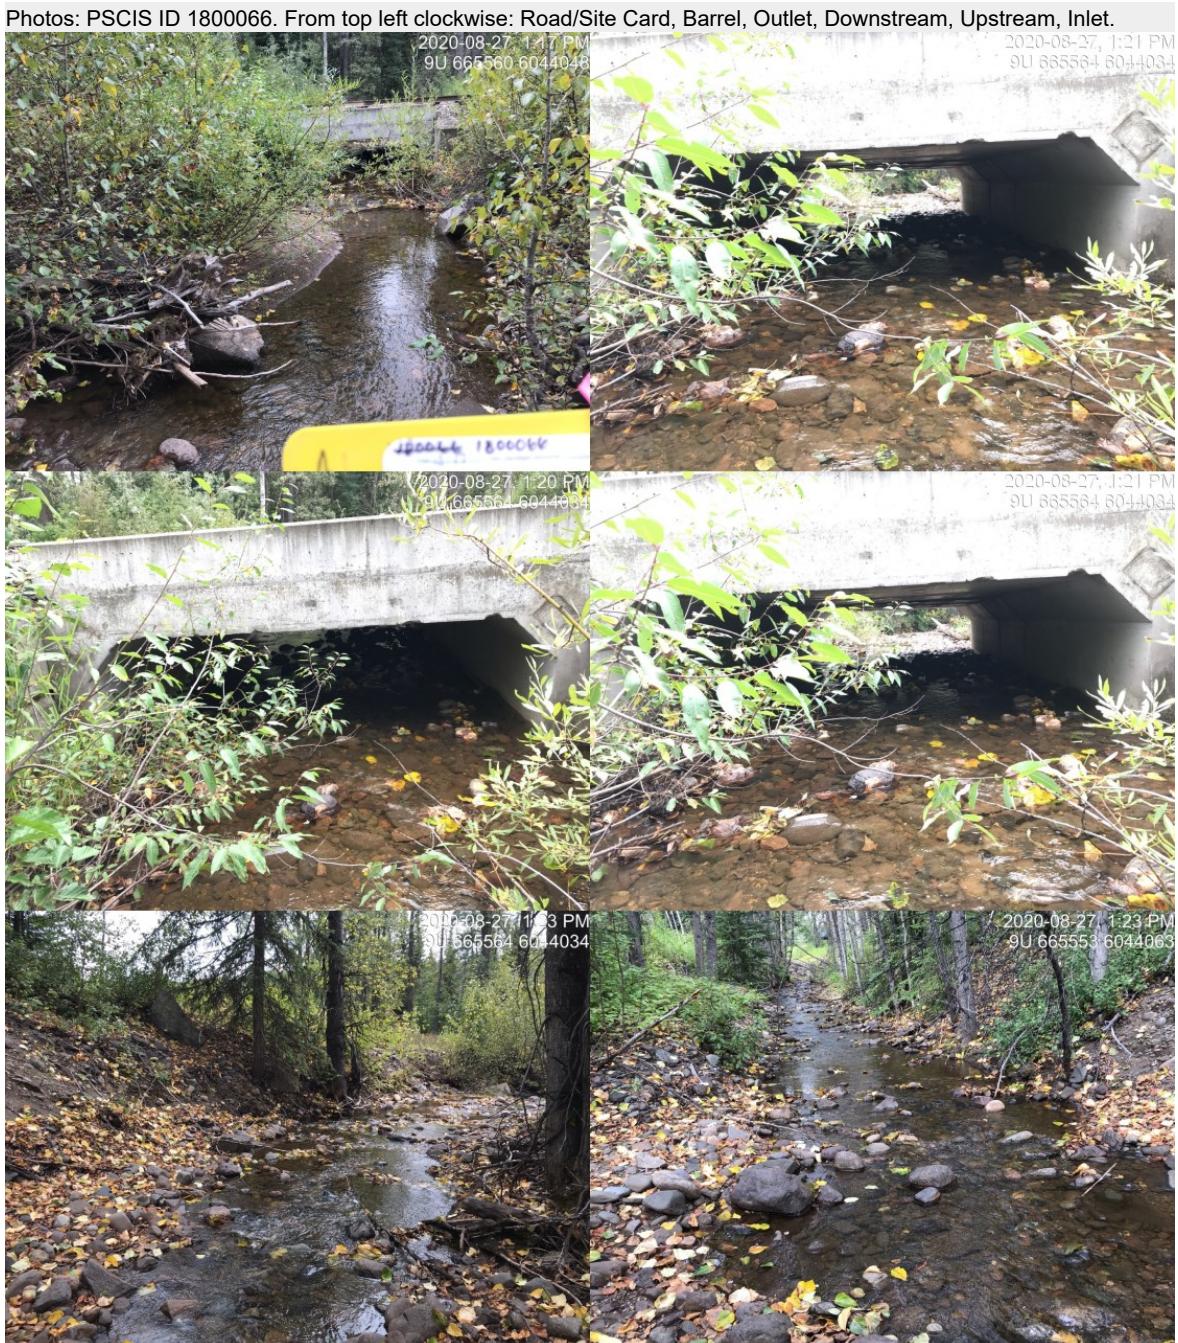
Comments: Bridge.

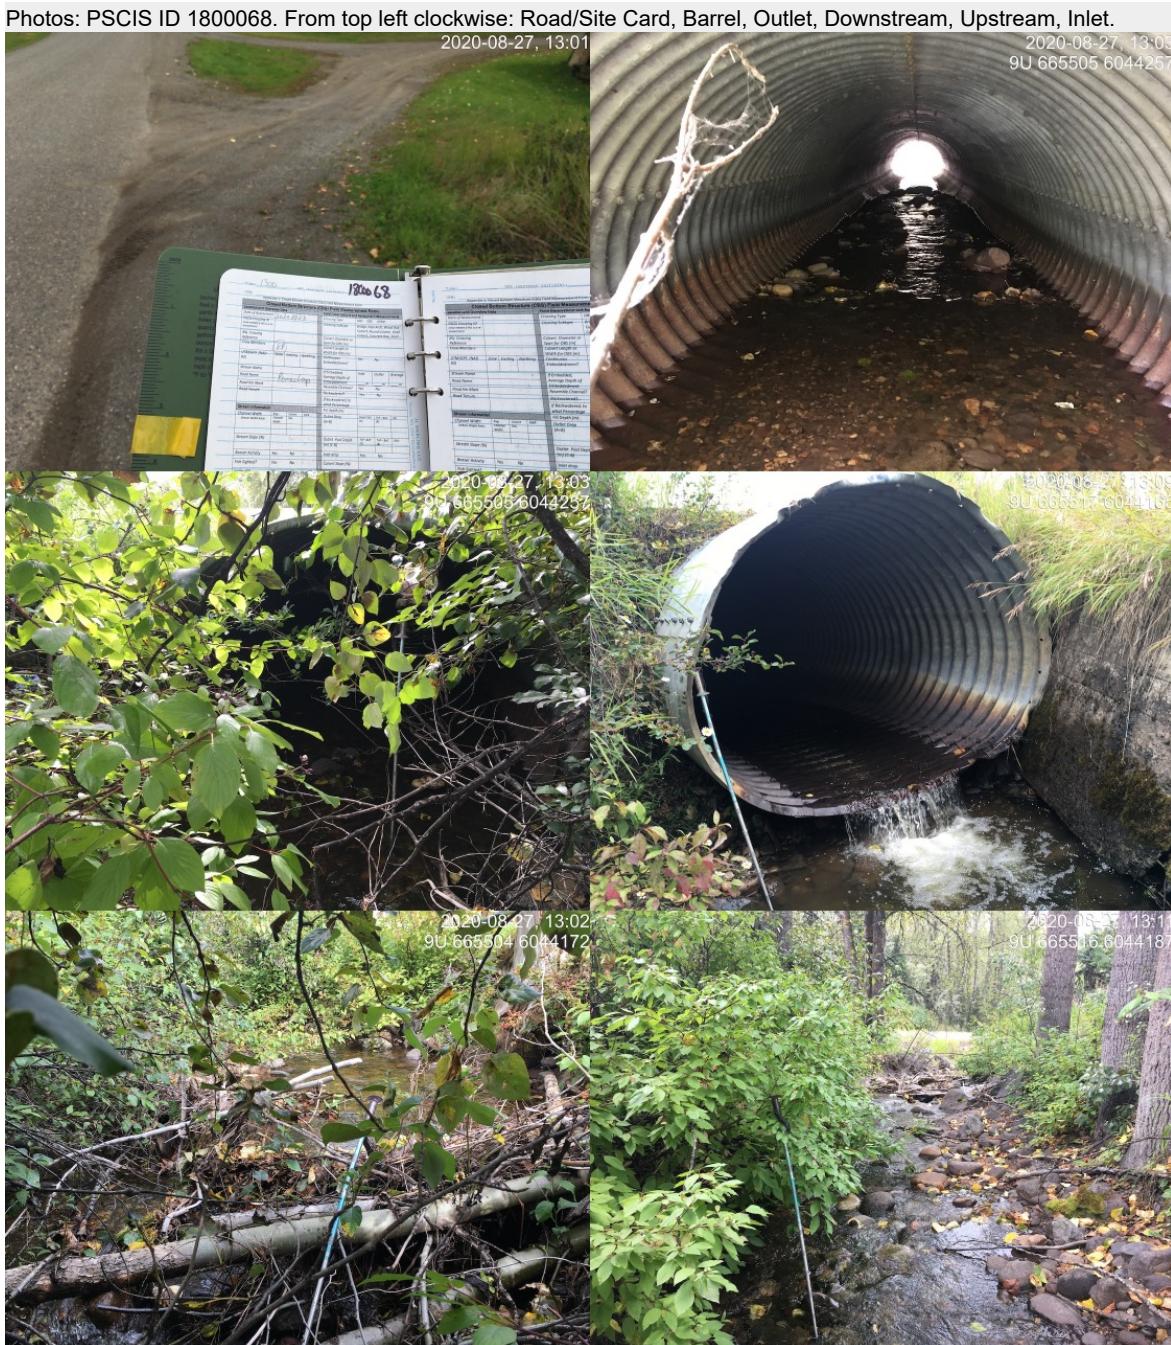
Comments: Ford. No issues.

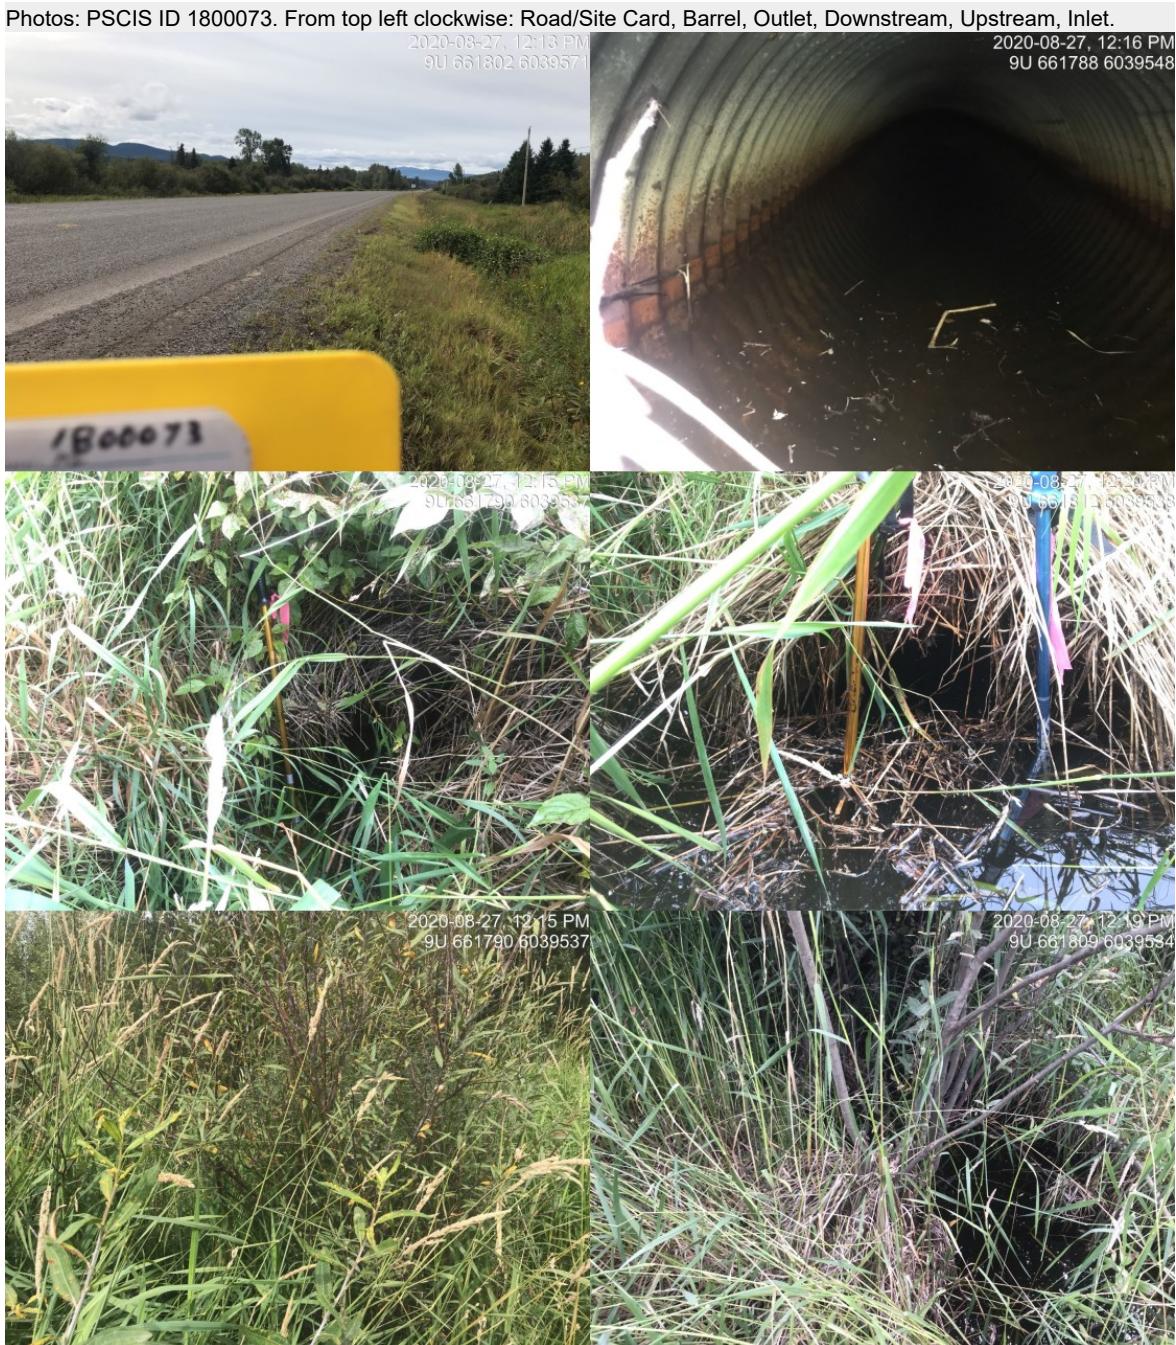
Location and Stream Data		Crossing Characteristics	
Date	2020-08-26	Crossing Sub Type	Round Culvert
PSCIS ID	197646	Diameter (m)	1
External ID	1802520	Length (m)	10
Crew	AI, KP	Embedded	No
UTM Zone	9	Depth Embedded (m)	—
Easting	672023	Resemble Channel	No
Northing	6005200	Backwatered	No
Stream	Tributary to Buck Creek	Percent Backwatered	—
Road	Spur off Parrot FSR	Fill Depth (m)	1.2
Road Tenure	R216960010	Outlet Drop (m)	0
Channel Width (m)	1.4	Outlet Pool Depth (m)	0.42
Stream Slope (%)	5	Inlet Drop	No
Beaver Activity	Yes	Slope (%)	1
Habitat Value	Medium	Valley Fill	Deep Fill
Final score	21	Barrier Result	Barrier
Fix type	Replace Structure with Streambed Simulation CBS	Fix Span / Diameter	3

Comments: Stream drains Sam Lake. Old log bridge type structure that is collapsing with round culvert inserted. Pipe contains beaver debris. Wetland habitat upstream.

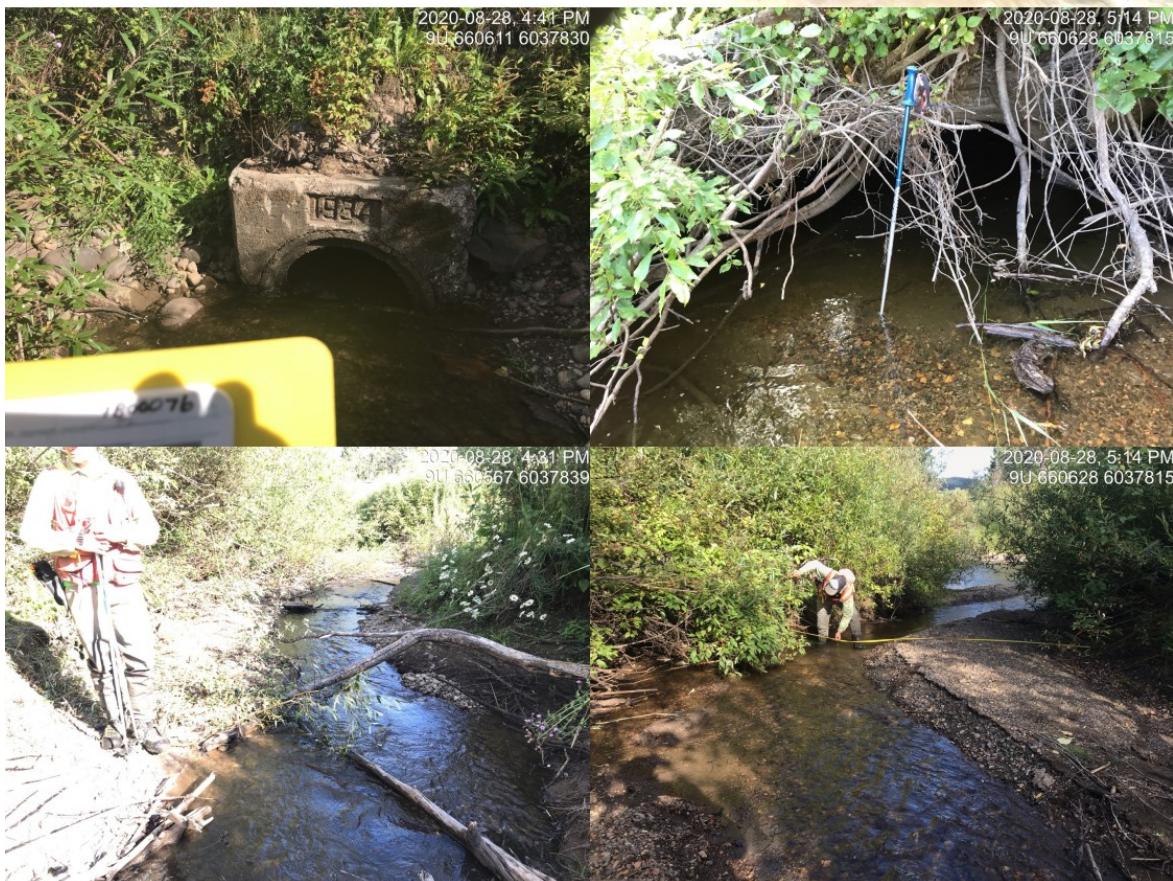
Photos: PSCIS ID 1800076. From top left clockwise: Road/Site Card, Barrel, Outlet, Downstream, Upstream, Inlet.

Location and Stream Data		Crossing Characteristics	
Date	2020-08-26	Crossing Sub Type	Round Culvert
PSCIS ID	197647	Diameter (m)	1
External ID	1804986	Length (m)	16
Crew	KP, AI	Embedded	No
UTM Zone	9	Depth Embedded (m)	—
Easting	651263.5	Resemble Channel	No
Northing	6012508	Backwatered	No
Stream	Tributary to Buck Creek	Percent Backwatered	—
Road	Carrier FSR	Fill Depth (m)	1.8
Road Tenure	FLNR Nadina 9772	Outlet Drop (m)	0.3
Channel Width (m)	1.5	Outlet Pool Depth (m)	0
Stream Slope (%)	2	Inlet Drop	No
Beaver Activity	No	Slope (%)	1.5
Habitat Value	Low	Valley Fill	Deep Fill
Final score	34	Barrier Result	Barrier
Fix type	Replace Structure with Streambed Simulation CBS	Fix Span / Diameter	3

Comments: Suspect no fish. Multiple fish survey sites located downstream. Dry at time of survey.

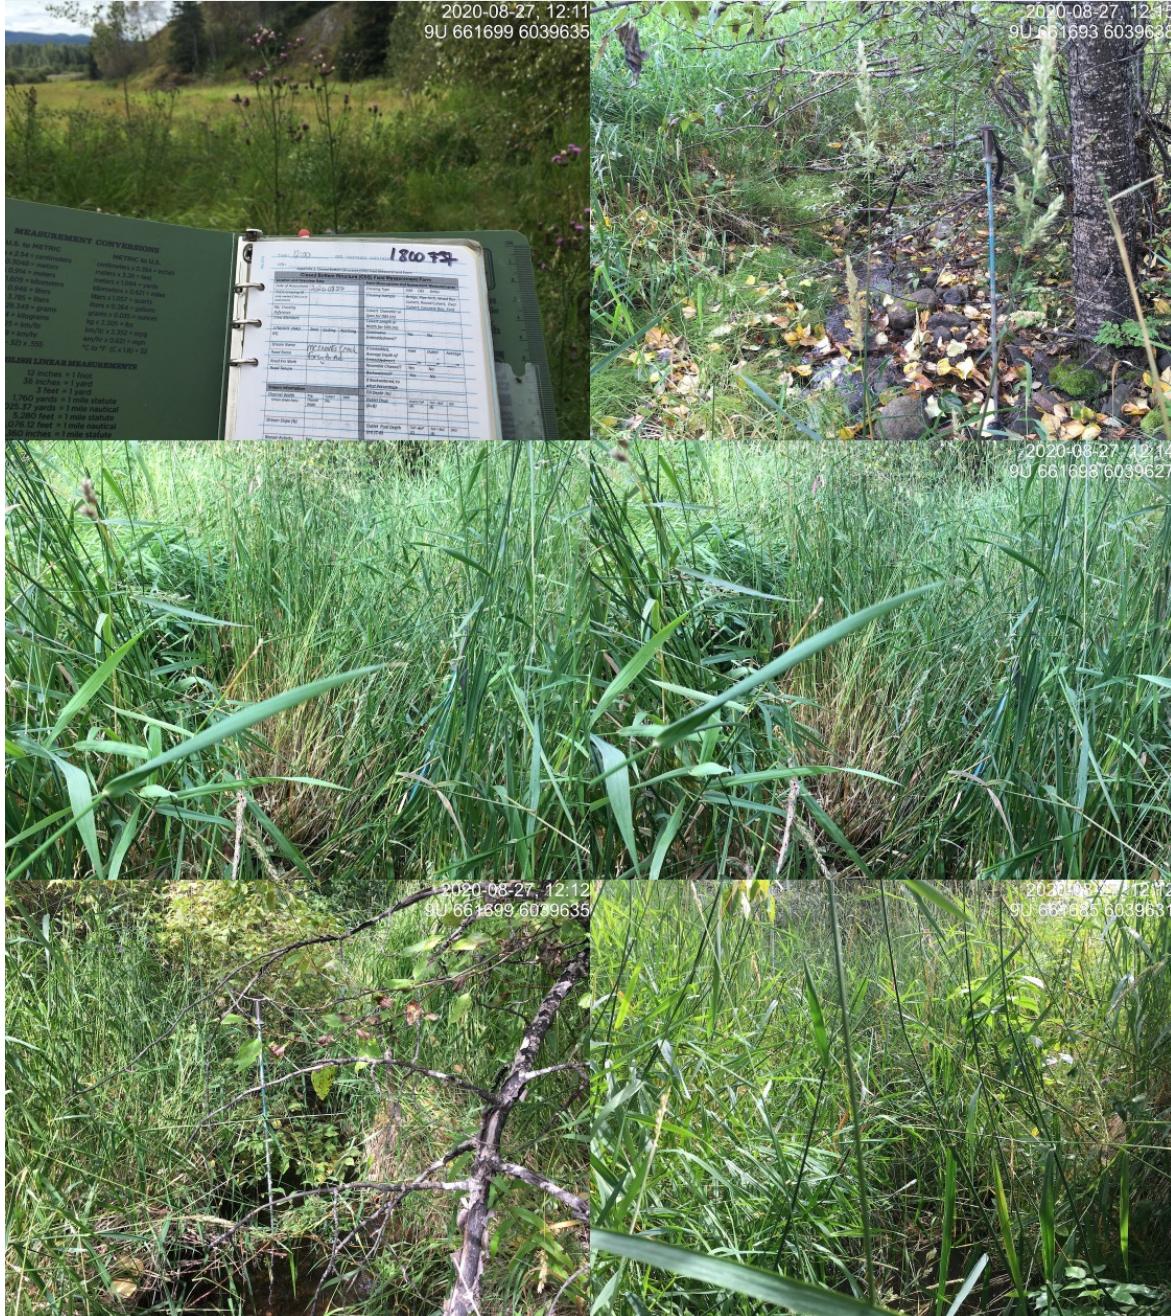
Photos: PSCIS ID 1800077. From top left clockwise: Road/Site Card, Barrel, Outlet, Downstream, Upstream, Inlet.

Comments: Bridge. No issues.

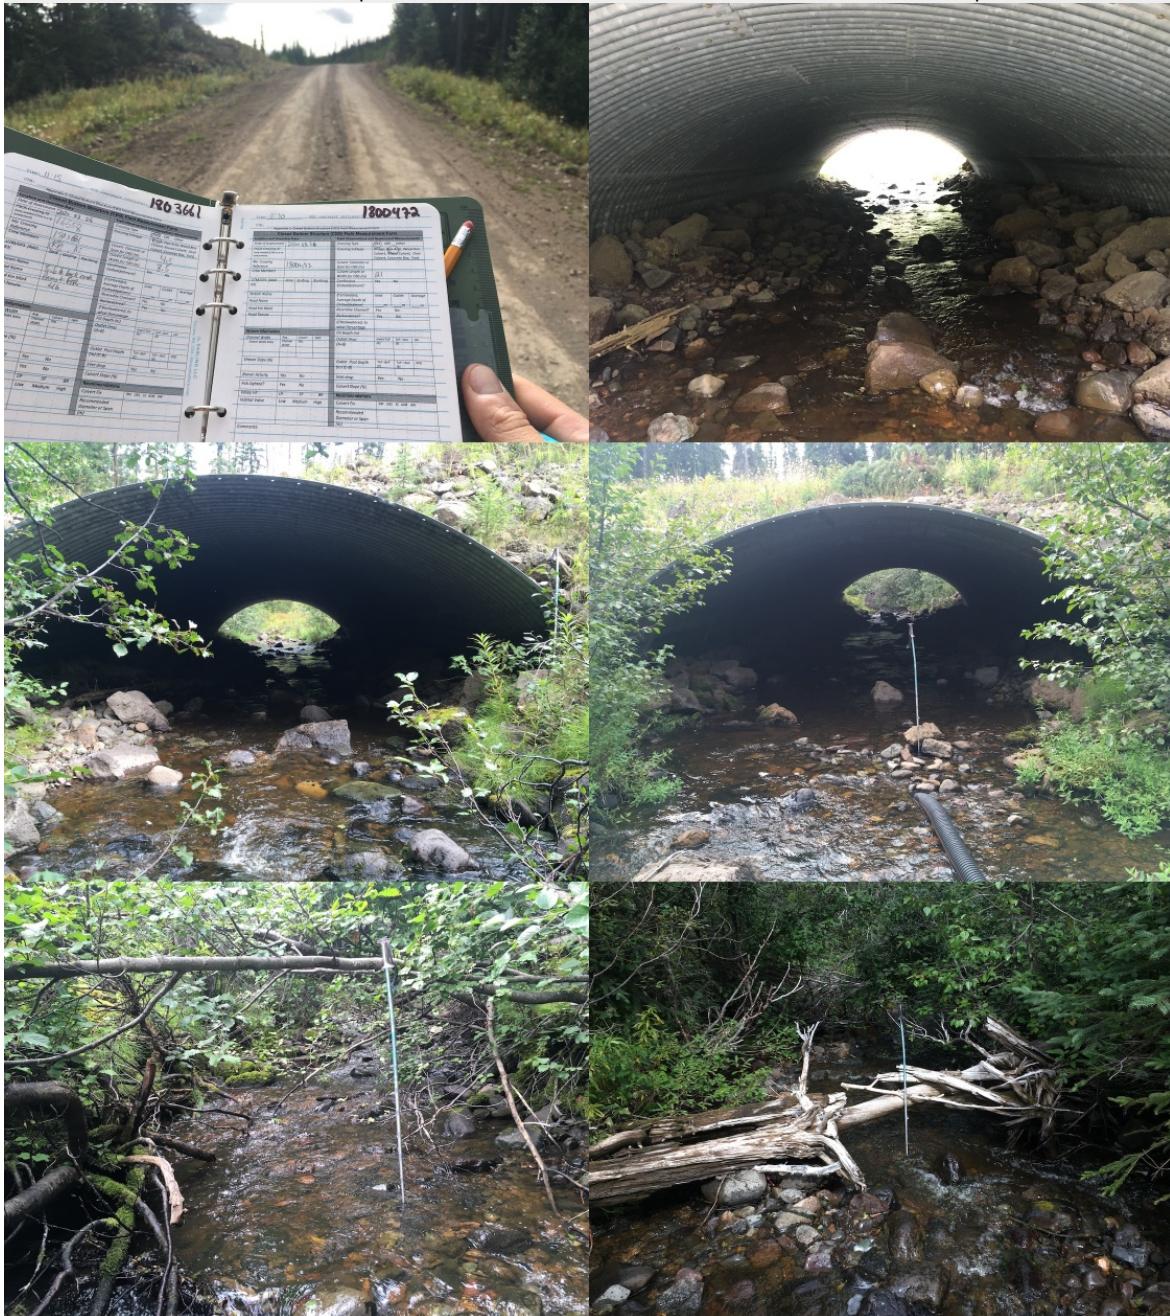
Photos: PSCIS ID 1800472. From top left clockwise: Road/Site Card, Barrel, Outlet, Downstream, Upstream, Inlet.

Comments: Ford. No issues.
