Appendix - Phase 1 Fish Passage Assessment Data and Photos

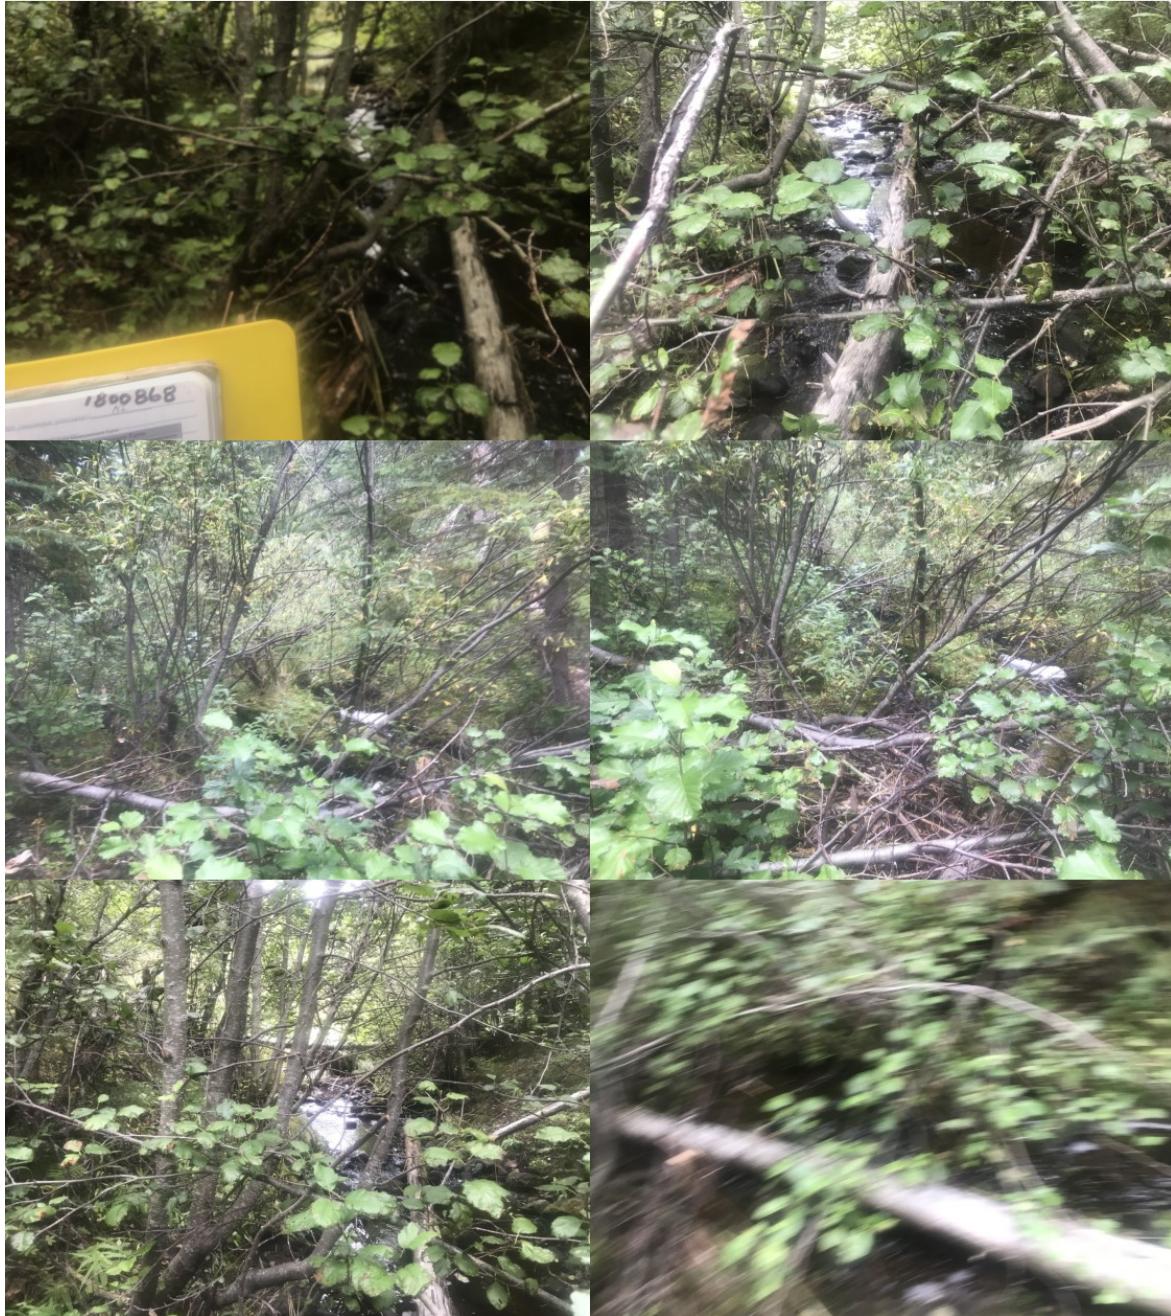
Photos: PSCIS ID 1800868. From top left clockwise: Road/Site Card, Barrel, Outlet, Downstream, Upstream, Inlet.

Comments: Ford. No issues.

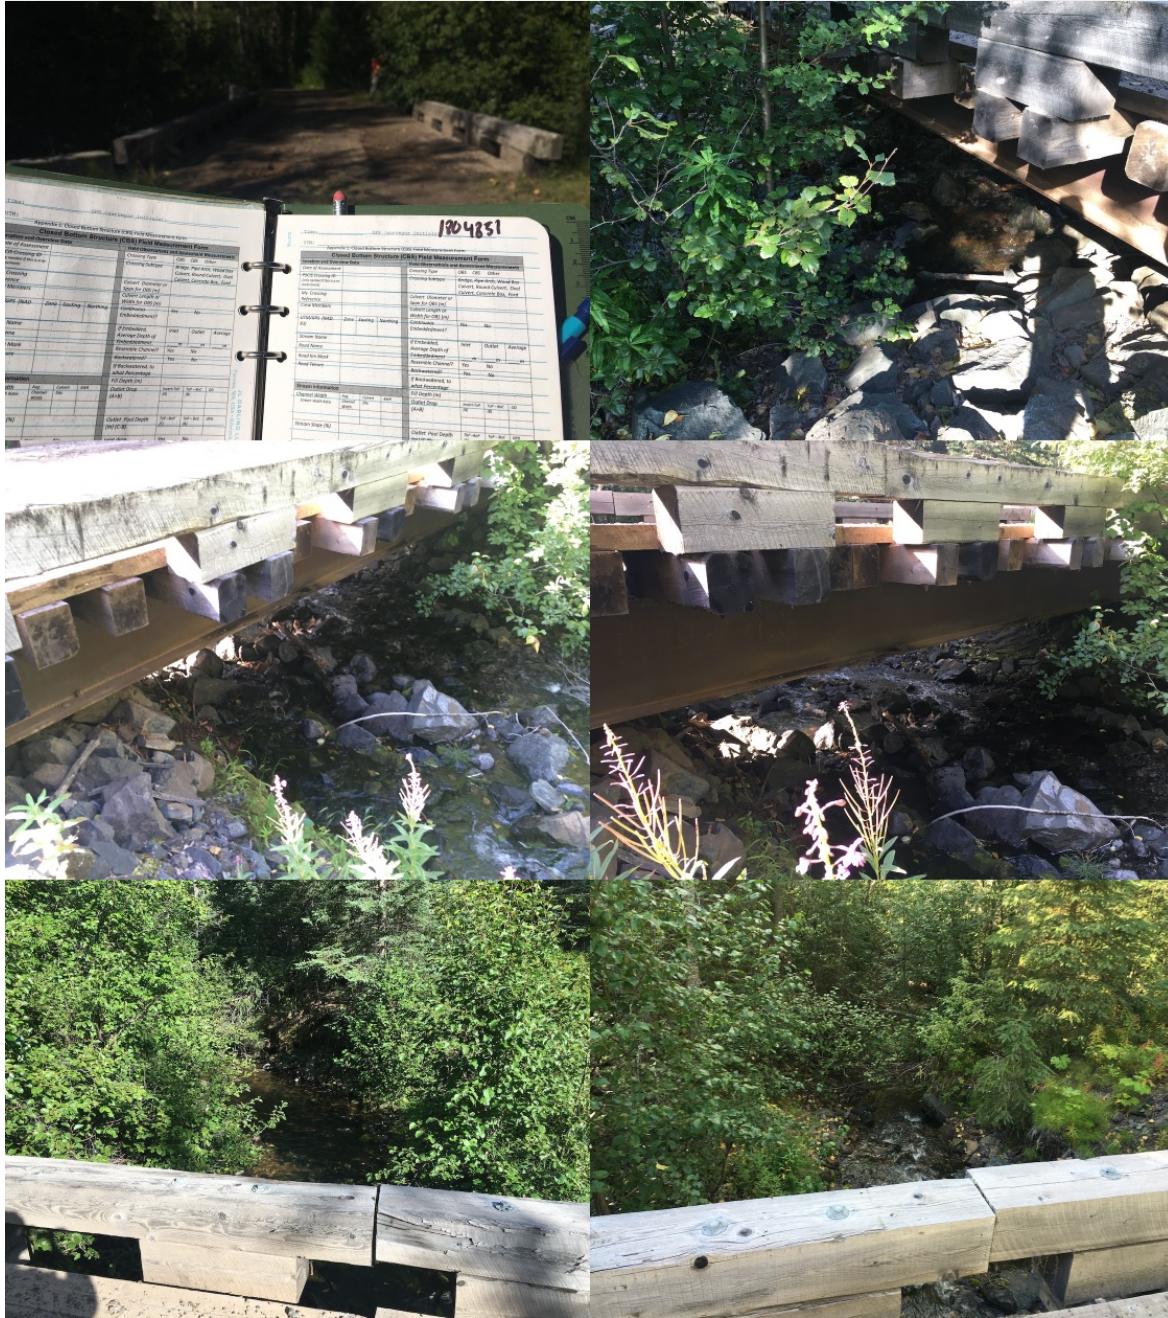
Photos: PSCIS ID 1804851. From top left clockwise: Road/Site Card, Barrel, Outlet, Downstream, Upstream, Inlet.

Comments: Appears passable. No concerns.

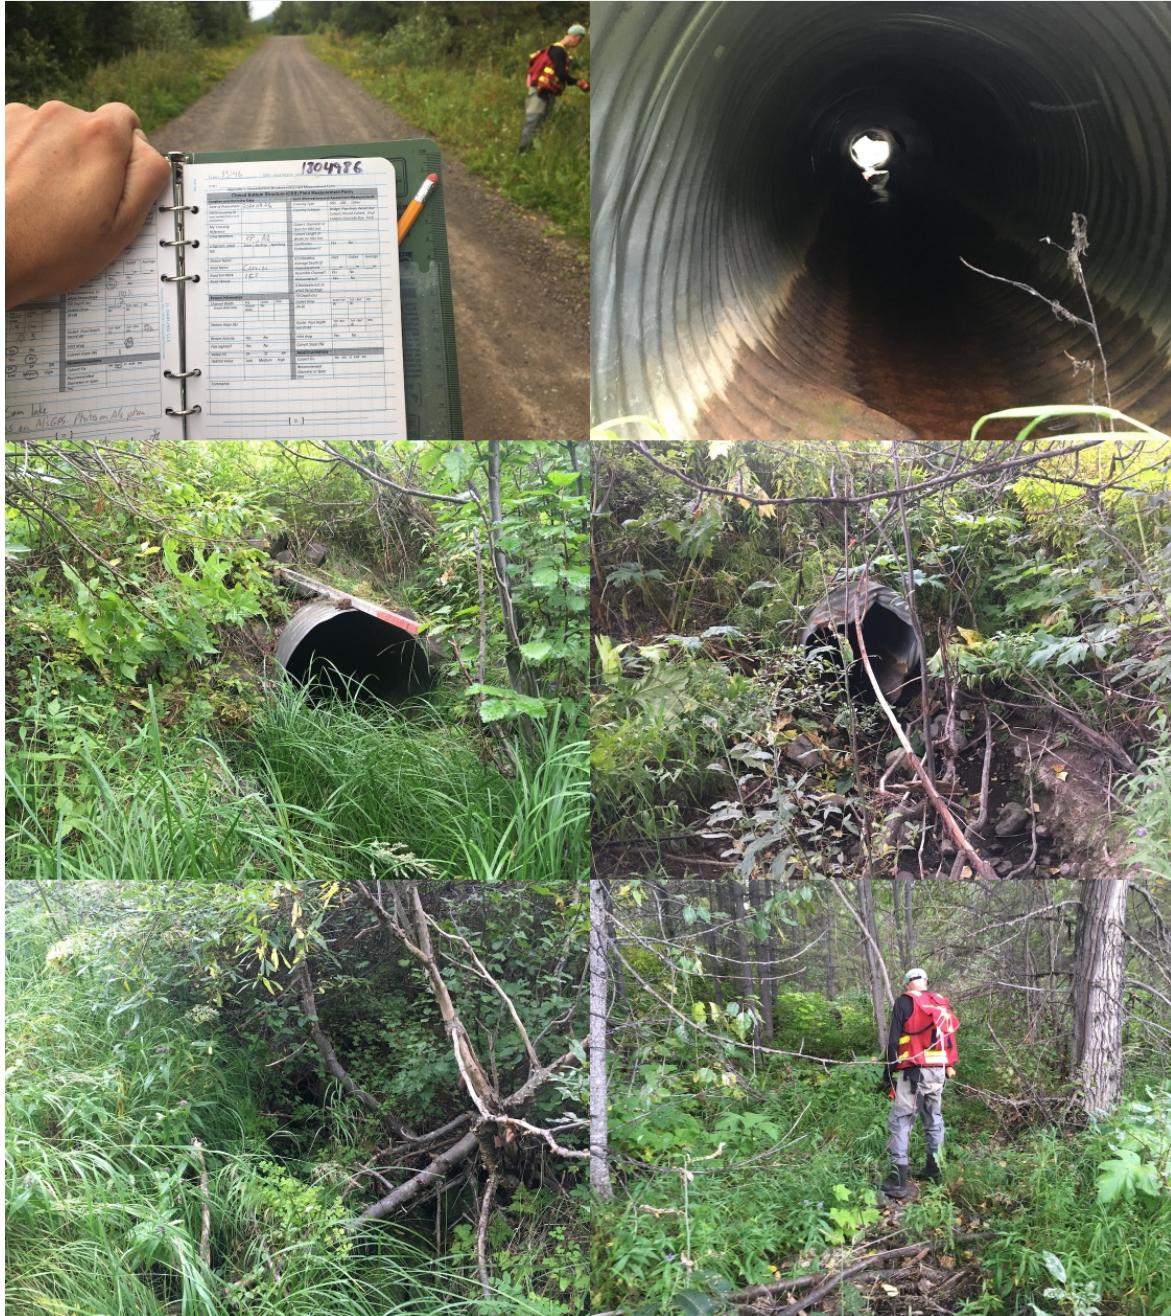
Photos: PSCIS ID 1804986. From top left clockwise: Road/Site Card, Barrel, Outlet, Downstream, Upstream, Inlet.

Comments: Appears passable. No concerns.

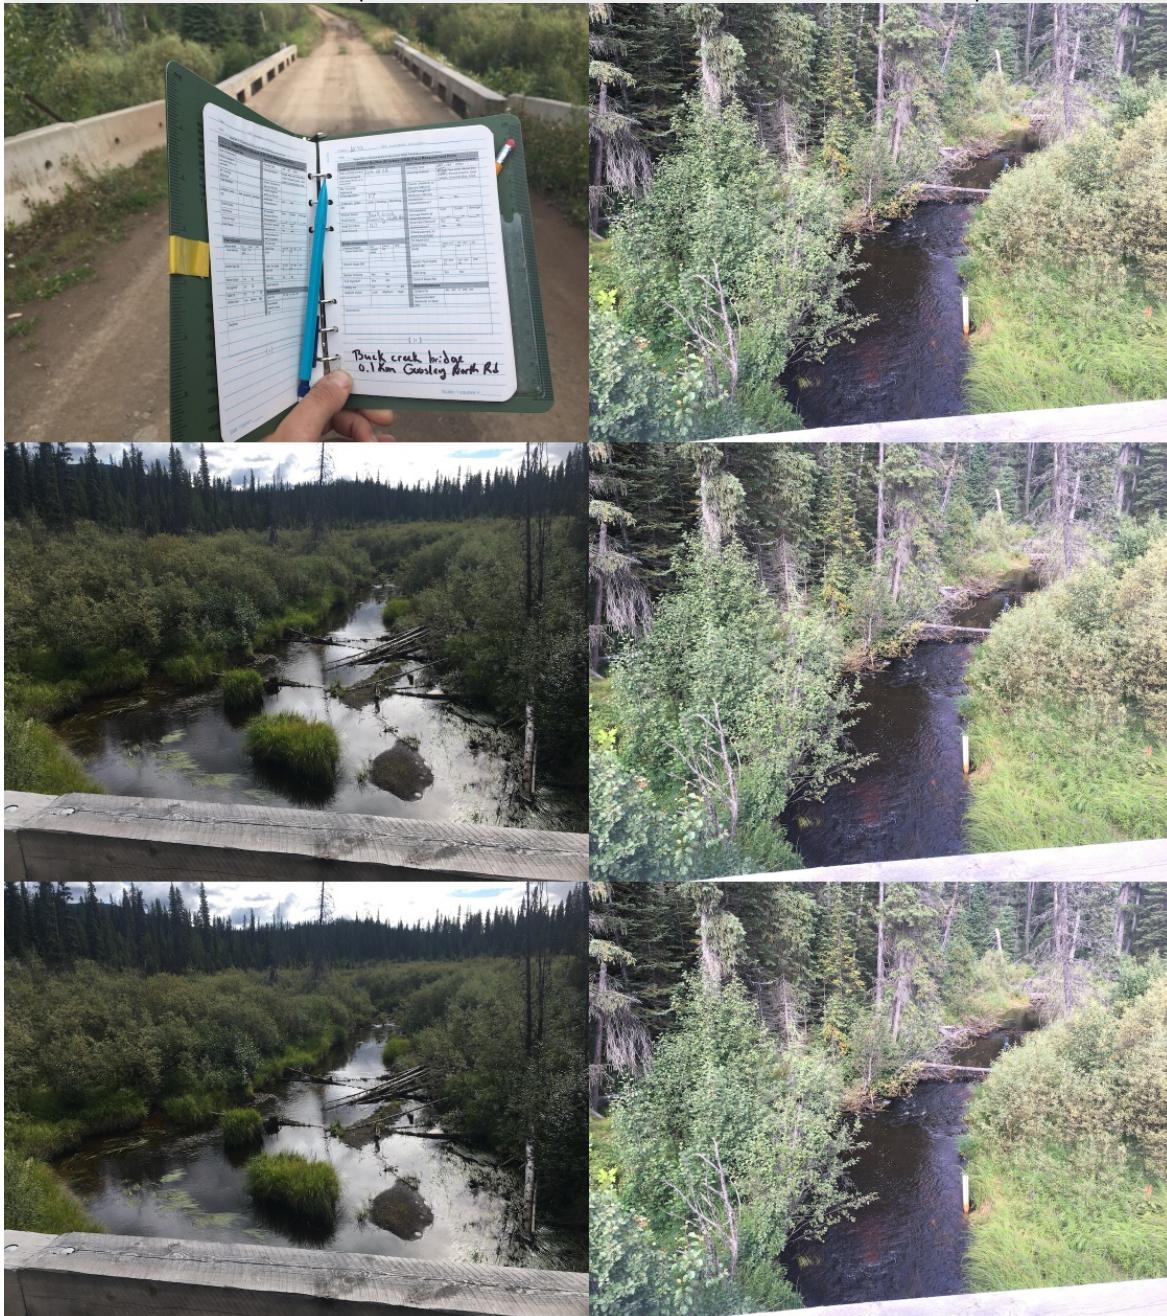
Photos: PSCIS ID 1805183. From top left clockwise: Road/Site Card, Barrel, Outlet, Downstream, Upstream, Inlet.

Comments: Habitat confirmation and minnowtrapping completed.

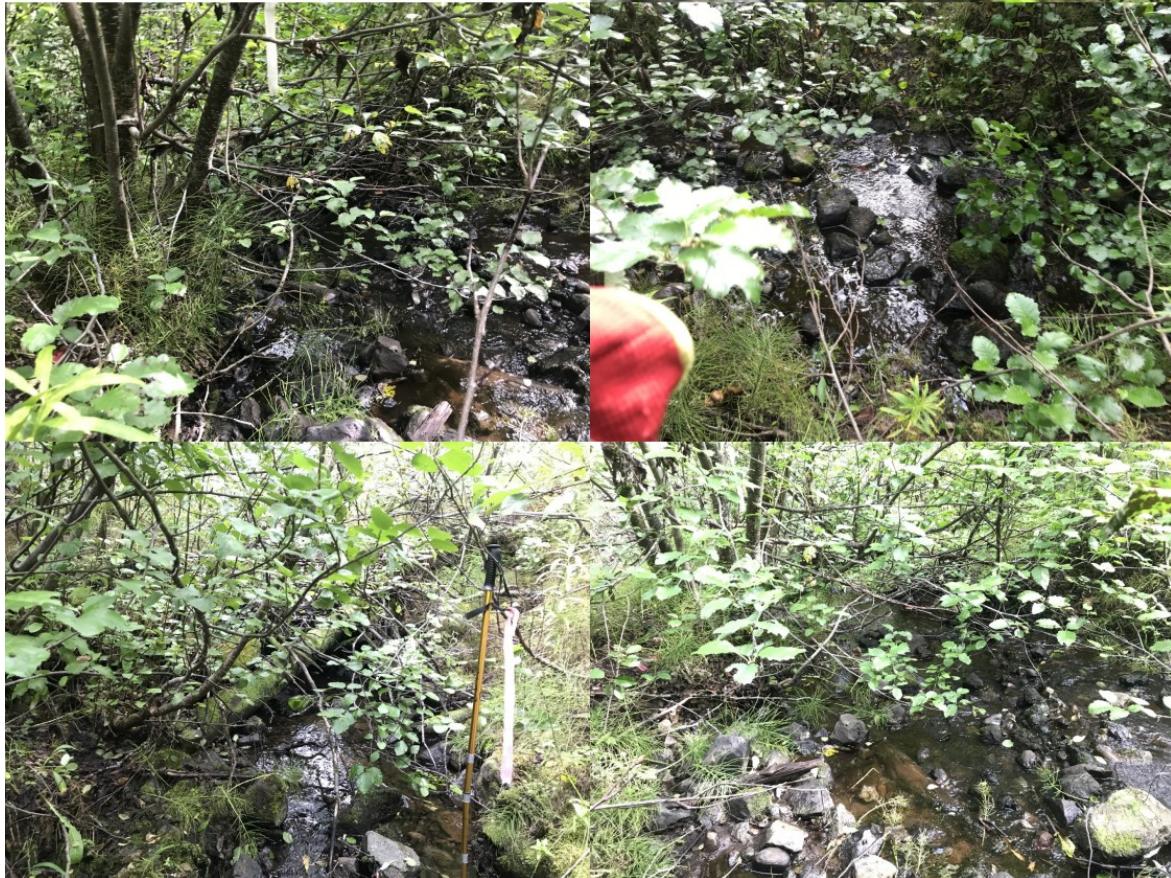
Photos: PSCIS ID 1805455. From top left clockwise: Road/Site Card, Barrel, Outlet, Downstream, Upstream, Inlet.

Comments: Habitat confirmation and sampling completed.

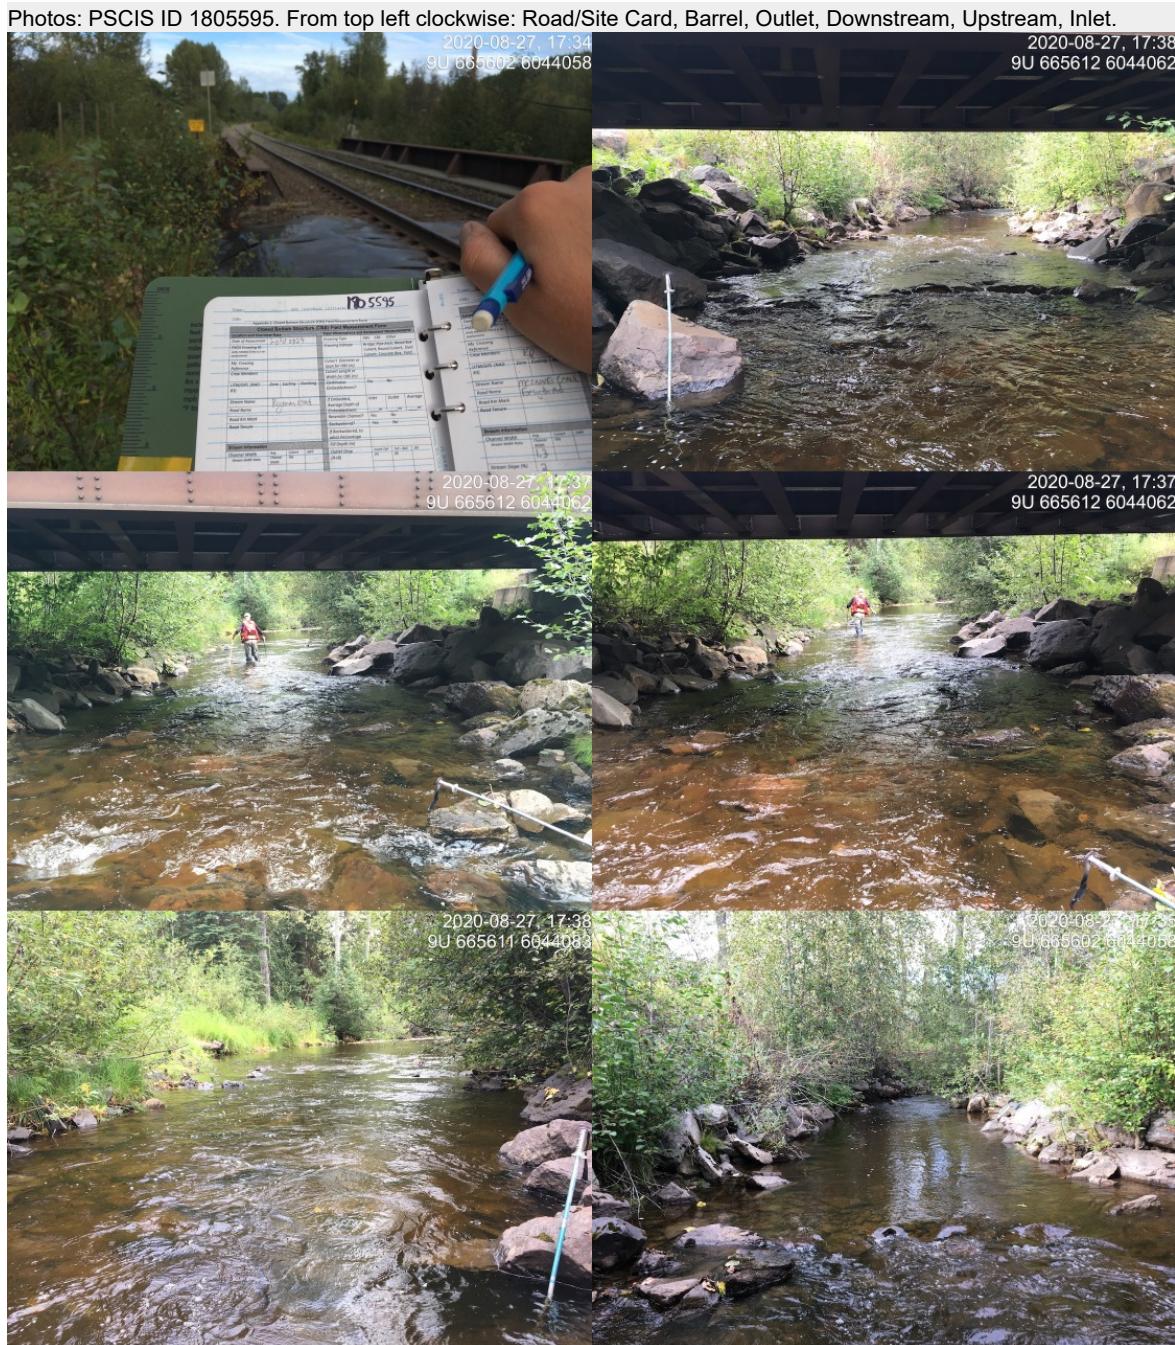
Comments: Habitat confirmation completed.
