DRAFT - Bulkley River and Morice River Watershed Groups Fish Passage Restoration Planning

Prepared for
Habitat Conservation Trust Fund
BC Fish Passage Remediation Program
Canadian Wildlife Federation

Prepared by
Al Irvine, B.Sc., R.P.Bio.
New Graph Environment
6 Regent St
Nelson, BC V1L 2P1

DRaFT - Version 0.0.2
2021-03-01

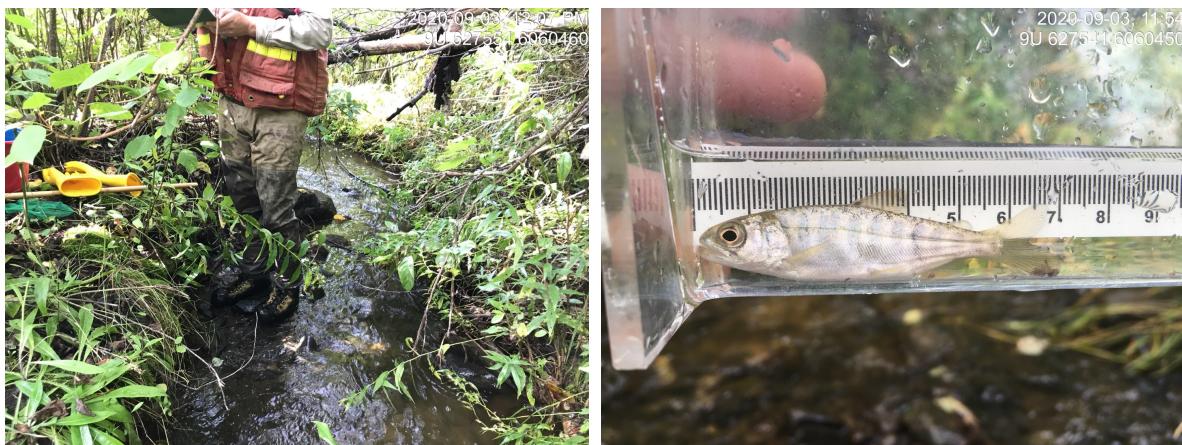
Figure 5.3: Left: Typical habitat downstream of PSCIS crossing 58159. Right: Chinook captured downstream of PSCIS crossing 58159.

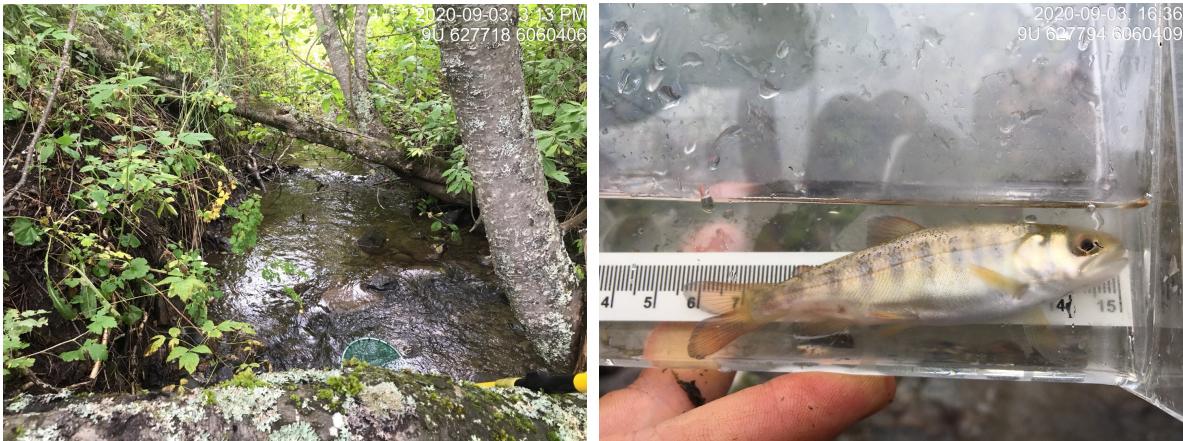
The stream was surveyed upstream from 58159 for 440m (Figure 5.4). Within the area surveyed, total cover amount was rated as abundant with large woody debris dominant. Cover was also present as small woody debris, undercut banks, overhanging vegetation, and instream vegetation (Table 5.5). The average channel width was 2.2m, the average wetted width was 1.8m and the average gradient was 2%. Habitat value was rated as moderate for salmonid rearing and spawning.

Figure 5.4: Left: Typical habitat upstream of PSCIS crossing 58159. Right: Coho captured upstream of PSCIS crossing 58159.

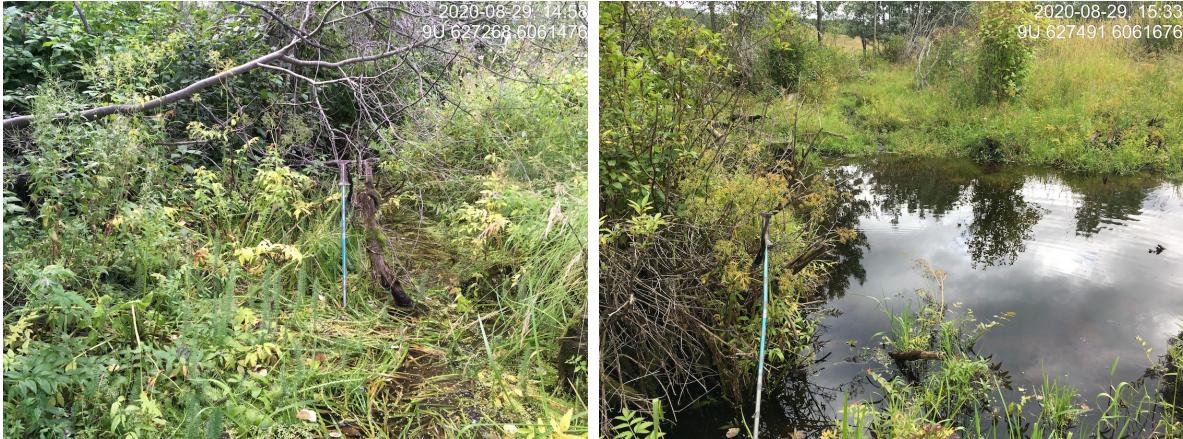
Figure 5.7: Left: Habitat upstream of PSCIS crossing 123445. Right: Habitat upstream of PSCIS crossing 123445.

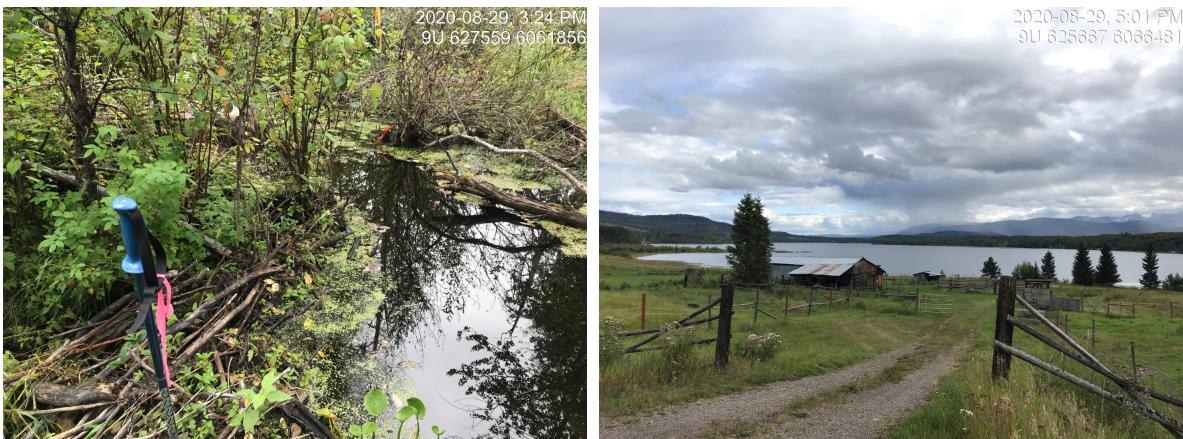
(Figure 5.8). Within the area surveyed, total cover amount was rated as abundant with overhanging vegetation dominant. Cover was also present as small woody debris, large woody debris, deep pools, and instream vegetation (Table 5.12). The average channel width was 8.5m, the average wetted width was 7.5m and the average gradient was 0.2%. Beaver activity was prevalent in the area surveyed and there was a large agricultural field located on the right bank of the stream. Habitat value was rated as moderate as it was considered an important migration corridor providing access to the lake.

Figure 5.8: Left: Habitat upstream of PSCIS crossing 123446. Right: Habitat upstream of PSCIS crossing 123446.

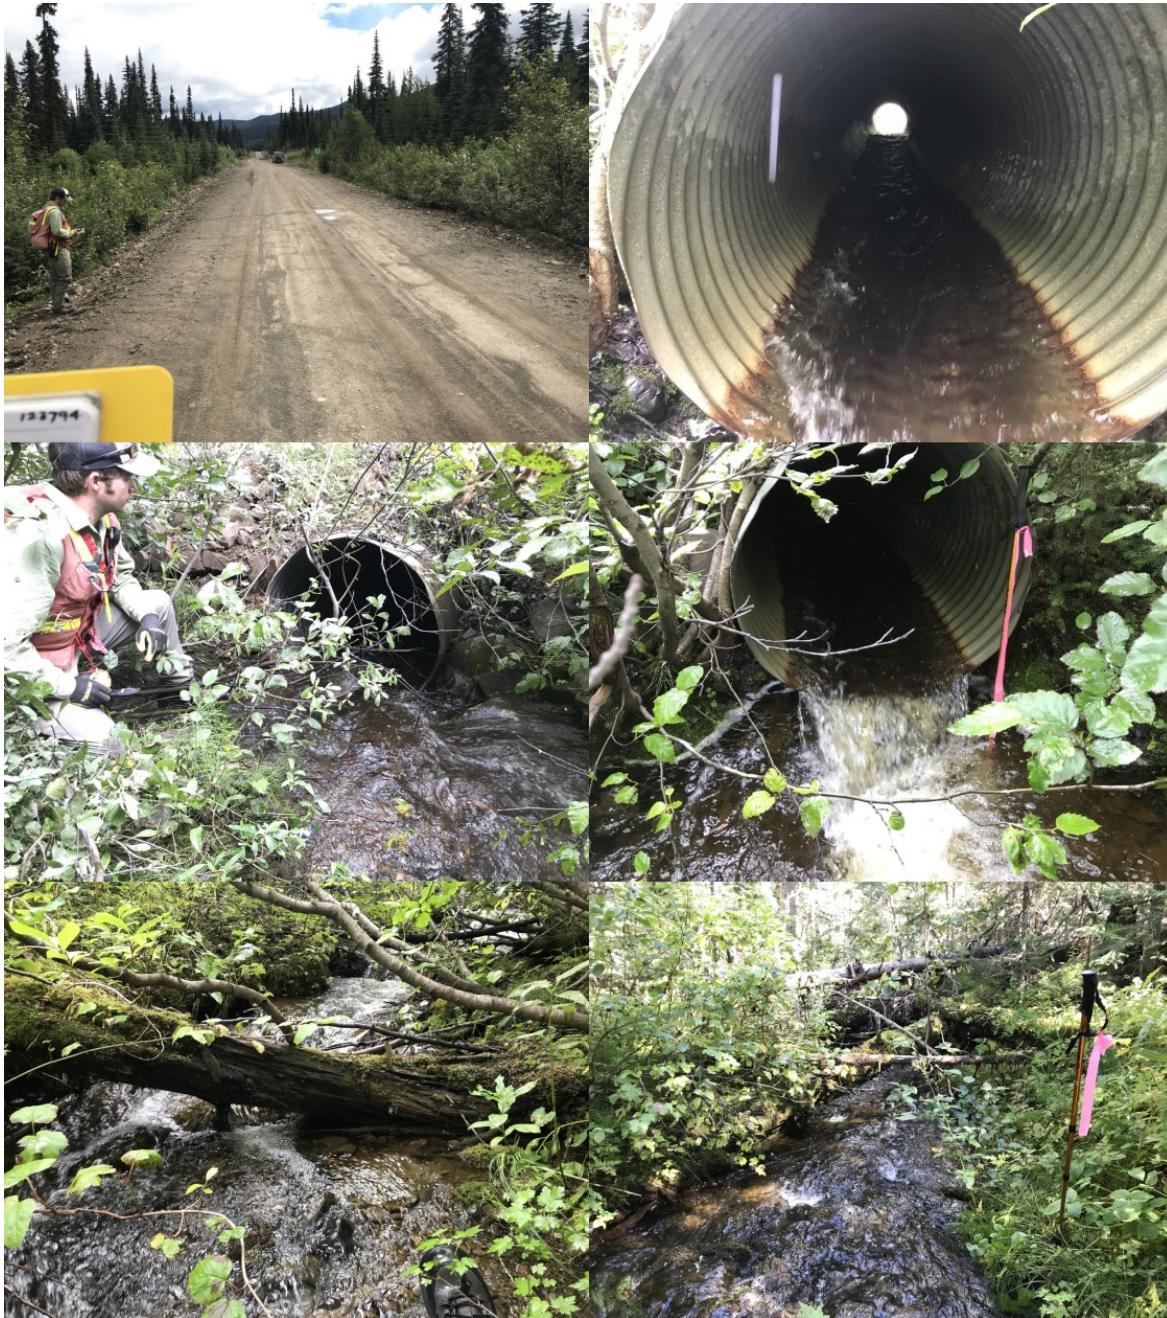
Comments: Smaller stream with good flow. Salmon points noted in adjacent stream. Recommend sampling upstream and downstream and habitat assessment of stream at associated PSCIS crossing 123785.

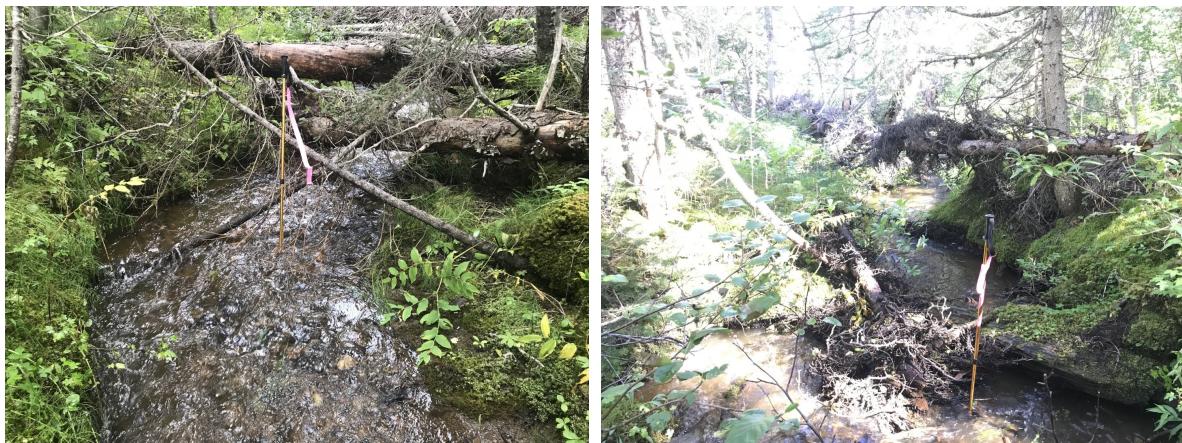
Figure 5.9: Left: Habitat downstream of PSCIS crossing 123794. Right: Habitat downstream of crossing 123794.

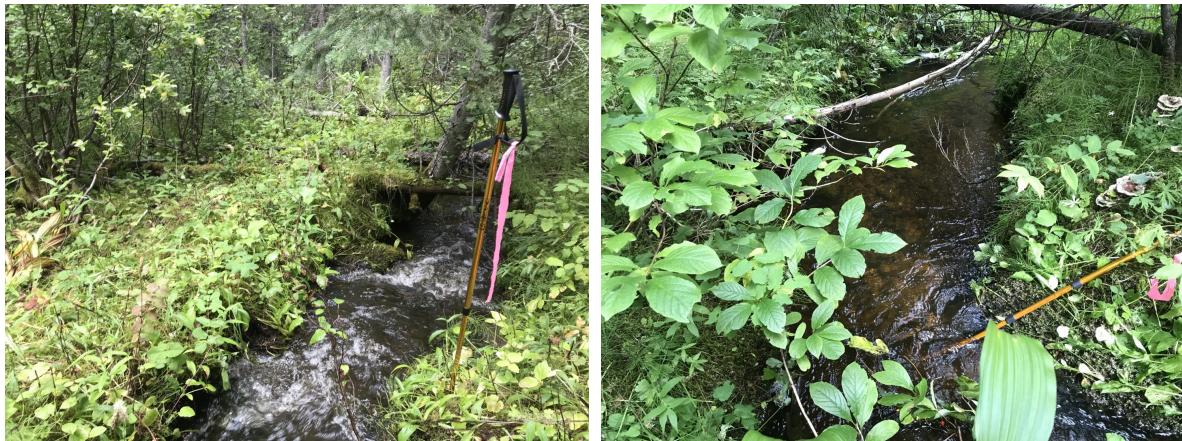
Figure 5.11: Left: Habitat downstream of PSCIS crossing 123795. Right: Habitat downstream of crossing 123795.

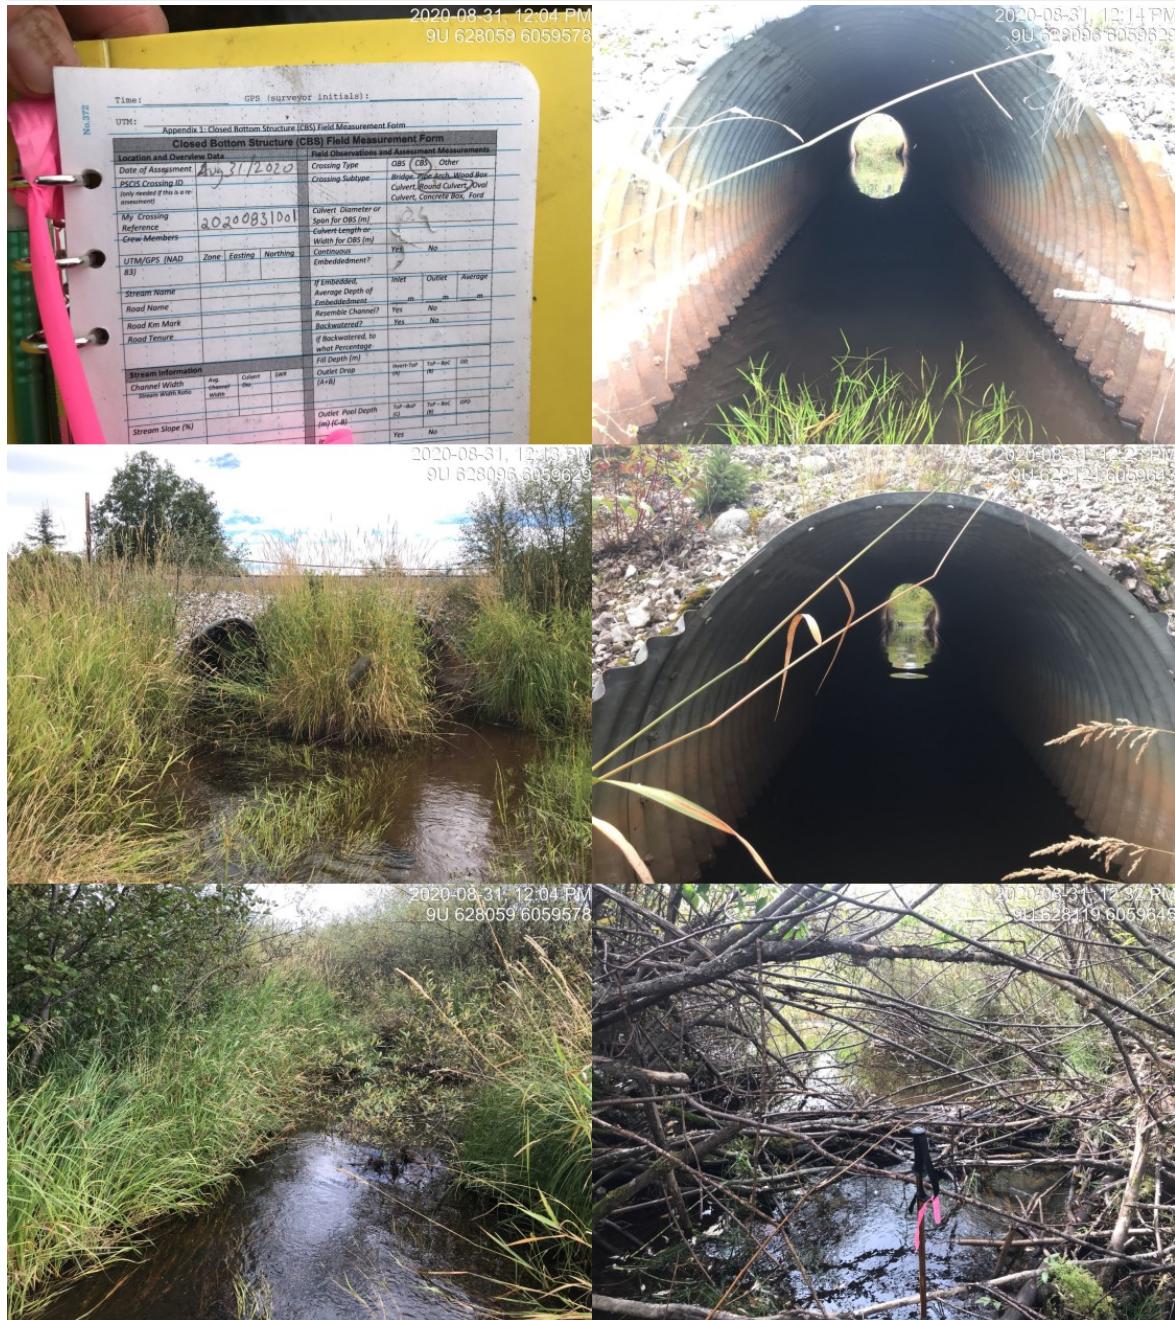
Table 5.25: Summary of habitat details for PSCIS crossing 124500.

Comments: Passable and fully backwatered structure. Landowner reports that lamprey (~40cm x 20) at crossing inside of the culvert in the past.

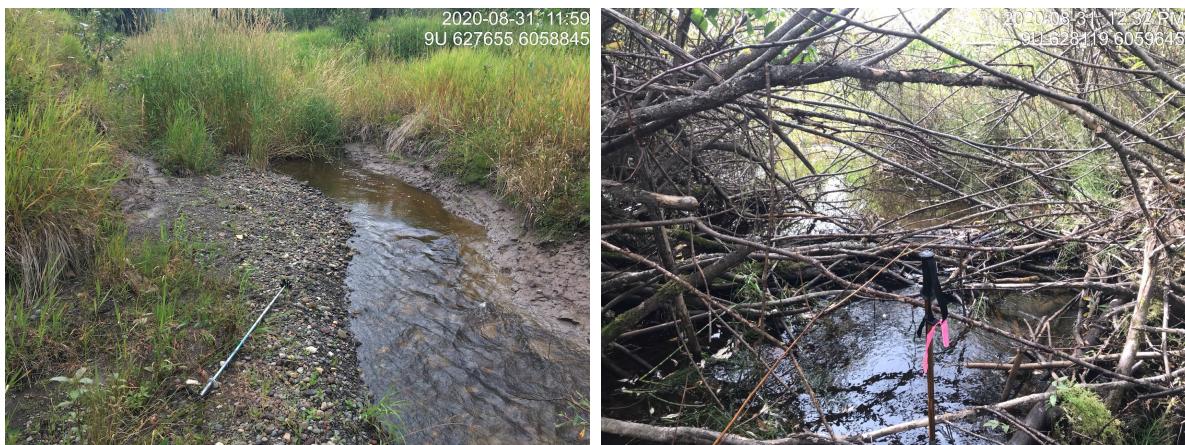
Figure 5.15: Left: Habitat downstream of PSCIS crossing 124500. Right: Habitat downstream of crossing 124500 below the railway culverts.

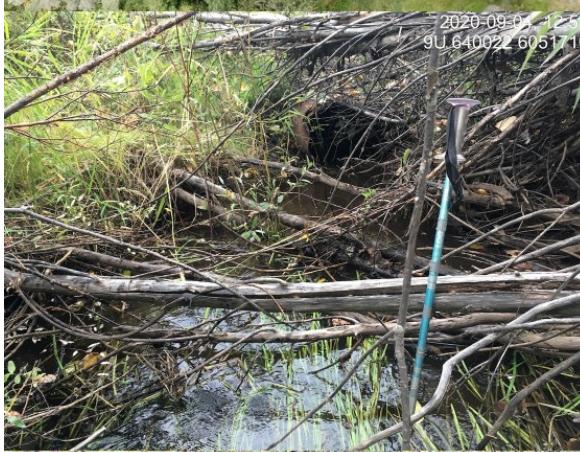
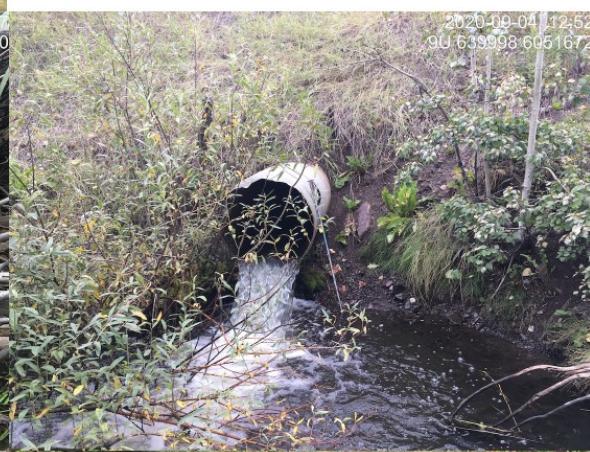
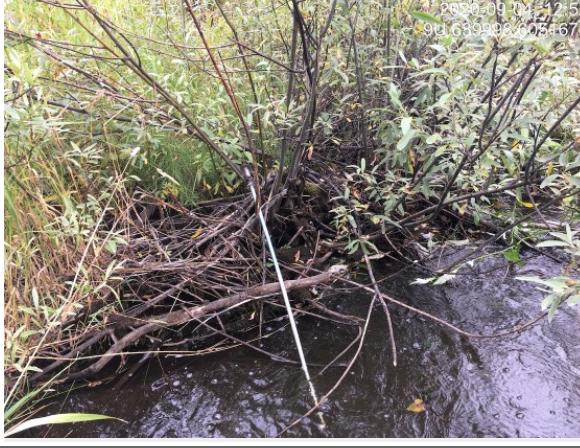
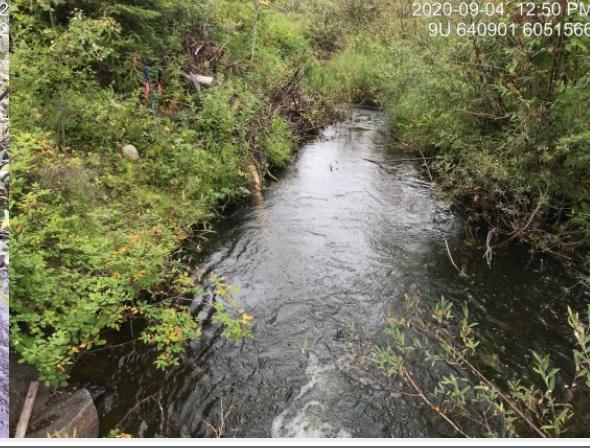
Comments: Flows into Deep Creek downstream. Electrofished upstream and downstream. Wetland type habitat upstream with CO captured below only. Candidate for backwatering?

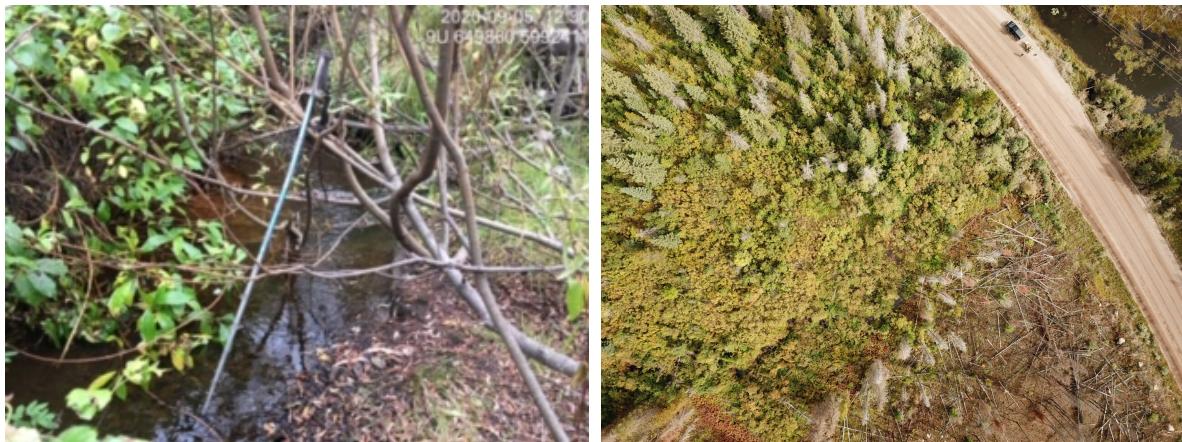
The stream was surveyed downstream from the culvert for 300m (Figure [5.22](#)). Overall, total cover amount was rated as moderate with overhanging vegetation dominant. Cover was also present as small woody debris, large woody debris, undercut banks, deep pools, and instream vegetation (Table [5.36](#)). The average channel width was 3.7m, the average wetted width was 3.2m and the average gradient was 1.1%. The dominant substrate was fines with gravels subdominant. A somewhat recent burn was noted within a forested area on left bank of stream. Habitat was rated as moderate as it was considered an important migration corridor with moderate value habitat for fry/juvenile salmonid rearing.

Figure 5.22: Left: Typical habitat downstream of PSCIS crossing 197360. Right: Aerial view of typical habitat downstream of PSCIS crossing 197360.

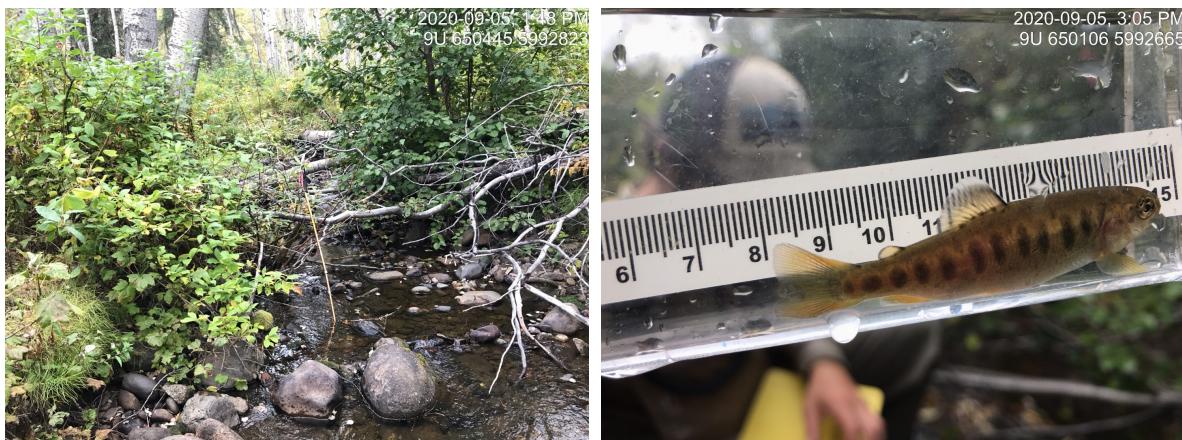
Figure 5.23: Left: Typical habitat upstream of PSCIS crossing 197360. Right: Rainbow trout captured upstream of PSCIS crossing 197360.

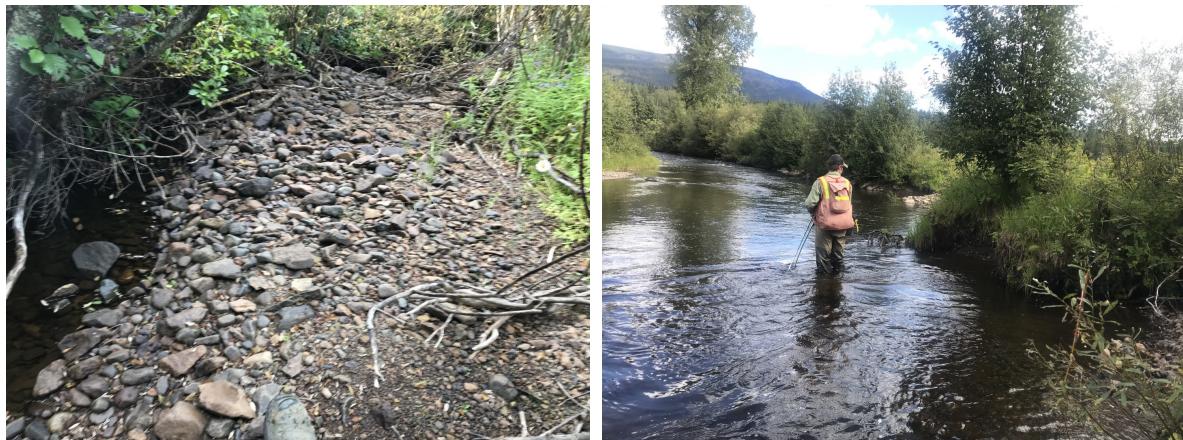
The stream was surveyed downstream from the culvert for 70m to the confluence with Buck Creek (Figure [??](#)). Total cover amount was rated as moderate with undercut banks dominant. Cover was also present as small woody debris, large woody debris, and overhanging vegetation (Table [5.42](#)). The average channel width was 4.6m, the average wetted width was 2.5m and the average gradient was 3%. The dominant substrate was gravels with cobbles subdominant. A fish (130mm) was observed in the culvert outlet pool and a substance suspected to be didymo was noted on the substrate. The habitat was rated as moderate value as it was considered an important migration corridor with habitat of moderate rearing potential for fry and juvenile salmonids.

Figure 5.24: Left: Habitat downstream of PSCIS crossing 197640. Right: Habitat downstream of crossing 197640 at the confluence with Buck Creek.

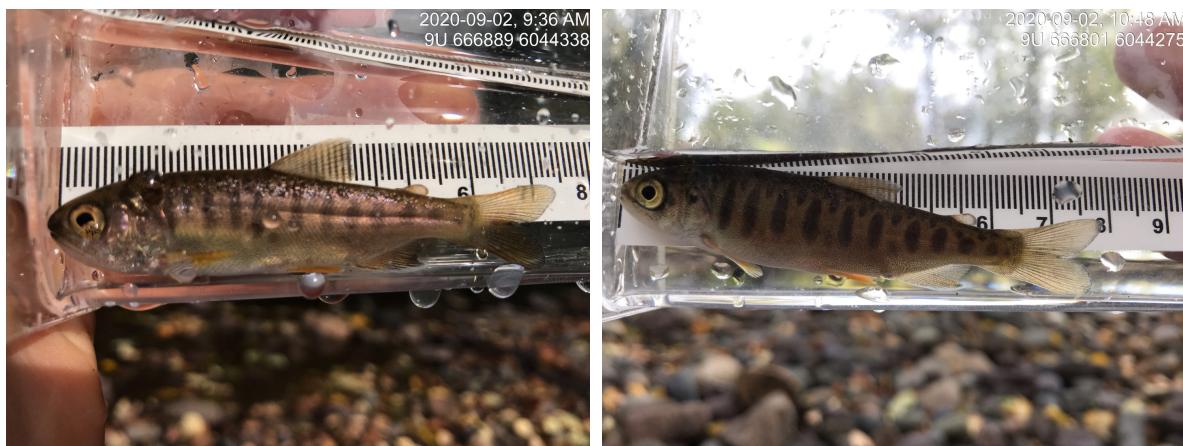
Minnowtrapping was conducted with three traps set overnight upstream as well as downstream of the crossing. A total of 5 coho and 6 rainbow trout were captured downstream with 1 coho and 9 rainbow trout captured upstream (Table 5.47 and (Figure 5.28).

Figure 5.28: Left: Coho captured downstream of PSCIS crossing 197658. Right: Coho captured upstream of PSCIS crossing 197658.

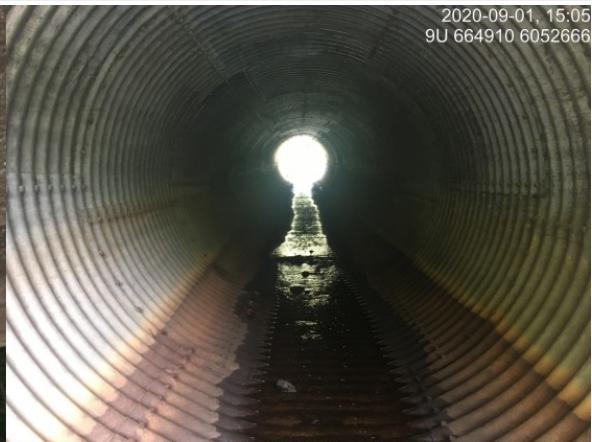
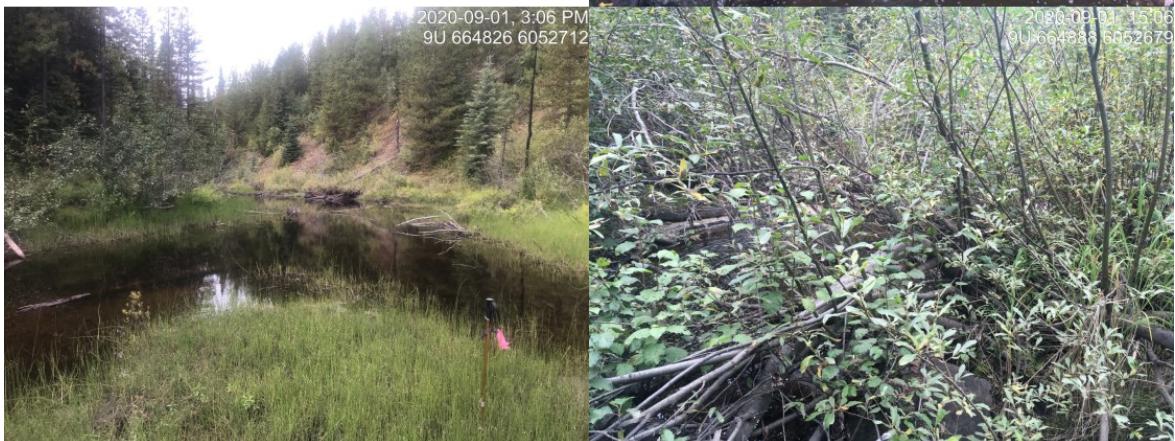
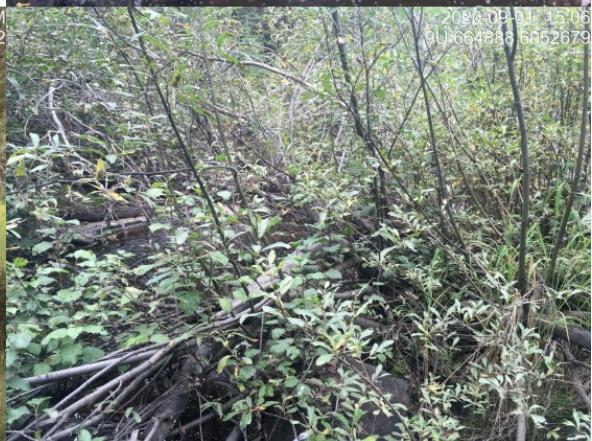
Comments: Fill depth approximatley 12m. Fish observed upstream of crossing.

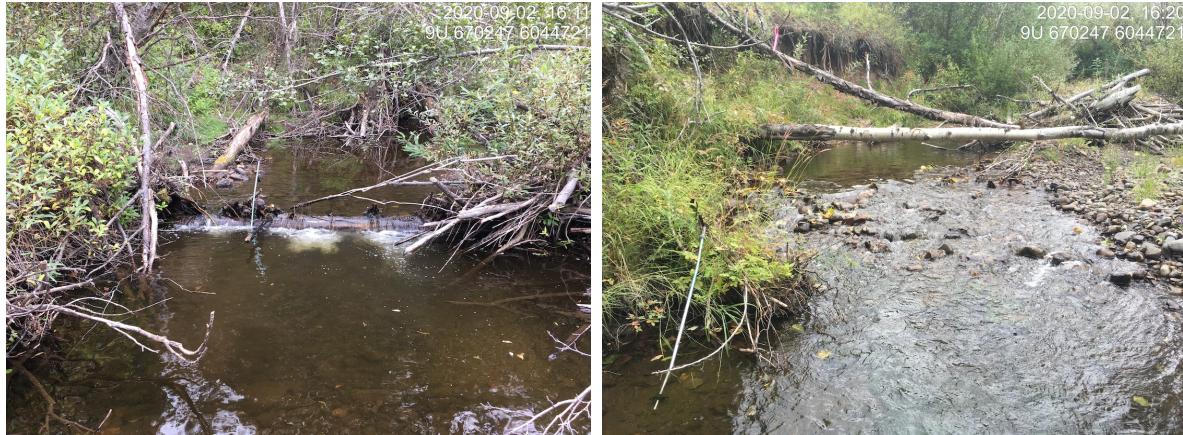
Figure 5.33: Left: Typical habitat downstream of PSCIS crossing 197663. Right: Typical habitat downstream of PSCIS crossing 197663.

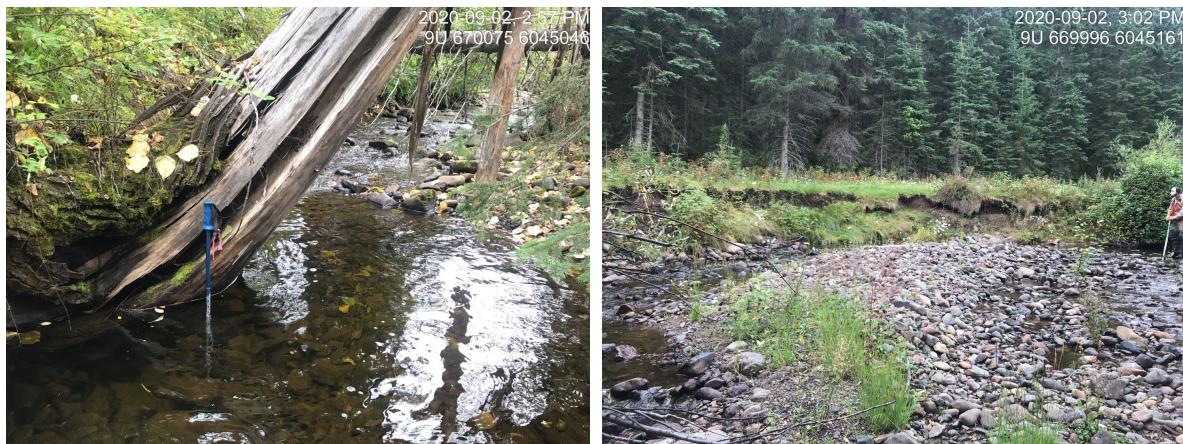
Figure 5.34: Left: Habitat upstream of PSCIS crossing 197663. Right: Habitat upstream of PSCIS crossing 197663.

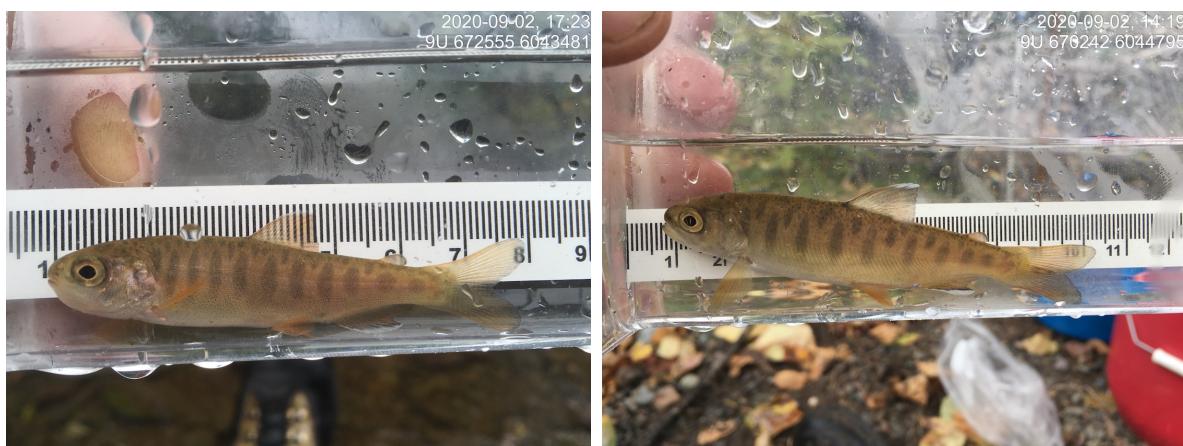
Figure 5.35: Left: Coho captured downstream of PSCIS crossing 197663. Right: Coho captured upstream of PSCIS crossing 197663.
