Elk River Watershed Group Fish Passage Restoration Planning

Prepared for Canadian Wildlife Federation

New Graph Environment

2020-12-22 DRaft

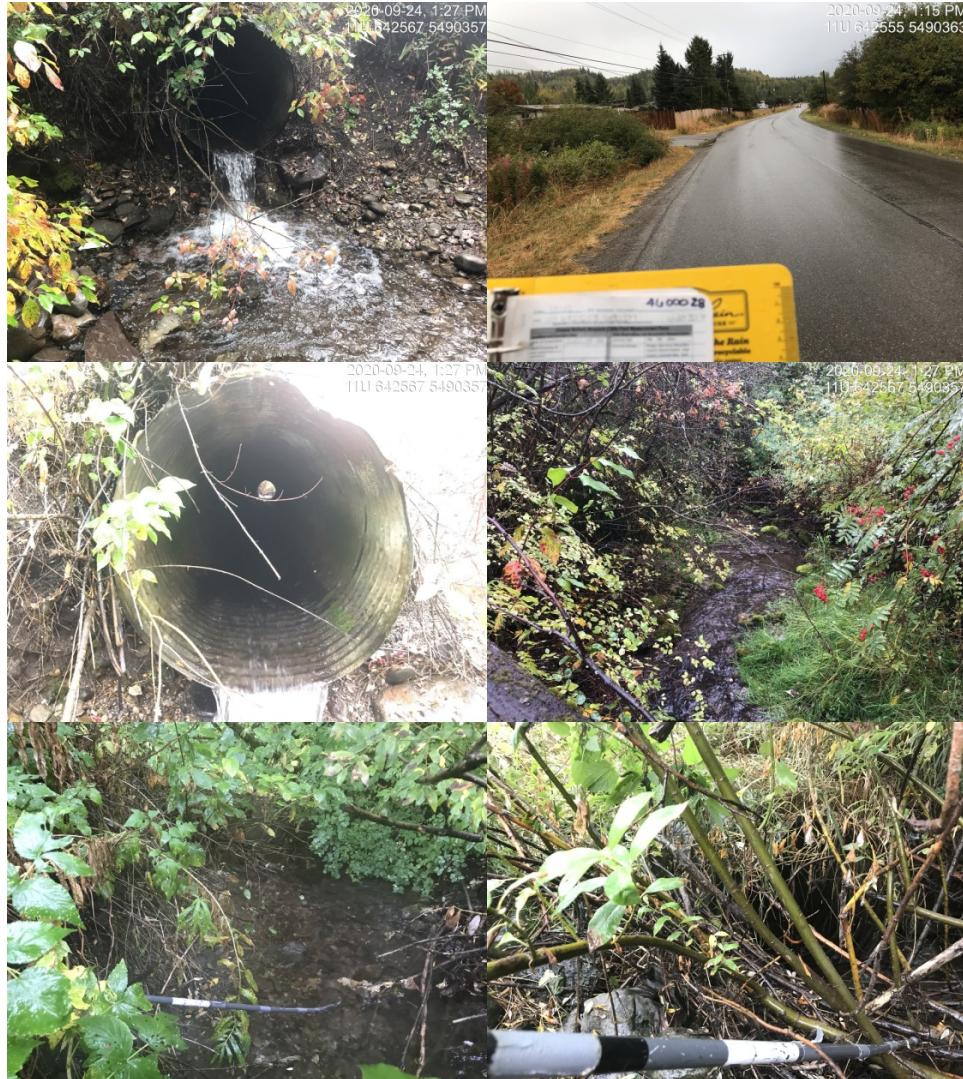
Photos: 4600028

Comments: Multiple fish observed in outlet pool (~190mm). Some gravels suitable for spawning located upstream.

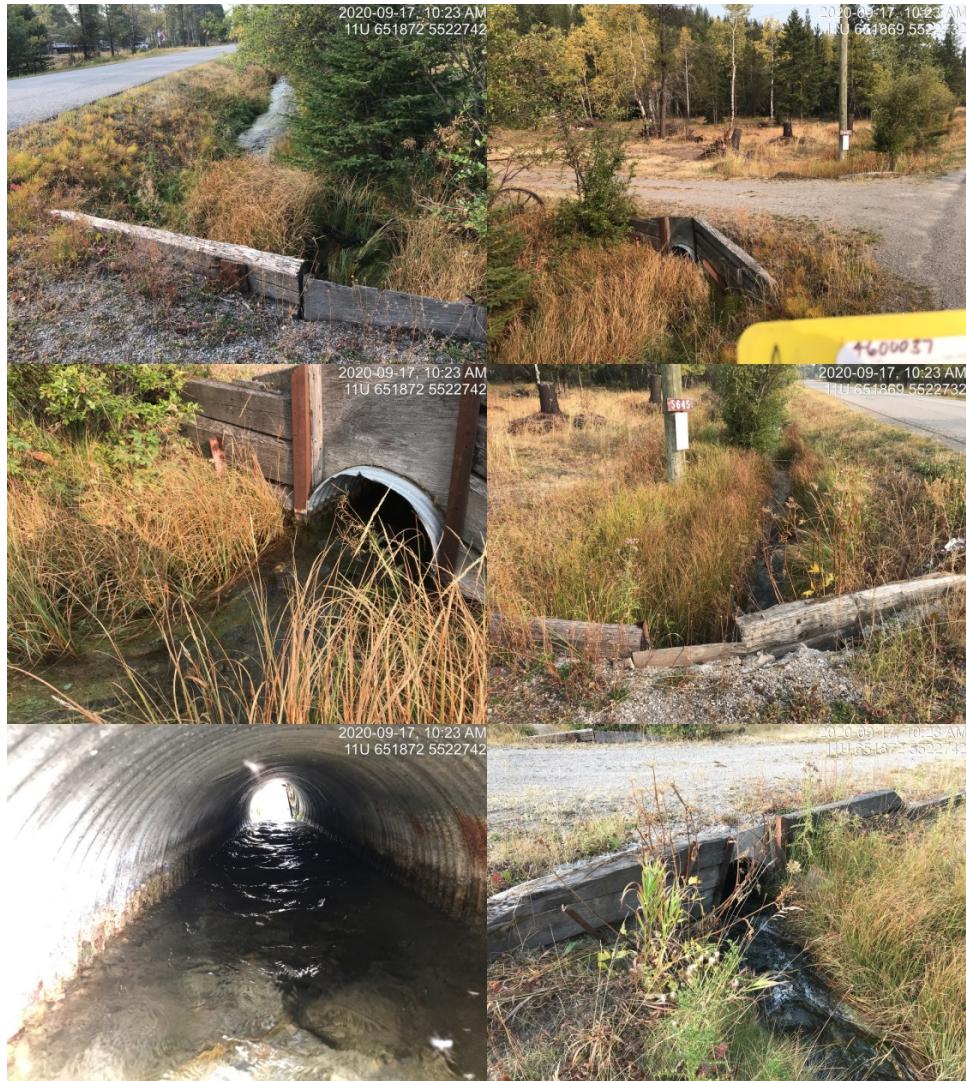
Photos: 4600037

Comments: Embedded culvert on private driveway. EB known upstream. Culvert does not appear likely to be significantly impacting upstream fish passage for juvenile or adult WCT at time of survey.

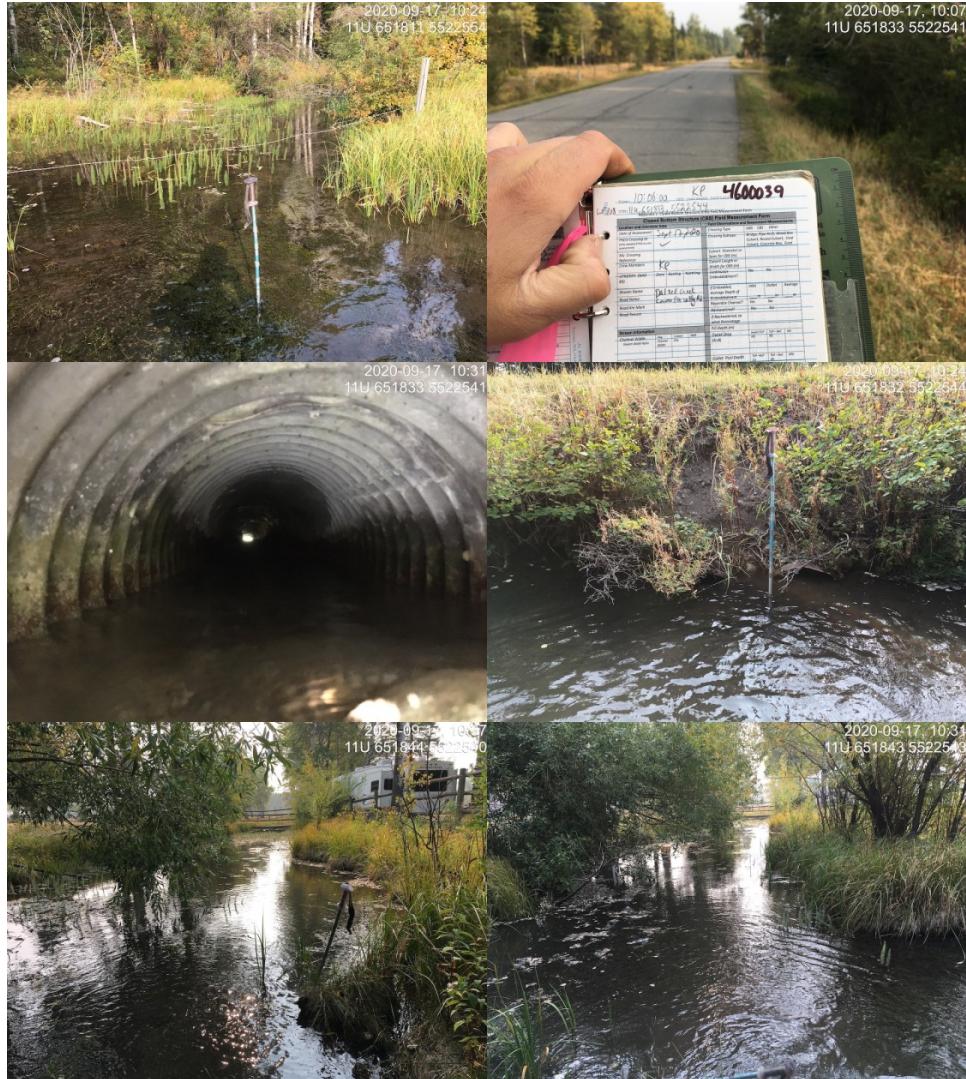
Photos: 4600039

Comments: Three barrels (.45m each). Two of the three have water flowing through them. Upstream and downstream channel widens out, slow flow through vegetated channel. Highly manipulated banks. Deep fine substrate on both sides of crossing. Upstream resembles a wetland. Crossing does not appear likely to be significantly impacting upstream fish passage for juvenile or adult WCT at time of survey.

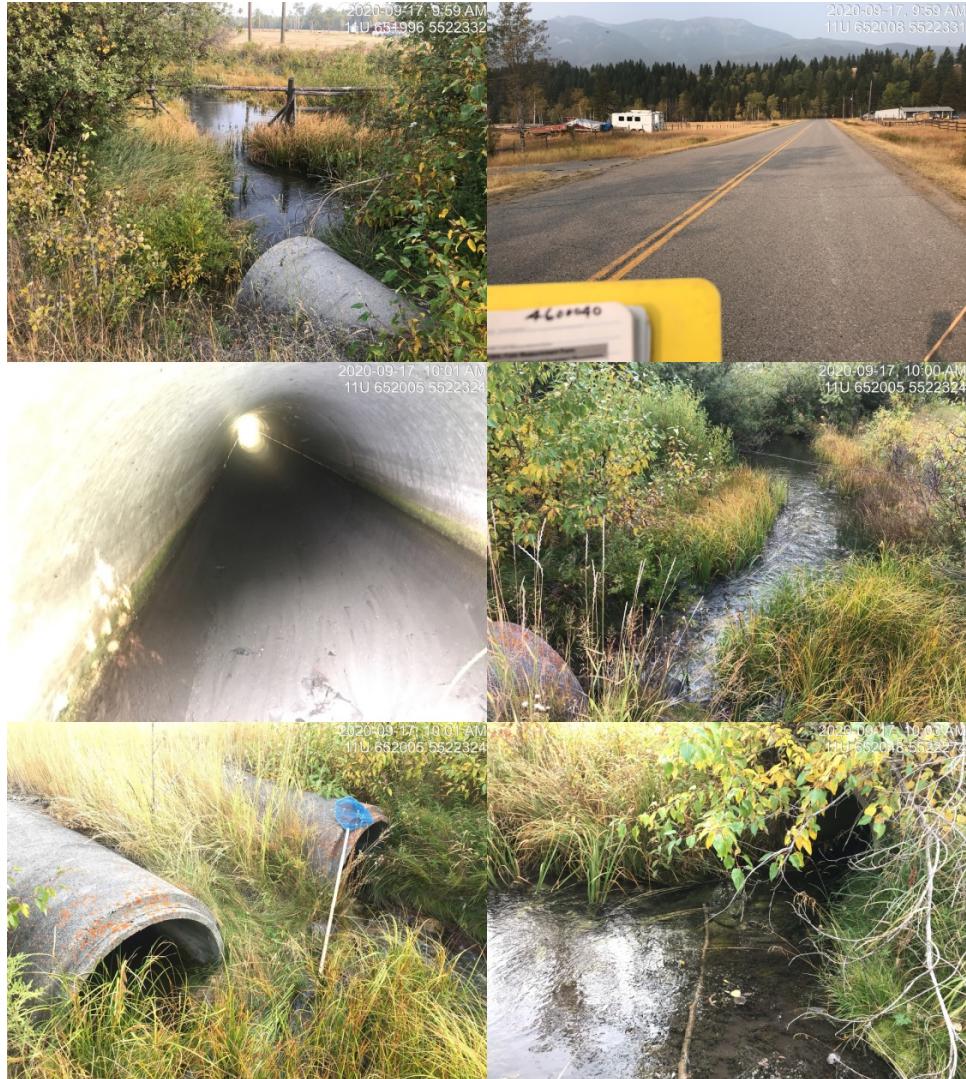
Photos: 4600040

Comments: Fenced private land upstream and downstream. Wetland area downstream. Culvert does not appear likely to be significantly impacting upstream fish passage for juvenile or adult WCT at time of survey.

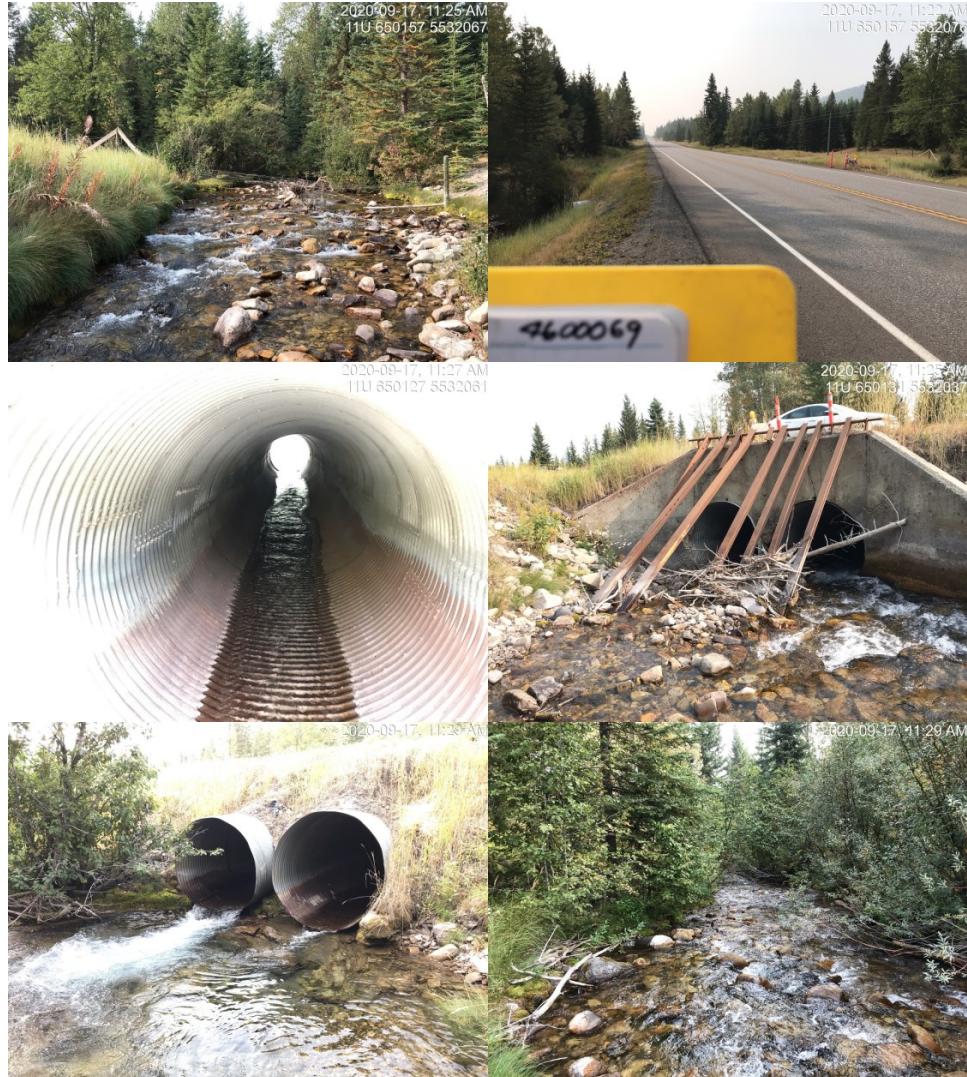
Photos: 4600069

Comments: Large stream with good flow. Flows currently mostly through south culvert which has slightly higher outlet drop. Similar elevation outlets so added together for width. Lazer level used for culvert slope. Cobble/boulder substrate. Boulder cover.

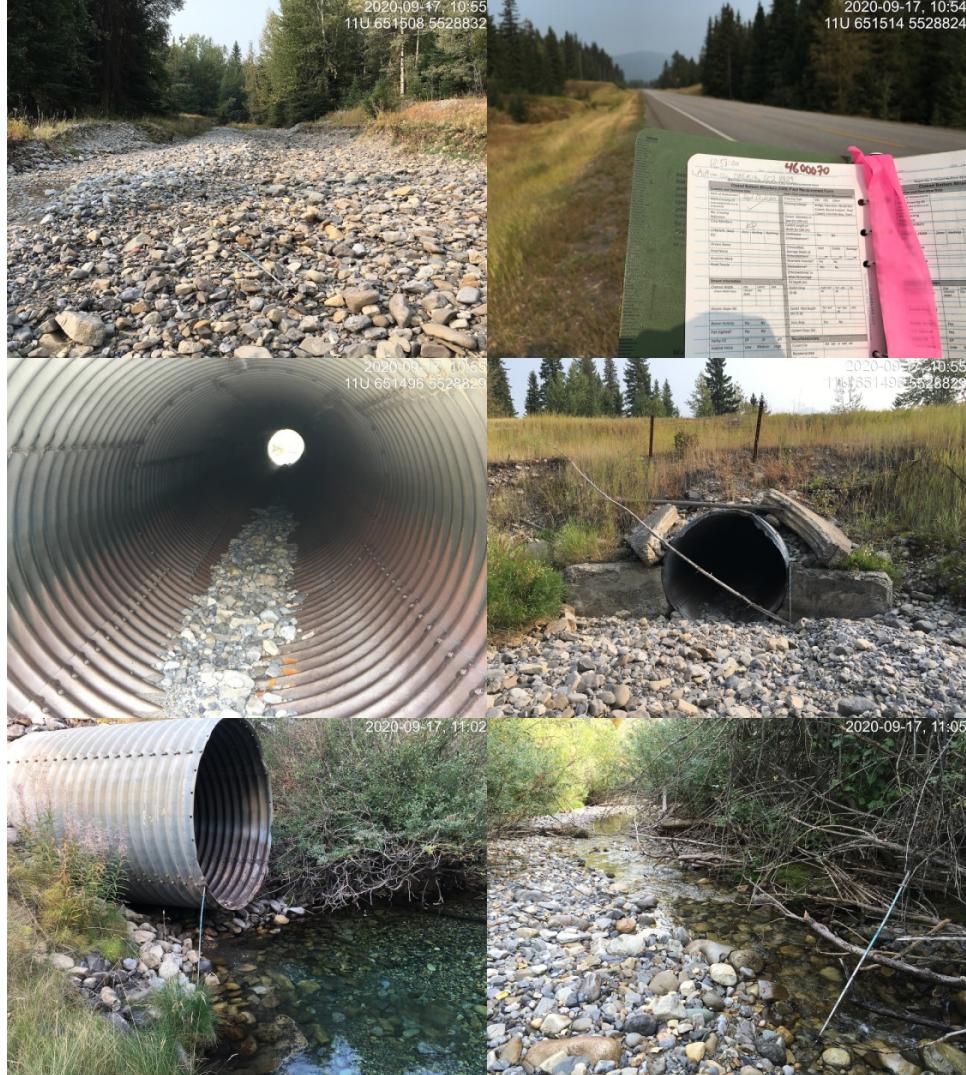
Photos: 4600070

Comments: Dewatered upstream of highway for 600m. Deep pool present downstream fed subsurface from northside of culvert. Approximately 9 WCT in outlet pool. Four fish ~300mm and 5 fish ~200 mm. High confidence that the larger fish were WCT as easy to recognize spotted backs from bank.

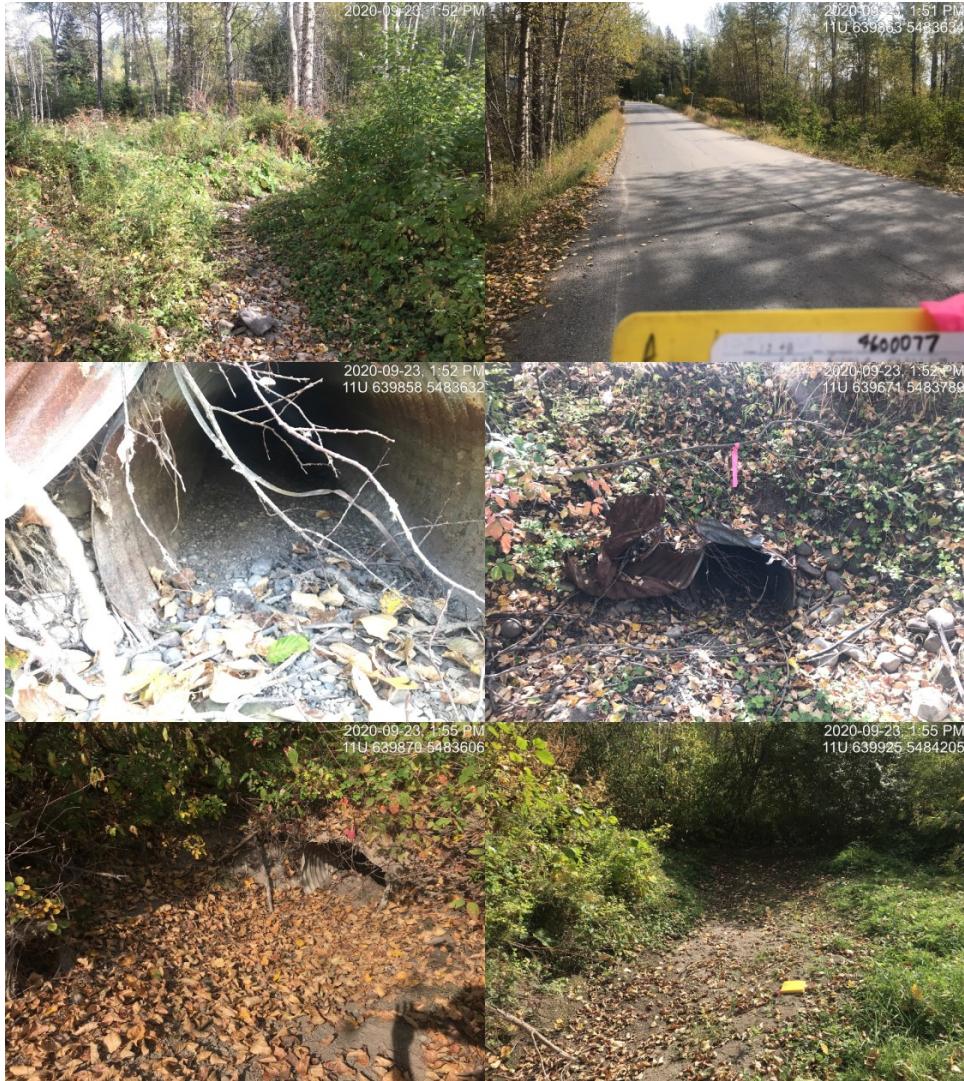
Photos: 4600077

Comments: Dry channel. Culvert is embedded.

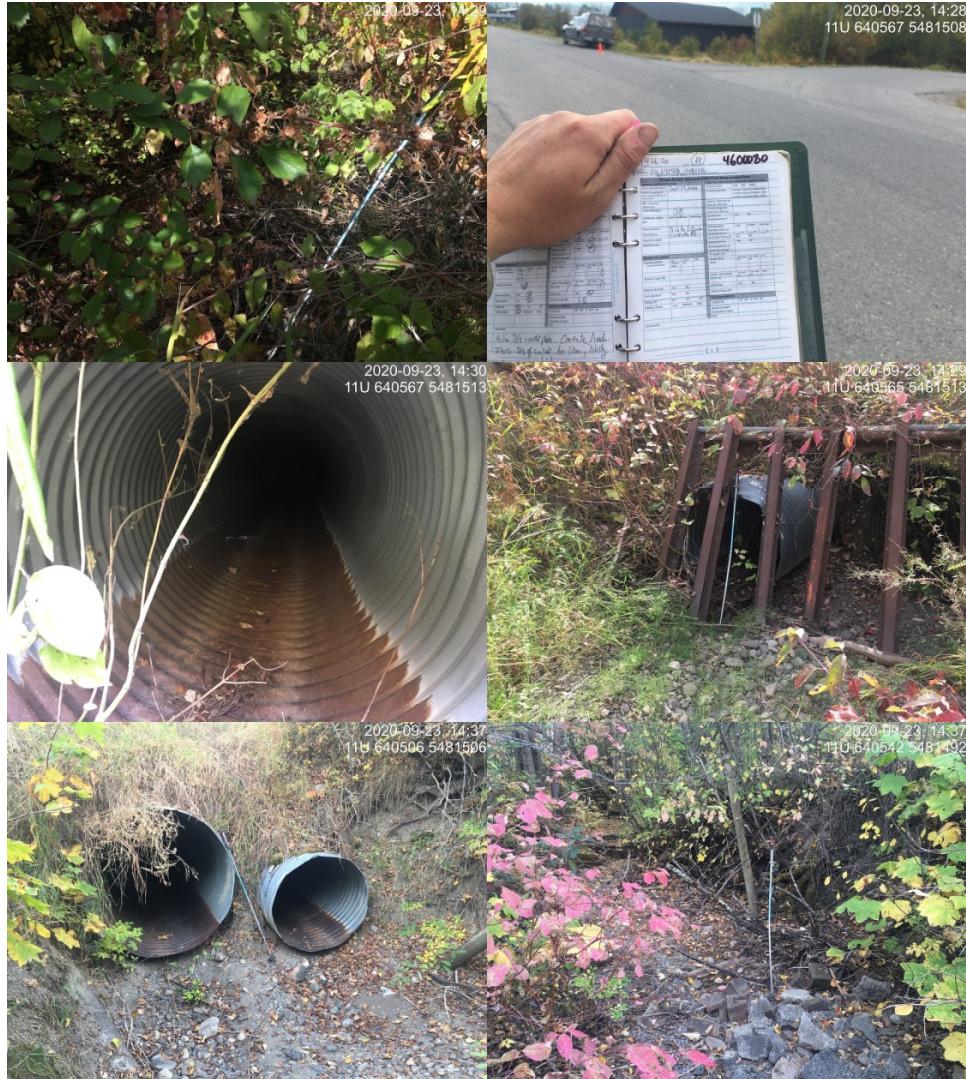
Photos: 4600080

Comments: 2 barrels, 0.90 and 1.1m. Debris rack on inlet. Stream dry at time of survey.

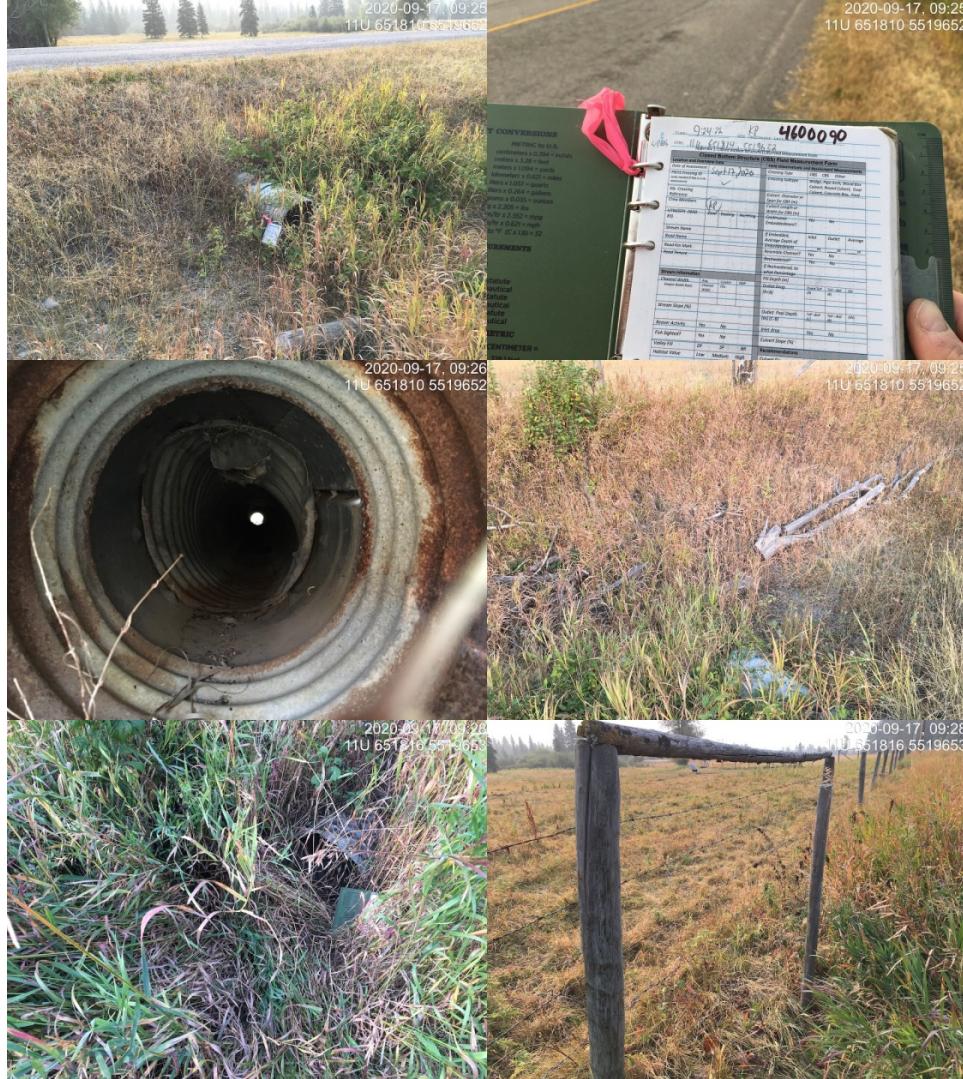
Photos: 4600090

Comments: No visible channel. Not likely fish habitat. Agricultural area.

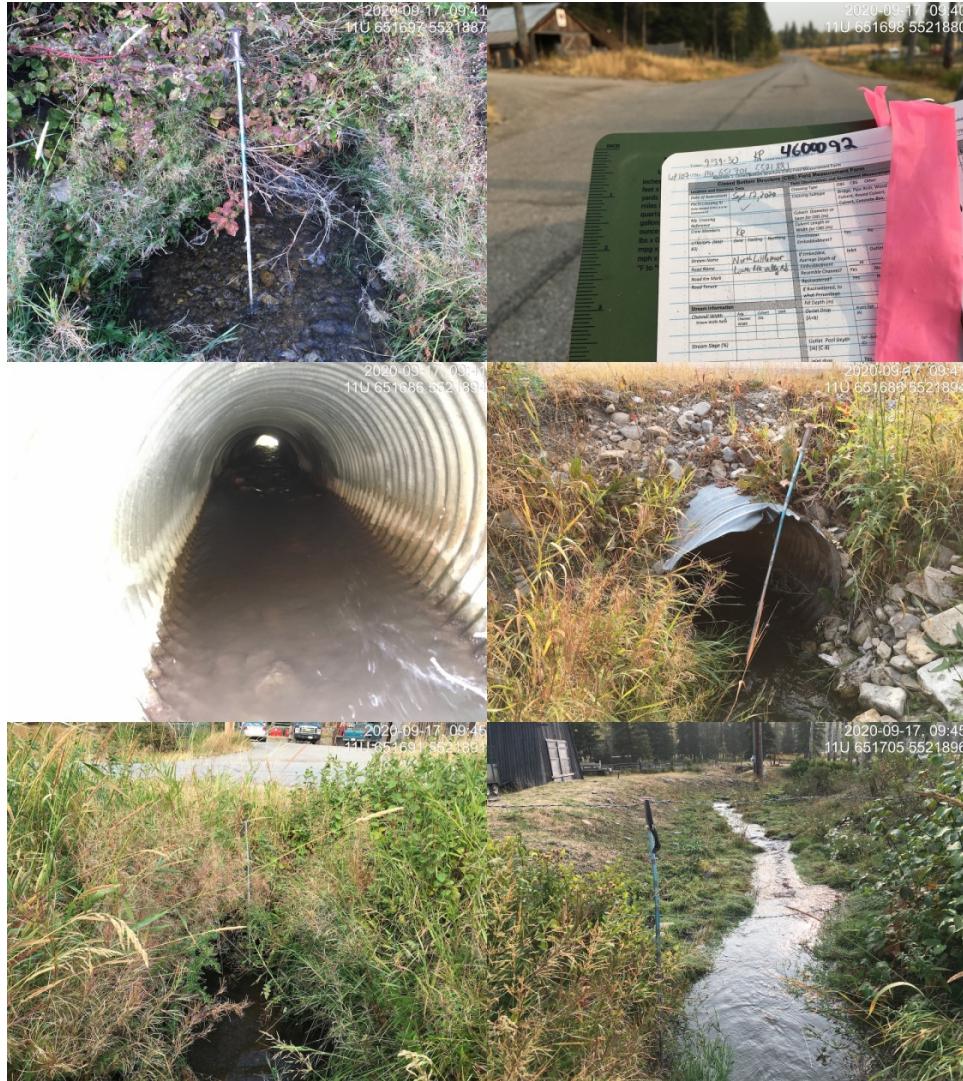
Photos: 4600092

Comments: Stream slope estimated due to fenced private land.

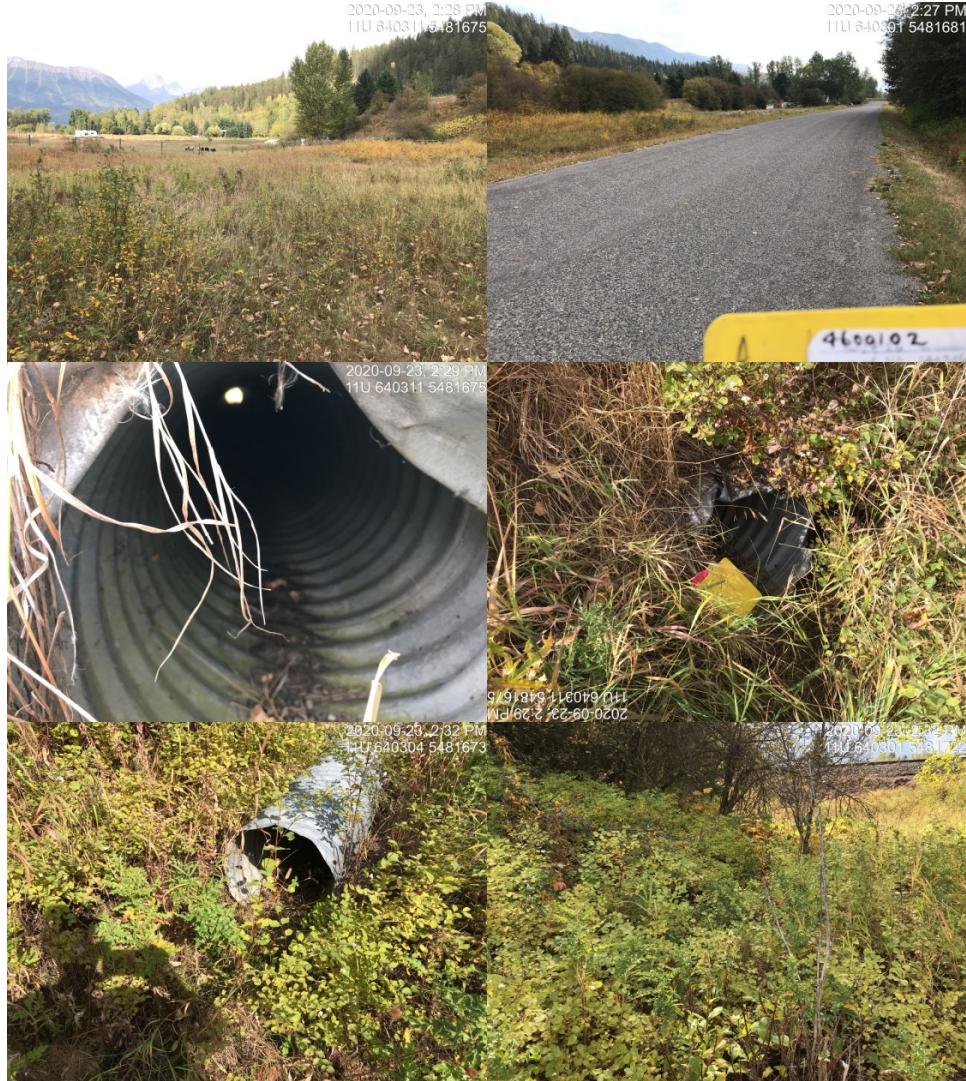
Photos: 4600102

Comments: Vegetated channel. Not likely fish habitat.

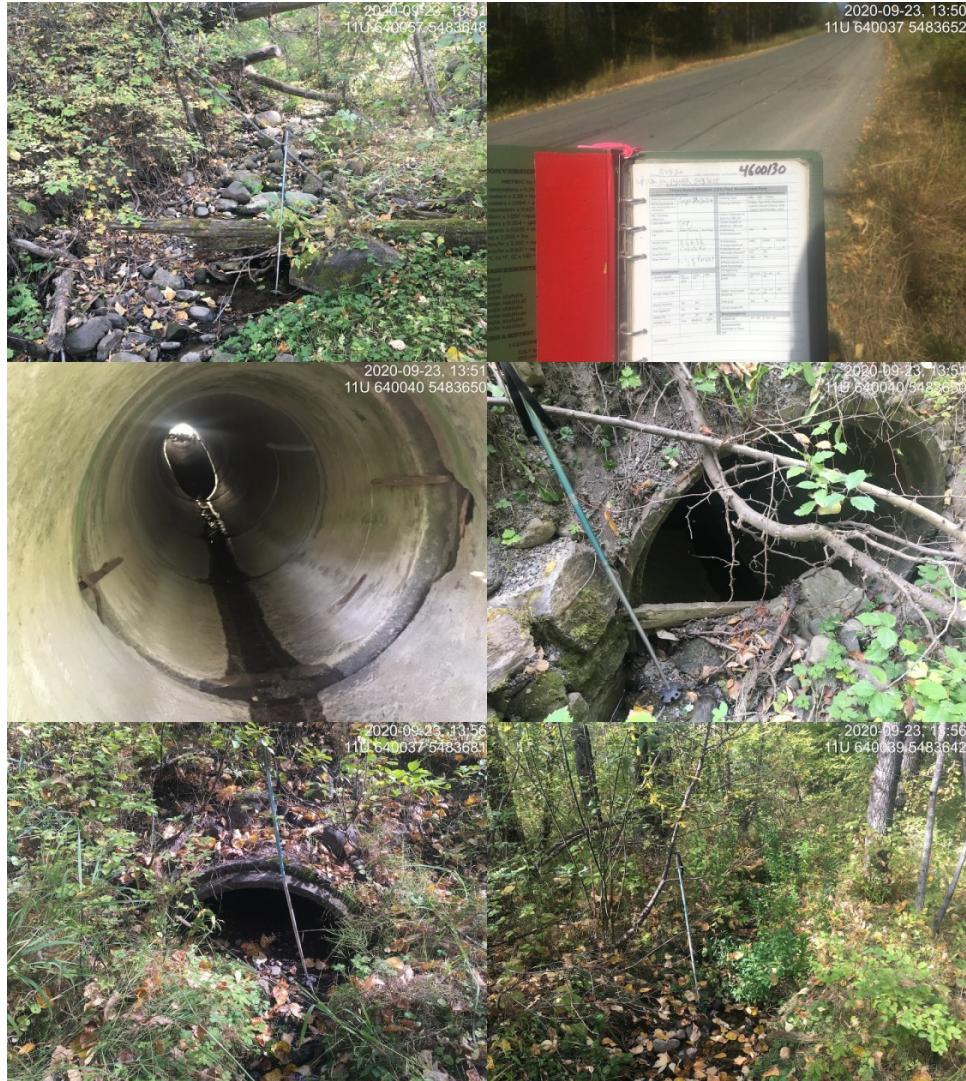
Photos: 4600130

Comments: Very low flow at time of survey and 0.5m inlet drop from debris. Very steep culvert, possibly 2 sections with further upstream section being much steeper.

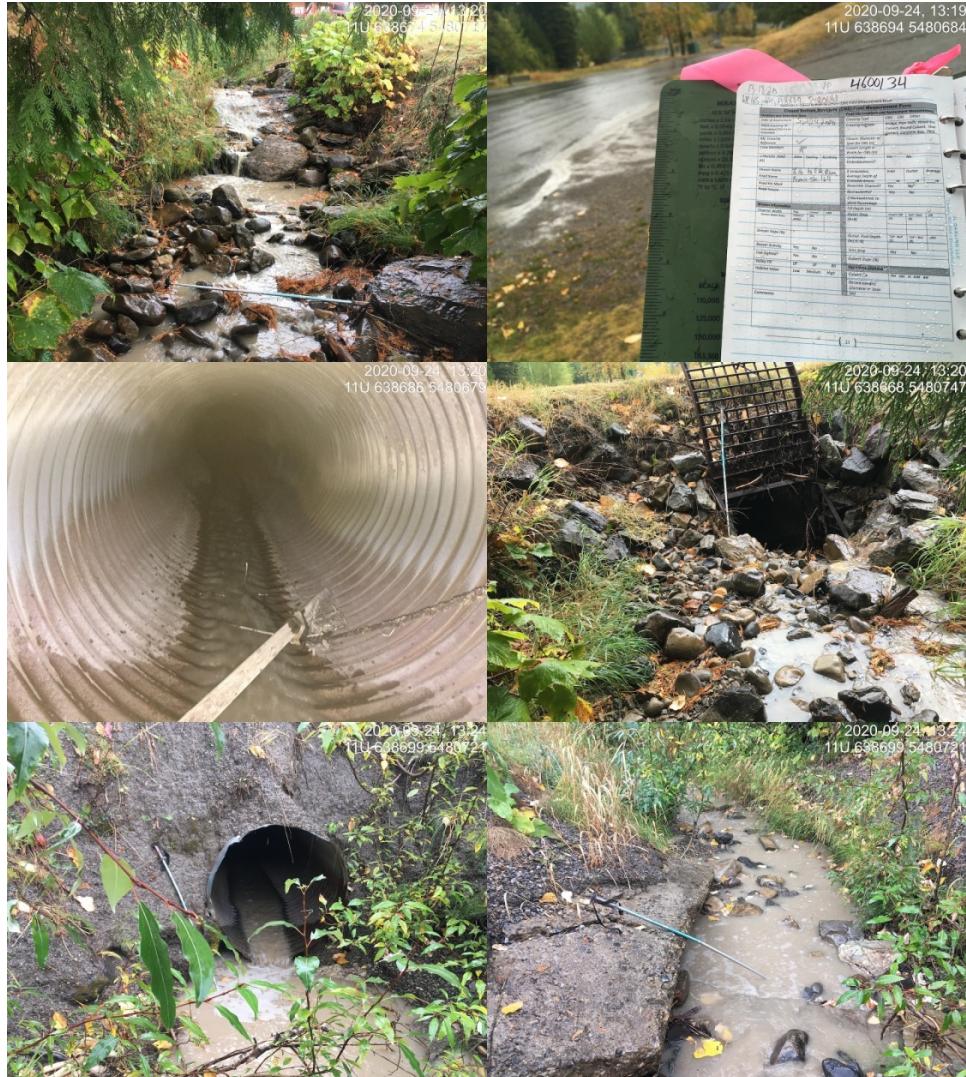
Photos: 4600134

Comments: Debris guard on inlet. Unable to see through the culvert to other end. Highly manipulated banks, drains large parking area and ski hill. Steep with placed rocks (rip rap) in spots upstream. Stream goes under large turn around, paved area. Culvert likely >1 piece with slight angle. Armoured banks downstream, lots of sediment (sand) form pavement and parking area.

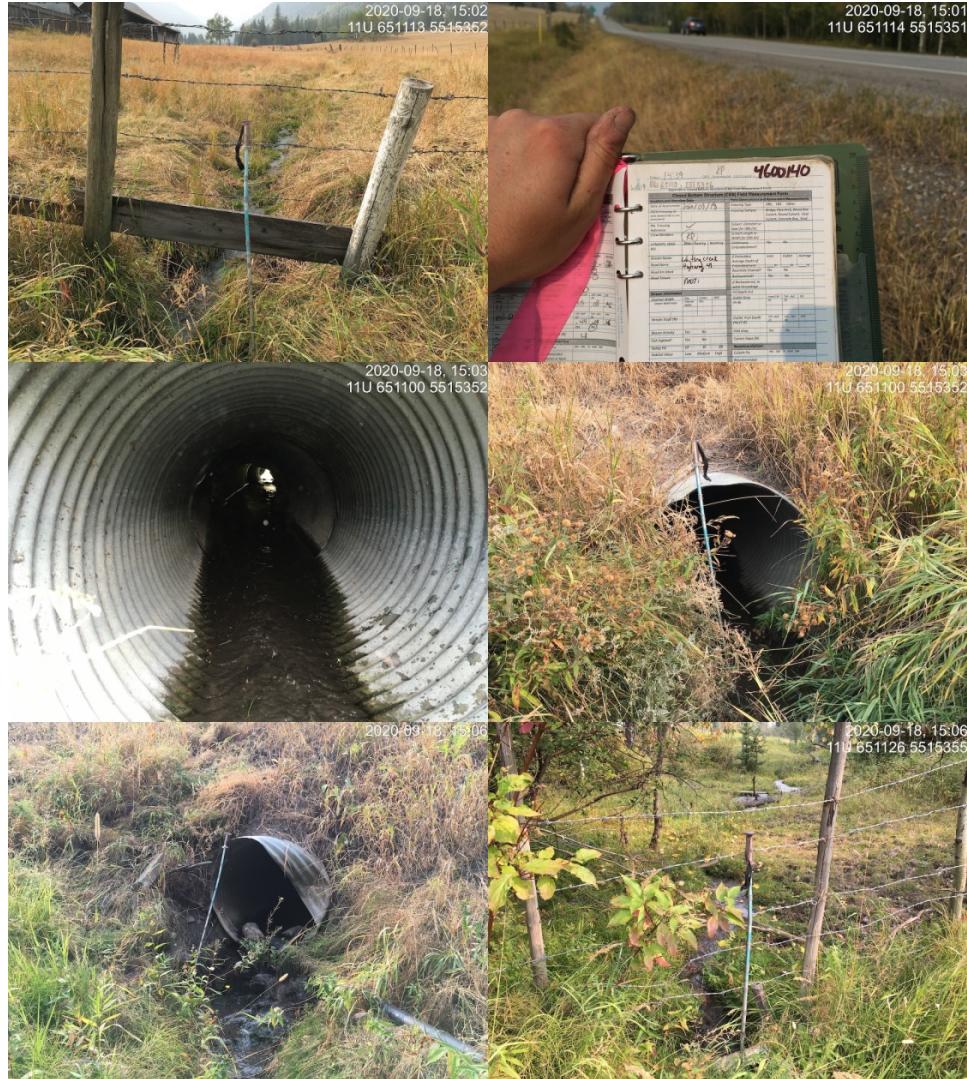
Photos: 4600140

Comments: No access up or downstream due to fenced private land. Stream slope estimated.
Water pipe intake at the outlet.

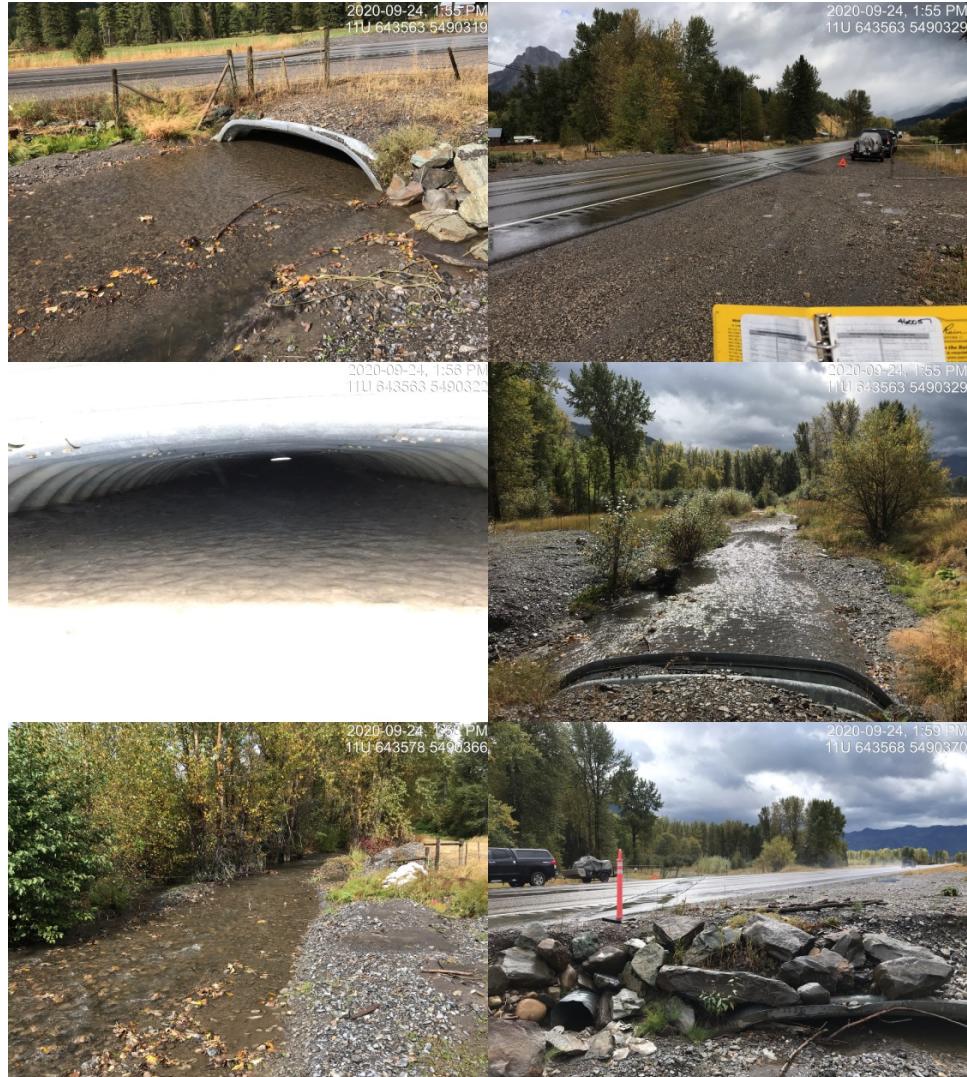
Photos: 4600157

Comments: This crossing is very full of debris and has been recently dredges. Less than 30cm freeboard from top of aggraded gravels at inlet and top of pipe arch. Newly installed overflow pipe (0.55 diameter) on left bank.

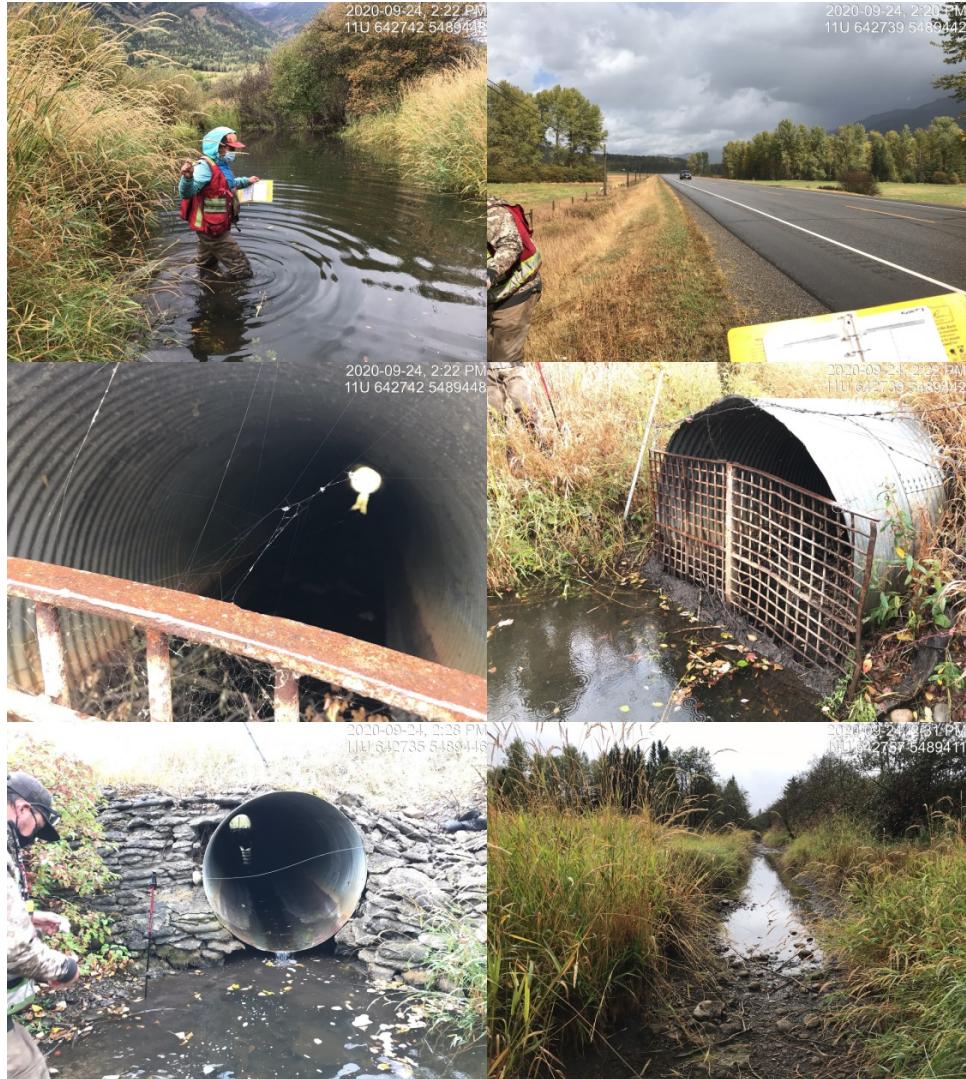
Photos: 4600158

Comments: Fish observed at upstream crossing on Bean Rd. Grate on inlet may prevent passage off adult fish. Fill depth estimated from photos.

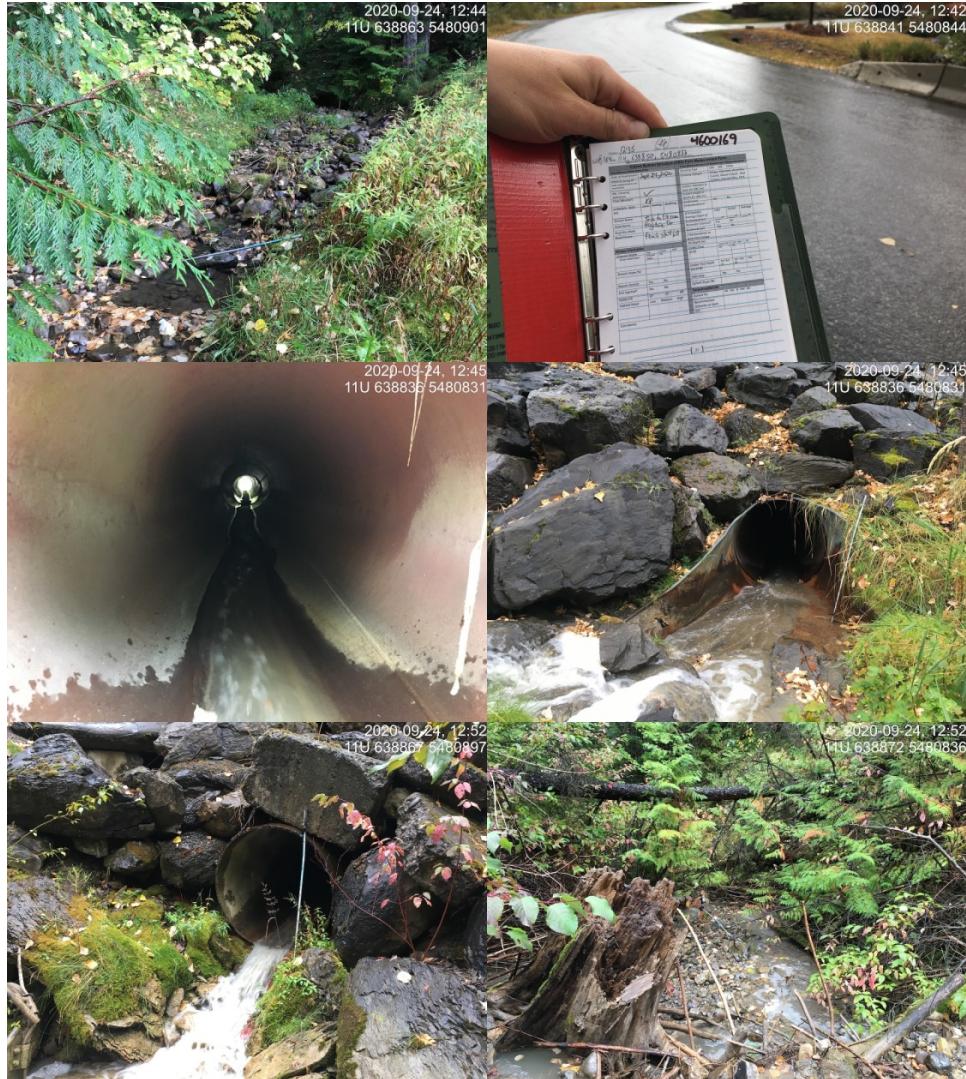
Photos: 4600169

Comments: Very recent heavy rains, 2 side channels for ski hill drainage infrastructure giving significant flow contributions just upstream of crossing, one of which is especially turbid (from large parking lot). Culvert not baffled, very steep. A lot of fill on paved access to condos. Old metal collar of culvert ripped off and in outlet pool.

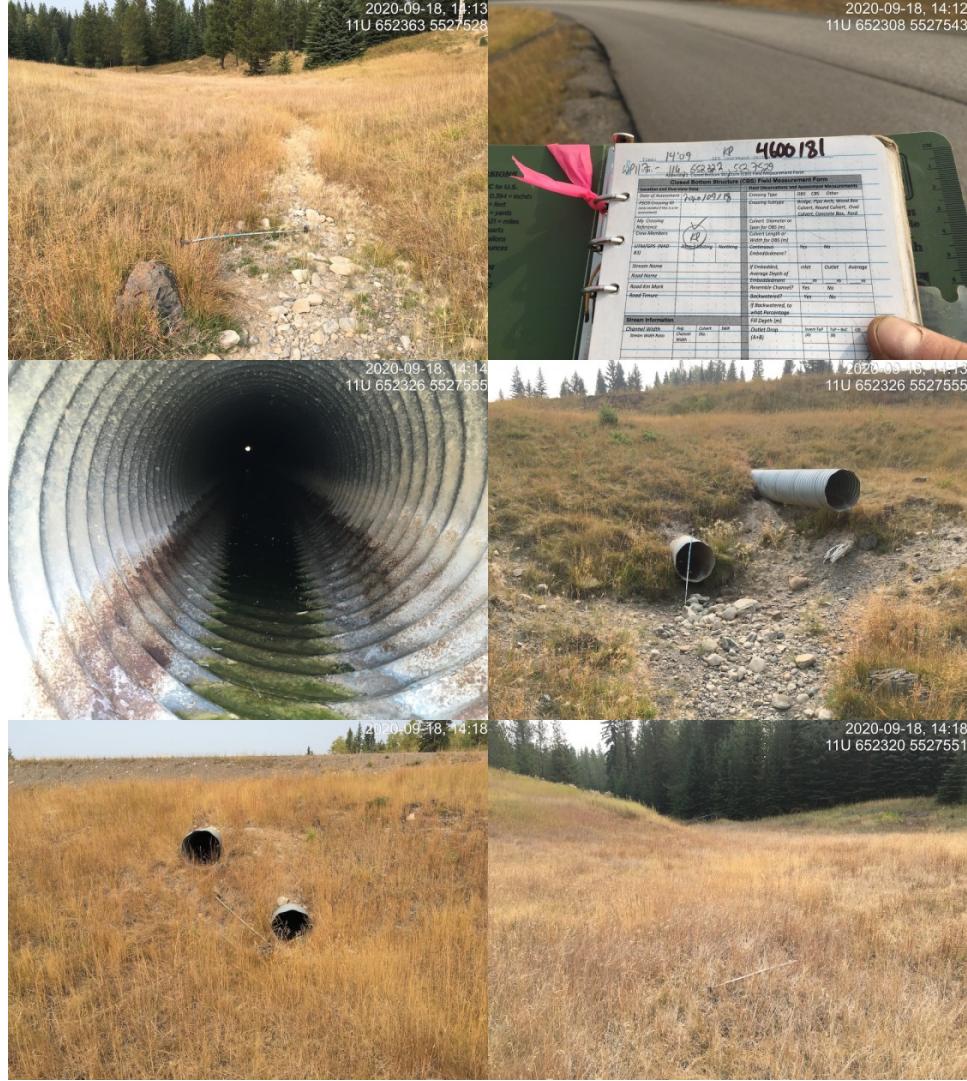
Photos: 4600181

Comments: Dry at time of survey, no channel present, area vegetated grassland. Two culverts, 0.60m in diameter. Top culvert 0.5m higher than the lower.

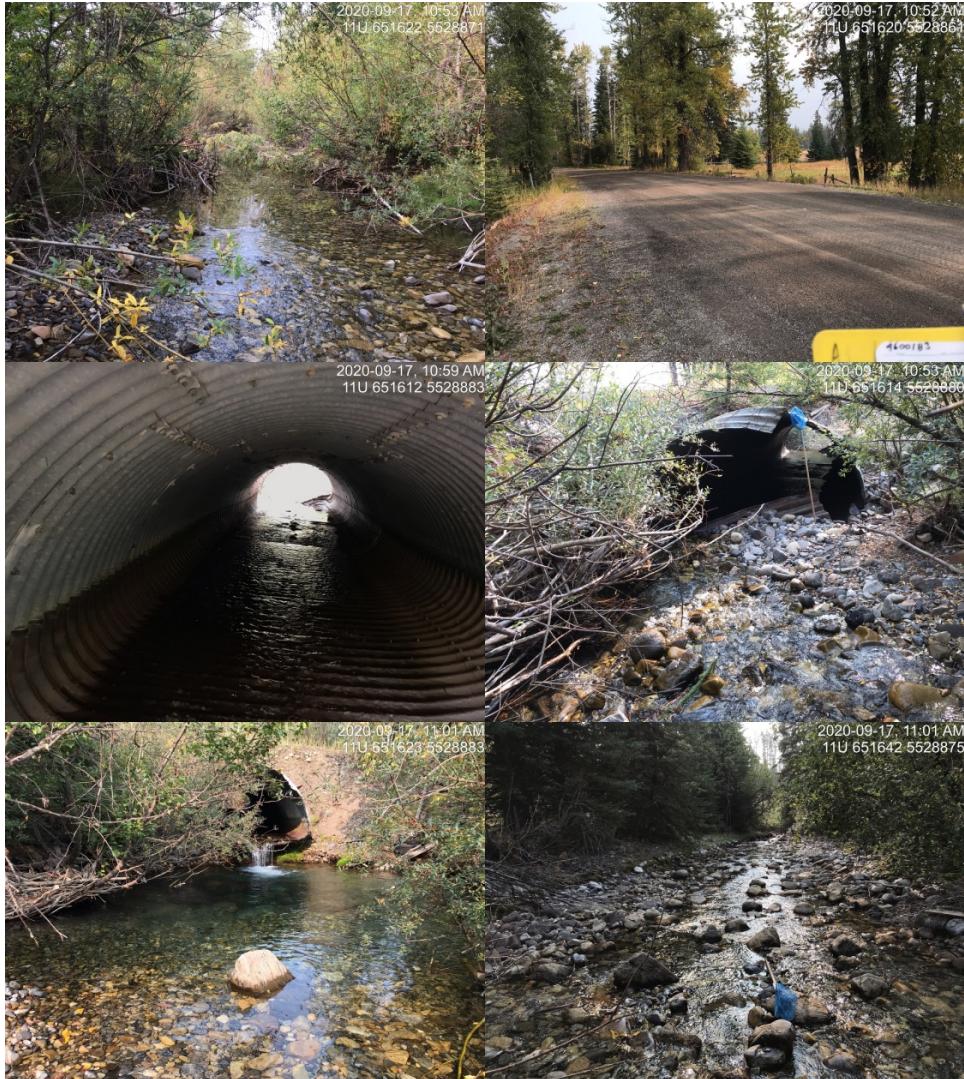
Photos: 4600183

Comments: Large stream with good flow at this crossing. Culvert inlet is damaged and there is a large outlet drop. Upstream of highway the stream is subsurface for ~600m.

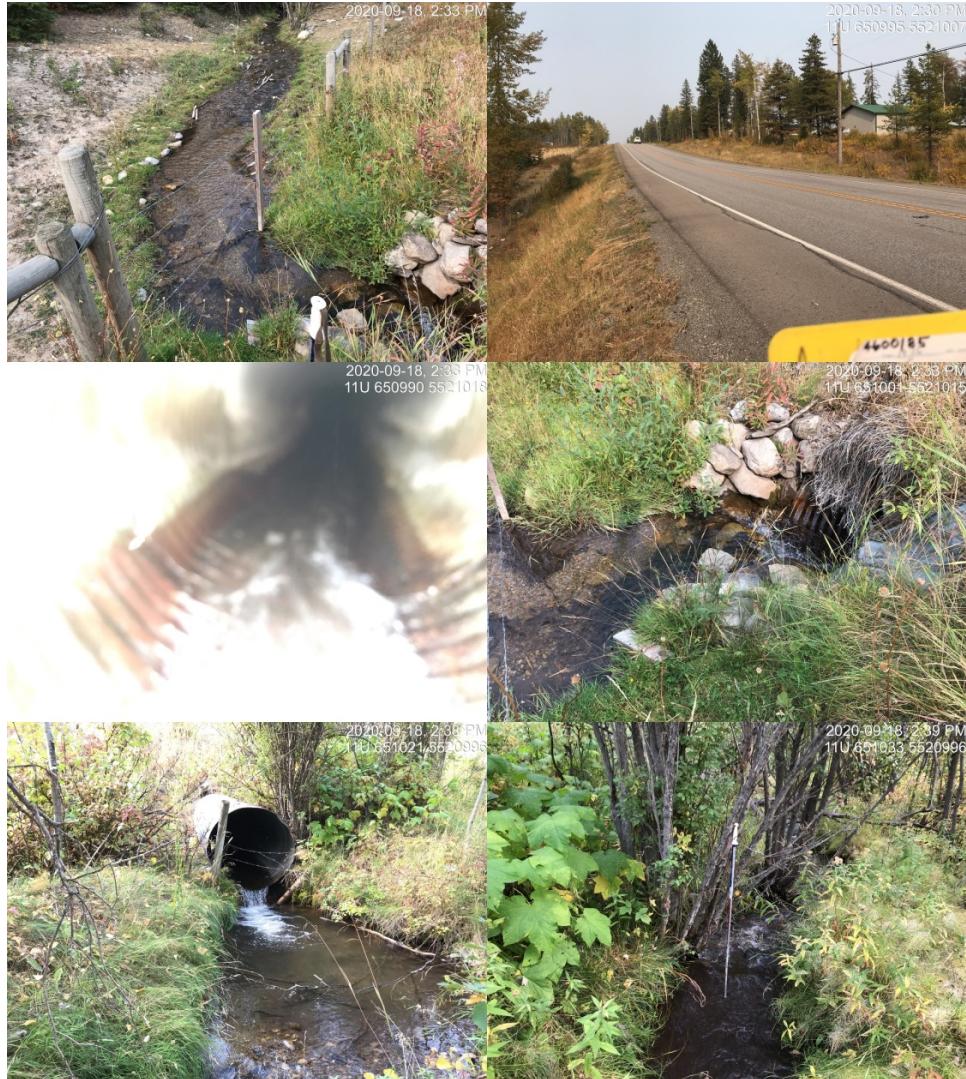
Photos: 4600185

Comments: Culvert has extension with corner, small stream with good flow. WCT and EB documented upstream. Gravels present suitable for WCT and EB spawning.

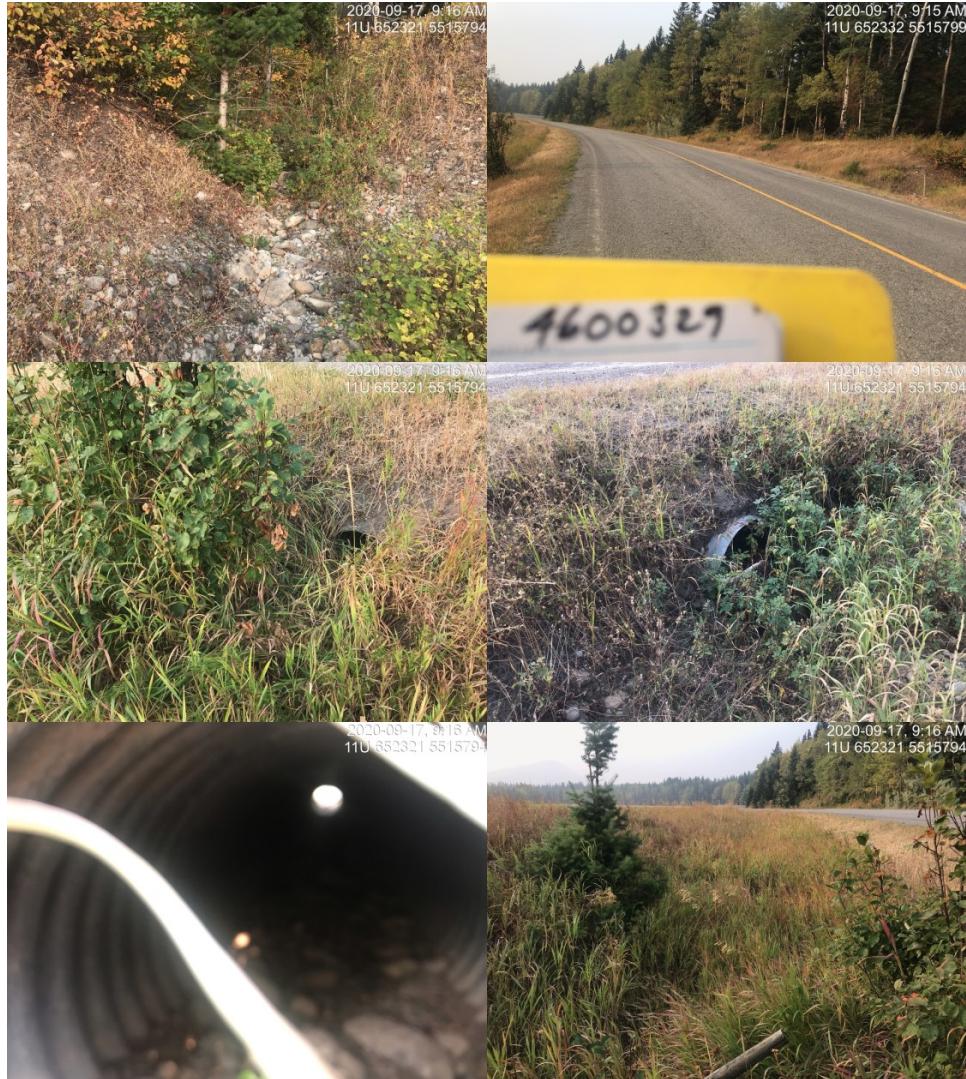
Photos: 4600329

Comments: Whiting creek appeared to not be present through agricultural field downstream. This appeared to be only channel present for Whiting crossing this road although the main Whiting channel is present upstream. Dry, heavily vegetated channel downstream. Defined channel upstream but seems unlikely to be fish bearing.
