Elk River Watershed Group Fish Passage Restoration Planning

Prepared for Canadian Wildlife Federation

New Graph Environment

2020-12-22 DRaft

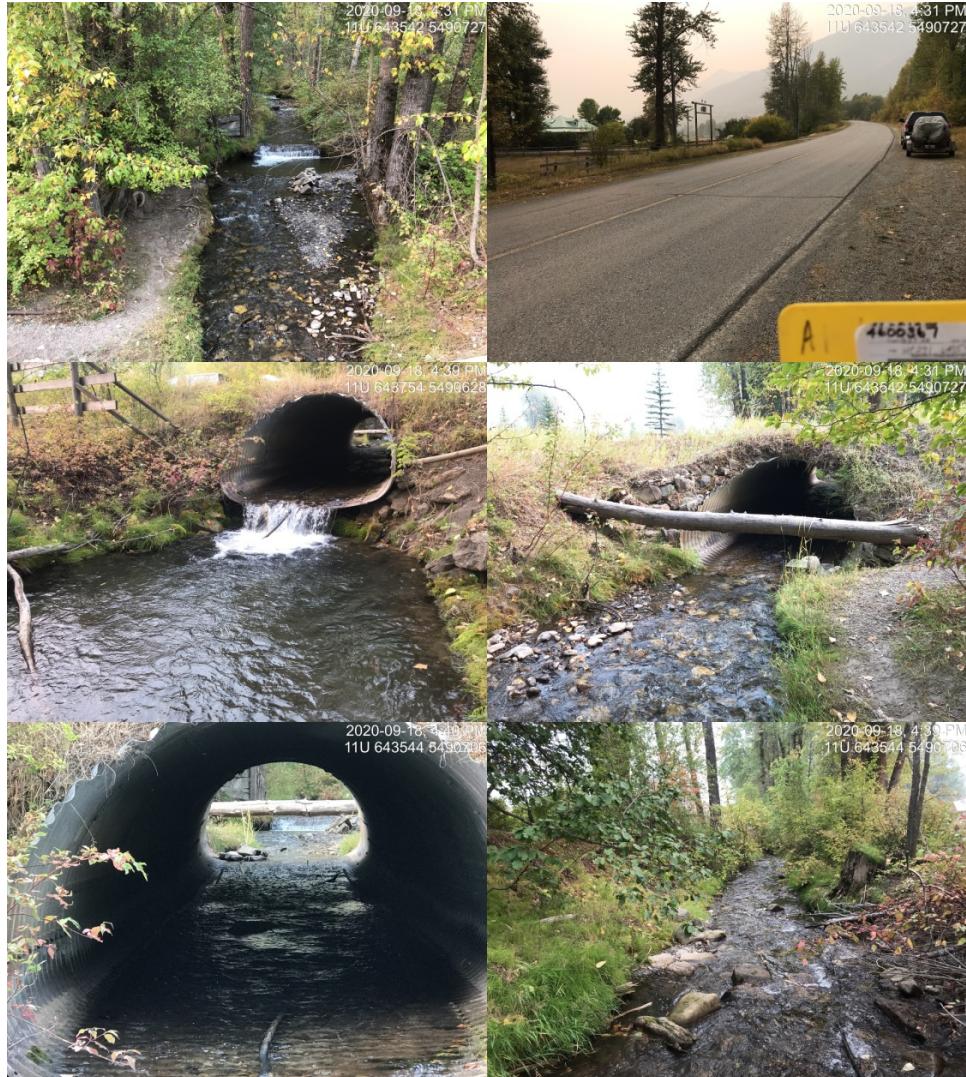
Photos: 4600367

Comments: Laser level used for culvert slope. WCT spawning system. See Management Plan for the Westslope Cutthroat Trout (*Oncorhynchus clarkii lewisi*) in British Columbia 2014
<http://a100.gov.bc.ca/pub/eirs/finishDownloadDocument.do?subdocumentId=9781>

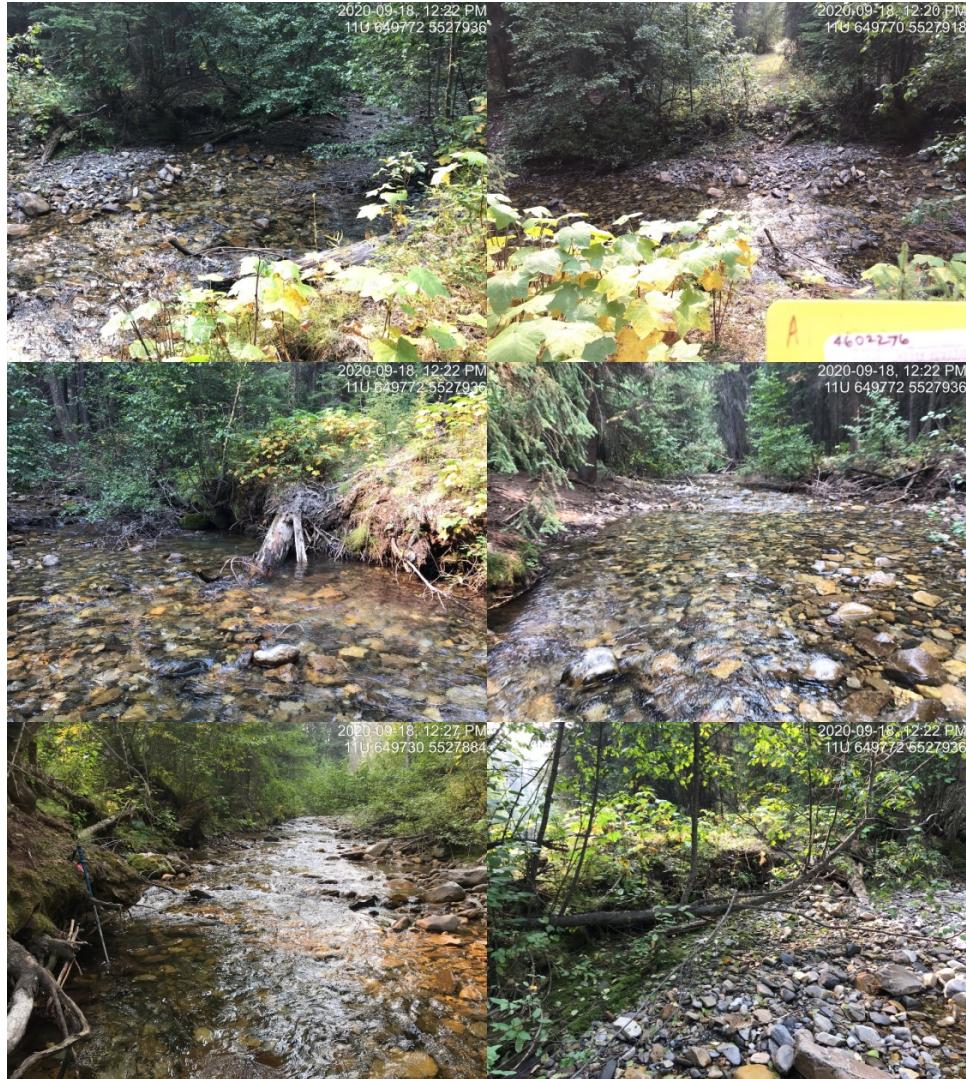
Photos: 4601205

Comments: Pulled crossing, no issues, is now a ford.

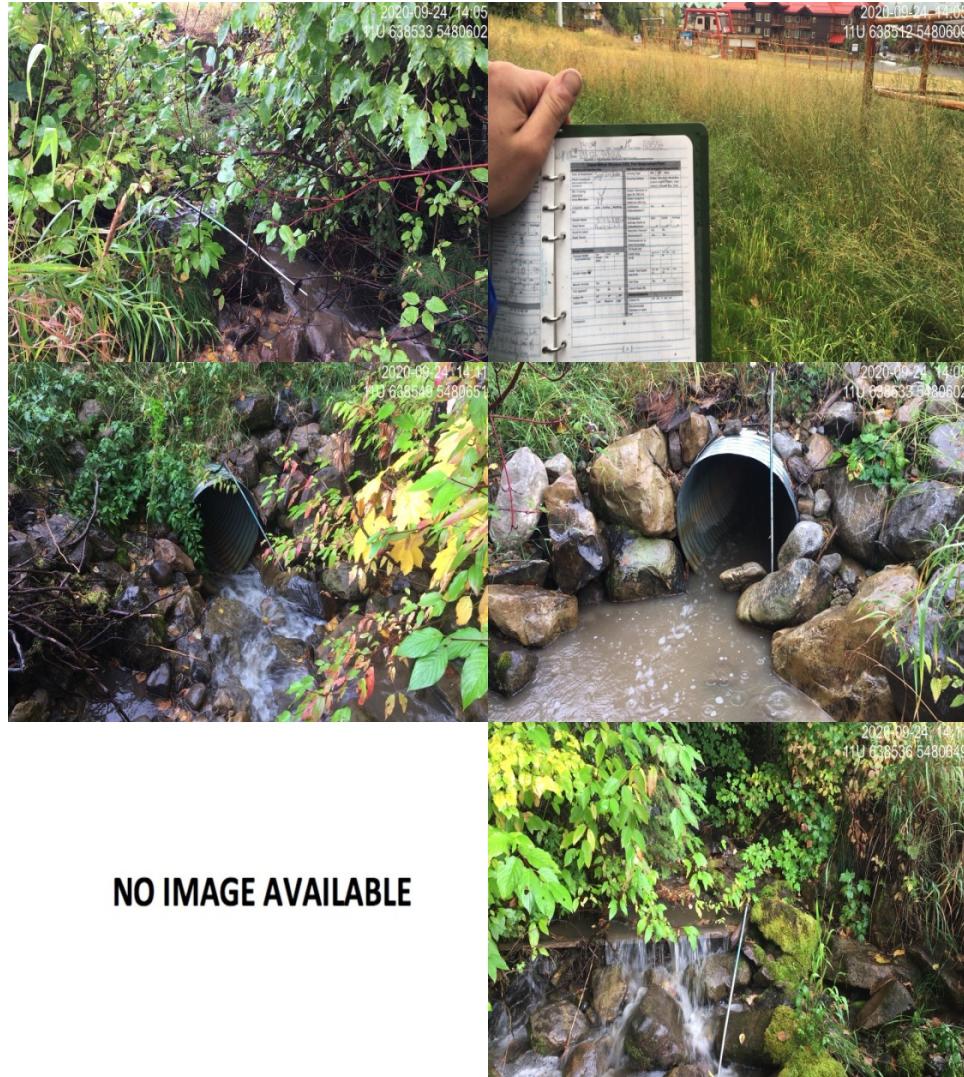
Photos: 4601556

Comments: Stream gradient immediately upstream of crossing is near 20%. Crossing is last of a series within close proximity to each other. The crossing downstream of this one is near 100m long. Likely more crossings upstream on ski hill infrastructure and access roads. Recent heavy rains.

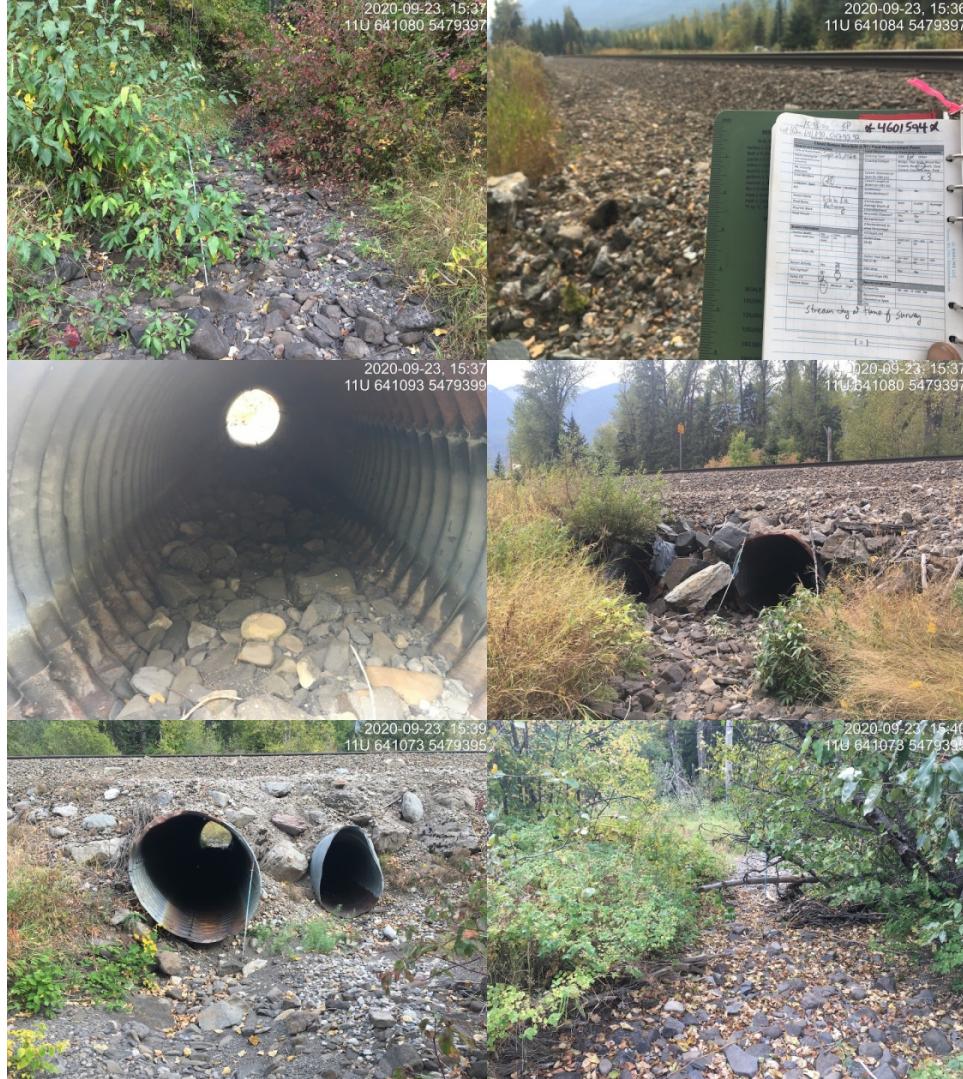
Photos: 4601594

Comments: Stream dry at time of survey. 2 barrels (0.80 and 1.5m in diameter), similar heights but 1.5m slightly lower. Smaller barrel inlet damaged.

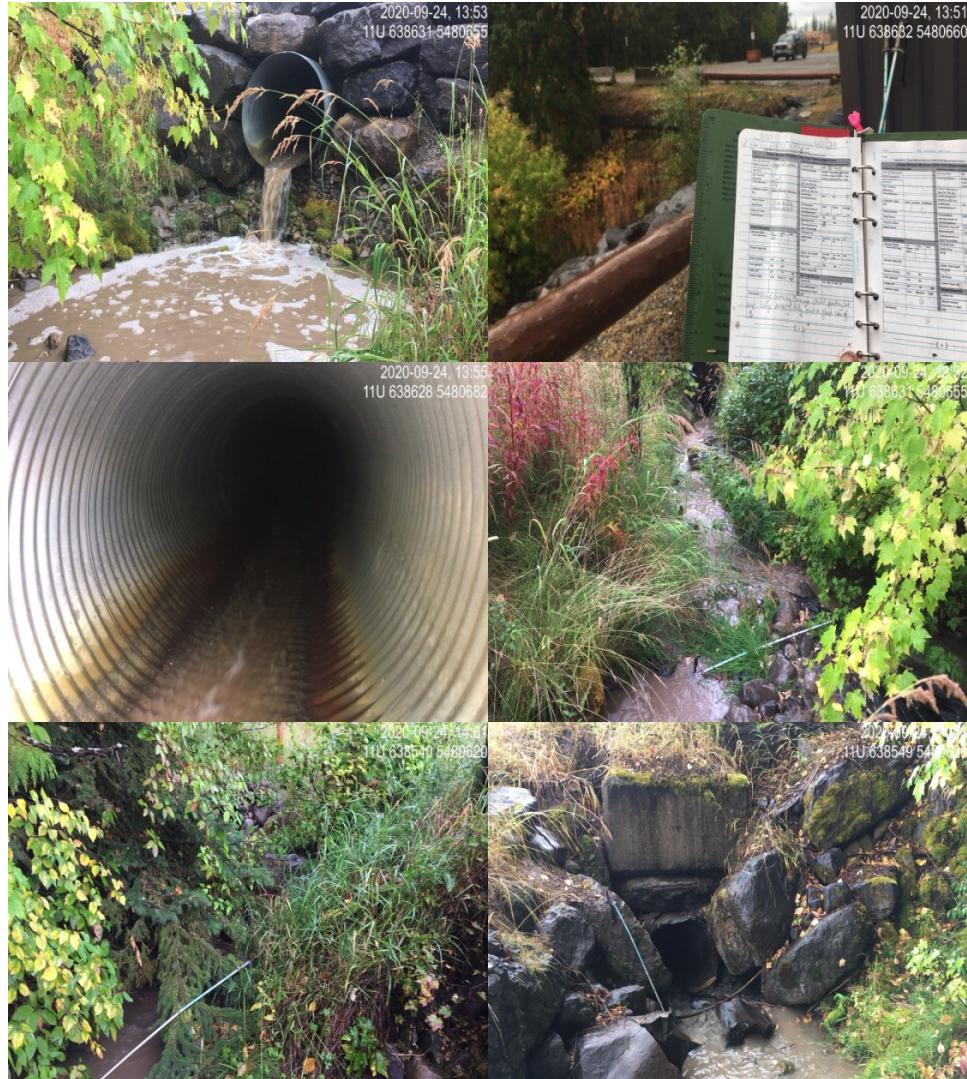
Photos: 4601639

Comments: Huge crossing through the ski hill parking lot and lodge area. Large outlet drop and pool, extremely long culvert (close to 100m) tied in with other drainage infrastructure at the base of the Fernie ski hill. Inlet drop about .15m.

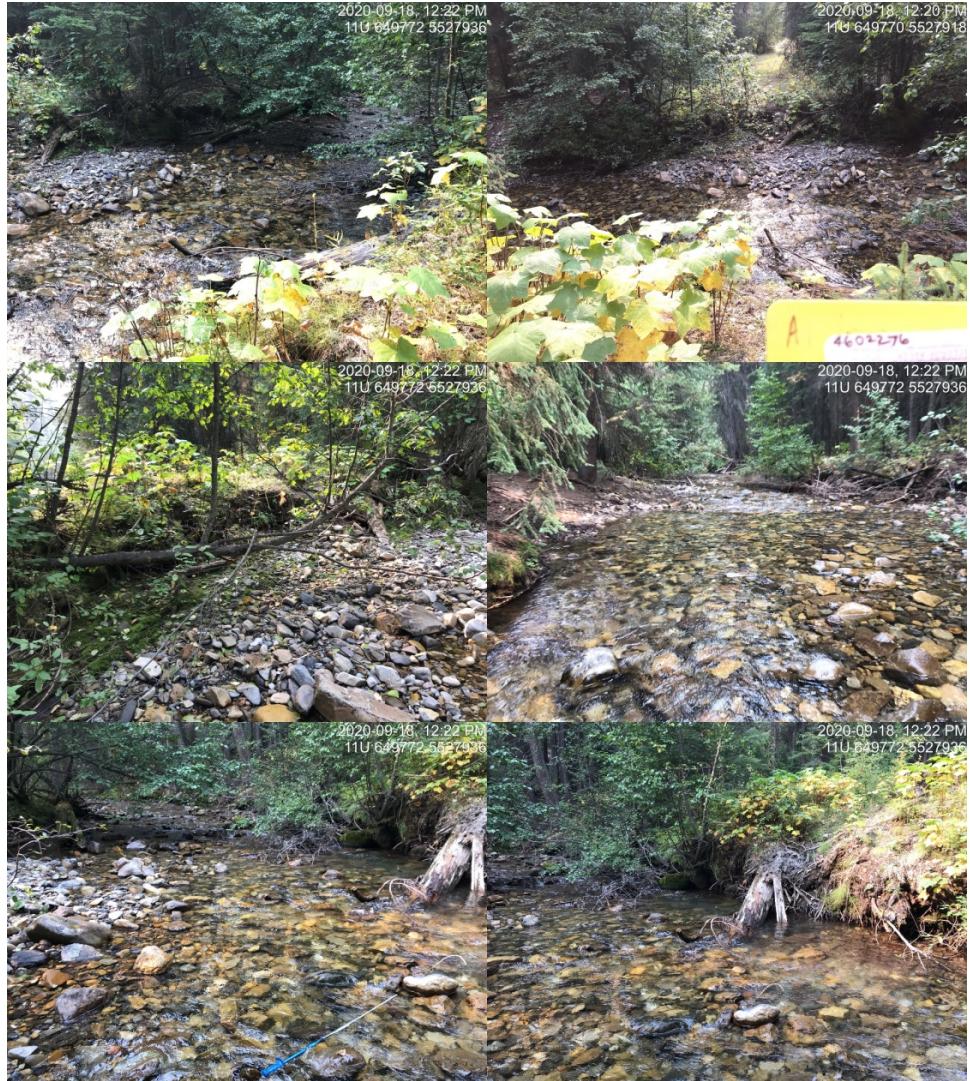
Photos: 4602276

Comments: Deactivated. Ford. no issues.

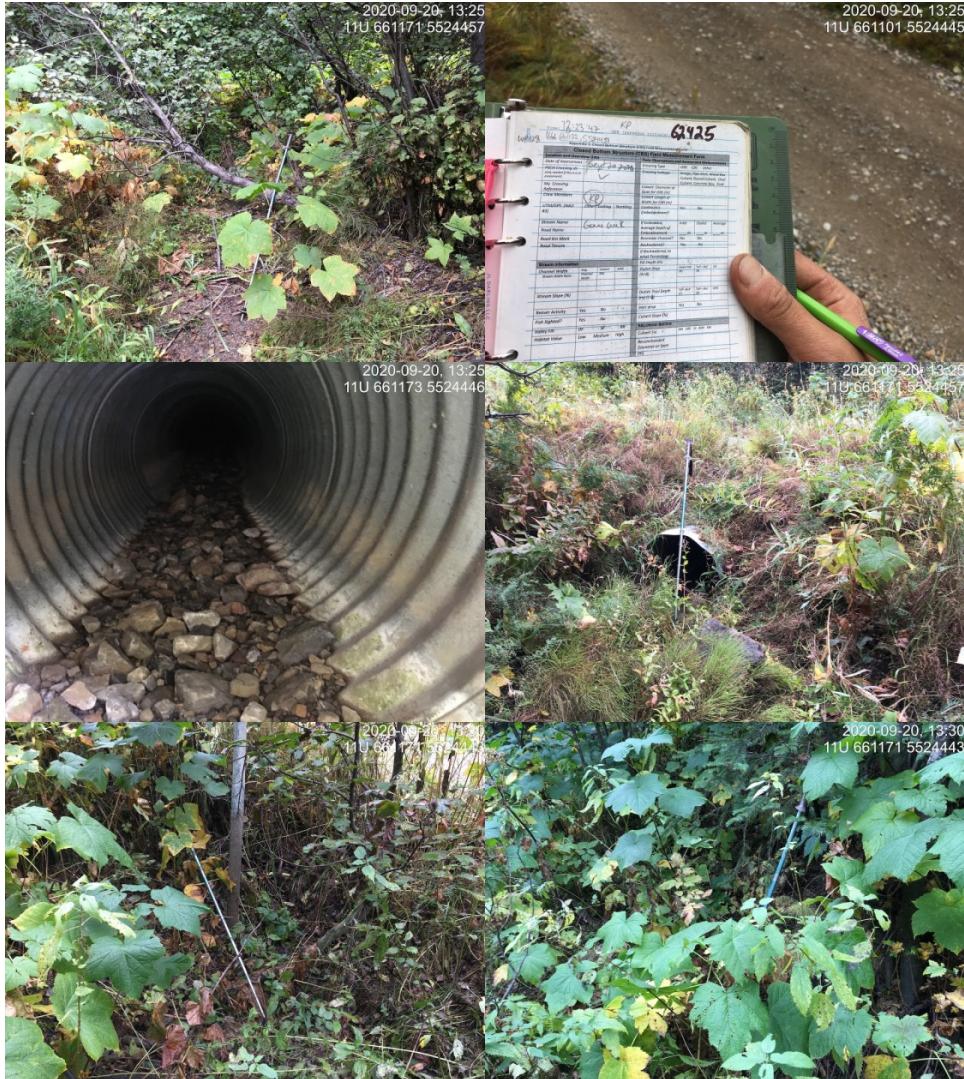
Photos: 4602533

Comments: Stream dry at time of survey, channel not visible for about 40 downstream. Water and channel appear about 65m downstream of crossing. Upstream side of crossing inlet not visible, covered by road fill or deep organic debris. Channel upstream non-existent and dry. This system (labelled as Grave creek on the map) must be a side channel or remnant channel.

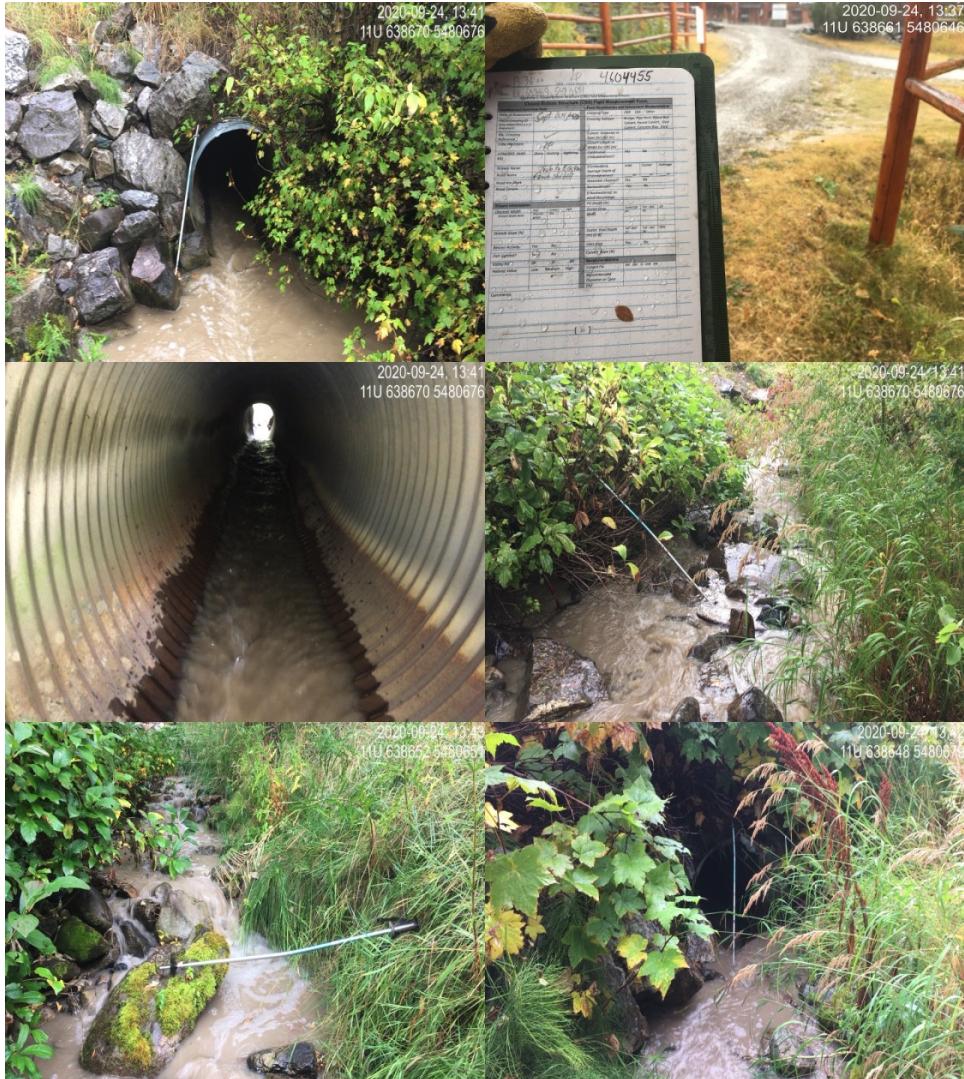
Photos: 4604455

Comments: Inlet drop about .40m, significant and looks like increased barrier. Crossing is Fernie ski hill gravel road. Currently high and turbid due to heavy rain.

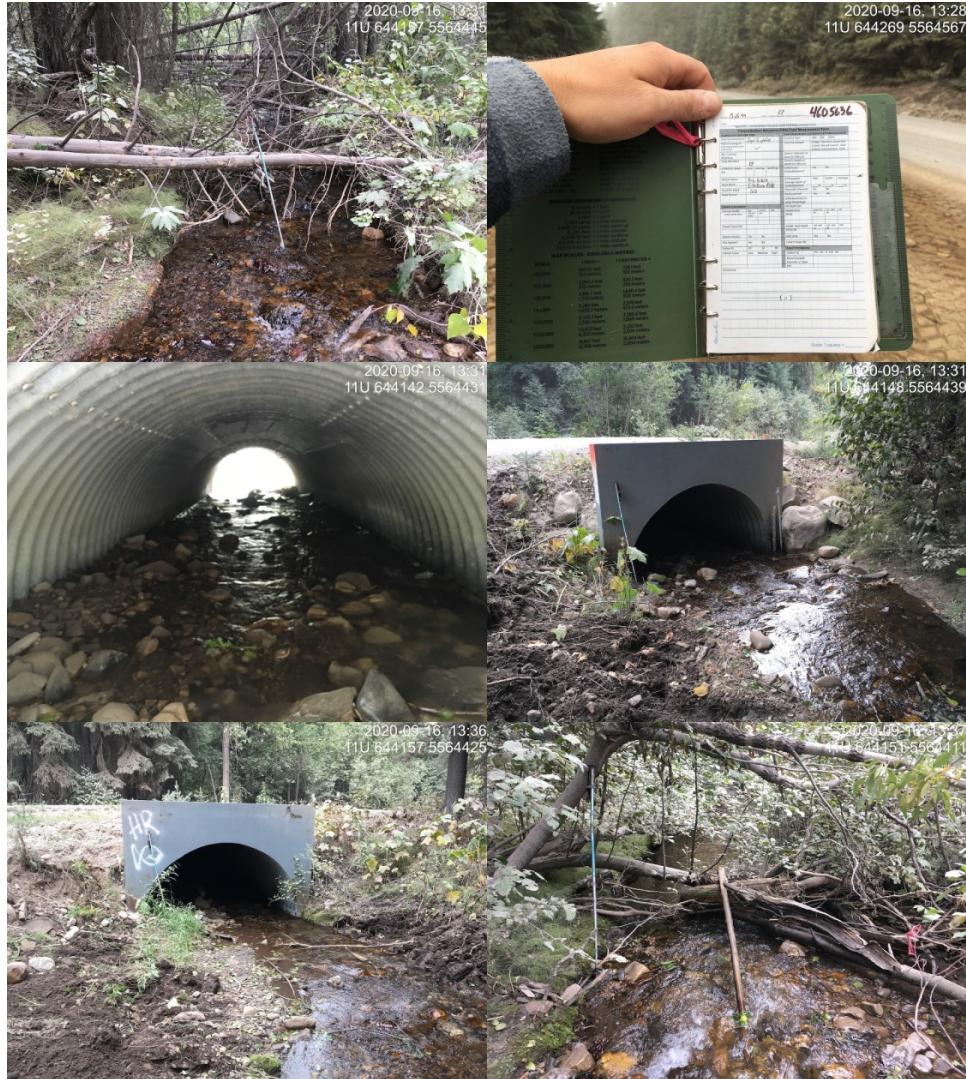
Photos: 4605636

Comments: Appears passable.

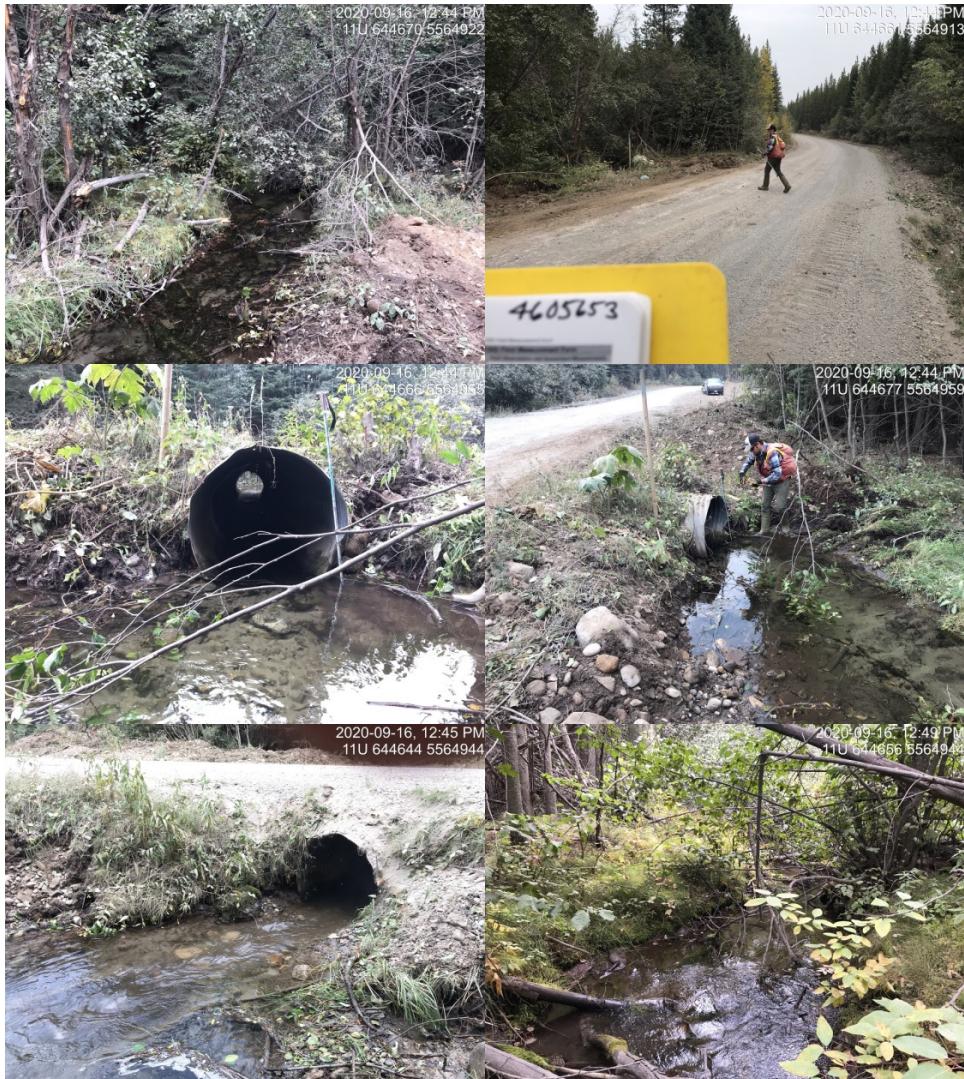
Photos: 4605653

Comments: Good habitat, habitat assessment (FHAP) conducted in 2016 (Masse Environmental Consultants Ltd.) for proposed coal mine EA (Bingay). Electrofished U/S and D/S, see provincial records and data submission file at <http://a100.gov.bc.ca/pub/acat/public/viewReport.do?reportId=52717>. Culvert does not appear to be barrier to any species at any life stage at time of survey. Could be barrier to small fish at high flows. EB and WCT recorded upstream.

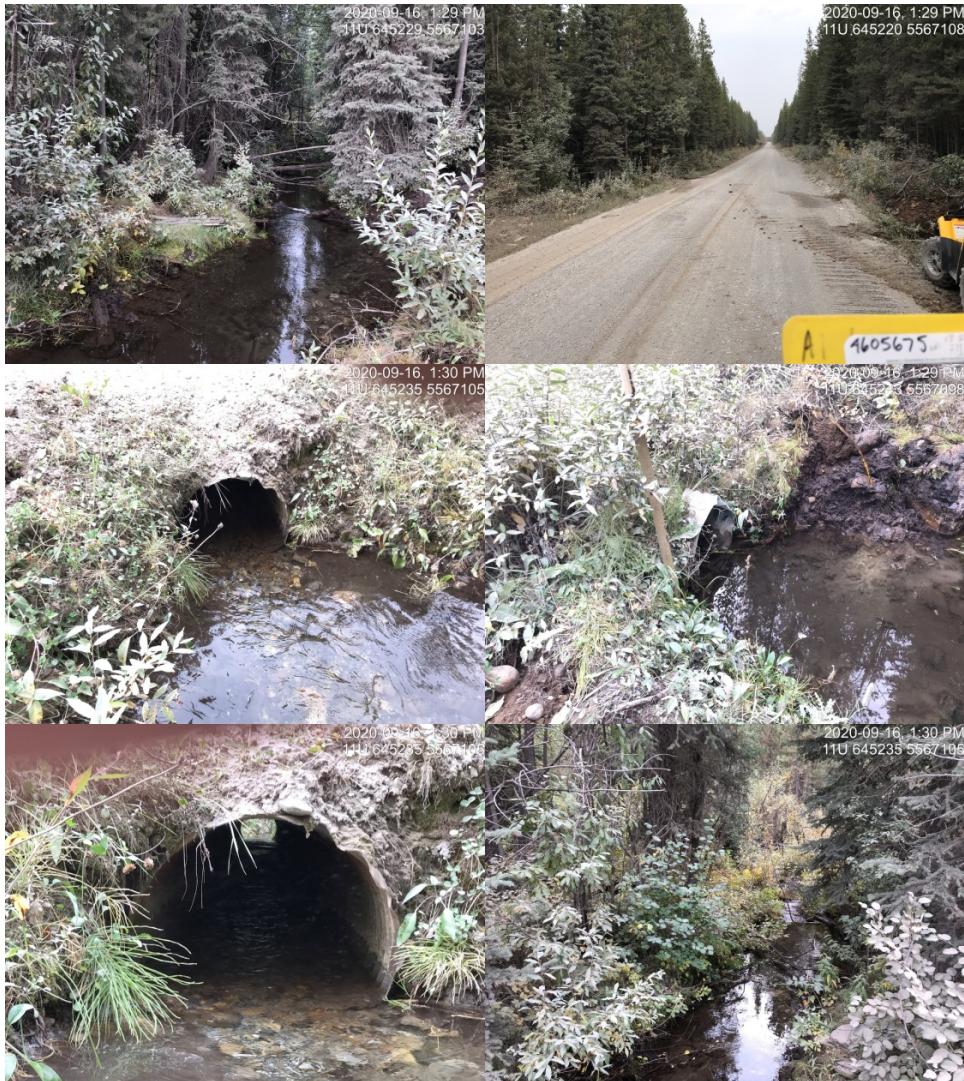
Photos: 4605675

Comments: Culvert slope estimate. Stream dredged upstream to remove sediments. Flows are slow through culvert and unlikely barrier for fry/parr for much of year. Crossing 4606244 is on deactivated spur upstream so very likely a ford, about 300m upstream same thing for 4604099.

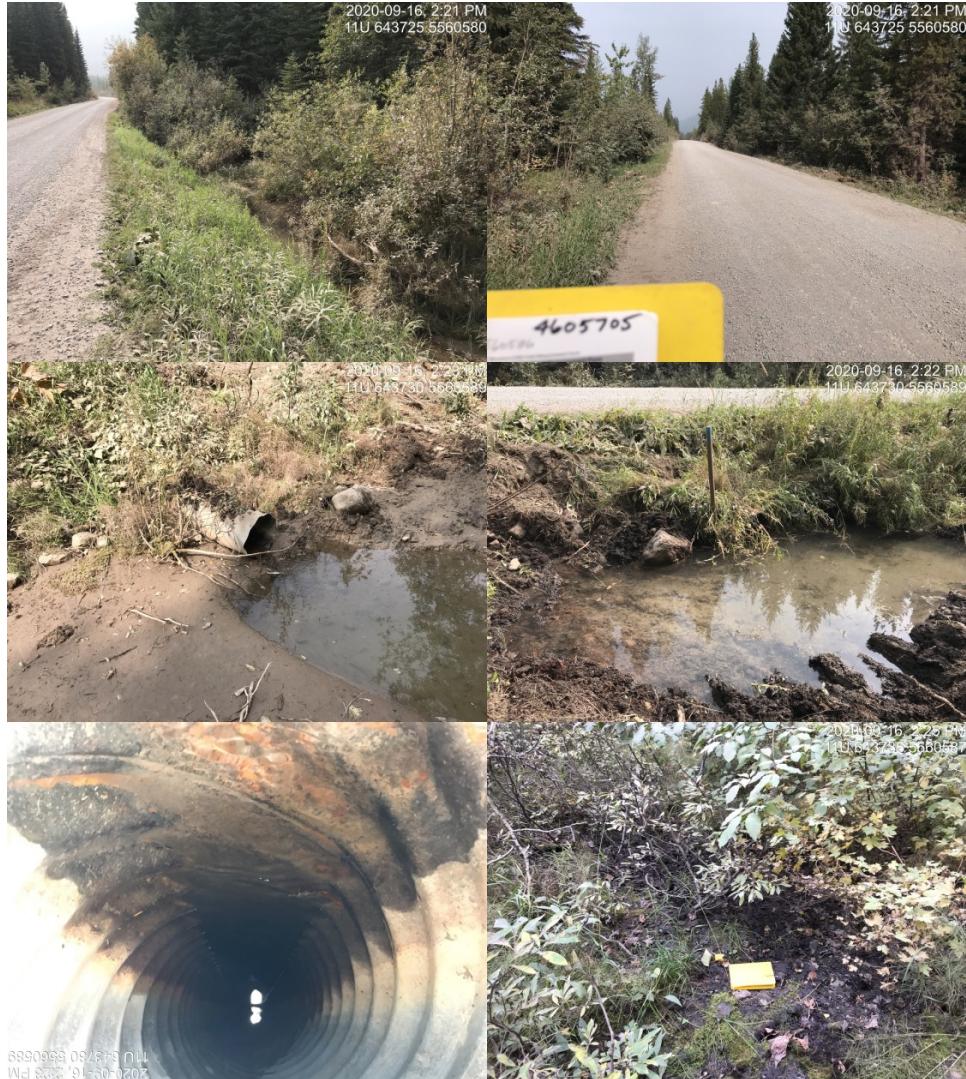
Photos: 4605705

Comments: Stream not located where mapped. Unlikely fish bearing. Flows into forest floor downstream of culvert.

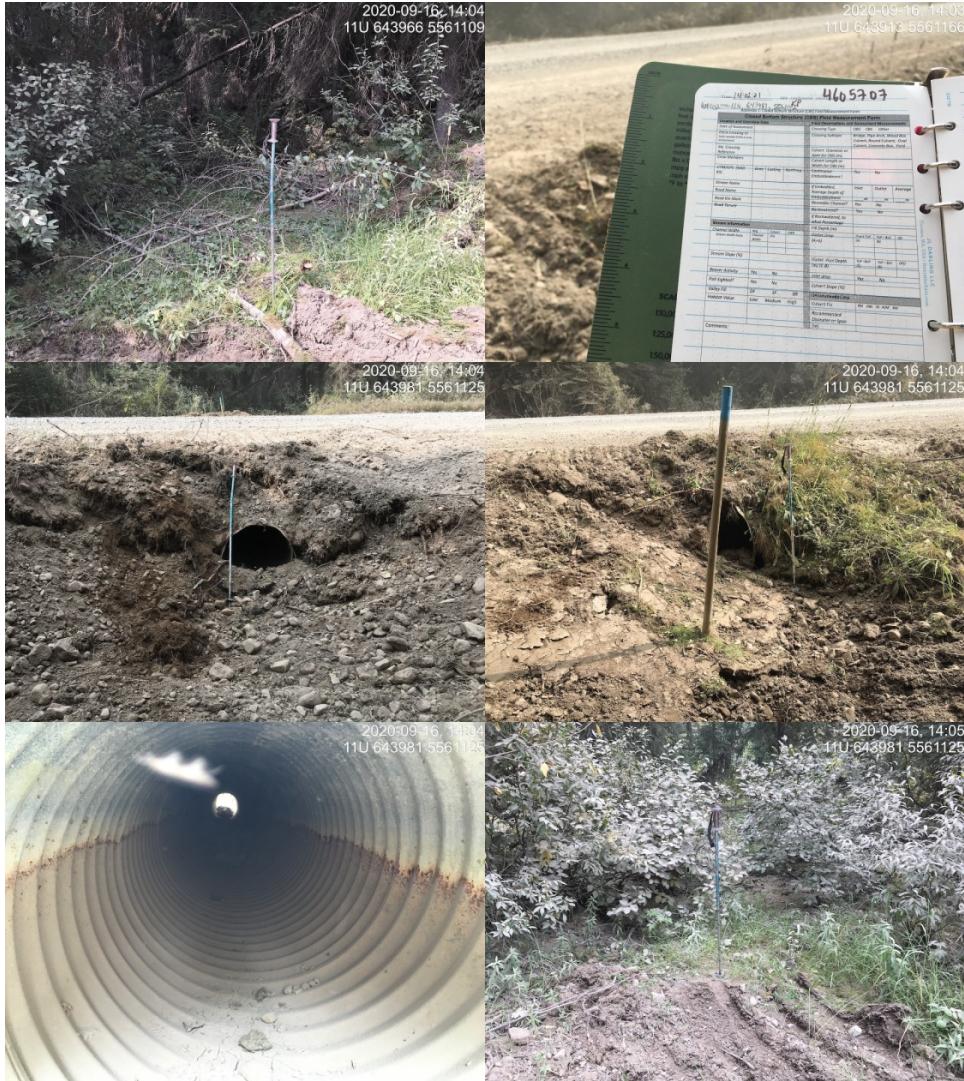
Photos: 4605707

Comments: Stream dry at time of survey. Vegetated channel, loaded with sediment. Inlet of culvert damaged, partly bent. Inlet and outlet area dredged. Not likely fish habitat.

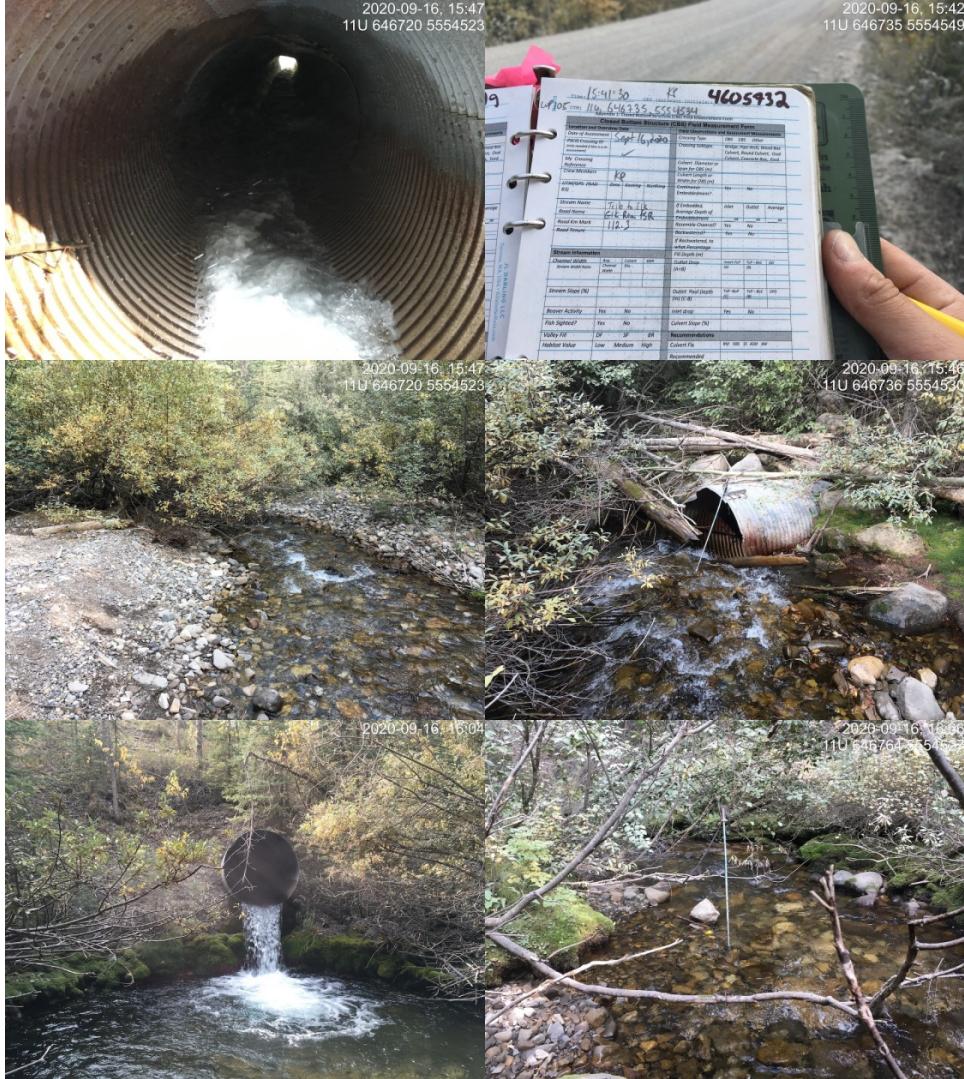
Photos: 4605732

Comments: Large perched culvert. High value habitat. Habitat confirmation and sampling conducted.

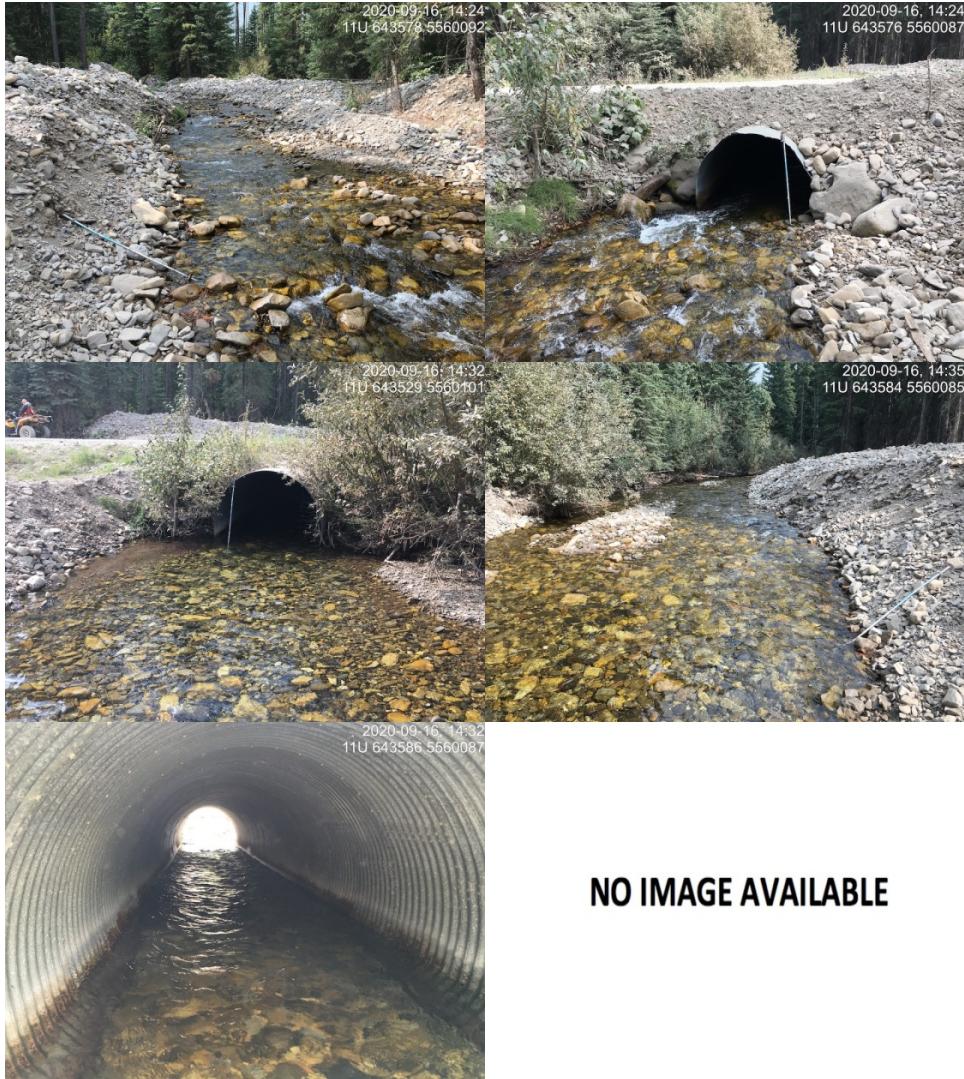
Photos: 4605742

Comments: Upstream past dredging natural channel 2.5m wide. Downstream below dredging extremely braided, original channel difficult to track. Channel widths >10m at times with substrate on top of banks and in bases of trees. Channel dredged upstream and downstream approximately 75m on each. Habitat assessment (FHAP) conducted in 2016 (Masse Environmental Consultants Ltd.) for proposed coal mine EA (Bingay). Electrofished D/S, see provincial records and data submission file at <http://a100.gov.bc.ca/pub/acat/public/viewReport.do?reportId=52717>.

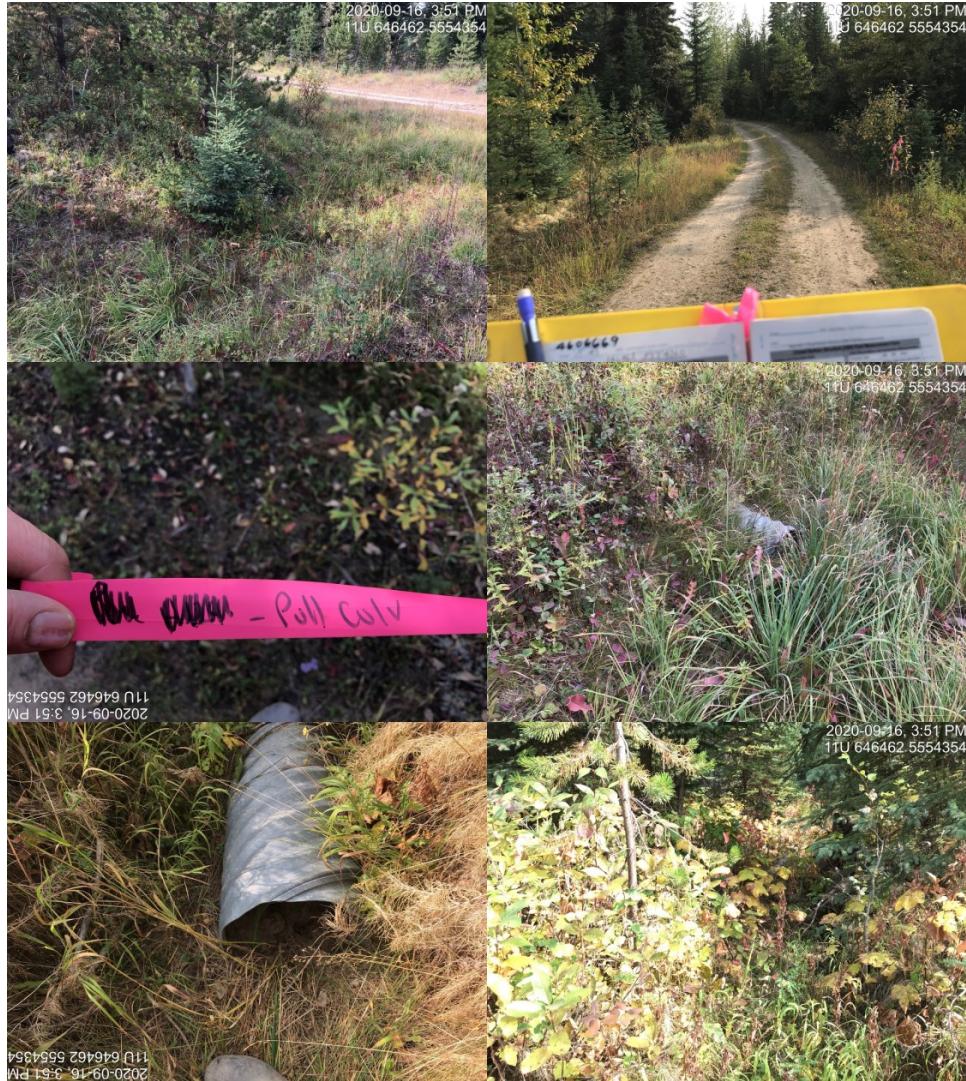
Photos: 4606669

Comments: Plan in place to deactivate entire network here (personal communication with local machinery operator). Dry, vegetated channel. Likely non-fish bearing.

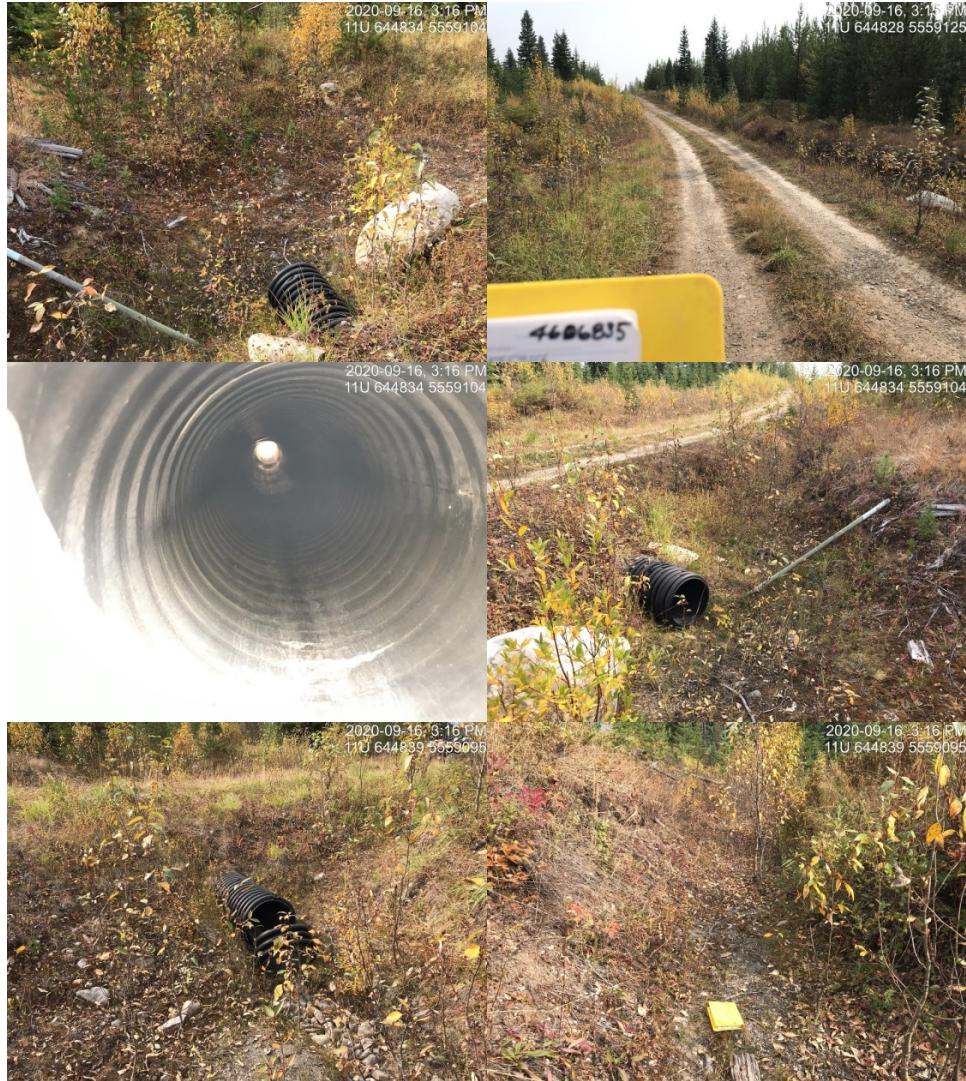
Photos: 4606835

Comments: Road is deactivated downstream so no crossings below (4607172, 4606929). Dry vegetated channel. Not likely fish bearing at this location.

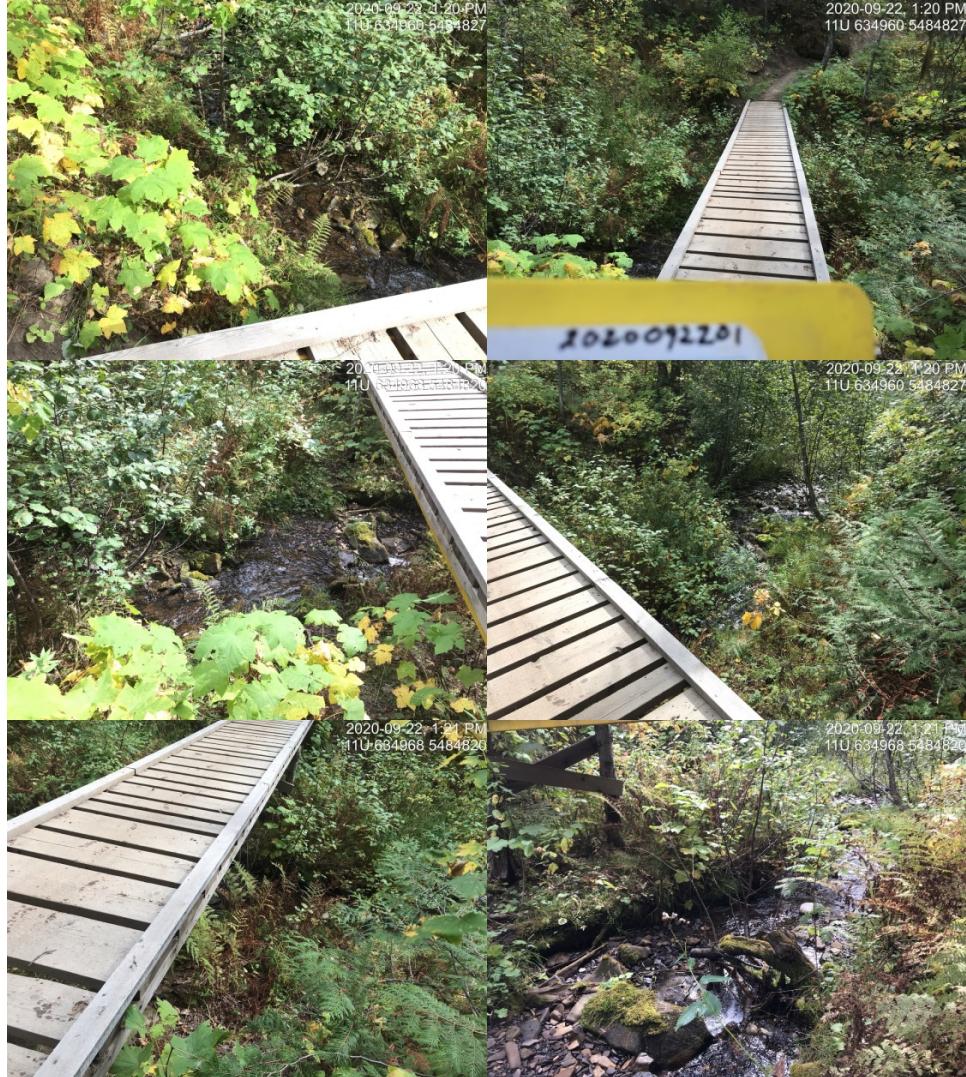
Photos: 2020092201

Comments: Bike trail.

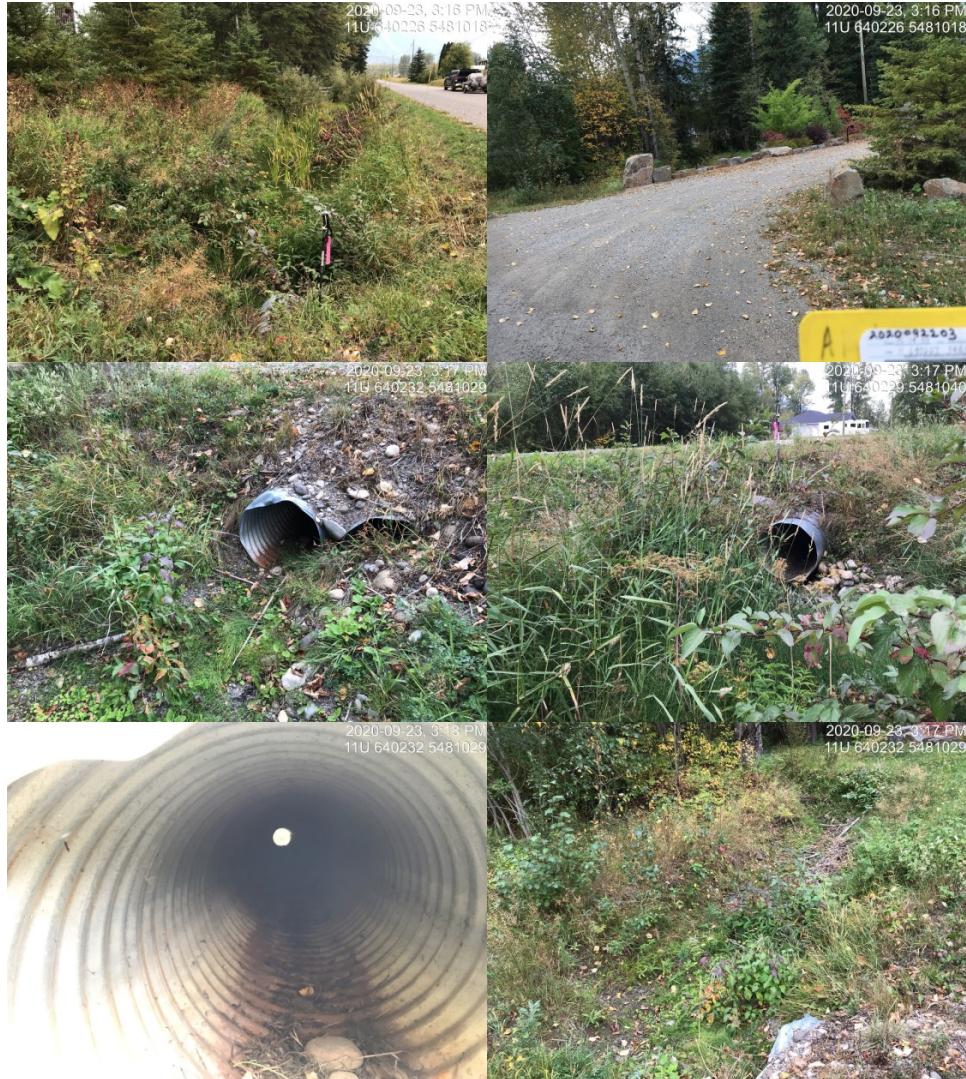
Photos: 2020092303

Comments: Dry, mostly vegetated channel. Not likely fish habitat. Two pipes, one buried by fill. Inlet elevated resulting in small area of wetland vegetation upstream.

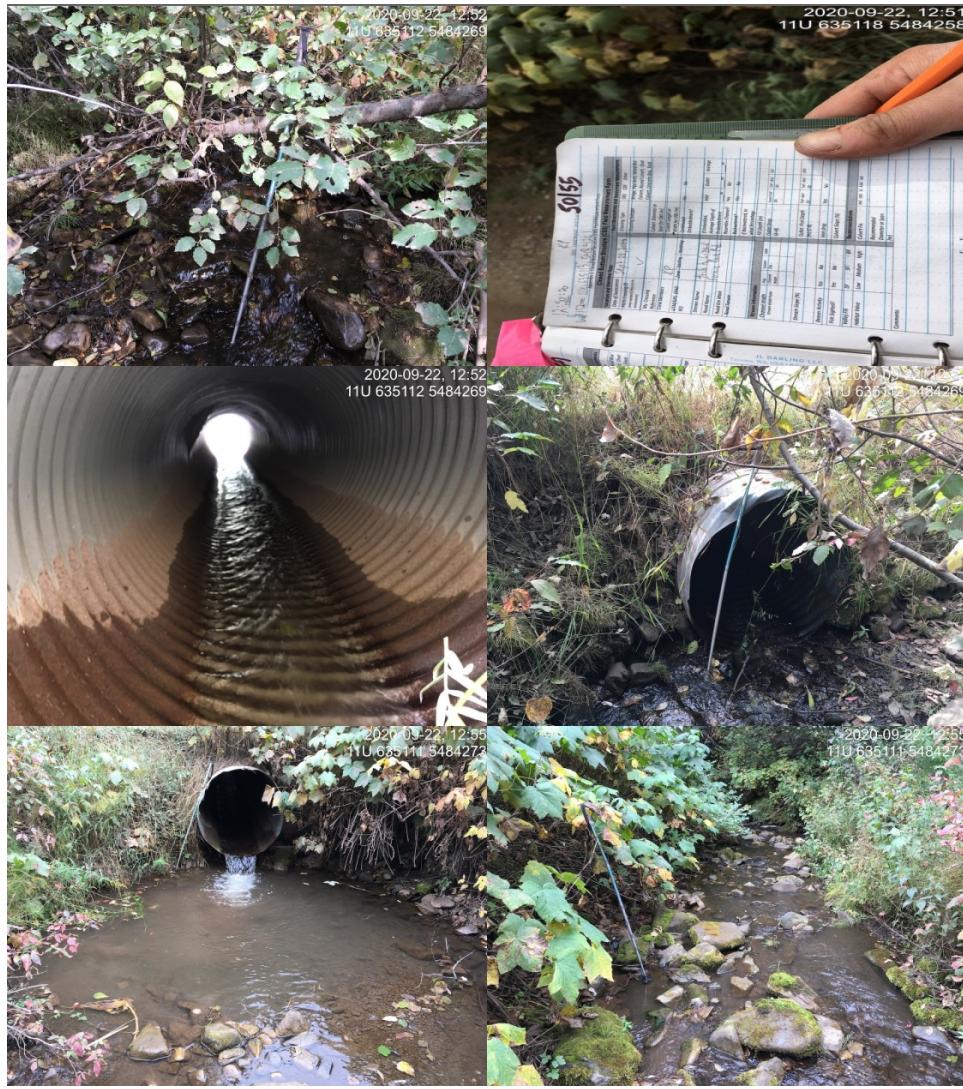
External ID	NA	Length (m)	11
Crew	KP, AI	Embedded	No
UTM Zone	11	Depth Embedded (m)	NA
Easting	635113	Resemble Channel	No
Northing	5484261	Backwatered	No
Stream	Tributary to Lizard Creek	Percent Backwatered	NA
Road	Island Lake Lodge Road	Fill Depth (m)	0.3
Road Tenure	MoTi recreation	Outlet Drop (m)	0.22
Channel Width (m)	2.25	Outlet Pool Depth (m)	0.45
Stream Slope (%)	4.3	Inlet Drop	Yes
Beaver Activity	No	Slope (%)	2.6
Habitat Value	Medium	Valley Fill	Deep Fill
Photos:

Structure replacement with an open bottomed culvert is recommended to provide unconstrained access to the habitat located upstream of PSCIS crossing 50155. The cost for work is estimated at \$125000 for a cost benefit of \$8700/linear m and \$9700/m².
