Elk River Watershed Group Fish Passage Restoration Planning

Prepared for Canadian Wildlife Federation

New Graph Environment

2020-12-22 DRaft

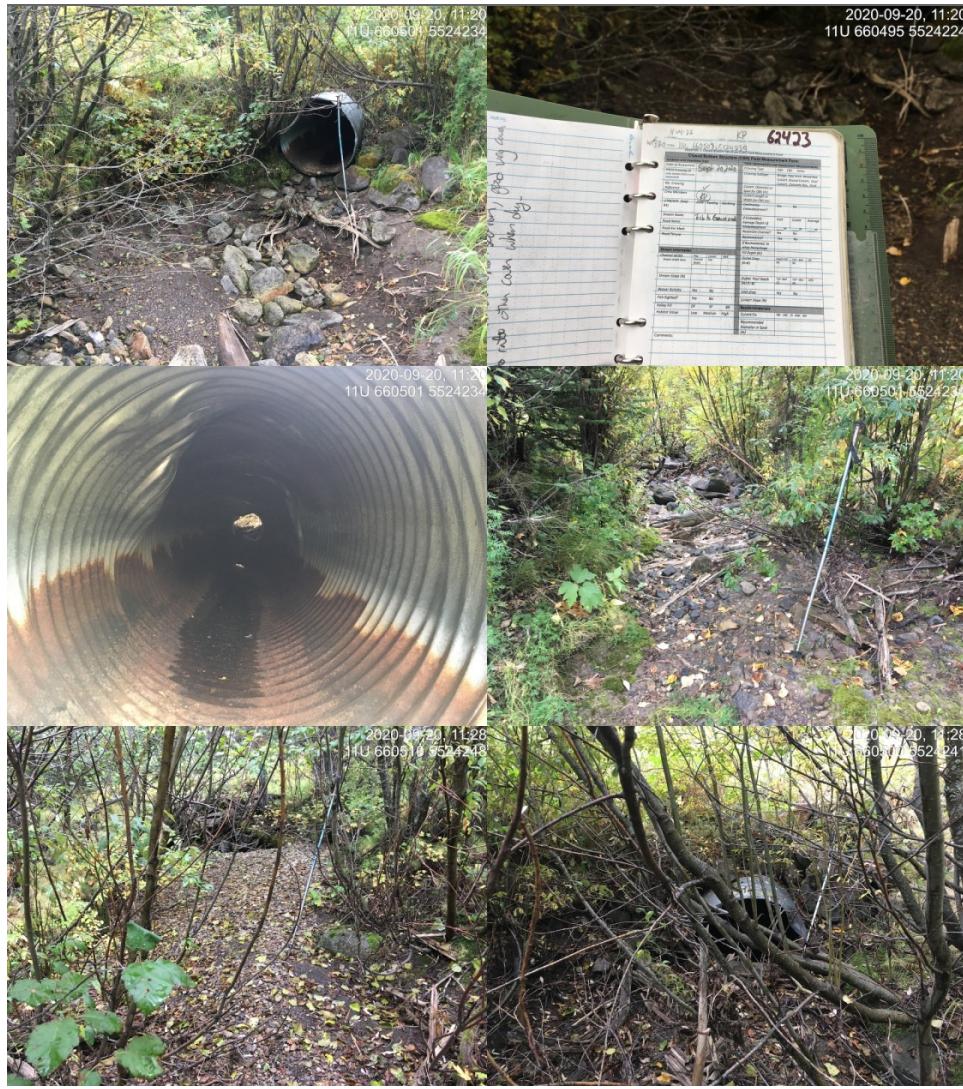
PSCIS ID	62423	Diameter (m)	0.9
External ID	NA	Length (m)	12
Crew	KP, AI	Embedded	No
UTM Zone	11	Depth Embedded (m)	NA
Easting	660508	Resemble Channel	No
Northing	5524239	Backwatered	No
Stream	Harriet Lake Creek	Percent Backwatered	NA
Road	Grave Creek FSR	Fill Depth (m)	0.3
Road Tenure	Unknown	Outlet Drop (m)	0.18
Channel Width (m)	1.44	Outlet Pool Depth (m)	0.6
Stream Slope (%)	4	Inlet Drop	Yes
Beaver Activity	No	Slope (%)	0.5
Habitat Value	Low	Valley Fill	Deep Fill

Structure replacement with an embedded culvert is recommended to provide access to the habitat located upstream of PSCIS crossing 62423. The cost for the work is estimated at \$25000 for a cost benefit of \$63100/linear m and \$45500/m².

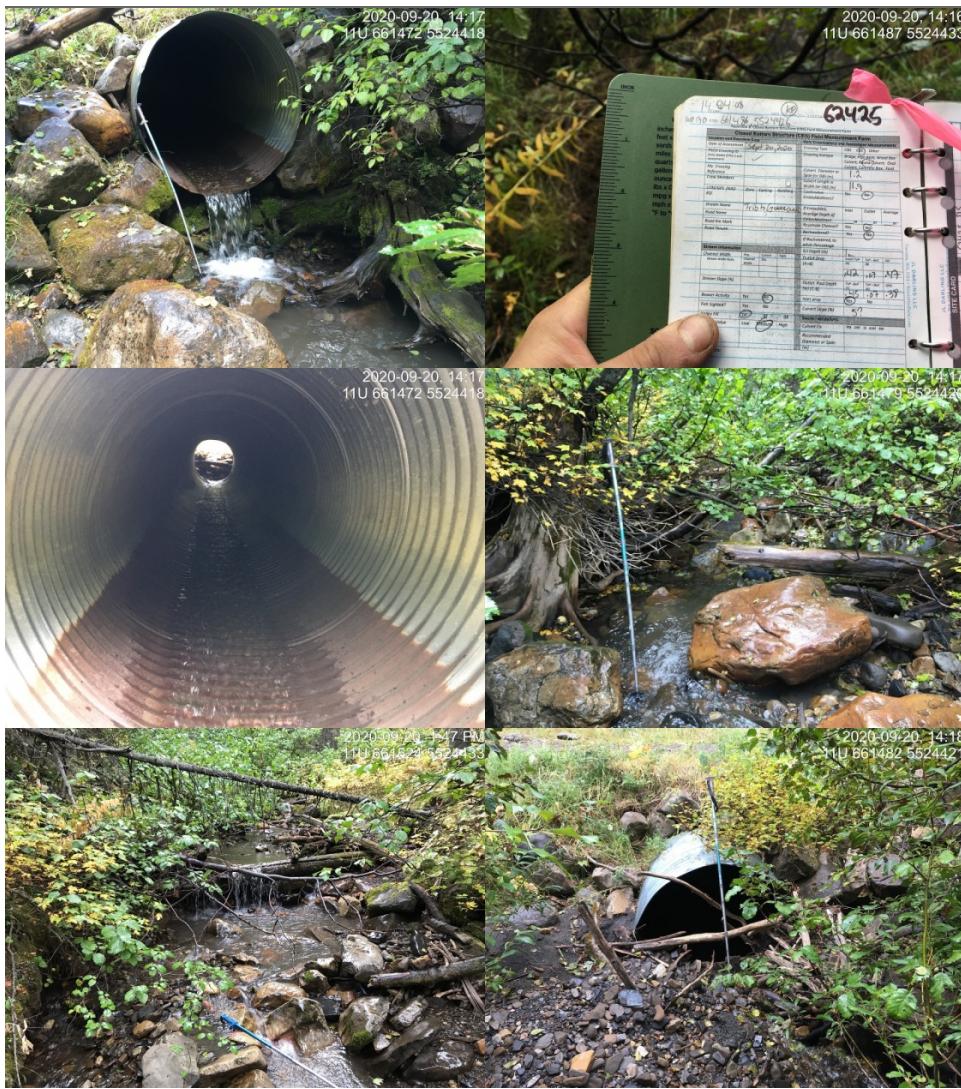
Location and Stream Data		Crossing Characteristics	
Date	2020-09-20	Crossing Sub Type	Round Culvert
PSCIS ID	62425	Diameter (m)	1.2
External ID	NA	Length (m)	12
Crew	KP, AI	Embedded	No
UTM Zone	11	Depth Embedded (m)	NA
Easting	661486	Resemble Channel	No
Northing	5524426	Backwatered	No

Stream	Grave Creek	Percent Backwatered	NA
Road	Spur	Fill Depth (m)	1
Road Tenure	Canfor R08362	Outlet Drop (m)	0.47
Channel Width (m)	3.7	Outlet Pool Depth (m)	0.38
Stream Slope (%)	7.5	Inlet Drop	Yes
Beaver Activity	No	Slope (%)	7.5
Habitat Value	Medium	Valley Fill	Deep Fill
Photos:

Replacing PSCIS crossings 62425 and 62426 with bridges is recommended to provide access to the habitat located upstream. The costs are estimated at \$125000 and \$125000 respectively for a combined cost benefit of \$17600/linear m and \$32000/m².

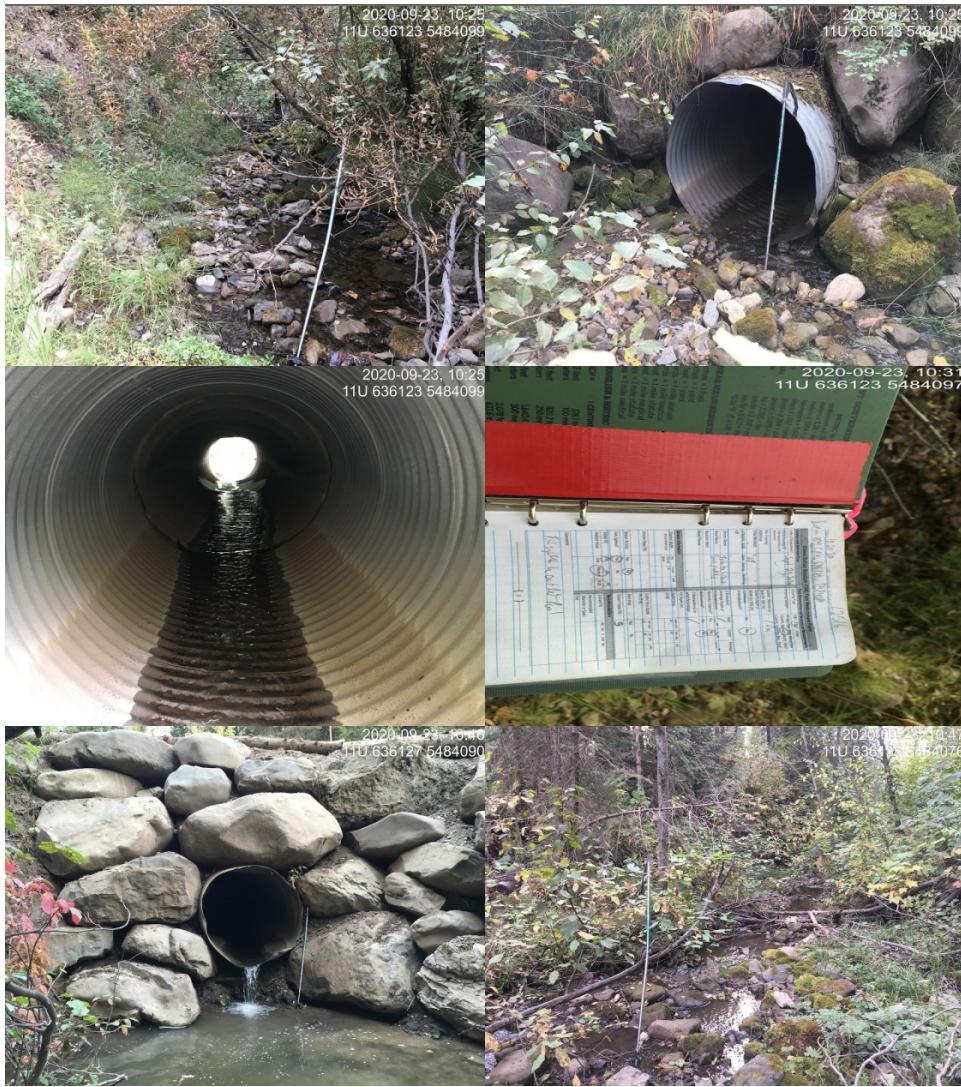
Location and Stream Data		Crossing Characteristics	
Date	2020-09-23	Crossing Sub Type	Round Culvert
PSCIS ID	62516	Diameter (m)	1.2
External ID	NA	Length (m)	11
Crew	KP, AI	Embedded	No

UTM Zone	11	Depth Embedded (m)	NA
Easting	636123	Resemble Channel	No
Northing	5484087	Backwatered	No
Stream	Tributary to Lizard Creek	Percent Backwatered	NA
Road	Island Lake Lodge Road	Fill Depth (m)	1.3
Road Tenure	MoTi recreation	Outlet Drop (m)	0.49
Channel Width (m)	2.47	Outlet Pool Depth (m)	0.8
Stream Slope (%)	2.67	Inlet Drop	No
Beaver Activity	No	Slope (%)	5
Habitat Value	Medium	Valley Fill	Deep Fill
Photos:

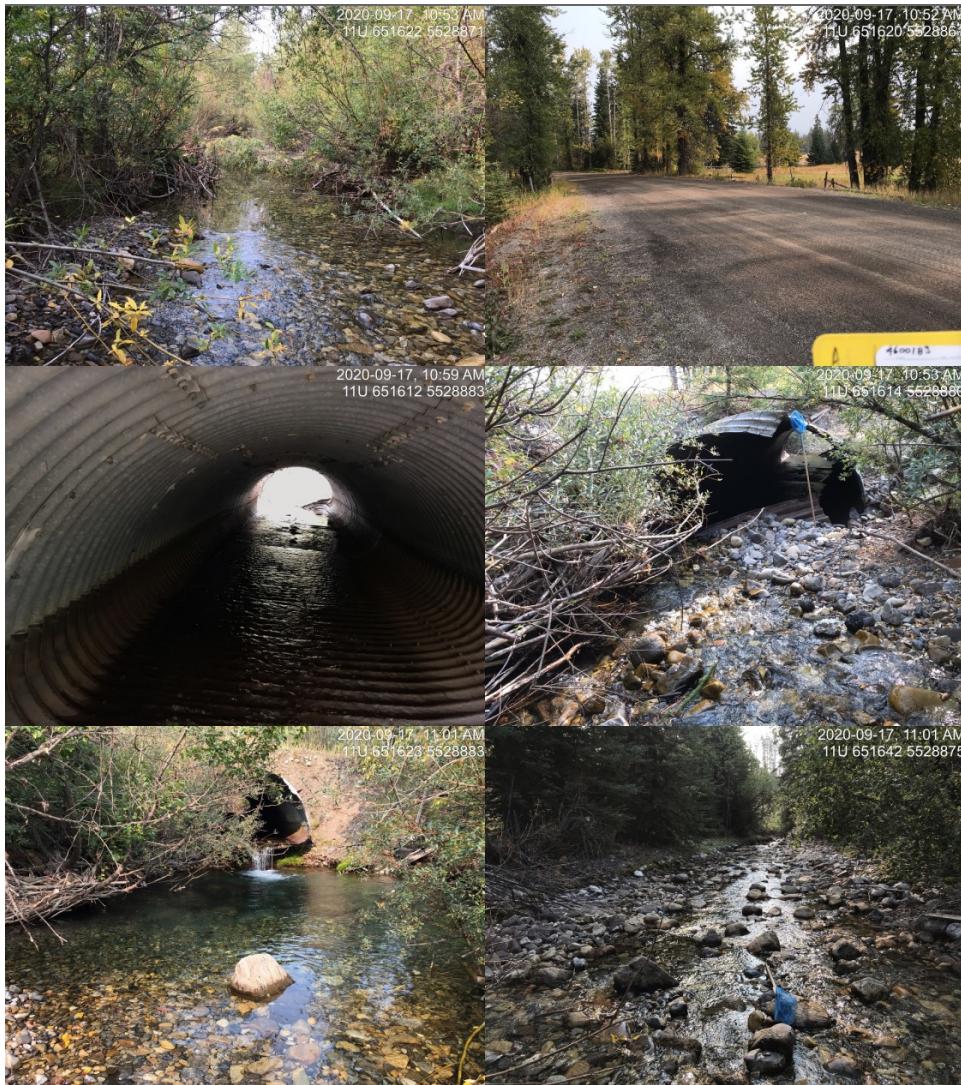
Stream	Brule Creek	Percent Backwatered	NA
Road	Busato Rd	Fill Depth (m)	1
Road Tenure	MoTi local	Outlet Drop (m)	0.7
Channel Width (m)	7.1	Outlet Pool Depth (m)	1.5
Stream Slope (%)	2	Inlet Drop	Yes
Beaver Activity	No	Slope (%)	4
Habitat Value	High	Valley Fill	Deep Fill

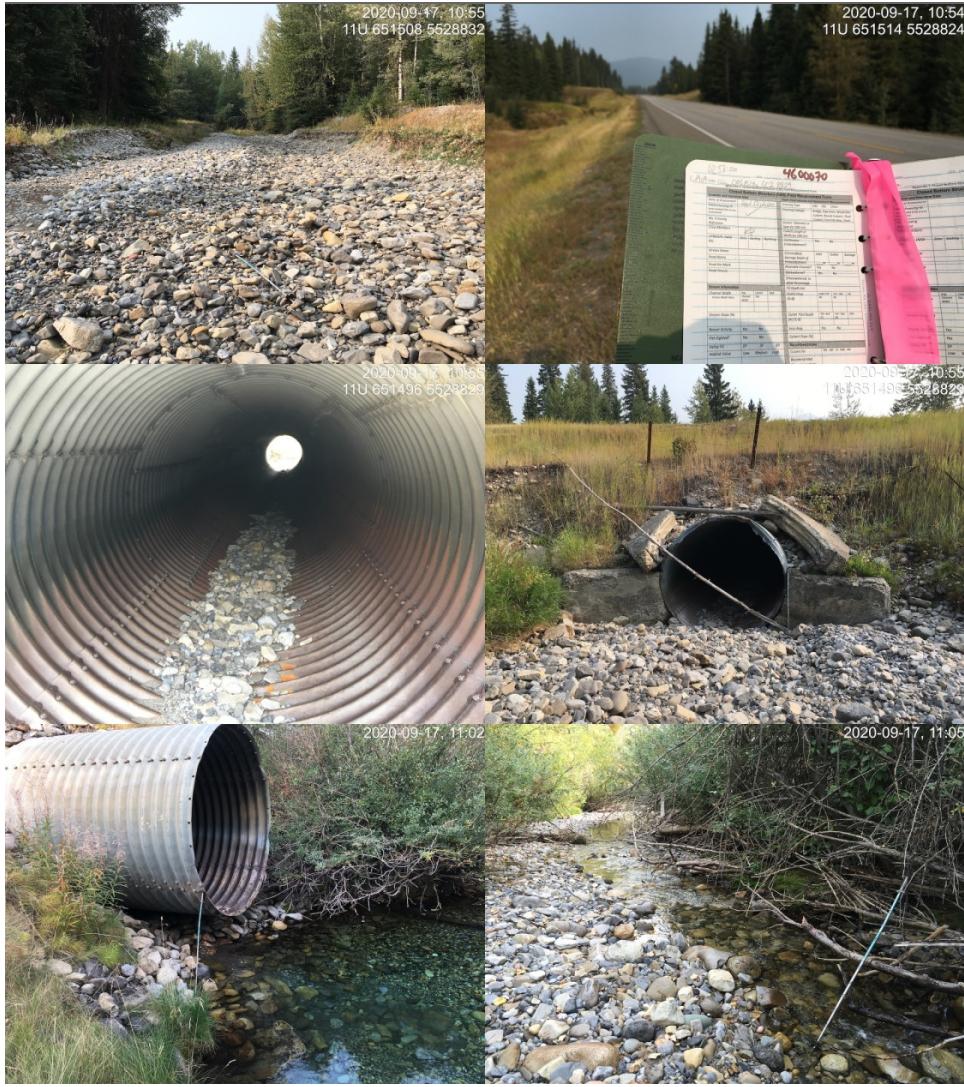
Table 5.19: Summary of fish passage reassessment for PSCIS crossing 197559.

Location and Stream Data		Crossing Characteristics	
Date	2020-09-17	Crossing Sub Type	Round Culvert
PSCIS ID	197559	Diameter (m)	2.5
External ID	NA	Length (m)	35
Crew	KP, AI	Embedded	Yes
UTM Zone	11	Depth Embedded (m)	0.05
Easting	651516	Resemble Channel	Yes
Northing	5528829	Backwatered	No
Stream	Brule Creek	Percent Backwatered	NA
Road	Highway 43	Fill Depth (m)	3
Road Tenure	MoTi highway	Outlet Drop (m)	0
Channel Width (m)	6.1	Outlet Pool Depth (m)	1.7
Stream Slope (%)	1.5	Inlet Drop	No
Beaver Activity	No	Slope (%)	2.5
Habitat Value	Medium	Valley Fill	Deep Fill
Photos:

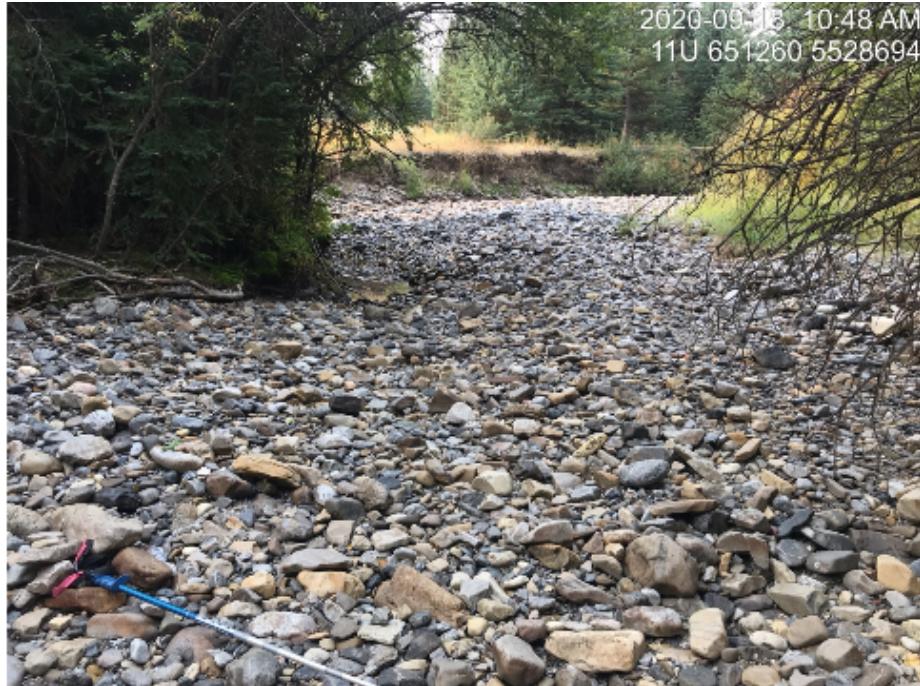
The stream was surveyed immediately upstream from 197559 for 1200m and then another 600m beginning at the ford (PSCIS 197536) 2km upstream for a total of 1600m. The channel was dewatered immediately upstream of Highway 43 with intermittent pools only to a distance approximately 670 m upstream. Upstream of the dewatered area, stream flows increased with increasing upstream distance. Overall, total cover amount was rated as moderate with deep pools dominant. Cover was also present as boulders and undercut banks (Table 5.20, Figure 5.19). The average channel width was 5.5m, the average wetted width was 2.3m and the average gradient was 3.5%. Overall, habitat upstream of 197559 was rated as high value habitat present suitable for resident and fluvial salmonid rearing and spawning.

Figure 5.21: Subsurface flow area upstream of PSCIS crossing 197559.

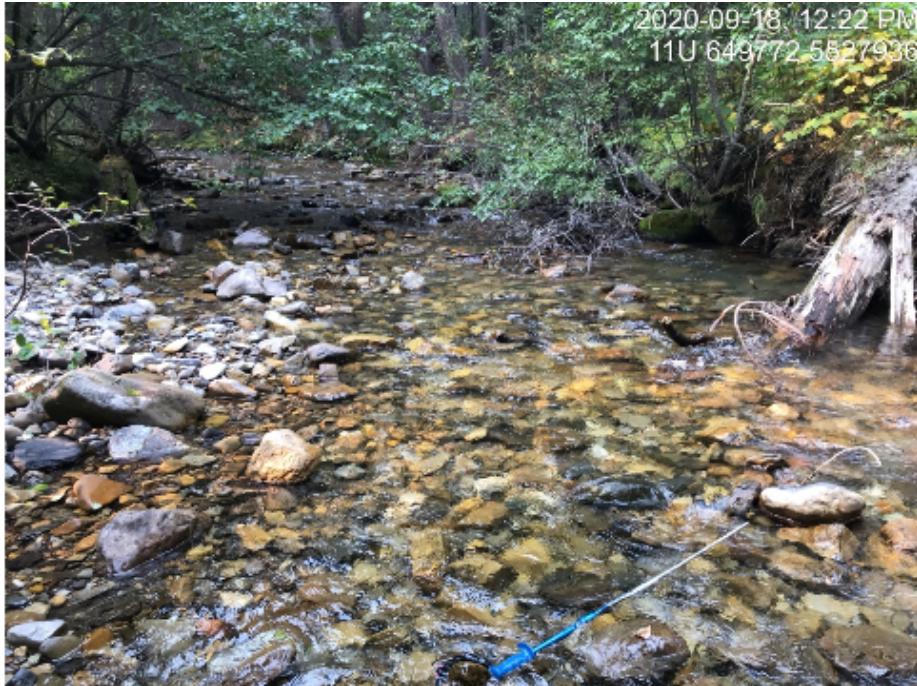
Figure 5.22: Typical habitat above dewatered area upstream of PSCIS crossing 197533.

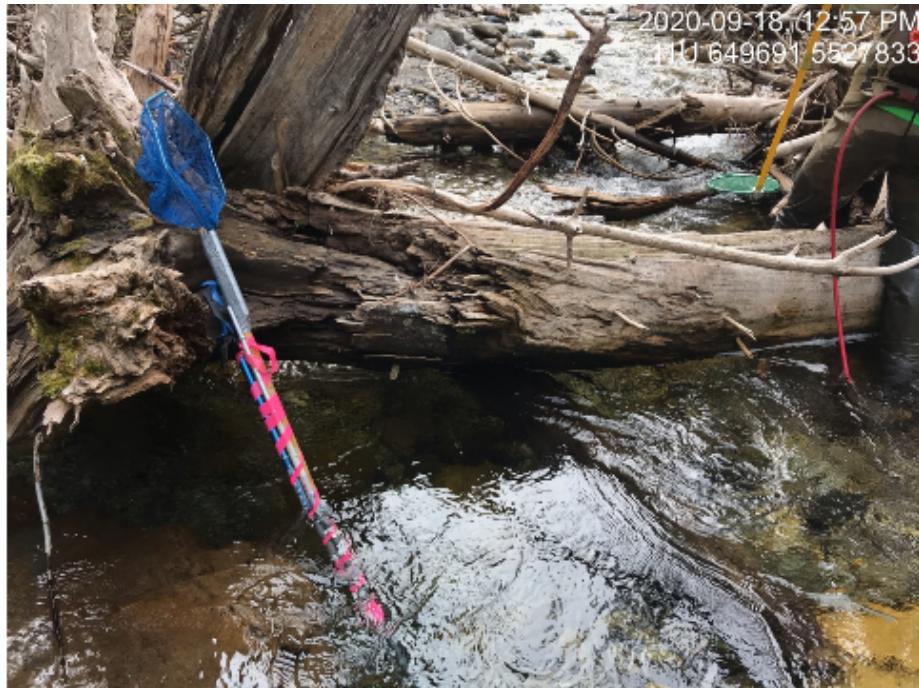
Figure 5.23: Habitat within electrofishing site upstream of PSCIS crossing 197533.

As properties on Busato Road could be accessed from either side of the road, removal of PSCIS 197533 could be explored as an option for providing access to the 125m of habitat located upstream and below PSCIS 197533. However, to facilitate an estimate of “worst case scenario”, costs for replacement of both crossing 197533 and 197533 with bridges are estimated at \$178000 and

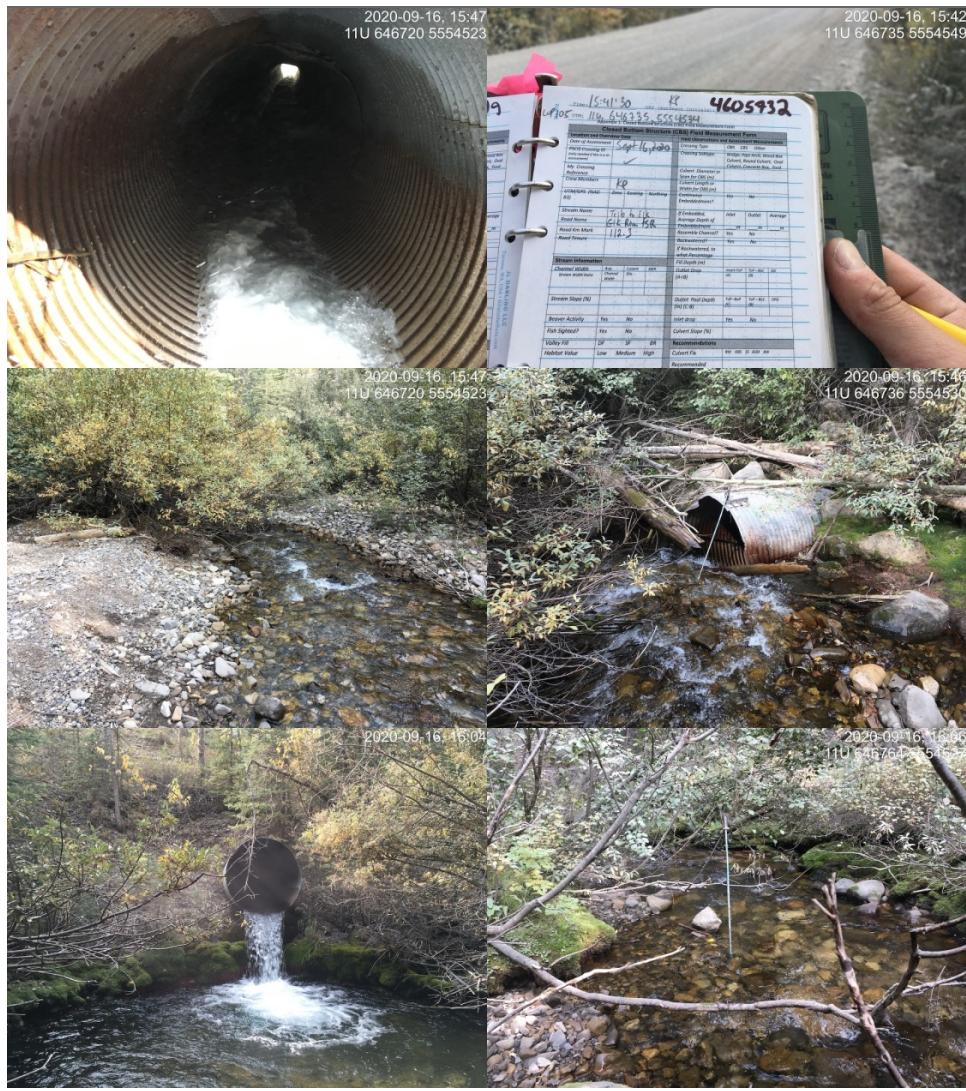
Table 5.22: Summary of fish passage reassessment for PSCIS crossing 197555.

There is an estimated 6km of mainstem habitat upstream of crossing 197555 with habitat in the areas surveyed upstream of the crossing rated as high value for fry and juvenile salmonid rearing. However, fish sampling results indicate that westslope cutthroat trout are not currently utilizing the stream and densities of bull trout are very low. This could be the result of the cold water conditions due to the positioning of the watershed at high elevation in the generally cold Rocky Mountain setting. Elk River FSR is a forest tenure licensee road of the Ministry of Forests, Lands, Natural Resource Operations & Rural Development. The crossing was ranked as a moderate priority for proceeding to design for replacement with an open bottomed structure.

Structure replacement with an open bottomed culvert is recommended to provide access to the habitat located upstream of PSCIS crossing 197555. Due to the large amount of fill on the road (8) the size of a replacement bridge was estimated at 25m. The cost for work is estimated at \$312000 for a cost benefit of \$21900/linear m and \$38400/m².

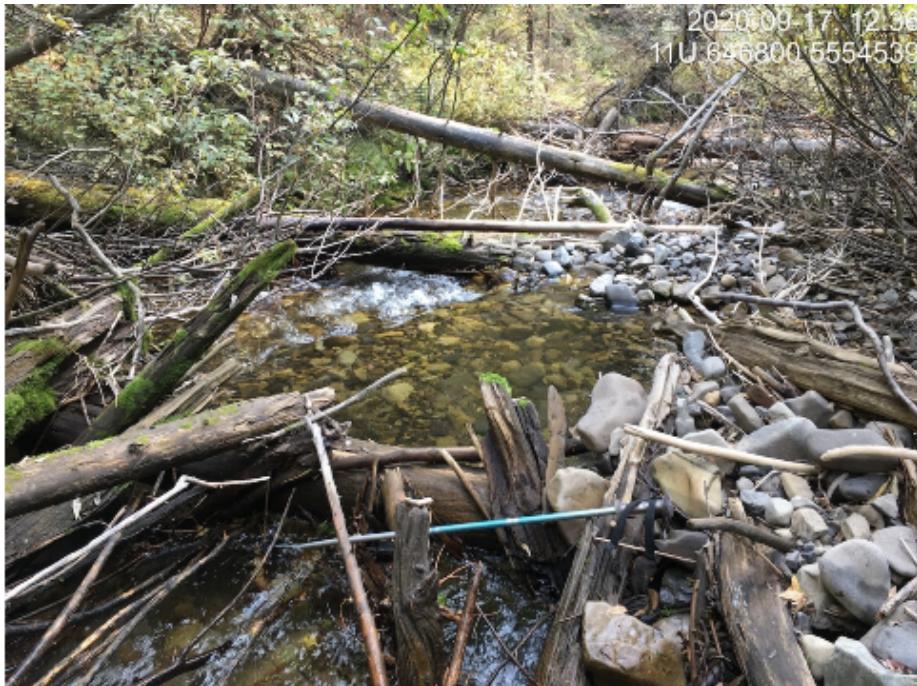
Figure 5.24: Typical habitat downstream of PSCIS crossing 197555.

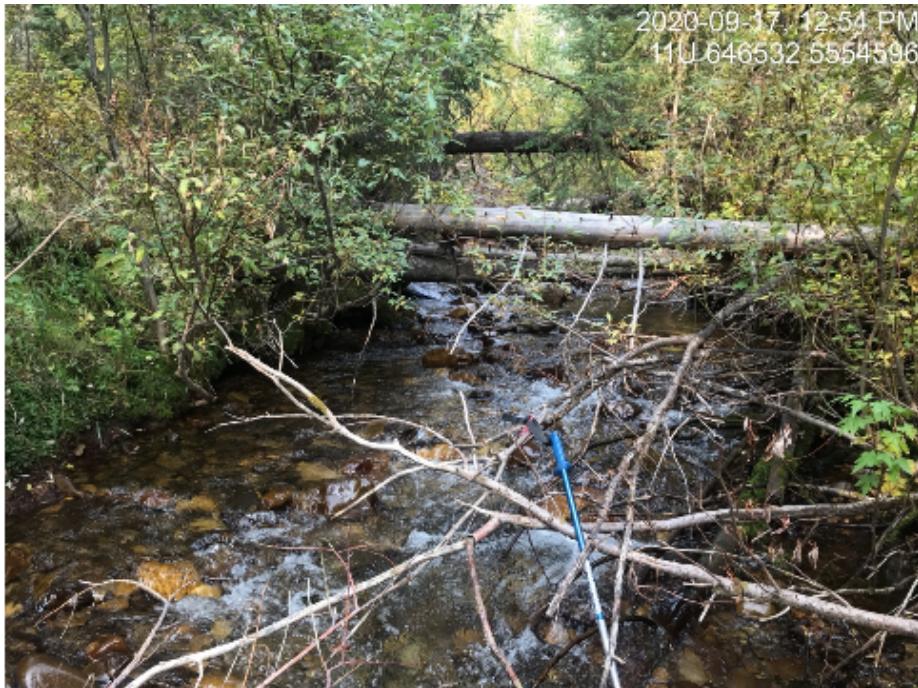
The stream was surveyed upstream from the culvert for 675m. Overall, total cover amount was rated as abundant with boulders as the dominant type. Cover was also present as small woody debris, large woody debris, undercut banks, deep pools, and overhanging vegetation (Table [5.23](#), Figure [5.25](#)). The average channel width was 5.9m, the average wetted width was 3.8m and the average gradient was 5.9%. The dominant substrate was cobbles with boulders subdominant. The stream had good flows with fry observed throughout the area surveyed. Pools to 0.6m deep (average residual depth = 0.4m) were present with pockets of gravel suitable for spawning throughout. Infrequent large woody debris jams to 0.5m high were also observed. Pockets of gravel suitable for resident and fluvial salmonid spawning were present throughout the area

Figure 5.25: Typical habitat upstream of PSCIS crossing 197555.

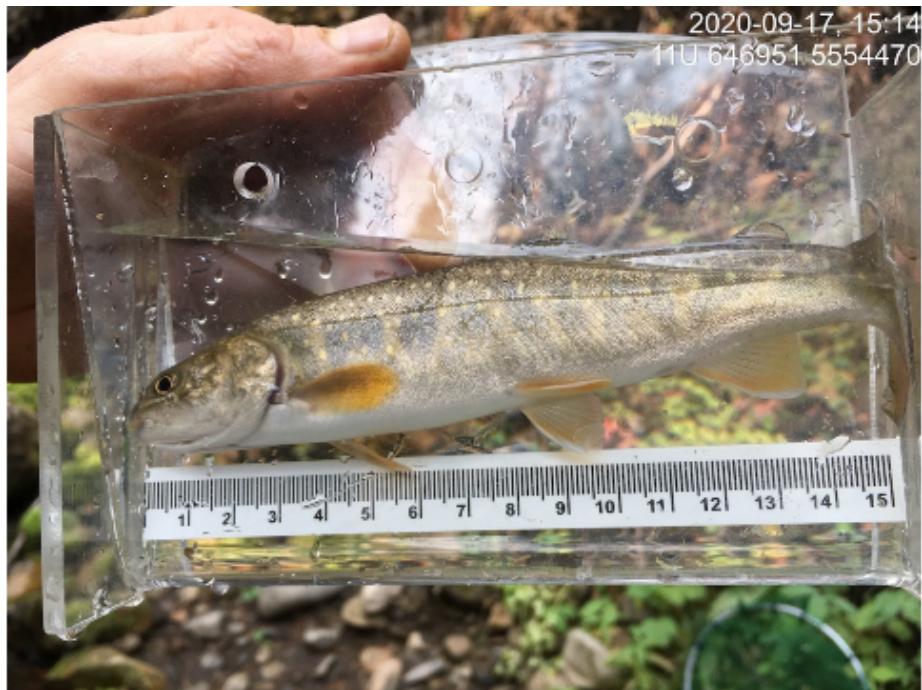
To assess potential impacts of the culvert on fish communities in the stream, electrofishing was conducted upstream and downstream of the crossing. One 150m site was sampled upstream and one 315m site was sampled downstream. One bull trout was captured downstream and no fish were captured upstream (Figure 5.26). Raw results are included in digital format as [Attachment 2](#) and summarized in Table [5.24](#).

Figure 5.26: Bull trout captured downstream of PSCIS crossing 197555.
