# Elk River Watershed Group Fish Passage Restoration Planning

2020-12-16

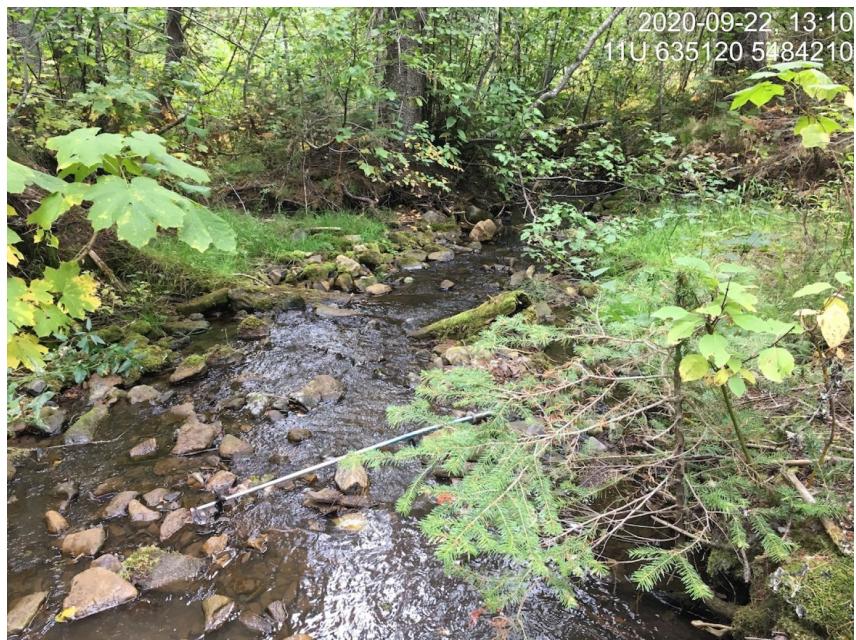
Figure 5.2: Typical habitat downstream of PSCIS crossing 50155.

Structure replacement with an open bottomed culvert is recommended to provide unconstrained access to the habitat located upstream of PSCIS crossing 50155. The cost for work is estimated at \$125000 for a cost benefit of \$8700/linear m and \$9700/m<sup>2</sup>.

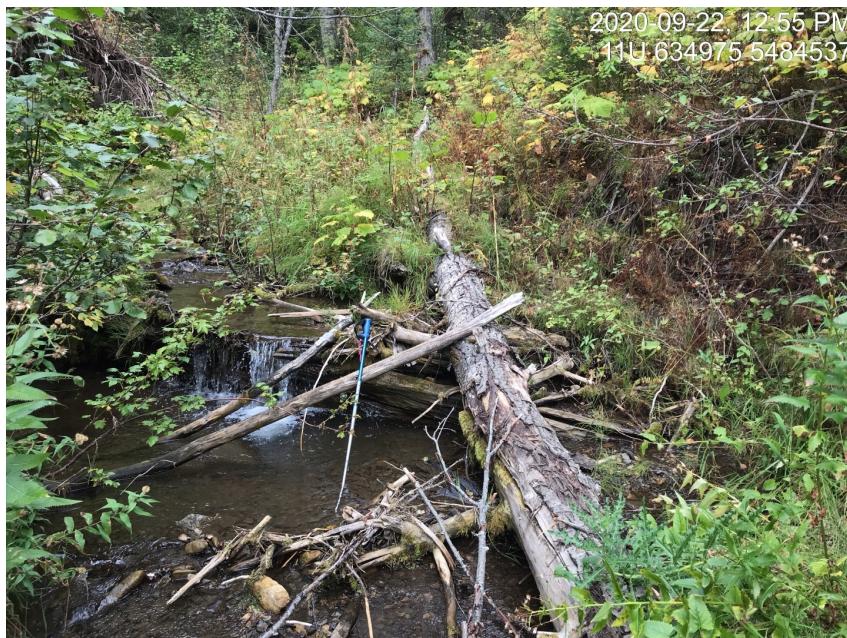
Figure 5.3: Typical habitat upstream of PSCIS crossing 50155.

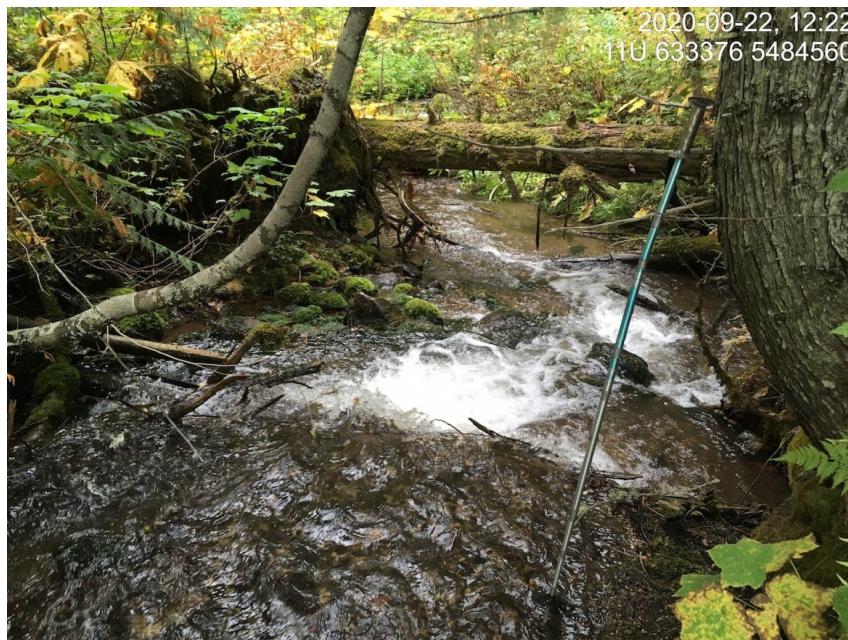
Figure 5.4: Typical habitat downstream of PSCIS crossing 50159.

Structure replacement with a bridge is recommended to provide access to the habitat located upstream of PSCIS crossing 50159. The cost for the work is estimated at \$125000 for a cost benefit of \$0/linear m and \$0/m<sup>2</sup>.

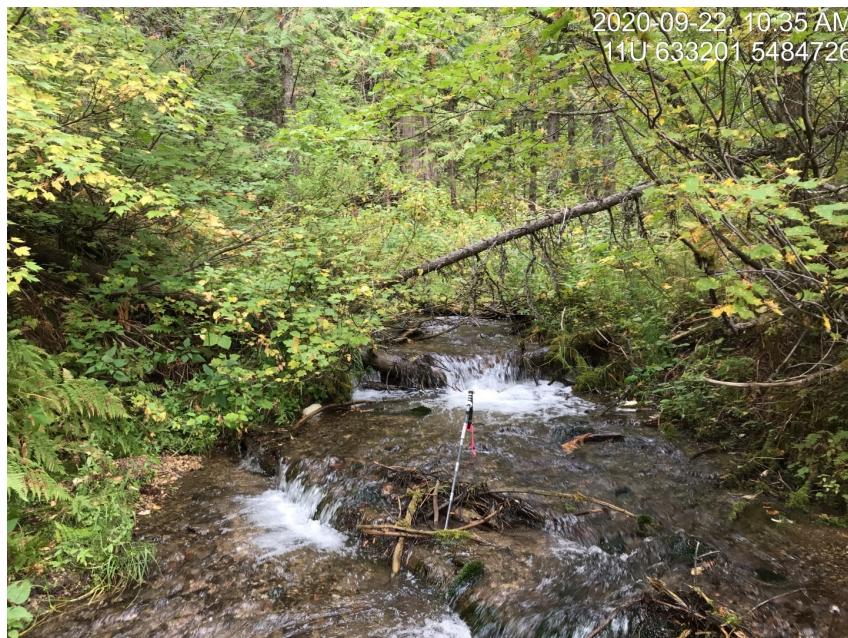
Figure 5.5: Typical habitat upstream of PSCIS crossing 50159.

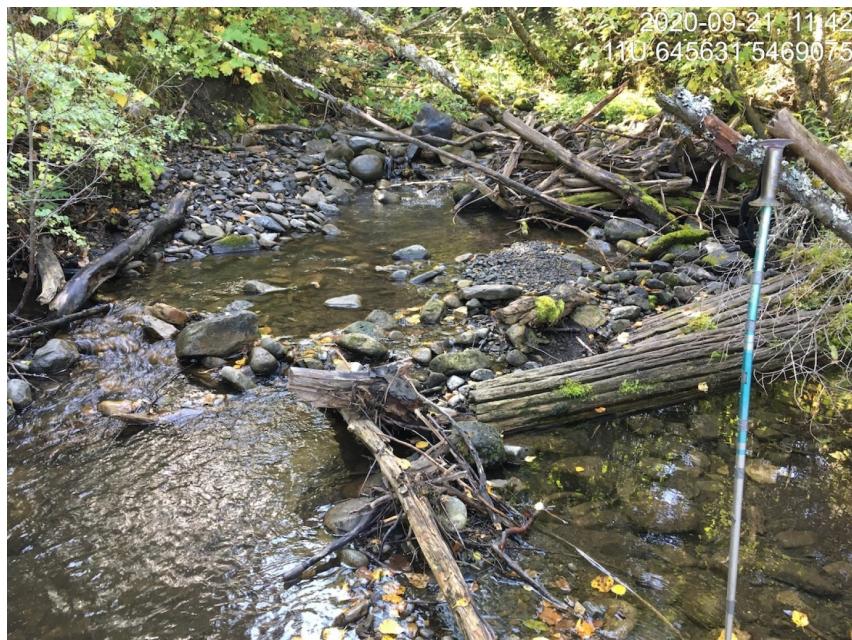
The stream was surveyed downstream from the culvert for 255m to the confluence with Morrissey Creek. The mouth of the stream is located approximately 500m upstream from the confluence of Morrissey Creek and the Elk River. Overall, total cover amount was rated as moderate with small woody debris dominant. Cover was also present as large woody debris, undercut banks, deep pools, and overhanging vegetation (Table 5.8, Figure 5.7). The average channel width was 4.3m, the average wetted width was 2.7m and the average gradient was 4.2%. The dominant substrate was cobbles with gravels subdominant. There were frequent pools formed by small and large woody debris ranging from 0.3 - 0.75m in depth (average residual depth = 0.4m). Pockets of small gravels suitable for resident salmonid spawning were also present. Habitat value was rated as high with good potential for fry/juvenile salmonid rearing.

Figure 5.7: Typical habitat downstream of PSCIS crossing 50185.

Structure replacement with an open bottomed culvert is recommended to provide unconstrained access to the habitat located upstream of PSCIS crossing 50185. The cost for work is estimated at \$125000 for a cost benefit of \$14400/linear m and \$30900/m<sup>2</sup>.

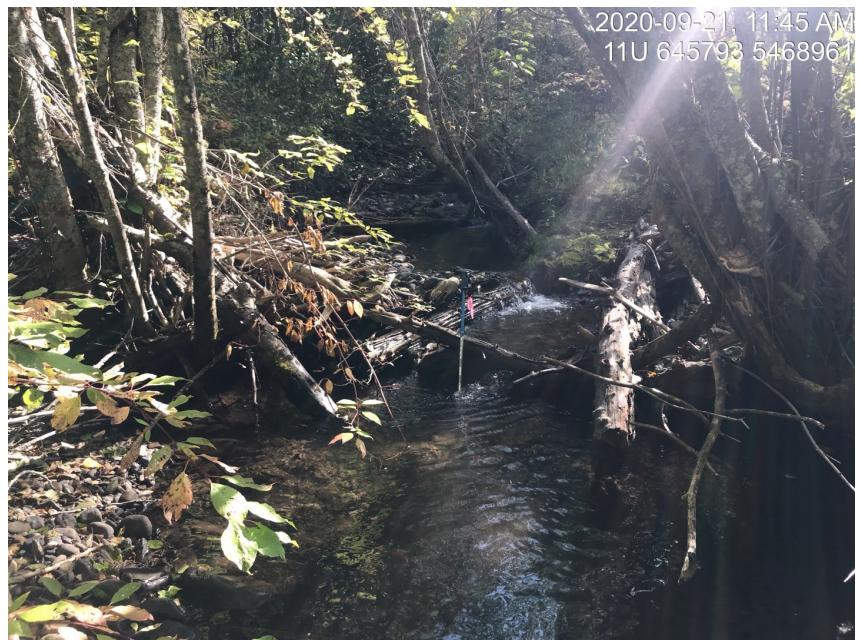
The stream was surveyed upstream from the culvert for 740m. Overall, total cover amount was rated as moderate with small woody debris dominant. Cover was also present as large woody debris, undercut banks, deep pools, and overhanging vegetation (Table 5.8, Figure 5.8). The average channel width was 4m, the average wetted width was 2.8m and the average gradient was 6.2%. The dominant substrate was cobbles with gravels subdominant. The stream had good flows with fry observed throughout the area surveyed. Pools to 0.6m deep (average residual depth = 0.4m) were present with pockets of gravel suitable for spawning throughout. Infrequent large woody debris jams to 0.5m high were also observed. There were frequent areas of gravels suitable for resident westslope cutthroat trout spawning. Habitat value was rated as high for fry and juvenile westslope cutthroat trout rearing.

Figure 5.8: Typical habitat upstream of PSCIS crossing 50185.

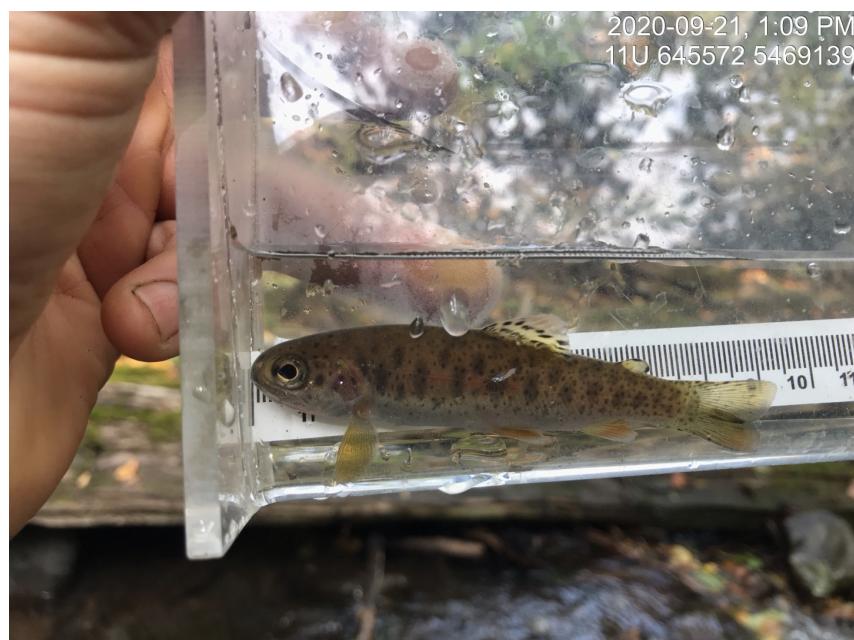
Figure 5.9: Westslope cutthroat trout captured upstream of PSCIS crossing 50185.

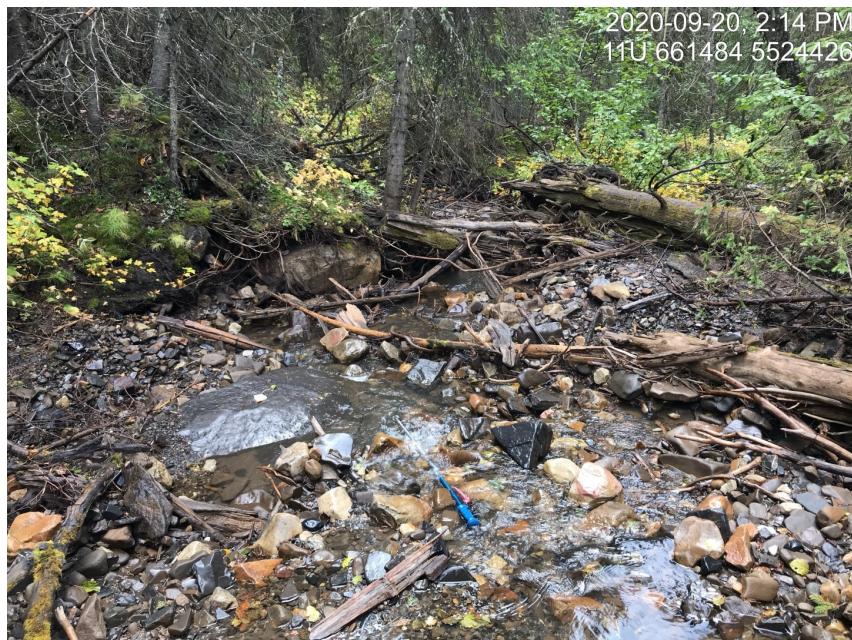
Figure 5.10: Typical habitat downstream of PSCIS crossing 62425.

Structure replacement with a bridge is recommended to provide access to the habitat located upstream of PSCIS crossing 62425. The cost for the work is estimated at \$125000 for a cost benefit of \$13500/linear m and \$24900/m<sup>2</sup>.

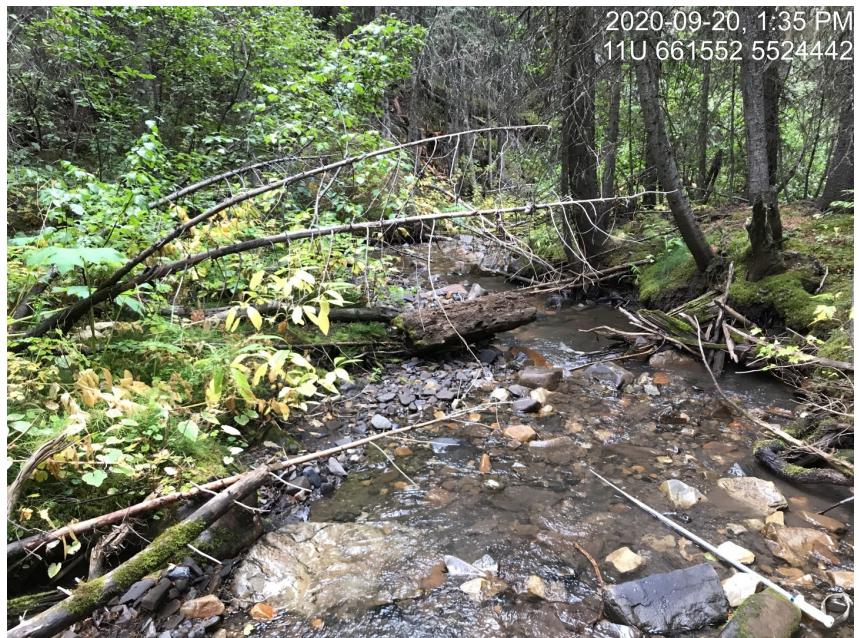
The stream was surveyed upstream from the culvert for 170m. Overall, total cover amount was rated as moderate with deep pools dominant. Cover was also present as large woody debris and boulders (Table 5.14, Figure 5.11). The average channel width was 3.5m, the average wetted width was 2.1m and the average gradient was 5%. There were abundant gravels suitable for resident westslope cutthroat trout spawning throughout (Figure 5.12). Fry were observed within the area surveyed to 540m upstream of the culvert where gradients increased to >20% for a distance of approximately 15m. Although no sampling was conducted, no fish were observed above this high gradient section. Habitat value was rated as NA for fry/juvenile salmonid rearing.

Figure 5.11: Typical habitat upstream of PSCIS crossing 62425 and downstream of PSCIS crossing 62426.

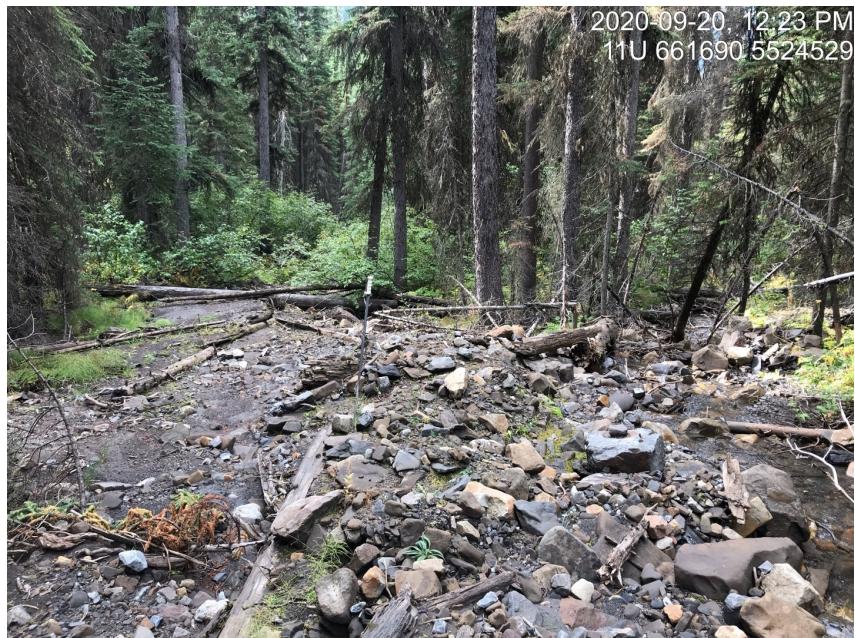
Figure 5.12: Grave Creek redirection out of historic channel located upstream of PSCIS crossing 62426.

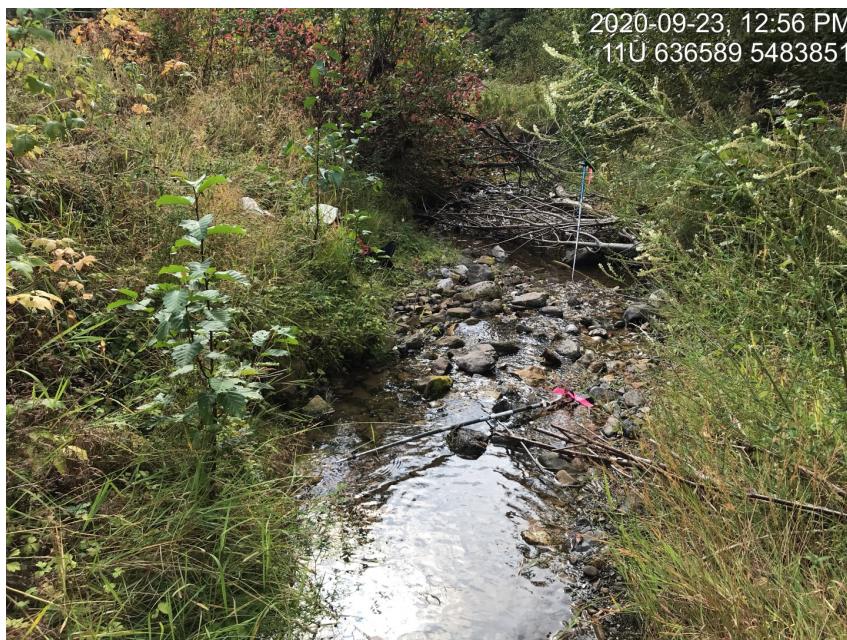
Figure 5.13: Typical habitat downstream of PSCIS crossing 62516.

Structure replacement with a bridge is recommended to provide access to the habitat located upstream of PSCIS crossing 62516. The cost for the work is estimated at \$125000 for a cost benefit of \$5000/linear m and \$6100/m<sup>2</sup>.

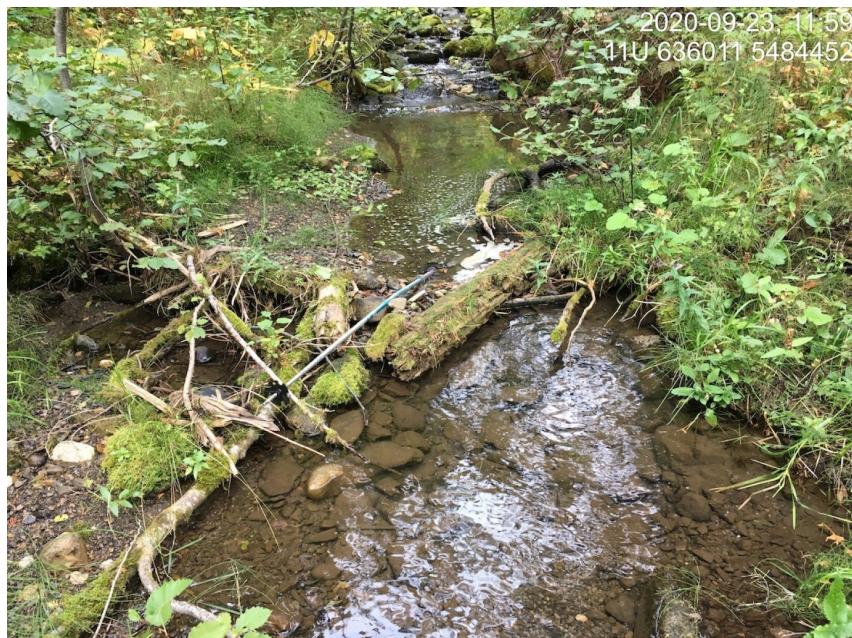
The stream was surveyed upstream from the culvert for 730m. Overall, total cover amount was rated as moderate with undercut banks dominant. Cover was also present as small woody debris, large woody debris, deep pools, and overhanging vegetation (Table 5.16, Figure 5.13). The average channel width was 2m, the average wetted width was 1.3m and the average gradient was 7.6%. There were abundant gravels suitable for resident westslope cutthroat trout spawning throughout (Figure 5.13). Fry were observed within the area surveyed to 540m upstream of the culvert where gradients increased to >20% for a distance of approximately 15m. Although no sampling was conducted, no fish

were observed above this high gradient section. Habitat value was rated as high for fry/juvenile salmonid rearing.

Figure 5.14: Typical habitat upstream of PSCIS crossing 62516.

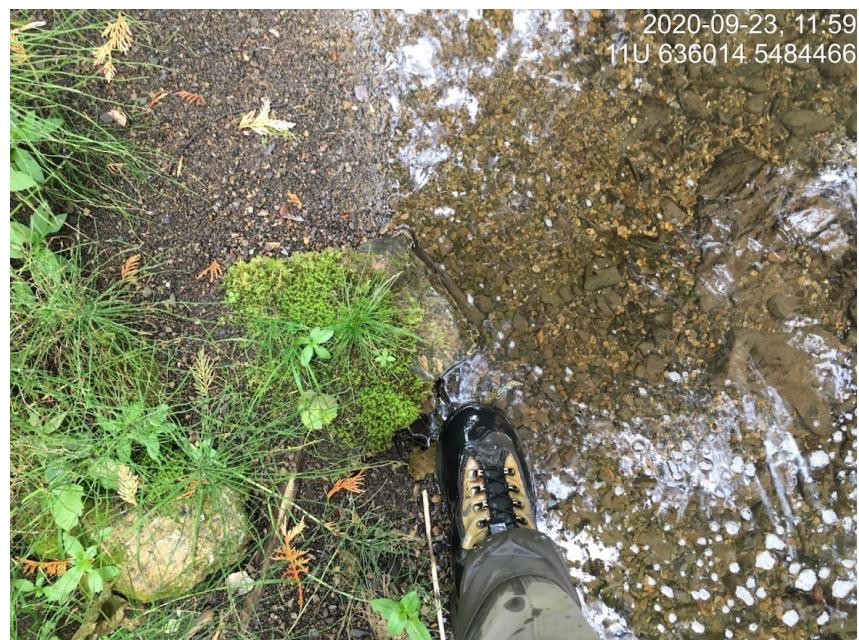
Figure 5.15: Gravels suitable for spawning upstream of PSCIS crossing 62516.

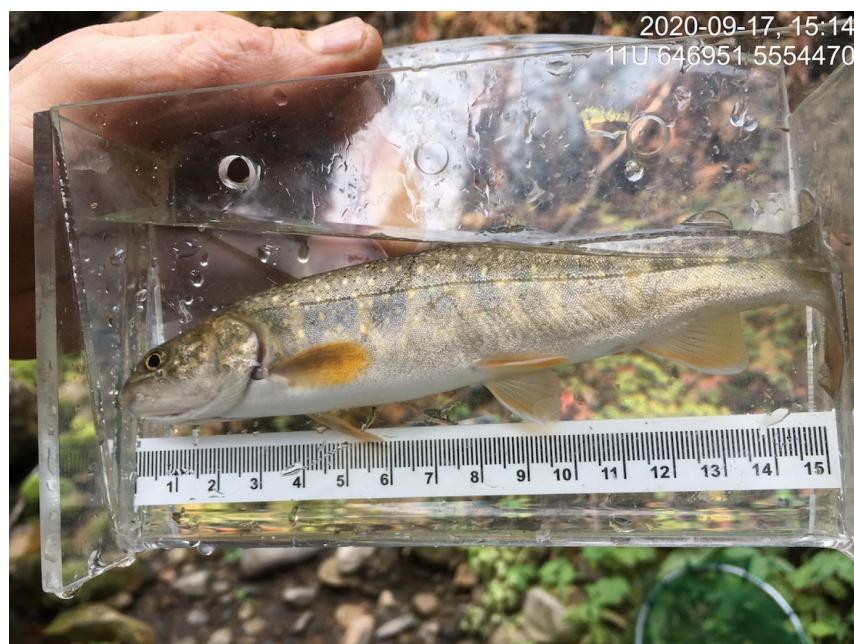
150m site was sampled upstream and one 315m site was sampled downstream. One bull trout was captured downstream and no fish were captured upstream (Figure 5.18). Raw results are included in digital format as Attachment 2 and summarized in Table 5.19.

Figure 5.18: Bull trout captured downstream of PSCIS crossing 197555.
