Bulkley River and Morice River Watershed Groups Fish Passage Restoration Planning

Prepared for
Habitat Conservation Trust Foundation - CAT21-6-288
BC Fish Passage Remediation Program
Canadian Wildlife Federation

Prepared by
Al Irvine, B.Sc., R.P.Bio.
New Graph Environment
on behalf of
Society for Ecosystem Restoration Northern BC

Version 0.1.1
2021-04-15

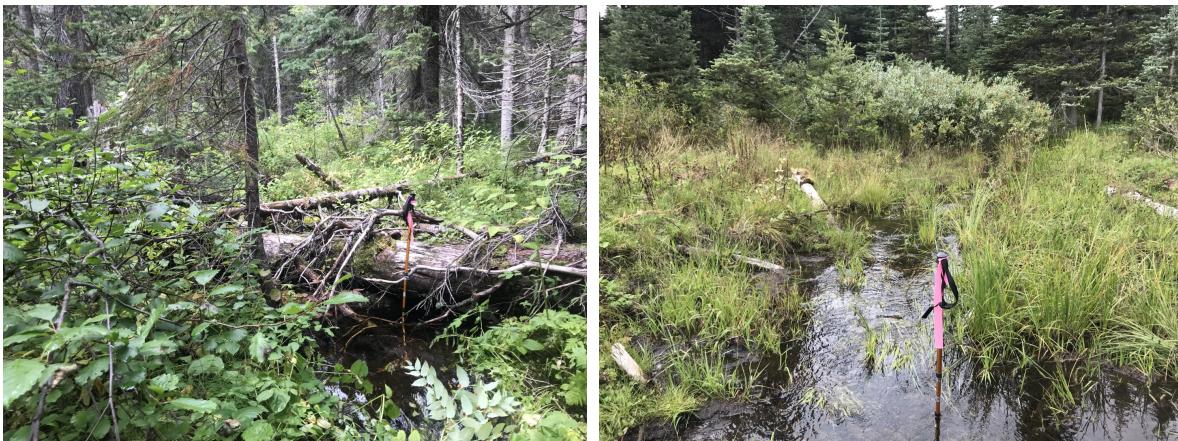
Figure 5.12: Left: Habitat upstream of PSCIS crossing 123795. Right: Cascade upstream of PSCIS crossing 123795.

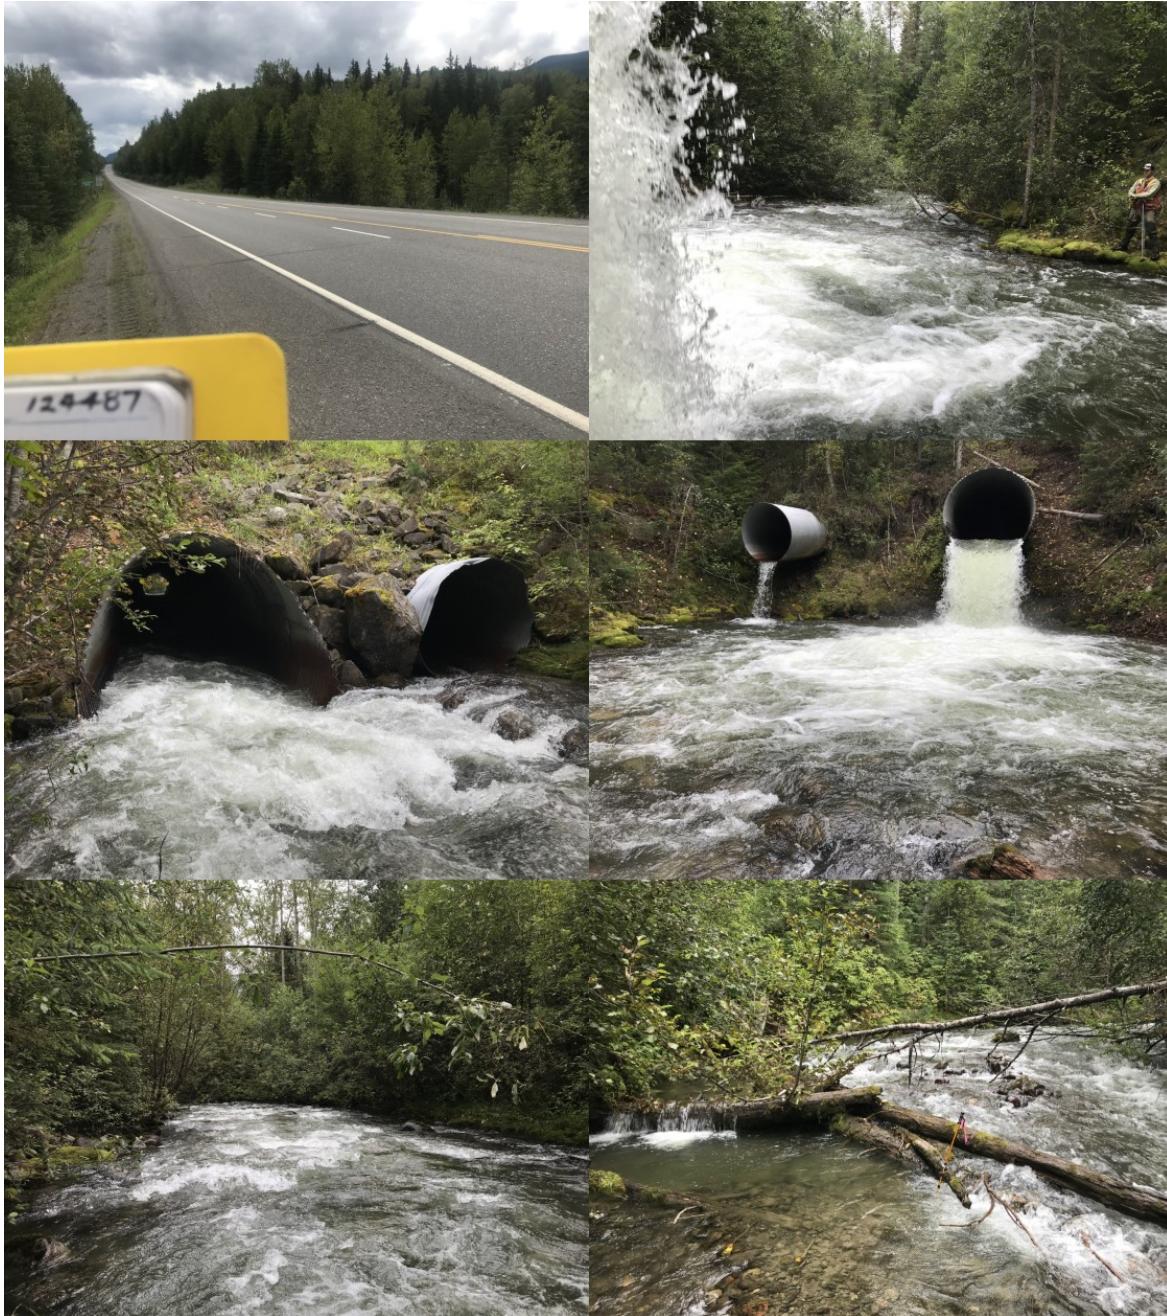
Table 5.22: Summary of habitat details for PSCIS crossing 124487.

Comments: Unpassable to all life stages and species. Fill depth is approximately 35m. Salomid (50cm) observed trying to ascend to outlet of main pipe.

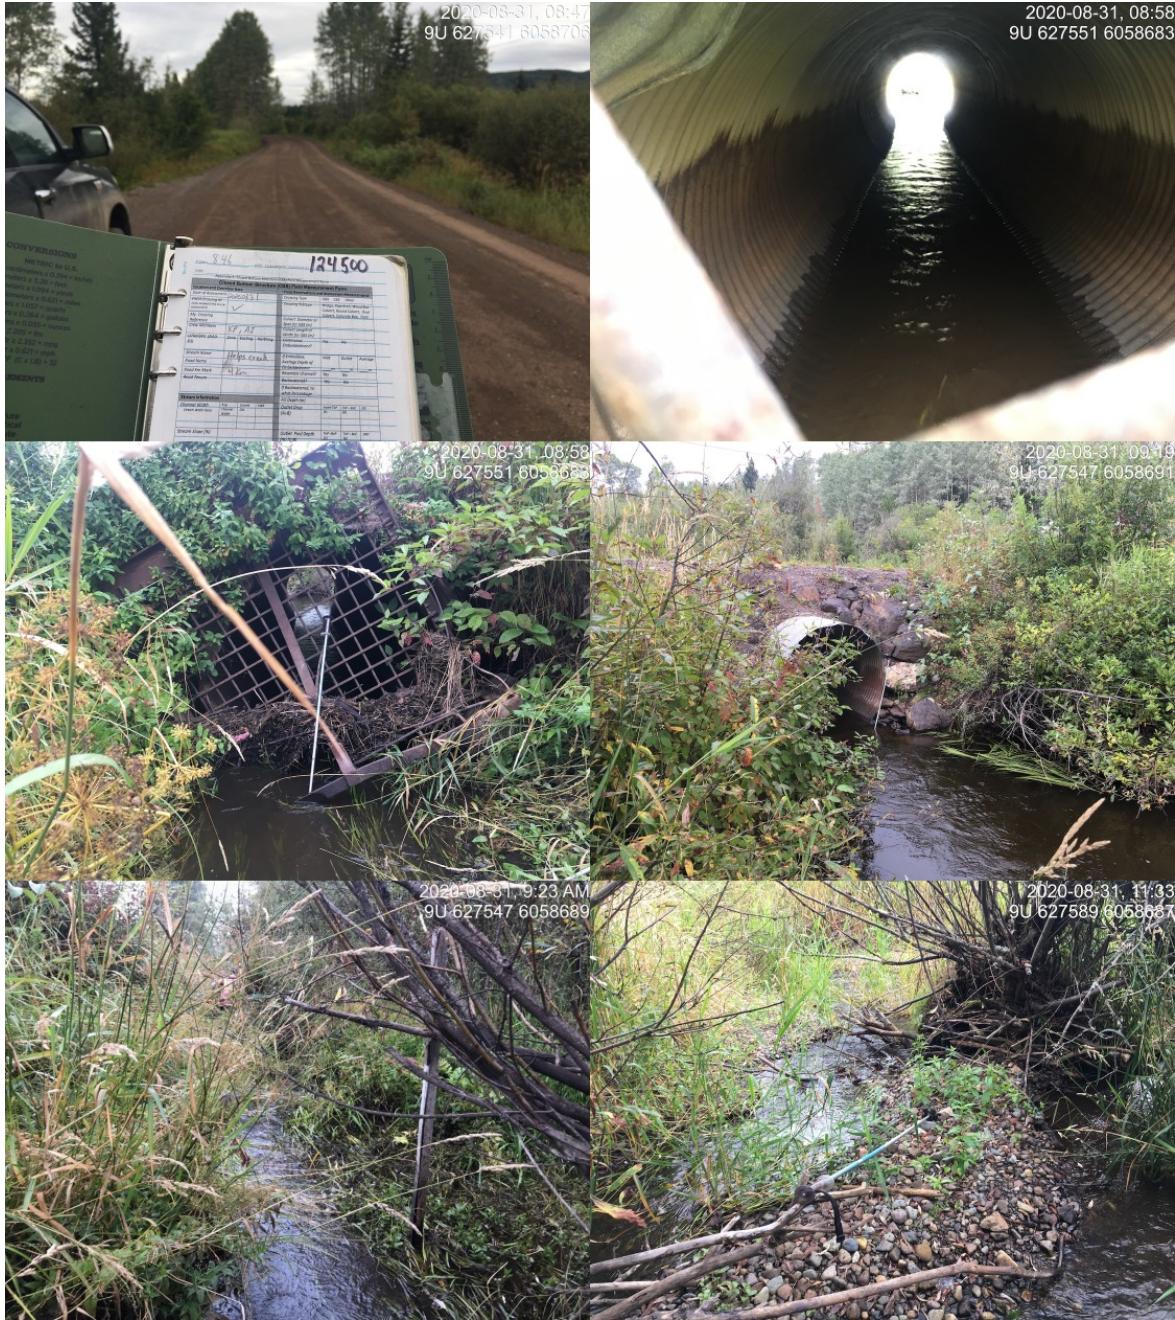
Comments: Wetland type habitat upstream with stream channel containing abundant gravels downstream.

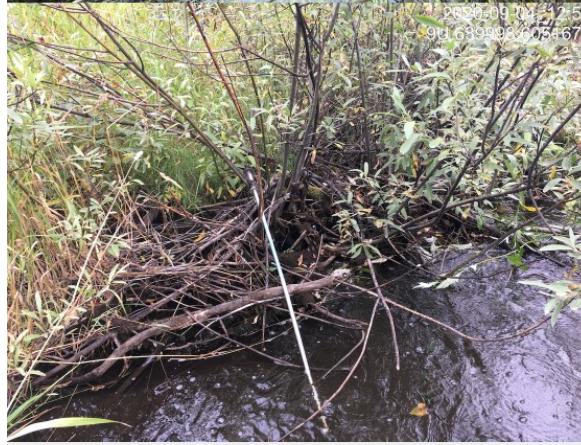
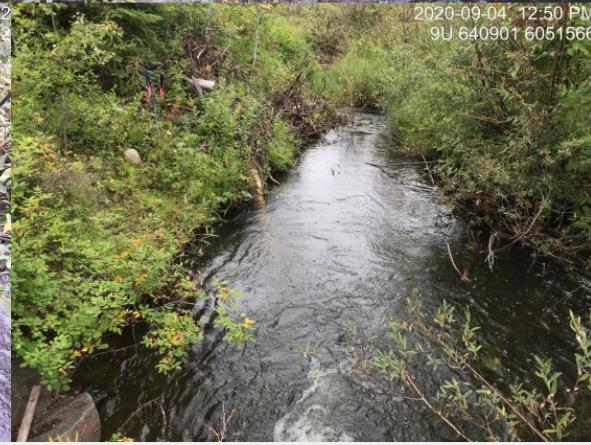
Table 5.29: Summary of fish passage assessment for PSCIS crossing 195288.

Comments: Flows into Deep Creek downstream. Electrofished upstream and downstream. Wetland type habitat upstream with CO captured below only. Candidate for backwatering?

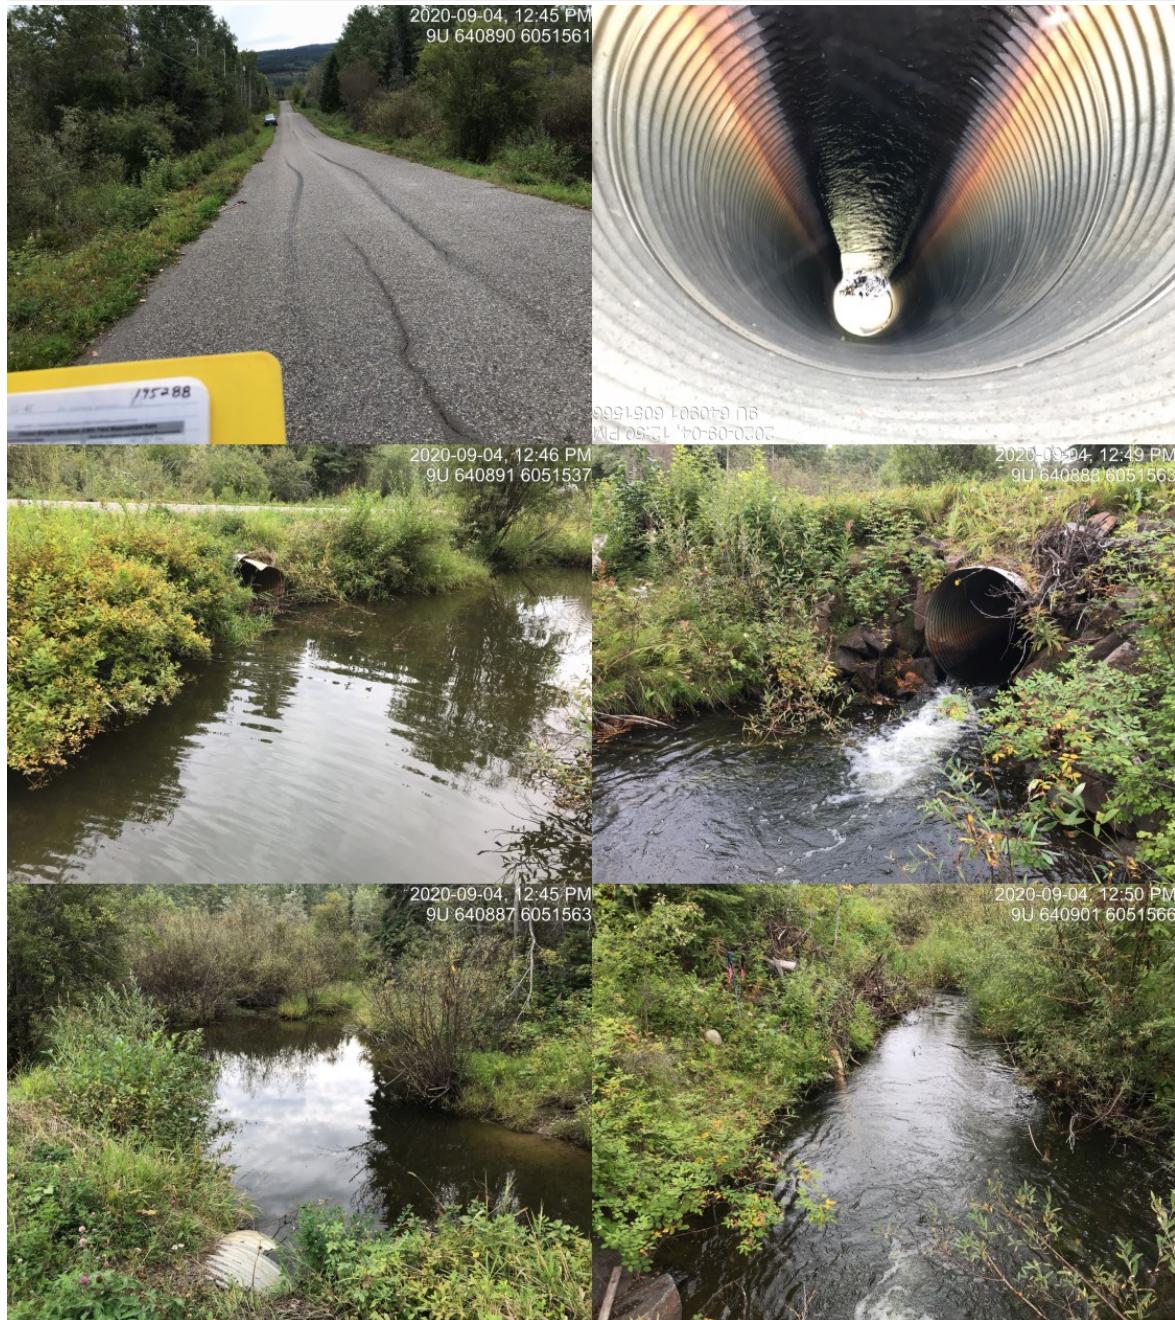
Comments: Wetland type habitat upstream and downstream. Drone flight conducted upstream to map immediate area upstream.

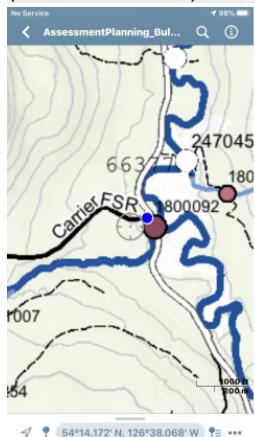
Comments: Large tributary on section of tributary connected to salmon bearing Buck Creek. Fish rising in outlet pool (estimated 130mm). Some cattle access points downstream.

Replacement of PSCIS crossing 197640 with a bridge (10m span) is recommended. The cost of the work is estimated at \$NA for a cost benefit of NA linear m/\$1000 and NAm²/\$1000.

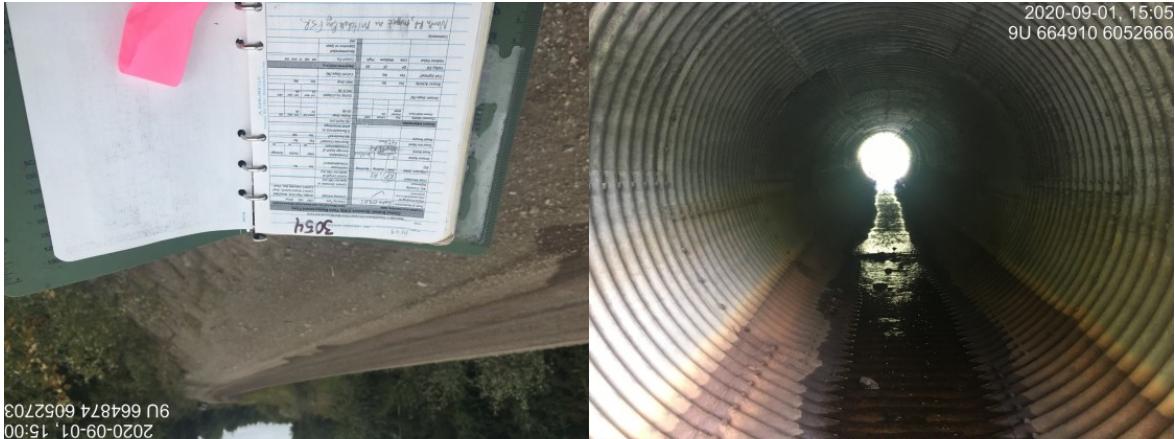
Comments: Fill depth approximatley 12m. Fish observed upstream of crossing.

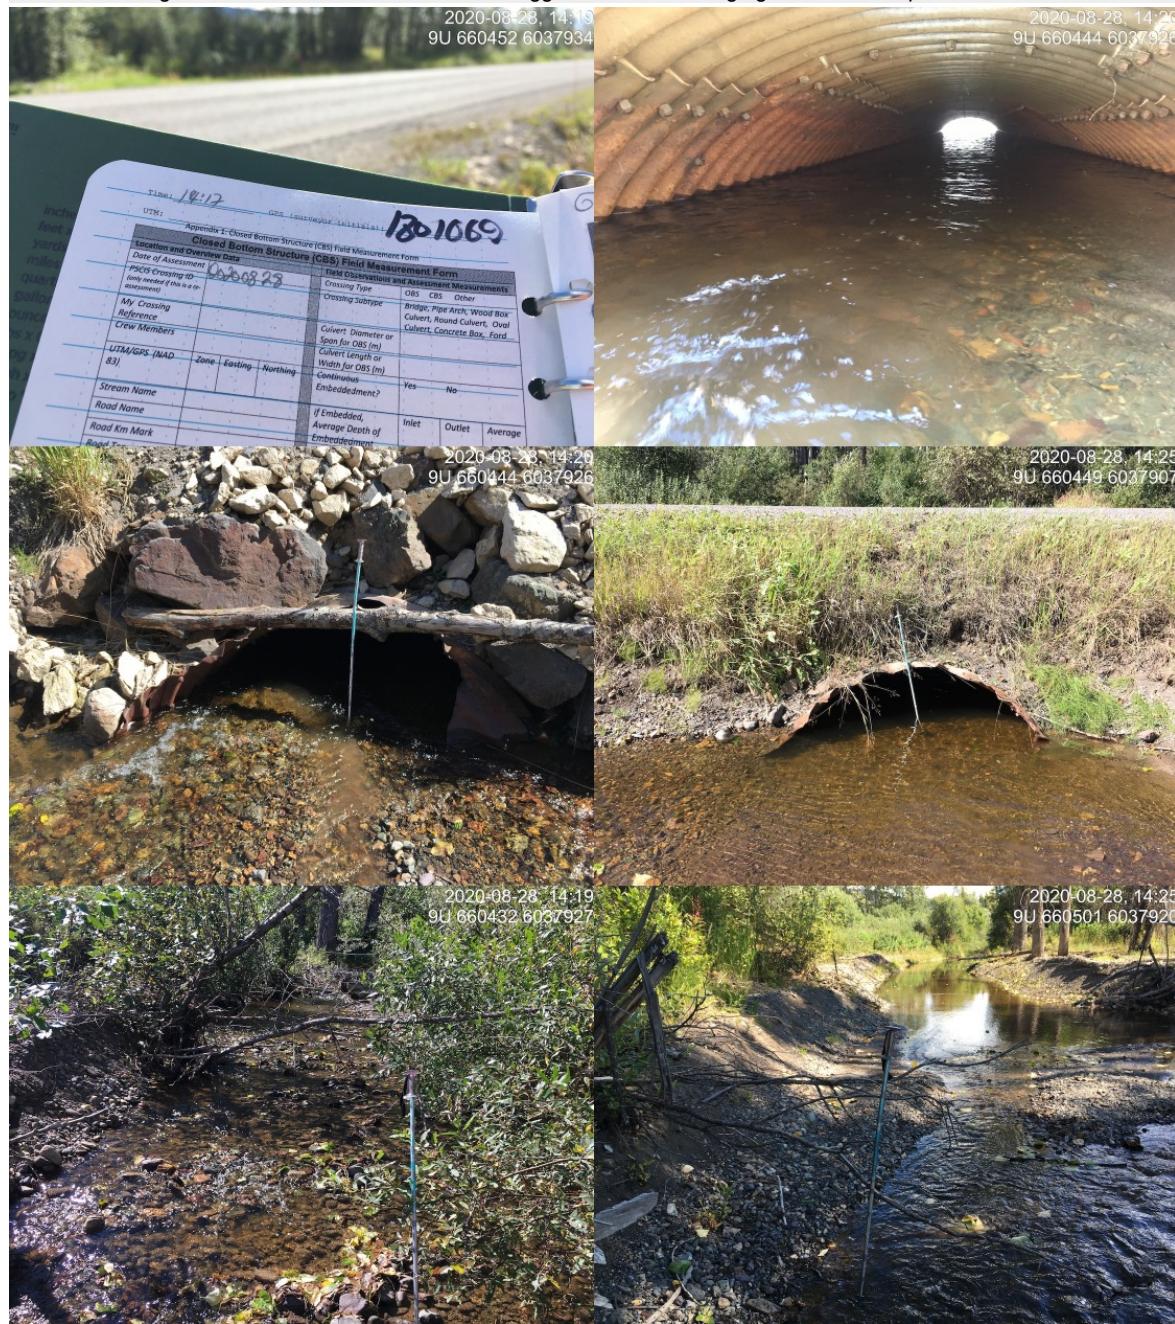
Table 5.64: Summary of fish passage assessment for PSCIS crossing 3042.

Comments: Targeted for habitat confirmation due to aggradation and dredging associated impacts on coho.

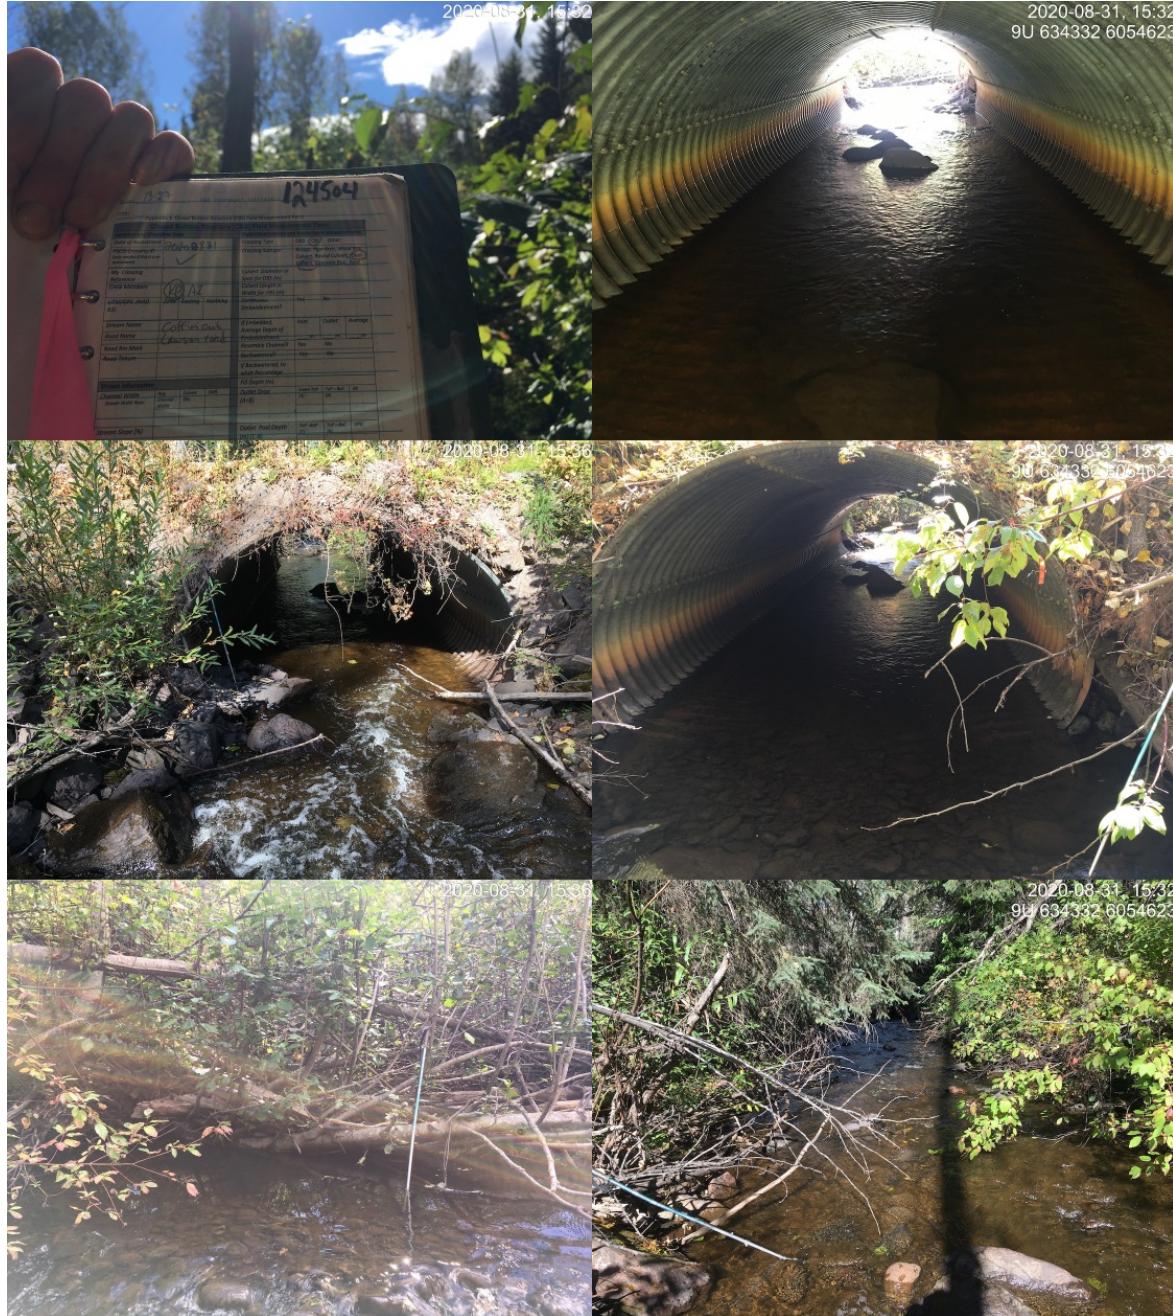
Table 5.75: Summary of habitat details for PSCIS crossings 197668 and 124504.

Date	2020-08-31	Crossing Sub Type	Round Culvert
PSCIS ID	124504	Diameter (m)	3
External ID	–	Length (m)	16
Crew	KP, AI	Embedded	Yes
UTM Zone	9	Depth Embedded (m)	0.15
Easting	634323	Resemble Channel	Yes
Northing	6054587	Backwatered	No
Stream	Coffin Creek	Percent Backwatered	–
Road	Lawson Road	Fill Depth (m)	0.5
Road Tenure	MoTi resource	Outlet Drop (m)	0.2
Channel Width (m)	5.3	Outlet Pool Depth (m)	0.1
Stream Slope (%)	2	Inlet Drop	No
Beaver Activity	No	Slope (%)	1
Habitat Value	High	Valley Fill	Deep Fill
Final score	24	Barrier Result	Barrier
Fix type	Replace with New Open Bottom Structure	Fix Span / Diameter	10
Photos: From top left clockwise: Road/Site Card, Barrel, Outlet, Downstream, Upstream, Inlet.

Comments: Partially embedded with several large boulders (30 - 50cm) in culvert. No outlet drop at the time of survey but there may be at lowest flow levels.

Replacement with bridges for 197668 (10m span) and 124504 (10m span) are recommended to provide unimpeded access to the habitat located upstream. An estimate of cost for replacement of 197668 is \$5,000,000 resulting in cost benefits of 0.8 linear m/\$1000 and $4.2\text{m}^2/\$1000$. An estimate of cost for replacement of 124504 is \$500,000 resulting in cost benefits of 8 linear m/\$1000 and $46.4\text{m}^2/\$1000$.

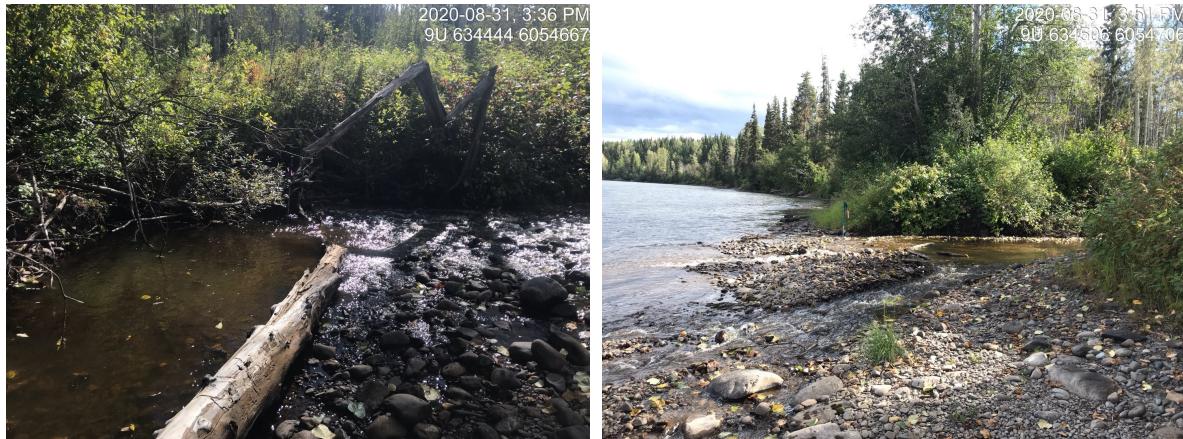
Figure 5.43: Left: Typical habitat downstream of PSCIS crossing 197668. Right: Coffin Creek downstream of PSCIS crossing 197668 at confluence with the Bulkley River.
