Bulkley River and Morice River Watershed Groups Fish Passage Restoration Planning

Prepared for
Habitat Conservation Trust Foundation - CAT21-6-288
BC Fish Passage Remediation Program
Canadian Wildlife Federation

Prepared by
Al Irvine, B.Sc., R.P.Bio.
New Graph Environment
on behalf of
Society for Ecosystem Restoration Northern BC

Version 0.1.0
2021-04-14

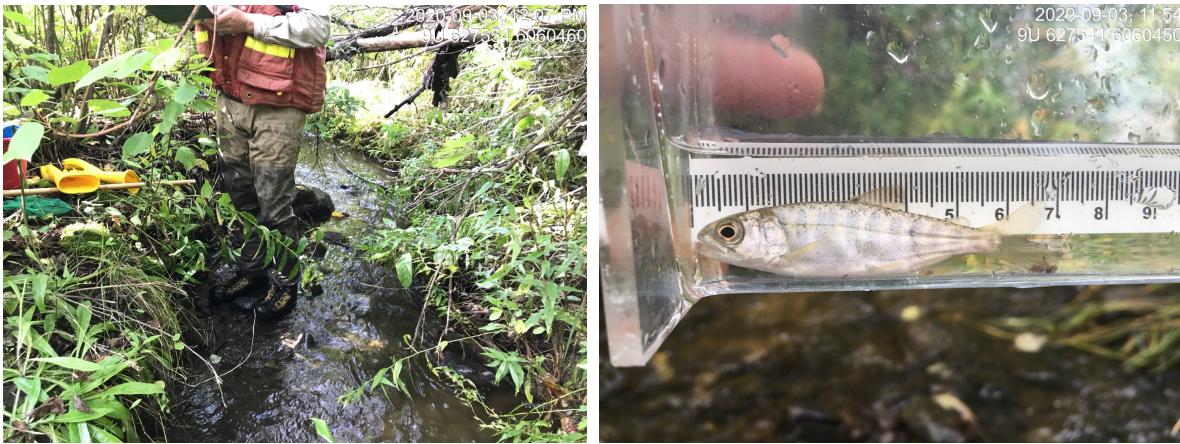
Figure 5.4: Left: Typical habitat downstream of PSCIS crossing 58159. Right: Chinook captured downstream of PSCIS crossing 58159.

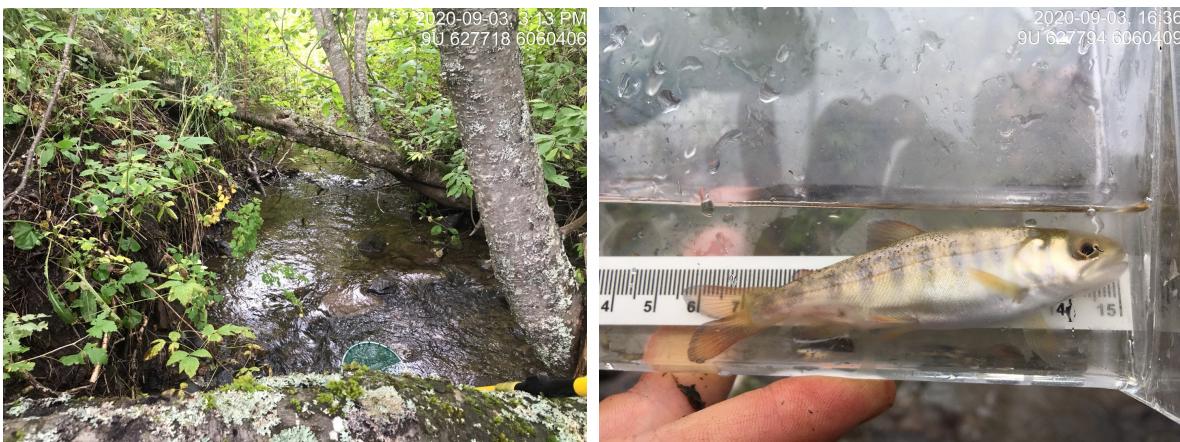
The stream was surveyed upstream from 58159 for 440m (Figure 5.5). Within the area surveyed, total cover amount was rated as abundant with large woody debris dominant. Cover was also present as small woody debris, undercut banks, overhanging vegetation, and instream vegetation (Table 5.5). The average channel width was 2.2m, the average wetted width was 1.8m and the average gradient was 2%. Habitat value was rated as moderate for salmonid rearing and spawning.

Figure 5.5: Left: Typical habitat upstream of PSCIS crossing 58159. Right: Coho captured upstream of PSCIS crossing 58159.

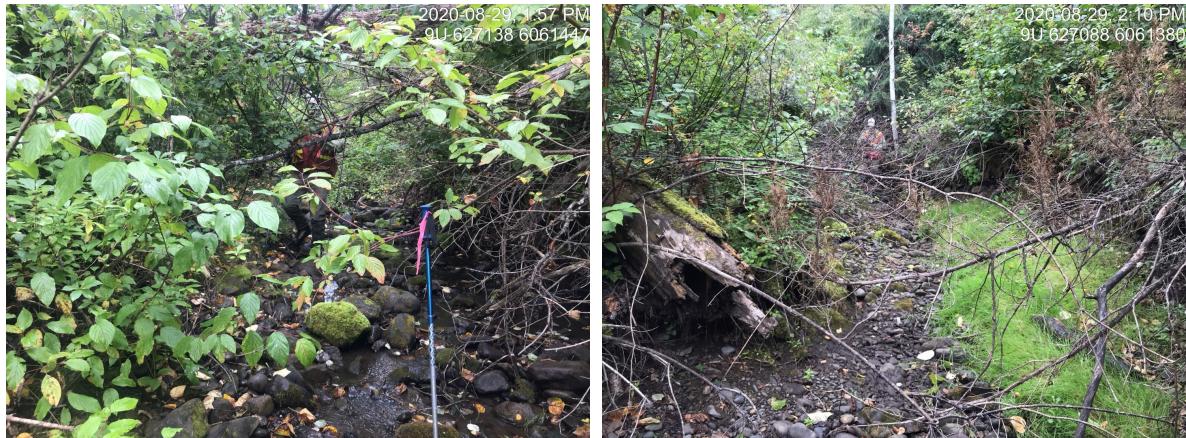
Figure 5.6: Left: Typical habitat downstream of PSCIS crossing 123445. Right: Typical habitat downstream of PSCIS crossing 123445.

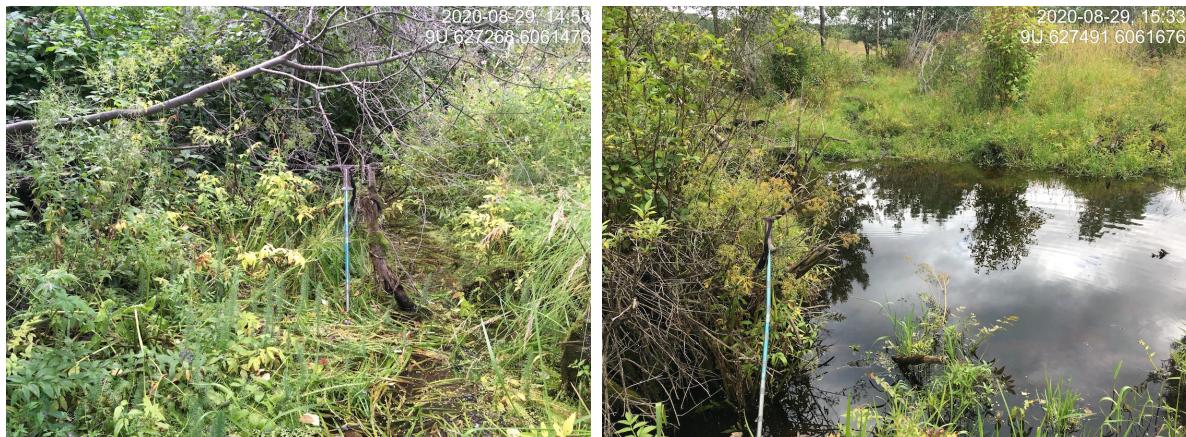
Figure 5.7: Left: Habitat upstream of PSCIS crossing 123445. Right: Habitat upstream of PSCIS crossing 123445.

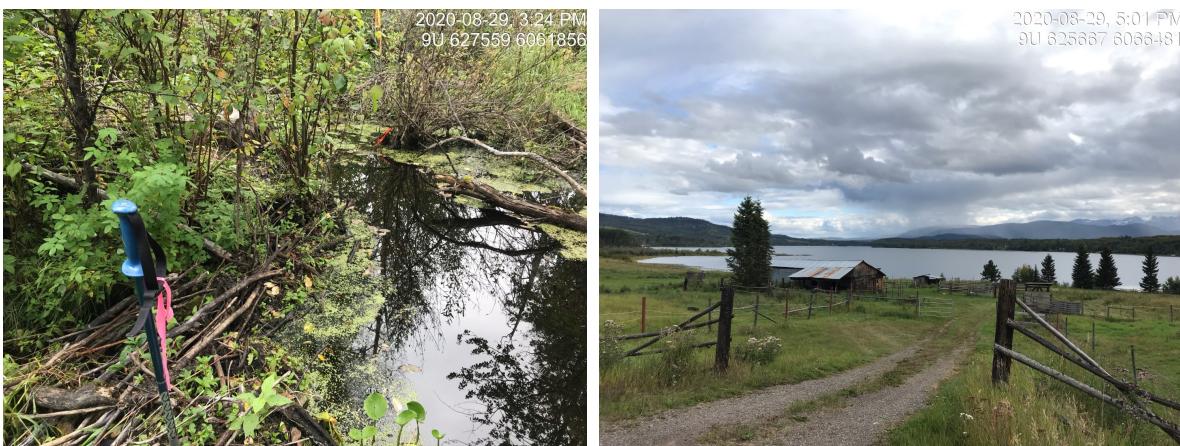
(Figure 5.8). Within the area surveyed, total cover amount was rated as abundant with overhanging vegetation dominant. Cover was also present as small woody debris, large woody debris, deep pools, and instream vegetation (Table 5.12). The average channel width was 8.5m, the average wetted width was 7.5m and the average gradient was 0.2%. Beaver activity was prevalent in the area surveyed and there was a large agricultural field located on the right bank of the stream. Habitat value was rated as moderate as it was considered an important migration corridor providing access to the lake.

Figure 5.8: Left: Habitat upstream of PSCIS crossing 123446. Right: Habitat upstream of PSCIS crossing 123446.

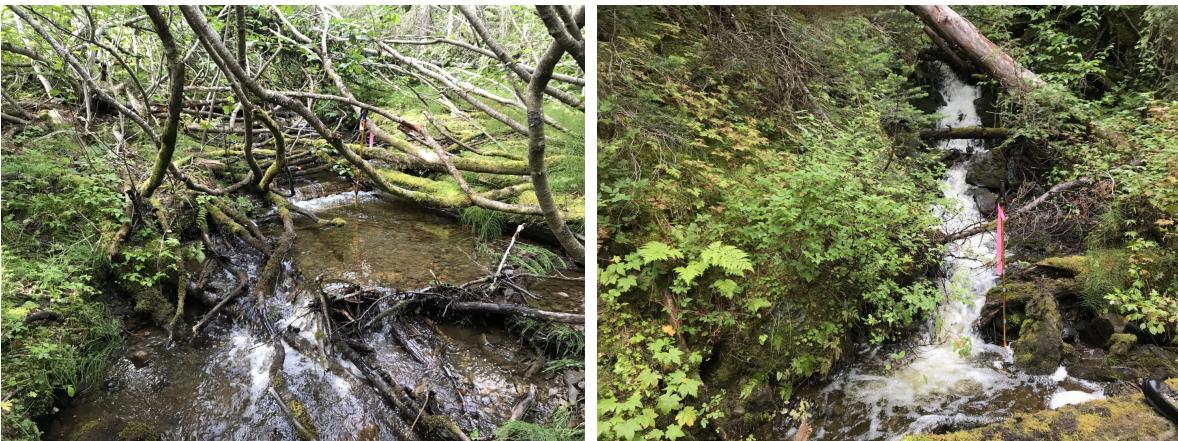
| PSCIS ID | Stream | Road | UTM (9U) | Fish Species | Habitat Gain (km) | Habitat Value | Priority | Comments |
|---|---|---|---|---|---|---|---|---|
| 123794 | Tributary to Blunt Creek | Blunt Creek FSR | 616100 6106763 | (RB) | 0.5 | Medium | moderate | Channel was noted as having good complexity with abundant gravels suitably sized for both coho and resident salmonid spawning. 4m high falls at top end of the site. |

Figure 5.10: Left: Habitat upstream of PSCIS crossing 123794. Right: Cascade upstream of PSCIS crossing 123794.

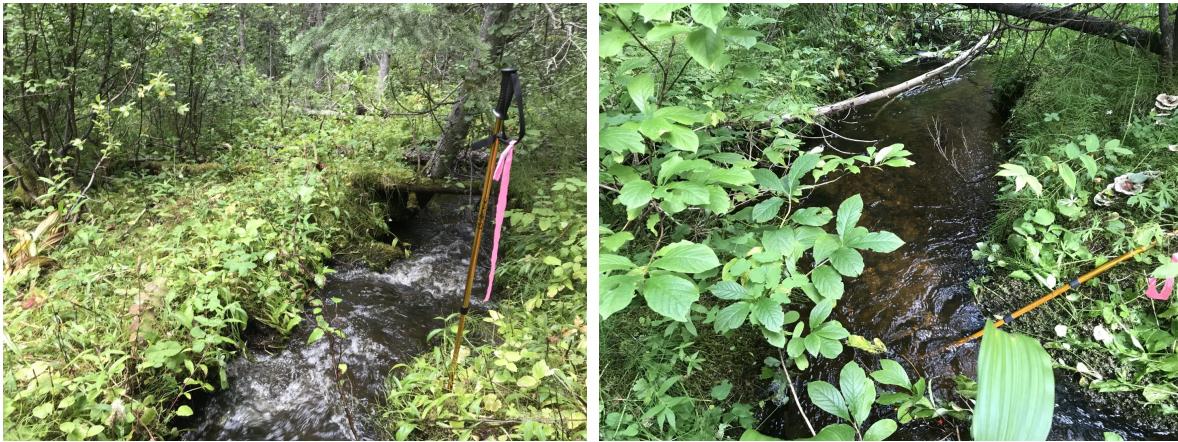
Figure 5.11: Left: Habitat downstream of PSCIS crossing 123795. Right: Habitat downstream of crossing 123795.

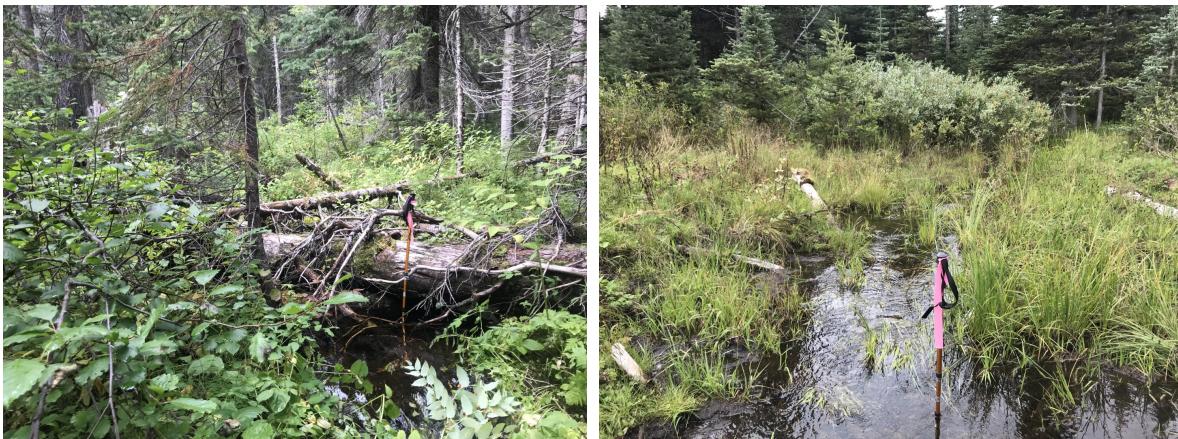
Figure 5.12: Left: Habitat upstream of PSCIS crossing 123795. Right: Cascade upstream of PSCIS crossing 123795.

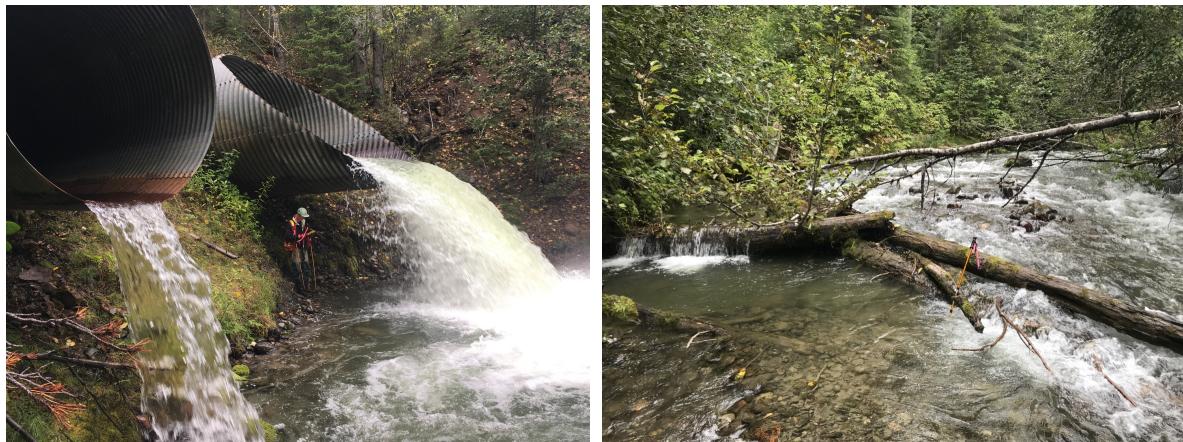
Figure 5.13: Left: Outlets of PSCIS crossing 124487. Right: Typical habitat downstream of crossing 124487 below the railway bridge and adjacent to the Bulkley River mainstem.

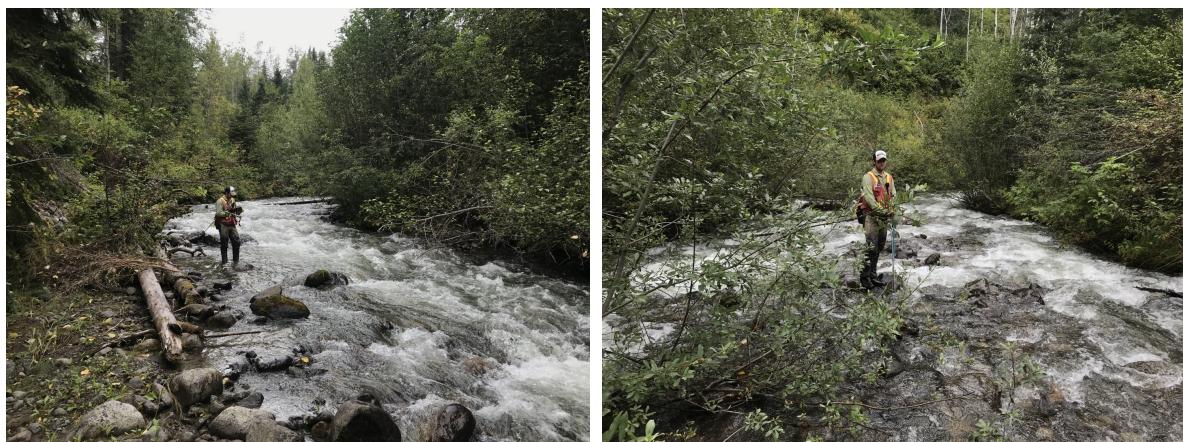
Figure 5.14: Left: habitat upstream of PSCIS crossing 124487. Right: Habitat upstream of PSCIS crossing 124487.

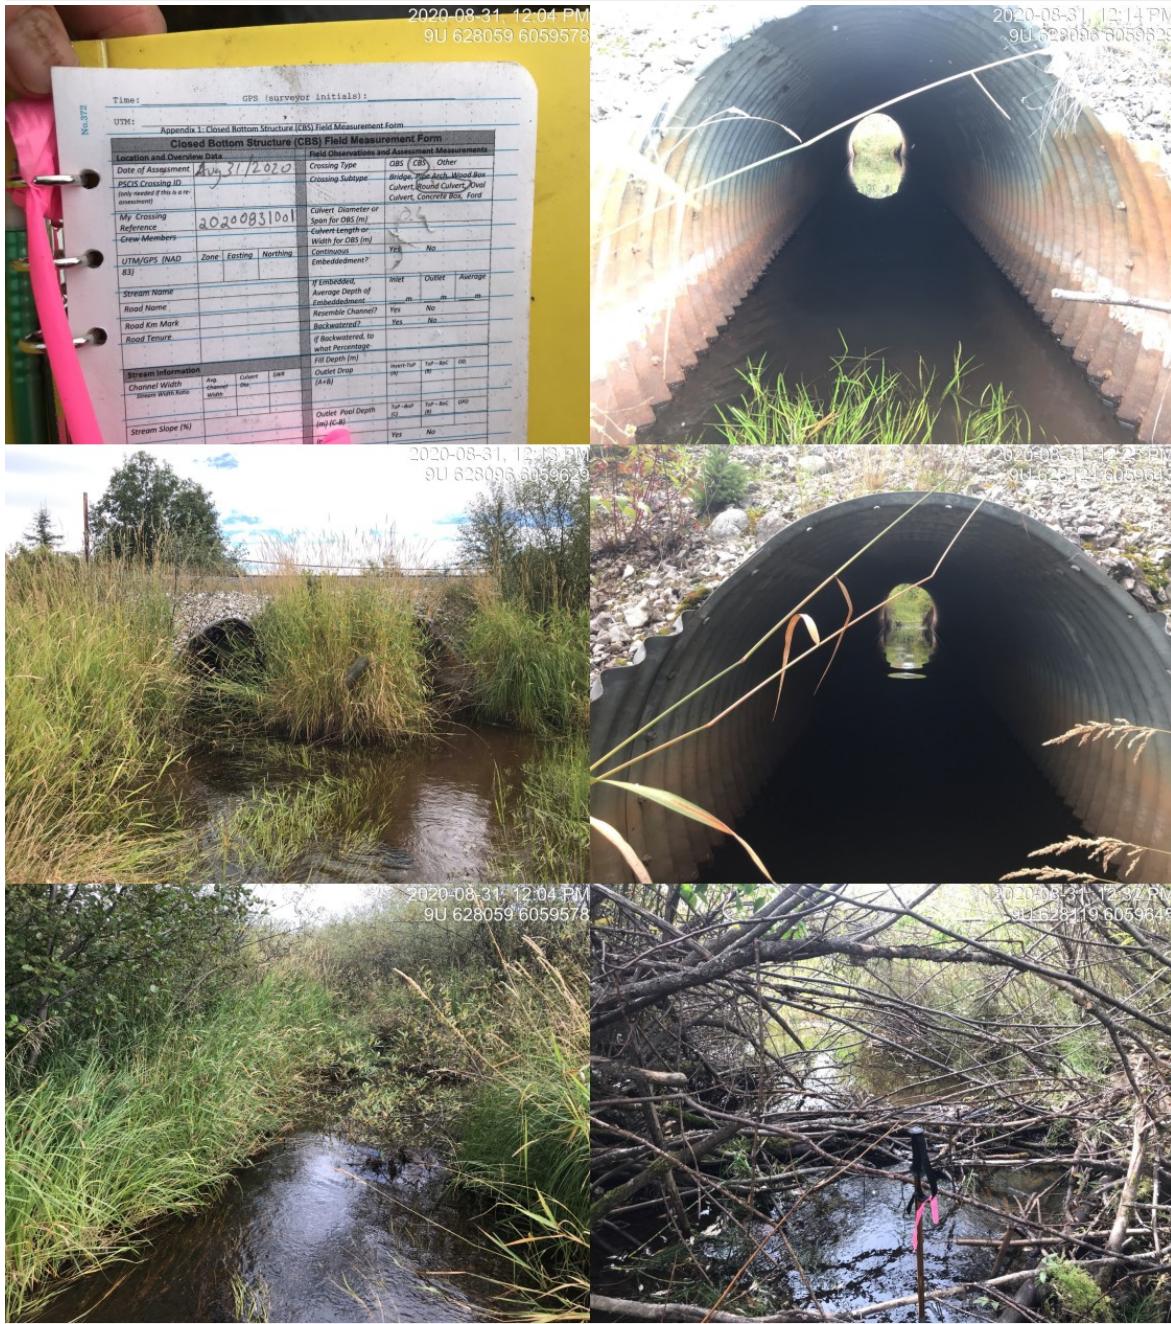
Comments: Passable and fully backwatered structure. Landowner reports that lamprey (~40cm x 20) at crossing inside of the culvert in the past.

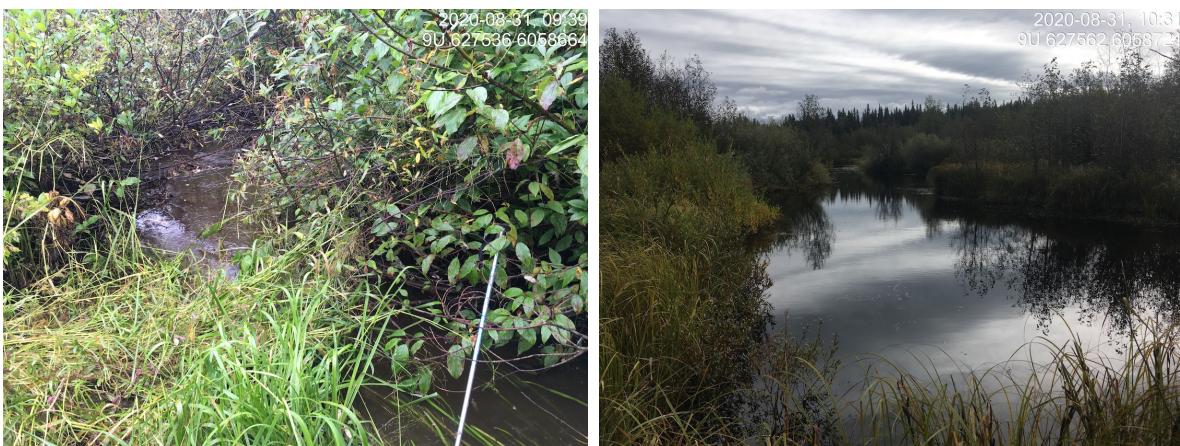
The stream was surveyed immediately upstream from 124500 for approximately 200m then an adjacent road was walked to access the stream 1100m upstream of the crossing within an area comprised of swamp ([Figure 5.16](#)). Within the area immediately upstream of Lawson Road, the stream had multiple braided channels flowing within beaver influenced wetland areas. Within the area surveyed, total cover amount was rated as moderate with small woody debris dominant. Cover was also present as large woody debris, undercut banks, deep pools, overhanging vegetation, and instream vegetation ([Table 5.26](#)). The average channel width was 4.8m, the average wetted width was 4.1m and the average gradient was 0.8%. The dominant substrate was fines with gravels subdominant. At top end of the site, the beaver ponds had wetted widths of approximately 12-14m wide and estimated depths of 1m. Habitat value was rated as moderate for salmonid rearing with habitat noted as suitable for coho and cutthroat rearing.

Figure 5.16: Left: Habitat upstream of PSCIS crossing 124500. Right: Habitat upstream of PSCIS crossing 124500.

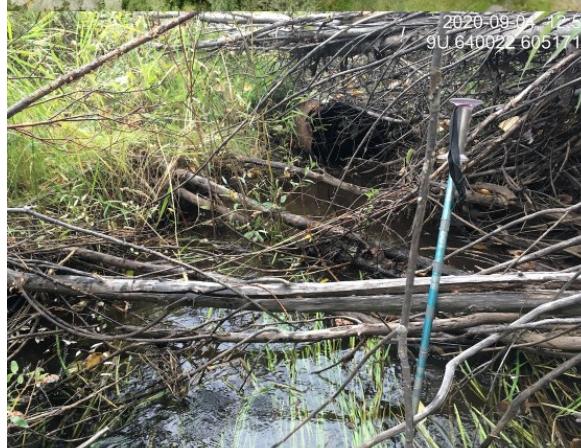
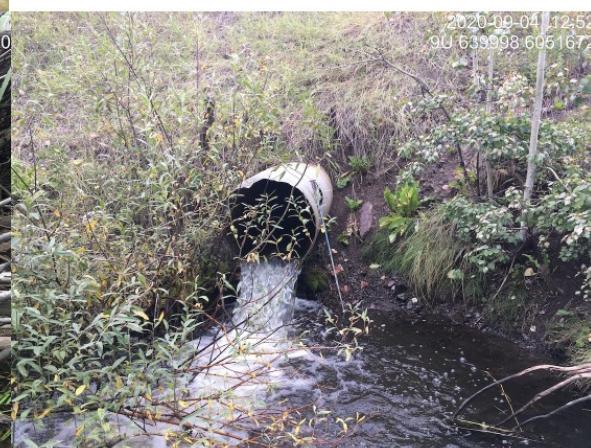
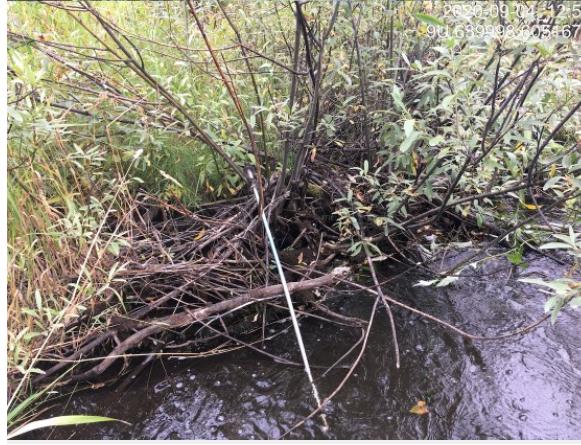
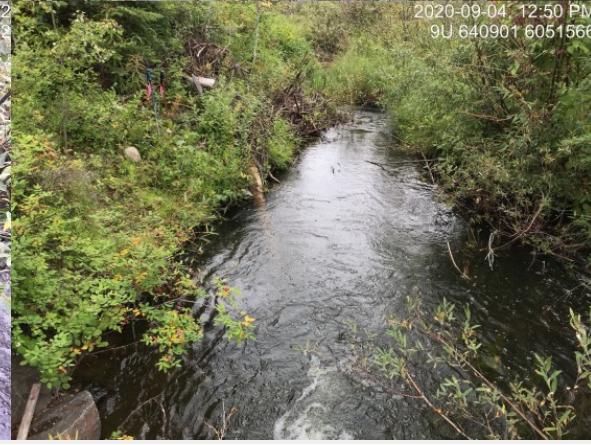
Comments: Flows into Deep Creek downstream. Electrofished upstream and downstream. Wetland type habitat upstream with CO captured below only. Candidate for backwatering?

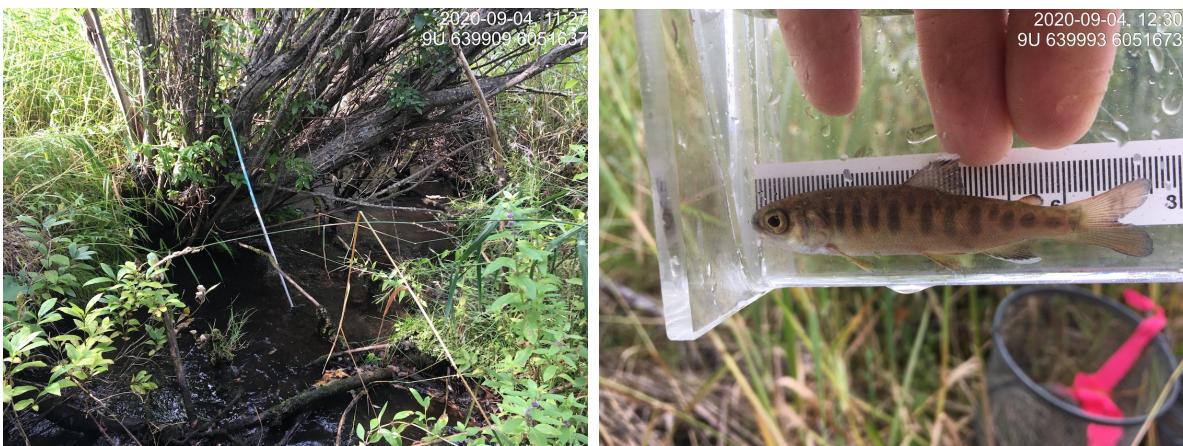
Figure 5.18: Left: Typical habitat downstream of PSCIS crossing 195290. Right: Coho captured downstream of PSCIS crossing 195290.

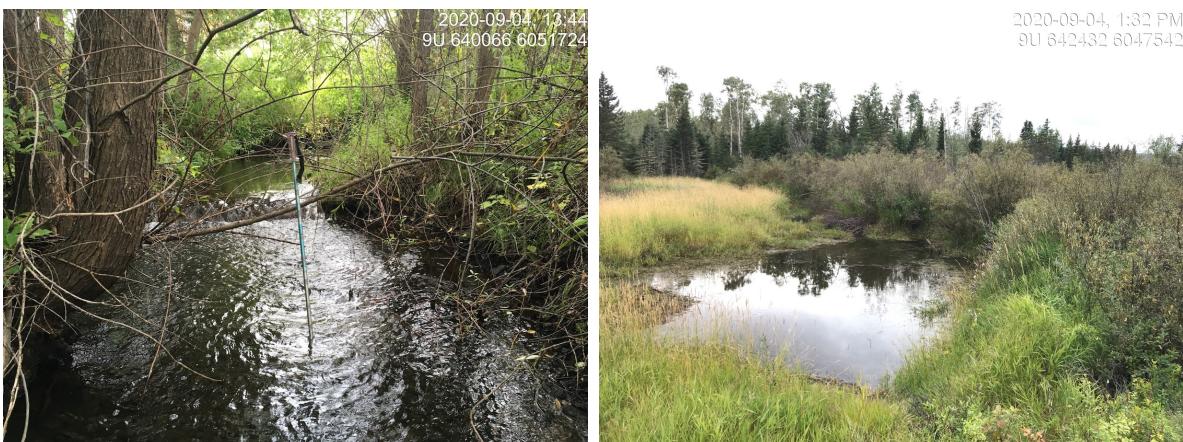
Figure 5.19: Left: Typical habitat upstream of PSCIS crossing 195290. Right: Wetland habitat upstream of PSCIS crossing 195290.

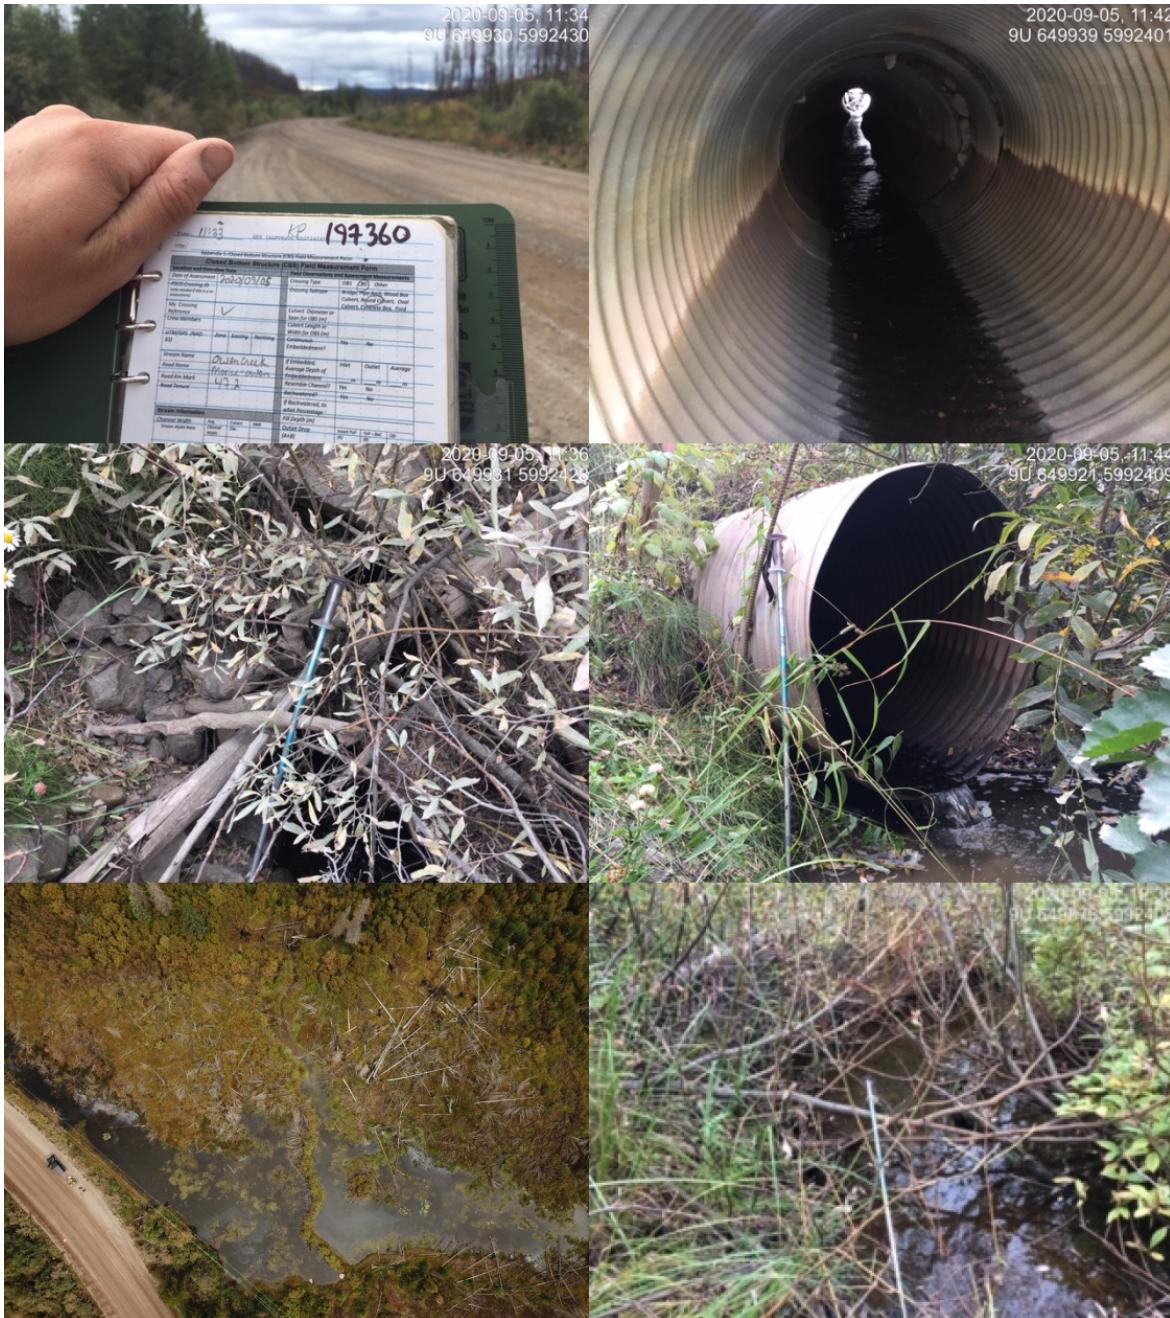
Table 5.37: Summary of fish passage assessment for PSCIS crossing 197669.

Comments: Wetland type habitat for first 300m upstream then 3m wide channel with cover available in all forms with pools suitable for juvenile RB and CO overwintering. Abundant gravels and small cobbles throughout suitable for CO or RB/ST spawning.

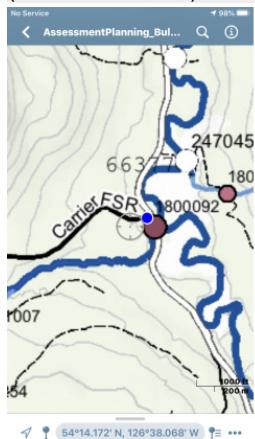
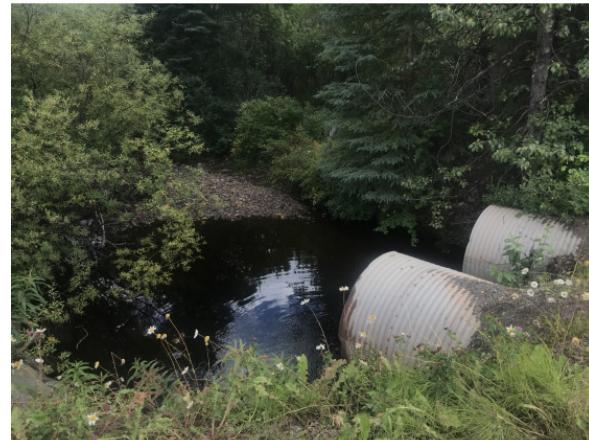
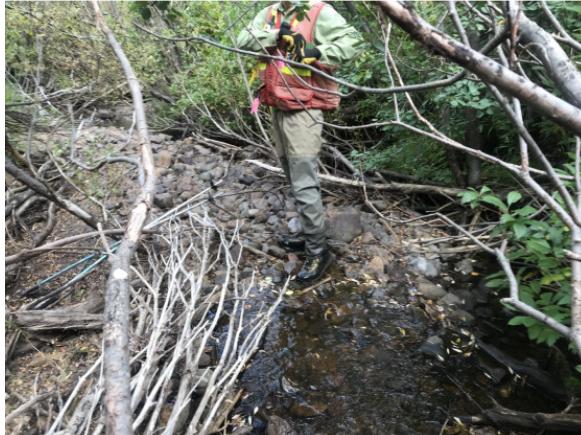
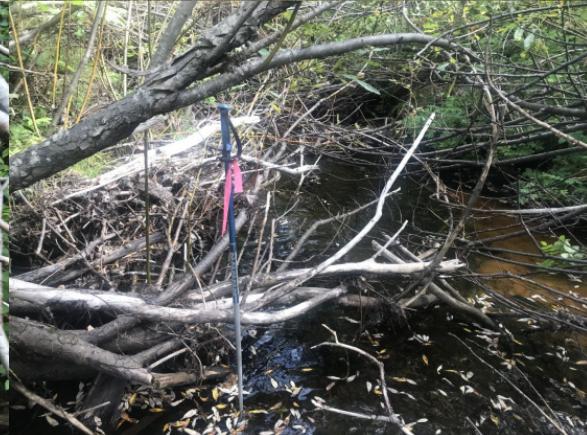
Comments: Large tributary on section of tributary connected to salmon bearing Buck Creek. Fish rising in outlet pool (estimated 130mm). Some cattle access points downstream.

| Location and Stream Data | • | Crossing Characteristics – | |
|---|--|---|---|
| Fix type | Replace with New Open Bottom Structure | Fix Span / Diameter | 10 |

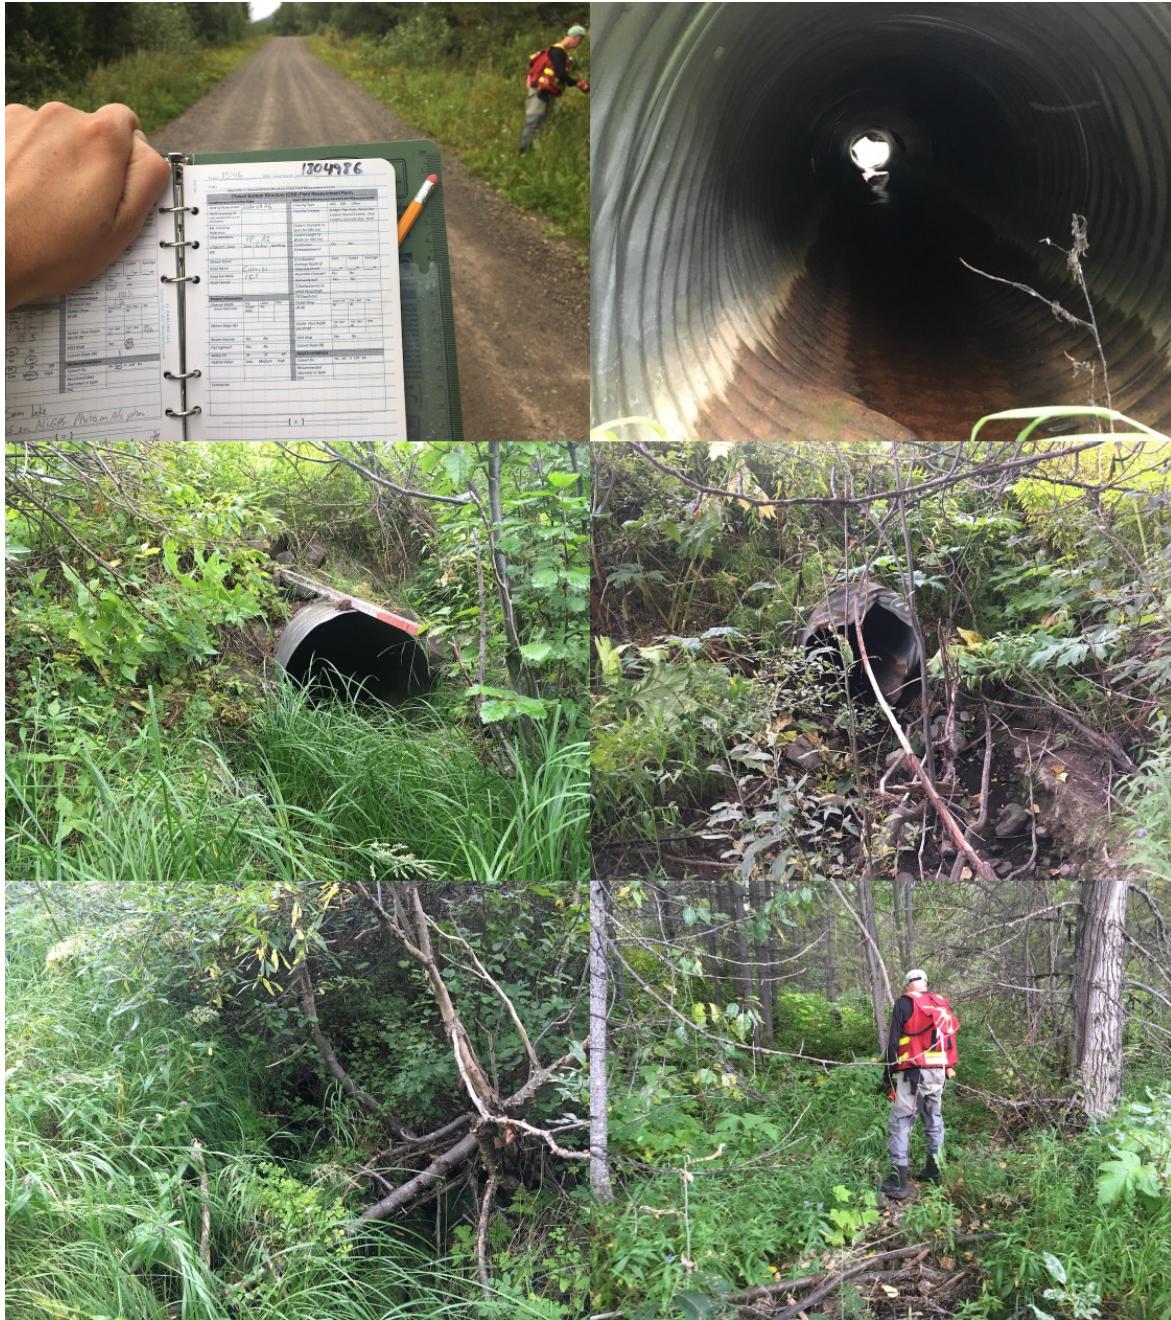
Comments: Suspect no fish. Multiple fish survey sites located downstream. Dry at time of survey.

| Fix type | Replace Structure with Streambed Simulation CBS | Fix Span / Diameter | 3 |

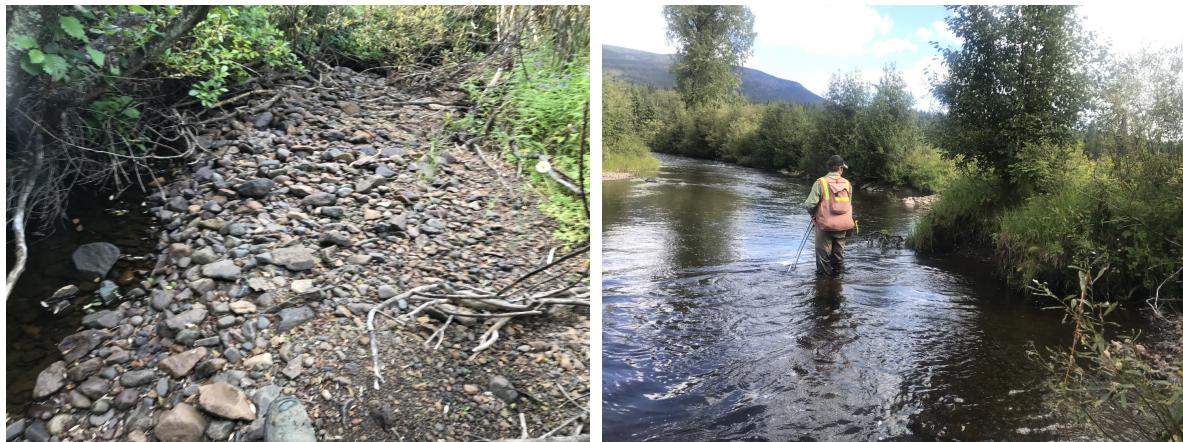
The stream was surveyed downstream from the culvert for 70m to the confluence with Buck Creek (Figure [??](#)). Total cover amount was rated as moderate with undercut banks dominant. Cover was also present as small woody debris, large woody debris, and overhanging vegetation (Table [5.44](#)). The average channel width was 4.6m, the average wetted width was 2.5m and the average gradient was 3%. The dominant substrate was gravels with cobbles subdominant. A fish (130mm) was observed in the culvert outlet pool and a substance suspected to be didymo was noted on the substrate. The habitat was rated as moderate value as it was considered an important migration corridor with habitat of moderate rearing potential for fry and juvenile salmonids.

Figure 5.24: Left: Habitat downstream of PSCIS crossing 197640. Right: Habitat downstream of crossing 197640 at the confluence with Buck Creek.

Replacement of PSCIS crossing 197640 with a bridge (10m span) is recommended. The cost of the work is estimated at \$NA for a cost benefit of NA linear m/\$1000 and NAm²/\$1000.

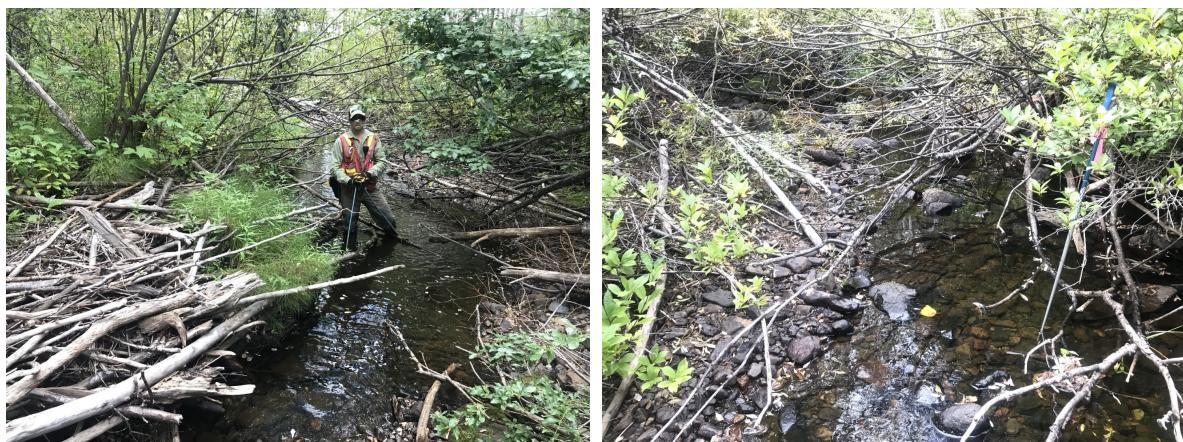
The stream was surveyed immediately upstream from 197640 for approximately 535m (Figure [??](#)). Within the area surveyed, total cover amount was rated as moderate with undercut banks dominant. Cover was also present as small woody debris, large woody debris, boulders, deep pools, and overhanging vegetation (Table [5.44](#)). The average channel width was 4.4m, the average wetted width was 2.2m and the average gradient was 2.5%. The dominant substrate was cobbles with boulders subdominant. Rare pockets of gravel suitable for spawning resident, fluvial and anadromous salmonids were noted. The stream appeared to be aggraded with side bars common. One salmonid (110mm - unidentified species) was observed just upstream of Buck Flats Road. Habitat value was rated as moderate value with moderate rearing potential for fry and juvenile salmonids.

A conservative estimate of mainstem habitat upstream of crossing 197640 is 4.2km to the top end of a 71ha wetland where rainbow trout have been recorded. Habitat in the areas surveyed upstream of the culvert were rated as moderate value for salmonid rearing with areas of wetland habitat likely suitable for rainbow trout, coho and steelhead rearing. Buck Flats Road is the responsibility of the Ministry of Transportation and Infrastructure. The crossing was ranked as a high priority for proceeding to design for replacement.

Figure 5.25: Left: Habitat upstream of PSCIS crossing 197640. Right: Habitat upstream of PSCIS crossing 197640.

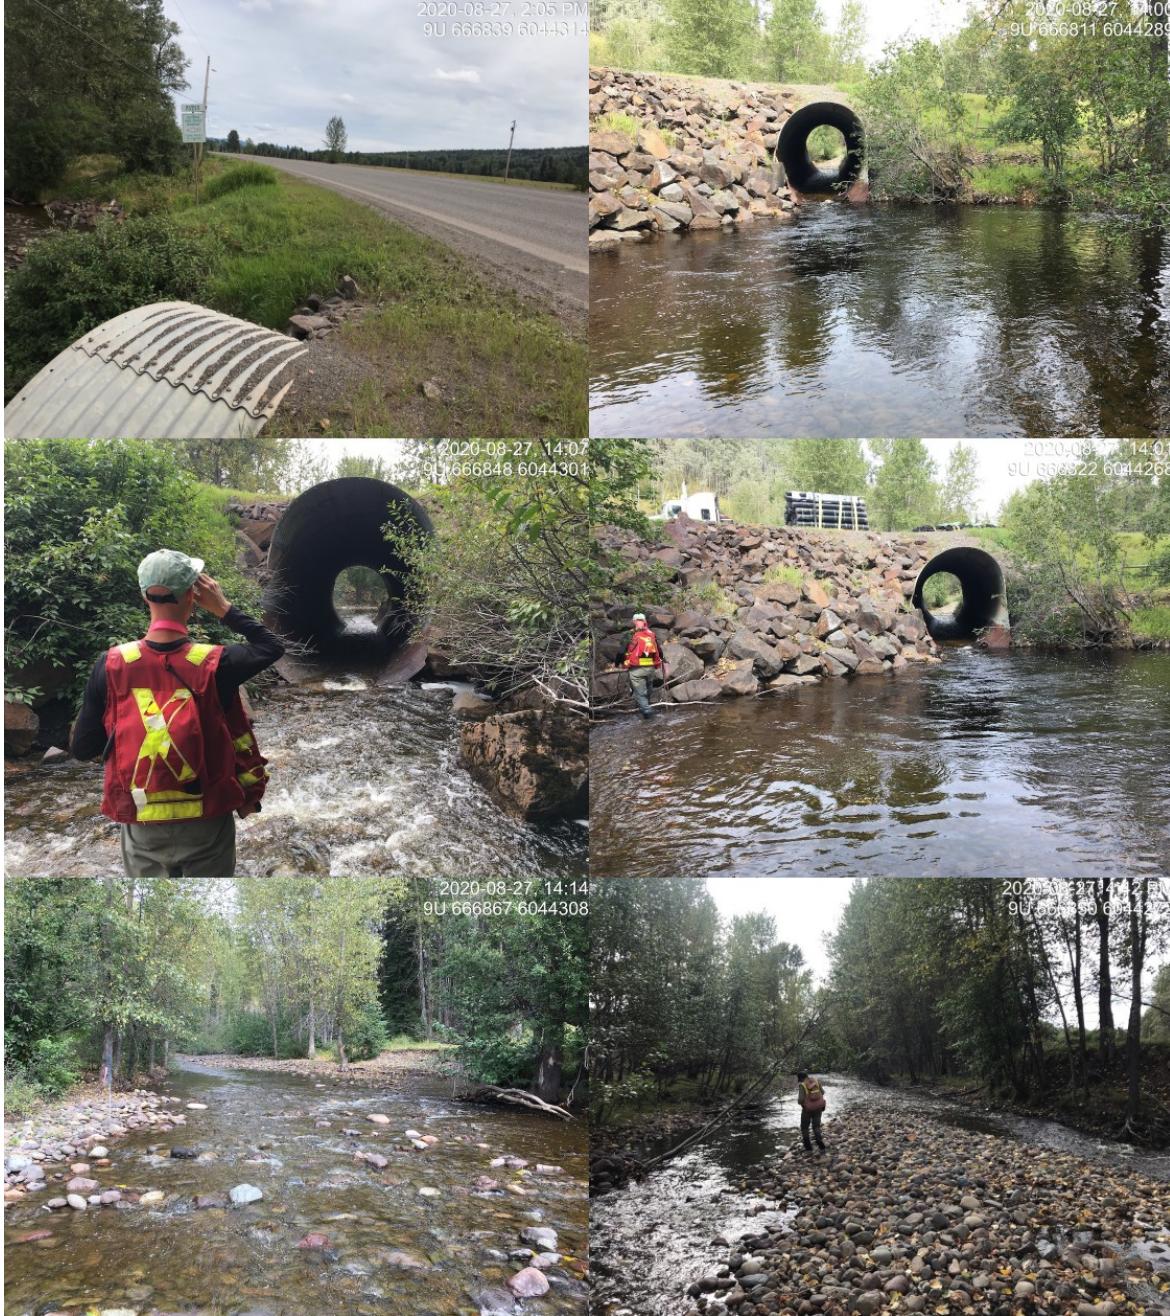
Table 5.47: Summary of habitat details for PSCIS crossing 197658.

Comments: Culvert is likely as passable for most species and life stages at most non-peak and non-lowest flows.
Streamkeepers have observed fry moving through culvert in overwintering studies.

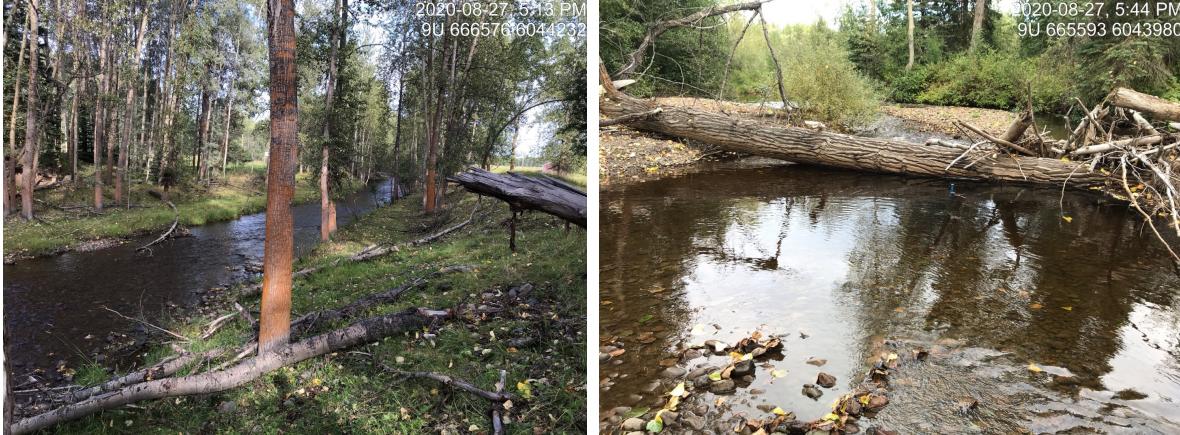
Below the railway bridge, the habitat was noted as far more complex than the area immediately below the highway culvert. Total cover amount was rated as abundant with overhanging vegetation dominant. Cover was also present as small woody debris, large woody debris, undercut banks, and deep pools. The average channel width was 8.6m, the average wetted width was 7.5m and the average gradient was 0.8%. The dominant substrate was cobbles with gravels subdominant. There were extensive sections of channel with deep glides (50-70 cm deep at the time of survey) with well developed riparian vegetation creating good structure for all species and life stages of salmonids. An algae layer was noted on the substrate. There were abundant large gravels and small cobbles present suitable for salmon spawning.

Figure 5.26: Left: Typical habitat immediately downstream of PSCIS crossing 197658. Right: Typical habitat downstream of crossing 197658 below the railway bridge and adjacent to the Bulkley River mainstem.

Structure replacement with a bridge (15.1m span) is recommended to provide access to the habitat located upstream of PSCIS crossing 197658. The cost of the work is estimated at \$7,550,000 for a cost benefit of 0.8 linear m/\$1000 and 10.3m²/\$1000.

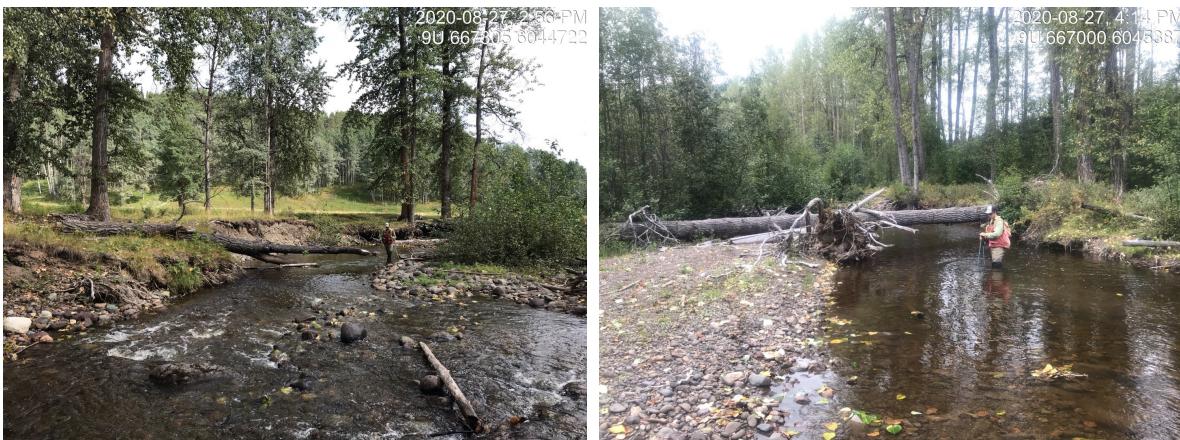
The stream was surveyed upstream from 197658 for 1400m (Figure 5.27). Within the area surveyed, total cover amount was rated as moderate with deep pools dominant. Cover was also present as small woody debris, large woody debris, boulders, undercut banks, and overhanging vegetation (Table 5.47). The average channel width was 12.9m, the average wetted width was 7.9m and the average gradient was 2.1%. The dominant substrate was cobbles with boulders subdominant. Within the area surveyed, riparian areas adjacent to both banks were used as rangeland with several cattle access points on the stream and evidence of understory shrub degradation from cattle grazing. The large stream had high habitat complexity including numerous pools up to 2m deep and frequent glide sections to 1m deep throughout. There were extensive areas of gravel suitable for spawning for resident and anadromous salmonid species. Habitat value was rated as high for resident and anadromous salmonid rearing and spawning.

Figure 5.27: Left: habitat upstream of PSCIS crossing 197658. Right: Habitat upstream of PSCIS crossing 197658.

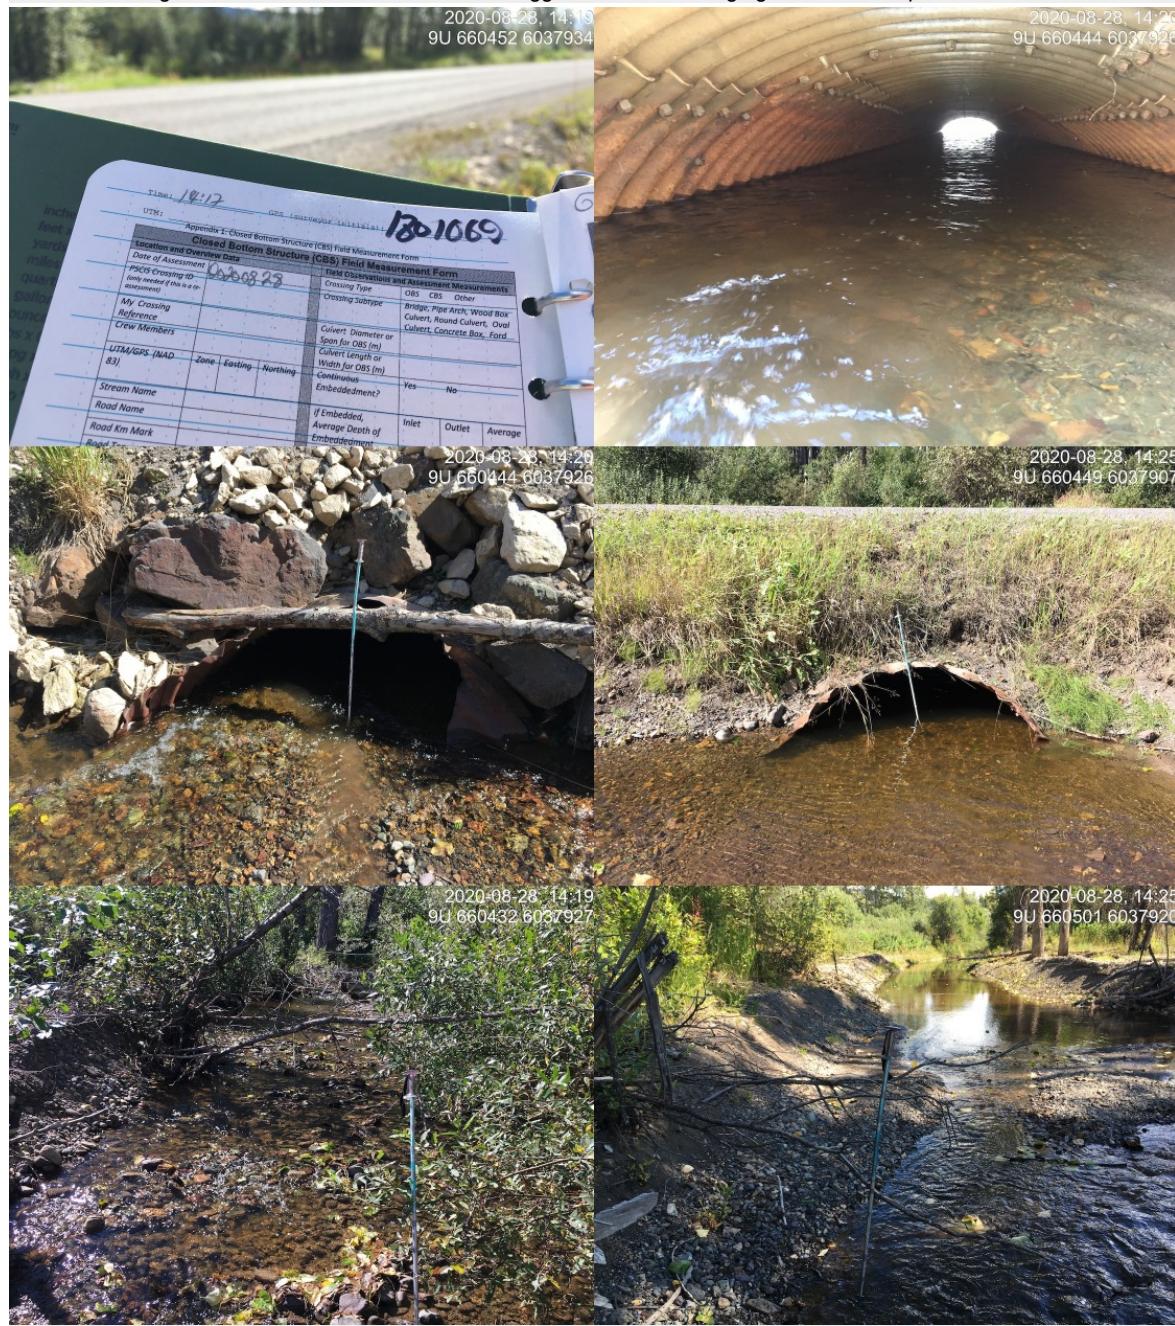
Comments: Habitat confirmation completed.

Comments: Targeted for habitat confirmation due to aggradation and dredging associated impacts on coho.
