Bulkley River and Morice River Watershed Groups Fish Passage Restoration Planning

Prepared for
Habitat Conservation Trust Foundation - CAT21-6-288
BC Fish Passage Remediation Program
Canadian Wildlife Federation

Prepared by
Al Irvine, B.Sc., R.P.Bio.
New Graph Environment
on behalf of
Society for Ecosystem Restoration Northern BC

Version 0.1.0
2021-04-14

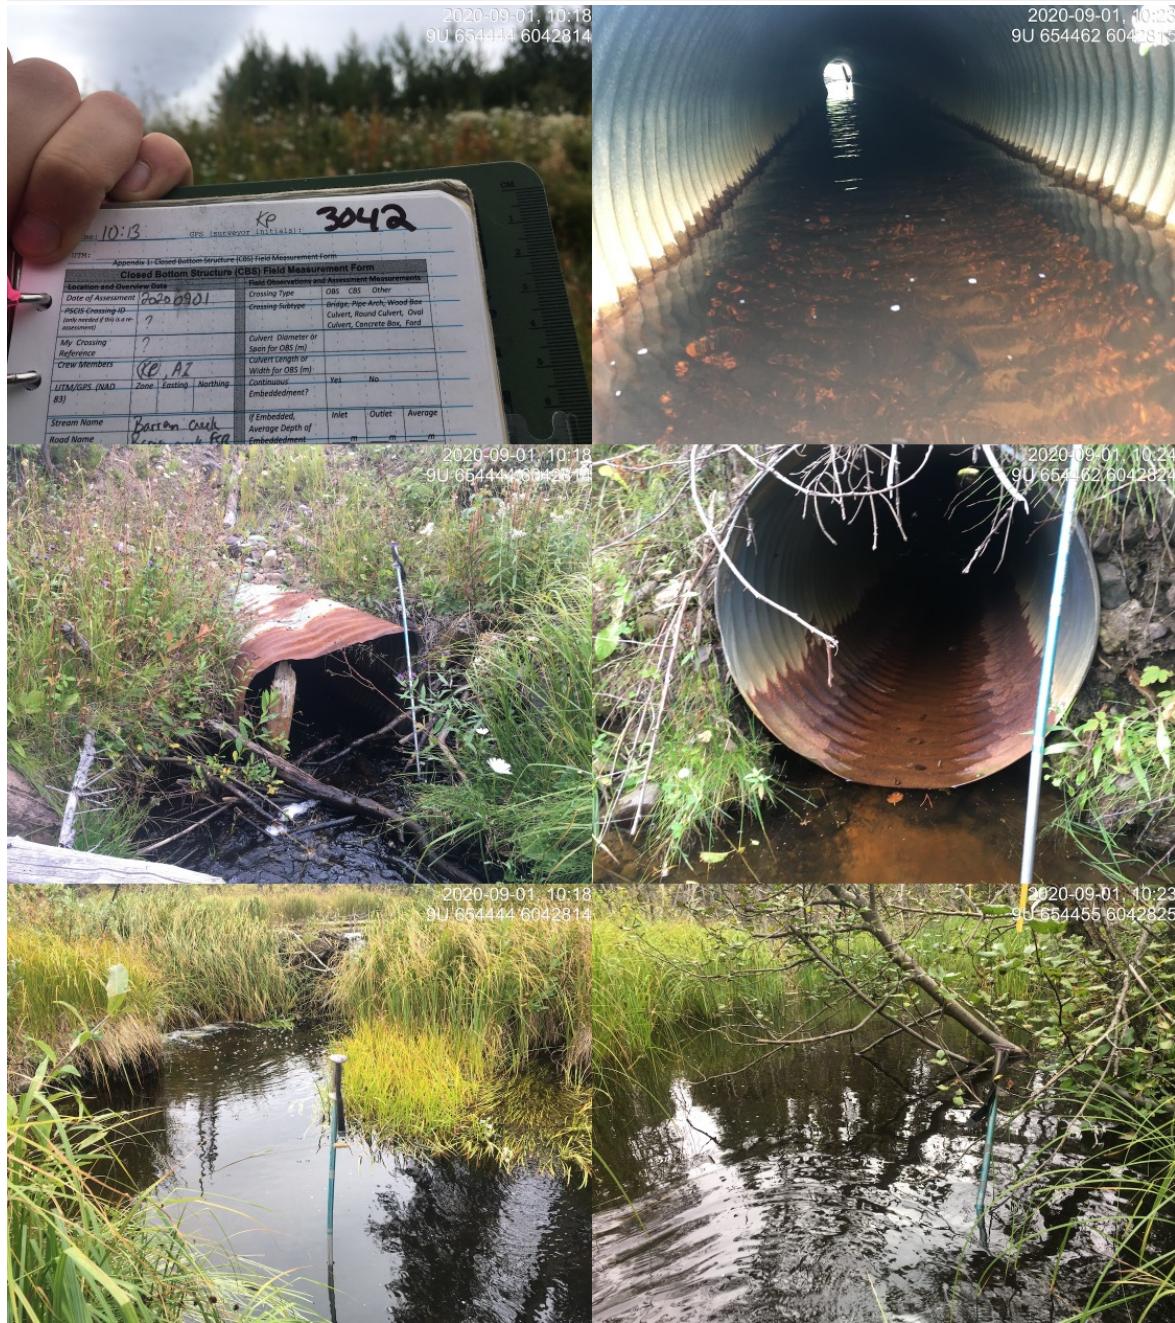
Comments: Beaver influenced stream with lake upstream.

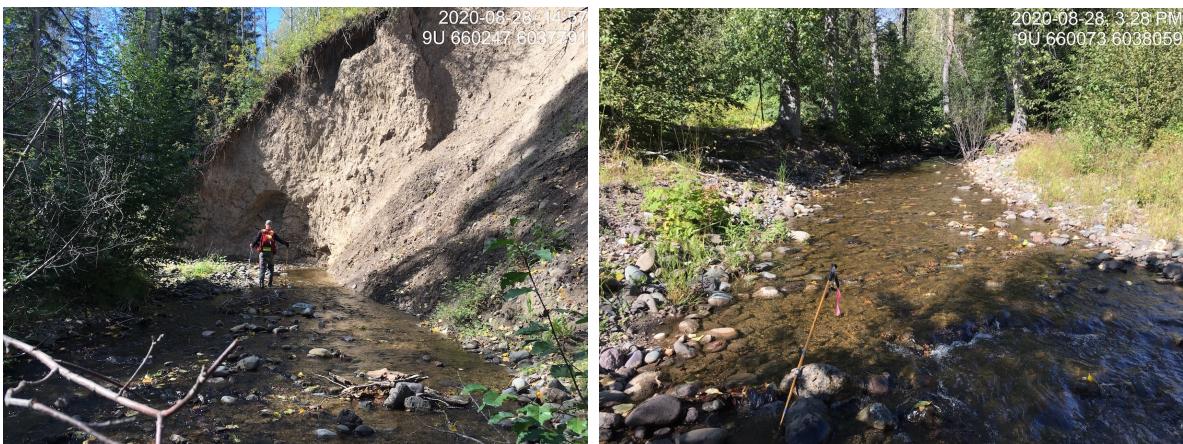
Barren Creek was surveyed upstream from 197664 for 800m (Figure 5.38). Within the area surveyed, total cover amount was rated as moderate with undercut banks dominant. Cover was also present as small woody debris, large woody debris, and overhanging vegetation (Table 5.65). The average channel width was 7.2m, the average wetted width was 4.7m and the average gradient

Figure 5.38: Left: Habitat upstream of PSCIS crossing 197664 and location of cutslope. Right: Habitat upstream of PSCIS crossing 197664.

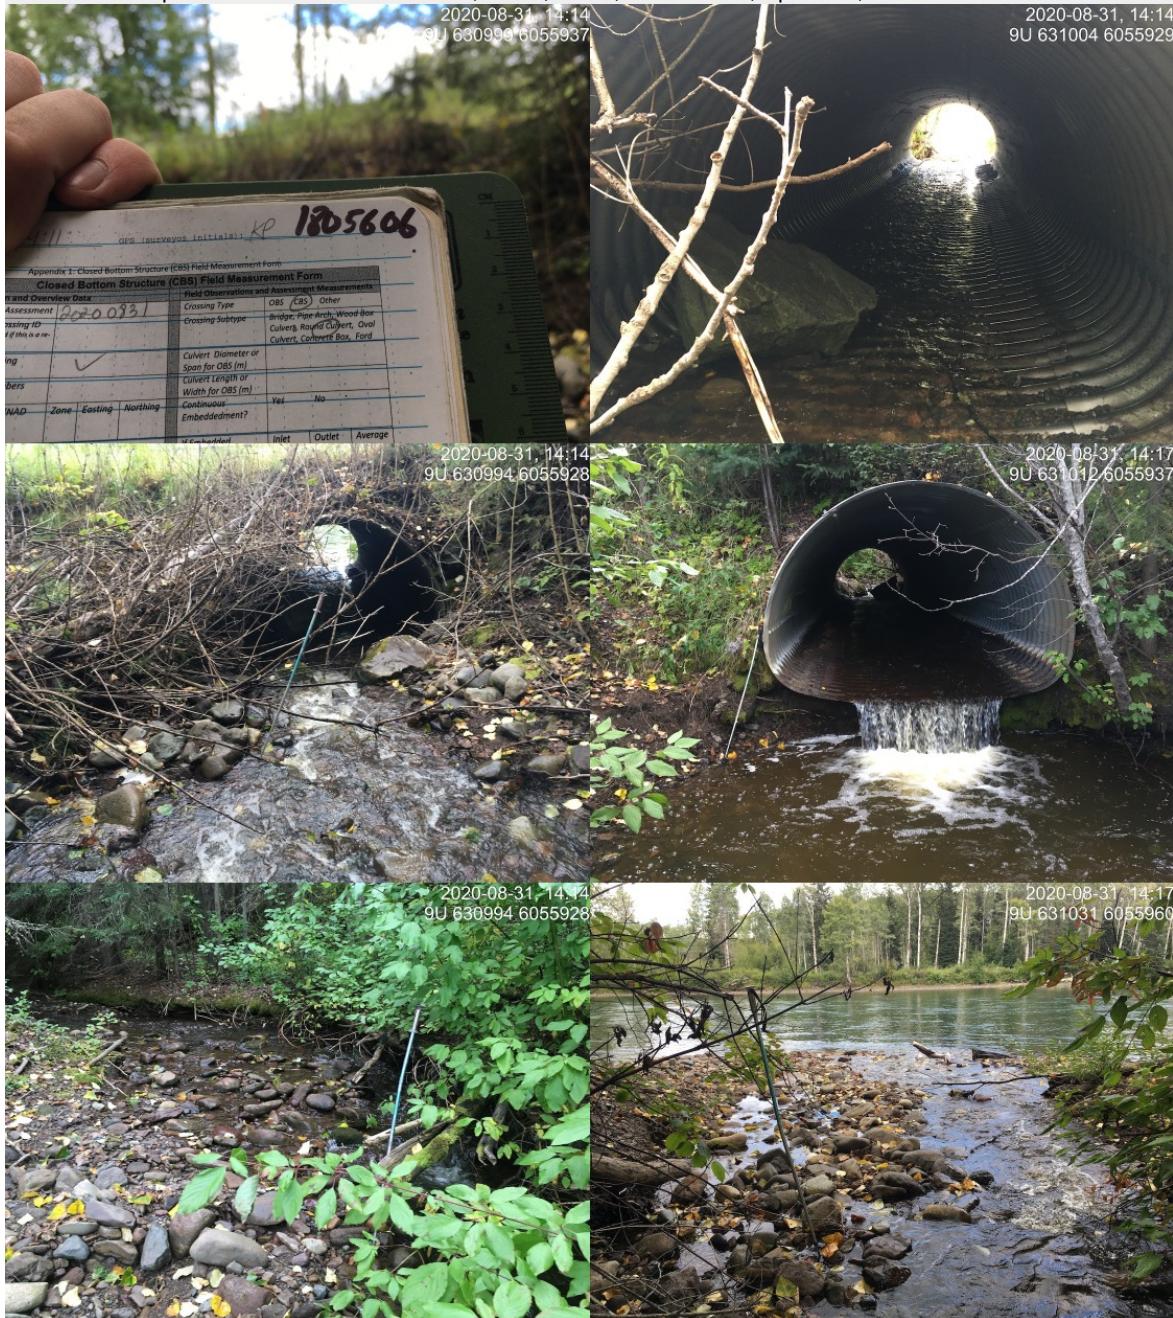
Comments: Approximately 17m from the outlet to the Bulkley River.
